## RDCK FLOODPLAIN AND STEEP CREEK STUDY

# Cooper Creek

**Final**  
**March 31, 2020**

BGC Document No.:  
**RDCK2-SC-007F**

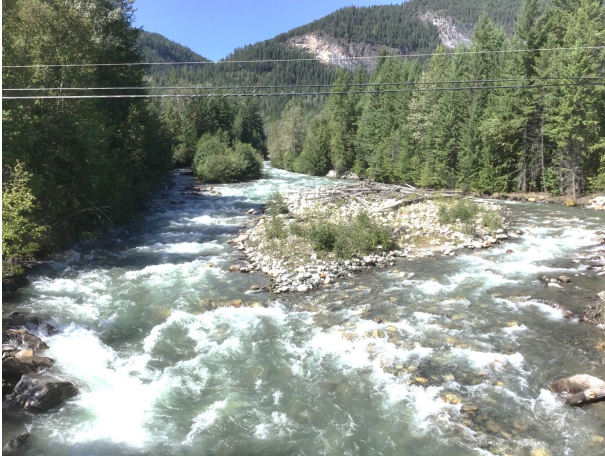
**A) On Cooper Highway Bridge looking upstream.**

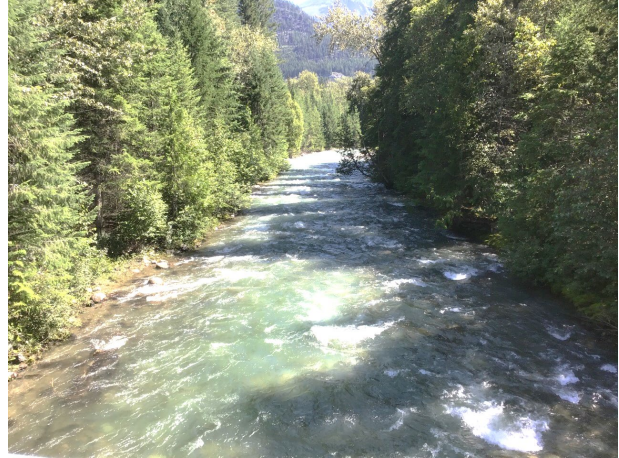
**B) On Cooper Highway Bridge looking downstream.**

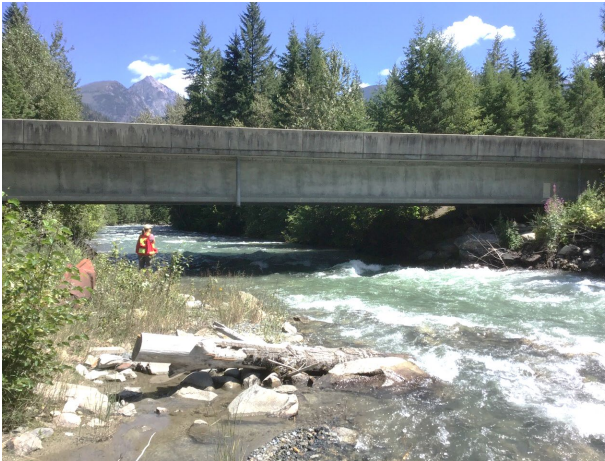
**C) Looking at Cooper Highway Bridge from upstream left bank.**

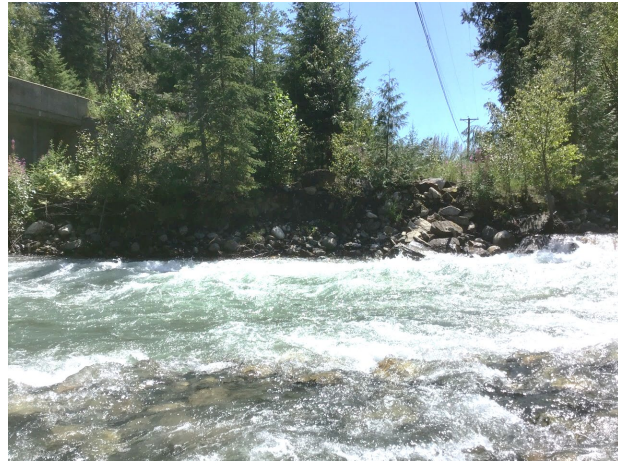
**D) On upstream left bank looking across at riprap on right bank, upstream of Cooper Highway Bridge.**

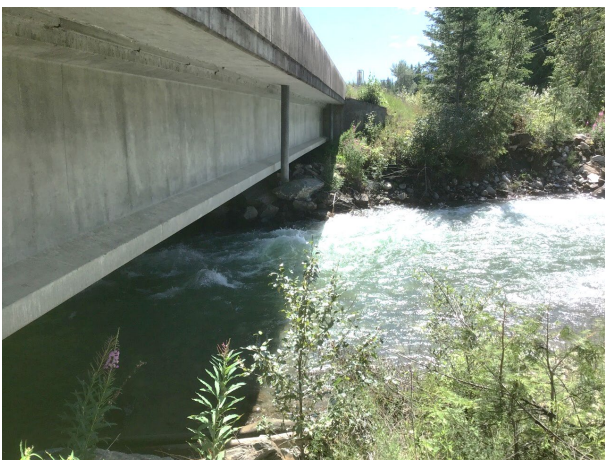
**E) Looking at Cooper Highway Bridge from the left (north) bank on upstream side.**

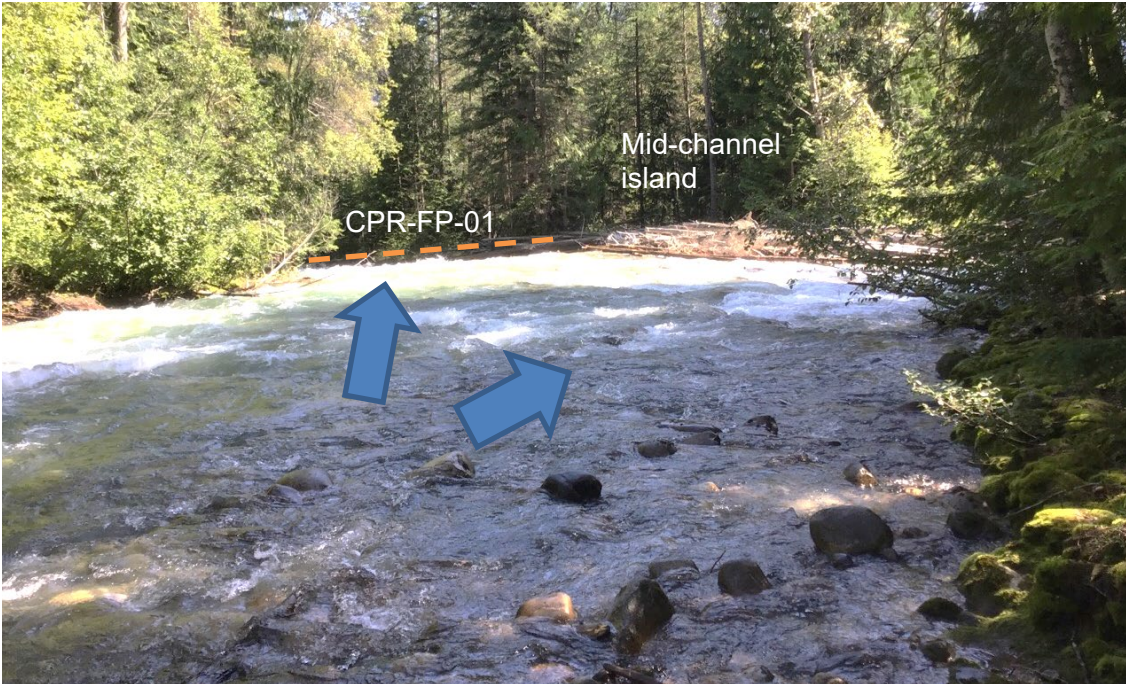
A) Location of CPR-FP-01 dike, 600 m upstream of Highway 31 bridge crossing on the left bank of the creek.

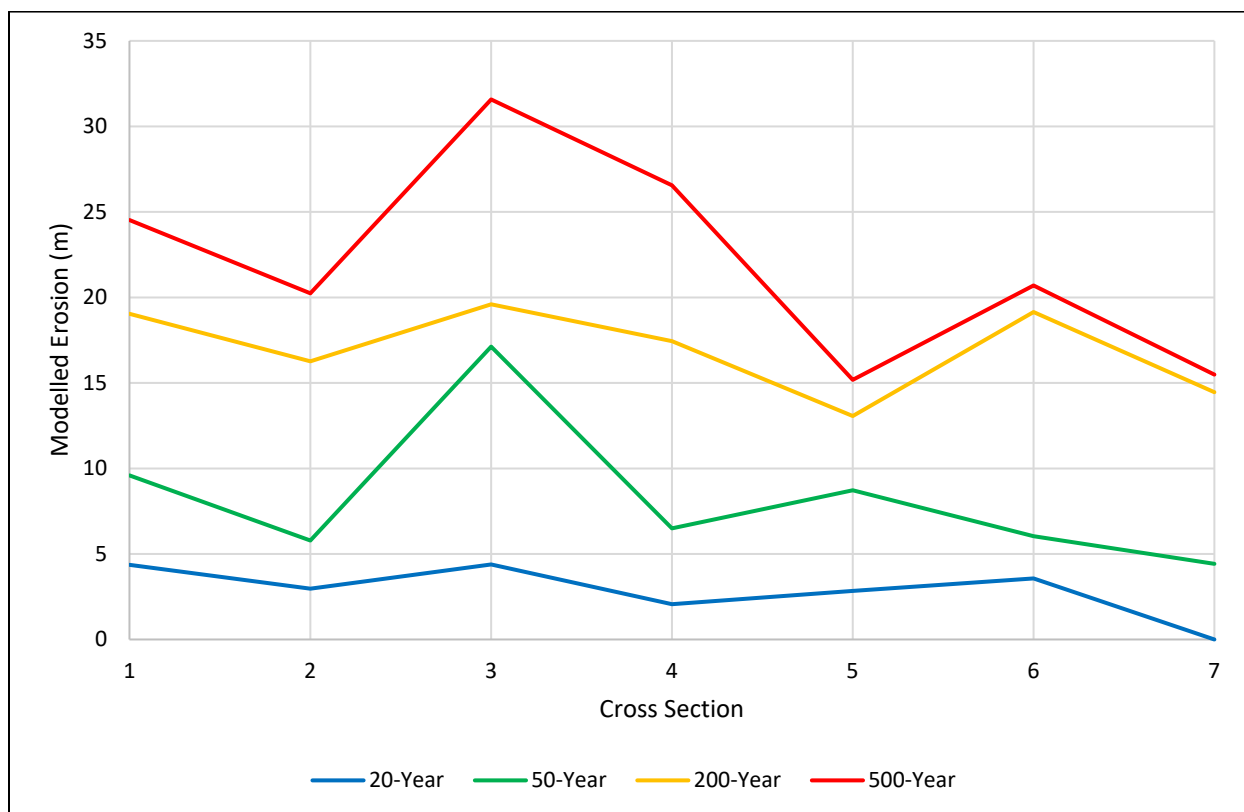
Figure 6-2 shows the 50% percentile modelled bank erosion at each cross-section. The predicted erosion differs between cross-sections based on the cross-section characteristics (e.g., channel geometry, channel slope,  $D_{84}$  grain size). Erosion peaks at cross-section 3 for all return periods, as the gradient is higher at cross-sections 3 and 4 (see Drawing 02A, 02B for locations) than at the remaining cross sections. The larger channel width at cross-section 4 limits the potential for erosion relative to cross-section 3. This pattern is consistent with the air photo assessment which has showed the greatest erosion at cross-section 3 in both in the pre- and post-channelization periods. The predicted erosion has the potential to impact the abutments of the Highway 31 bridge, but no properties are likely to be affected. Cross-section 7, which has a wide channel geometry and low gradient, has the lowest predicted erosion for all return periods except the 200-year event.

**Figure 6-2. Cooper Creek 50<sup>th</sup> percentile bank erosion model results at each cross-section.**

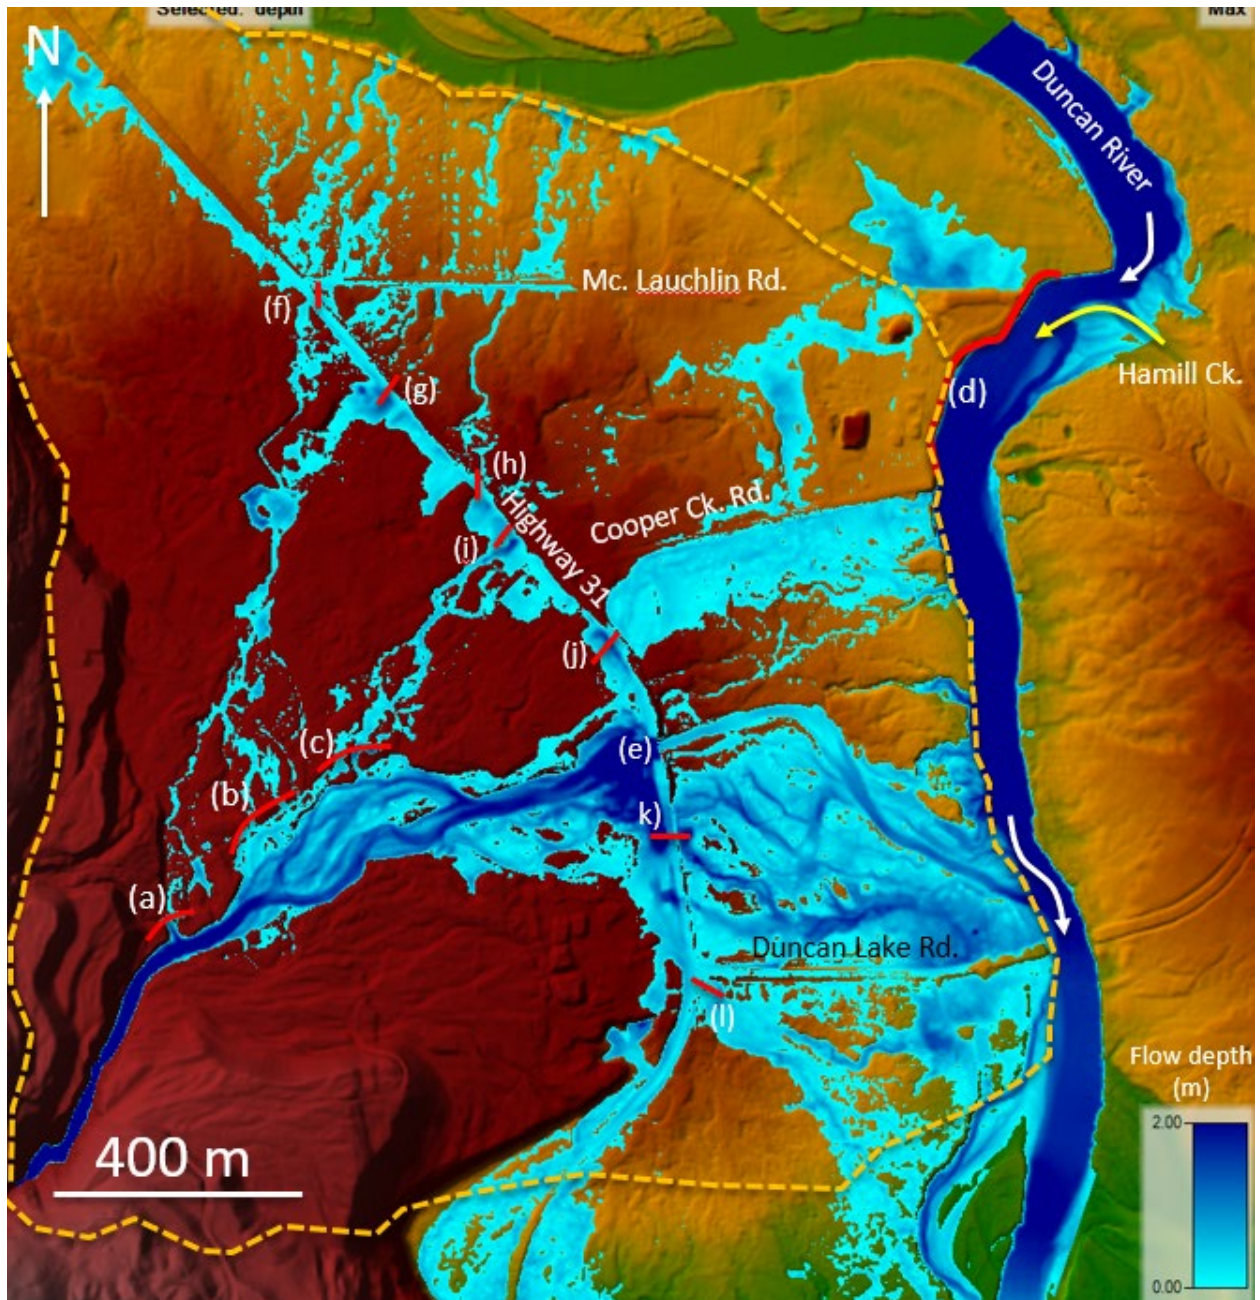
Figure 7-1. Flood inundation map showing flow depths for a 500-year return period clear-water flood on Cooper Creek and conceptual-level mitigation options for Cooper Creek fan. Note that these options have not been tested by numerical modelling and only serve as an impetus for further discussion. Other options will likely be developed at the conceptual design level.

Mitigation Option	Description
a, b, c	Deflection berms along the northern portion of upper Cooper Creek to avoid avulsions to the northern fan sector
d	Bank erosion protection for Hamill Creek-related erosion on the west side of Duncan River
e	Bank protection upstream of Highway 31 bridge abutment to avoid outflanking
f, g, h, i, j, k, l	Relief culverts beneath Highway 31 to avoid upstream ponding, overtopping and highway erosion.

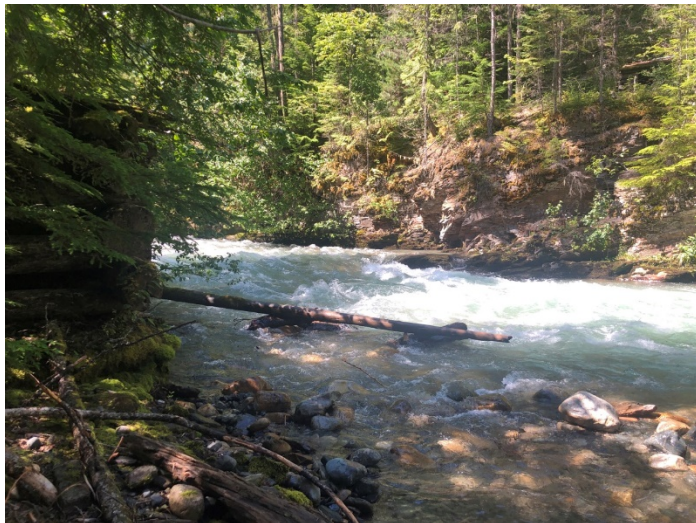
**Photo 7.**  
**Standing on the right (south) bank bar looking upstream (flow is left to right) at Cooper Creek, approximately 150 m downstream of the fan apex. Note the bedrock exposure on the left bank across the creek. Photo: BGC, July 25, 2019.**

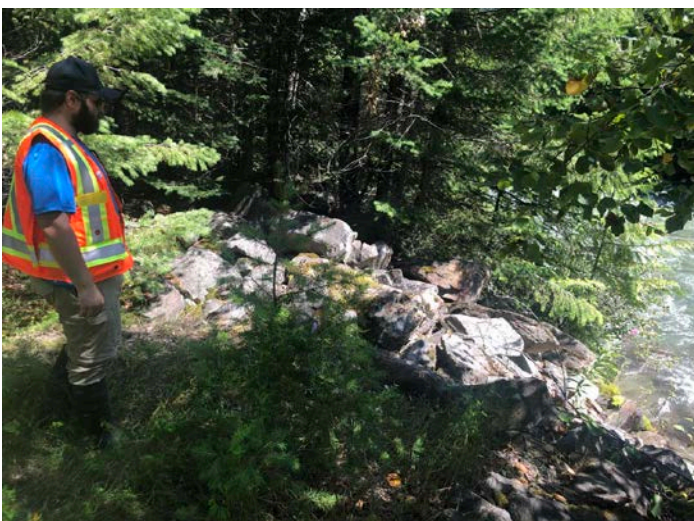
**Photo 14.**  
**Standing immediately downstream of the Highway 31 bridge on the left (north) bank looking at the riprap.**  
**Photo: BGC, July 25, 2019.**

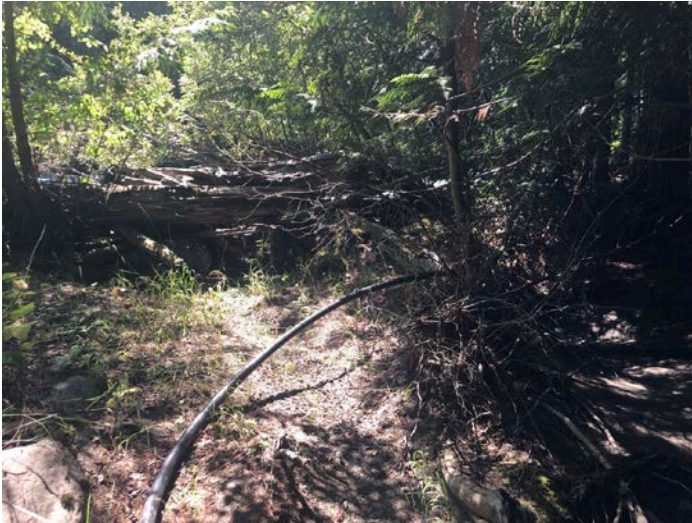
**Photo 15.**  
Standing on the left (north) bank of Cooper Creek looking at large woody debris blocking historical overflow channel. Sand is visible on channel bed, indicating recent flow; however, vegetation has re-established in channel. Location is approximately 150 m downstream of the Cooper Creek Highway bridge. Photo: BGC, July 25, 2019.

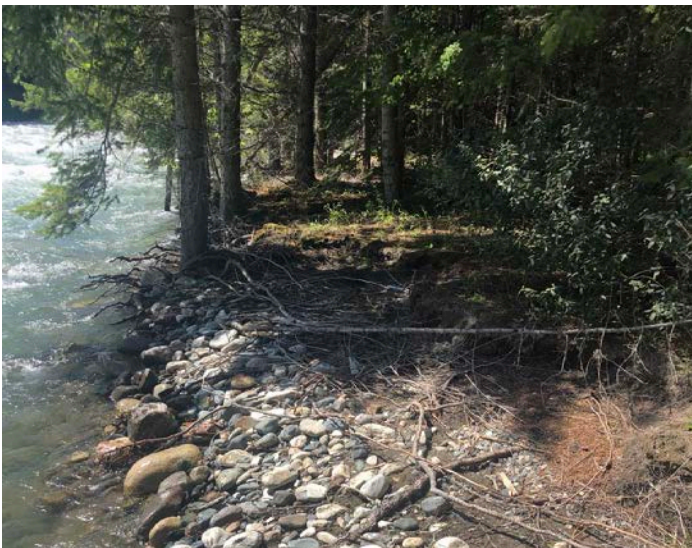
**Photo 16.**  
Standing on the left (north) bank of Cooper Creek looking upstream at bank erosion, approximately 200 m downstream of the Cooper Creek Highway bridge. Photo: BGC, July 25, 2019.

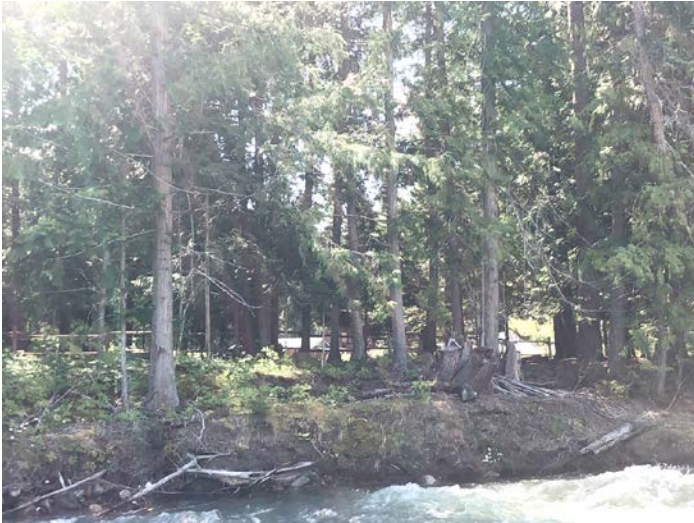
**Photo 20.**  
Standing on the left bank bar looking across to right bank (flow is right to left) at bank erosion approaching fence line, approximately 300 m upstream of the mouth. Photo: BGC, July 25, 2019.

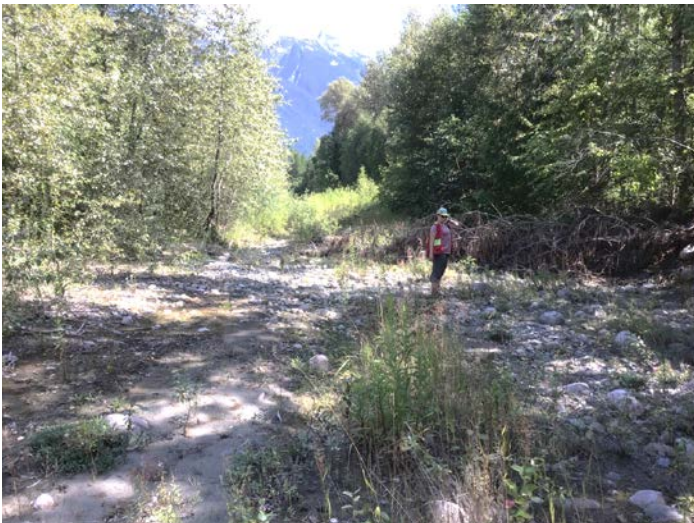
**Photo 21.**  
Standing in dry previous creek channel to the north of Cooper Creek looking downstream, approximately 300 m upstream of the mouth. Photo: BGC, July 25, 2019.
