RDCK FLOODPLAIN AND STEEP CREEK STUDY

Duhamel Creek

Final
March 31, 2020

BGC Document No.:
RDCK2-SC-008F

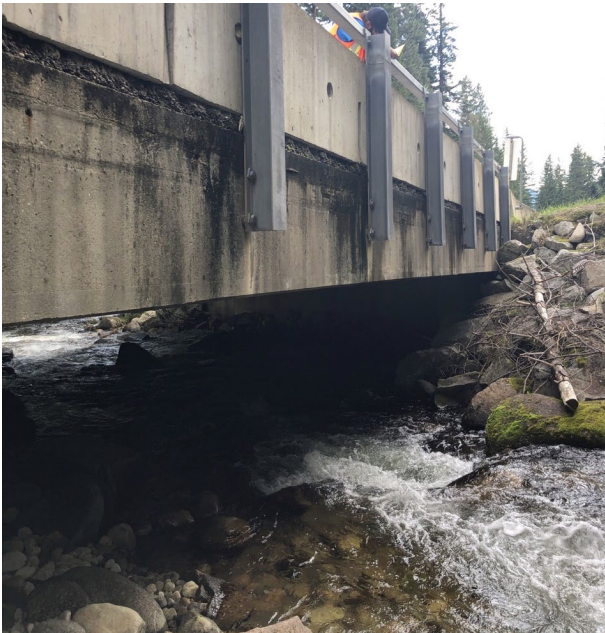
C) On upstream left bank looking at right bank riprap armoring under Duhamel Highway 3A West Bridge crossing the western channel.

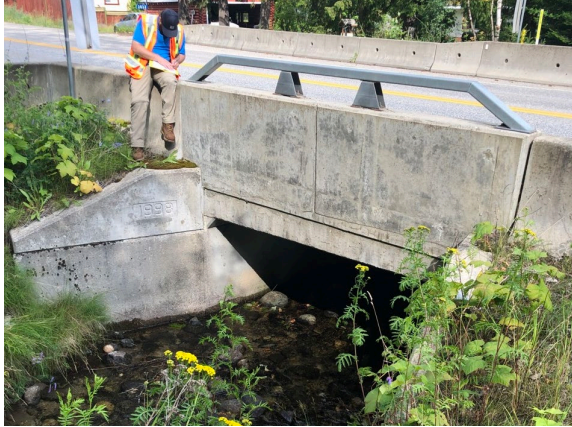
A) Looking downstream at Duhamel Highway 3A East Bridge.

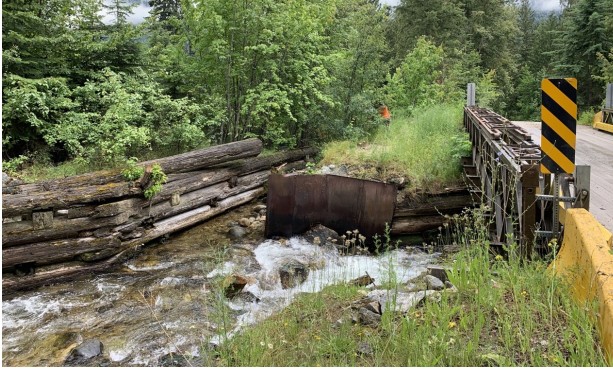
A) Looking downstream (south) at DHL-FP-01 (on the left) and DHL-FP-03 (bifurcation structure "V") with Duhamel Creek Road Bridge on the right.

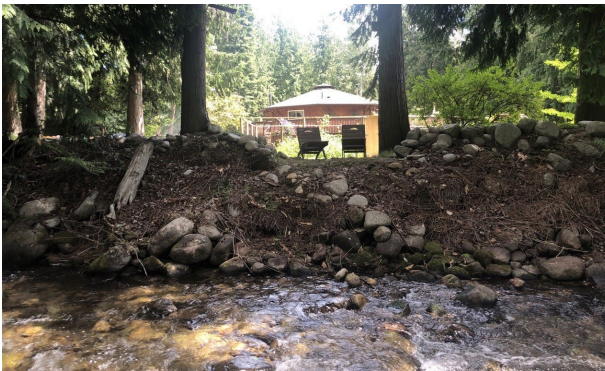
C) DHL-FP-06: Berm constructed of sub-rounded cobbles and old concrete foundation approximately 1.5 m high on left bank approximately 80 m upstream of Lower 6 Mile Road on the western channel.

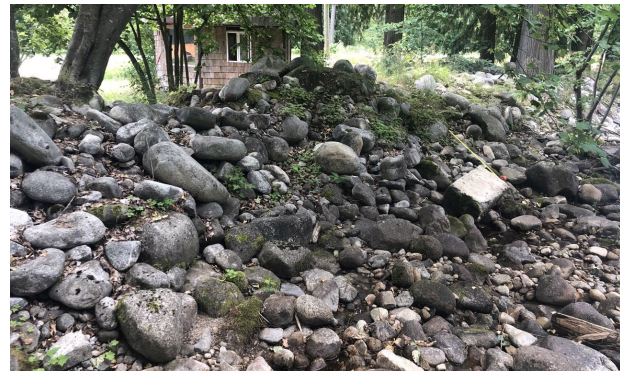
D) DHL-FP-06: Berm constructed of sub-rounded cobbles and old concrete foundation approximately 40 m upstream left bank of Lower 6 Mile Road on the western channel.

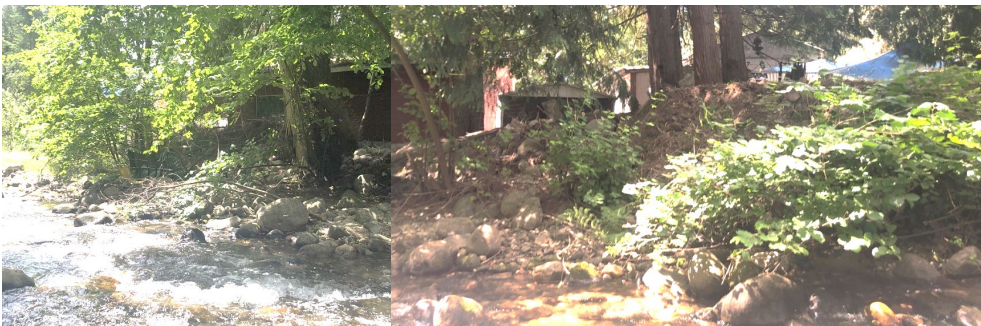
E) DHL-FP-07: Low point on the right bank approximately 80 m upstream of Lower 6 Mile Road on the western channel.

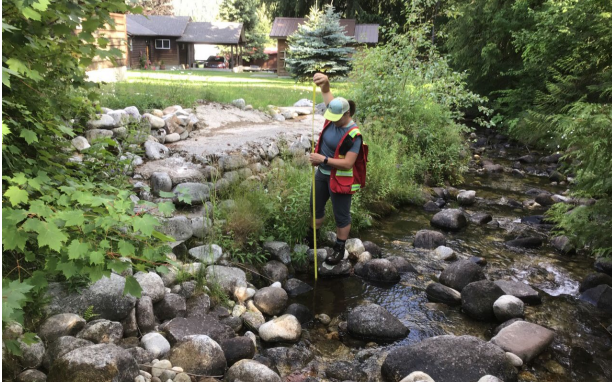
A) DHL-FP-10: Concrete wall on left bank, approximately 30 m downstream of bifurcation structure looking downstream.

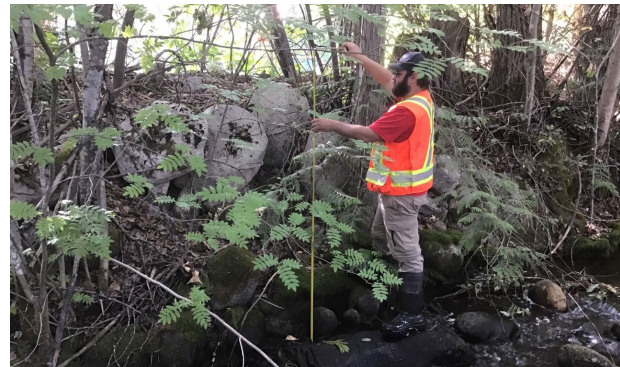
D) DHL-FP-11: Approximately 80 m upstream of Highway 3A looking at left bank with 1 m boulders. Similar sized material was observed on right bank (DHL-FP-10).

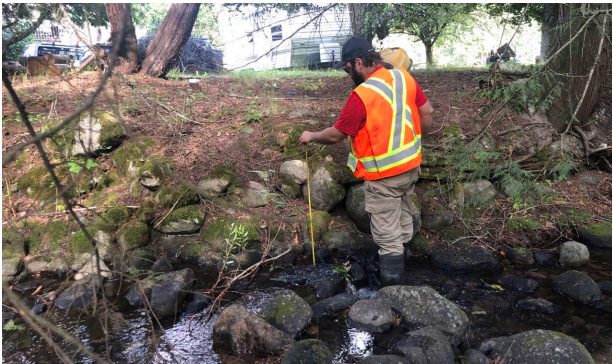
E) DHL-FP-10: Looking at left bank, approximately 70 m upstream of Highway 3A.

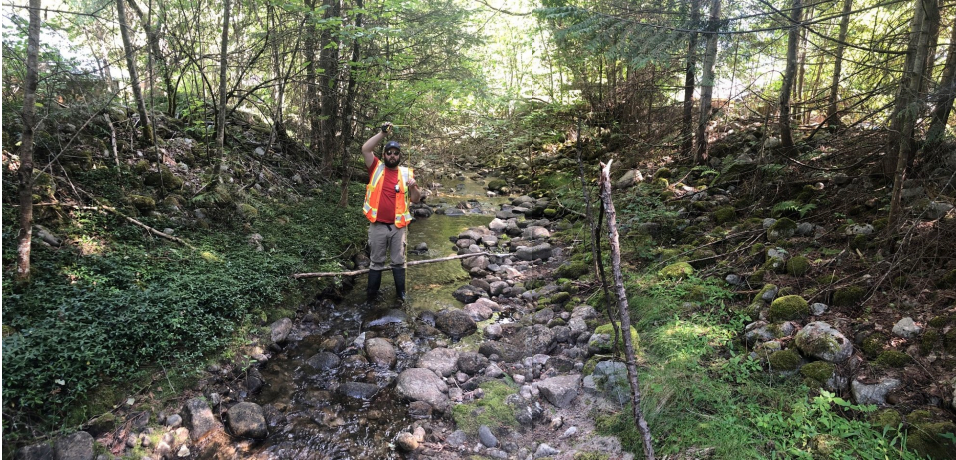
A) DHL-FP-15 & 16: In the channel, approximately 40 m downstream of Lower 6 Mile Road, looking upstream. Berms on both banks are approximately 2 m to 2.5 m tall.

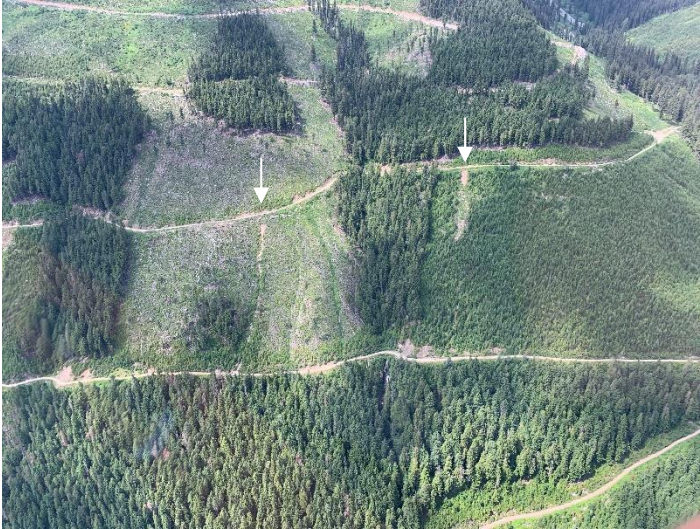
Photo 8.
Overview photo taken during helicopter overflight looking west and down at recent debris avalanches (indicated with arrows) upslope of Duhamel Creek approximately 8.5 km upstream of lake outlet. Photo: BGC, July 6, 2019.

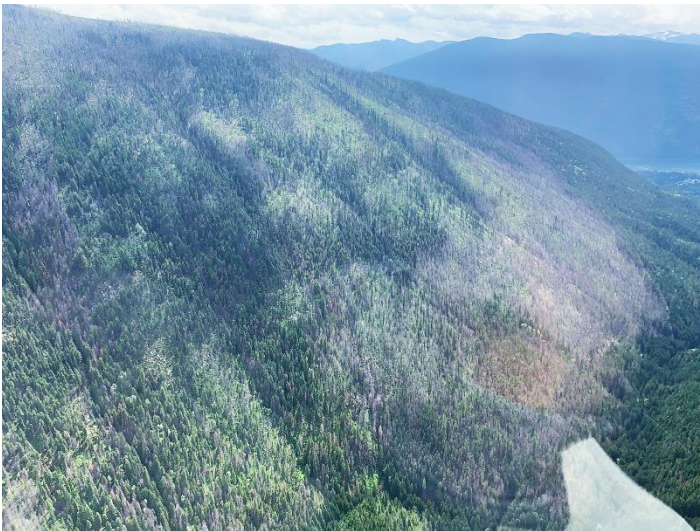
Photo 11.
Overview photo taken during helicopter overflight looking southeast at forest that burned in 2015 on eastern slope of Duhamel Creek, approximately 6 km upstream of lake outlet. Photo: BGC, July 6, 2019.

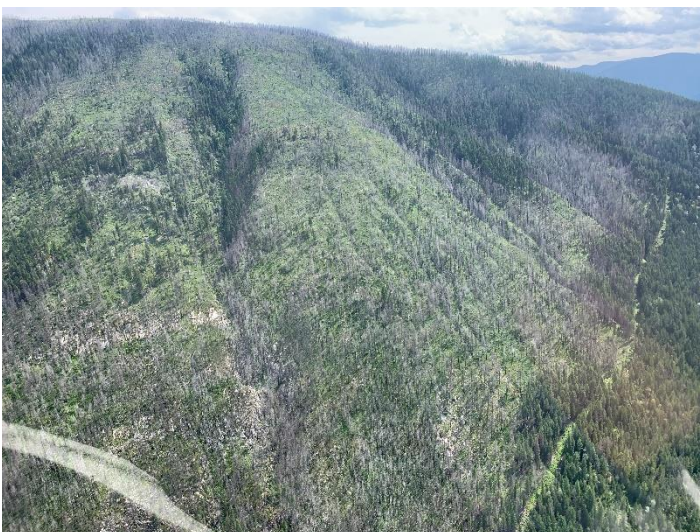
Photo 12.
Overview photo taken during helicopter overflight looking east at forest that burned in 2015 on eastern slope of Duhamel Creek, approximately 3.8 km upstream of lake outlet. Note the surficial erosion and erosion riling in the burned area, and the man-made firebreak to the right of the photo. Photo: BGC, July 6, 2019.

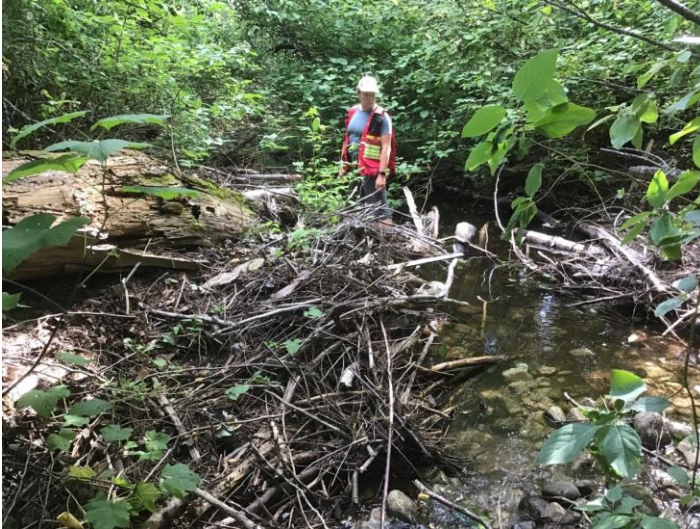
Photo 13.
Debris piled up on the Duhamel Creek banks approximately 100 m upstream of the east outlet to Kootenay Lake. Photo: BGC July 27, 2019.
