## RDCK FLOODPLAIN AND STEEP CREEK STUDY

# Redfish Creek

**Final**  
**March 31, 2020**

BGC Document No.:  
**RDCK2-SC-003F**

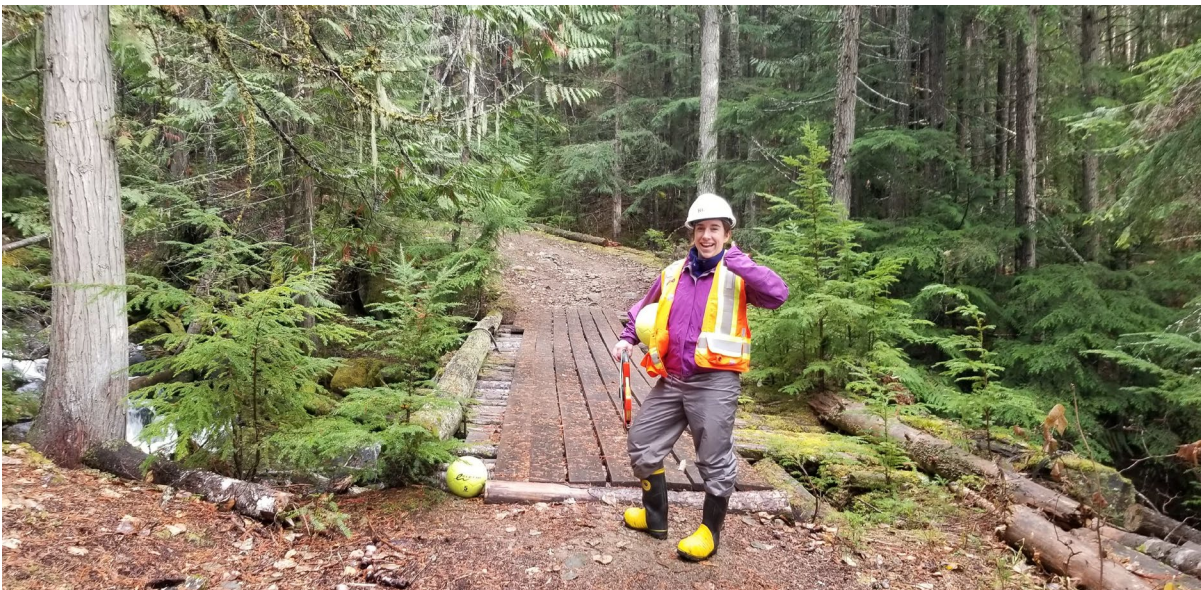
**Forestry Bridge crossing on Redfish Creek near fan-delta apex. Looking east.**

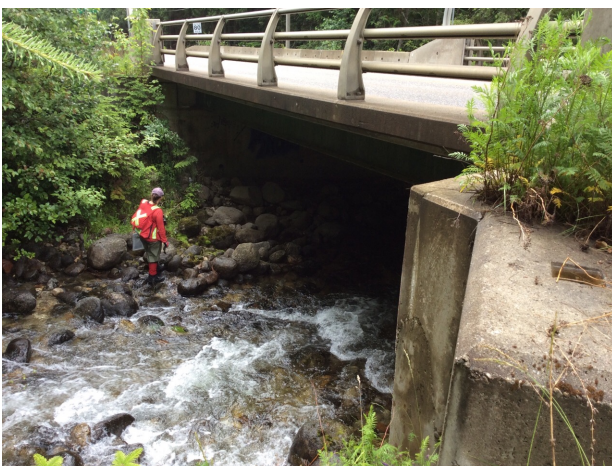
**Standing on the upstream right bank looking east at the Redfish Highway Bridge (flow is into the bridge).**

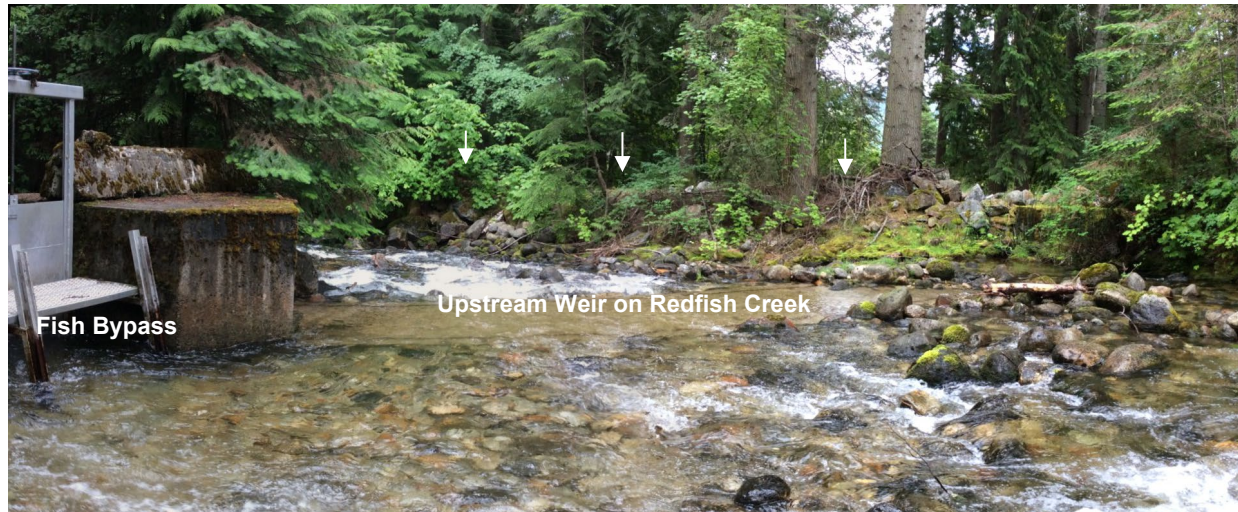
Looking downstream (south) at upstream weir on Redfish Creek with fish bypass to the left, and dike on right bank (RFS-FP-01). Arrows indicate dike crest.

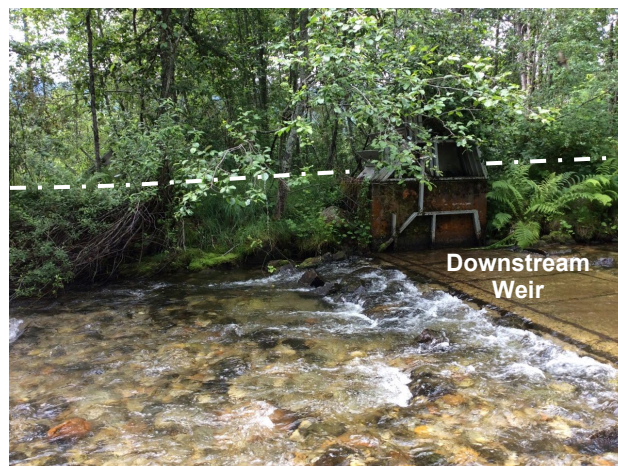
Looking southwest across creek at downstream weir, and Redfish Creek Dike (RFS-FP-03 located on the right bank). Dashed line indicates approximate dike crest.

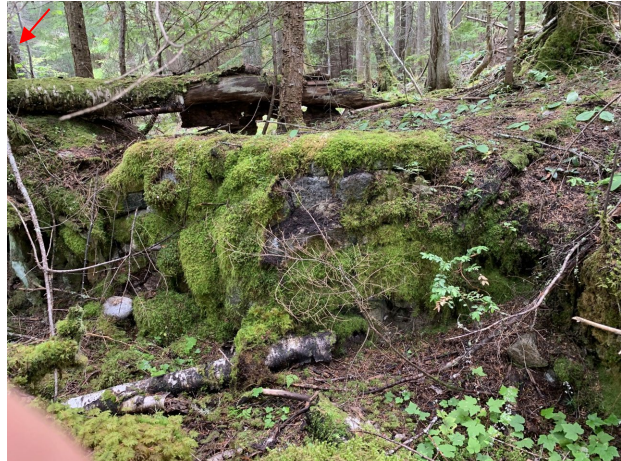
**RFS-LP-02.** Looking south at headwall of the old water intake on the right bank. For reference, note arrow indicating same tree as in image below.

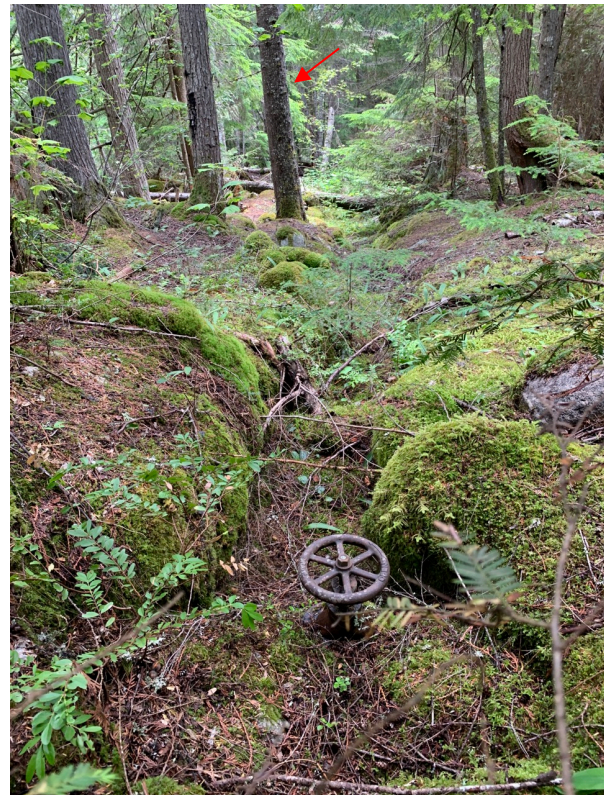
**RFS-LP-02.** Looking south valve of water intake and along pipe trench (pipe removed). For reference, note arrow indicating same tree as in image above.

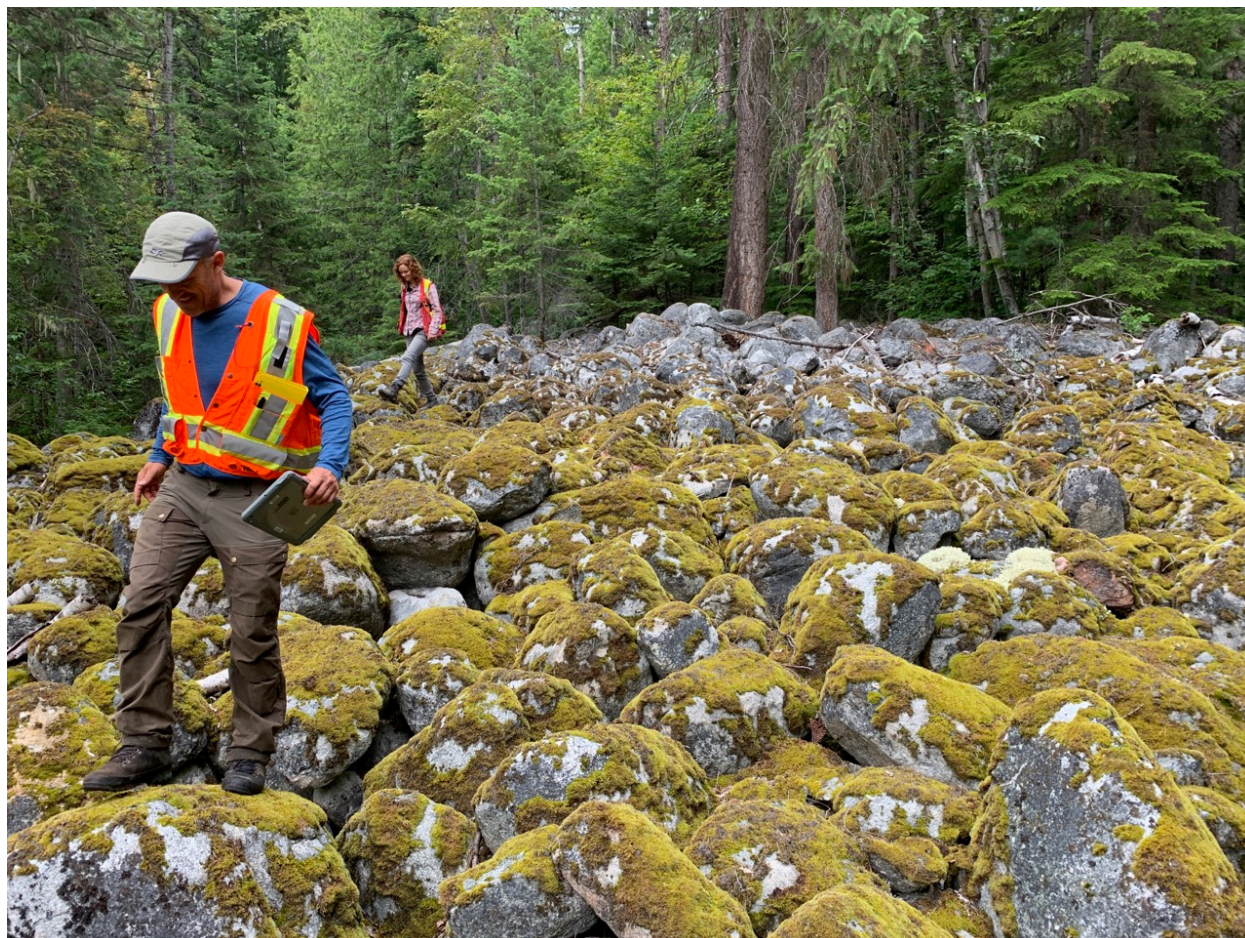
**Figure 5-2. Boulder lobe on the upper Redfish Creek fan-delta estimated to be hundreds of years old. BGC photograph of July 10, 2019.**

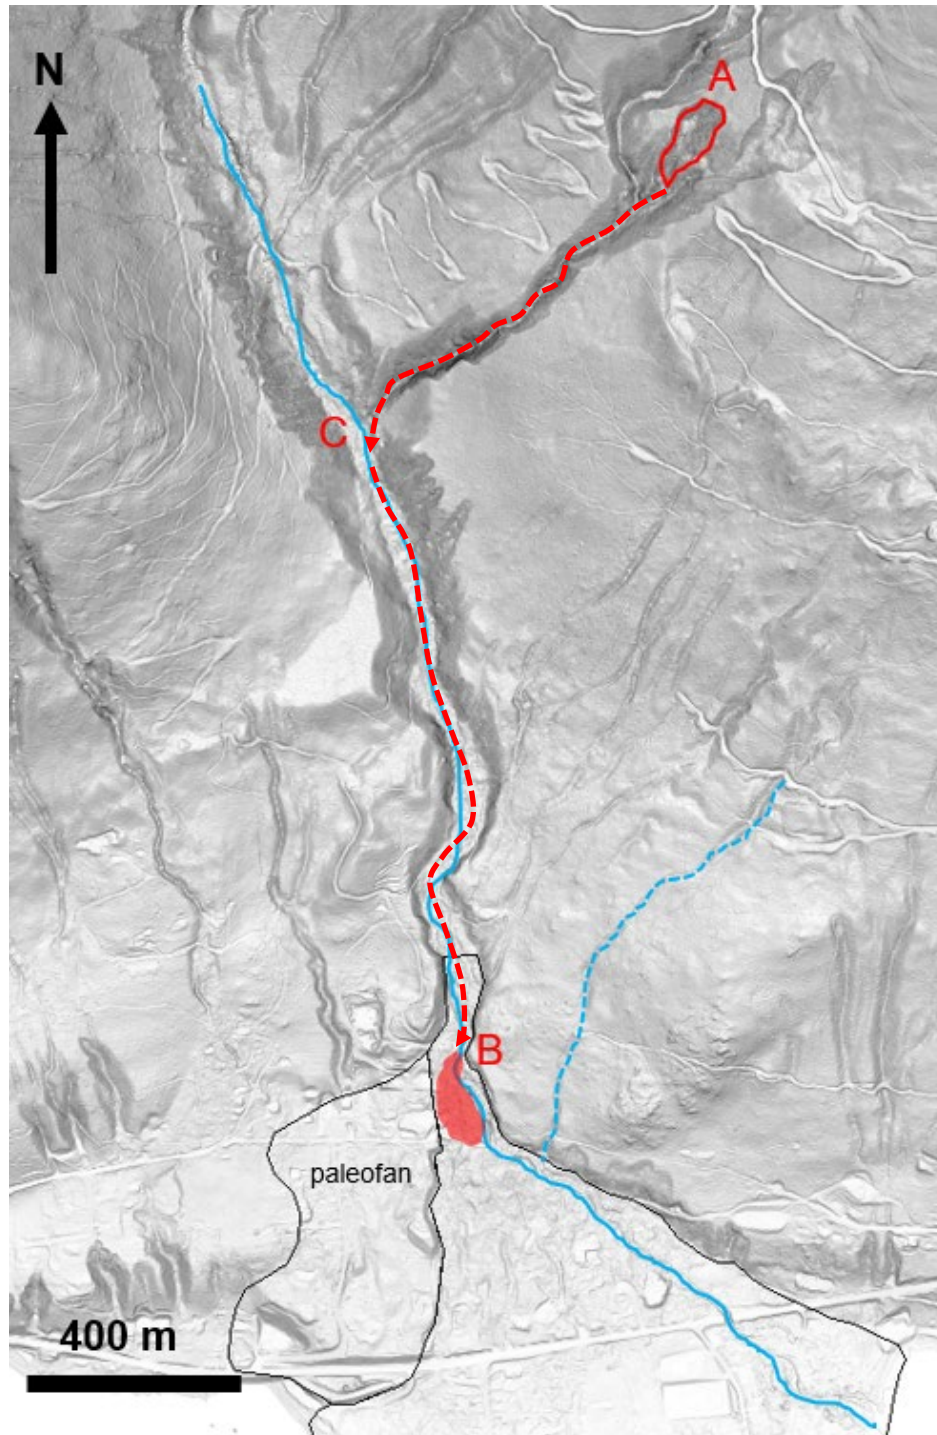
**Figure 5-3. Screenshot of the Redfish fan-delta and tributary with landslide scarp (A) to which the debris flow deposit at location B is attributed. The debris flow model was started with a total volume of 90,000 m<sup>3</sup> and a peak flow of 1400 m<sup>3</sup>/s at location C. Also shown is the potential path of a small debris flow (blue dashed line) that could block Redfish Creek channel on the fan-delta.**

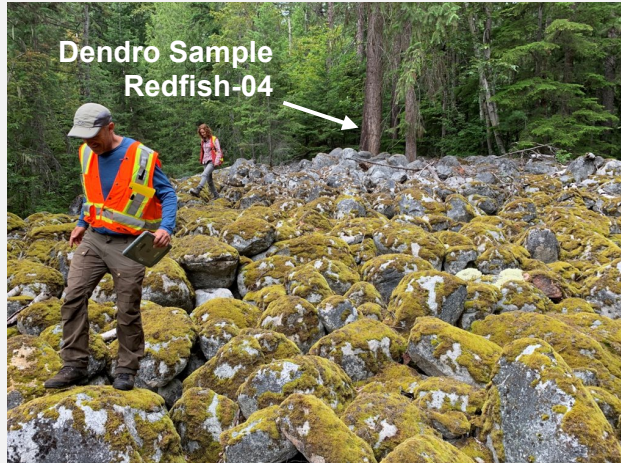
5	Minimum age of bare boulder deposit from dendrogeomorphology sample (Redfish-04) is 104 years (oldest visible ring in 1915).	Looking north at largest pine tree on at upper edge of bare boulder deposit where dendrogeomorphology sample Redfish-04 was taken.

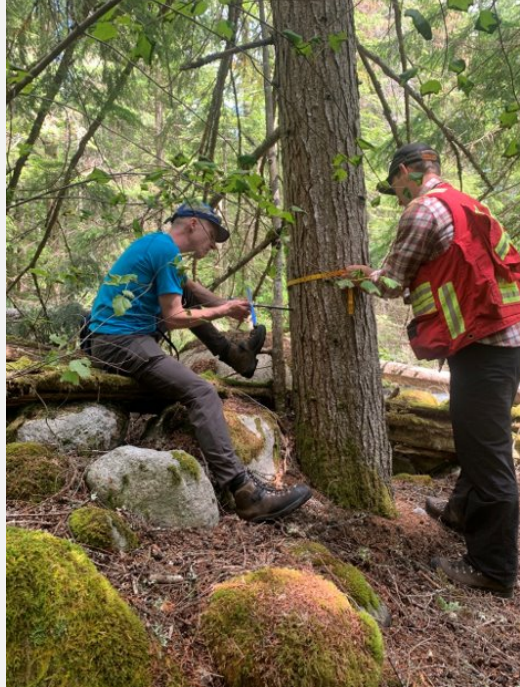
Location	Comment	Image	Location	Comment	Image
10	Boulder lobe with 0.5 to 1.0 m diameter boulders.	<p data-bbox="873 237 1463 298">Looking downslope (southeast) at moss-overgrown boulder lobe where field personnel is standing.</p>

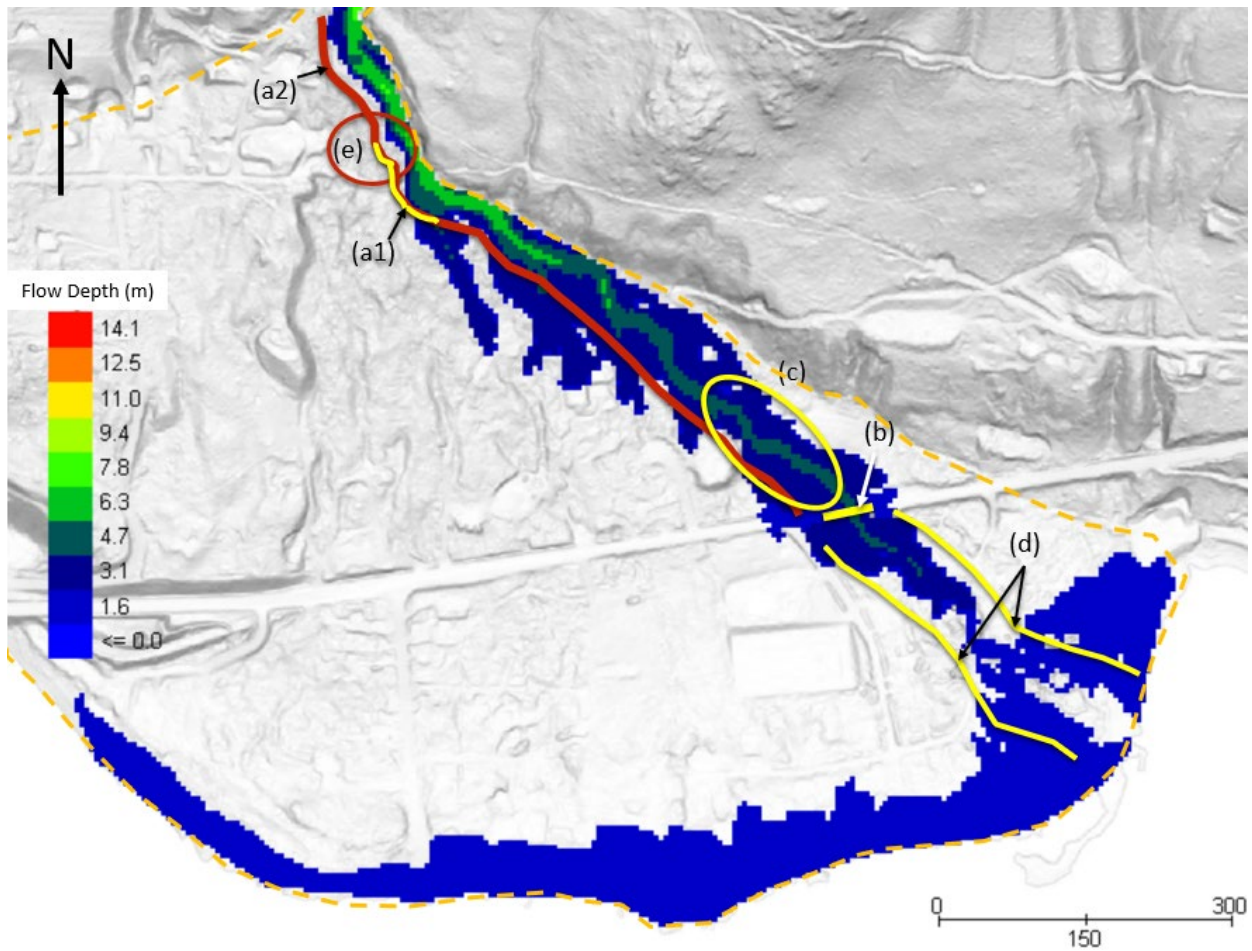
**Figure 7-1. Debris flow inundation map showing flow depths for a 300- to 1000-year return period debris flow on Redfish Creek and conceptual-level mitigation options for Redfish Creek fan-delta. Debris-flow mitigation options are in red, and debris flood mitigation options are in yellow. Note that these options have not been tested by numerical modelling and only serve as an impetus for further discussion. Other options will likely be developed at the conceptual design level.**

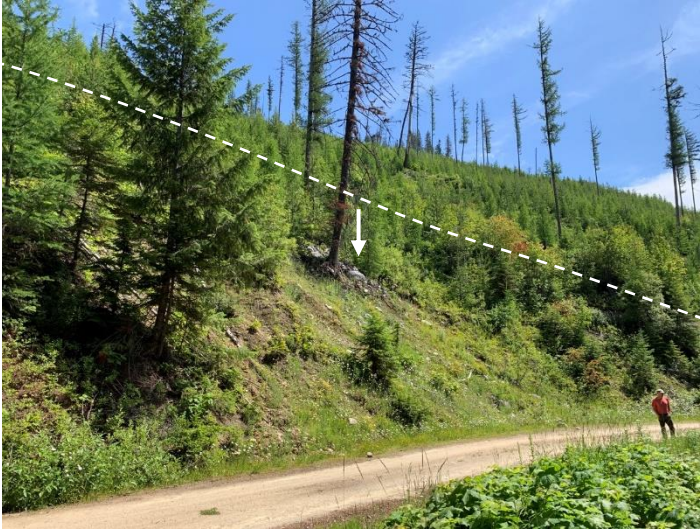
**Photo 8.**  
Looking east on Redfish-Liard Creek FSR at overgrown side scarp (dashed line) of debris avalanche. Note arrow pointing to rounded granitic boulders contained in till. See Drawing 05 for location. Photo: BGC, July 10, 2019.

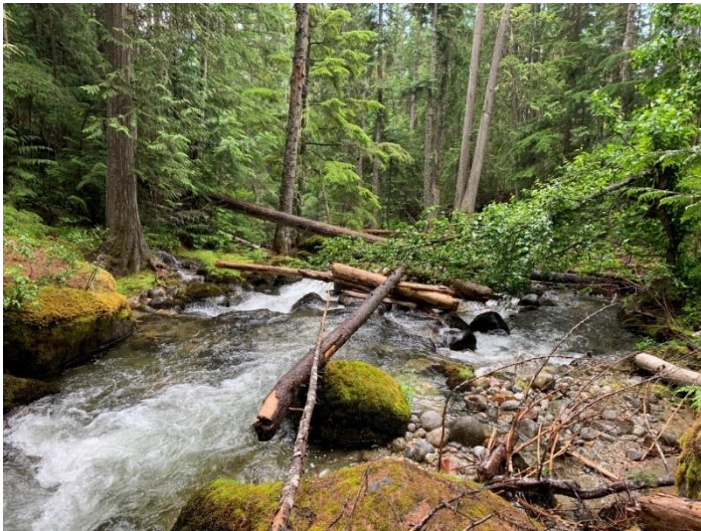
**Photo 9.**  
Looking downstream (south) at woody debris accumulation on Redfish Creek near fan apex. Photo: BGC, July 2, 2019.

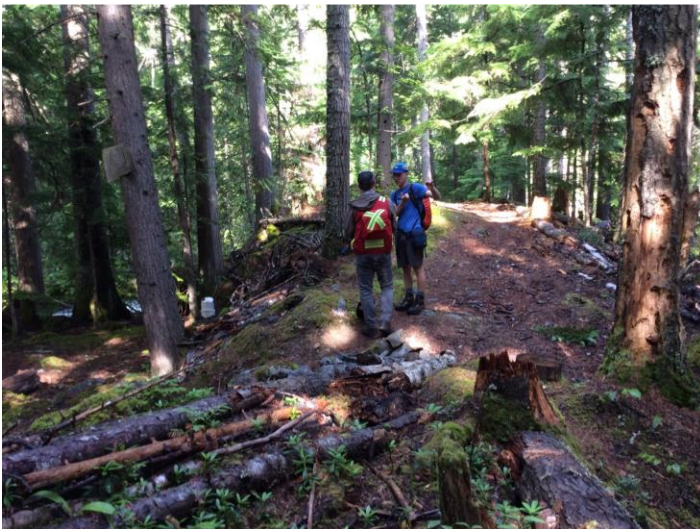
**Photo 10.**  
Natural berm approximately 2 m high extending along the right bank approximately 400 m downstream from fan apex. Photo: BGC, July 2, 2019.

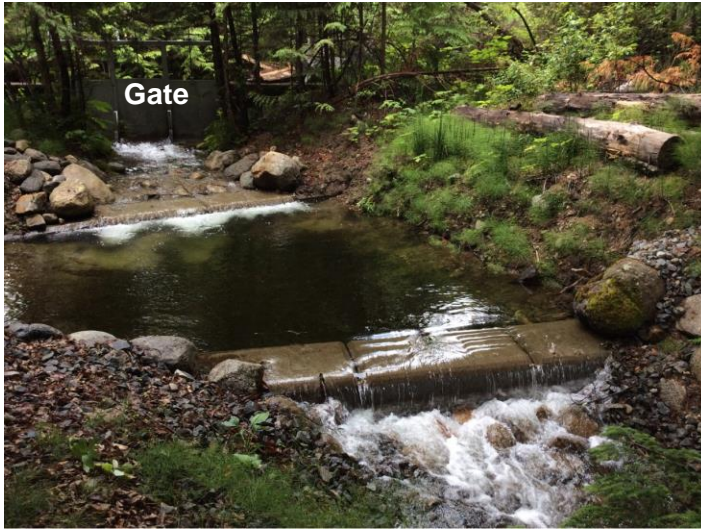
**Photo 11.**  
Looking upstream (north) at gate regulating flows diverted from Redfish Creek. In the foreground of the photo is the uppermost pool of the Redfish Creek spawning channel, partially built with prefabricated concrete blocks. Photo: BGC, July 3, 2019.

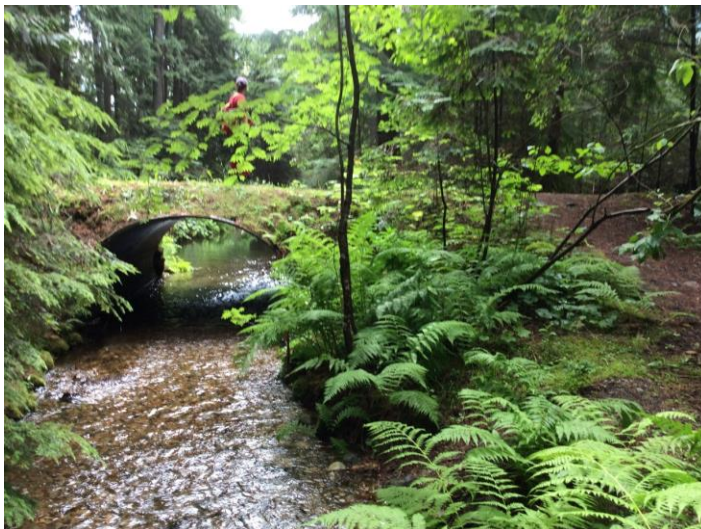
**Photo 12.**  
Standing approximately 120 m downstream of the gate shown in photo above and looking downstream, along the Redfish Creek spawning channel crossing with arch culvert. The arch culvert is approximately 3 m wide with 1.5 m of clearance to the water at the time of photo. Photo: BGC, July 3, 2019.

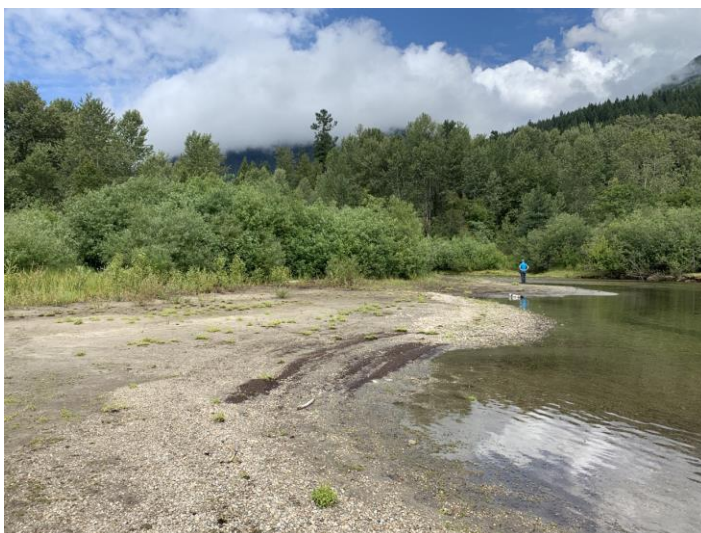
**Photo 13.**  
Standing on the shore of Kootenay Lake looking east at the outlet of Redfish Creek. Photo: BGC, July 3, 2019.
