RDCK FLOODPLAIN AND STEEP CREEK STUDY

Wilson Creek

Final
March 31, 2020

BGC Document No.:
RDCK2-SC-006F

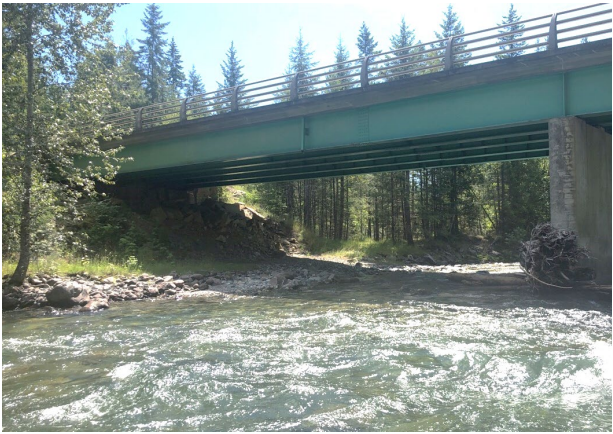
B) Mid channel, looking at left bank at rip rap armouring.

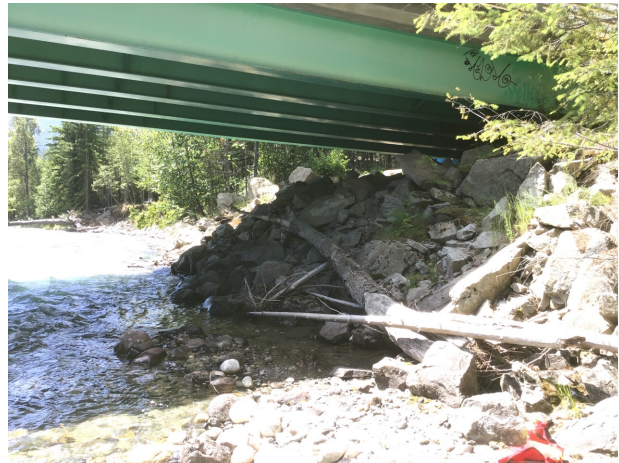
C) Looking downstream at right bank at rip rap armouring.

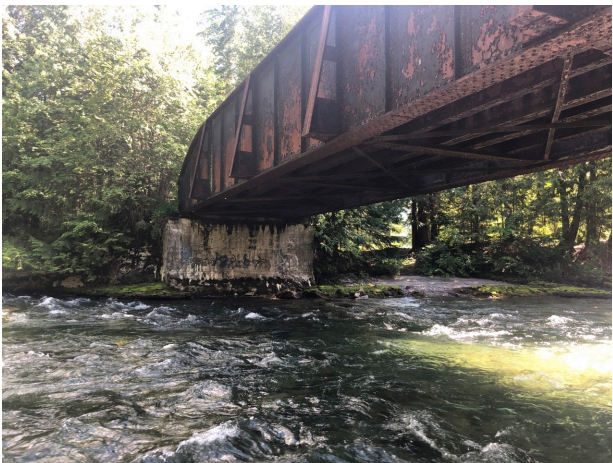
F) On right bank looking at the Nakusp and Slovan Railway Trail Bridge left bank abutment.

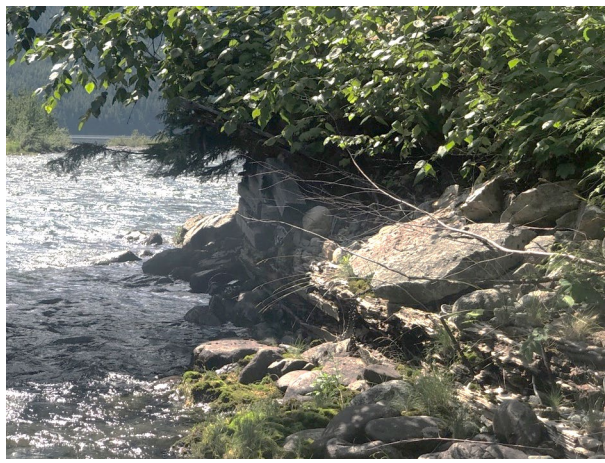
G) On right bank looking at the Nakusp and Slovan Railway Trail Bridge right bank abutment.

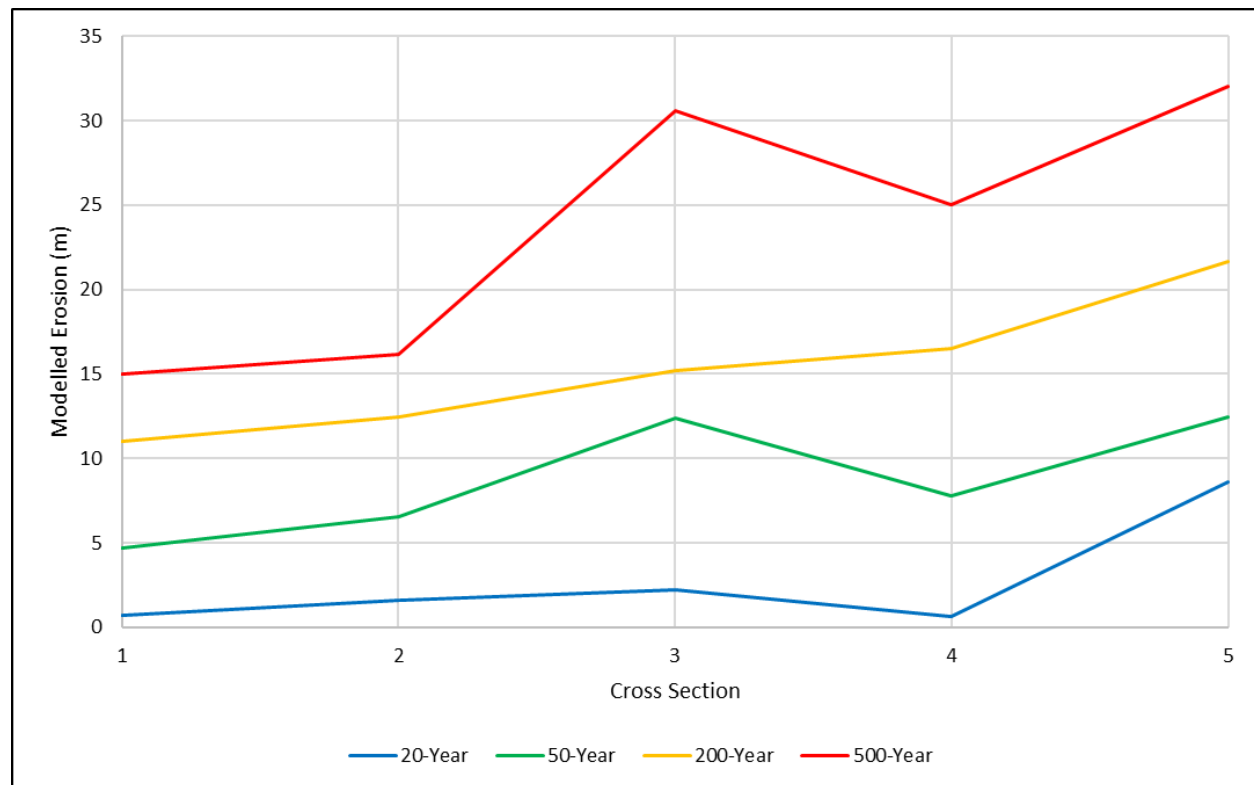
Figure 6-3. Wilson Creek 50th percentile bank erosion model results at each cross-section.

(see Drawings 02A, 02B). The abutments of the Highway 6 bridge may be at risk from progressive erosion.

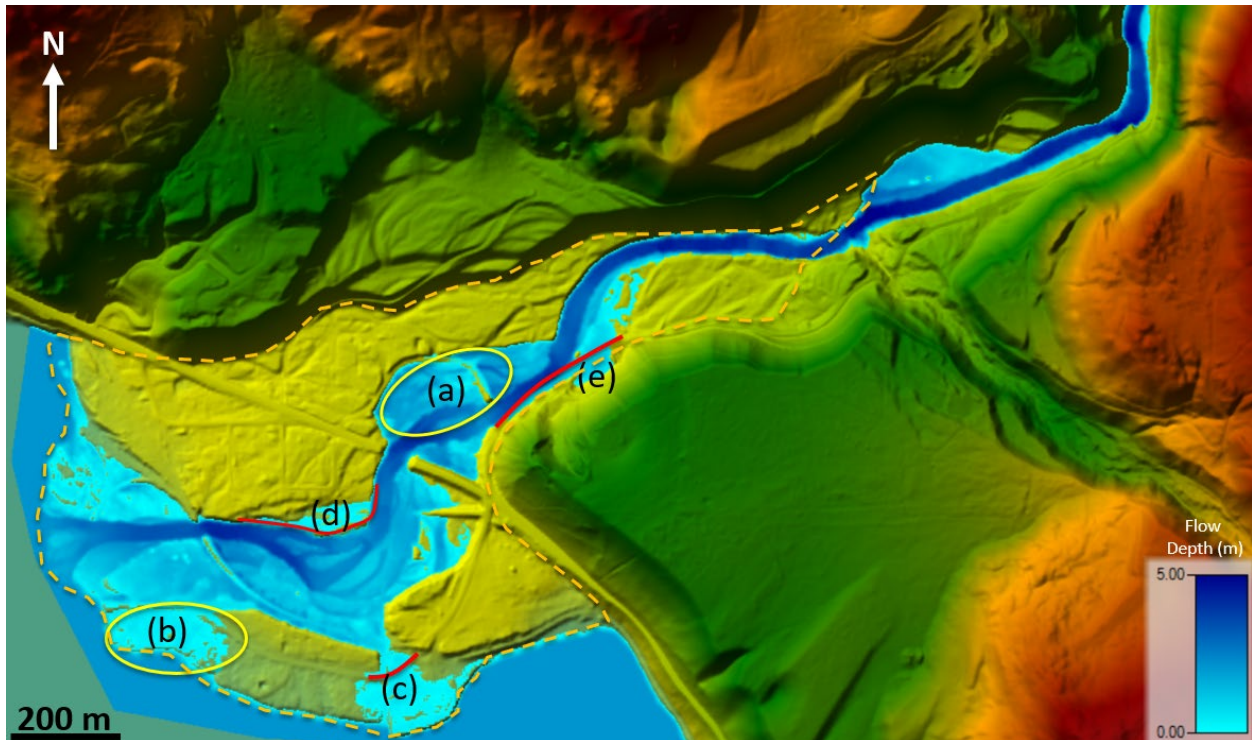
Figure 7-1. Flood inundation map showing flow depths for a 500-year return period clearwater flood on Wilson Creek and conceptual-level mitigation options for Wilson Creek fan-delta. Note that these options have not been tested by numerical modelling and only serve as an impetus for further discussion. Other options will likely be developed at the conceptual design level.

- Signs could be erected warning residents and tourist from using trails and roads that will likely be severed, flooded or otherwise damaged during floods.

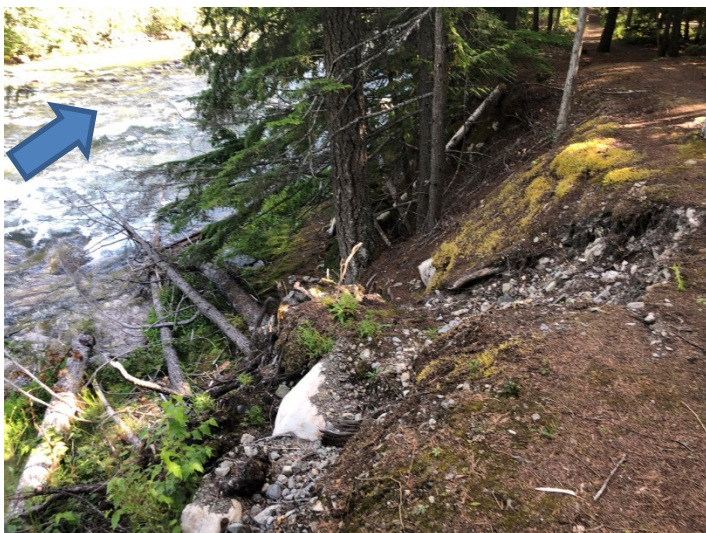
Photo 3.
Standing on the right bank of Wilson Creek in Roseberry Provincial Park, approximately 0.5 km upstream of the Highway 6 bridge. Looking at erosion of the right bank. Photo: BGC, July 26, 2019.

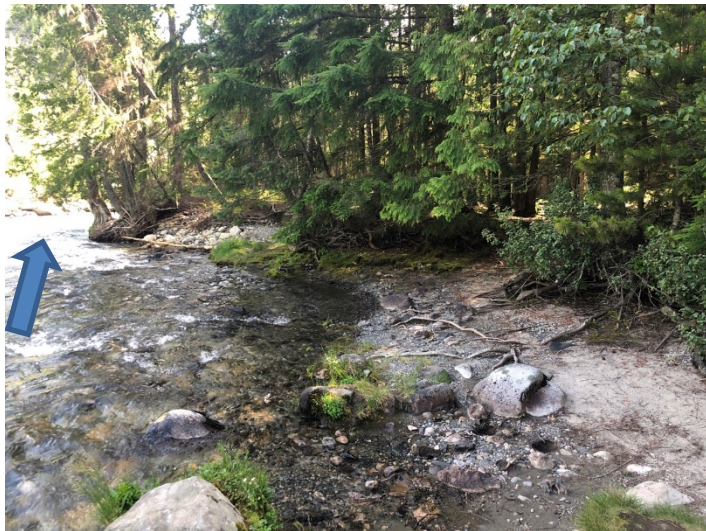
Photo 5.
Standing on the edge of Wilson Creek, looking at erosion of the right bank along Roseberry Provincial Park, approximately 0.4 km upstream of the Highway 6 bridge. Photo: BGC, July 26, 2019.

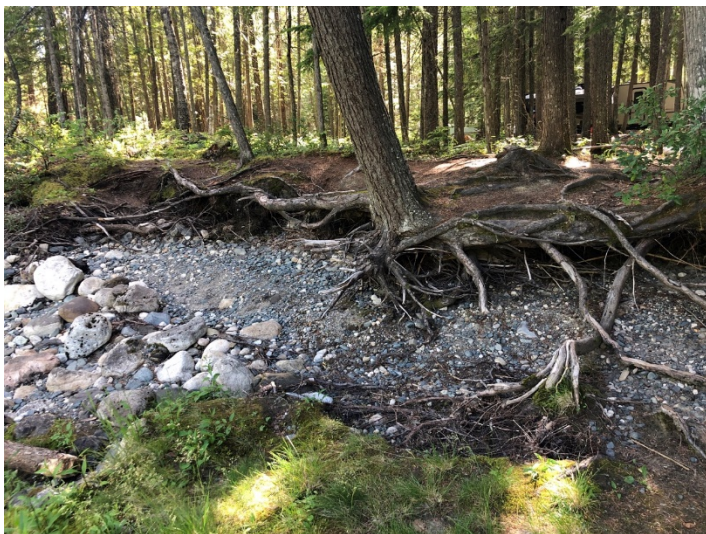
Photo 6.
Standing on the edge of Wilson Creek, looking at erosion of the right bank along Roseberry Provincial Park, approximately 0.4 km upstream of the Highway 6 bridge. Photo: BGC, July 26, 2019.

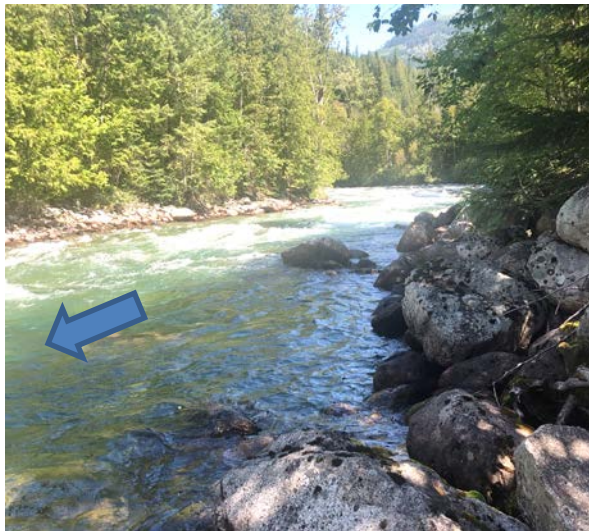
Photo 8.
Standing on the left bank of Wilson Creek looking upstream, approximately 0.3 km upstream of the Highway 6 bridge. Bank protection along Wilson Creek Road East visible on left bank. Photo: BGC, July 26, 2019.

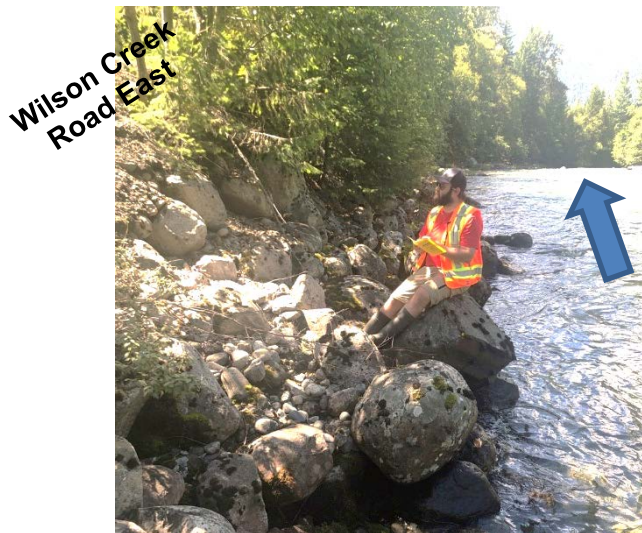
Photo 9.
Standing on the left bank of Wilson Creek looking downstream, approximately 0.3 km upstream of the Highway 6 bridge. Bank protection along Wilson Creek Road East visible on bank. Some protection material has moved and bank has slumped. Photo: BGC, July 26, 2019.

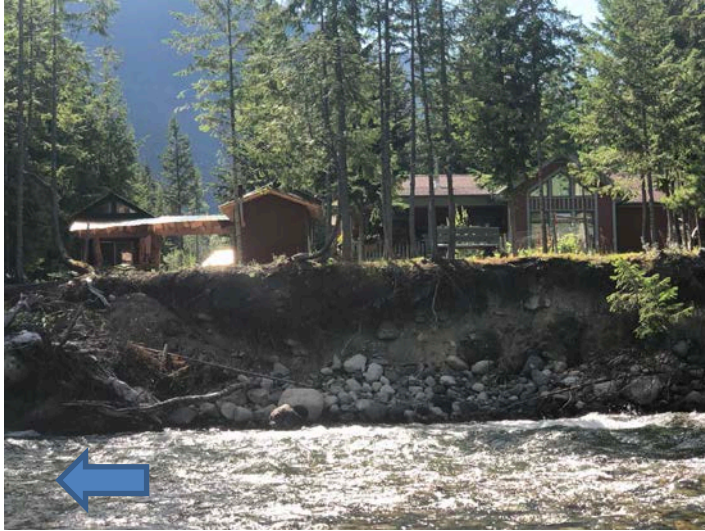
Photo 13.
Standing on the left bank of Wilson Creek looking across at bank erosion on the right bank just downstream of the Hwy 6 bridge. Photo: BGC, July 26, 2019.

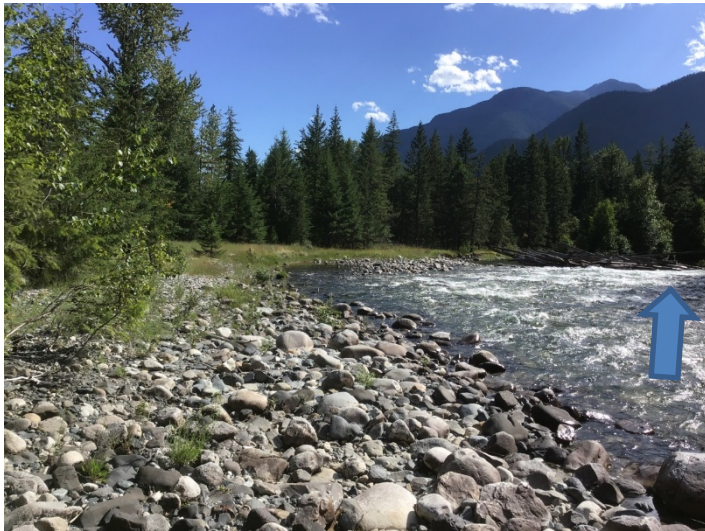
Photo 14.
Standing on the left bank of Wilson Creek looking downstream at low left bank, approximately 0.1 km downstream of the Hwy 6 bridge. Photo: BGC, July 26, 2019.

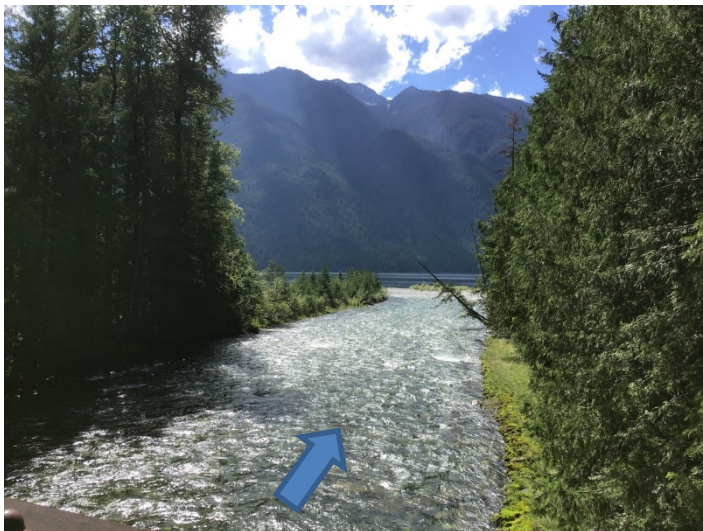
Photo 17.
Standing on the rail bridge looking downstream at the Wilson Creek outlet to Slocan Lake. Note mid-channel cobble deposit. Photo: BGC, July 26, 2019.

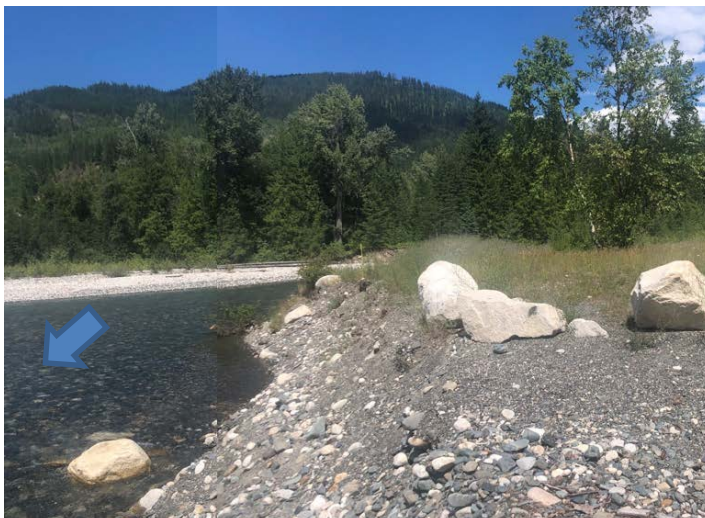
Photo 21.
Standing at the Wilson Creek outlet on Slokan Lake on the left bank looking upstream at bank erosion. Photo: BGC, July 26, 2019.
