BC Ministry of Forests, Lands, and Natural Resource Operations  
and Rural Development

POST-WILDFIRE NATURAL HAZARDS RISK ANALYSIS  
AKOKLI FIRE (N71686)

February 8, 2022

Report Number: 21.510.01.04.02

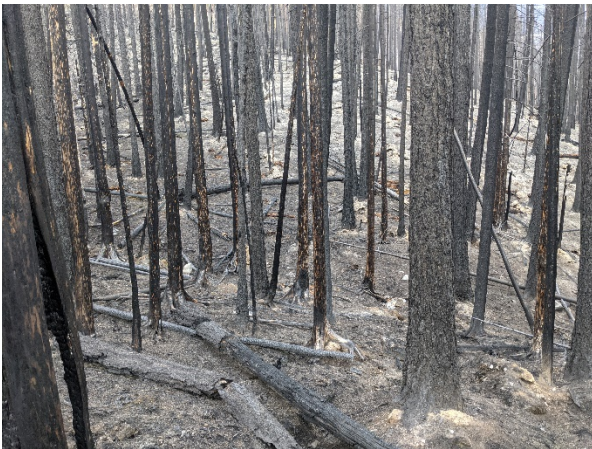
**Photo 9.** Example of high burn severity area - Akokli Drainage

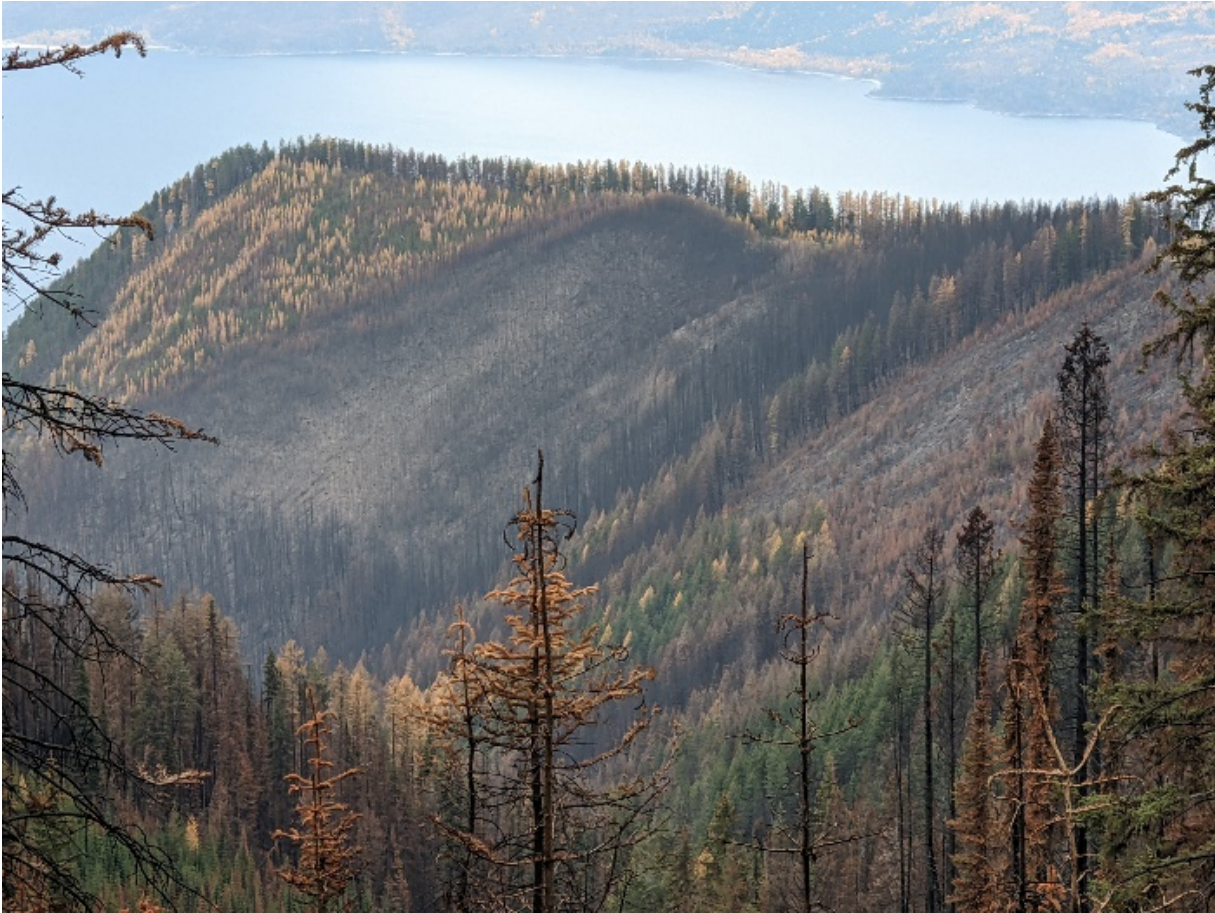
**Photo 11.** High burn severity in drainage A1

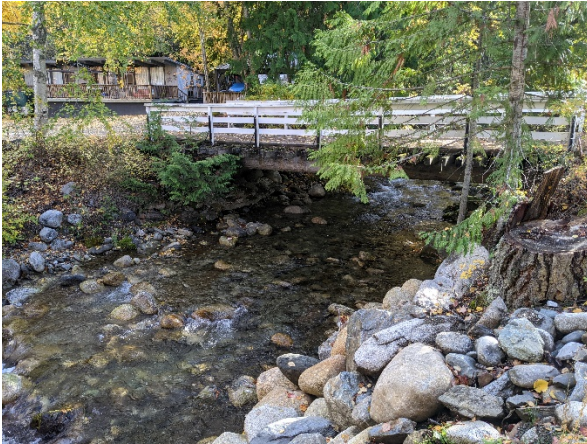
While the incremental post wildfire hazard is considered low for flooding and debris floods, if a large event were to occur the potential for the creek flows to be diverted out of the creek channel is considered high resulting in a MODERATE PARTIAL RISK to the buildings. The natural hazard of potential flooding/debris floods should be reviewed in light of what appears to be relatively low freeboard at the fan and the previous known events which nearly caused damage to the local bridge (refer to Recommendations Section 8.2).

**Photo 12.** Local bridge across Akokli Creek on the fan

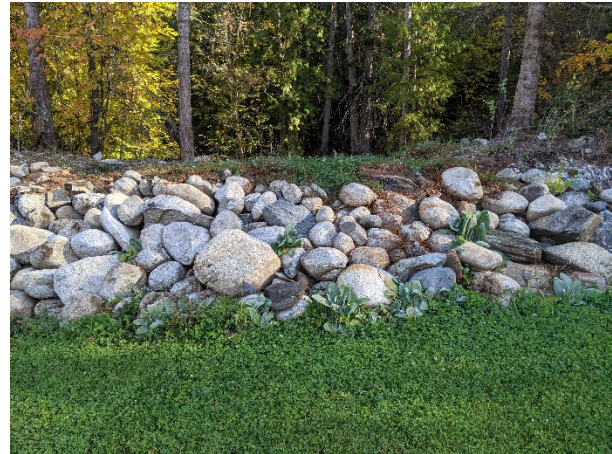
**Photo 15.** Berms constructed or reinforced on the Akokli Creek Fan

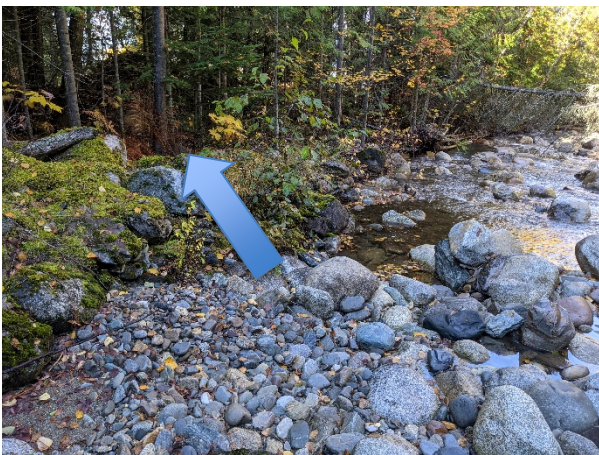
**Photo 16.** Low point near fan apex

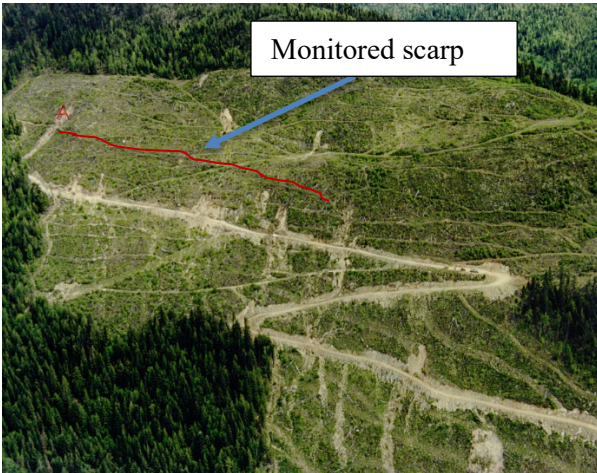
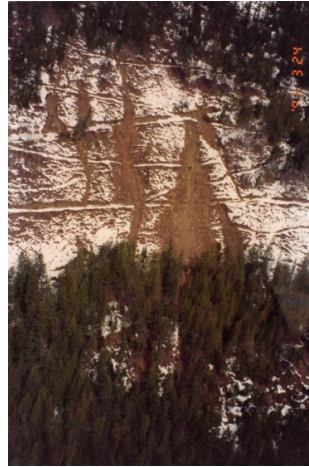
Based on the above observations, the partial risk to residences and Highway 3A on the Charles Creek fan is estimated to be LOW.

**Photo 20.** 1997 Charles Creek Landslides

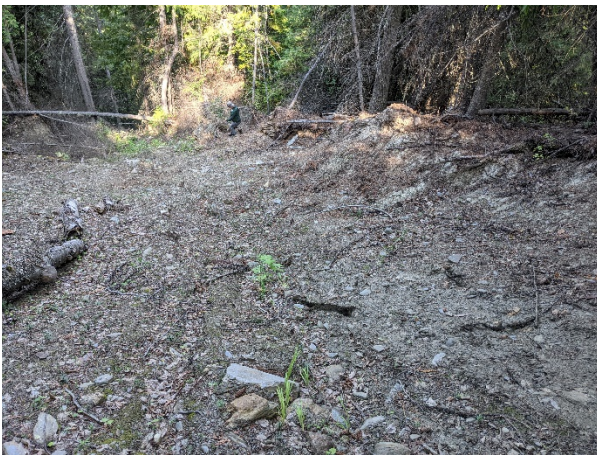
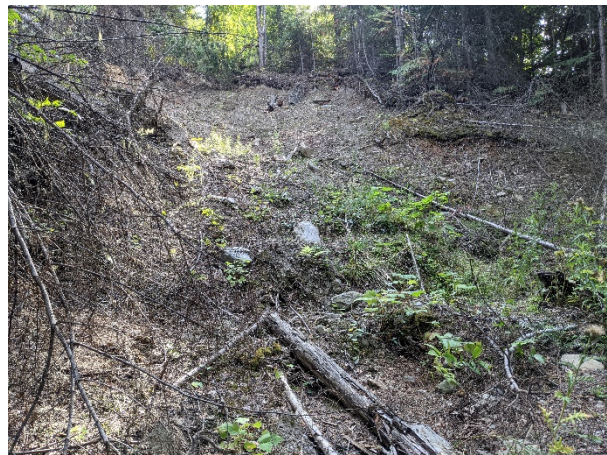
**Photo 22.** 5 km McGregor FSR landslide

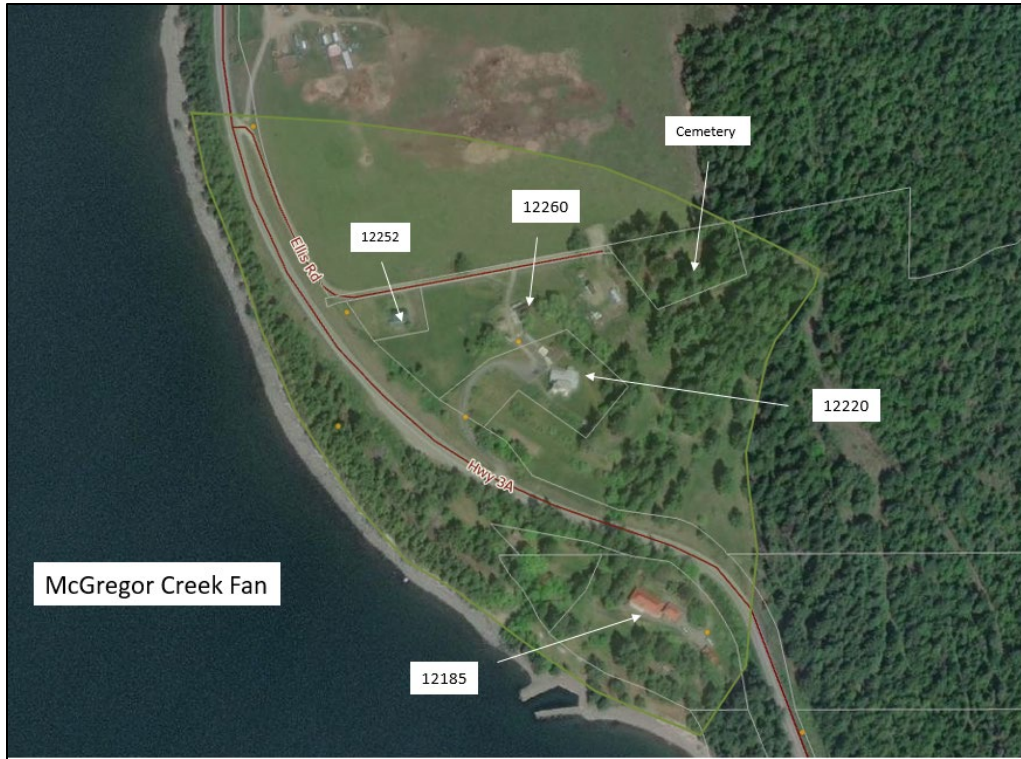
Figure 5 shows four houses and a cemetery on the fan. The creek channel is well incised from the apex of the fan to Hwy 3A (Photo 24). However, there is man-made obstruction in the gully at the apex of the fan in the form of a road crossing and water intake pond (Photo 25).

Figure 5. McGregor Creek fan elements at risk

Individual home owners may be able to further mitigate the hazard by constructing a debris flow deflection berm or berms upslope of their house provided the berm(s) does not re-direct flows or debris towards other residences on the fan (refer to Recommendations Section 8.3).

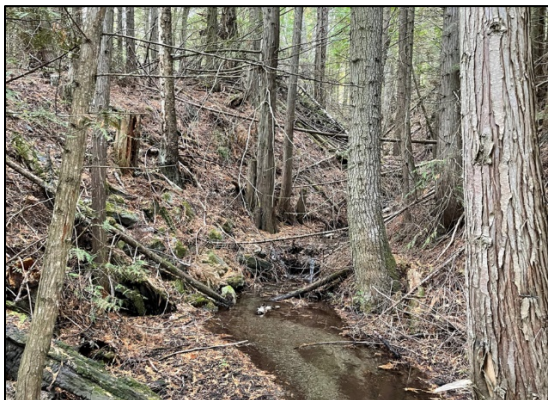
Photo 24. View of McGregor Creek channel mid slope on fan

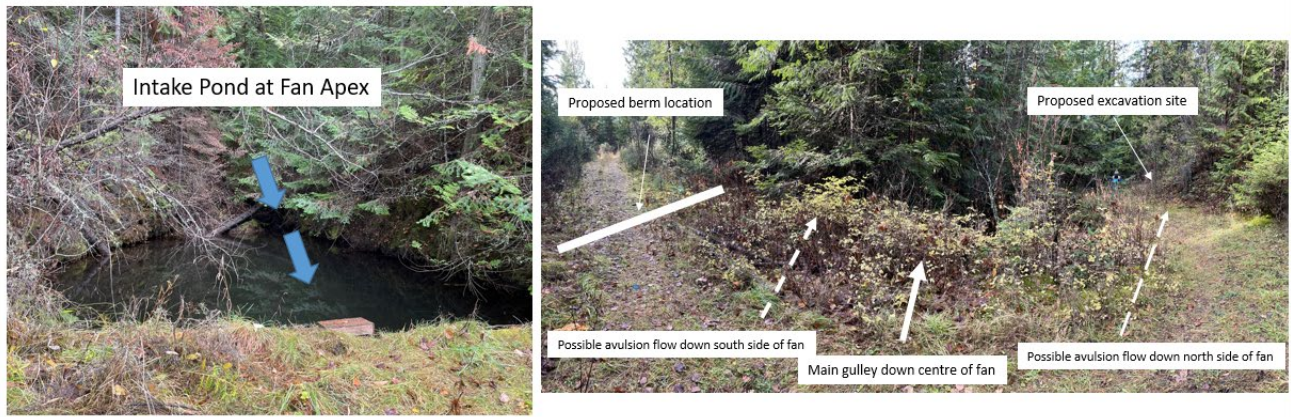
**Photo 25.** Water intake pond and road crossing at apex of McGregor Creek fan

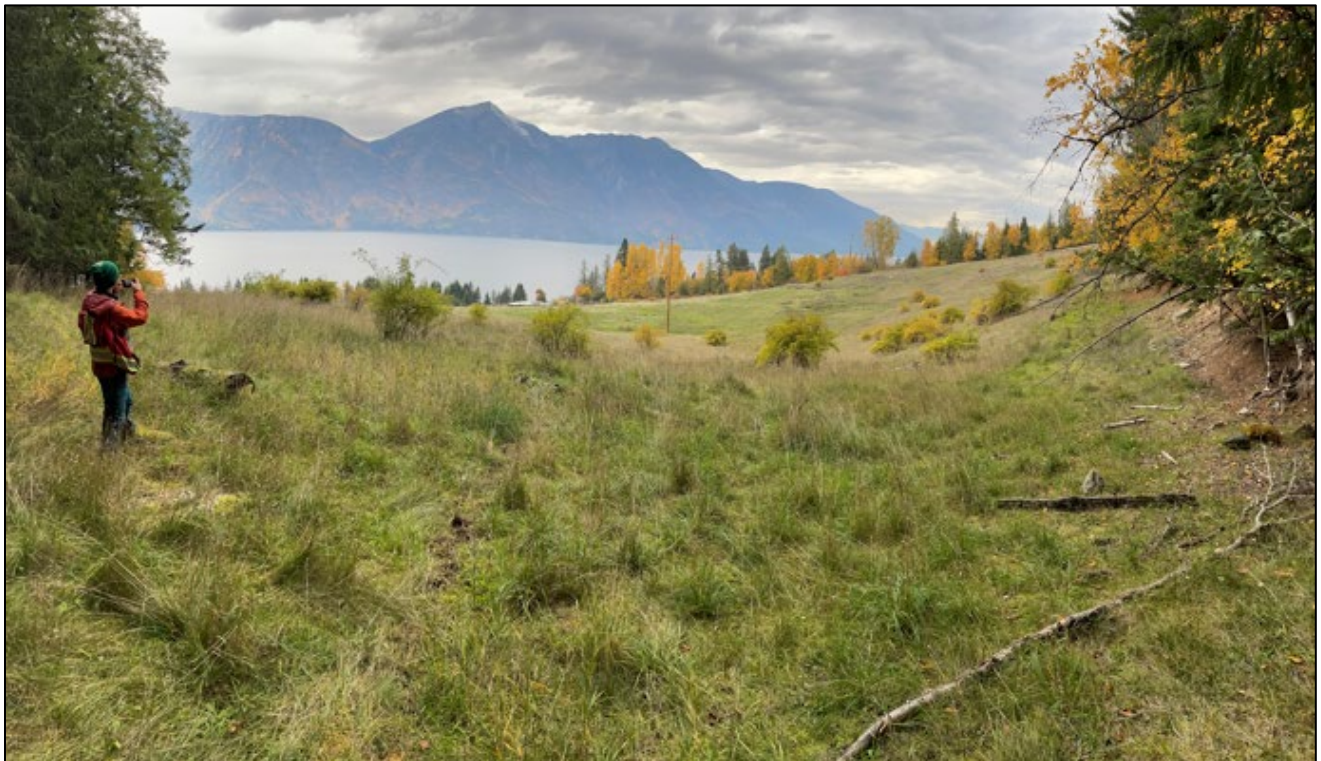
**Photo 26.** View looking north west to runout area for debris flowing to the north from the apex of the fan

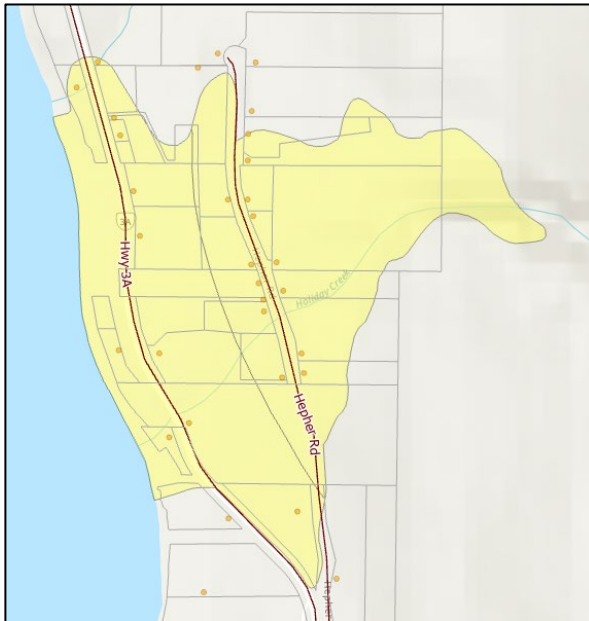
**Figure 7A.** Source RDCK webmap

Figure 7A, taken from the RDCK webmap, indicates that there are eight houses on the east (upslope) side of Hephher Road, 14 houses between Hephher Road and Hwy 3A and three houses between Hwy 3A and the lake. The fan boundaries estimated using LiDAR imagery (Figure 7B) shows similar house numbers except for 9 houses (instead of 3) between Hwy 3A and the lake. The exact fan boundary was not located in the field. The boundaries presented in Figures 7A and 7B should be taken as approximations - houses located near the boundary could still be at risk even if shown to be located outside the delineated fan boundary.

Based on the above observations and interpretations, there is estimated to be a MODERATE TO HIGH PARTIAL RISK TO THE HOUSES/RESIDENTS located above Hepher Road and a MODERATE PARTIAL RISK TO THE HOUSES/RESIDENTS below Hepher Road.

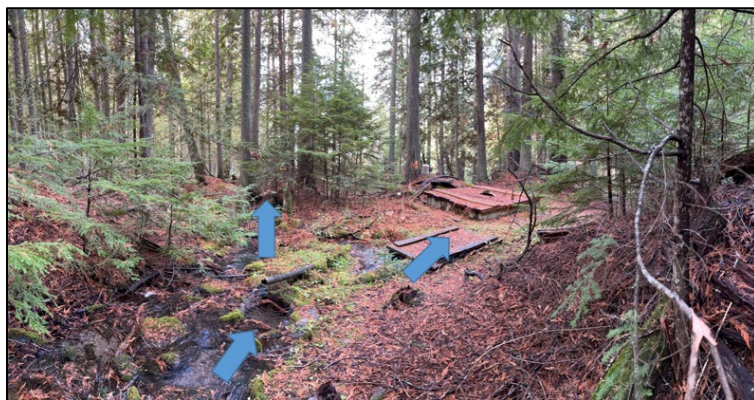
**Photo 27.** View looking downslope (west) at water intake on Holiday Creek

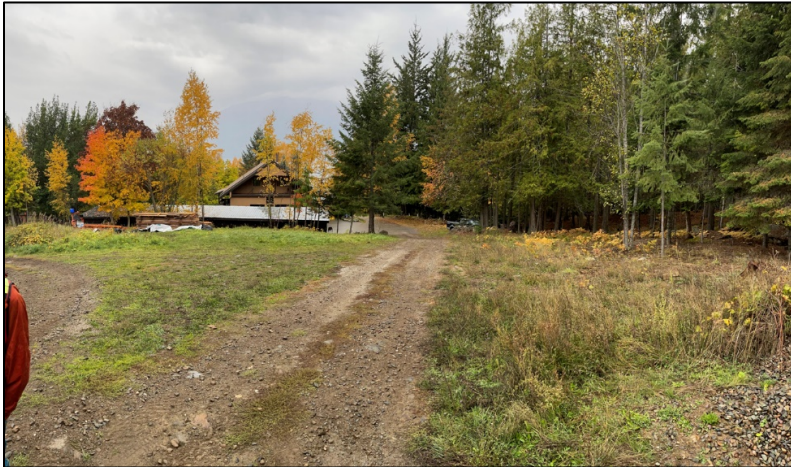
While the overall fan surface gradient from the apex to the lake is 19%, the gradient from the apex to just above Hwy 3A is 15%. The dwelling at 12734 Hwy 3A is located approximately 400 m from the apex of the fan. The fan surface gradient upslope and proximal to the dwelling ranges from 8% to 14%. The PARTIAL RISK IS CONSIDERED LOW for this house location. This lower gradient and distance between the house and the apex of the fan, as well as the absence of gully features (Photo 29) that could direct flow towards the house renders the likelihood of debris flow material other than shallow slow moving sediment laden floodwaters reaching the houses as low.

**Photo 29.** View looking north at house at 12734 Hwy 3A. The fan slopes east to west. The house is located approximately 400 m from the apex of the fan.

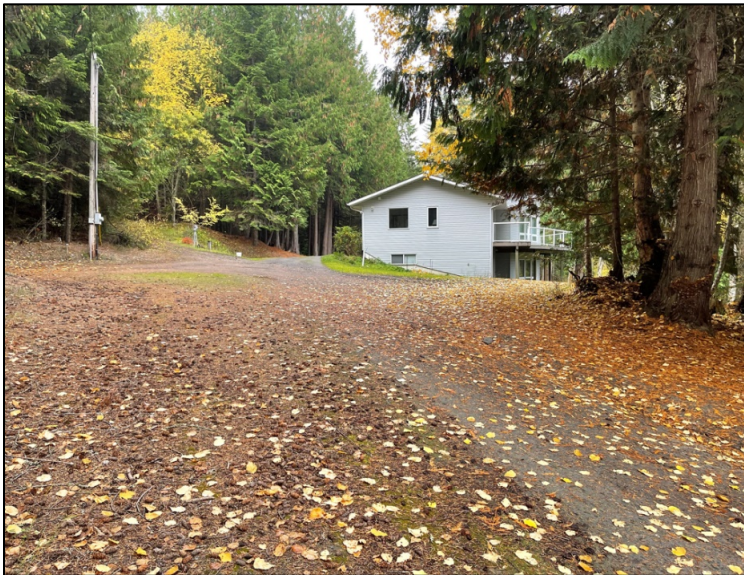
The dwelling at 12850 Hwy 3A (Photo 30) located approximately 240 m from the apex of the North Mack Creek is also assessed with at LOW PARTIAL RISK. The fan surface gradient at the house is 16% and there are no gully features to direct flow towards the house.

**Photo 30.** View looking south at house at 12850 Hwy 3A. The fan slopes left to right. The house is 240 m from the apex of the North Mack Creek fan.

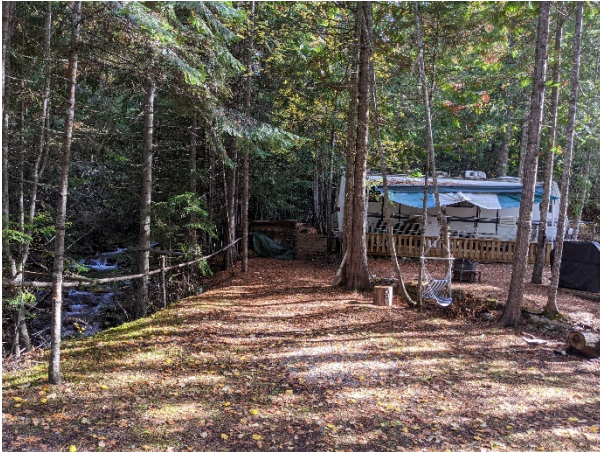
While the incremental post wildfire hazard is considered low, if a large event were to occur the potential for the creek flows to be diverted out of the creek channel at the fan apex is considered high resulting in a MODERATE PARTIAL RISK to the local buildings. Consideration should be given by BC Parks to increase the freeboard at the fan apex to reduce the likelihood of the creek being diverted down the left side of the fan towards the cabins and houses (refer to Recommendations Section 8.2).

**Photo 33.** Lockhart Creek fan apex
