January 3, 2023  
Project No.: 2325001

**Re: Steep Creek Hazards Assessment – FINAL**

## **1.0 INTRODUCTION**

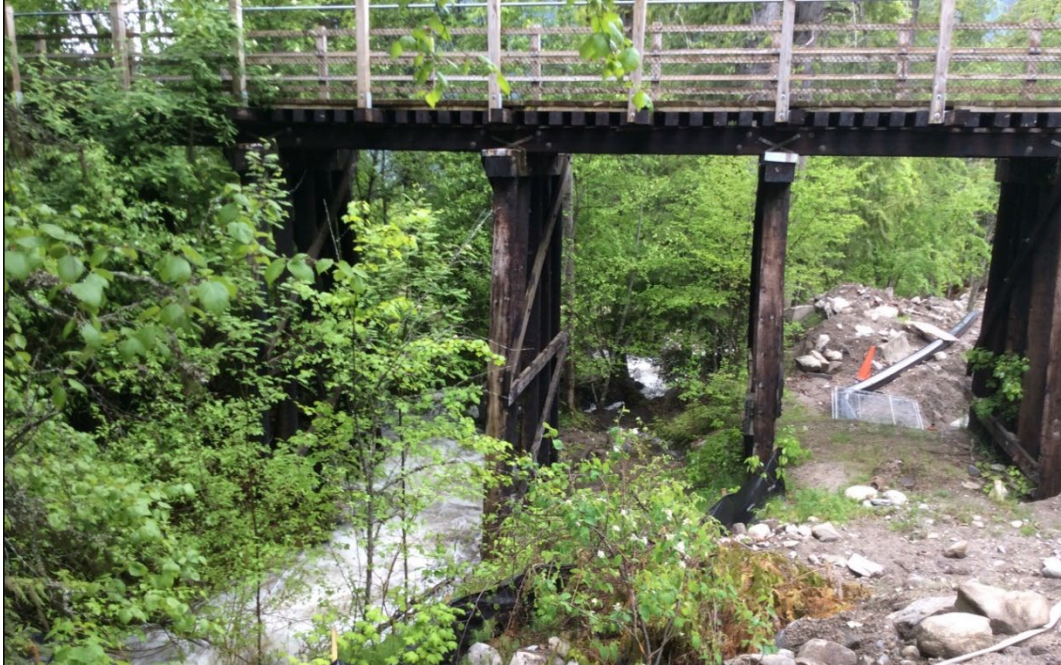
At the fan apex, Anderson Creek passes below a trestle bridge (Figure 3-2). The wooden trestles are vulnerable to damage from debris-flood impact. Immediately downstream of the fan apex near Svoboda Rd, a new water facility has recently (2022) been constructed. During BGC's site visit, an existing deflection berm/flooding dike to the south appeared to have been removed to grant access (Figure 3-3A). BGC noted that this could allow an avulsion towards the South into a residential neighbourhood near Davies Park. BGC informed the City of this issue (email on June 15, 2022) and replacement of the berm was completed (Figure 3-3B). BGC has not visited the site since the berm replacement and cannot comment further on the design or condition of the structure.

**Figure 3-2. Trestle bridge over Anderson Creek near the fan apex. Wooden trestles would likely suffer major damage during a debris flood. Photo: BGC, June 12, 2022.**

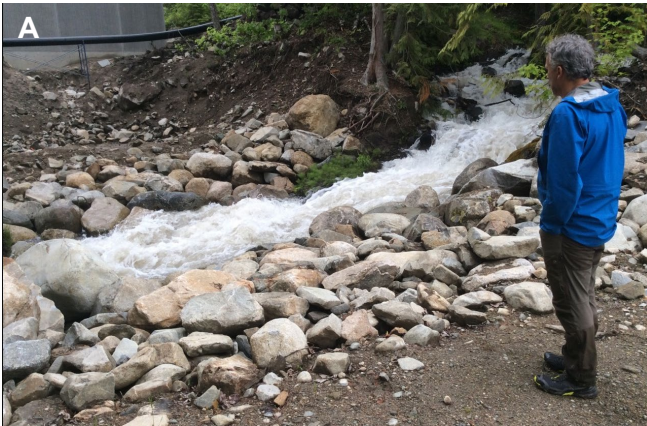
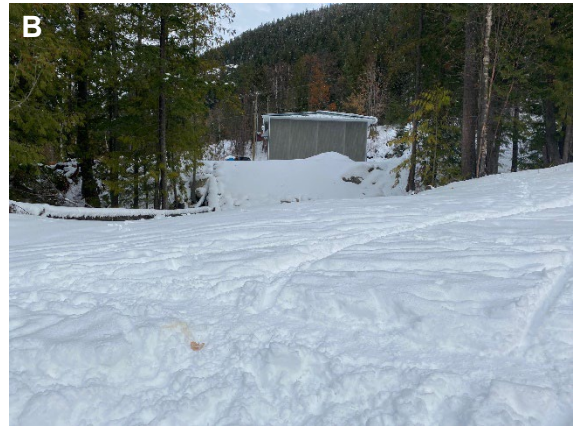
**Figure 3-3. Anderson Creek near the fan apex. A) The left (west) lateral berm appeared to have been removed adjacent to the new water facility. Photo: BGC June 12, 2022. B) The left (west) lateral berm was replaced. Photo: Nelson, December 13, 2022.**

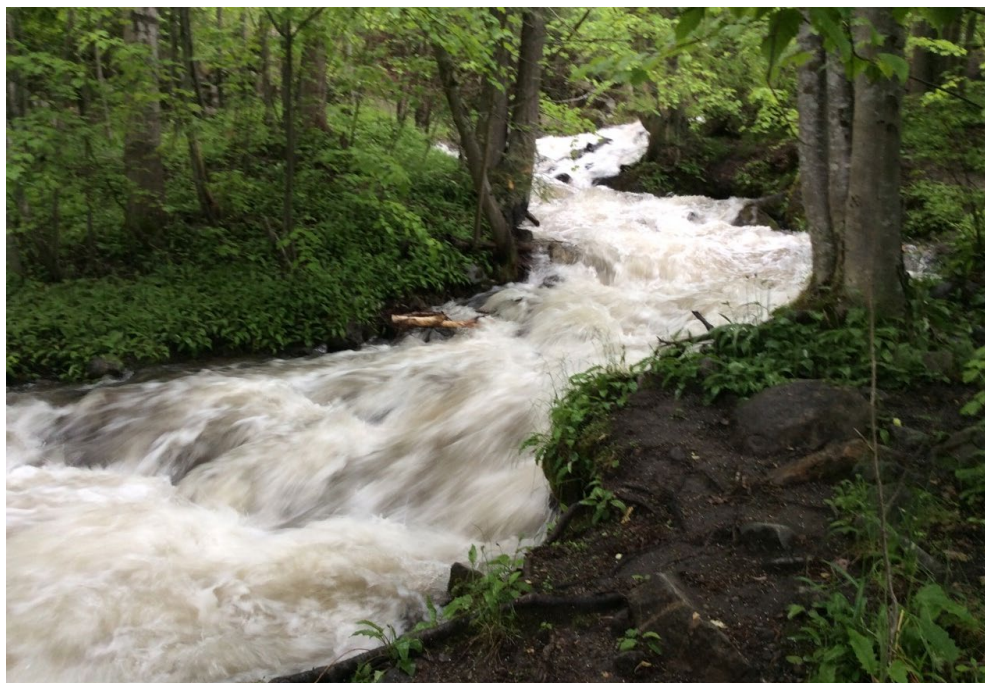
Downstream of the water facility, Anderson Creek is relatively poorly confined through the reach to Elwyn Drive, increasing the potential for the creek to overtop the banks and flood adjacent areas (Figure 3-4). At Elwyn Drive, an engineered trash rack has been constructed to catch organic debris and larger boulders before they can enter the Elwyn Creek culvert which has been equipped with an overflow culvert (Figure 3-5). At the time of BGC's site visit, water flow was too

**Figure 3-4. Anderson Creek during high flows between the new water facility and Elwyn Drive. The creek is relatively unconfined in this section. Photo: BGC, June 12, 2022.**

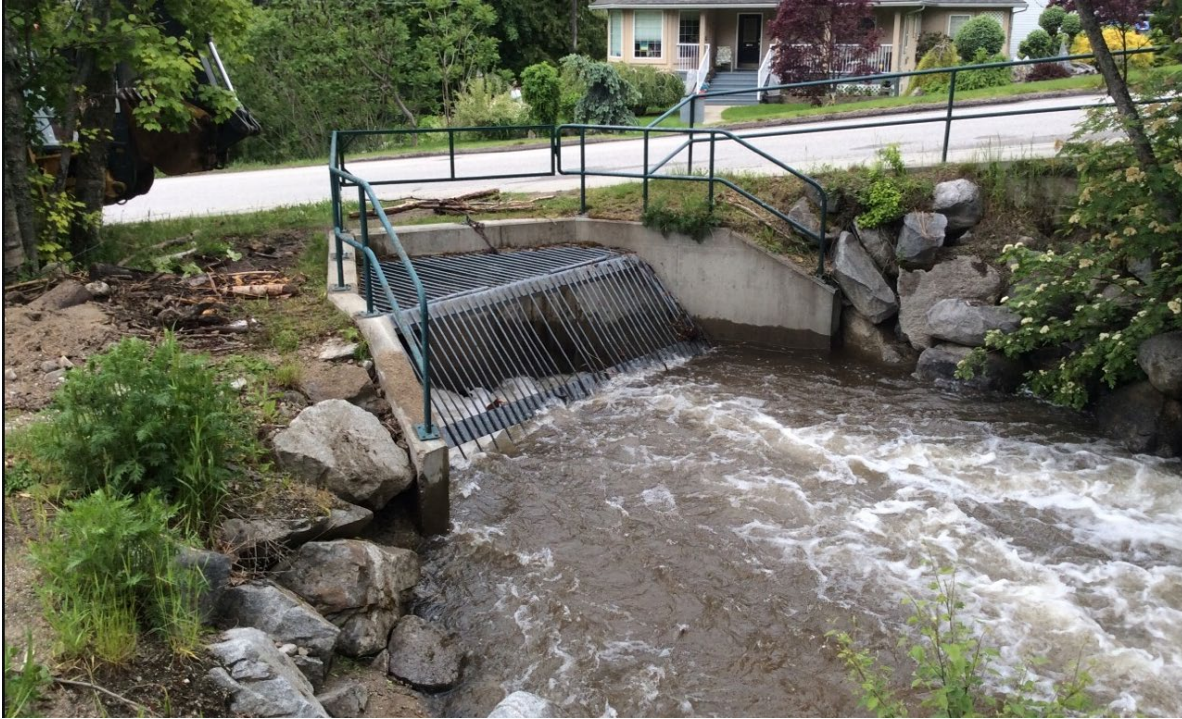
**Figure 3-5. High flows at the upper culvert on Elway Drive with an engineered trash rack to avoid organic debris and large boulders from entering the culvert. Photo: BGC, June 12, 2022.**

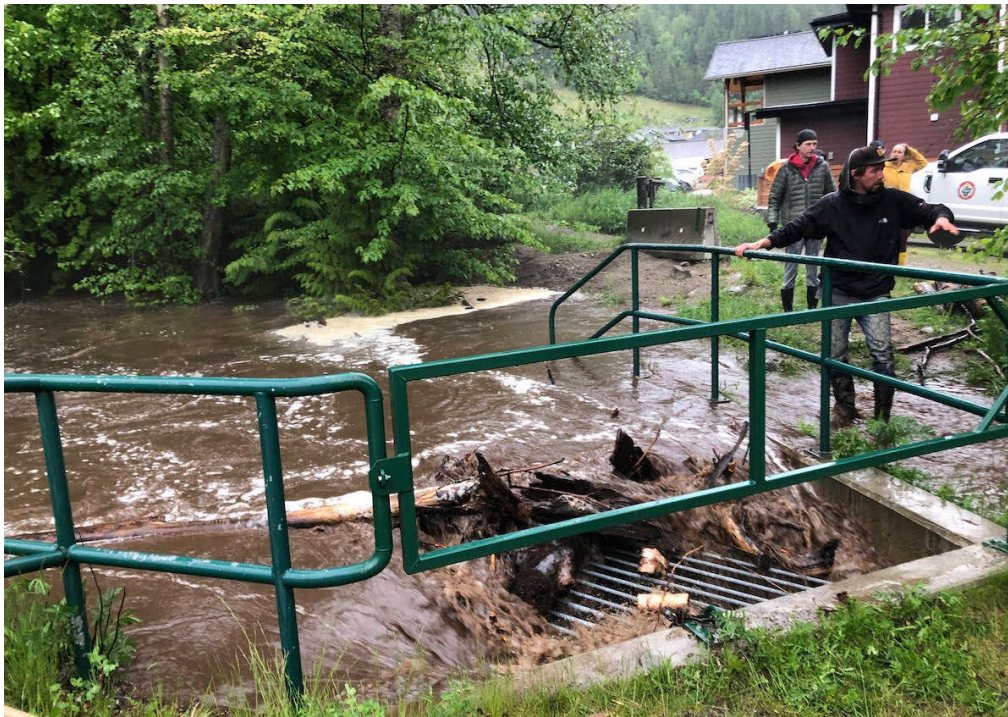
**Figure 3-6. Overflowing culvert at Anderson Creek (June 2nd, 2020, Photo: Nelson Star)**

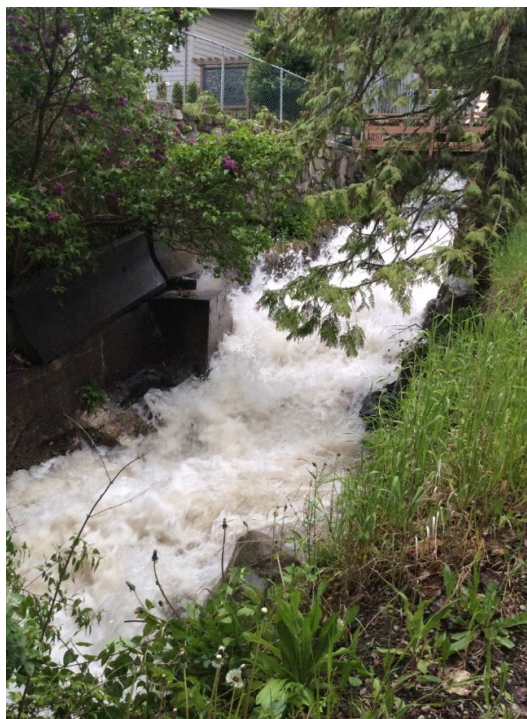
Within the developed sections, the creek is highly confined with property lines going right to the creek's boundary. Because of the confinement and the creek's steepness it flows fast and exerts high erosive forces against its bed and banks. This has prompted landowners to mitigate in various forms from well-stacked angular riprap to improvised protection measures (Figure 3-7).

**Figure 3-7. Anderson Creek between Gordon and Fell St. Note the make-shift mitigation works on the right (d/s looking) channel bank in the form of a jersey barrier. Photo: BGC, June 12, 2022.**

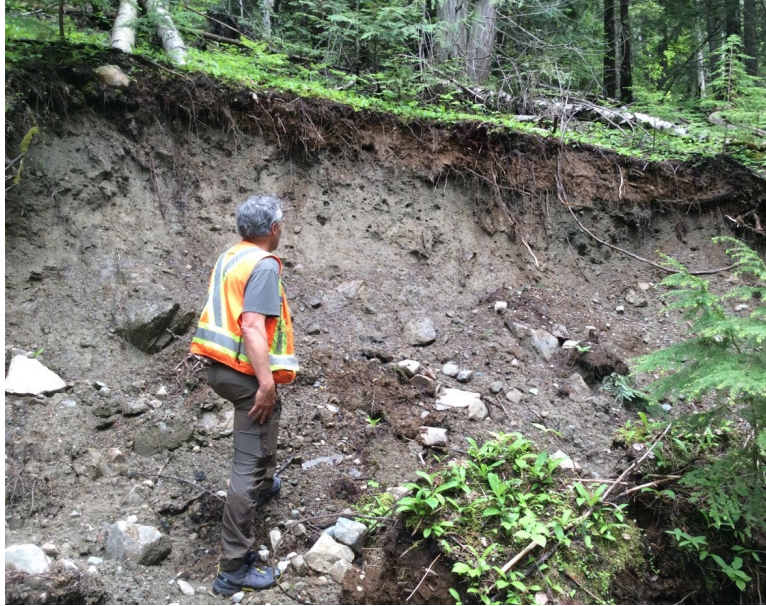
The creek is deeply incised in till as evidenced by some road cuts (Figure 3-9). As BGC did not traverse the length of the creek during this reconnaissance study, it is unknown if bedrock is encountered in the creek's base, though BGC considers this likely given the extent of incision. In places the till may be masked by overlying colluvium (Figure 3-10).

**Figure 3-9.** Till exposure along a property access road at approximately elevation 820 m near the Ward Creek drainage. Photo: BGC, June 12, 2022.

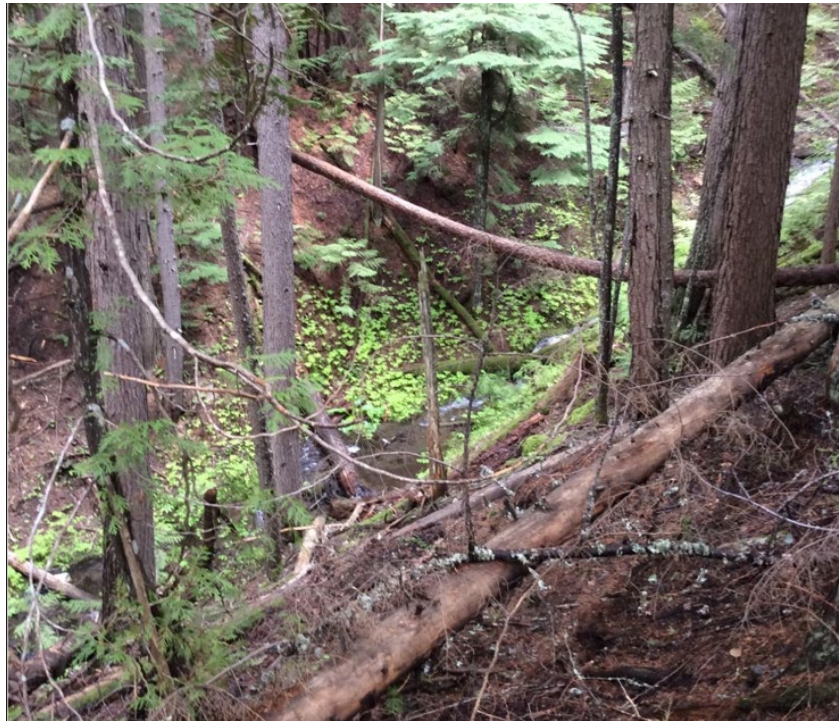
**Figure 3-10.** Ward Creek at approximately elevation 940 m. The creek is incised in till. No bedrock was encountered during the reconnaissance field investigation. Photo: BGC, June 12, 2022.

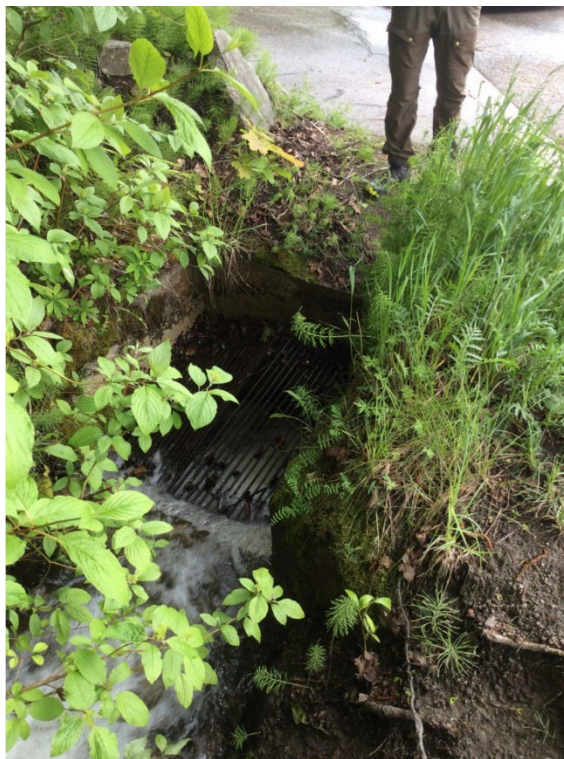
**Figure 3-11. Culvert on Ward Creek at Fort Sheppard Drive. Photo: BGC, June 12, 2022.**

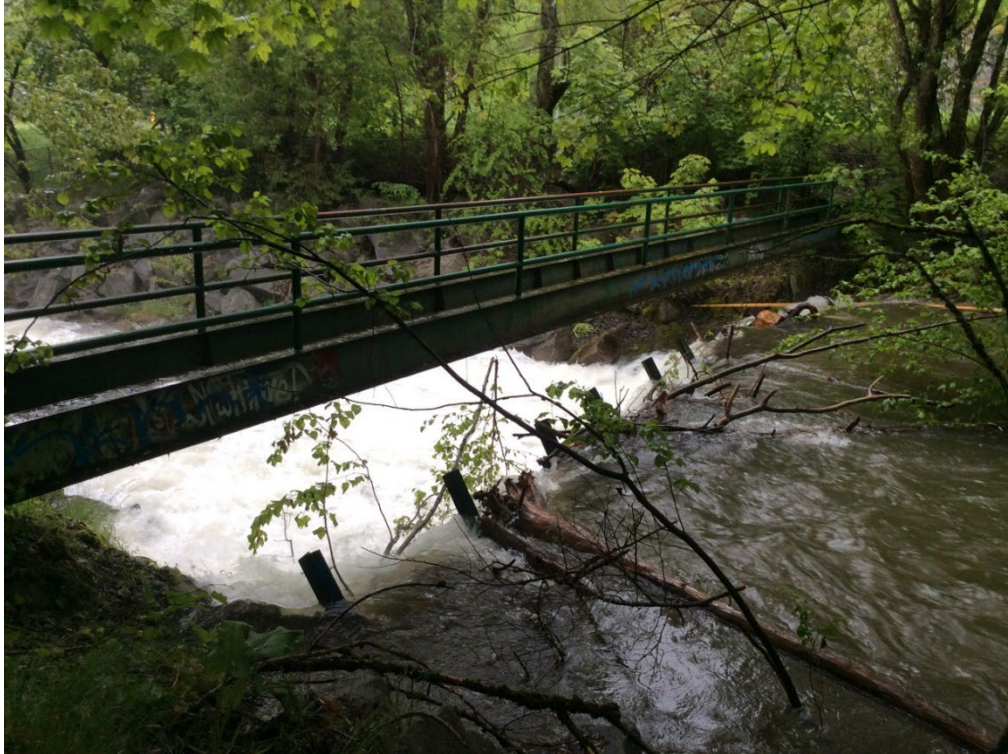
Cottonwood Creek is crossed by several bridges to access private property from Highway 6 upstream of the City of Nelson. Within the City, Cottonwood Creek has a weir and an organic debris barrier situated approximately 60 m upstream of the main culverts where Vancouver Street meets Mines Road (Figure 3-12). The barrier consists of double-T-bars embedded in the concrete weir crown. Some appear to have been displaced (bent). This barrier may be successful in capturing some organic debris, however, in a major runoff event, BGC expects that substantial amounts of logs and woody debris could overtop the structure.

**Figure 3-12. Debris barrier across Cottonwood Creek approximately 60 m upstream of culvert below Highway 6. Photo: BGC, June 12, 2022.**

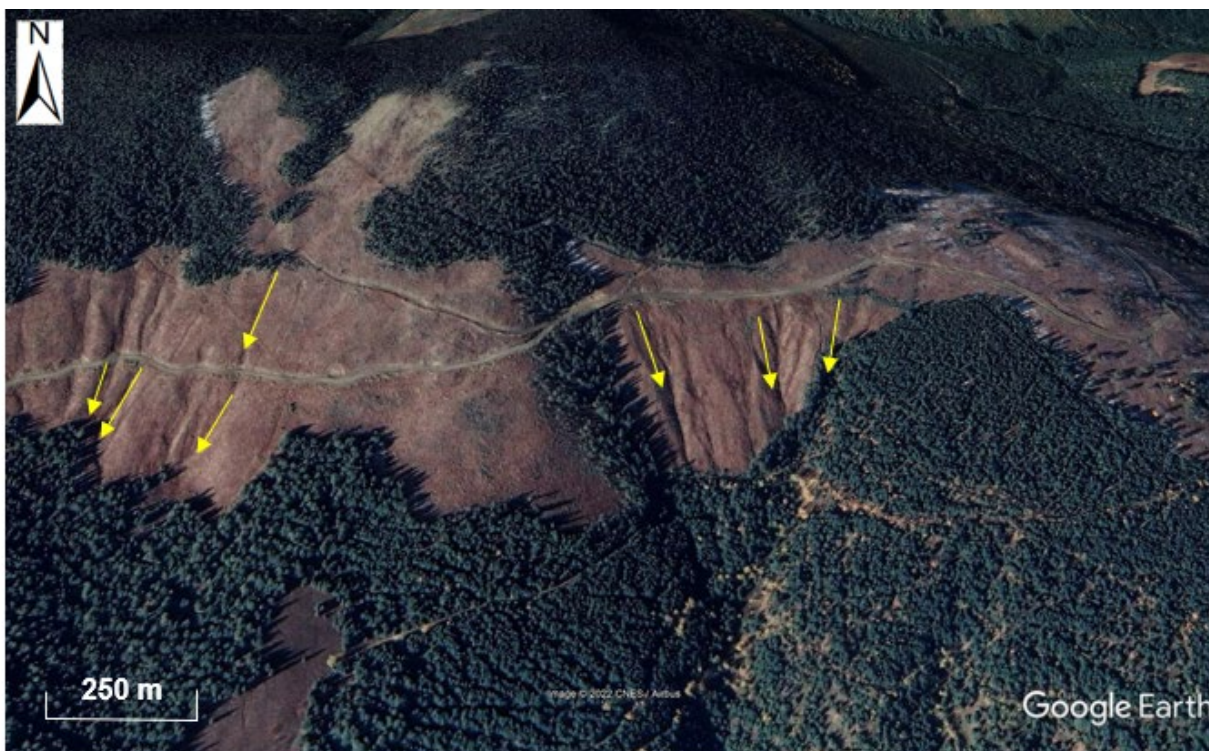
**Figure 3-13. Detail of recent clearcutting in steep terrain the upper Giveout Creek watershed. Oblique Google Earth image. Areas particularly susceptible to debris-flow initiation are shown with yellow arrows. Image: Google Earth 10-18-2021.**

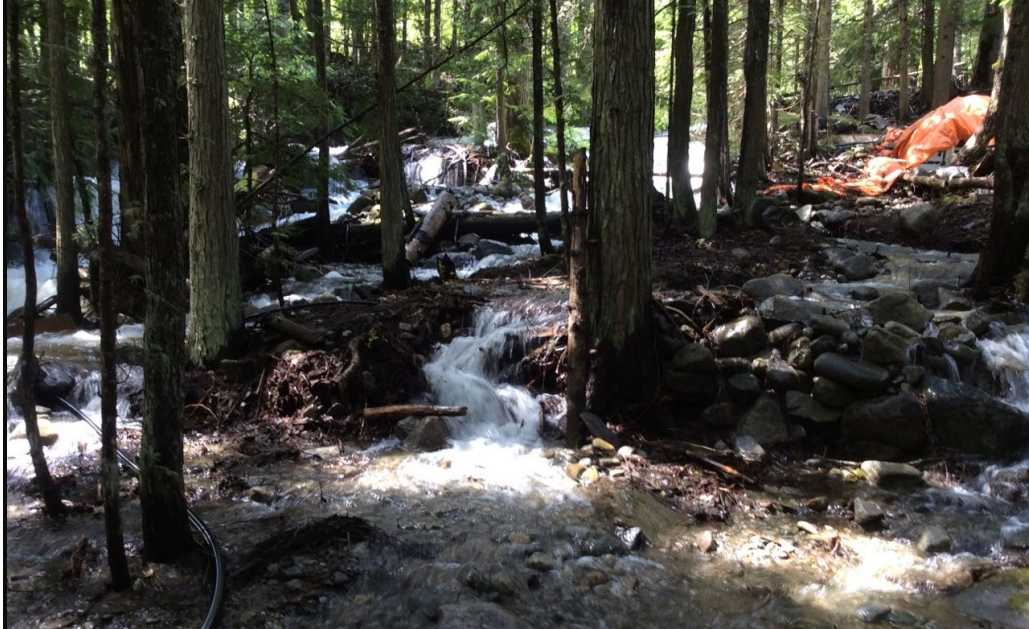
The Giveout Creek fan is inhabited with a combination of mobile and manufactured homes and other residences (Figure 3-14). Mobile and manufactured homes are more vulnerable to the impact forces associated with debris flows than other building construction types. In BGC’s field reconnaissance, BGC noted multiple locations where Giveout Creek is poorly confined to the

**Figure 3-15. Giveout Creek through a poorly confined section of its fan. Numerous water intakes were noted with abundant pipes and other infrastructure in the flow path. Photo: BGC, June 12, 2022.**

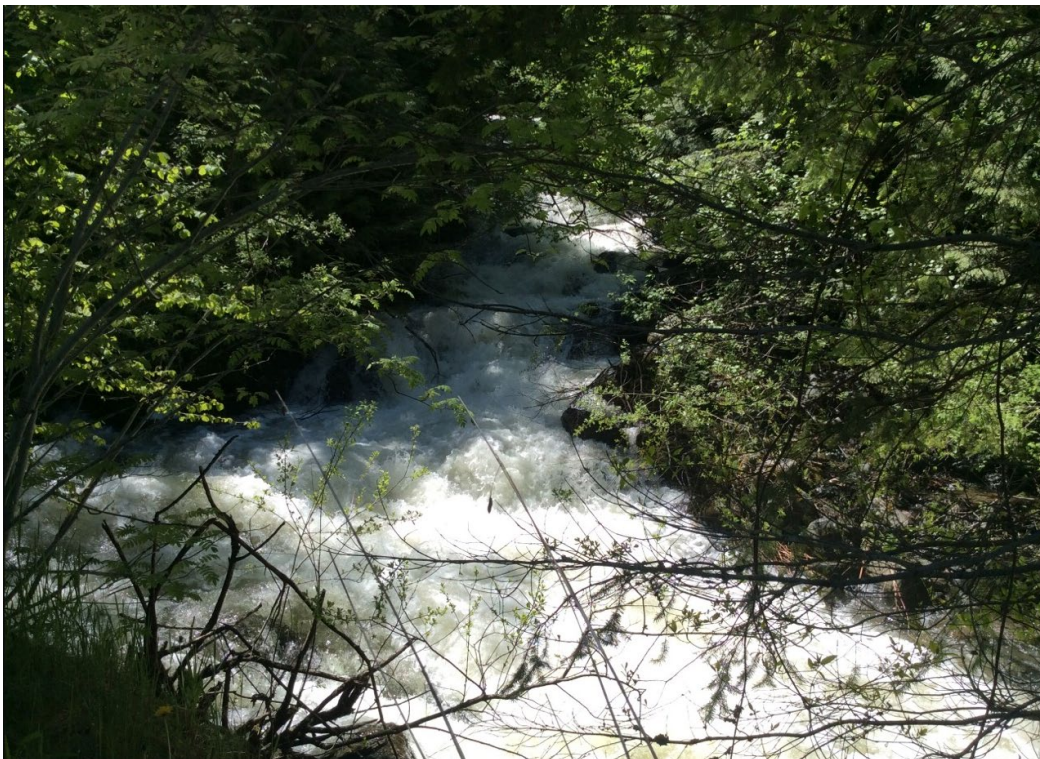
creek channel and avulsion potential exists (Figure 3-15). Cottonwood Creek flows northward along the base of the Giveout Creek fan immediately adjacent to Highway 6 (Figure 3-16).

**Figure 3-16. Giveout Creek at the confluence with Cottonwood Creek photographed from across Cottonwood Creek at Highway 6. Photo: BGC, June 12, 2022.**

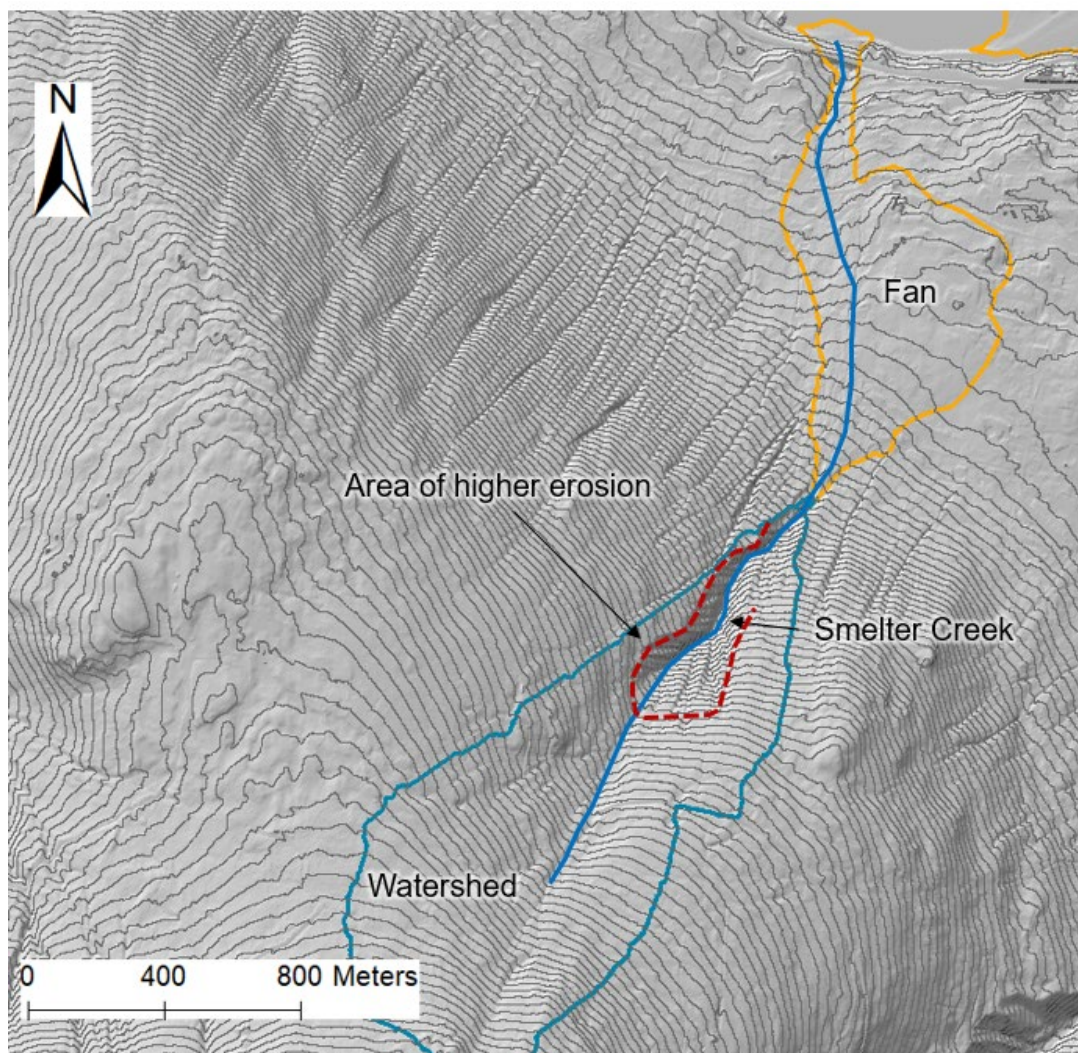
**Figure 3-17. Smelter Creek watershed (teal) and fan (orange). Outlined in red is an area of particularly high erosion that should be investigated in the field. Contour interval is 10 m.**

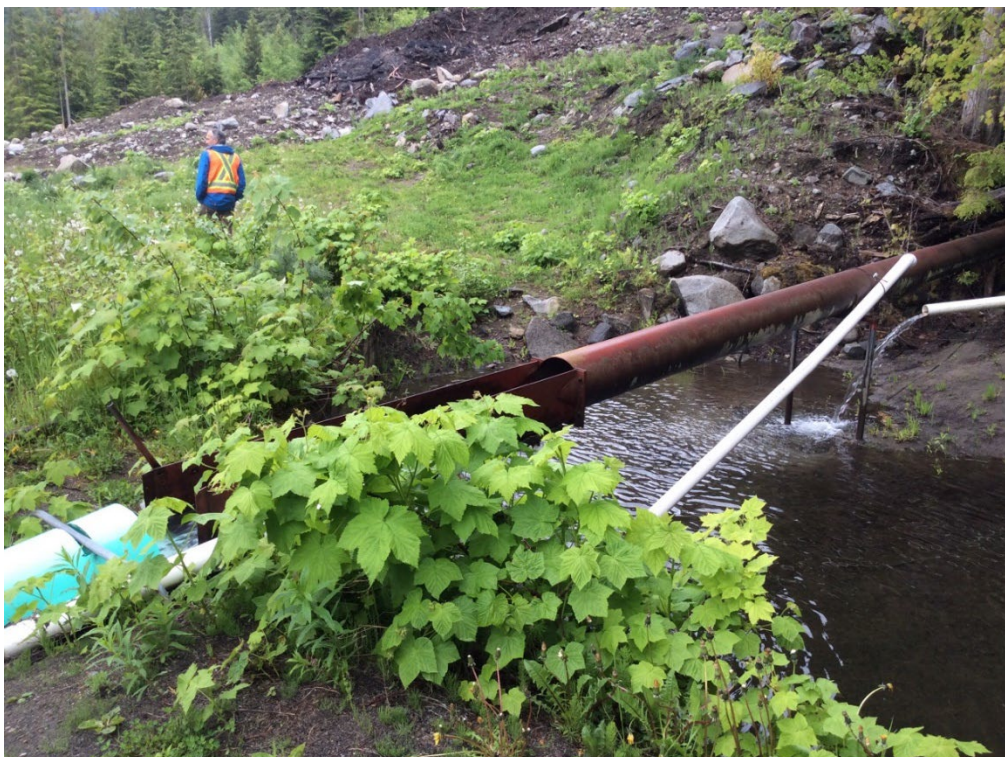
Recent excavations on the upper fan appear to be associated with housing development plans and golf course expansion. The subsurface consists of large boulders with up to 1 m diameter which is typical for debris-flow fans. A small water retention pond and some water works (presumably for golf course irrigation) were noted at an elevation of approximately 730 m (Figure 3-18).

**Figure 3-18. Small water retention pond and water diversion works on Smelter Creek, looking east. In the background recent ground disturbance associated with possible housing development and golf course expansion. Photo: BGC, June 12, 2022.**
