POST-WILDFIRE NATURAL HAZARD RISK ASSESSMENT

RECONNAISSANCE REPORT

FIRE: N71245 Cultus Creek	FIRE YEAR: 2021	DATE OF REVIEW: August 13, 2021 DATE OF REPORT: March 28, 2022
----------------------------------	------------------------	---

AUTHOR: Tim Giles, MSc, PGeo, Senior Geoscientist, Westrek Geotechnical Services Ltd. (Westrek)

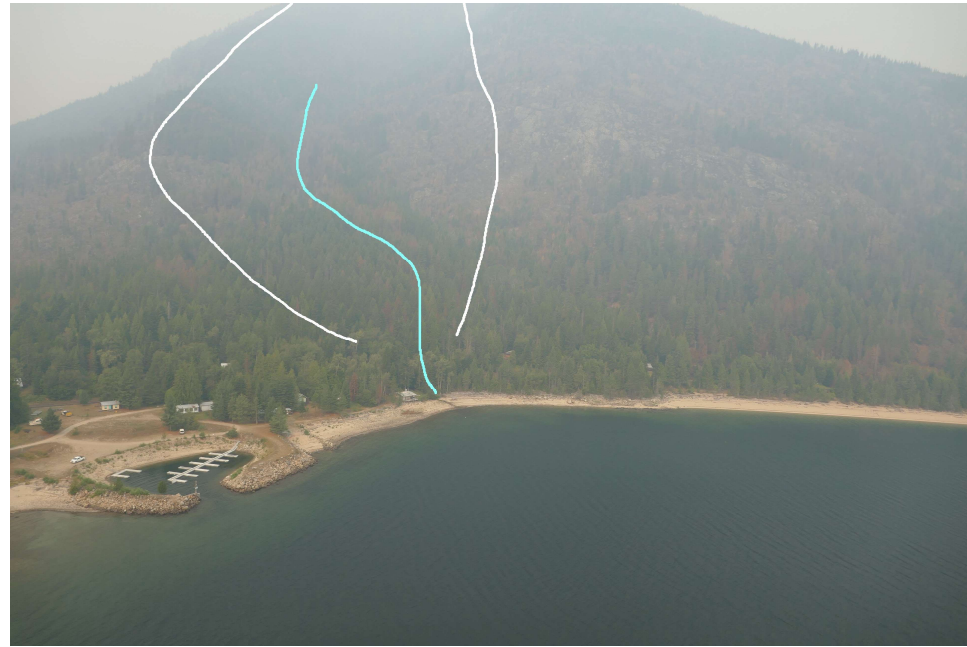
A steep gully at the south end, referred to as Tye Creek (Photos 1, 2 + 3), was significantly burned and further work was completed to determine the expected hydrogeomorphic hazard. The Melton ratio (watershed relief divided by the square root of watershed area) is used to differentiate flood and debris flow watersheds (Wilford 2004¹). The Melton ratio for this gully is 1.067, indicating that the expected hydrogeomorphic event is a debris flow. For the most part, the gradient of the channel varies from 40% and 60%, which will be sufficient to transport a debris flow to the fan. The fan surface has a gradient of around 20%, suggesting debris flows are likely to cross the fan and reach the lakeshore. The fan was mostly unburned,

Photo 1: View looking northwest up the Tye Creek draw (creek in blue, watershed boundary in white). The Cultus Creek valley is visible at the left of the image. The boat basin and most of the recreational properties are on the Cultus Creek fluvial fan.

There is an estimated moderate likelihood that a debris flow could impact the buildings, road and the CP Rail line along the base of these slopes. It is recommended that the affected stakeholders confirm this risk and manage it where possible.

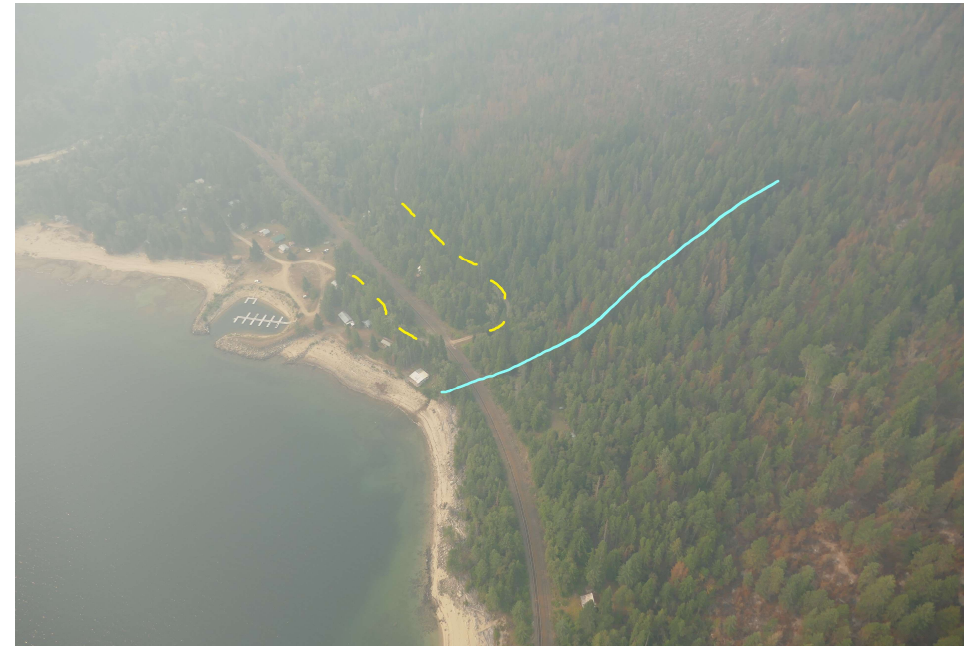
and the trees might provide some protection from debris flow events. This fan coalesces with the Cultus Creek fluvial fan along the lakeshore; several buildings, a road and the CP Rail line cross the fan.

If a landslide enters Tye Creek, it will likely transition into a debris flow and reach the lake. The fan was mostly unburned, and the channel gradient decreases across it, suggesting that a debris flow might arrest on the fan surface.

Photo 2: View looking south across the alluvial fan of Tye Creek (creek in blue). The CP Rail line cross the mid-fan. Amongst the trees upslope of the rail line is a road (yellow dashed line) and some buildings.

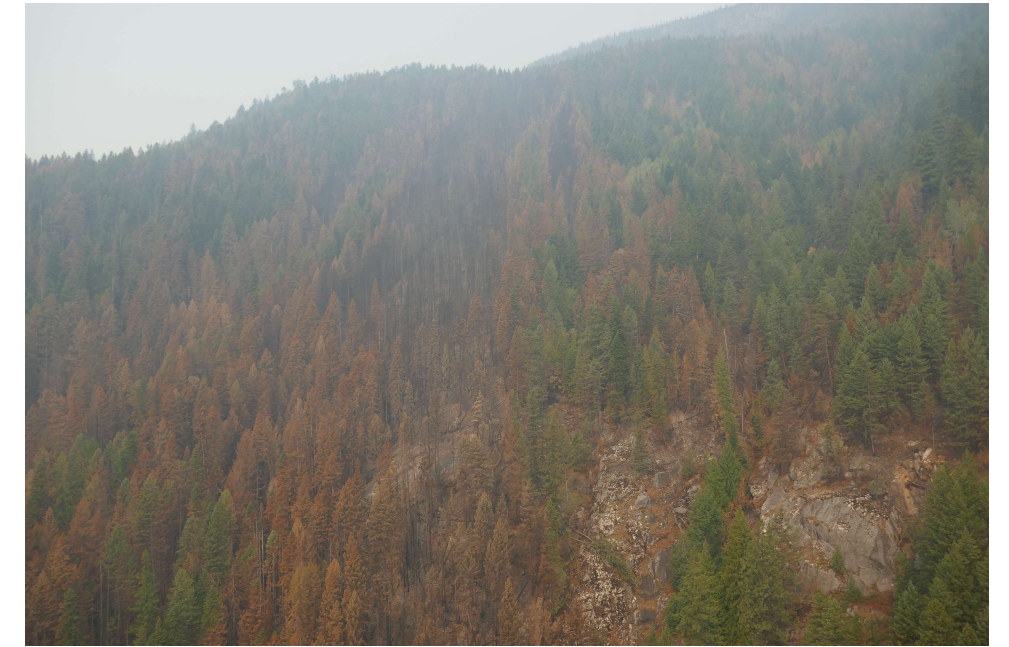
Photo 3: View of the steep upper slopes of the Tye Creek drainage. The significant patch of high burn severity is located across the upper creek channel.

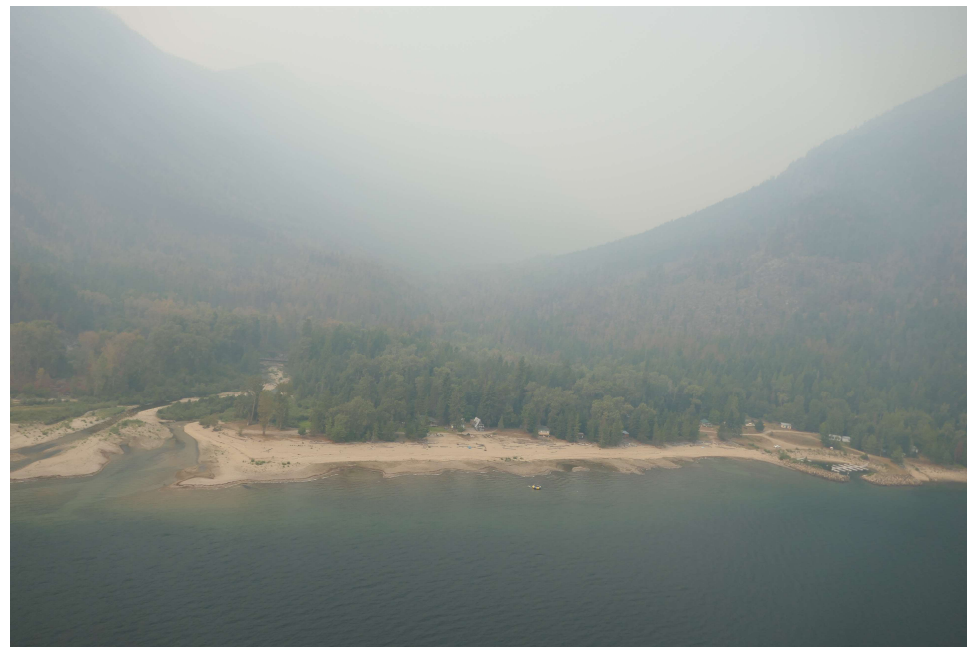
Cultus Creek is low gradient with steep-sided valley walls that flows into Kootenay Lake across a large fluvial fan (Photo 4). In the lower watershed, the south-facing slopes are a patchwork of older fire scars, exposed bedrock and logged cutblocks. The north-facing slope is covered with a dense canopy of trees, which is dissected by numerous gullies and some snow avalanche paths.

Photo 4: View looking over the Cultus Creek fluvial fan and up the Cultus Creek valley.

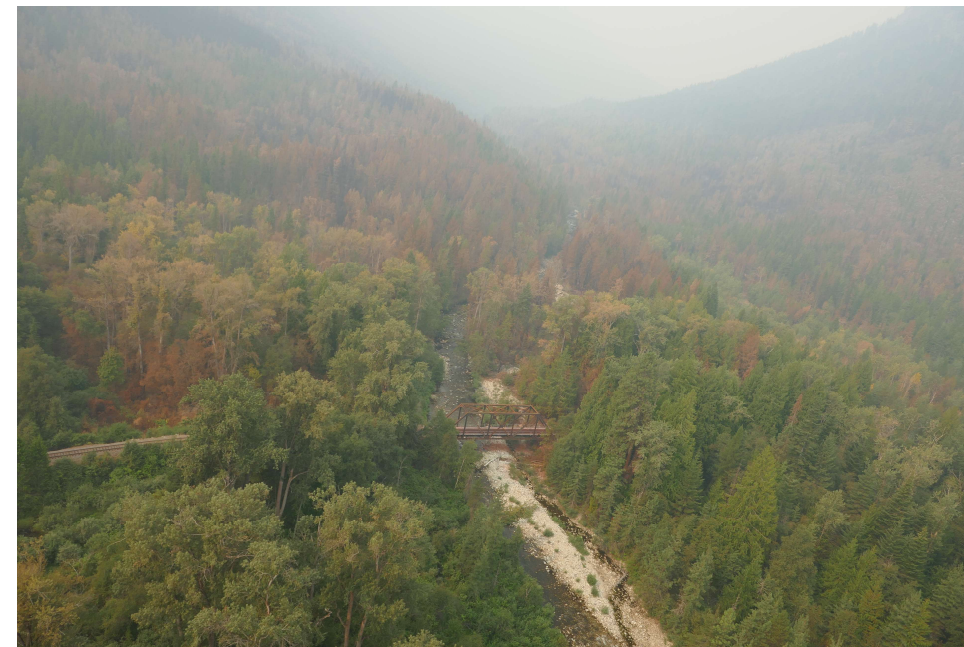
The CP Rail Line crosses Cultus Creek using a bridge on the large fluvial fan (Photo 5).

The recreational properties, roads and the CP Rail line and bridge crossing on the fan should not be impacted.

Photo 5: The CP Rail bridge across Cultus Creek.

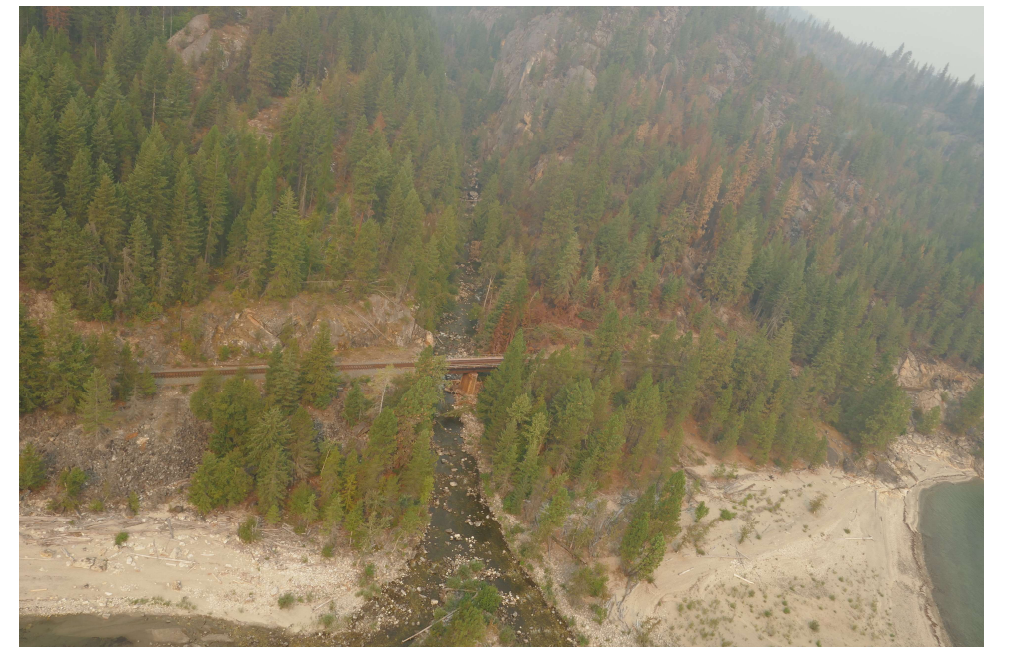
No active roads are within the fire perimeter, although the Next Beach Recreation Site is located on the north side of the fan, and the CP Rail line crosses creek using a bridge on the small, bedrock-controlled part of the fan (Photo 6).

The Next Beach Recreation Site on the fan should not be impacted, nor should the CP Rail bridge crossing.

Photo 6: The CP Rail bridge across Next Creek.
