Development Permit

DP2302A (May)

10377 Highway 3A, Gray Creek, BC

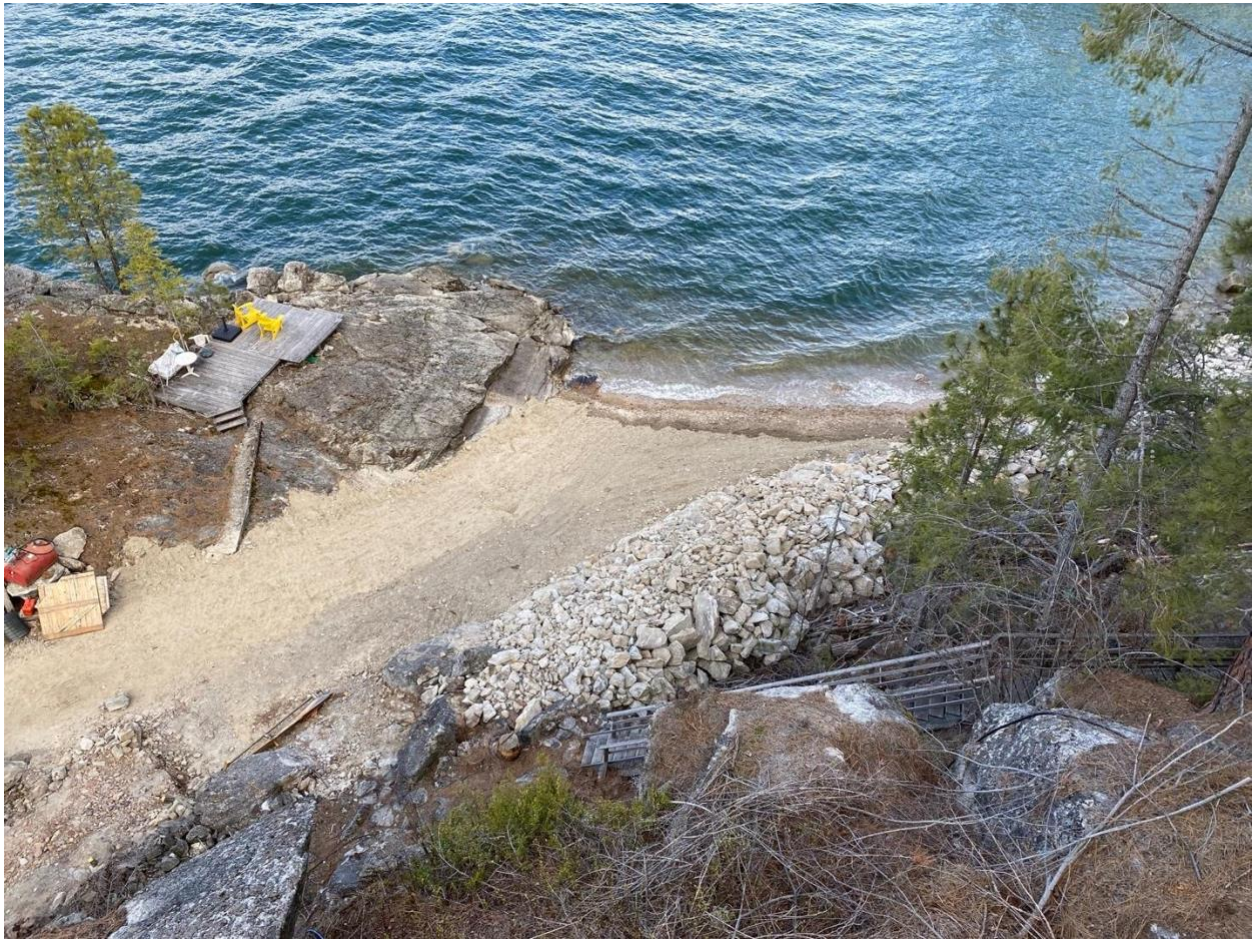
Figure 9. Overhead view of the north channel showing foreshore cleared of boulders and debris.

All rock fragments under 15 cm in diameter appear to be removed in the northern channel spanning an approximate distance of 10 m wide and 25 m long north of the natural lake boundary (Appendix A: Figure 9). As determined in the RAA report, previous site conditions held the potential for juvenile fish rearing habitat (Appendix B). Consequently, the removal of all rock fragments may impact fish rearing habitat on-site by:

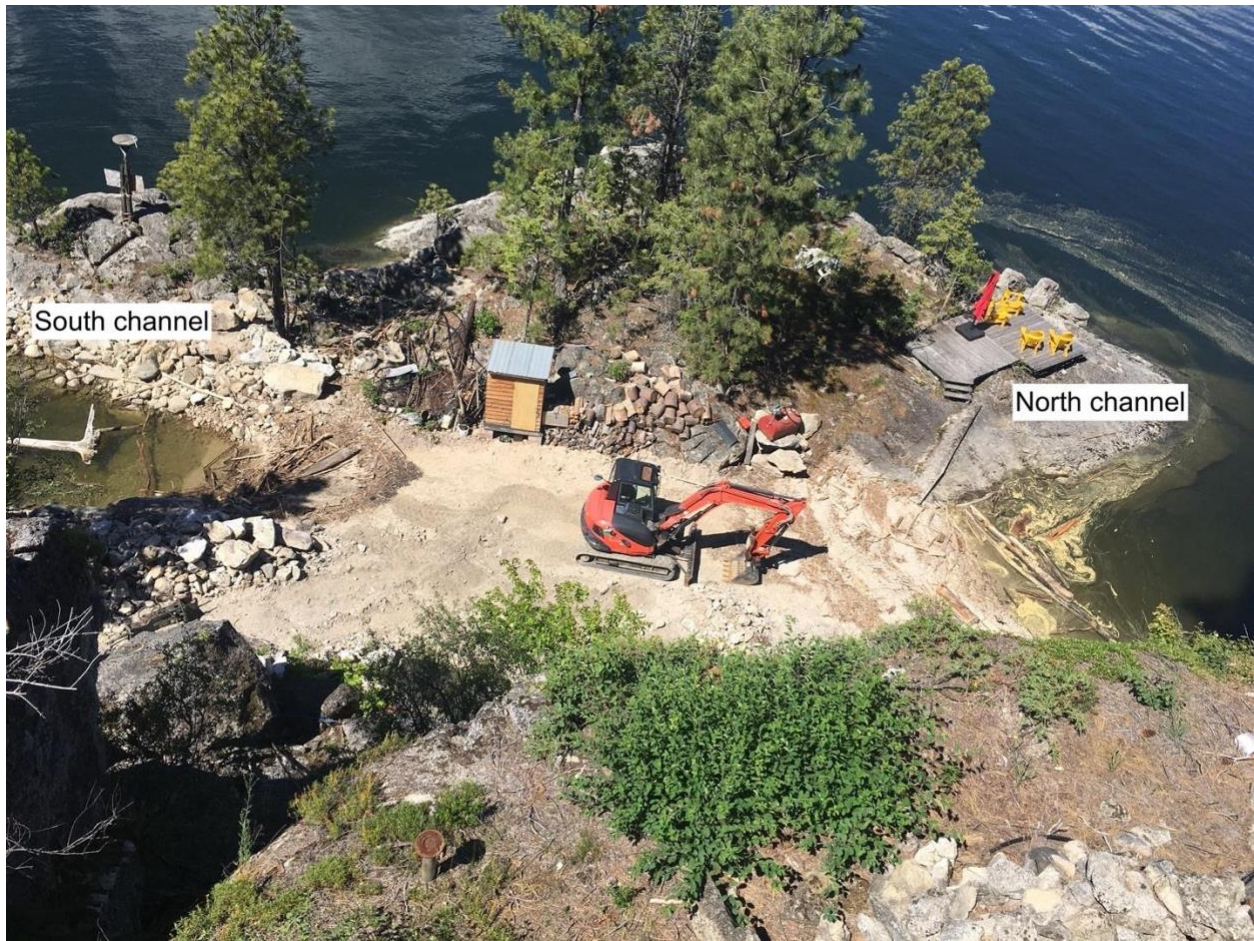
Figure 10. Overhead view of the site following construction activities.

Terrestrial conditions were assessed as those above the natural lake boundary (i.e., high-water mark). A path approximately 10 m wide was observed from north to south connecting the two channels on-site (Appendix A: Figure 10). The path was predominantly sand with minimal coarse rock fragments and no coarse woody debris above the natural lake boundary (Appendix A: Figure 11). No vegetation was seen growing in the sandy area.

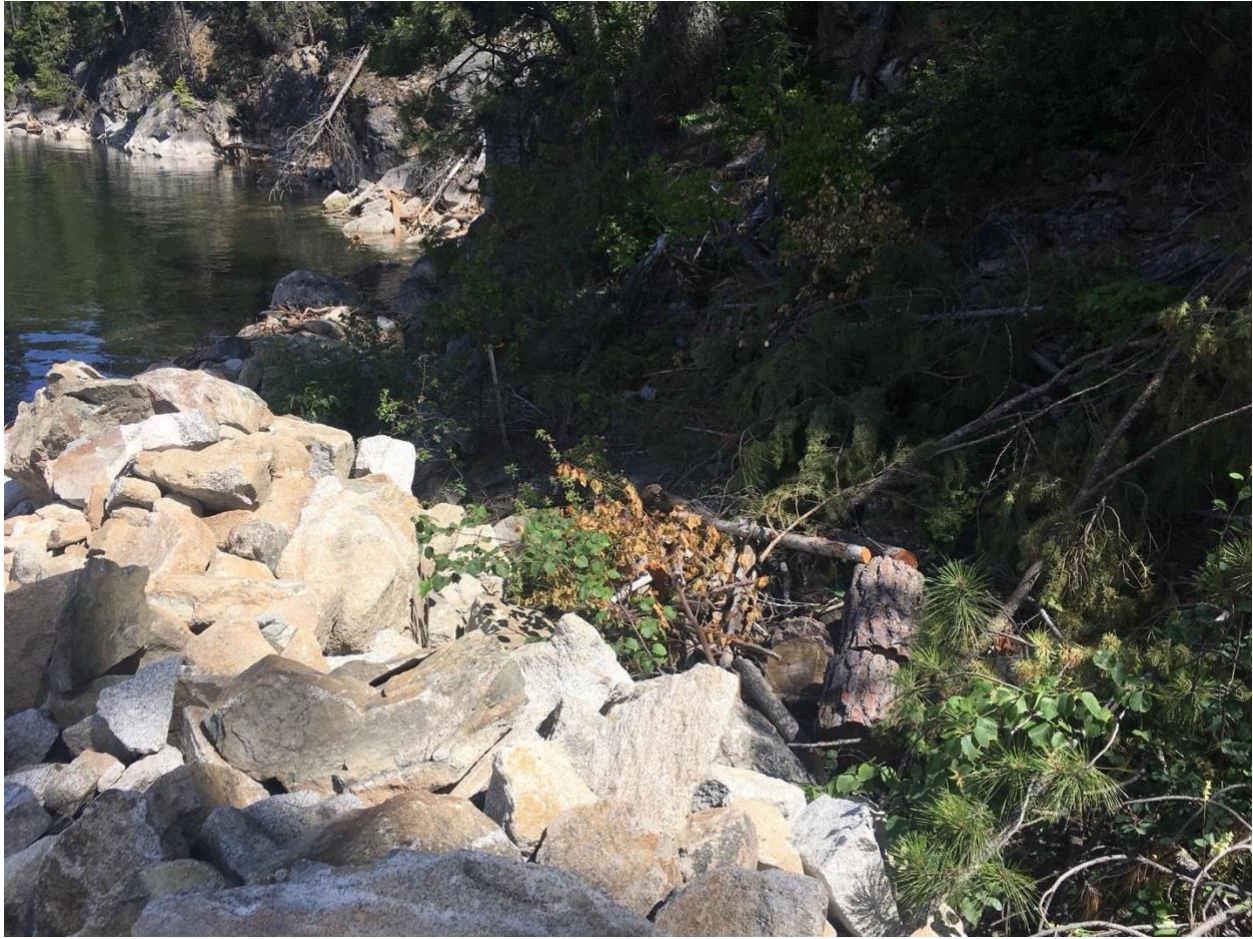
Figure 12. The eastern shoreline of the north channel where trees were removed.

The property owner reported removing three ponderosa pine (*Pinus ponderosa*) and three Douglas fir (*Pseudotsuga menziesii*) trees on-site due to damage from a storm during the 2021-2022 winter. The QEP confirmed the location along the north channel's eastern shore (Appendix A: Figure 12). No other vegetation was observed to be removed along the shoreline during construction.

Atop the rock berm, twelve trees (six ponderosa pine and six Douglas fir) should be planted at a 2 m spacing to replace the trees removed during construction. If the birch sapling is harmed during the recontouring of the rock berm, then two birch trees should be planted in replacement to maintain adequate microsites. The total number of trees is inflated to account for a 50% survival rate following planting. The juvenile trees should be planted as container stock in the spring of 2023. In addition, any added topsoil should be covered with mulch to prevent erosion and maintain sufficient soil moisture.

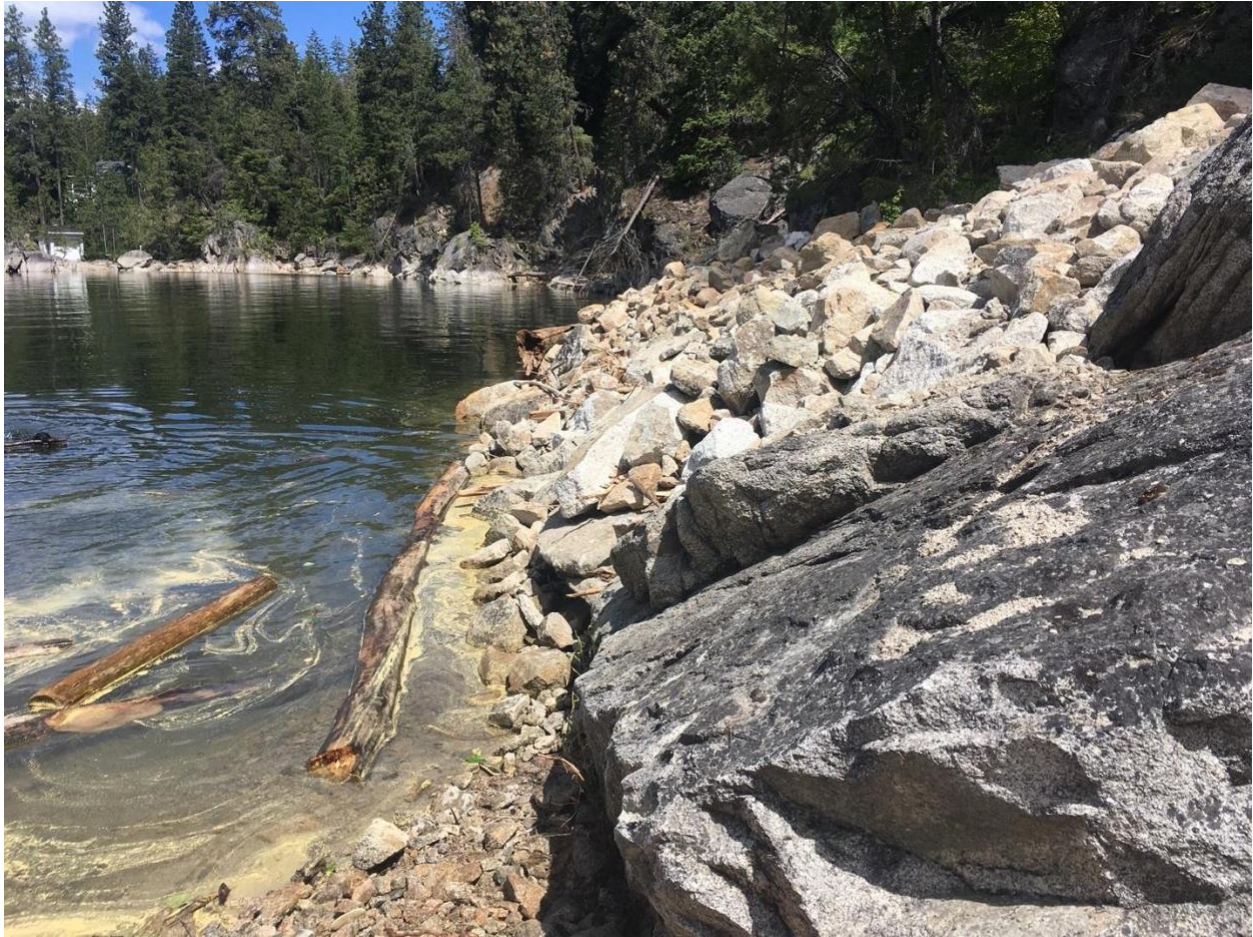
Figure 13. Rock berm along the eastern shore of the north channel.

A rock berm approximately 1-2 m tall, 25 m long, and 5-10 m wide was observed along the eastern shore of the north channel (Appendix A: Figure 13). The berm was built of rock material removed during construction ranging from 10-100 cm in diameter at an approximate 75% (or 36°) slope. The berm covered a stretch of natural vegetation approximately 1 m wide along the shoreline. One young paper birch (*Betula papyrifera*) appeared unharmed by the surrounding rock fragments (Appendix A: Figure 14). No vegetation appeared to be growing on the berm at the time of the site visit, other than the birch sapling.

The rock berm was observed to cover a 1-5 m wide foreshore section along the north channel's eastern edge. Rock fragments in the foreshore varied from 10-100 cm in diameter. The northern portion of the rock berm gradually slopes downward to meet the natural ground of the foreshore. During high water levels, there is a potential for water to pool behind the rock berm and trap fish. Woody debris was observed to have collected behind the rock berm during the peak high-water levels in early June, providing evidence for the potential for fish entrapment (Appendix A: Figure 17). No vegetation appeared to be growing on the berm foreshore at the time of the site visit.

The rock berm should be reprofiled to the natural, pre-construction foreshore geometries (reduced height and more gradual slope), using past photos and the surrounding shoreline as a guide. Larger rocks (>40 cm) should be returned to the foreshore for fish habitat to mimic pre-construction site conditions, while smaller rocks can be stored above the high-water mark by creating a talus-like habitat area for revegetation. Special care should be taken to eliminate existing fish stranding opportunities and prevent new ones from being created. Specifically, the northern end of the berm should be levelled with the eastern shoreline to eliminate the potential for fish entrapment during high water in the spring.

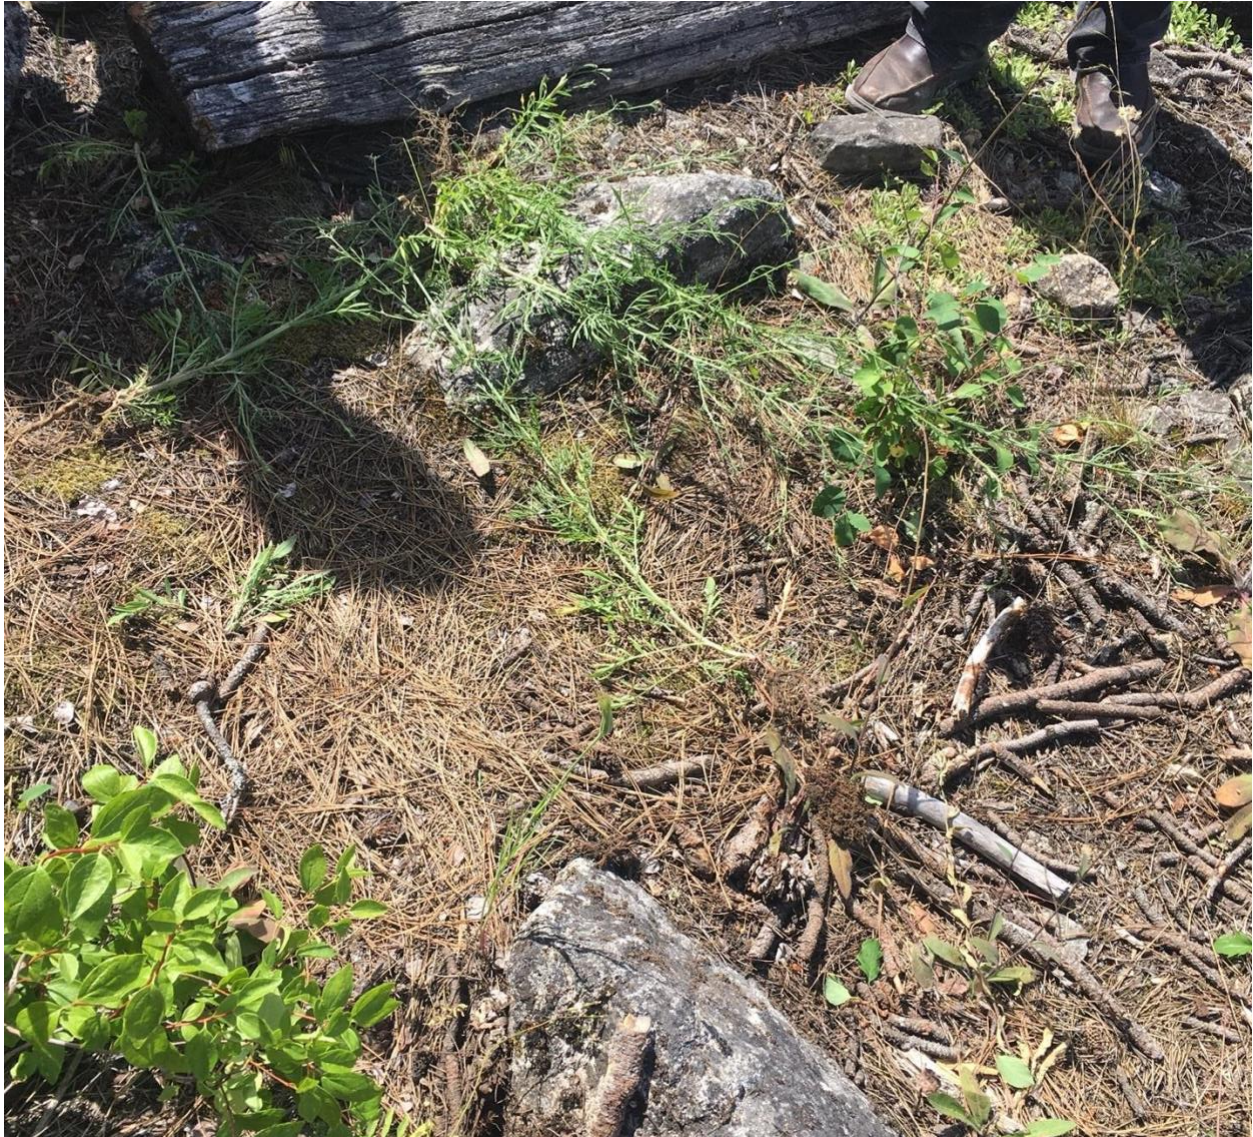
Figure 16. Spotted knapweed manually removed by KES during the June 30 site visit.

Spotted knapweed (*Centaurea stoebe*) and downy brome (*Bromus tectorum*) were observed on-site along the footpath leading from the house to the site, beginning approximately 10 m north-east of the dismantled boathouse (Appendix A: Figure 16).

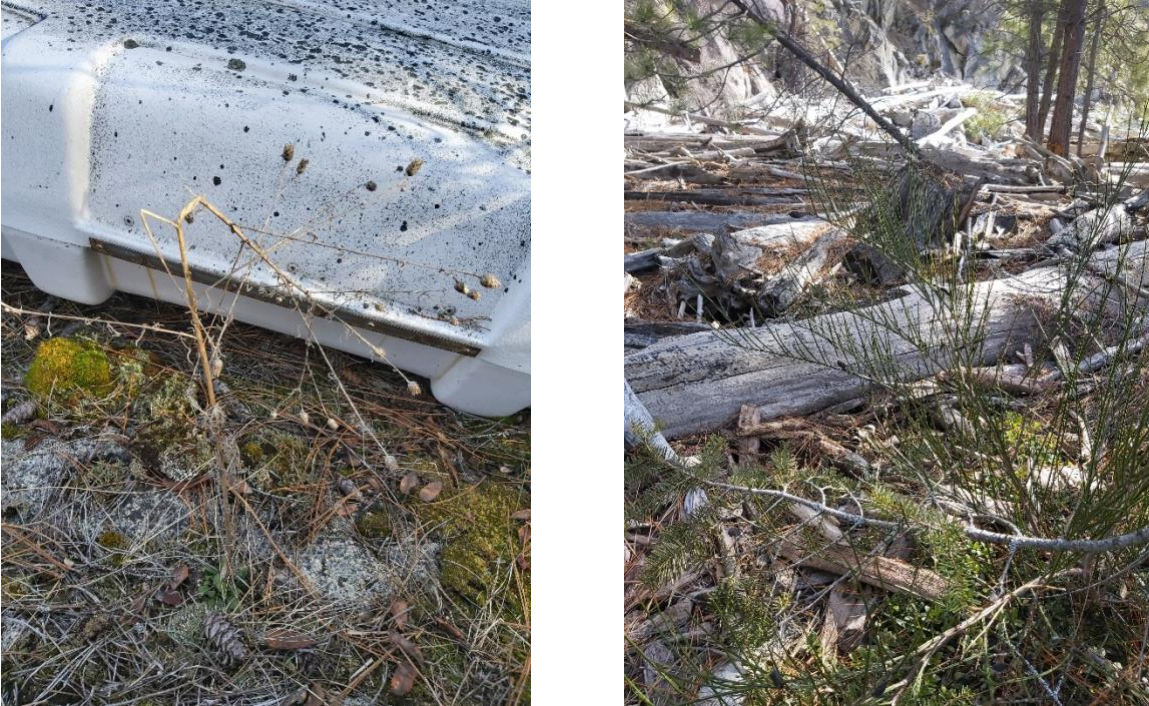
Figure 8. Invasive plant species found within the assessed property boundaries.

Two invasive plant species were observed on the assessed property and are presumed to have originated from populations along the side of the highway (Figure 8). These species were also observed 200 m up and downstream of the assessed property. Spotted knapweed (*Centaurea stoebe*) should be manually removed and chemically controlled, with extra care taken in its application given the proximity to the high water mark. Existing spotted knapweed skeletons should be carefully removed in such a manner that reduces the likelihood of spreading seeds in the process. Scotch broom (*Cytisus scoparius*) should also be removed through manual and chemical means. Plants should be dug or pulled, taking care to remove as much of the root as possible. Scotch broom may also be controlled via chemical means in the spring.

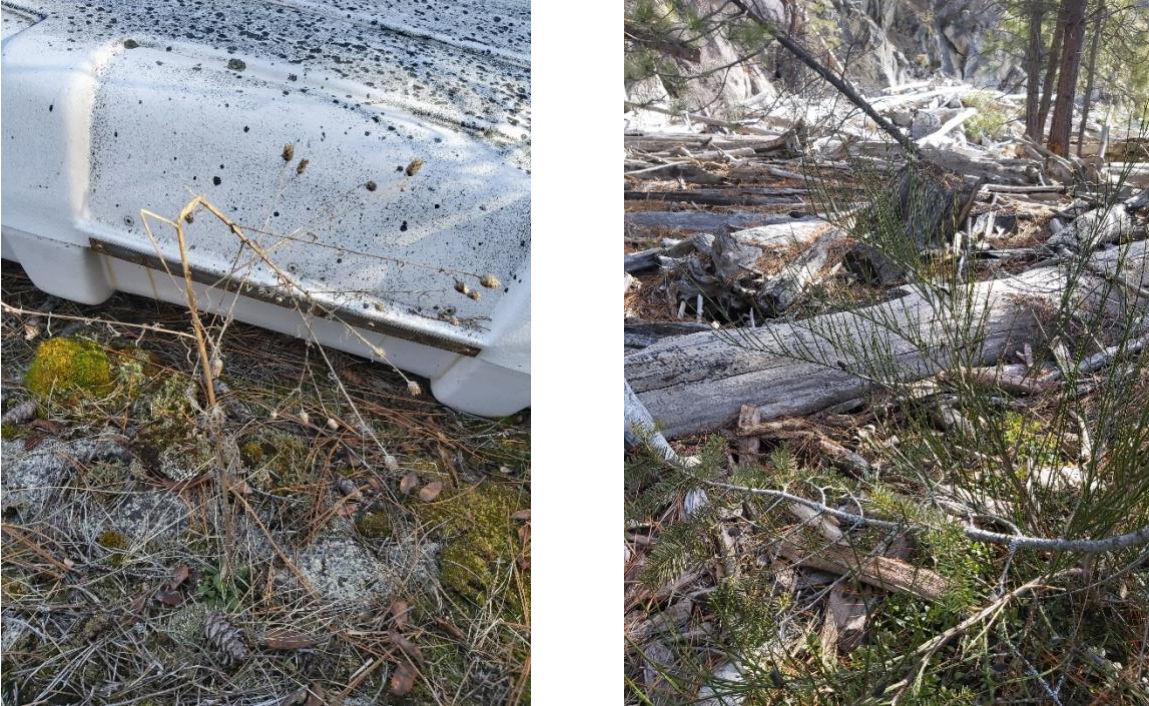
Figure 9. Invasive plant species found within the assessed property boundaries (spotted knapweed (left), scotch broom (right)).

Two invasive plant species were observed on the assessed property and are presumed to have originated from populations along the side of the highway (Figure 8). These species were also observed 200 m upstream and downstream of the assessed property.

- Herbicides are effective against knapweed, including “Round Up”.
- Careful attention must be paid to minimize non-target damage (i.e., implementing selective application), including the use of cut surface application.
- There will be no application of herbicides within 2 m of the high water mark.
- Herbicide use should only be considered if population numbers are overwhelming high for manual removal methods.
