May 8, 2023

From: Sarah Crookshanks, P.Geo., Ministry of Forests

Re: Talbott Creek debris slide and debris flood

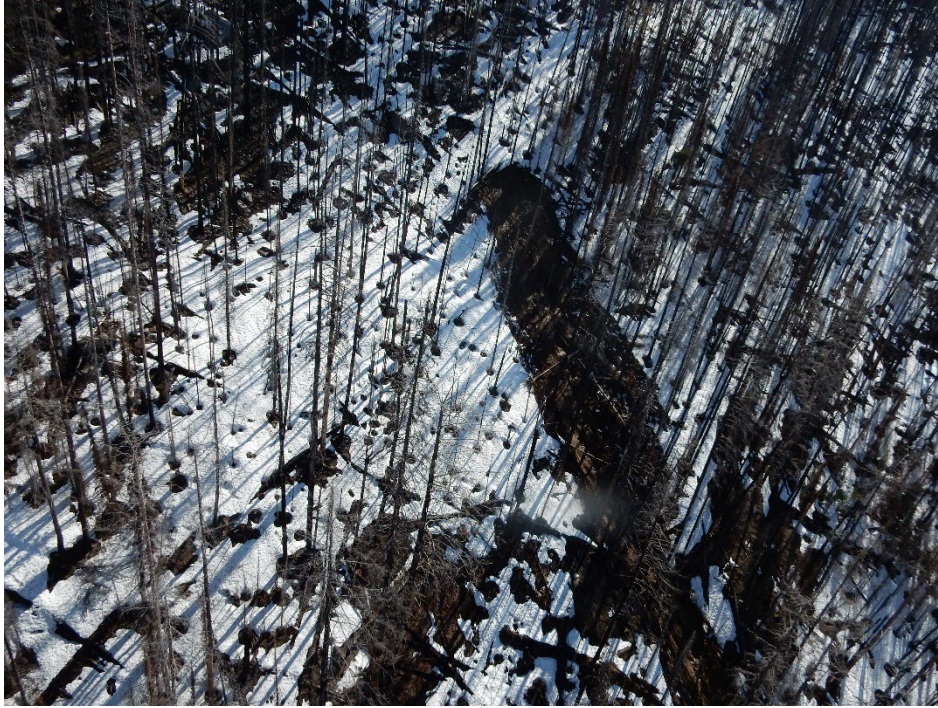
A small gully headwall debris slide in the Talbott Creek watershed resulted in a debris flood that travelled 2.5 km down to valley bottom. The initiation point at 1700 m (49° 35' 0" N, 117° 41' 23" W) and slide path are shown on the map in Figure 1. Photos of the debris slide and ridge top conditions are shown in Figures 2 and 3.

The debris slide was triggered by snowmelt runoff. The preceding hot temperatures caused high snowmelt rates likely exacerbated by the loss of canopy due to the 2020 wildfire. The area upslope of the initiation point is completely burned, composed of both moderate and high burn severity. The lack of canopy would also be expected to result in greater snow accumulation, increasing the amount of meltwater. The drainage area above the initiation point is approximately 2.5 ha, extending up to ridgetop at 1850 m.

Figure 2. Headwall debris slide in the Talbott Creek watershed.

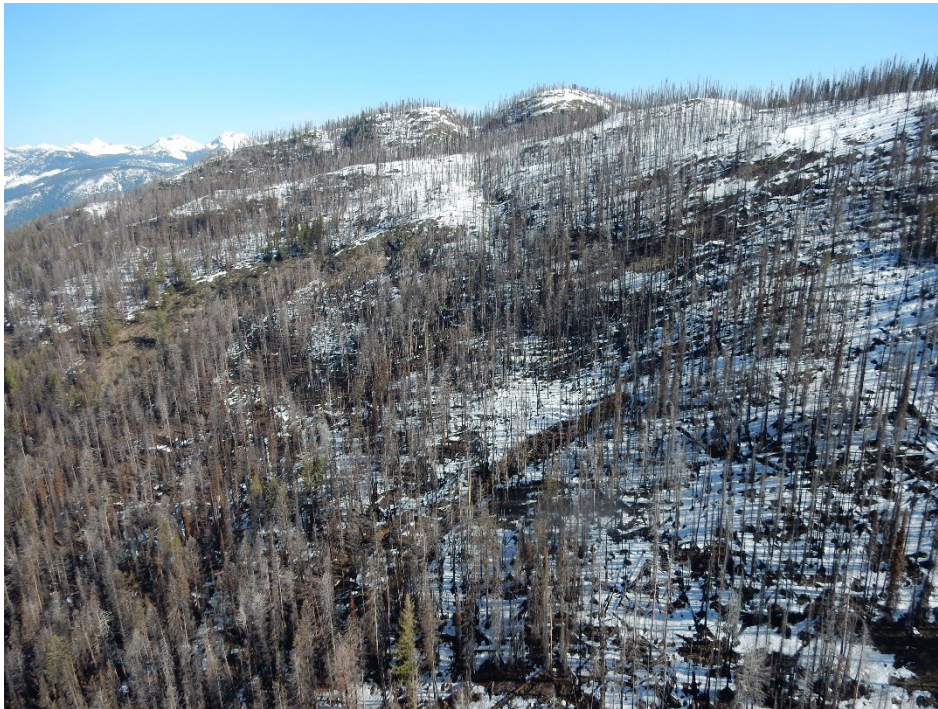
Figure 3. Oblique view looking west of the Talbott Creek debris slide.

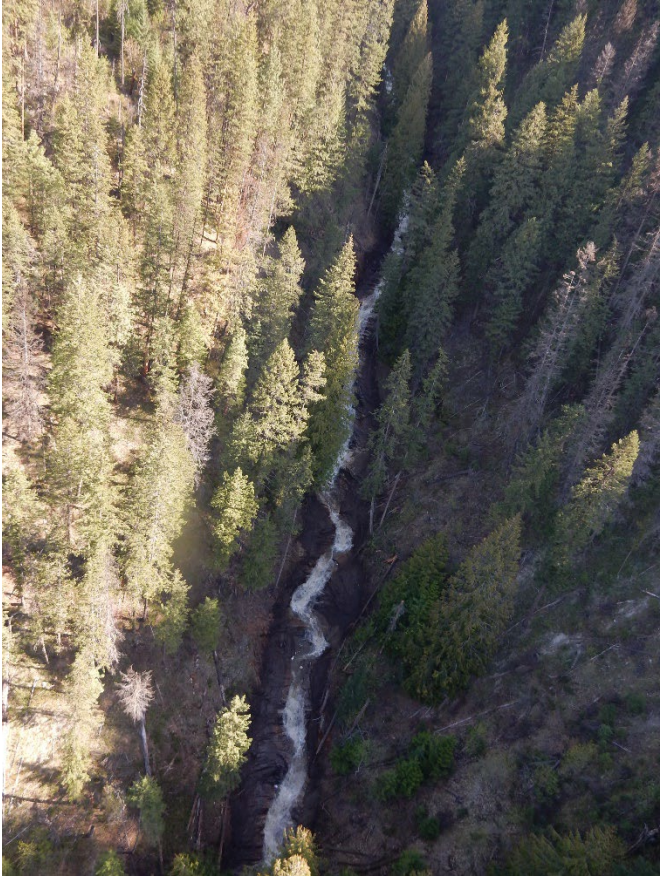
Many segments of the Talbott Creek channel have been scoured to bedrock (Figure 4), and as such there is little remaining transport volume along those reaches. The channel gradient in the headwater area is ~60%, and 40-50% along the middle portion of the channel. If another event occurs, it is likely to be smaller since there is less material available to be eroded.

Figure 4. Debris flood path down Talbott Creek.

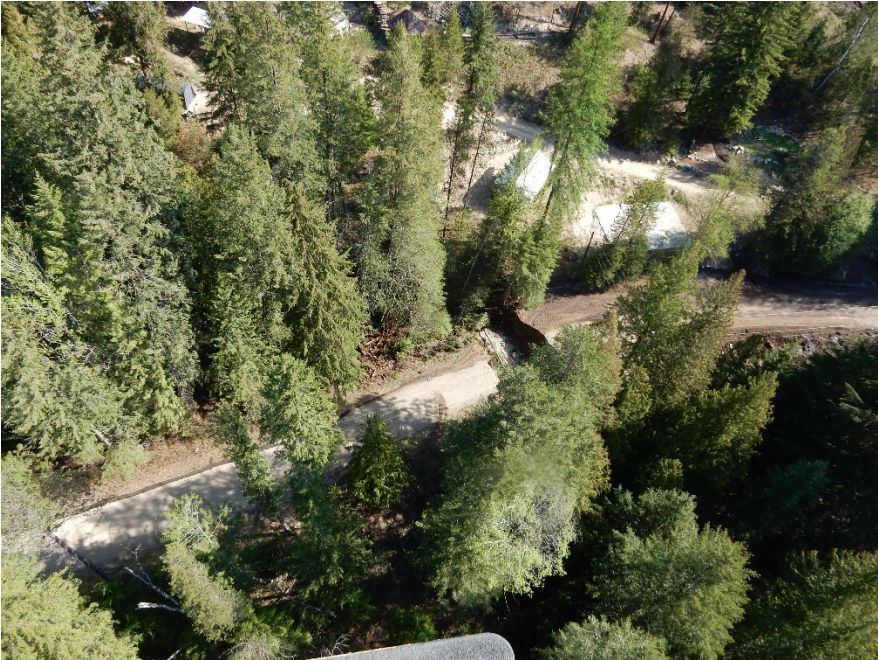
The debris flood plugged the culvert under Little Slokan South Road, then spilled onto the road and eroded through the road prism causing nuisance property damage at 3303 Little Slokan South Road. No dwelling or structure was impacted at this location. The water intake structures at the fan apex were also damaged.

Figure 5. Talbott Creek at Little Slovan South Road.

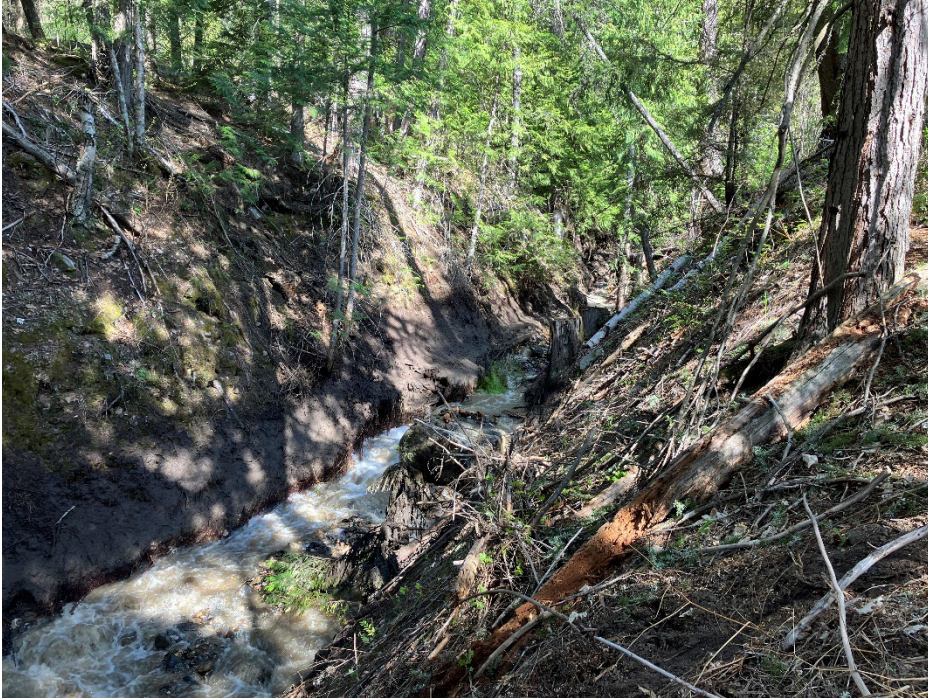
The channel is highly incised for 150 m upstream of the road and 50 m downstream of the road. A small pulse of sediment and water avulsed out of the channel at a water diversion structure 200 m upstream from the road and ran down a private access road located to the west of the Talbott Creek channel. In the event of a large debris flow on Talbott Creek, the flow could avulse at this location impacting the property at 3279 Little Slocan South Road. The landowner at this location was advised of the ongoing

Figure 6. Talbott Creek upstream of the Little Slocan South Road.

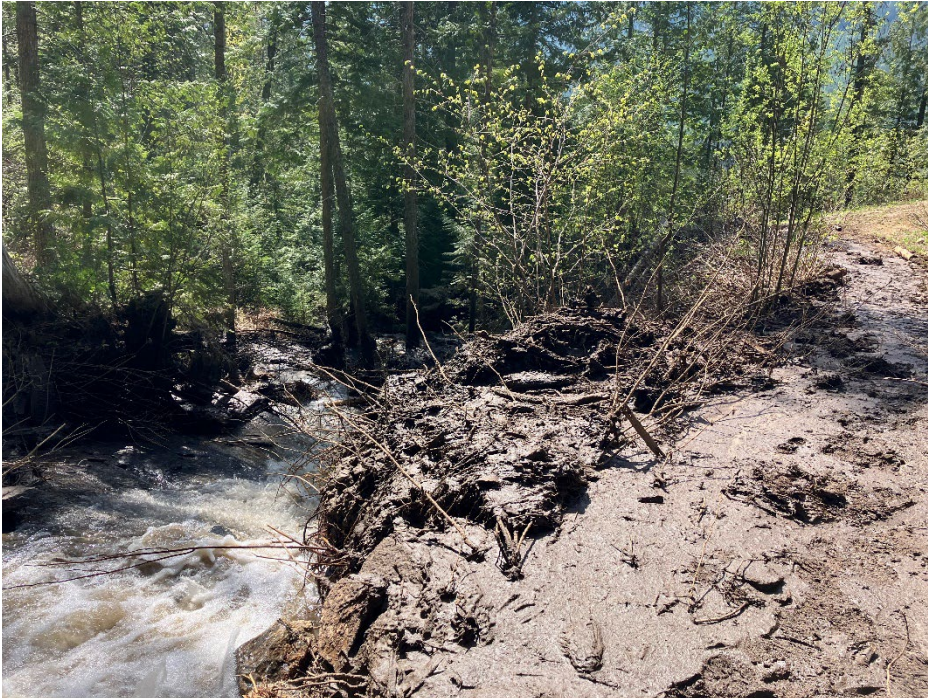
Figure 7. Talbott Creek at its fan apex with a small avulsion down a private road west of the channel.

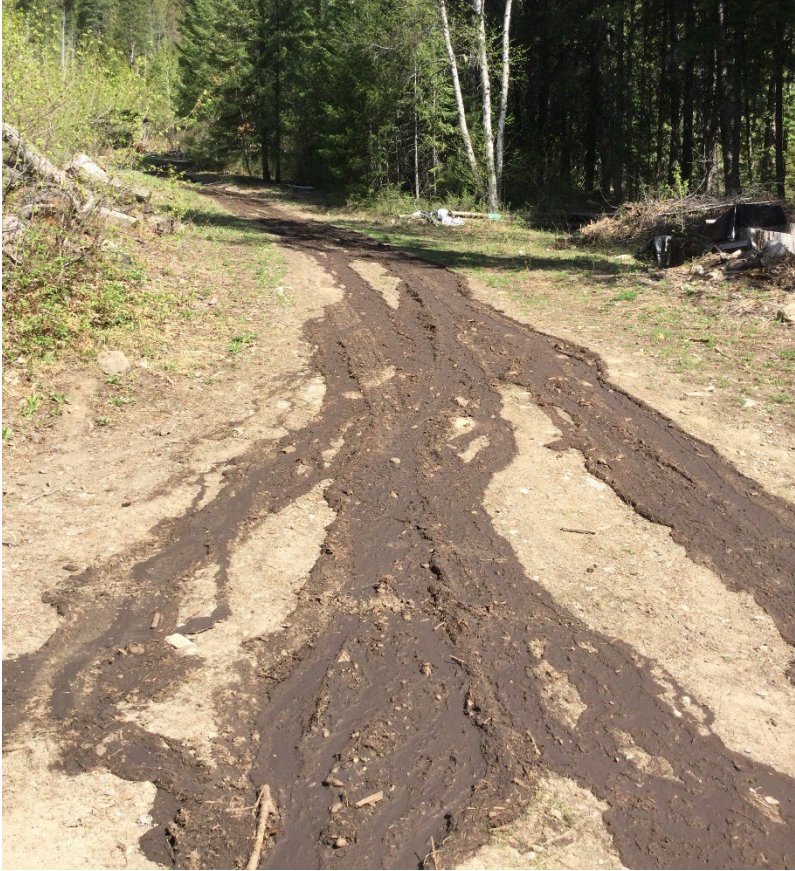
Figure 8. The runout of the small avulsion on Talbott Creek showing mud deposition along a private access road at 3279 Little Slovan South Road.

hazard of another geohazard event on Talbott Creek. I recommended that he avoid spending time in the channel fixing his water intake channel until the snowmelt rates moderated.
