May 7, 2023

Regional District of Central Kootenay  
Emergency Management Program

Re: Unnamed Creek Little Slocan South Road Landslide

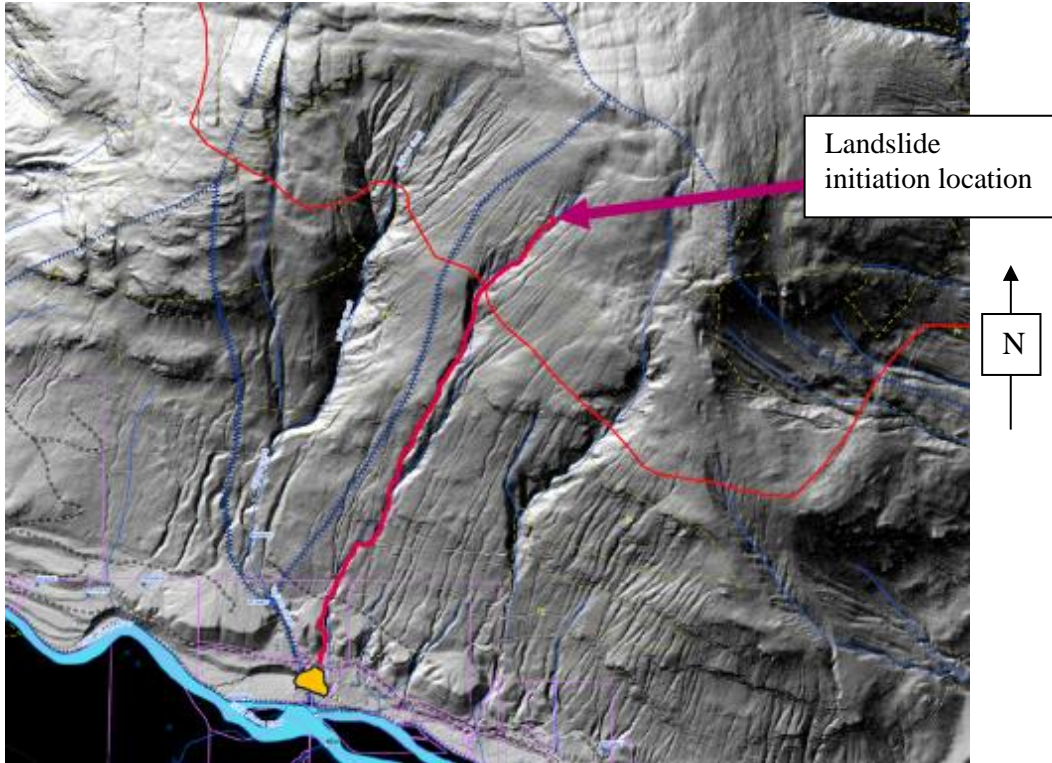
The landslide was primarily mobilized as a debris flow at the location shown in Figure 2. Photos 1 and 2 show the typical channel condition post-debris flow. A small debris slide was observed at approximately the 1550m elevation (Photo 3 and Figure 3) which was responsible for the debris flow initiation. The debris slide initiation was located within and downslope of areas of moderate and high burn severity. The drainage area above the debris slide is about 15 hectares extending up to the height of land at 1850m.

Figure 2 Landslide transport path on LiDAR image

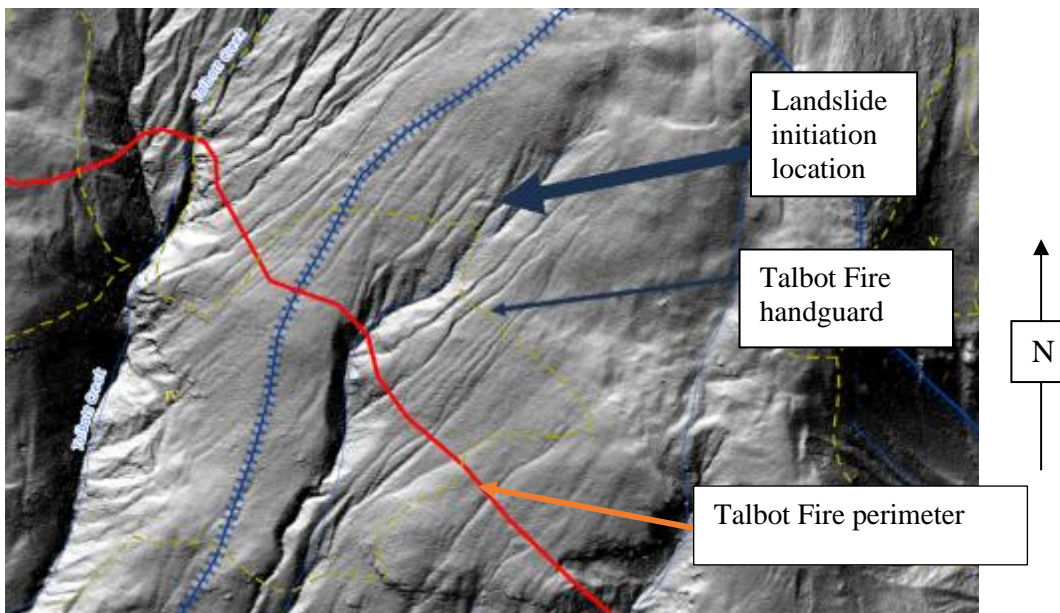
Figure 3 Landslide initiation on LiDAR image

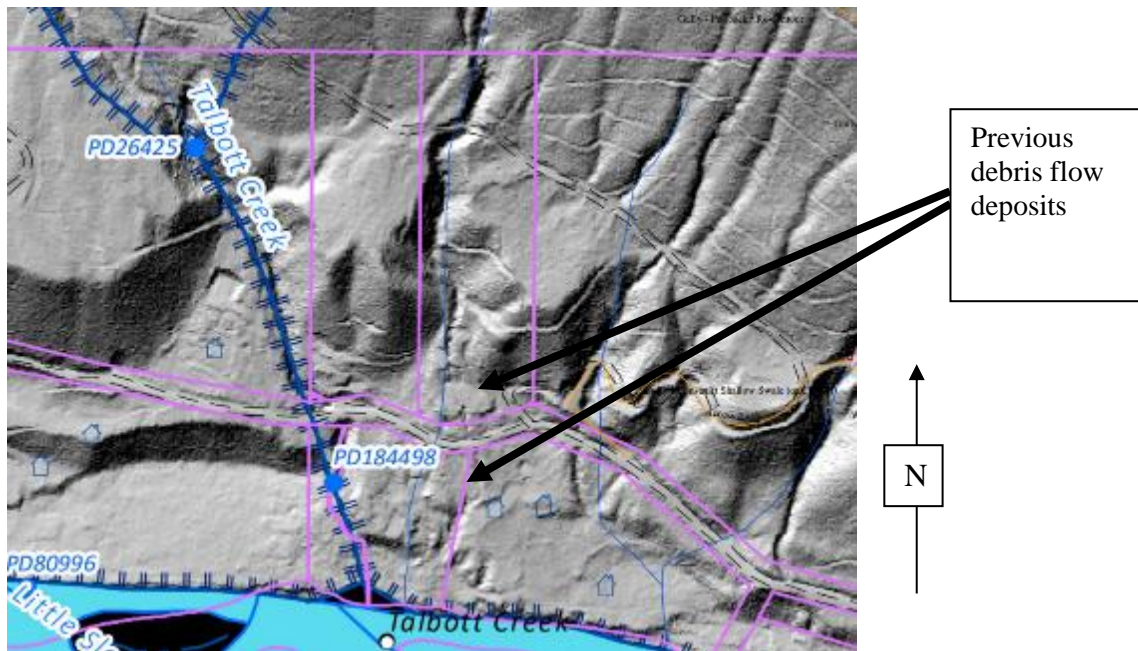
elevation (Photo 5). Figure 4 shows historical debris flow deposits. The total landslide path was approximately 2.3 km.

Figure 4 UCET fan and previous debris flow deposits on LiDAR image

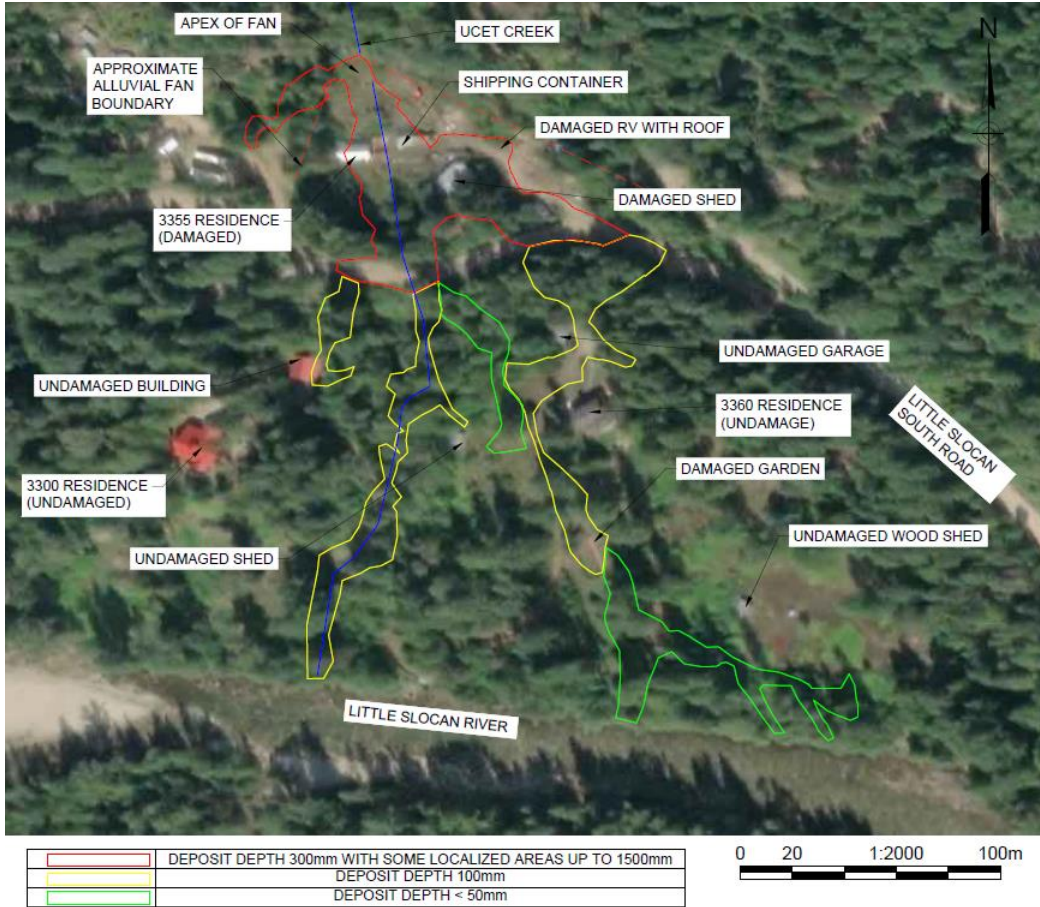
**Figure 5.** Plan view sketch of the landslide deposit

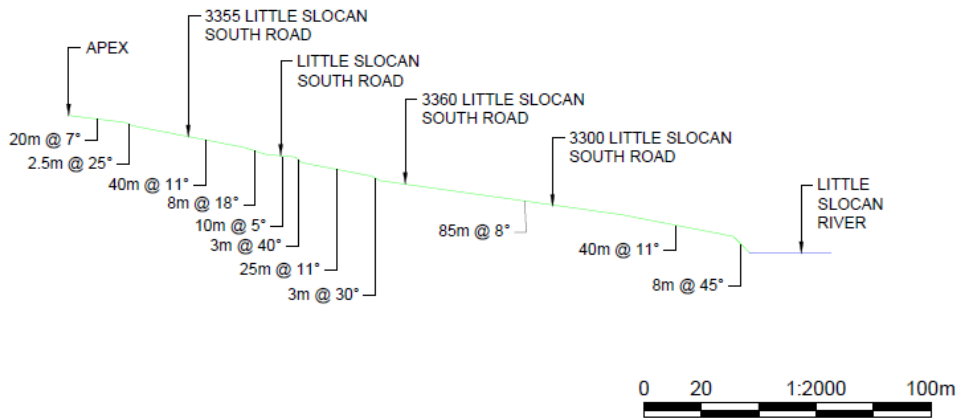
**Figure 6.** Profile sketch of the fan at the creek location

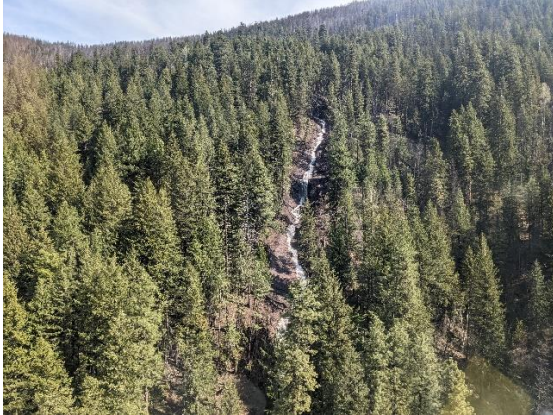
**Photo 1.** Debris flow path lower channel

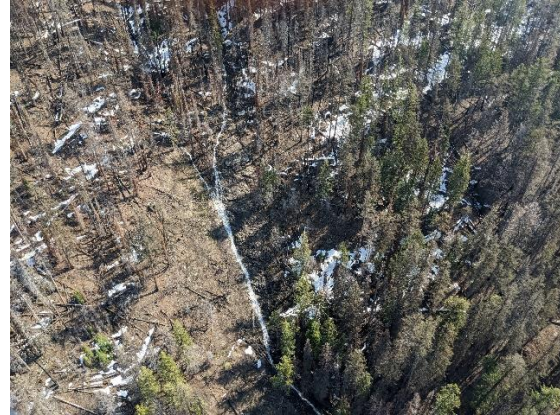
**Photo 2.** Debris flow path upper channel

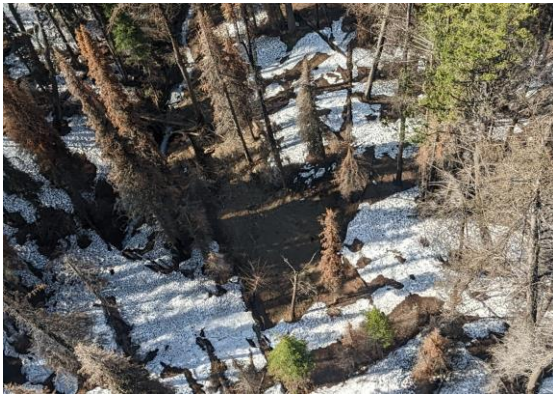
The debris flow was caused by the initiation of the small debris slide at the 1550m elevation. This debris slide was likely initiated by stream bank undercutting caused by high stream flows due to consecutive very hot and sunny days (30 degrees) resulting in a very rapid snowmelt. The snow cover was patchy at the debris slide initiation location (50% snow cover). The moderate to high burn severity due to the 2020 Talbot Wildfire (upslope of the debris slide initiation location) would have resulted in a higher snowpack and quicker snowmelt under radiant conditions exacerbating the runoff flow volumes.

**Photo 3.** Gully sidewall debris slide at 1550m

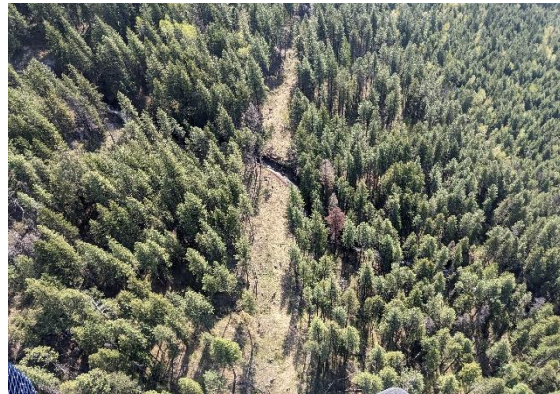
The debris flow traveled through a lower to mid-slope machine fire guard located at the 820m elevation (Photo 4) and remained confined in the channel until it flowed over the fan at 570m

**Photo 4.** Debris flow path through lower fire guard

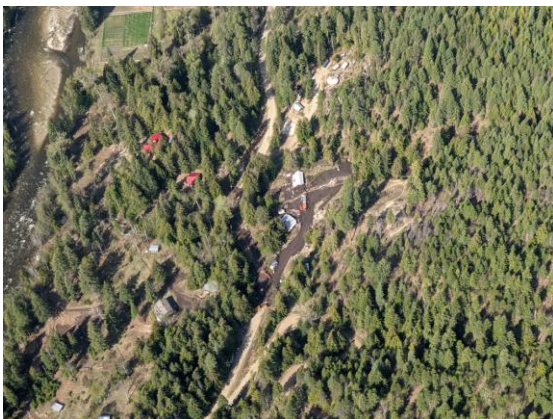
**Photo 5.** Debris flow deposit

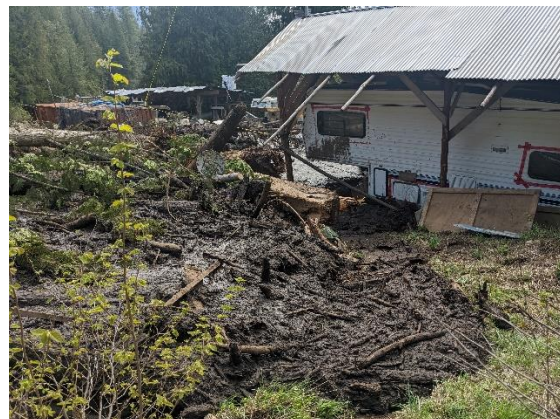
Significant damage occurred to infrastructure at 3355 Little Slocan South Road (Photo 6) which is located on the alluvial fan directly below the fan apex. Debris was directed to the east down a driveway access road to the Little Slocan South Road. Nuisance debris was carried to portions of the properties located on the lower side of Little Slocan South Road (see Figure 5) due to debris flowing down the driveway (3355) and due to the culvert blockage on Little Slocan South Road. The total landslide deposit volume is estimated at between 2,500 and 5,000m<sup>3</sup>. Unit debris flow volume per channel length was calculated at 1 to 2m<sup>3</sup>/m which is consistent with the author's experience with other debris flows in primarily bedrock-controlled channels. A profile sketch at the creek location is shown in Figure 6.

**Photo 6.** Debris flow deposit lobe adjacent to occupied dwelling at 3355 Little Slocan South Road

The property at 3355 Little Slocan South Road is located high on the alluvium fan and exposed to future debris flows (even small volume debris flows). Given the significant snowpack still present between the 1550m and 1850m elevations and the lingering effects of the Talbot Wildfire it is recommended that the property at 3355 remain on evacuation order until this snow has melted. The owner/resident of 3355 was provided a verbal summary of this hazard and recommendation that the property not be occupied at this time. The owners/residents of 3300 were notified of the potential hazard relating to the potential for a culvert failure at the Talbot Creek crossing and were advised to stay clear of the Talbot Creek drainage (adjacent to their property).

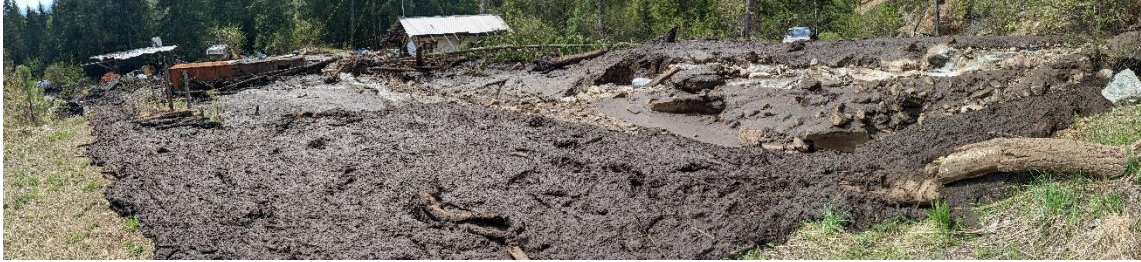
**Photo 7.** Debris flow deposit. Note lodged debris above and adjacent to the shipping container directing some flow down the driveway to the east and onto Little Slocan South Road.
