REGIONAL DISTRICT OF CENTRAL KOOTENAY

RIONDEL WATER AND DRAINAGE SERVICES COMMUNITY ADVISORY COMMITTEE DISCUSSION NOTES

Reference: Condition Assessment for Existing Drainage Infrastructure at Riondel, BC- Rev B

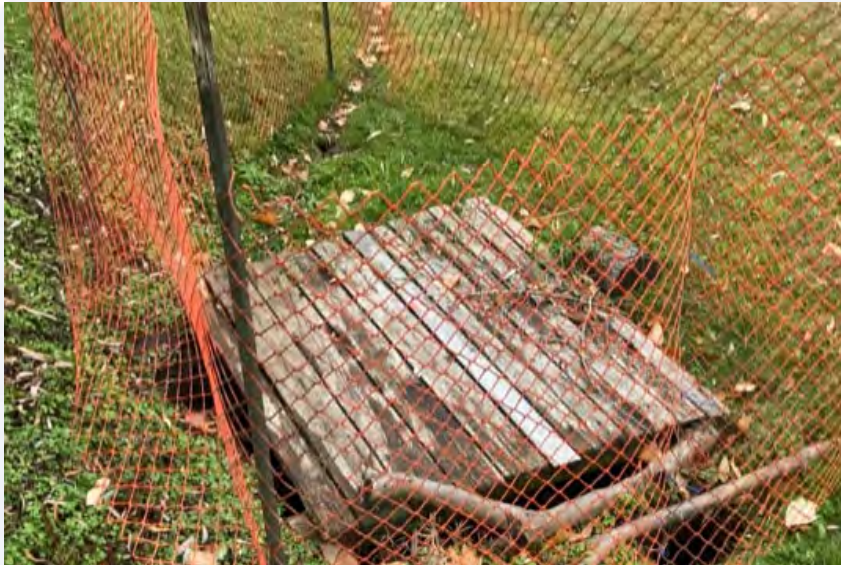
Ainsworth South Replacement

- Two new catch basins on Ainsworth might cost \$20,000 but the line also needs replacement
- Due to catch basin size, even temporary traffic rated lids might cost \$10,000
- Catch basins have been barricaded for now and staff is recommending catch basin and line replacement in 2024

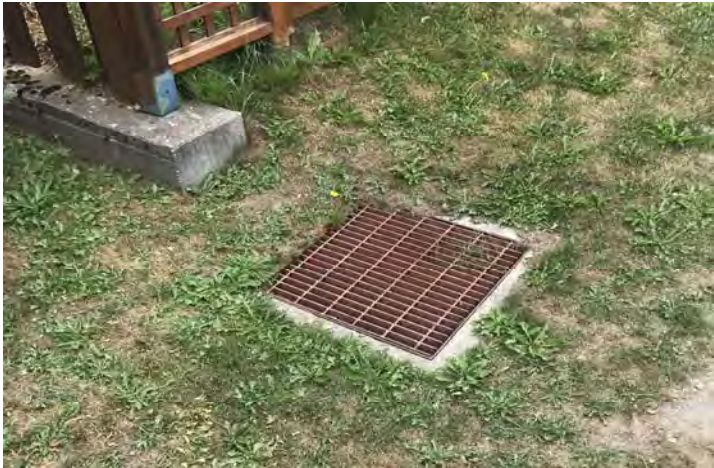
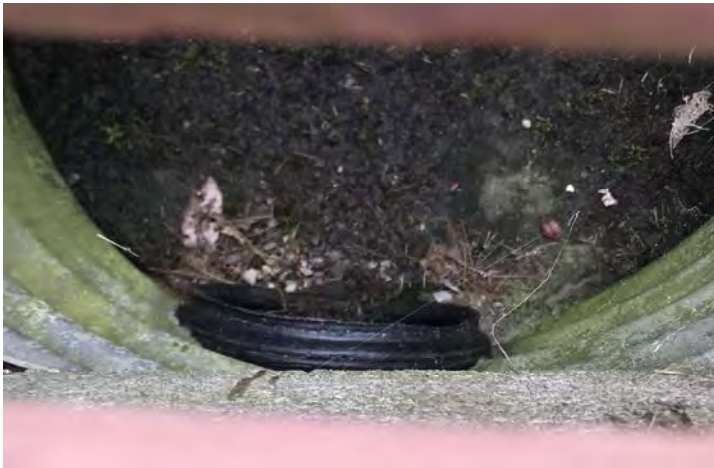
<u>Basin #:</u> CB 1	<u>Material:</u> CSP, Steel grate	<u>Material Condition:</u> Fair *Non Standard
	<u>Depth:</u> 70cm	
	<u>Sediment:</u> Low	
<u>Inlet(s):</u> 200mm Big O HDPE	<u>Comments:</u> Grate likely not traffic rated	
<u>Outlet(s):</u> 200mm Big O HDPE

Overall Condition **Poor**

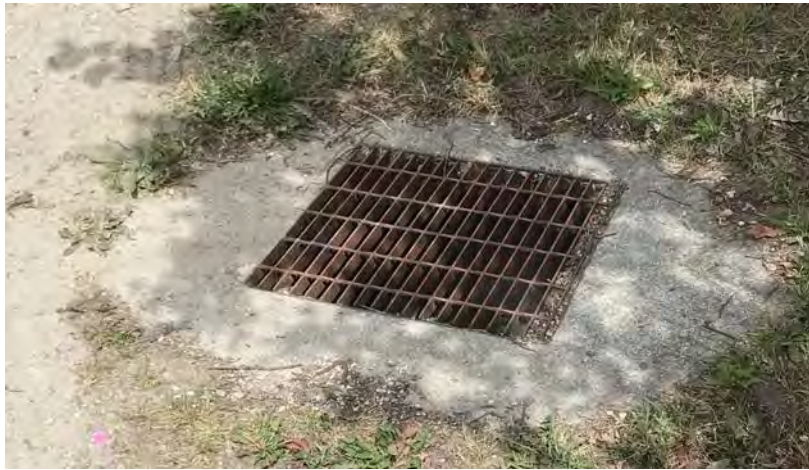
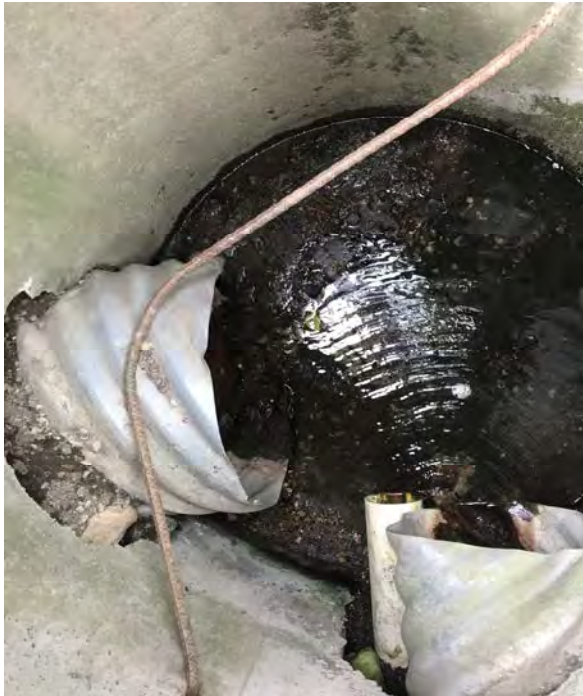
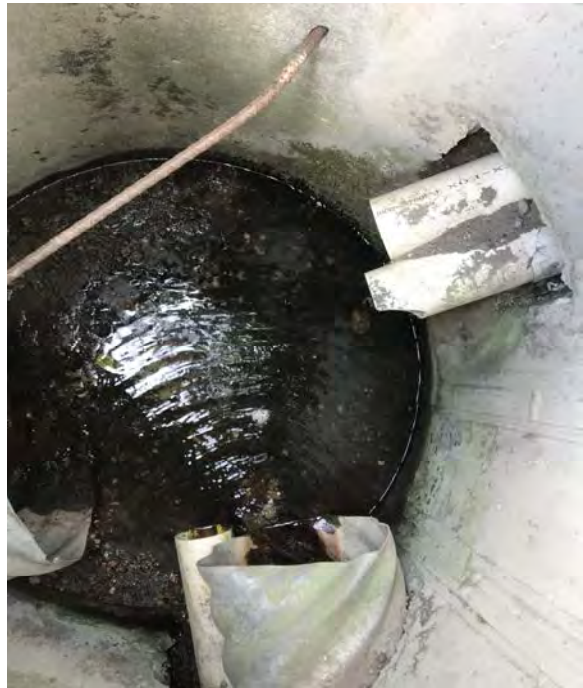
Basin #: CB 2	Material: Concrete	Material Condition: Fair *Non Standard
	Depth: 137cm	
	Sediment: Medium	
Inlet(s):	100mm (4") PVC (Private connection) 100mm (4") PVC (Private connection) 100mm (4") PVC (Private connection) 300mm (12") CSP	Comments: Rebar located inside for unknown reason. PVC connections are from unknown locations, but are likely from private property. Grate likely not traffic rated.
Outlet(s):	500mm (20") CSP

Overall Condition **Poor**

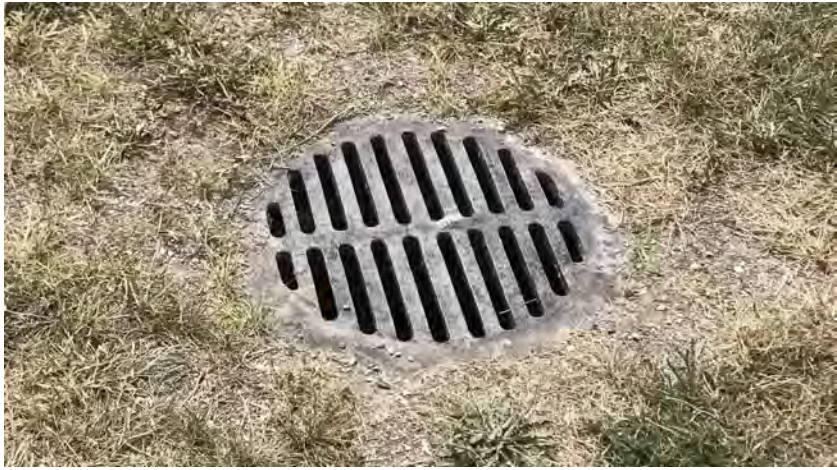
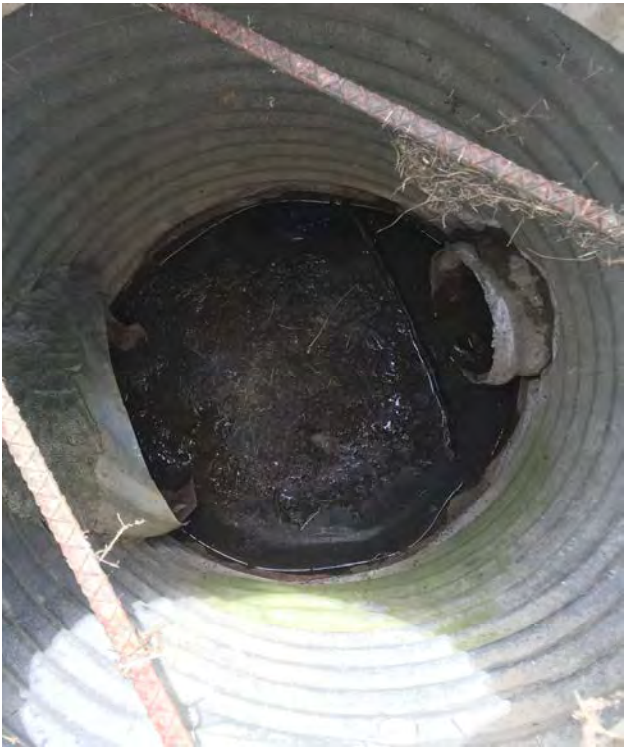
Basin #: CB 3	Material: CSP	Material Condition: Poor *Non Standard
	Depth: 133 cm	
	Sediment: Medium	
Inlet(s): 500mm (20") CSP	Comments: Bulges in catch basin wall noted. Outlet flows to an unlocated catch basin or t's into drainage pipe.	
Outlet(s): 300mm (12") CSP

Overall Condition **Poor**

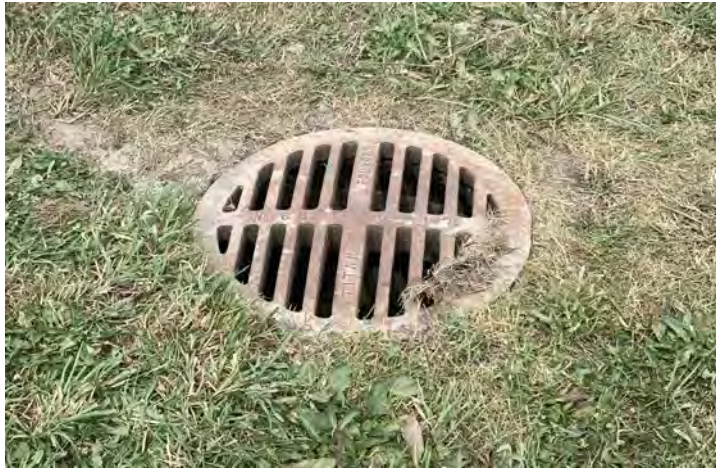
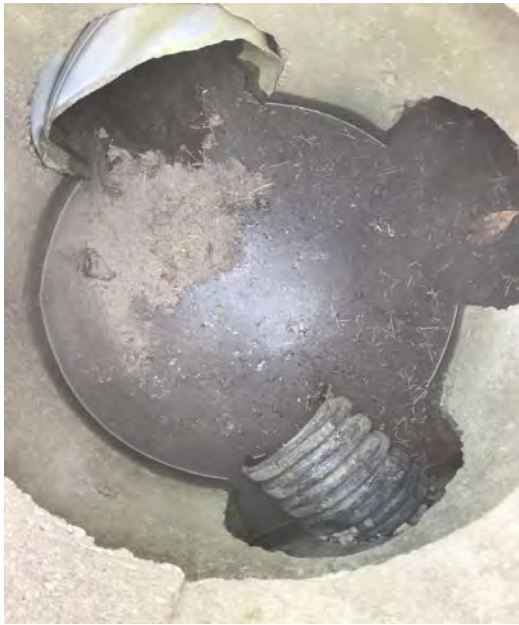
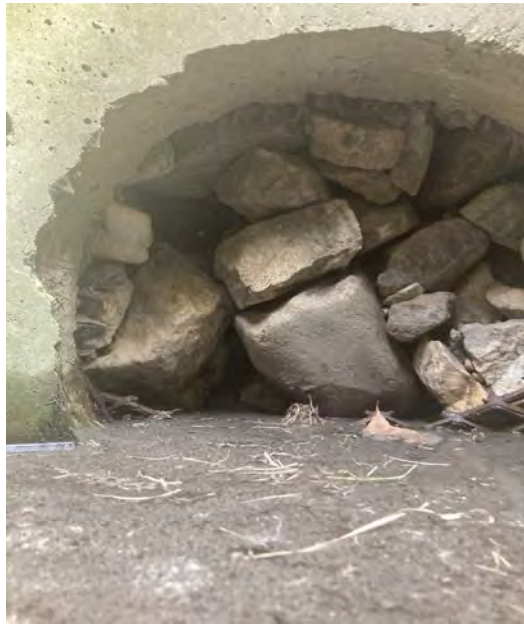
Basin #: CB 4	Material: Concrete	Material Condition: Fair *Non Standard
	Depth: 116cm	
	Sediment: Low	
Inlet(s): 200mm (8") Big O HDPE (Private connection) Infiltration Inlet	Comments: Additional inlet filled with rocks, likely to accommodate infiltration - not standard practice. Big O HDPE inlet is coming from adjacent private property.	
Outlet(s): 500mm (20") CSP

Overall Condition **Poor**

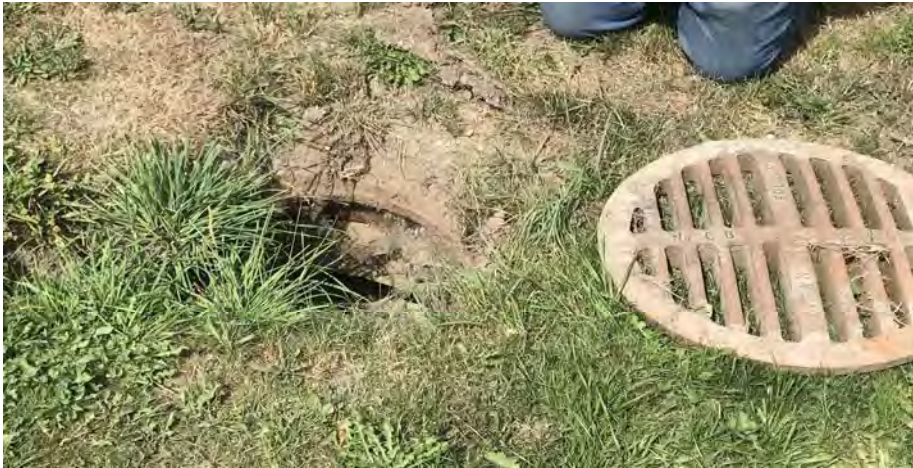
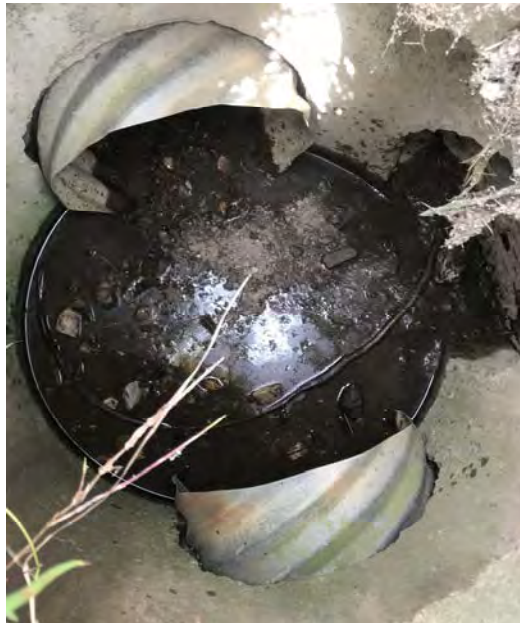
<u>Basin #:</u> CB 5	<u>Material:</u> Concrete	<u>Material Condition:</u> Fair *Non Standard
	<u>Depth:</u> 105cm	
	<u>Sediment:</u> Low	
<u>Inlet(s):</u> 500mm (20") CSP	<u>Comments:</u> Additional inlet filled with rocks. Grate was covered with dirt and difficult to access	
<u>Outlet(s):</u> 500mm (20") CSP Infiltration Inlet

Overall Condition **Poor**

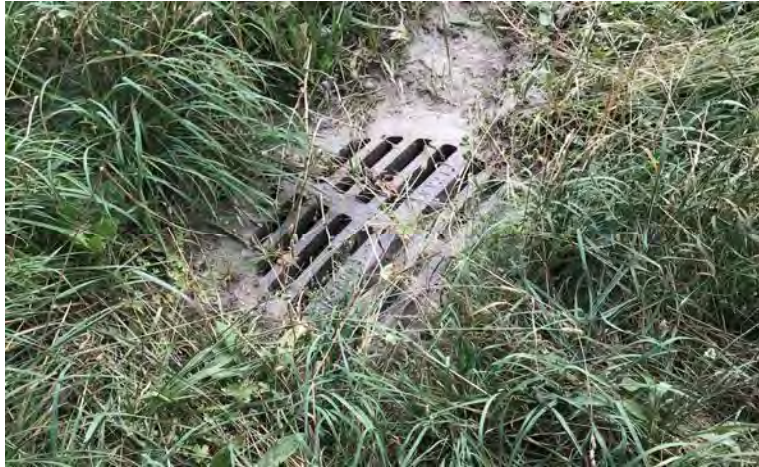
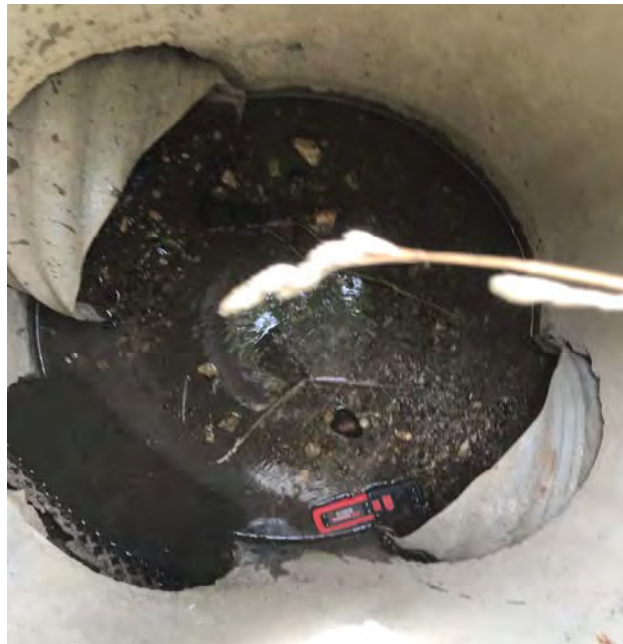
<u>Basin #:</u> CB 6	<u>Material:</u> Concrete	<u>Material Condition:</u> Fair *Non Standard
	<u>Depth:</u> 135cm	
	<u>Sediment:</u> Medium	
<u>Inlet(s):</u> 500mm (20") CSP Infiltration Inlet	<u>Comments:</u> Additional inlet hole filled with rocks. It has been reported that water runs around the catch basin, although the ground is graded appropriately.	
<u>Outlet(s):</u> 500mm (20") CSP

Overall Condition **Poor**

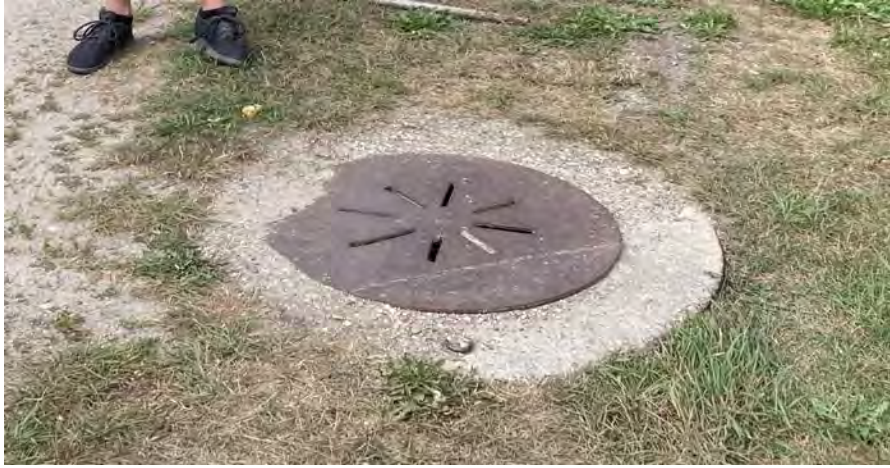
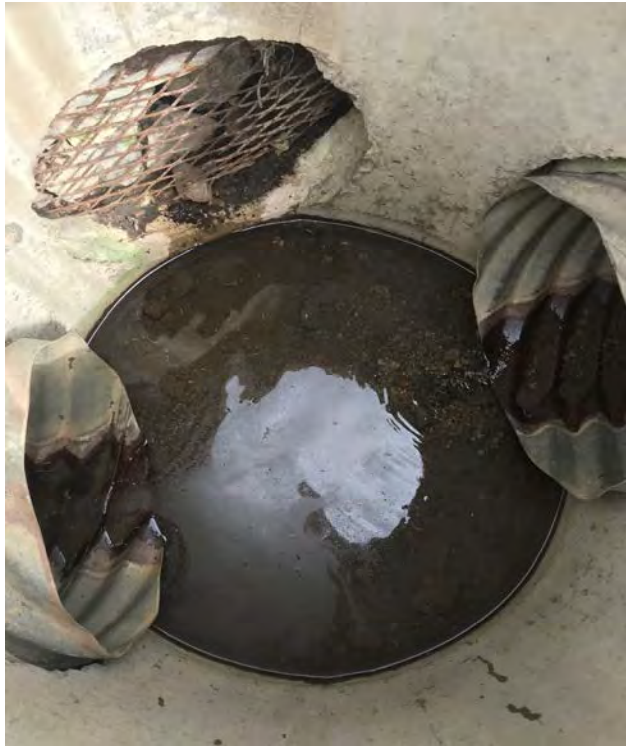
<u>Basin #:</u> CB 7	<u>Material:</u> Concrete	<u>Material Condition:</u> Fair *Non Standard
	<u>Depth:</u>	
	<u>Sediment:</u> Low	
<u>Inlet(s):</u> 500mm (20") CSP Infiltration Inlet	<u>Comments:</u> Additional inlet filled with rocks. Non-standard grate.	
<u>Outlet(s):</u> 500mm (20") CSP

Overall Condition **Poor**

- Clear sediment from existing catch basins and culverts.
- Replace the following non-standard lids from catch basins with concrete tops and steel grates to allow surface water ingress.
 - Catch Basin #7
 - Catch Basin #8
 - Catch Basin #9
 - Catch Basin #16
 - Catch Basin #21
 - Catch Basin #22
 - Catch Basin #26
- Lower the lid level of the following above grade catch basins.
 - Catch Basin #16
 - Catch Basin #17
 - Catch Basin #19
 - Catch Basin #21
 - Catch Basin #22
 - Catch Basin #23
- Locate source of all private connections to the drainage system, confirm with RDCK.
- Connect the drainage ditch on Mcgarvy St to allow drainage into catch basin #23. The drainage discharge below catch basin #23 is considered to be an MoTI culvert.

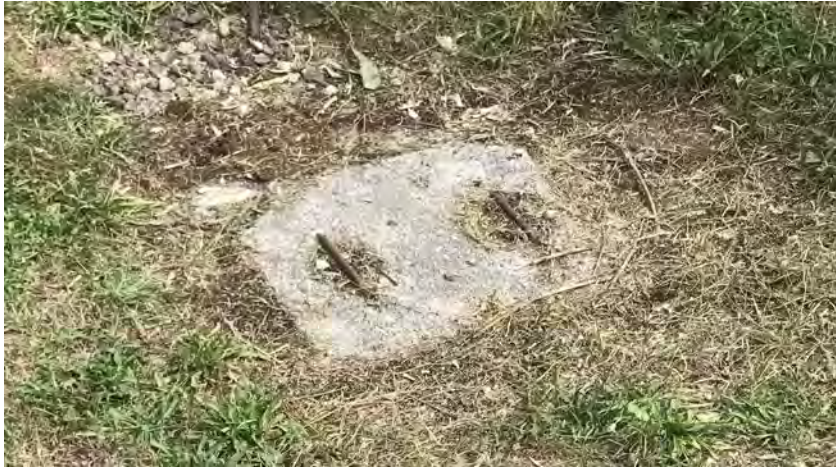
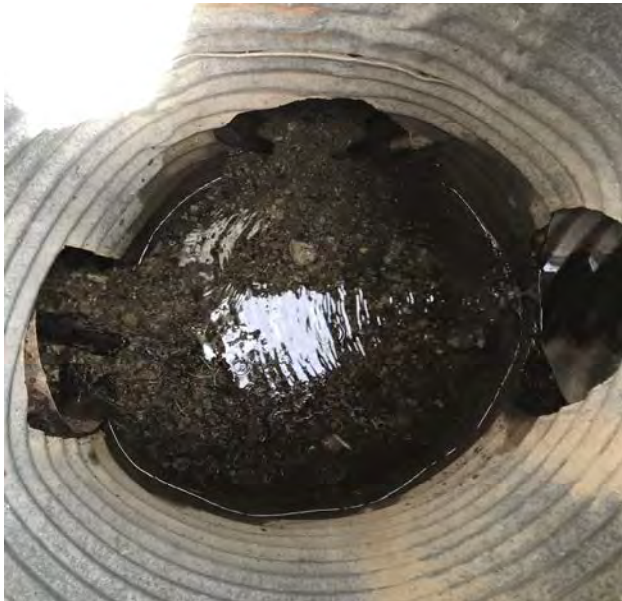
Basin #: CB 8	Material: CSP	Material Condition: Poor *Non Standard
	Depth: 140cm	
	Sediment: Medium	
Inlet(s): 500mm (20") CSP 500mm (20") CSP	Comments: Concrete manhole lid. Warping noted in CSP walls. Additional inlet from abandoned line from CB 21. Abandoned line is no longer connected to CB 21 and there are no additional catch basins located between CB 21 and CB 8. No grate for inflow.	
Outlet(s): 500mm (20") CSP

Overall Condition **Poor**

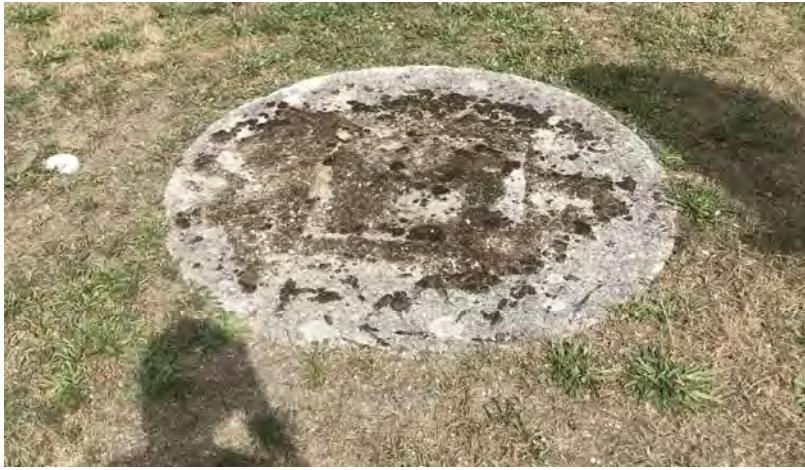
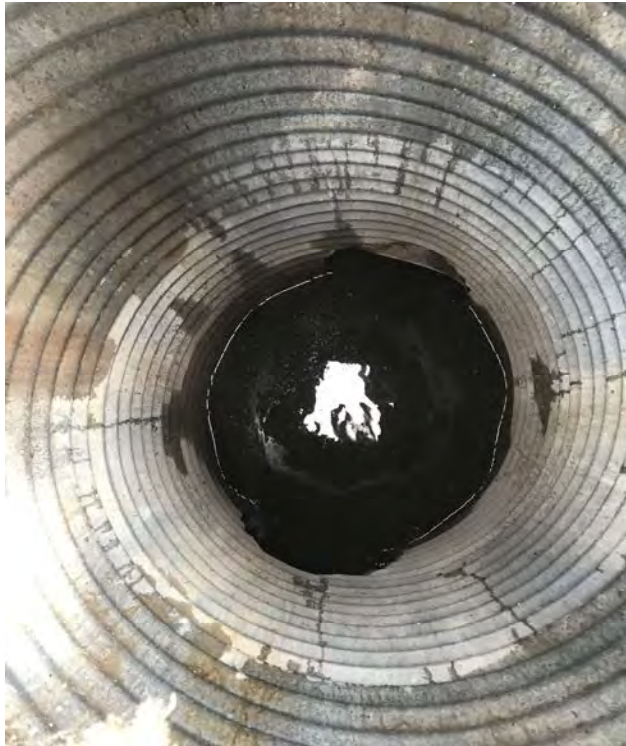
<u>Basin #:</u> CB 9	<u>Material:</u> CSP	<u>Material Condition:</u> Fair *Non Standard
	<u>Depth:</u> 190cm	
	<u>Sediment:</u> Medium	
<u>Inlet(s):</u> 500mm (20") CSP	<u>Comments:</u> Lid is a concrete manhole lid and does not allow inflow. Outlet t's into culvert crossing Eastman Ave.	
<u>Outlet(s):</u> 500mm (20") CSP

Overall Condition **Poor**

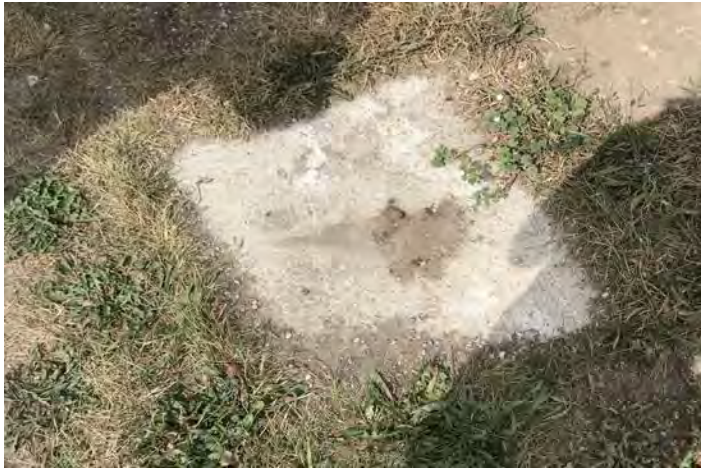
<u>Basin #:</u> CB 10	<u>Material:</u> Unknown (concrete lid)	<u>Material Condition:</u> Poor *Non Standard
	<u>Depth:</u> Unknown	
	<u>Sediment:</u> Unknown	
<u>Inlet(s):</u> Unknown	<u>Comments:</u> Unable to remove lid. Catch basin does not have a manhole lid so this section of drainage infrastructure is likely for groundwater drainage only.	
<u>Outlet(s):</u> Unknown

Overall Condition Poor

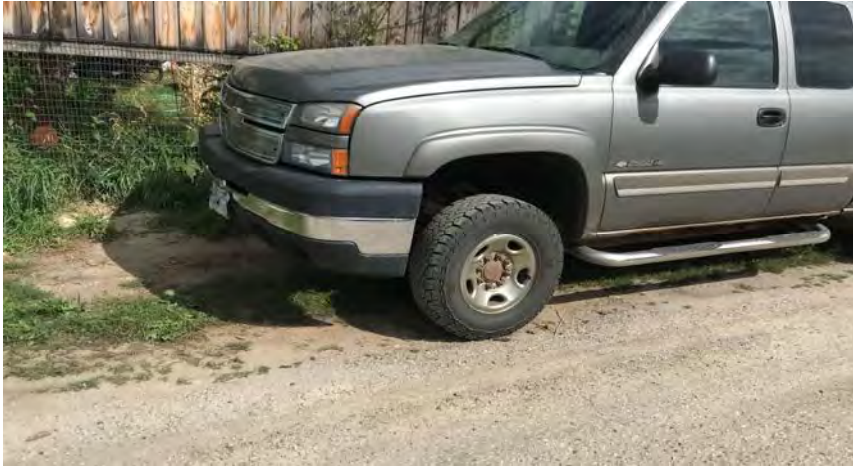
<u>Basin #:</u> CB 11	<u>Material:</u> Unknown (concrete lid)	<u>Material Condition:</u> Unknown *Non Standard
	<u>Depth:</u> Unknown	
	<u>Sediment:</u> Unknown	
<u>Inlet(s):</u> Unknown	<u>Comments:</u> Located underneath truck. Unable to remove lid. Catch basin does not have a manhole lid so this section of drainage infrastructure is likely for groundwater drainage only.	
<u>Outlet(s):</u> Unknown

Overall Condition Poor

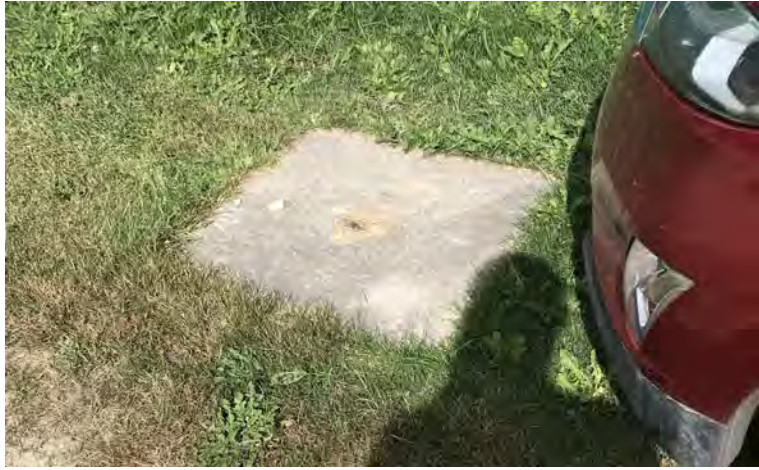
<u>Basin #:</u> CB 12	<u>Material:</u> Unknown (concrete lid)	<u>Material Condition:</u> Unknown *Non Standard
	<u>Depth:</u> Unknown	
	<u>Sediment:</u> Unknown	
<u>Inlet(s):</u> Unknown	<u>Comments:</u> Unable to remove lid. Catch basin does not have a manhole lid so this section of drainage infrastructure is likely for groundwater drainage only.	
<u>Outlet(s):</u> Unknown

Overall Condition Poor

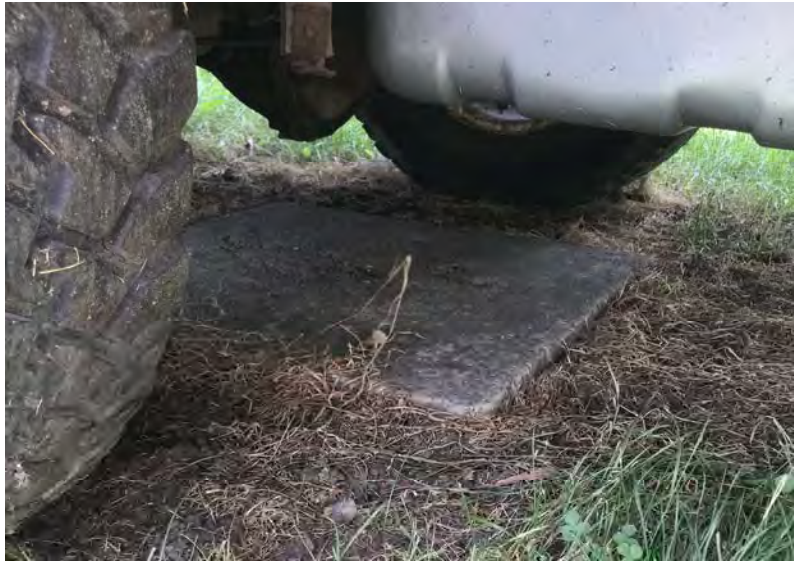
<u>Basin #:</u> CB 13	<u>Material:</u> Unknown (concrete lid)	<u>Material Condition:</u> Unknown *Non Standard
	<u>Depth:</u> Unknown	
	<u>Sediment:</u> Unknown	
<u>Inlet(s):</u> Unknown	<u>Comments:</u> Located under truck. Unable to remove lid. Catch basin does not have a manhole lid so this section of drainage infrastructure is likely for groundwater drainage only.	
<u>Outlet(s):</u> Unknown

Overall Condition **Poor**

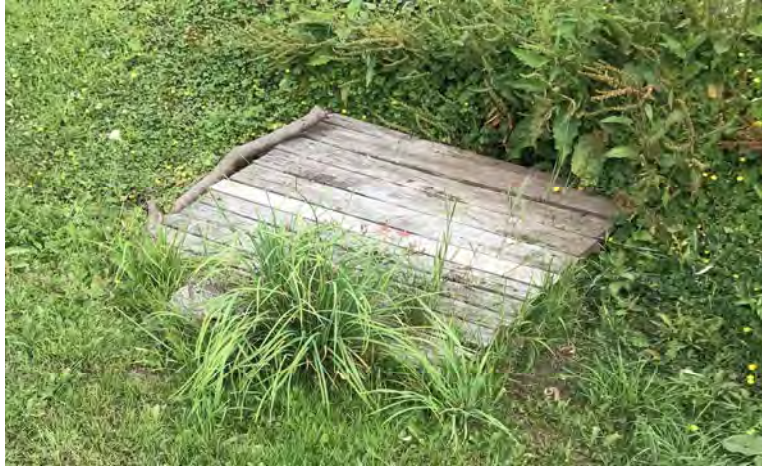
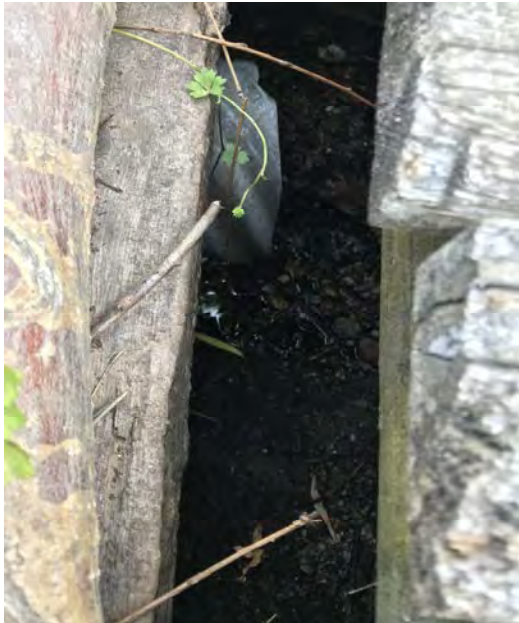
Basin #: CB 14	Material: Wood	Material Condition: Very Poor Dangerous *Non Standard
	Depth:	
	Sediment: Medium	
Inlet(s): 100mm (4") wrapped steel ~200mm (8") Wrapped Steel	Comments: Pipe entering the manhole has a hole in it. There are gaps surrounding the catch basin as well that could be a hazard. Replacement is deemed a high priority.	
Outlet(s): 250mm (10") CSP

Overall Condition **V. Poor**

- Replace wooden catch basins 14 and 25 with their associated piping (1050mm dia. concrete manhole with steel grate recommended). The catch basins in their current state provide a safety concern. It is recommended to replace storm sewer piping from catch basin 14 to the concrete weir or investigate a drainage swale.
- Clear and grade the inlet and outlet of culvert #7 crossing Galena Bay Wharf Rd (MoTI scope).

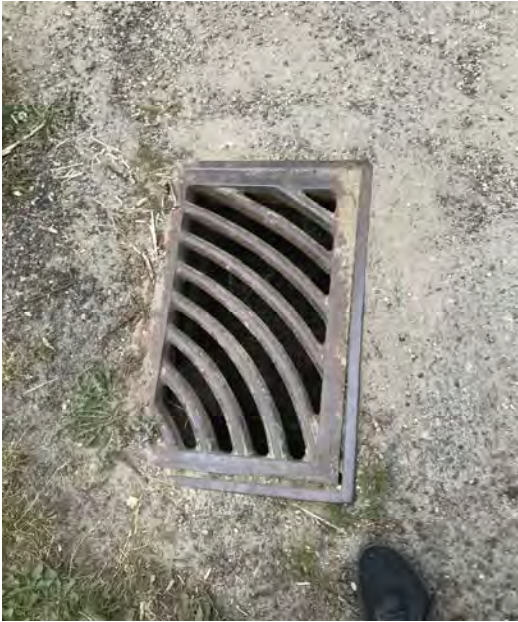
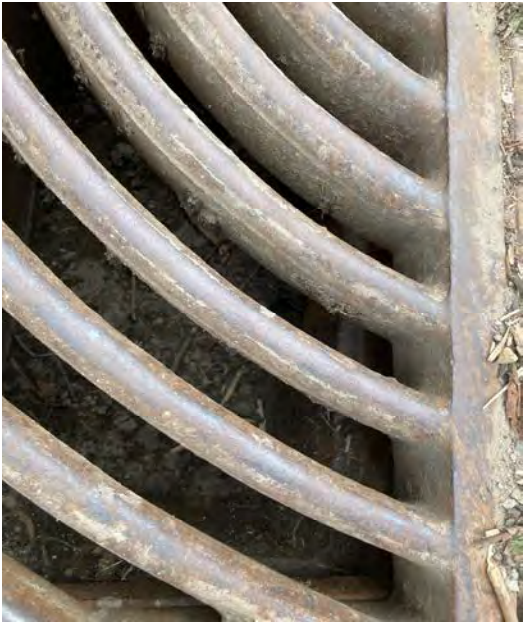
Basin #:	CB 15	Material:	Material Condition: Fair *Non Standard
		Depth: Shallow	
		Sediment: High	
Inlet(s):		Comments: Catch basin located in road and drains to CB 14.	
Outlet(s): 100mm (4") Wrapped Steel

Overall Condition **Poor**

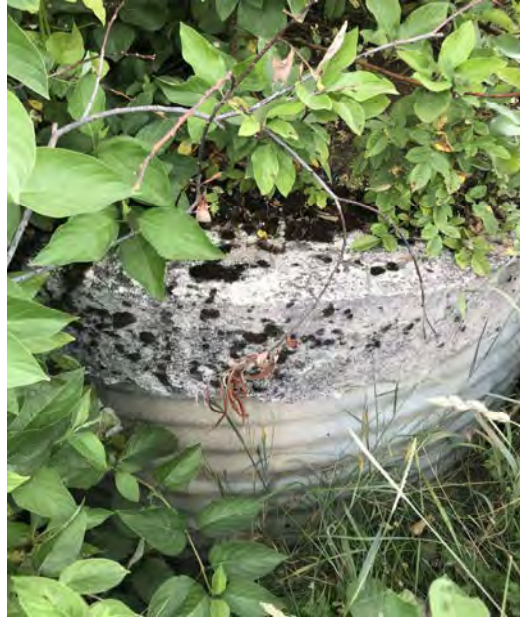
Basin #:	CB 16	Material:	CSP	Material Condition:	Fair *Non Standard
		Depth:	200cm		
		Sediment:	Medium		
Inlet(s):	500mm (20") CSP	Comments: Overgrown. Top of catch basin is well above ground level. There is a hole cut in the side from inspection ~10 years ago			
Outlet(s):	500mm (20") CSP

Overall Condition **Poor**

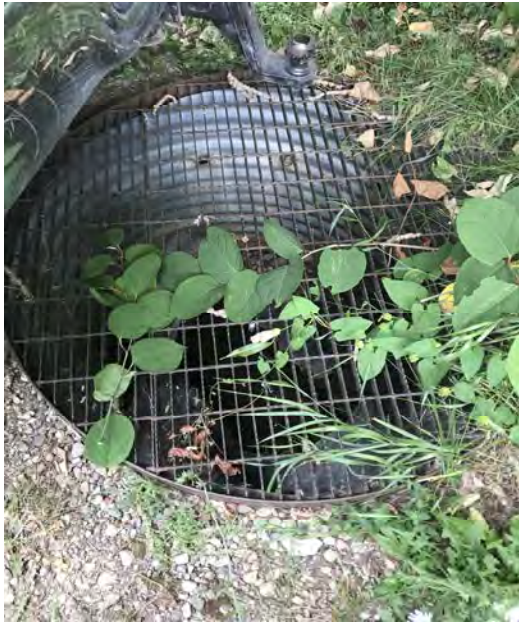
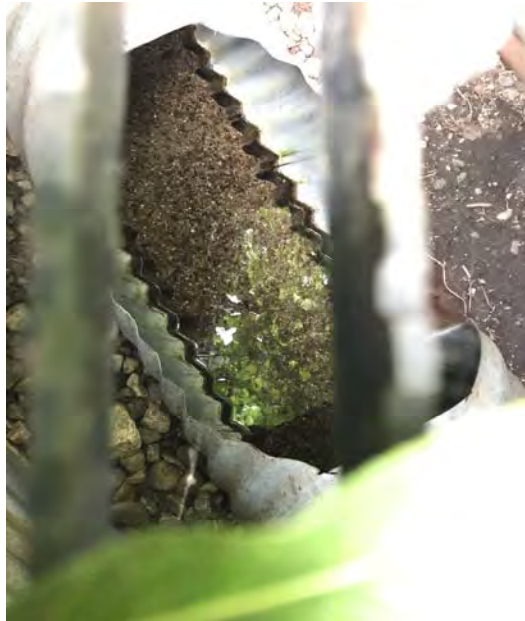
<u>Basin #:</u> CB 17	<u>Material:</u> CSP	<u>Material Condition:</u> Fair *Non Standard
	<u>Depth:</u> 113cm	
	<u>Sediment:</u> High	
<u>Inlet(s):</u> 500mm (20") CSP	<u>Comments:</u> Non-standard grate, not traffic rated. Grate is too high to allow surface inflow.	
<u>Outlet(s):</u> 500mm (20") CSP

Overall Condition **Poor**

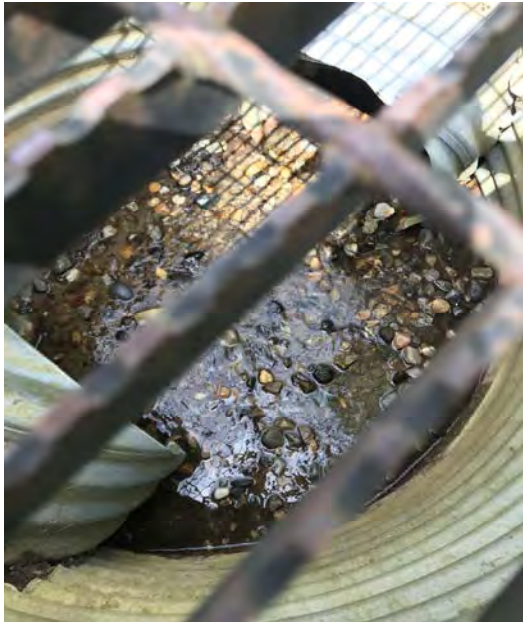
<u>Basin #:</u> CB 18	<u>Material:</u> CSP	<u>Material Condition:</u> Fair *Non Standard
	<u>Depth:</u> 114cm	
	<u>Sediment:</u> Medium	
<u>Inlet(s):</u> 500mm (20") CSP	<u>Comments:</u> 125cm width	
<u>Outlet(s):</u> 500mm (20") CSP

Overall Condition **Poor**

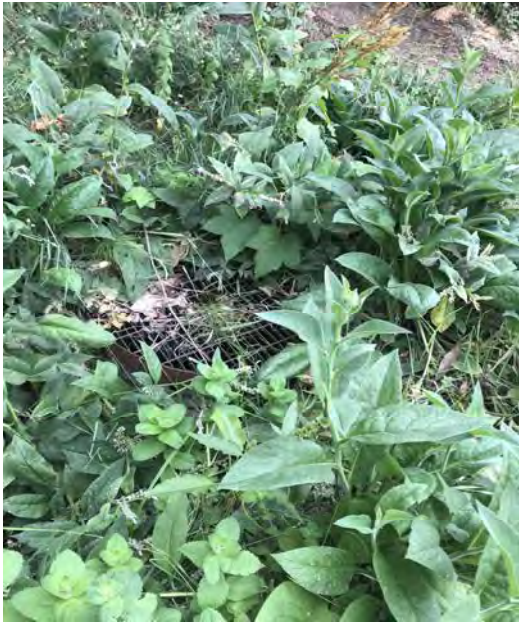
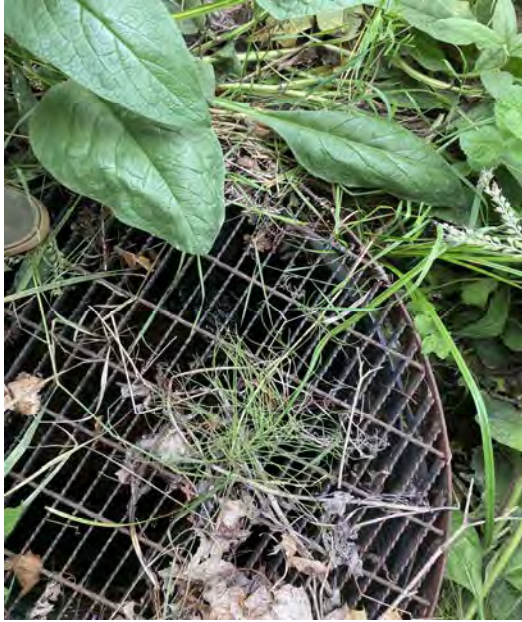
Basin #: CB 19	Material: CSP	Material Condition: Fair *Non Standard
	Depth: 147cm	
	Sediment:	
Inlet(s): 500mm (20") CSP	Comments: Overgrown. 125cm width. Located in a very wet area. Surface flow is noted entering it even during dry conditions. Inflow is entering from side cuts as the grate is too high.	
Outlet(s): 500mm (20") CSP

Overall Condition **Poor**

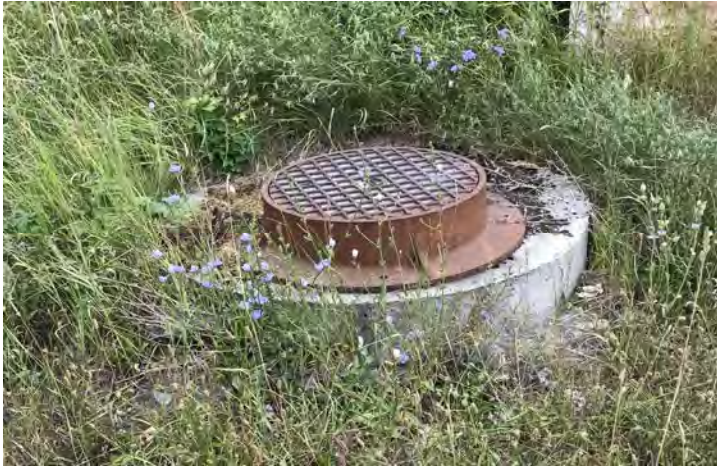
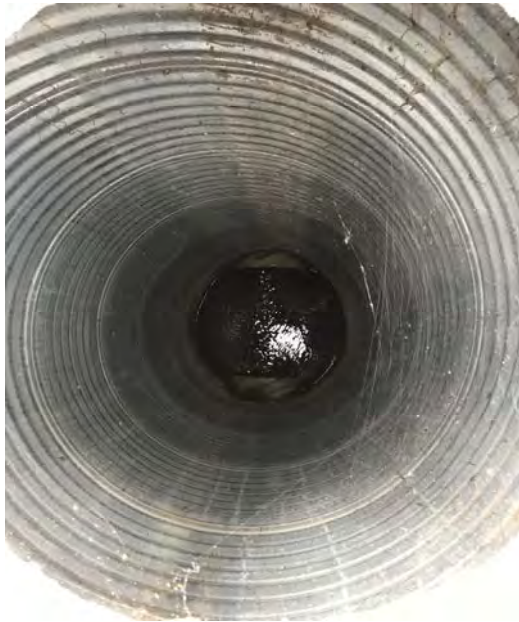
<u>Basin #:</u> CB 21	<u>Material:</u> CSP	<u>Material Condition:</u> Fair *Non Standard
	<u>Depth:</u> 430cm	
	<u>Sediment:</u>	
<u>Inlet(s):</u> 500mm (20") CSP	<u>Comments:</u> Lid is above ground, does not allow inflow. No sign of outlet connecting CB 21 to CB 8.	
<u>Outlet(s):</u> 500mm (20") CSP

Overall Condition **Poor**

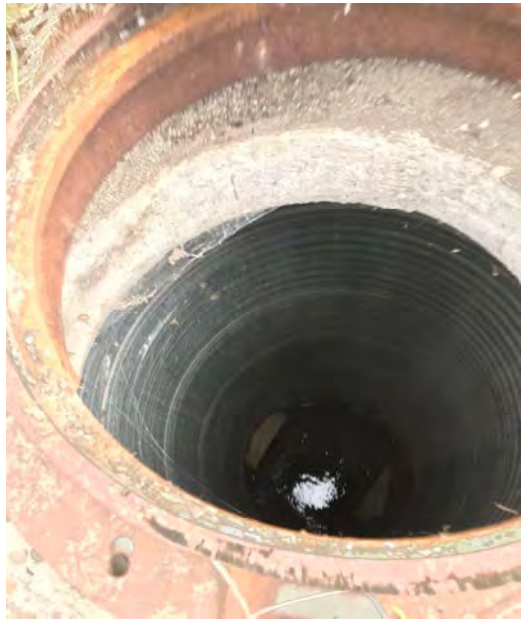
<u>Basin #:</u> CB 22	<u>Material:</u> CSP	<u>Material Condition:</u> Fair *Non Standard
	<u>Depth:</u> 425cm	
	<u>Sediment:</u>	
<u>Inlet(s):</u> 500mm (20") CSP	<u>Comments:</u> Lid is above ground and does not allow for inflow.	
<u>Outlet(s):</u> 500mm (20") CSP

Overall Condition **Poor**

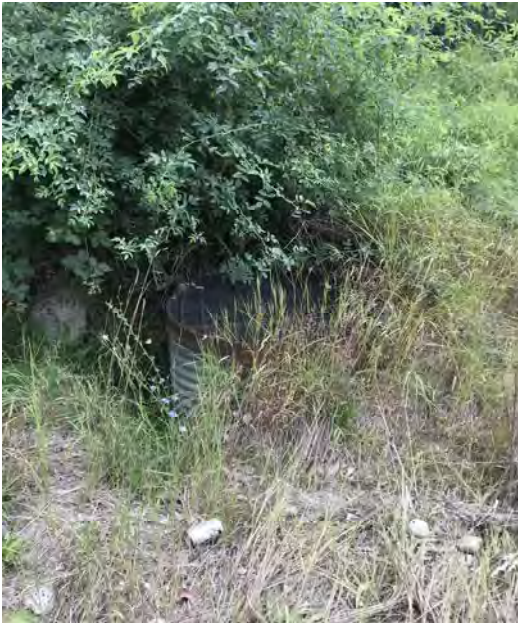
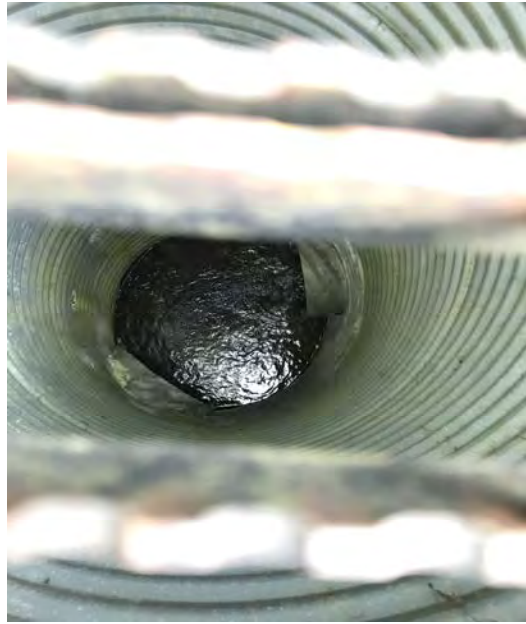
Basin #: CB 23	Material: CSP	Material Condition: Fair *Non Standard
	Depth: 324cm	
	Sediment:	
Inlet(s): 500mm (20") CSP 12 punched holes	Comments: Overgrown and above ground. The drainage ditch does not directly connect to the catch basin. There are 12 inlets drilled into the catch basin walls in a circle at ~235cm depth. The holes are likely draining water from the ground. No pipes appear to be connected to these 12 holes.	
Outlet(s): 600mm (24") CSP

Overall Condition **Poor**

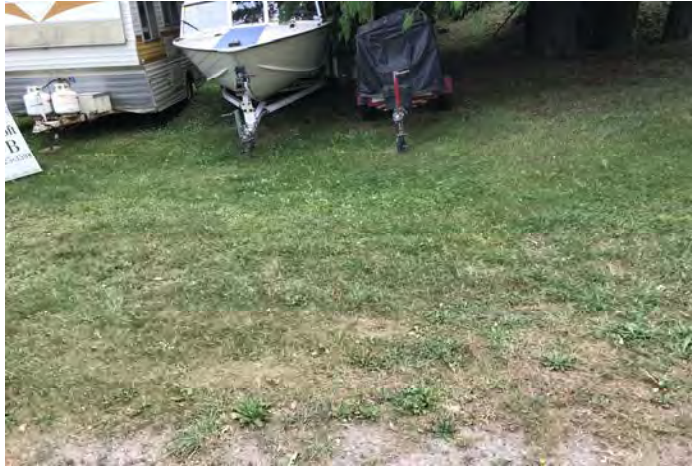
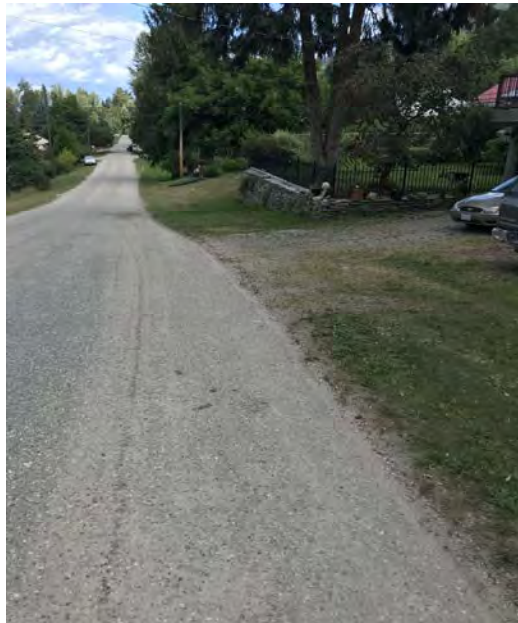
<u>Basin #:</u> CB 24	<u>Material:</u> Unknown	<u>Material Condition:</u> Unknown
	<u>Depth:</u> Unknown	
	<u>Sediment:</u> Unknown	
<u>Inlet(s):</u> Unknown. Likely 300mm (12") CSP	<u>Comments:</u> Unable to locate catch basin. It has likely become buried. Located in front of 1520 Ainsworth Ave.	
<u>Outlet(s):</u> Unknown. Likely 200mm (8") wrapped steel

Overall Condition **V. Poor**

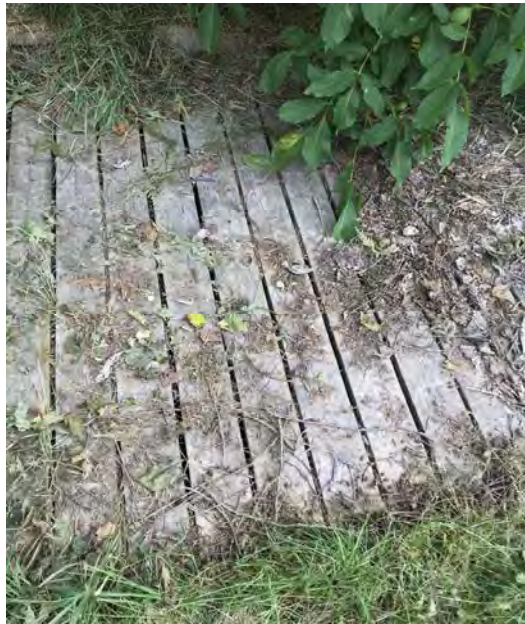
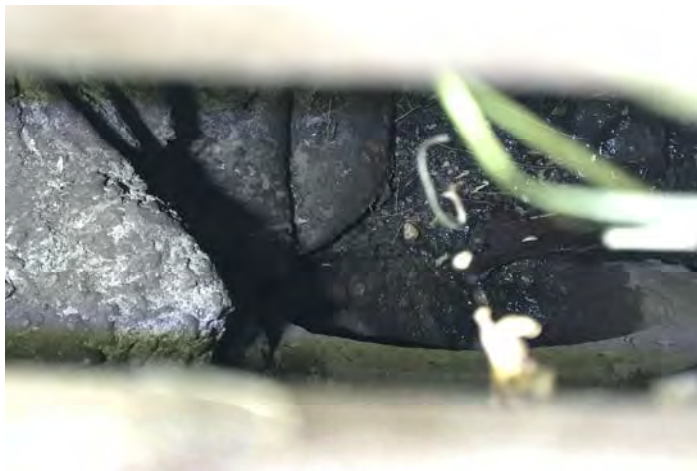
Basin #:	CB 25	Material:	Wood	Material Condition:	Very Poor *Non Standard
		Depth:	Shallow		
		Sediment:	High		
Inlet(s):	~200mm (8") wrapped steel			Comments: Replacement deemed a high priority for safety	
Outlet(s):	~200mm (8") wrapped steel

Overall Condition **V. Poor**

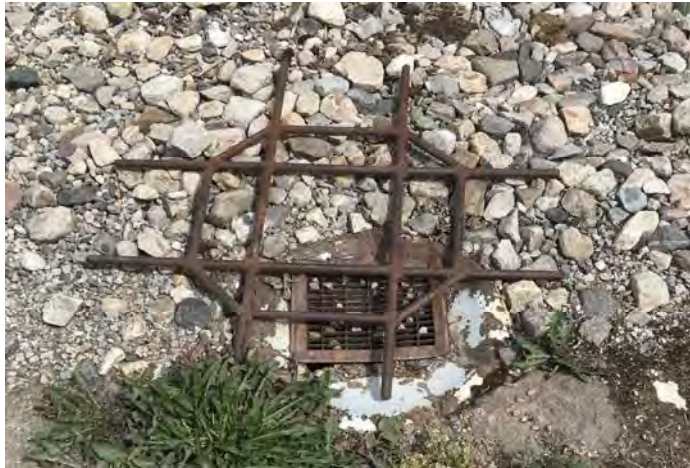
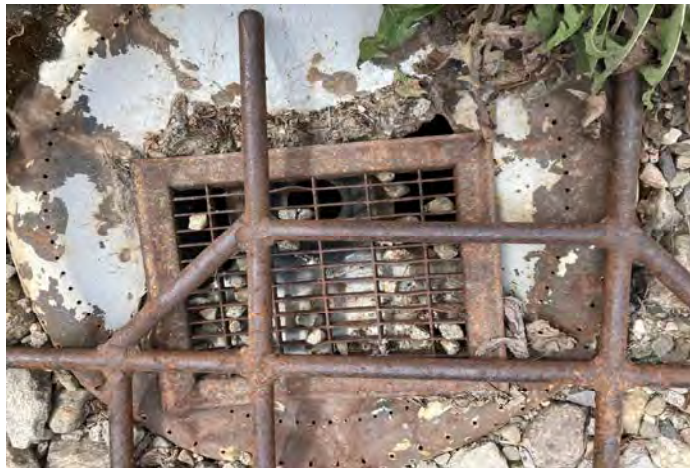
<u>Basin #:</u> CB 26	<u>Material:</u> Non standard	<u>Material Condition:</u> Poor *Non Standard
	<u>Depth:</u> 72cm	
	<u>Sediment:</u> Medium	
<u>Inlet(s):</u> 100mm/150mm poly (likely perforated)	<u>Comments:</u> Inlet pipe is likely perforated and draining ground water. Catch basin is likely a private install. Inlet to catch basin likely drains the nearby garage.	
<u>Outlet(s):</u> 200mm (8") Big O HDPE

Overall Condition **V. Poor**

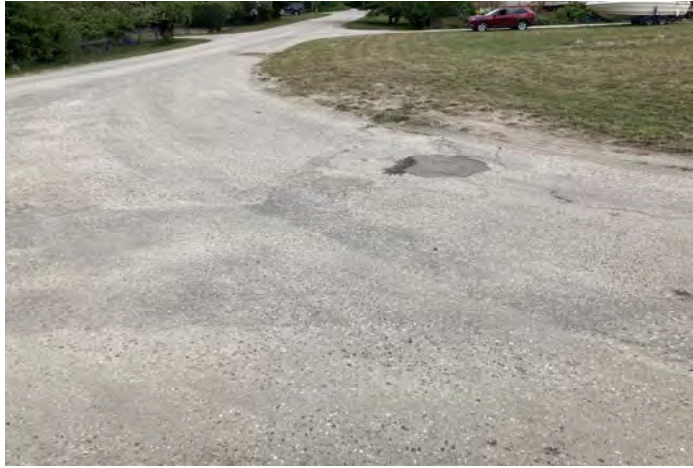
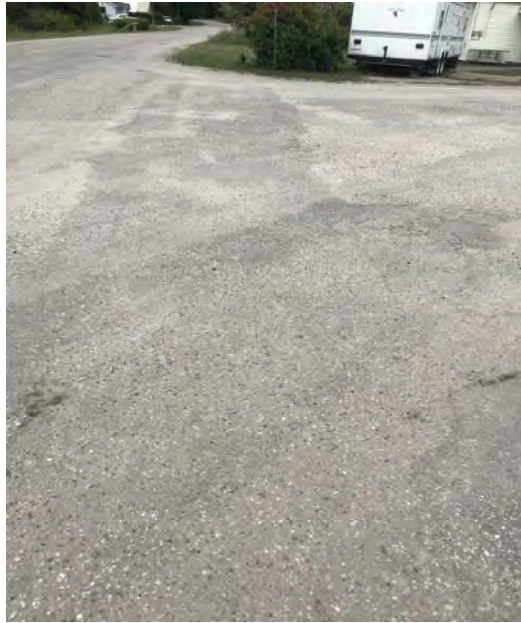
Basin #: CB 27	Material: Unknown	Material Condition: Unknown
	Depth: Unknown	
	Sediment: Unknown	
Inlet(s): Likely 300mm (12") CSP Likely 500mm (20") CSP	Comments: Buried catch basin or outlet from CB 3 directly ties into underground pipe. Located underneath intersection of Hedley St and Eastman Ave.	
Outlet(s): Likely 500mm (20") CSP

Overall Condition V. Poor

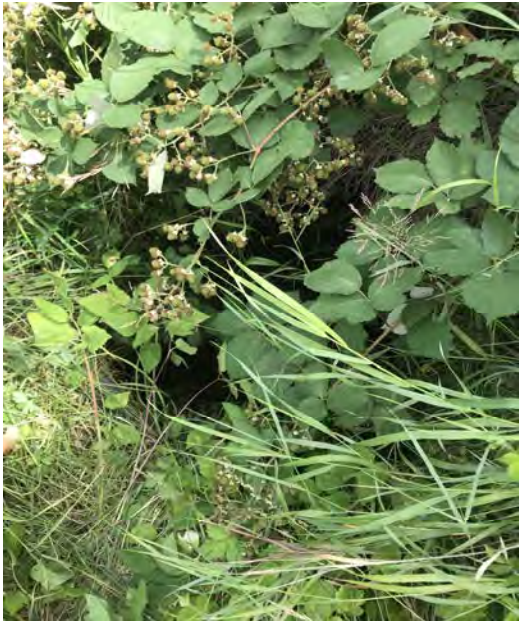
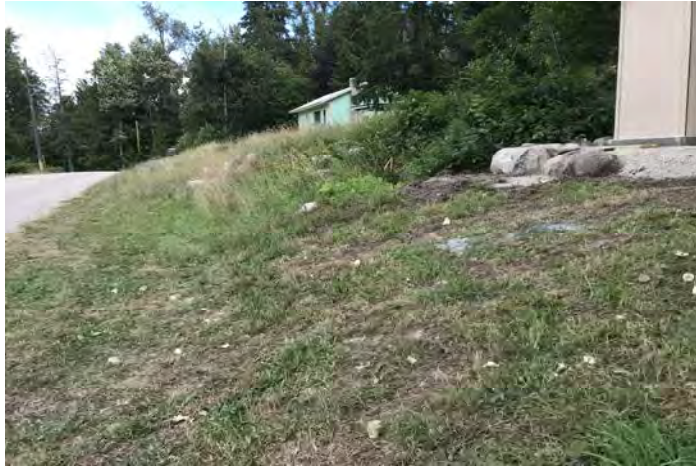
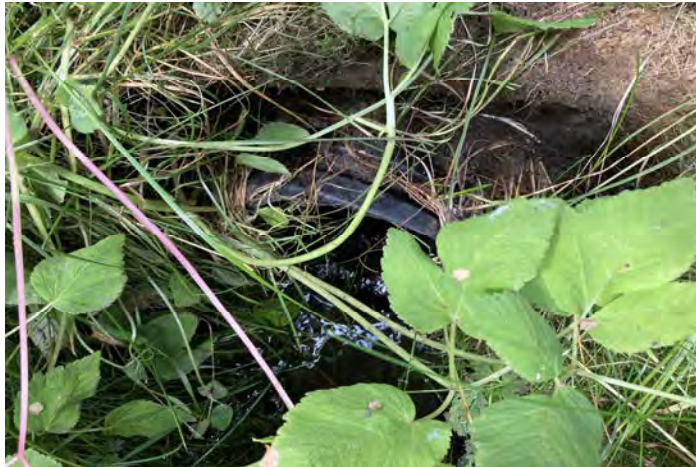
Basin #:	CB 28	Material:	Poly	Material Condition:	Unknown
		Depth:	Unknown		
		Sediment:	Unknown		
Inlet(s):				Comments:	
				Illegal catch basin or steep inlet pipe located on private property. No lid is present and the catchbasin/inlet pipe was flooded at time of inspection. Likely connects to a deep storm line between catch basins	
Outlet(s):		PVC

Overall Condition **V. Poor**

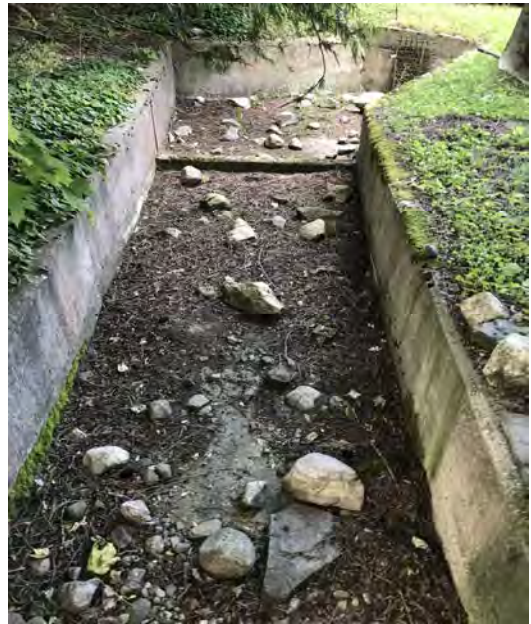
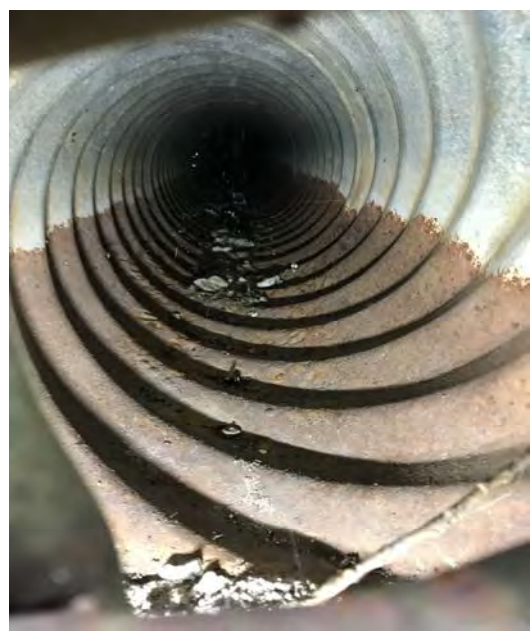
Basin #:	Weir	Material:	Concrete; CSP	Material Condition:	Fair
		Diameter:	300mm		
		Sediment:	Low

Comments: Concrete channel and weir are in fair condition, with some stones and debris in the channel. CSP pipe is in fair condition and connects to catch basin #24 (previously unnumbered) which was not located.

Overall Condition **Fair**

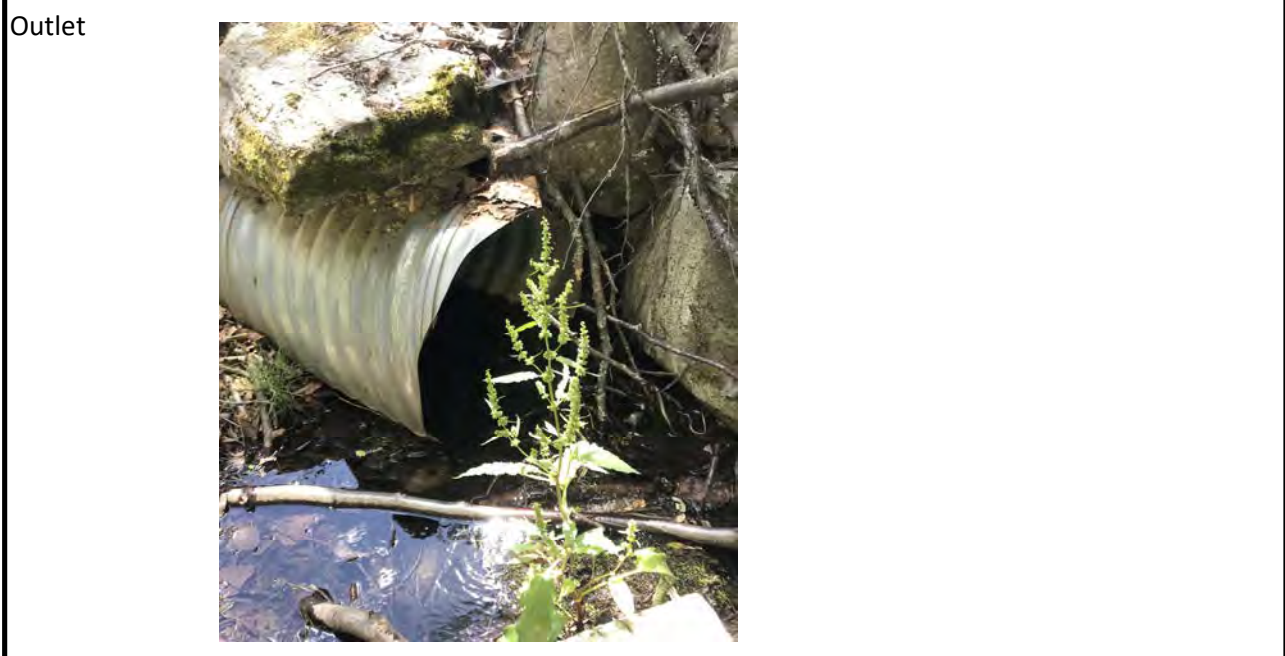
Inlet

Comments: Culvert crosses McGarvey St, connecting catch basin #23 and a drainage ditch.

Overall Condition **Fair**
