REGIONAL DISTRICT OF CENTRAL KOOTENAY

RIONDEL WATER AND DRAINAGE SERVICES COMMUNITY ADVISORY COMMITTEE DISCUSSION NOTES

Reference: Condition Assessment for Existing Drainage Infrastructure at Riondel, BC- Rev B

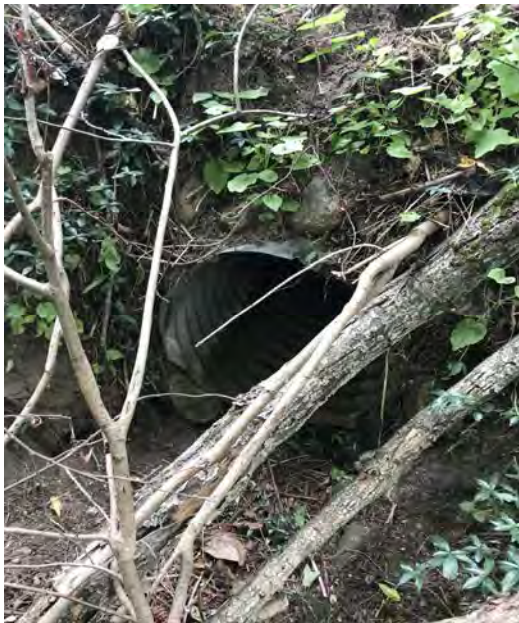
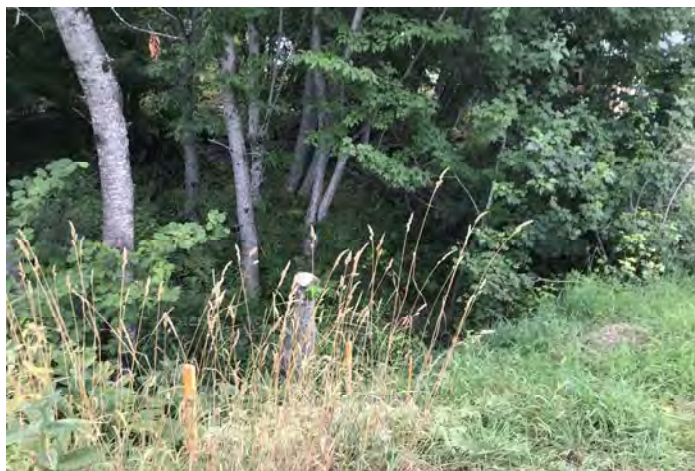
Outlet

Basin #:	CV 3	Material:	CSP	Material Condition:	Fair
		Diameter:	600mm		
		Sediment:	Medium

Overall Condition **Fair**

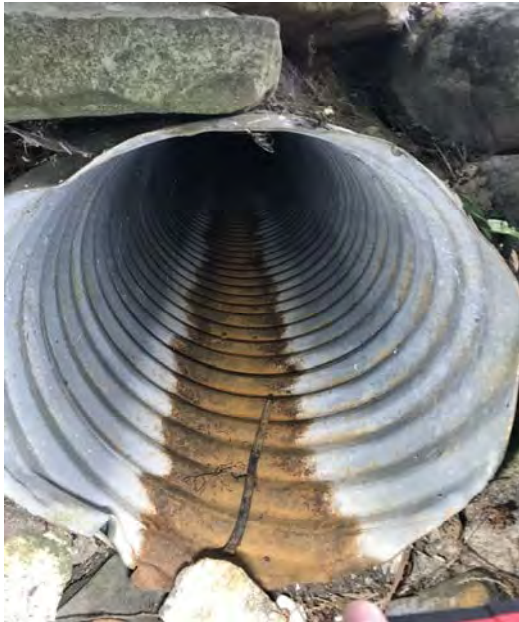
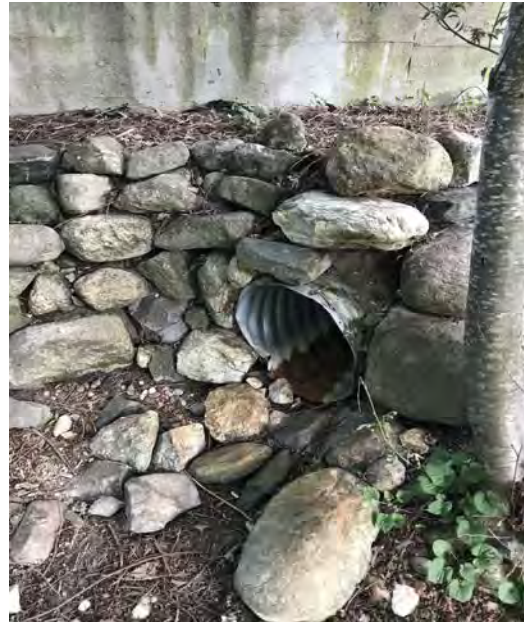
Outlet

Basin #:	CV 4	Material:	Big O HDPE; CSP	Material Condition:	Fair
		Diameter:	200mm (ID); 500mm		
		Sediment:	Medium

Overall Condition **Fair**

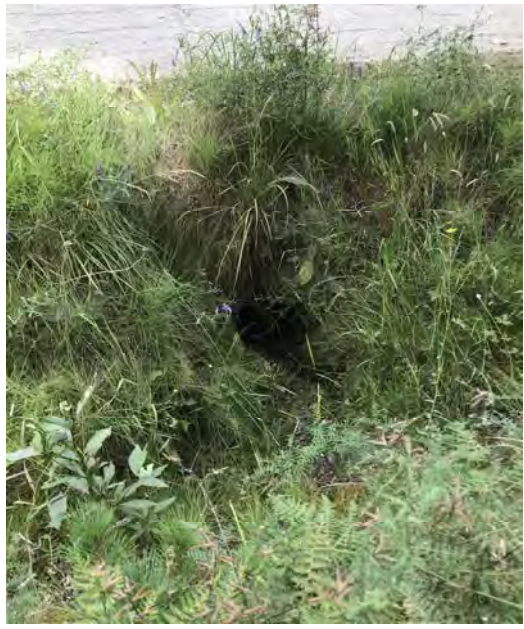
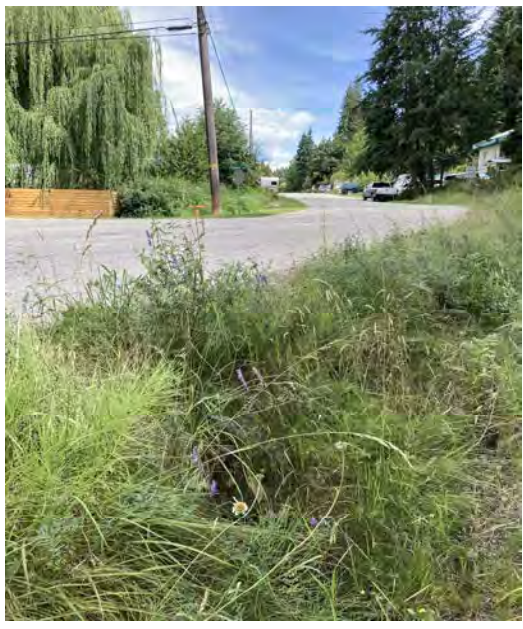
Inlet

Basin #:	CV 5	Material:	CSP	Material Condition:	Fair
		Diameter:	300mm		
		Sediment:	Medium

Comments: Culvert crosses Riodel Rd and connects two drainage ditches. Pipe is in fair condition but could be cleaned up.

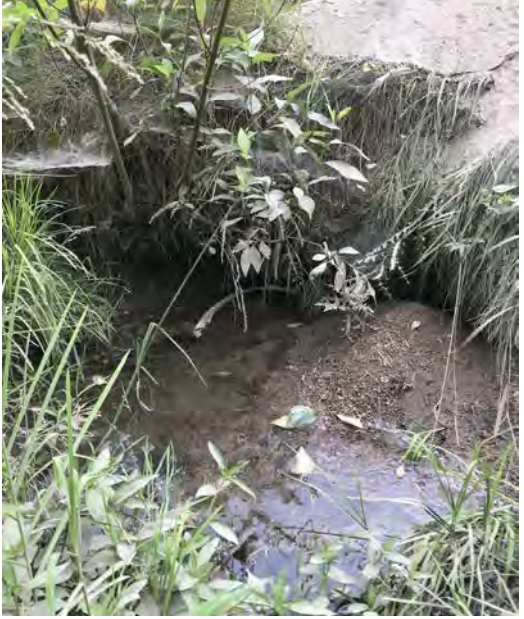
Outlet

Overall Condition **Fair**

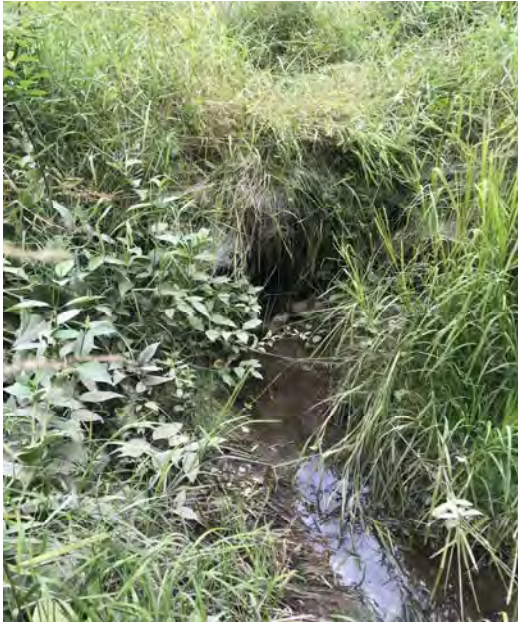
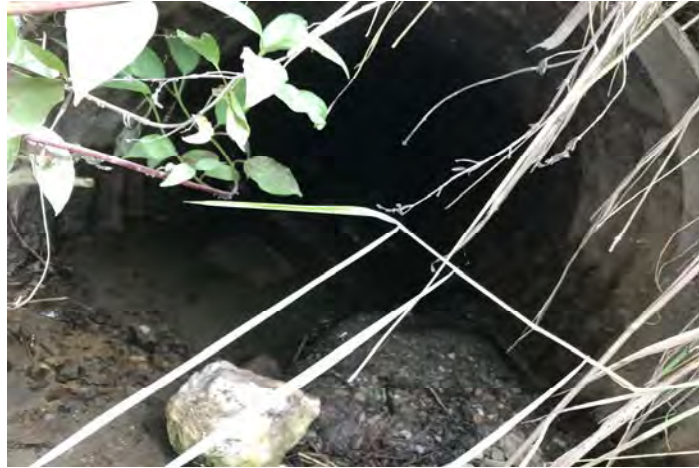
Inlet

Basin #:	CV 6	Material:	CSP	Material Condition:	Fair
		Diameter:	600mm		
		Sediment:	High

Comments: Culvert crosses Folwer St and connects a drainage ditch to an unknown location. There is a concrete pad on the North side of Fowler St that may be covering a catch basin. The culvert may continue into the neighbouring property (416 Folwer St). Recommended to confirm culvert outlet and replace concrete pad with a steel grate if covering a catch basin. Culvert should be graded appropriately for MoTI.

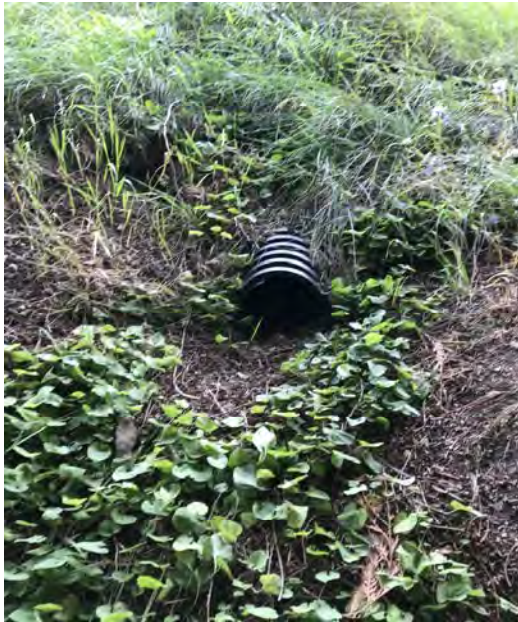
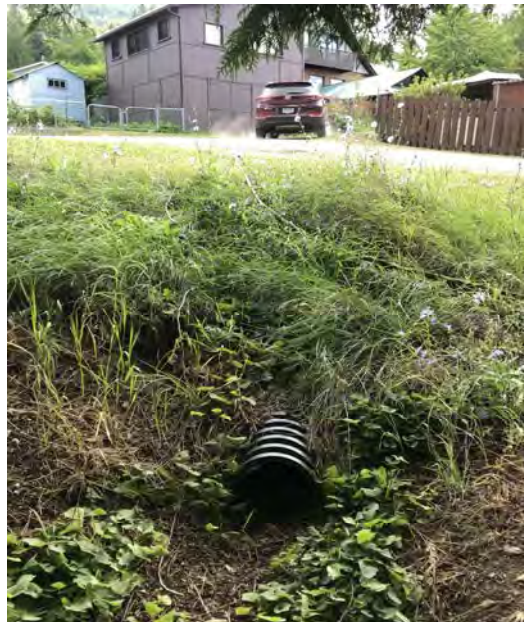
Outlet

Basin #:	CV 8	Material:	Big O HDPE	Material Condition:	Good
		Diameter:	~200mm (ID)		
		Sediment:	Low

Overall Condition **Fair**
