REGIONAL DISTRICT OF CENTRAL KOOTENAY
DEVELOPMENT PERMIT
DP19013D (Ramirez)

Riparian Assessment Report

5336 Amundsen Road, Kaslo

11/2/2020

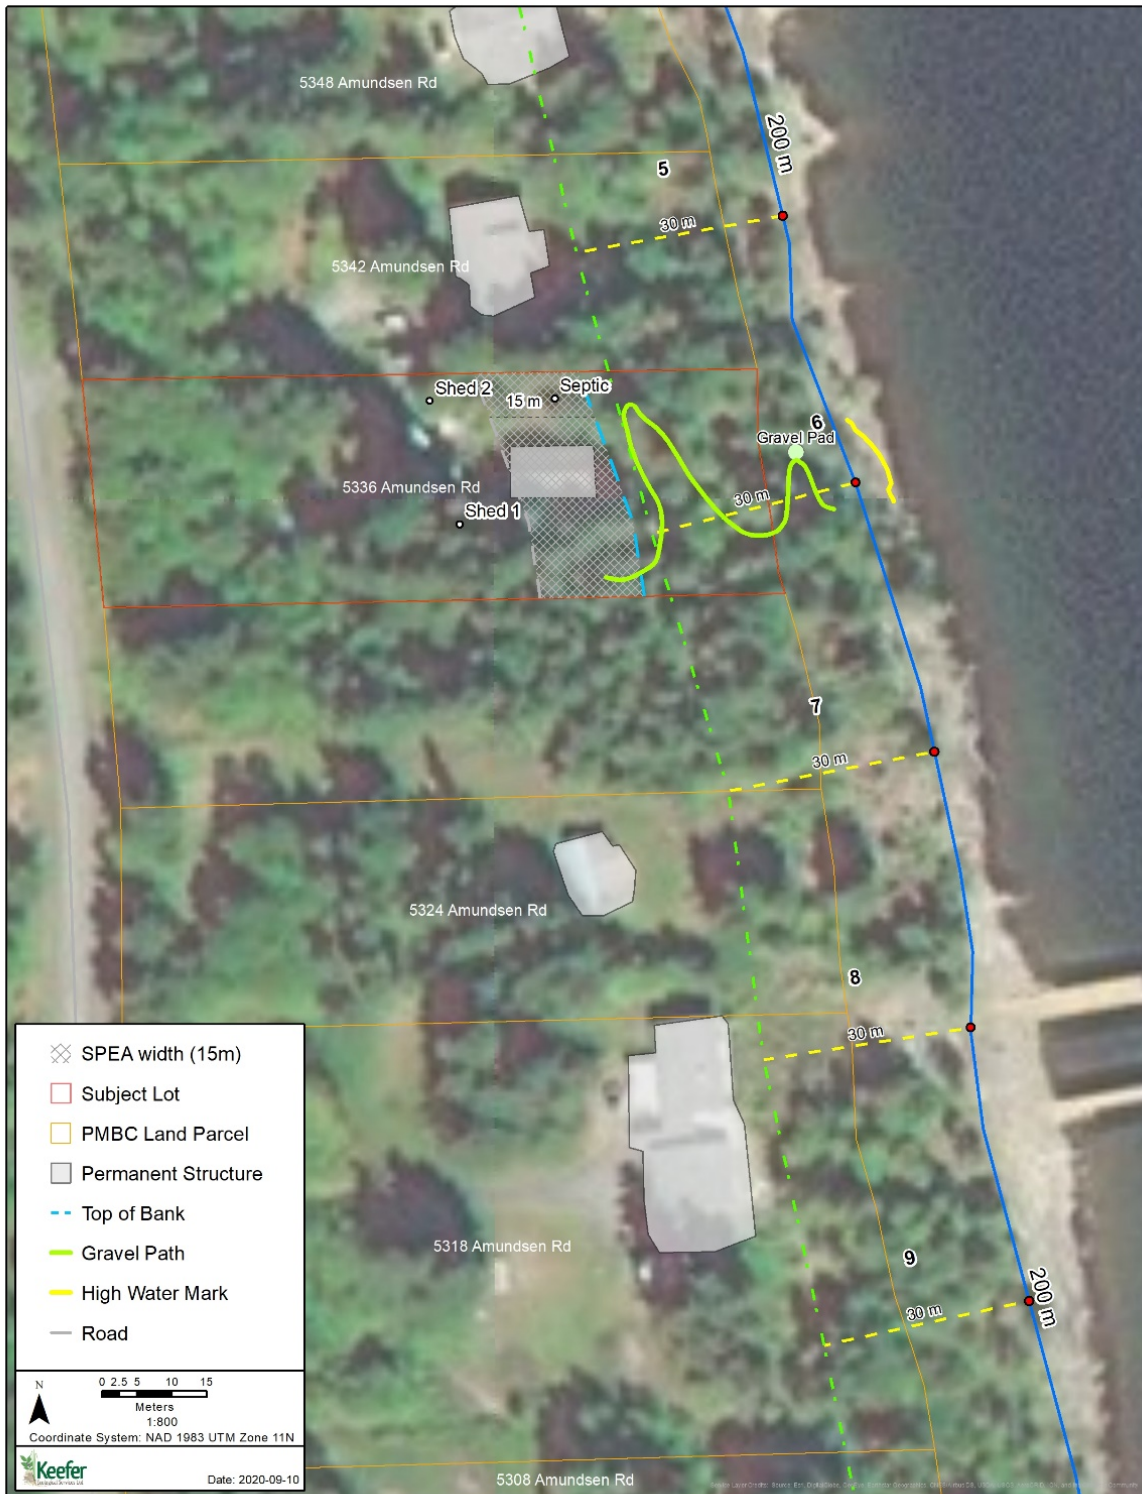
Figure 3. Overview map of the assessed property following the in-field inspection.

As for the assessed property, the TOB ran diagonally through the parcel (from south to north), with approximately 7 m to the first permanent structure (concrete foundation) on the south side of the property and 0 m from the TOB to the first permanent structure (concrete foundation and septic tank) on the north side (Figure 3). Other permanent structures within 30 m of the TOB included a telephone pole (approximately 25 m from TOB). The average slope from the TOB to the first permanent structure was less than 12 degrees. The average slope from the TOB to the bottom of the bank was approximately 65 degrees.

Disturbances within 30 m of the high-water mark include:

- Electrical box (~14 m)
- End of the gravel pathway leading down from the house (~7 m)
- Gravel pad for sitting area (~12 m)
- A portion of the gravel pathway leading to/from the house

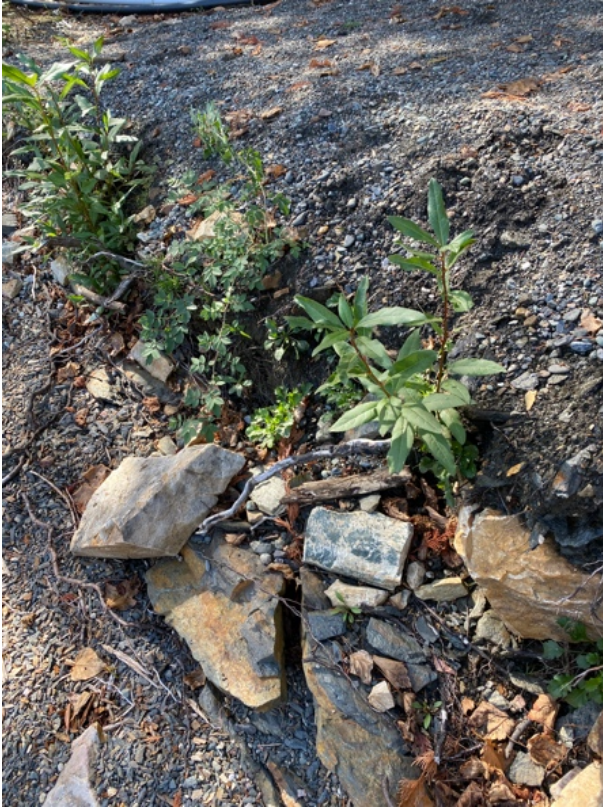
A site survey completed by Michael Keefer of Keefer Ecological Services Ltd. on September 28, 2020, indicated that extensive natural revegetation should be expected on the site (Figure 5). In order to accelerate the restoration process, the following revegetation plan is recommended. It should be noted that the site will be deliberately over-planted to account for expected mortality of juveniles, and over-seeded to account for dispersal and failed germination of native grass seeds.

Figure 5. Evidence of natural revegetation occurring in Zone 3.

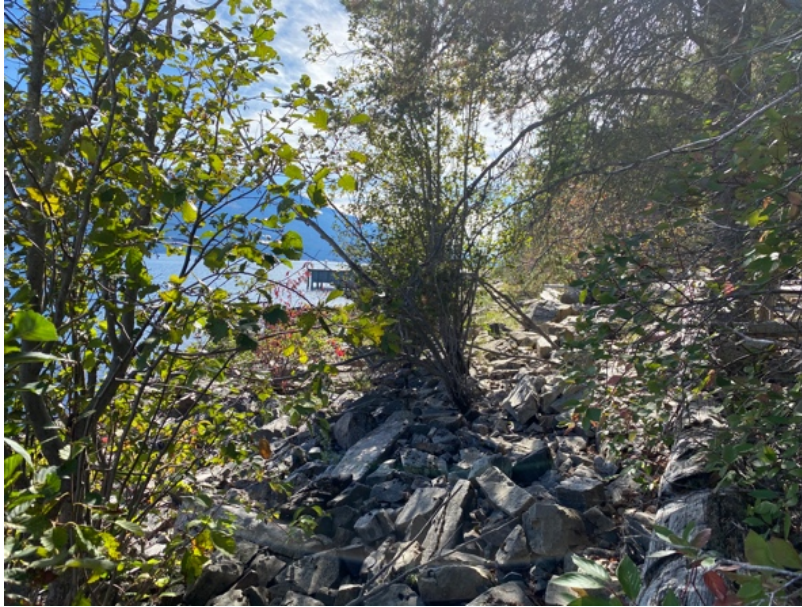
Figure 6 illustrates a reference condition at the high-water mark on the adjacent property to the south, including established flood-resistant vegetation as well as mixed size and quality of rock and wood litter, including coarse wood debris (CWD).

Figure 6. Vegetative reference conditions at the high-water mark on adjacent property to the south of the assessed property.

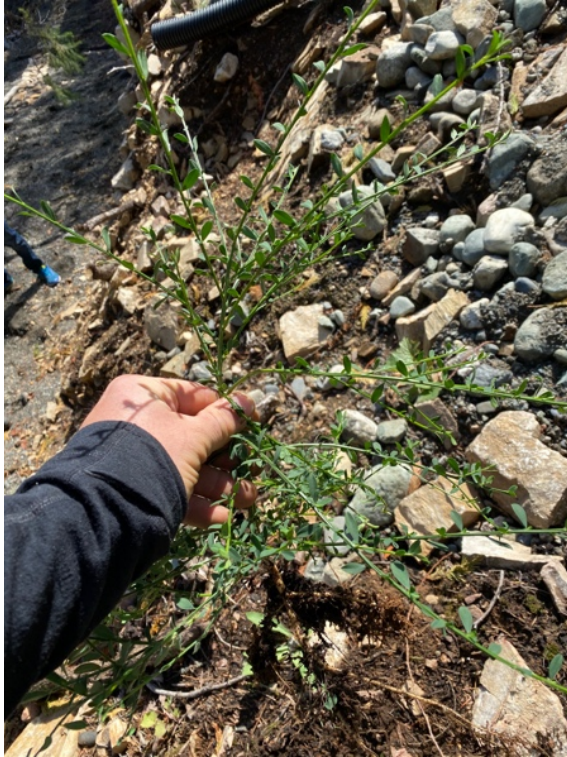
Surveying of the site revealed the presence of the following invasive plant species, all of which are characteristic of disturbed sites: Scotch broom, spotted knapweed, and bull thistle. Figure 7 shows a pulled Scotch broom plant from the site survey, which suggests the pit-run infill material was likely contaminated with Scotch broom seeds. This species is of particular concern as seeds can remain viable in the seed bank for many years (Bossard, 1993). In addition, both Scotch broom and spotted knapweed are allelopathic, meaning they can have direct negative effects on adjacent plants. The presence of these three species will be controlled as part of site management activities to ensure restoration goals are achieved.

Figure 7. Young Scotch broom plant pulled during site survey, likely from pit-run fill material.

Monitoring for Scotch broom, spotted knapweed, and bull thistle will also take place. The absence of Scotch broom and spotted knapweed in years 1 and 2 is a priority as they can negatively affect the establishment of the targeted native plant species. Species identification support and removal processes will be provided to the property owners as per the communication plan.

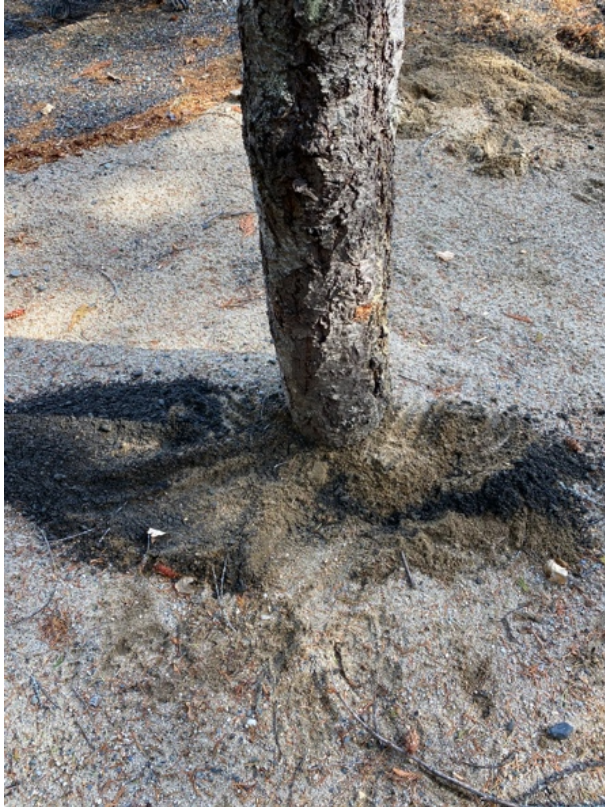
Figure 8. Zone 2 tree negatively affected by fine gravel substrate.

Moving upslope towards the TOB, Zone 2 (Figure 4) will be planted with two Douglas fir (*Pseudotsuga menziesii*) and three paper birch (*Betula papyrifera*) juveniles. The prominent Douglas fir tree in Zone 2 (Figure 8) was observed to be negatively impacted by the fine gravel substrate layer surrounding its stem. The fine material will be removed until the natural ground level is uncovered immediately around this tree in order to reduce this unnecessary stress. The existing gravel pad will be reduced in size and the site naturalized through revegetation efforts.

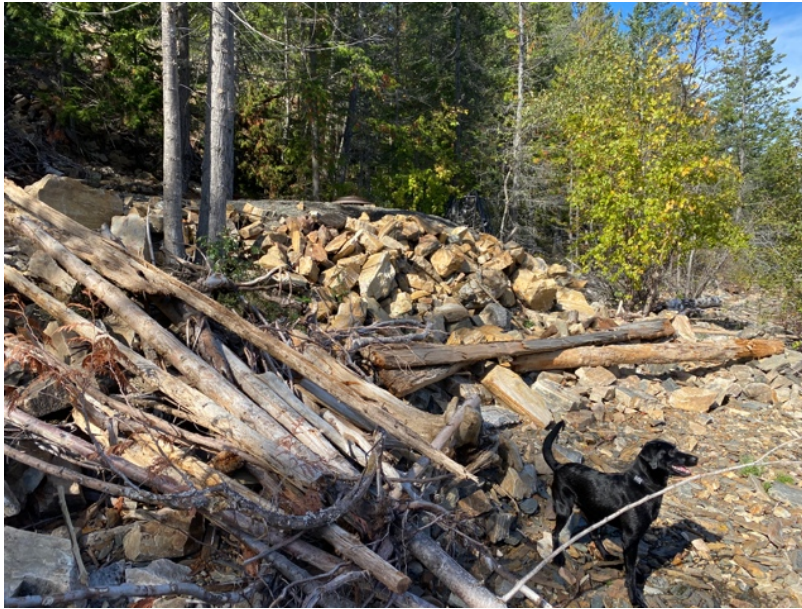
Figure 9. CWD to be used for slope stability in Zone 3, with residual debris used in Zone 6 and Zone 2.

In Zone 3, moving further upslope towards the TOB (Figure 4), coarse woody debris (CWD; Figure 9) should be anchored into the slope to provide stability, with additional CWD being used similarly in Zone 6 and placed throughout Zone 2. Natural regeneration of numerous species including wild rose (*Rosa* sp.), is already occurring in Zone 3 (Figure 10), which will be supplemented with two chokecherry (*Prunus virginiana*) juveniles, and two Douglas fir juveniles. All of Zone 3 should be lightly seeded with the prescribed grass mix (500 seeds/m²).

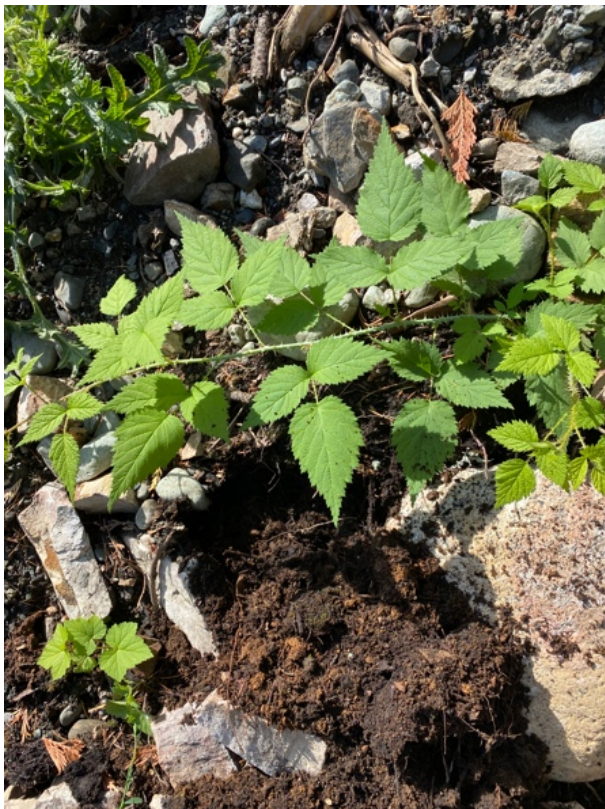
Figure 10. Natural ingress of blackcap raspberry (*Rubus leucodermis*) and thimbleberry (*Rubus parviflorus*) in Zone 3.

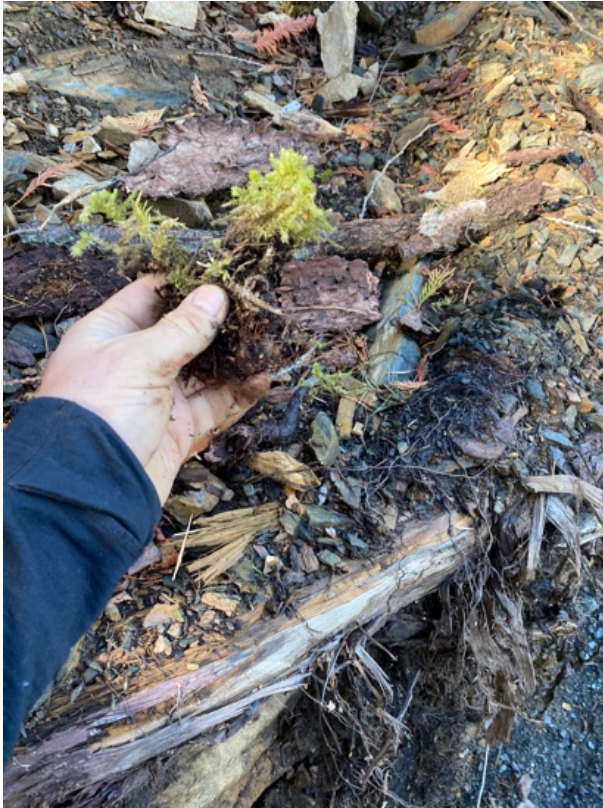
Figure 11. Example of moss divot to be transplanted in the cut-bank along the Zone 4/5 boundary, and throughout Zone 5.

The walking path that runs through Zone 4 (Figure 4) needs to be narrowed to approximately one metre width. Moss divots (Figure 11) from on-site should be transplanted to shady patches of the uphill cut slope along the boundary between Zones 4 and 5. In addition, red osier dogwood should be planted along the cut slope to support slope stability. On the fill side of the path five kinnikinnick (*Arctostaphylos uva-ursi*) plugs should be planted in the sunny top 15 metres of the fill. Zone 5 (Figure 4) consists primarily of a rockface. Only light grass seeding (500 seeds per square metre) and transplantation of moss divots (Figure 11) will occur as dictated by available substrate.

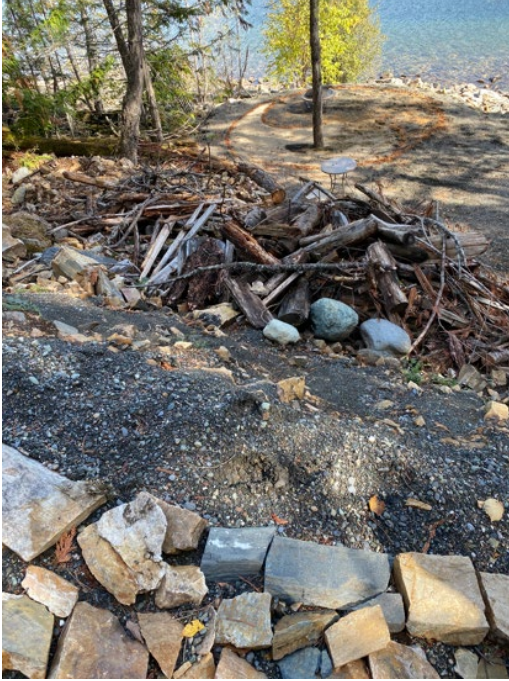
Figure 12. CWD from Zone 3 to be situated on Zone 6 hill prior to topsoil placement.

The overarching objective for Zone 6 (Figure 4) is to maintain vegetation compliance with FireSmart BC guidelines. As such, this zone will be revegetated primarily with shrubs, with the exception of three western larch (*Larix occidentalis*) seedlings. Shrub species selection is targeted towards attracting pollinators and consists of eight Saskatoon berry (*Amelanchier alnifolia*), two ocean spray (*Holodiscus discolor*), and two mock orange (*Philadelphus lewisii*) shrubs. As the site was levelled using pit-run gravel, the soil is likely highly xeric and topsoil will need to be applied throughout the Zone to support shrub and tree establishment. Prior to application of topsoil, CWD from Zone 3 (Figure 12) should be placed on the hill (Figure 13) to improve slope stability and help reduce erosion potential. Topsoil should be applied to a depth of 15 cm across the zone, with a depression in the pit-run established around each

plant such that the topsoil depth will be 30 cm. Light grass seeding should also be completed throughout Zone 6 following topsoil application. Adding a modified brush layer as well as willow staking may be organized by a sub-contractor at a later date.

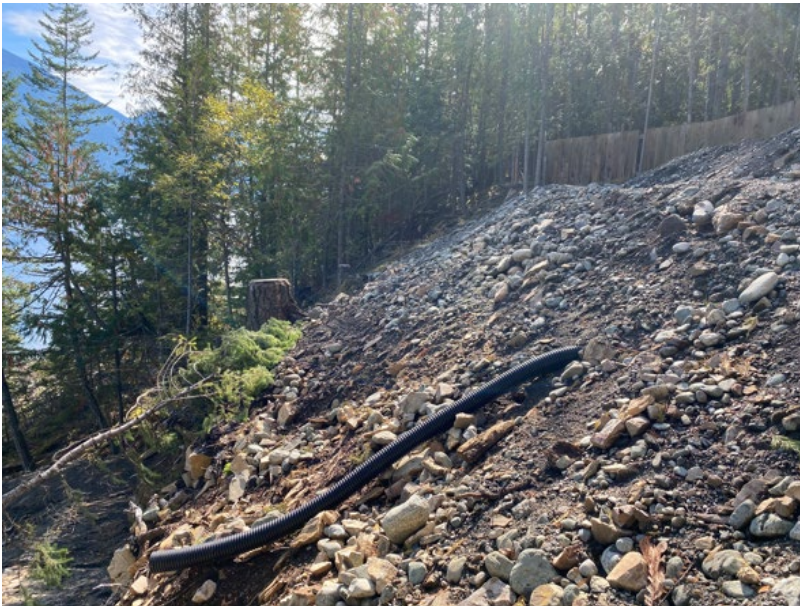
Figure 13. Slope of Zone 6 to be improved with CWD anchoring, slope texturing, and possible soil bioengineering using willow.
