Development Permit Application

Referral Form – RDCK File DP2406A

10377 Highway 3A, Sanca
Lot 2 District Lot 4595 Kootenay District Plan 4523 (PID: 010-421-874)
Electoral Area 'A'

Environmental Report

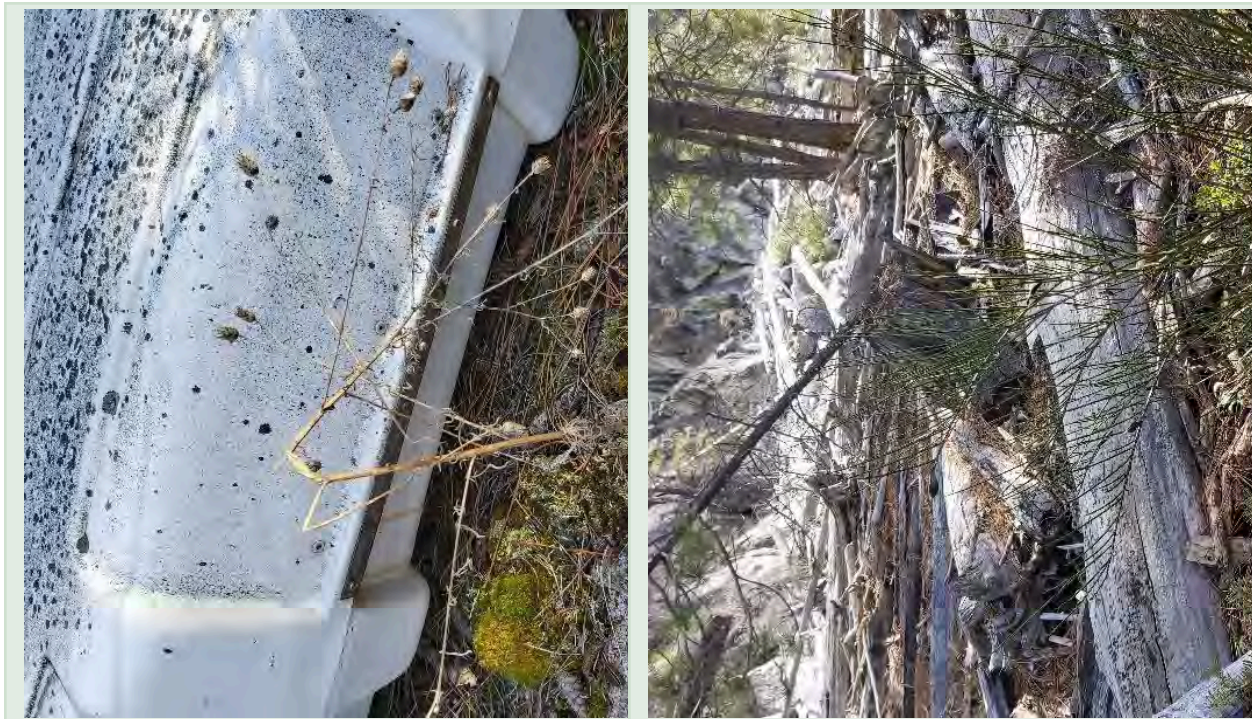
Two invasive plant species were observed on the assessed property and are presumed to have originated from populations along the side of the highway (Figure 8). These species were also observed 200 m up and downstream of the assessed property. Spotted knapweed (*Centaurea stoebe*) should be manually removed and chemically controlled, with extra care taken in its application given the proximity to the high water mark. Existing spotted knapweed skeletons should be carefully removed in such a manner that reduces the likelihood of spreading seeds in the process. Scotch broom (*Cytisus scoparius*) should also be removed through manual and chemical means. Plants should be dug or pulled, taking care to remove as much of the root as possible. Scotch broom may also be controlled via chemical means in the spring.

Figure 8. Invasive plant species found within the assessed property boundaries.

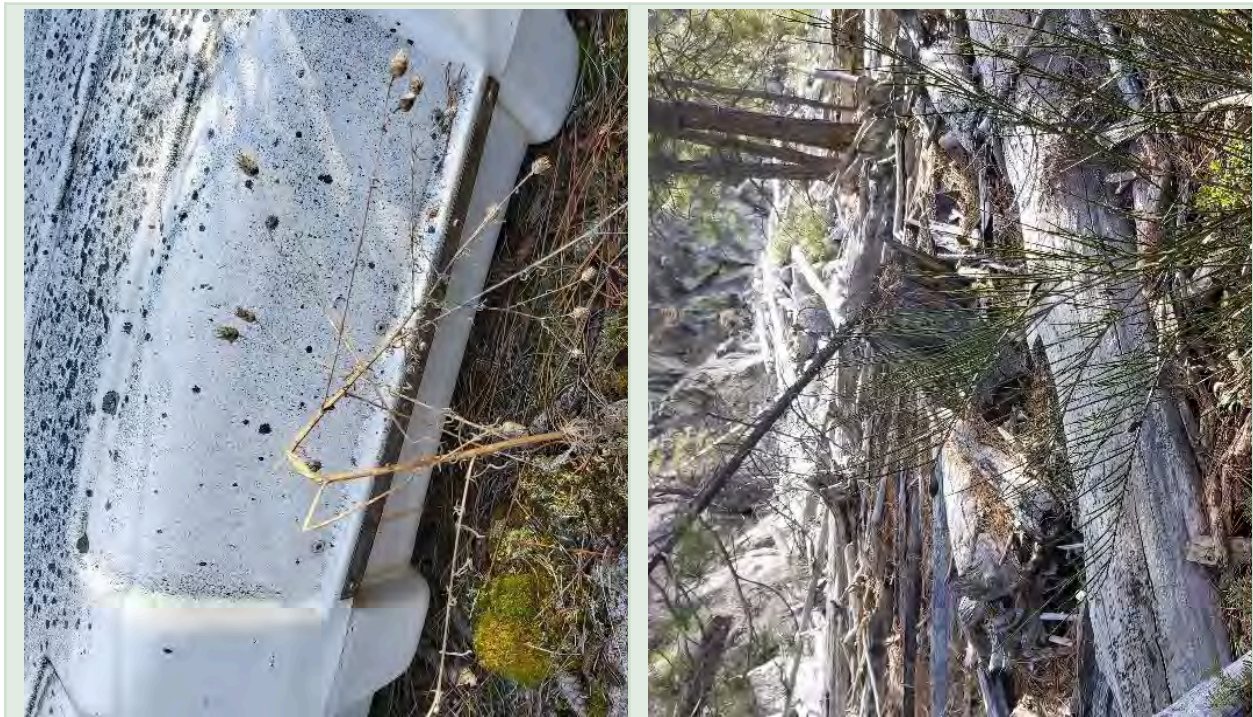
Two invasive plant species were observed on the assessed property and are presumed to have originated from populations along the side of the highway (Figure 1). These species were also observed 200 m upstream and downstream of the assessed property.

Figure 1. Invasive plant species found within the assessed property boundaries (spotted knapweed (left), scotch broom (right)).

- Herbicides are effective against knapweed, including "Round Up".
- Careful attention must be paid to minimize non-target damage (i.e., implementing selective application).
- There will be no application of herbicides within 2 m of the high water mark.
- Herbicide use should only be considered if population numbers are overwhelmingly high for manual removal methods.

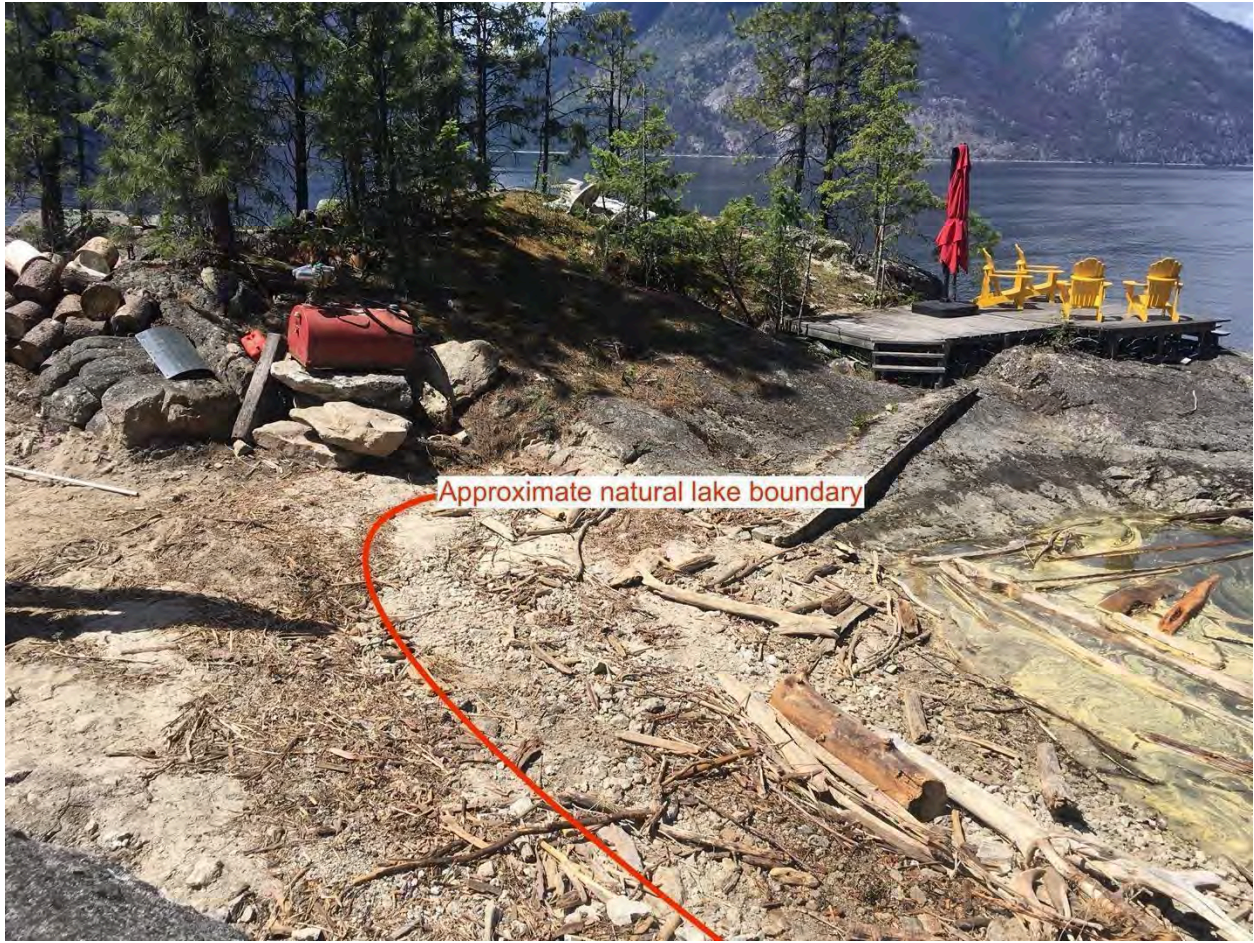
Terrestrial conditions were assessed as those above the natural lake boundary (i.e., high-water mark). A path approximately 10 m wide was observed from north to south connecting the two channels on-site (Appendix A: Figure 10). The path was predominantly sand with minimal coarse rock fragments and no coarse woody debris above the natural lake boundary (Appendix A: Figure 11). No vegetation was seen growing in the sandy area.

Figure 11. The north channel facing west with sand above the natural lake boundary and coarse fragments on the foreshore.

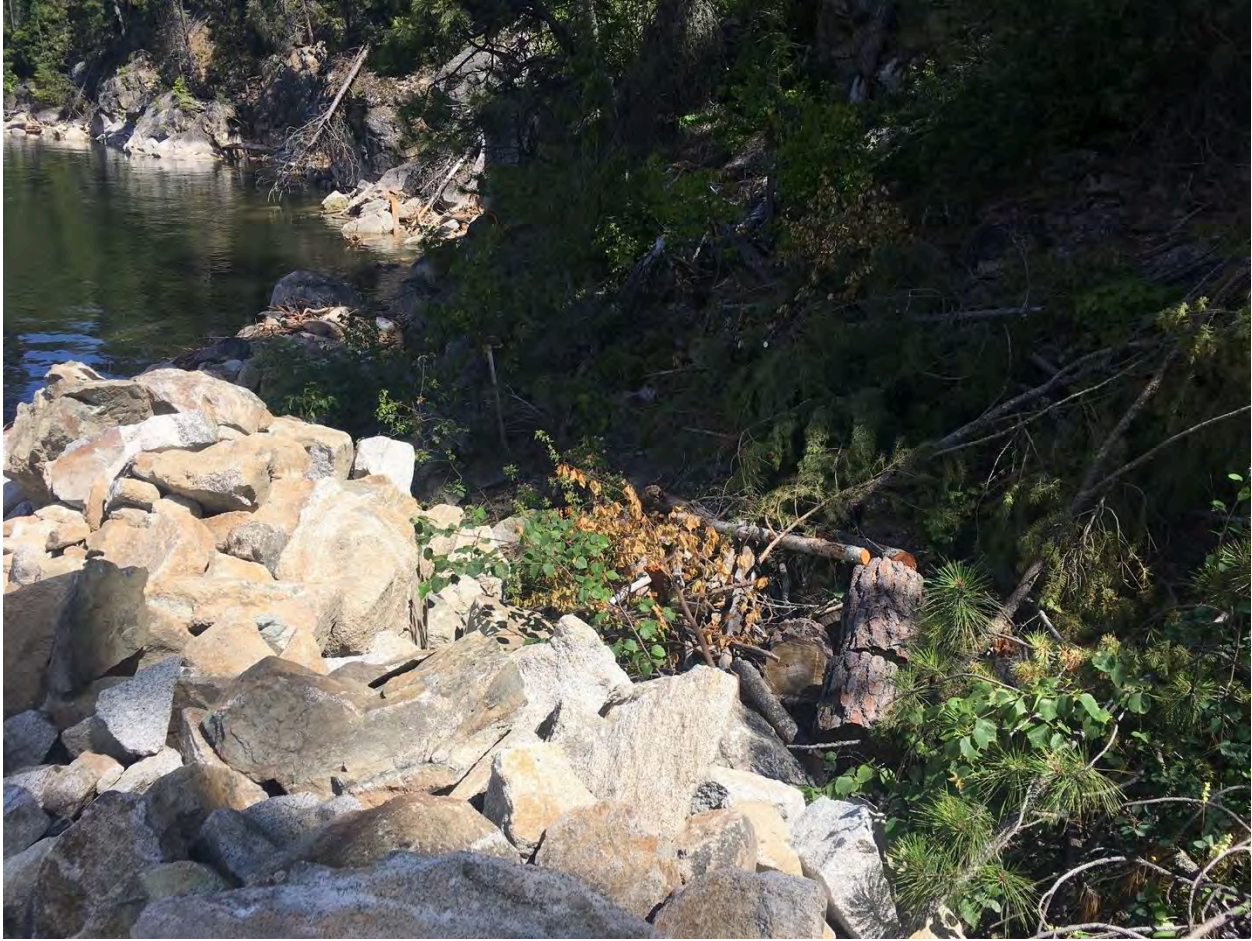
Figure 12. The eastern shoreline of the north channel where trees were removed.

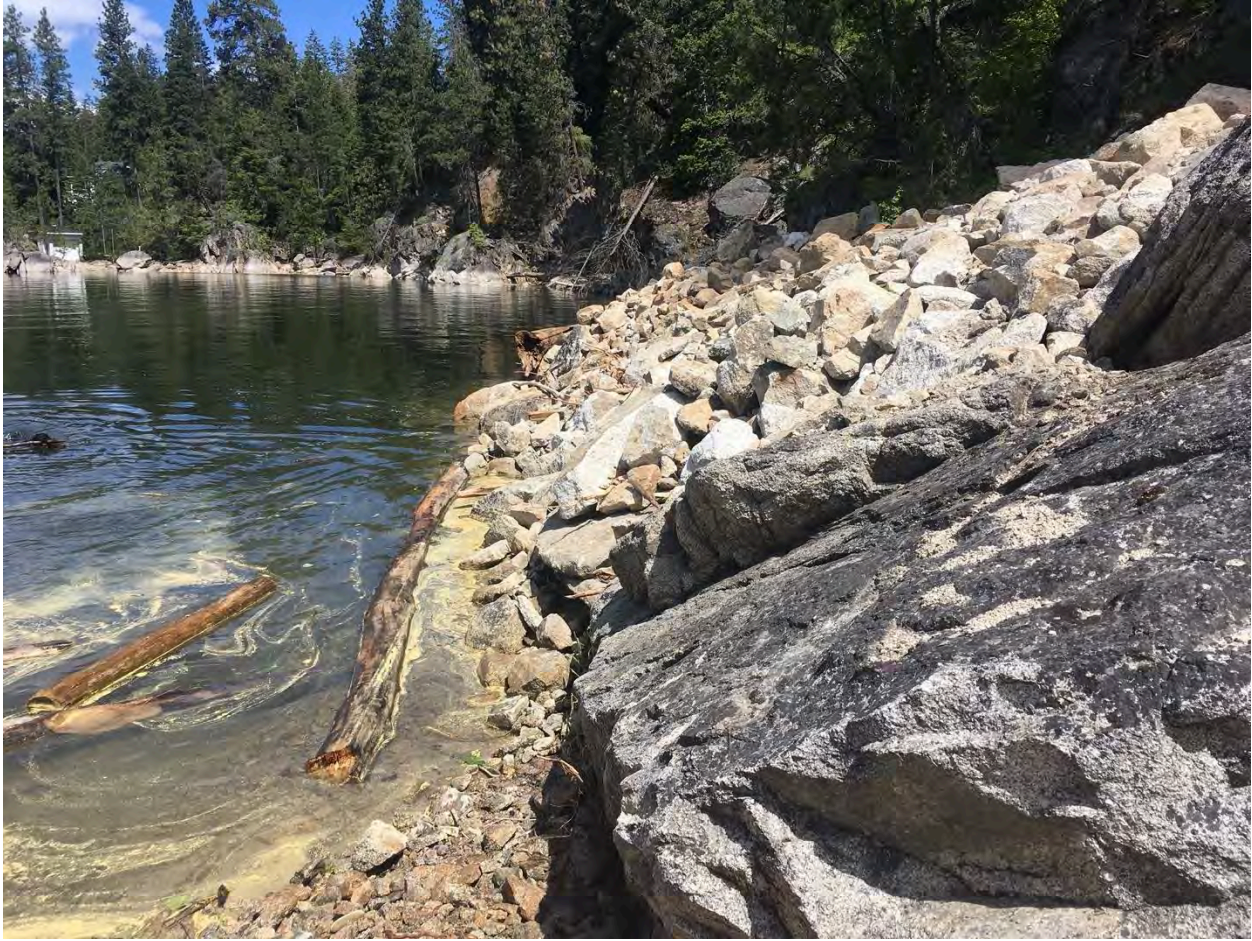
Figure 13. Rock berm along the eastern shore of the north channel.

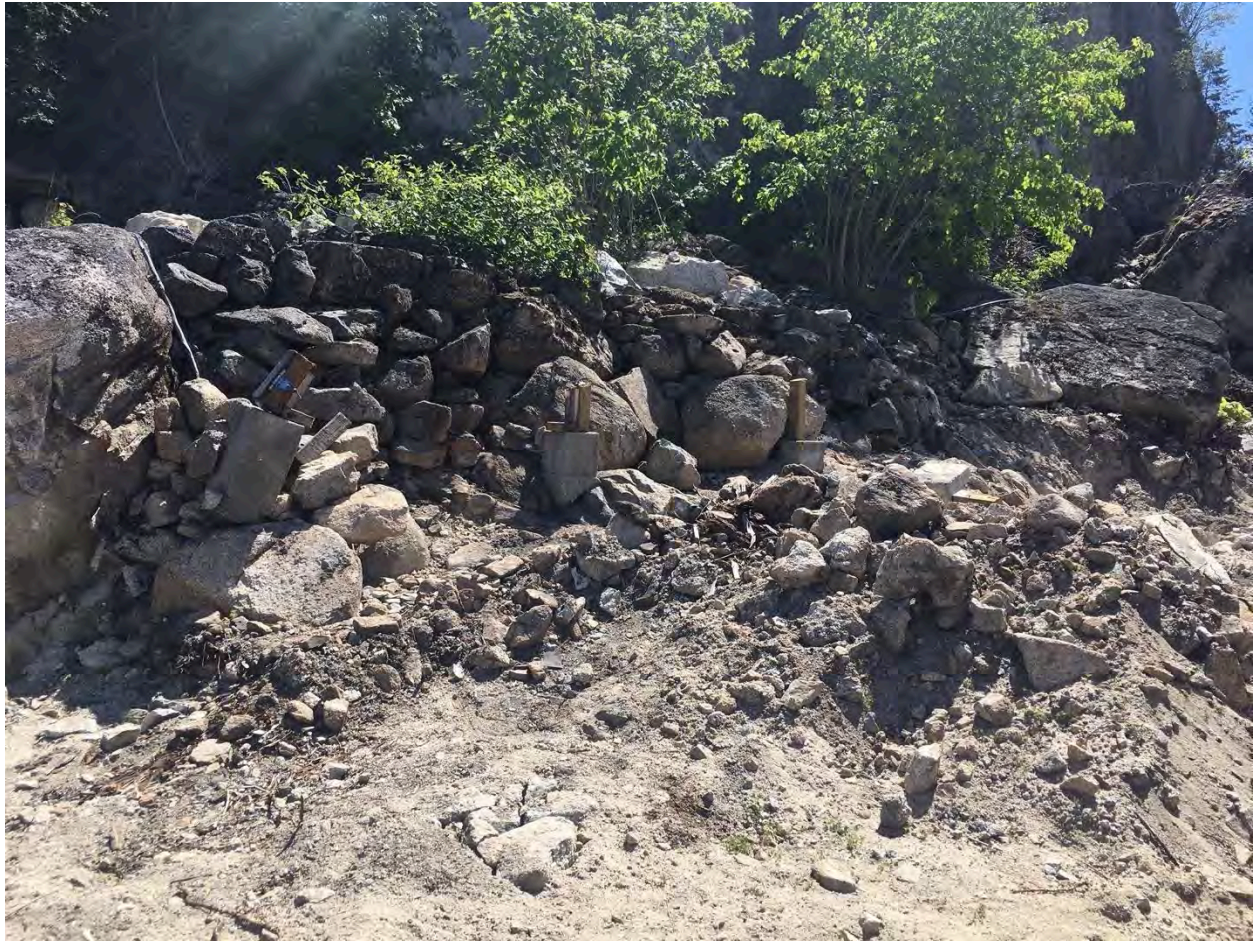
Figure 15. Rock fragments along the eastern perimeter of the dismantled boathouse.

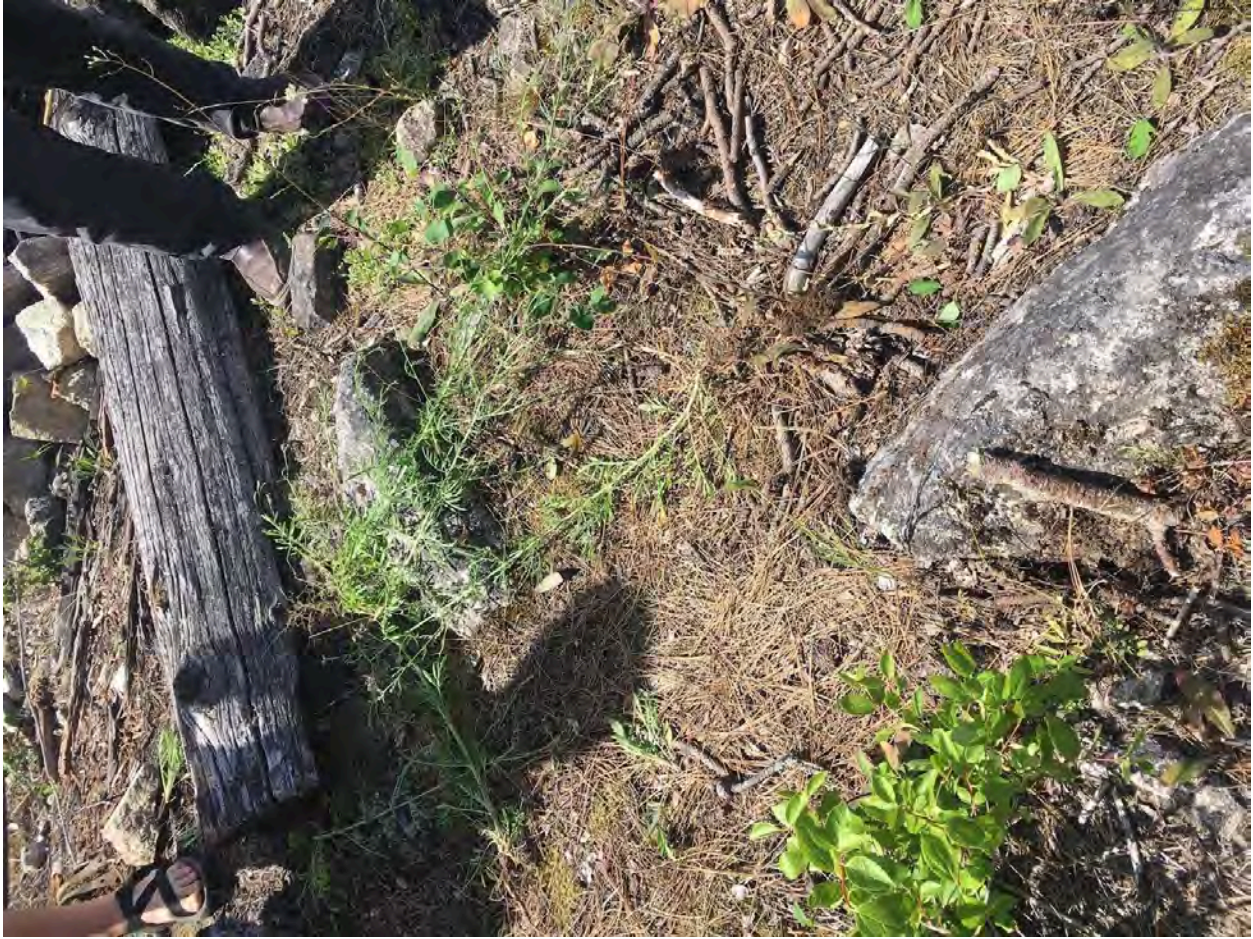
Figure 16. Spotted knapweed manually removed by KES during the June 30 site visit.

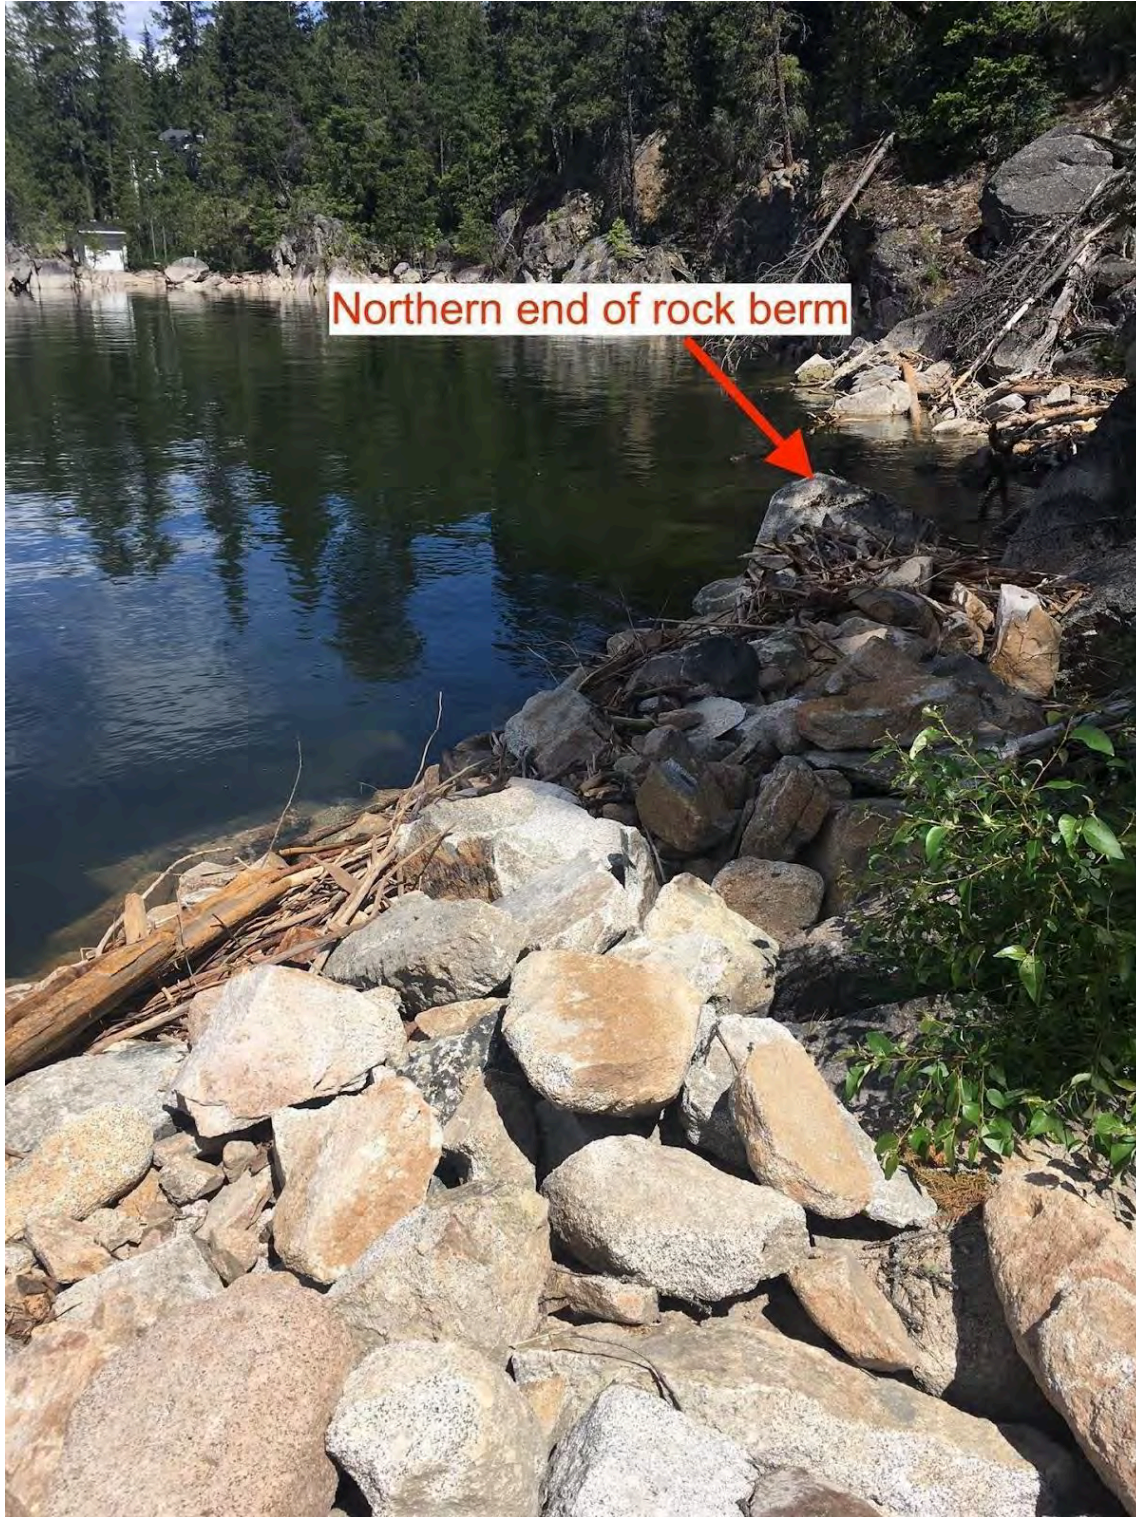
Figure 17. The northern end of the rock berm displaying a collection of woody debris deposited behind during high-water levels.

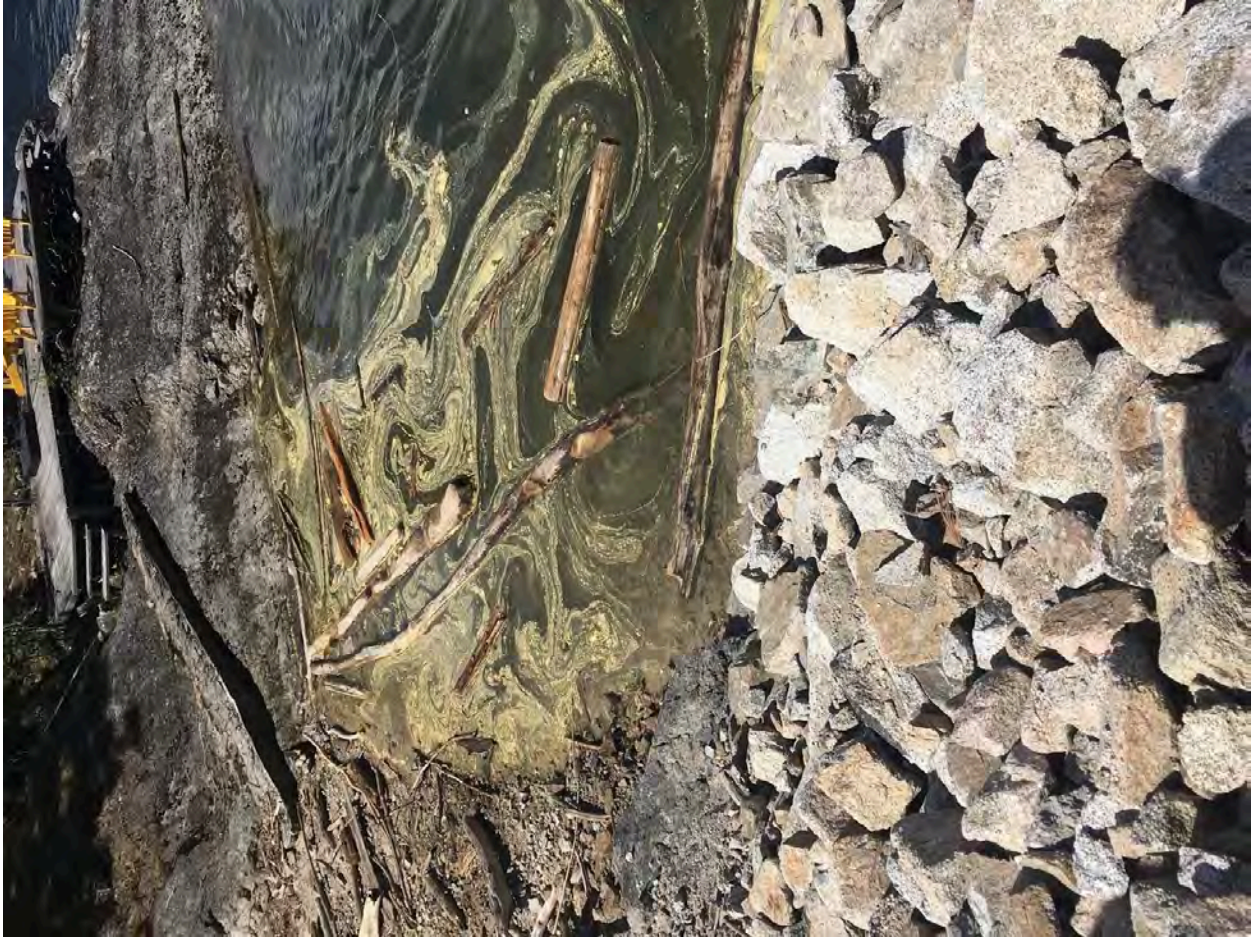
Figure 18. Location of the recommended construction of a machine access slope.

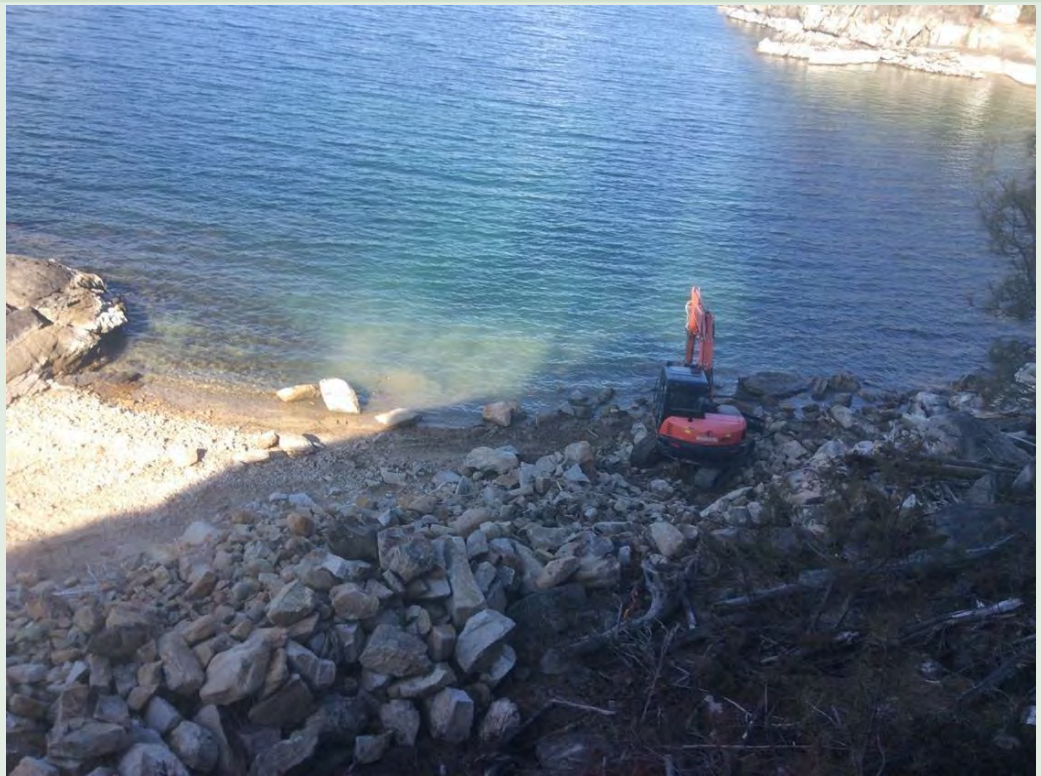
-
Observation of
temporary and
localized
sedimentation

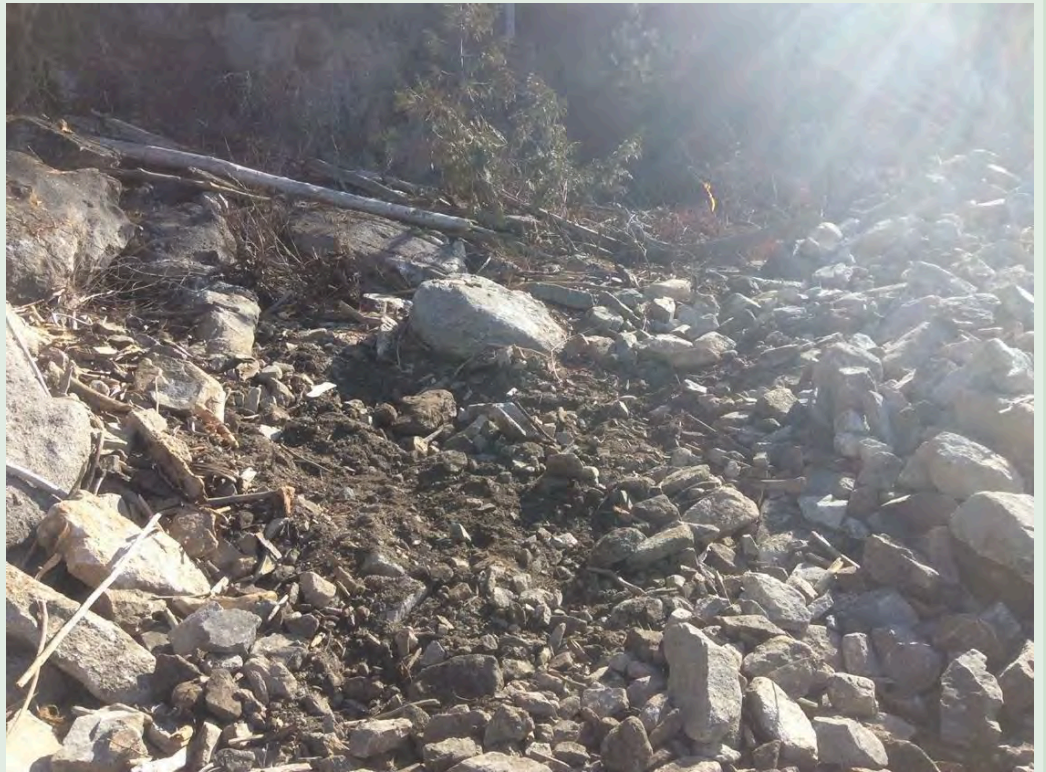
-
The access ramp
on the north
edge of the rock
berm and the
elimination of the
potential fish
entrapment area
