# Development Permit

DP2316D (Gorgiev)

**5324 Amundsen Road, Mirror Lake BC**  
**Riparian Assessment**

Project Number 2023-1094

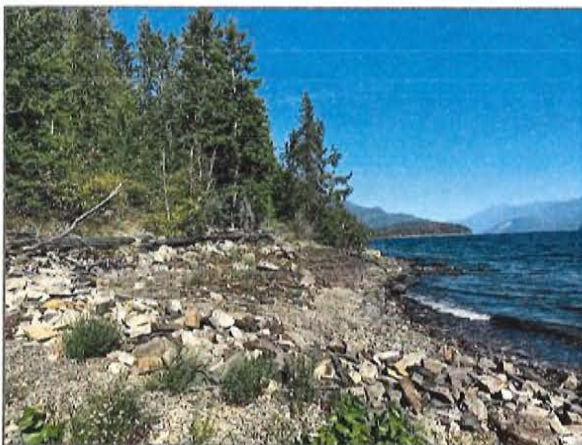
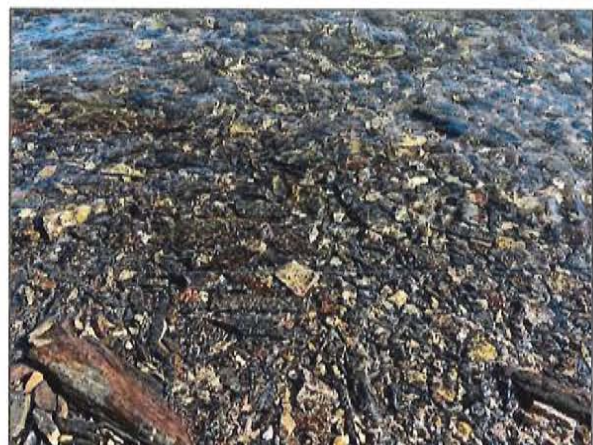
One watercourse was identified on the subject property: Kootenay Lake. Kootenay Lake borders the subject property along the eastern boundary; it is a long, narrow and deep lake with a surface area of approximately 400 km<sup>2</sup>. Kootenay Lake's main inflows include the Lower Duncan River to the north and the Kootenay River to the south and drains through the West Arm into the Kootenay River. Lake levels can vary up to 4 m throughout the year, affecting the extent of the exposed shoreline. The foreshore of the property consists of a sloped beach (~20-25% gradient), with the substrate mainly consisting of gravel, cobble with some boulders and exposed bedrock (Photo 1 and Photo 2).

Photo 1. Shoreline looking north along front of property.  
Photo 2. Shallow water habitat along shoreline.

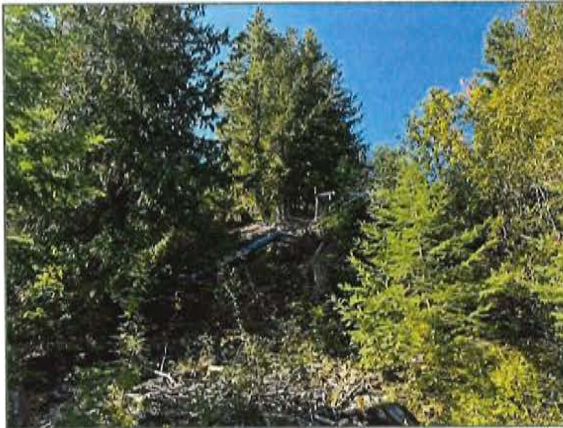
The riparian area along Kootenay Lake is generally intact and supports a mix of both mature and young trees, shrubs and herbaceous species (Photo 3 thru Photo 6). Tree species consist of Interior Douglas-fir (*Pseudotsuga menziesii*), paper birch (*Betula papyrifera*), Western redcedar (*Thuja plicata*), and regenerating black cottonwood (*Betula occidentalis*). The shrub community includes Douglas maple (*Acer glabrum*), falsebox (*Pachistima myrsinites*), kinnikinnick (*Arctostaphylos uva-ursi*), mountain alder (*Alnus incana*), mountain ash (*Sorbus sitchensis*), ocean spray (*Holodiscus discolor*), Oregon grape (*Mahonia aquifolium*), red-osier dogwood (*Cornus sericea*), rose sp (*rosa sp*), snowberry (*Symphoricarpos albus*), soopalallie (*Shepherdia canadensis*) and thimbleberry (*Rubus parviflorus*). Herbaceous species include common wormwood (*Artemisia absinthium*) and grass spp. (*Poa spp.*).

Photo 3. Mixed young and mature forest in riparian area

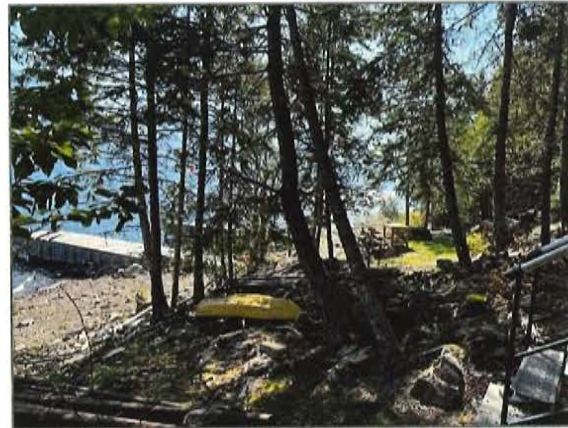
Photo 4. Conifer trees along shoreline.

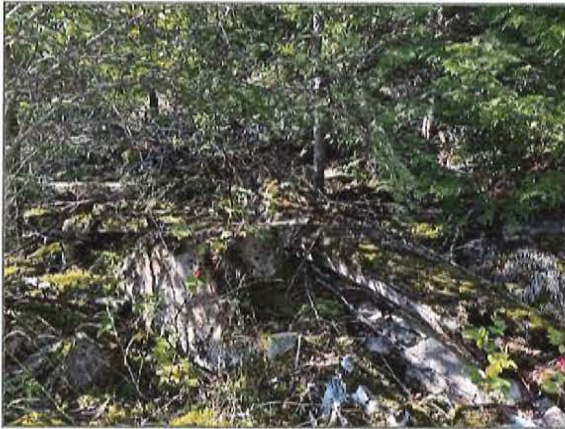
Photo 5. Rocky riparian area, shallow topsoil with minimal shrub layer.

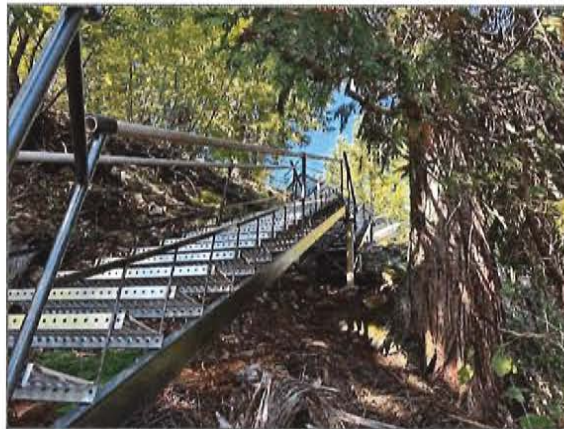
Photo 6. Mature Western redcedar tree within assessment area next to staircase.

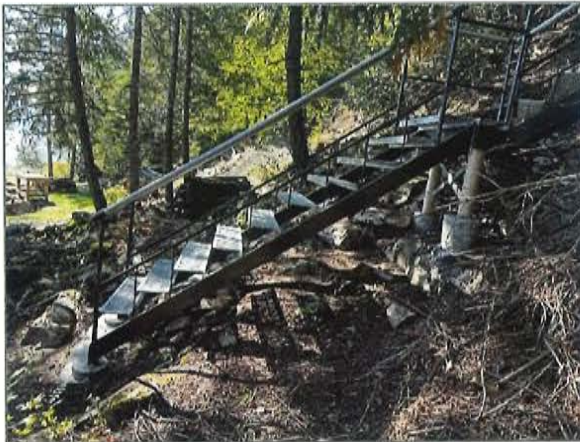
The Owner is seeking approval for the authorization of the constructed elevated stairway down to the waterfront. The elevated stairway is ~34 m long by 1 m wide (Photo 7 thru Photo 9) and has a total footprint of ~34 m<sup>2</sup> within the 30 m WDP area. The stairway is located over a steep embankment down to the foreshore and is sited mostly along an existing foot path alignment. It is constructed with metal grate and handrail, steel posts and concrete footings.

Photo 7. View of access trail down to foreshore at south end of property (July 26, 2023).

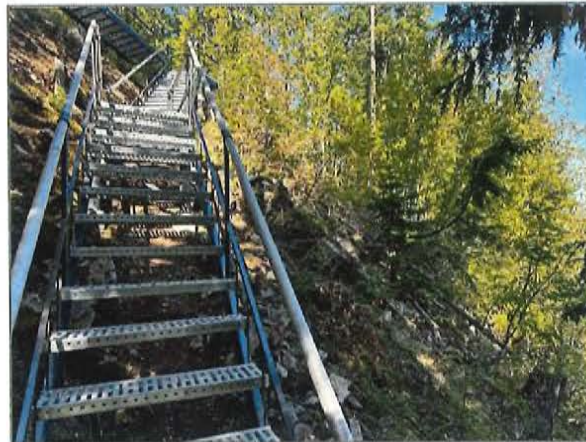
Photo 8. View of constructed metal grate stairway and deck (July 26, 2023).

The stairway is elevated approximately 0.5-1 meter above the ground and utilizes steel grating as the decking material, which allows light and rainfall to penetrate through for the benefit of vegetation growth. This design also provides passage underneath for small animals. Larger mammal migration is not expected to be greatly impacted as migration to and from the foreshore can be navigated along either side of the stairway, along the beach and vegetated area below the stairway and the flat area above the stairway.

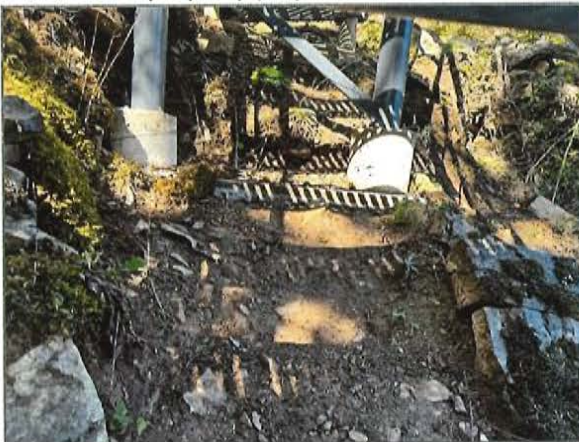
Photo 9. Disturbed soil under stairway

The impact assessment considered the existing site conditions and construction of the stairway. Effects of the stairway development within the SPEA include loss of potential tall shrub and tree habitat within the stairway footprint (~34 m<sup>2</sup>) and minor soil disturbance during the construction causing a potential pathway for erosion and non-native plant establishment to occur.

- 6.3 Disturbed soils within the SPEA shall be reseeded with a native riparian seed blend both under and around the stairway.

around the stairway. Disturbed soils shall be reseeded with the following recommended native riparian seed blend (Table 3) both under and around the stairway. In addition, if invasive weeds are observed they shall be managed accordingly (Section 5.10). Additional monitoring and/ or post inspection are not proposed.

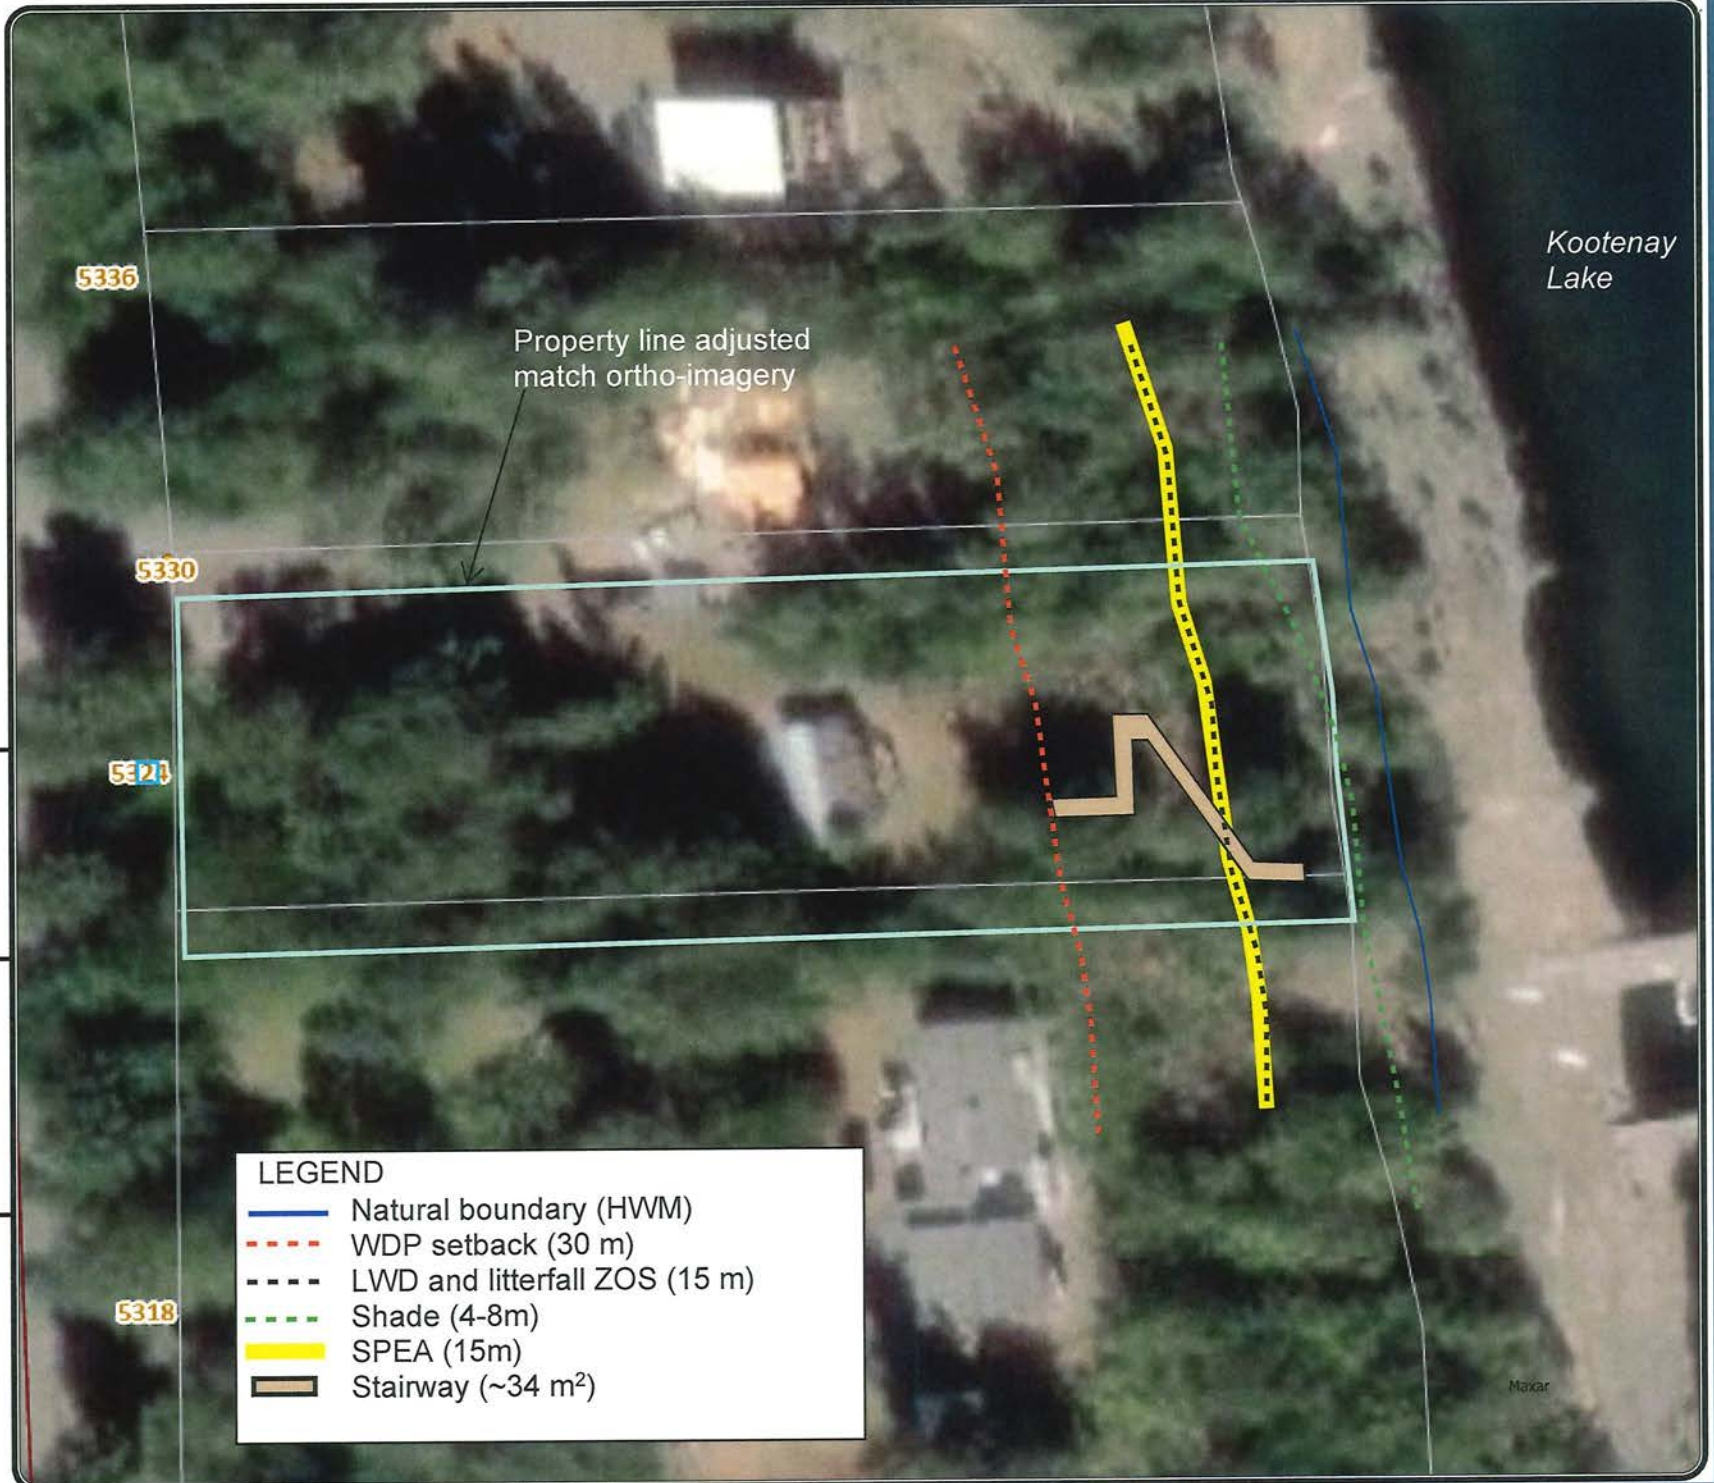
The visible **natural boundary** of Kootenay Lake was observed to be approximately ~8 m east of the eastern property line (RDCK mapping 2023) and is shown on the Site Plan (Appendix 2). The **natural boundary** is commonly referred to as the "**high water mark**" around a lake or wetland. Based on the definition of high water mark<sup>1</sup>, the natural boundary shown on the Site Plan will be used to delineate the 30 m RDCK WDP area and streamside protection and enhancement area (SPEA) setbacks in accordance with the Riparian Area Protection Regulation (RAPR).

- Natural boundary (HWM)
- WDP setback (30 m)
- LWD and litterfall ZOS (15 m)
- Shade (4-8m)
- SPEA (15m)
- Stairway (~34 m<sup>2</sup>)

Additional development on the site should occur outside of the SPEA (see Appendix 2). If future development within the 30 m WDP is proposed, a new WDP application will be required prior to any construction.
