RDCK FLOODPLAIN AND STEEP CREEK STUDY

Procter Creek

Final
March 31, 2020

Prepared by BGC Engineering Inc. for:
Regional District of Central Kootenay

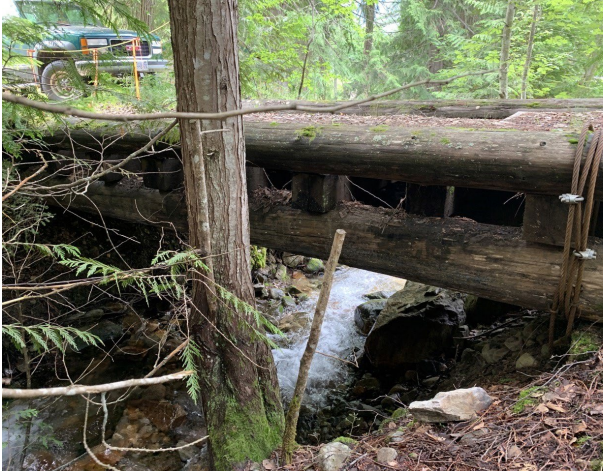
A) PRT-BR-1. Looking downstream towards wooden vehicle bridge approximately 130 m downstream of the fan apex.

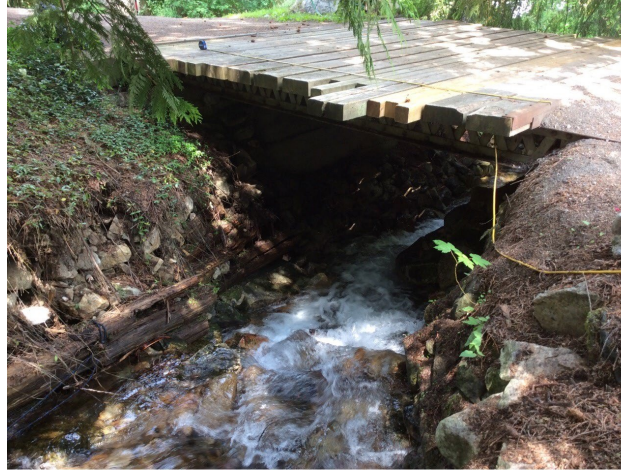
B) PRT-BR-2. Looking downstream towards a wooden bridge with metal frame.

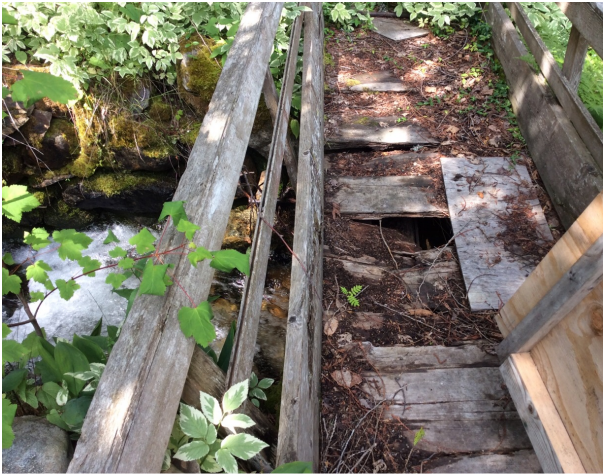
C) PRT-BR-3. Rotting footbridge over channel. Bridge is approximately 0.8 m high.

Procter Creek passes under five bridges and five culverts on the fan-delta, (Drawing 02A, Drawing 02B, Drawing 06, Figure 3-7 and Figure 3-8). Of the ten structures, only three culverts are listed in the Data Catalogue published by the Ministry of Transportation and Infrastructure (MOTI) – Construction and Maintenance (Table 3-2). BGC subcontracted Explore to survey the river channel and document the dimensions of each hydraulic structure. The survey was completed on September 5, 2019. Key dimensions are summarized in Table 3-2. Bridge and culvert locations IDs are listed in Table 3-2 and are shown on Drawing 02A, 02B. There are three wooden bridges in the upper fan upstream of Woodside Avenue. The furthest upstream is a wooden bridge (Figure 3-7A). The next bridge in the downstream direction, PRT-BR-2, is a wooden bridge installed for residential access (Figure 3-7B). Upstream and downstream of the residential bridge, the channel has been heavily modified over the course of decades with visible crib and cobbles that have been placed on the channel banks. PRT-BR-3 is a footbridge with a rotten deck (Figure 3-7C).

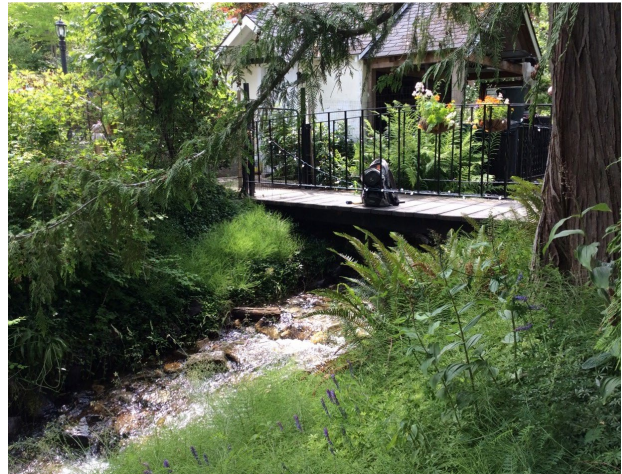
D) PRT-BR-4. Wooden footbridge with metal railing approximately 5 m wide, 1.6 m high.

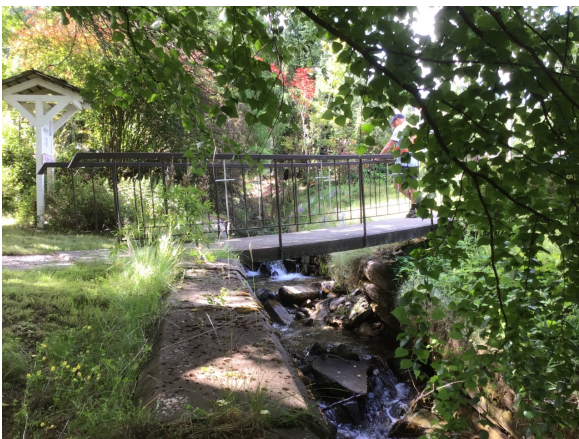
E) PRT-BR-5. On right bank looking upstream at church bridge.

A concrete footbridge (PRT-BR-5), which sits on a concrete wall and a log crib structure, provides access by foot to the Church of the Sacred Heart (Figure 3-7E). During the July site visit, BGC noted the poor state of the log crib structure, which may no longer provide a stable base for the footbridge. The Procter Creek channel gradient is approximately 11% from the fan apex to Procter Lane. Immediately downstream of Procter Lane, the gradient diminishes to 6% until the outlet at Kootenay Lake.

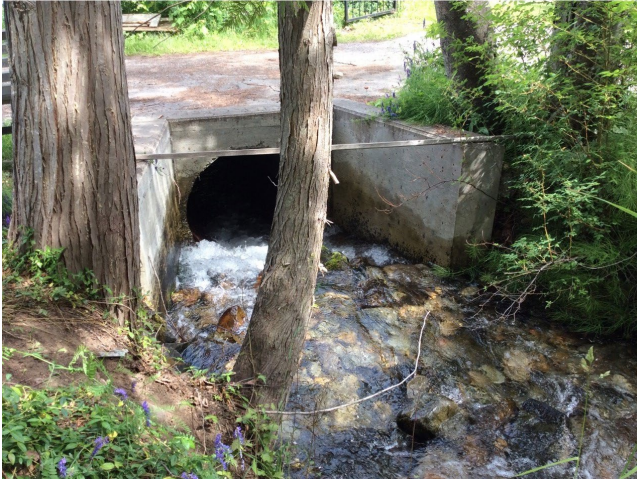
A) PRT-CV-1. Looking upstream towards the culvert at Woodside Avenue.

PRT-CV-2 conveys the flow under Procter Lane (alleyway) with an outlet approximately 40 m upstream of Railway Avenue. This portion of the creek is confined by a combination of concrete, metal flashing and rock to be approximately 1.5 m wide. The Railway Avenue culvert (PRT-CV-3, Figure 3-8C) is the largest of the culverts along Procter Creek. and the outlet falls 1.3 m to a plunge pool (Figure 3-8C). Twin culverts (PRT-CV-4, Figure 3-8D) convey the creek below the CP railway. Just upstream of the twin culverts at the railway is a trash rack with 18 cm spacing made from cantilevered rails cast in a concrete base. The railway is approximately 0.8 m above the left (larger) culvert and discharges into a plunge pool. The Jones Road culvert (PRT-CV-5) is the most downstream culvert on Procter Creek (Figure 3-8E).

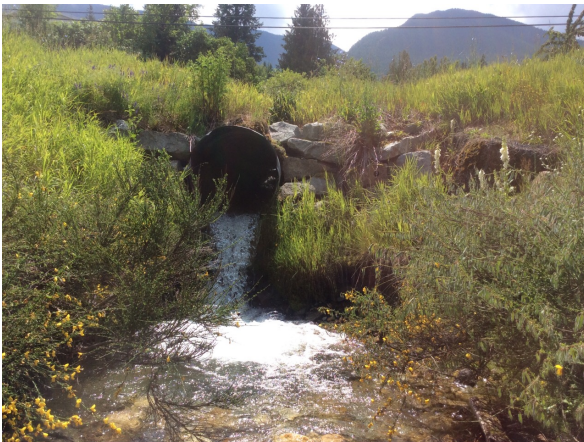
C) PRT-CV-3. Looking upstream at the outlet of Railway Avenue culvert.

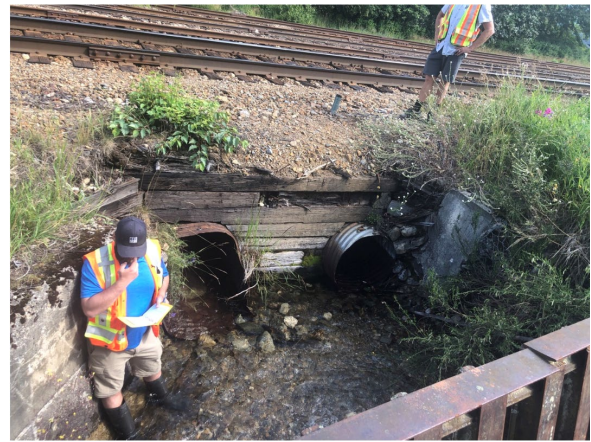
D) PRT-CV-4. Looking downstream at twin culverts under railway with trash rack in foreground.

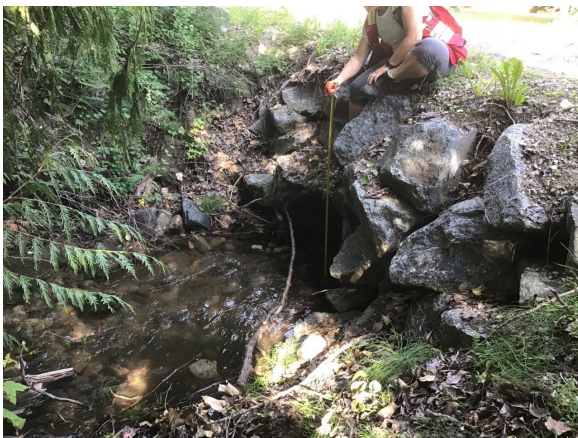
E) PRT-CV-5. Looking at outflow of Jones Road culvert

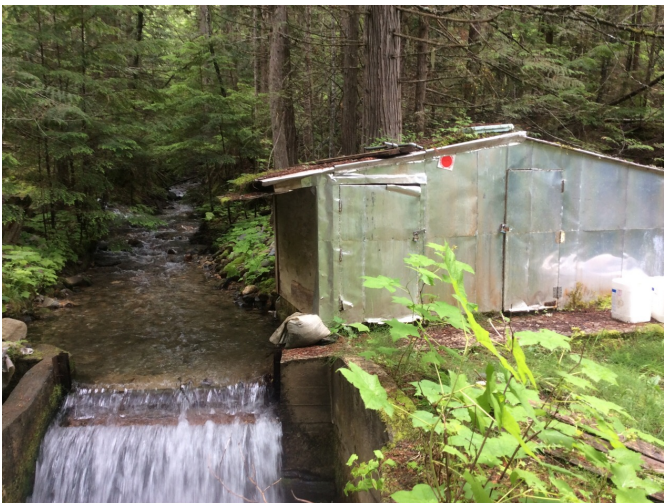
A) Looking upstream towards weir and water intake structure. B) Top view sketch of Procter Creek weir structure.

Approximately 320 m downstream of the fan apex, there is a concrete weir and a water intake structure (Figure 3-9). The concrete opening is 1.8 m wide with stop logs to adjust the height of the weir. This structure is the farthest upstream point included in the survey, completed by Explore on September 5, 2019. On the date of the survey, the difference from the weir to the top concrete walls of the intake structure was measured to be 0.1 m. The channel and intake structure have a low freeboard, and this has been identified as a potential avulsion location from BGC field observation.

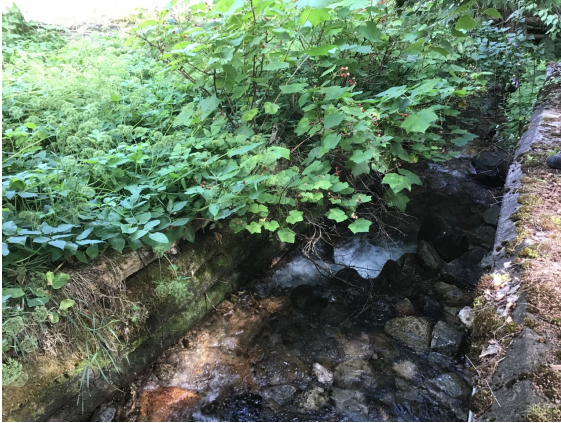
A) Looking downstream at mid-fan near the church.

At mid-fan near the church, the creek is confined by a concrete wall on the left bank and a log crib structure on the right (Figure 3-10A). The bank protection is metal flashing just upstream of Procter Lane, while downstream the creek is contained in a concrete flume (Figure 3-10B & C). Gabion baskets line the creek from the Railway Avenue culvert outlet to the railway trash grate. One gabion basket on the right bank 3 m from the Railway Avenue culvert outlet has broken and gravel material has washed out; however, the remaining baskets are all intact (Figure 3-10D). Downstream of the railway culvert, the stream is lined with a log crib structure of unknown length (Figure 3-10E).

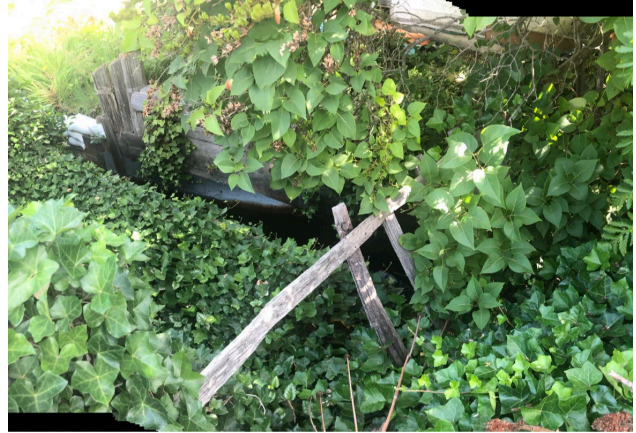
B) Metal flashing containing the creek upstream of Procter Lane

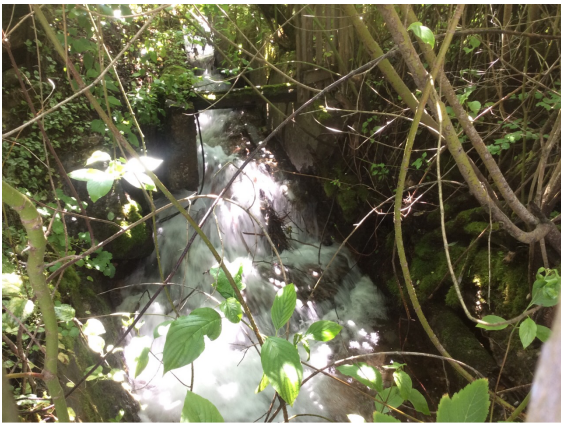
C) Looking upstream of Railway Avenue at concrete flume.

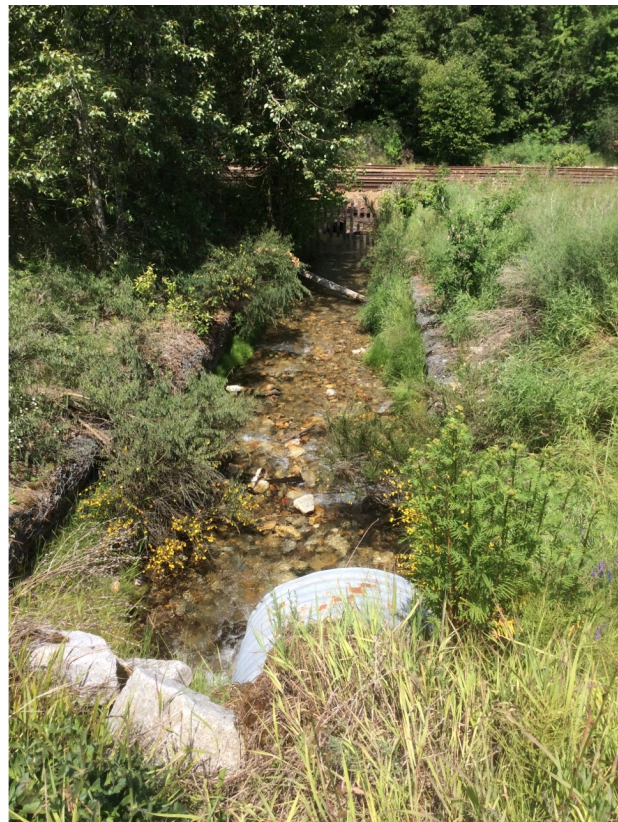
D) Looking downstream at gabion baskets lining creek from outlet of Railway Avenue towards railway.

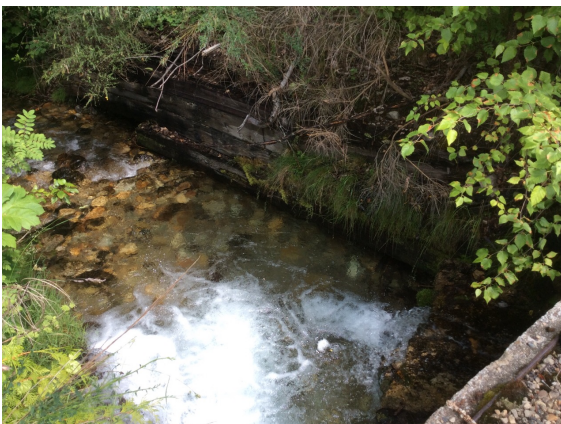
E) Looking downstream at outlet of railway culvert showing log crib bank protection.

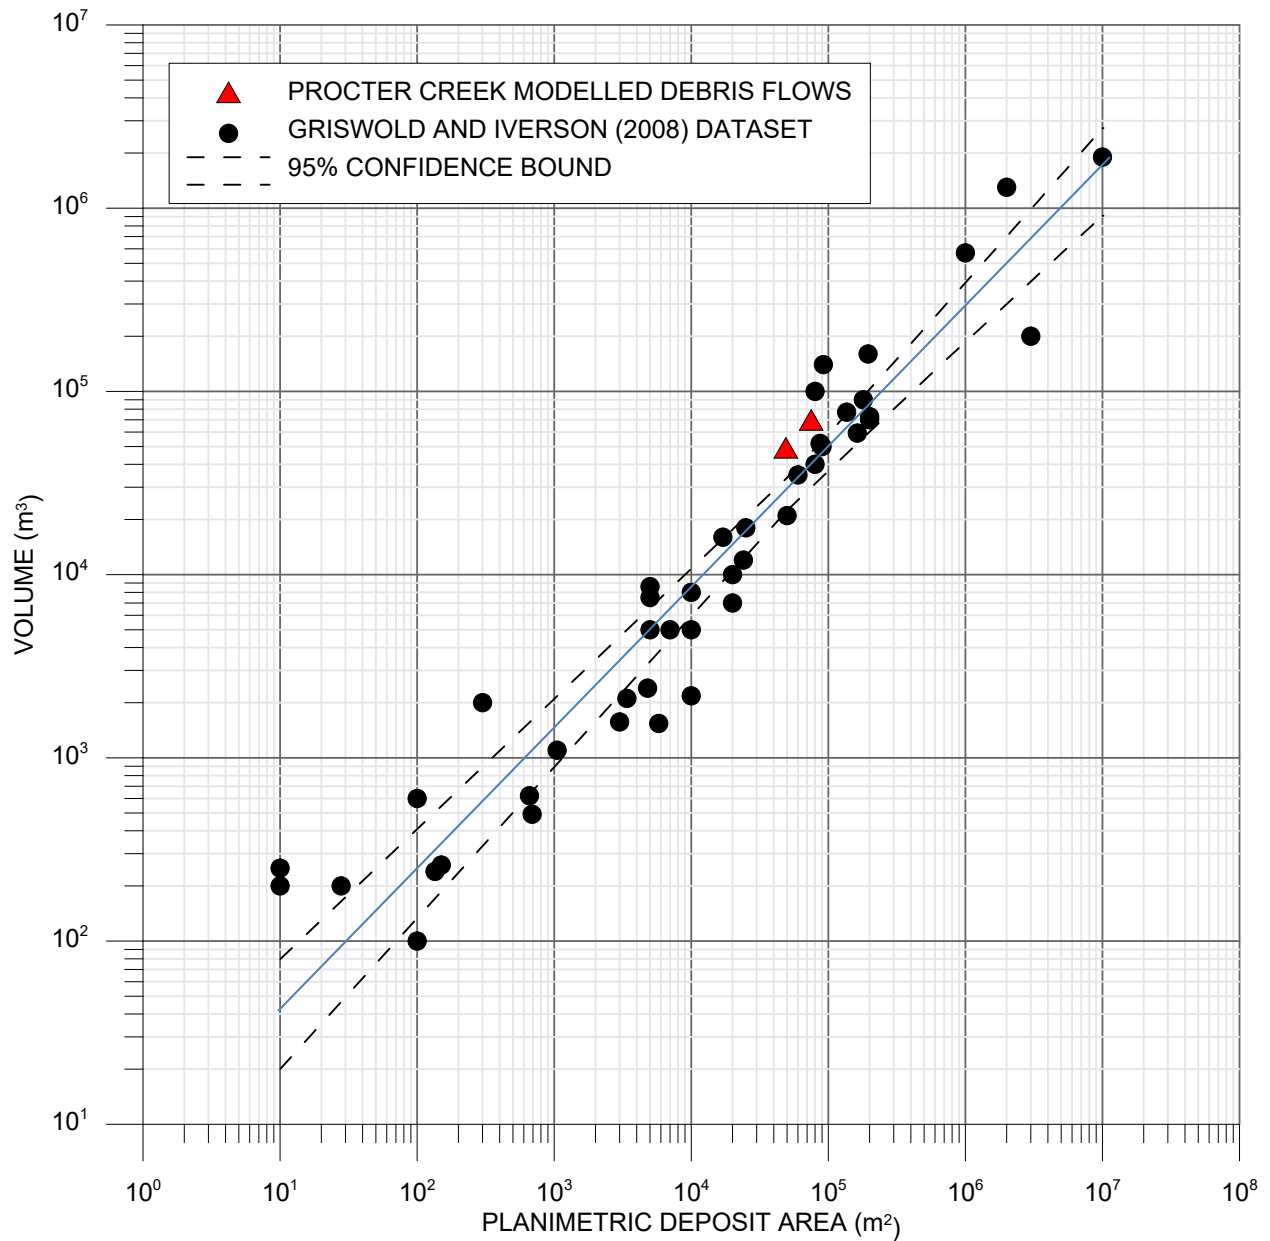
Figure 6-3. Modelled event volumes for Procter Creek (red) in comparison to typical non-volcanic debris flow dataset (black) developed by Griswold and Iverson (2008).

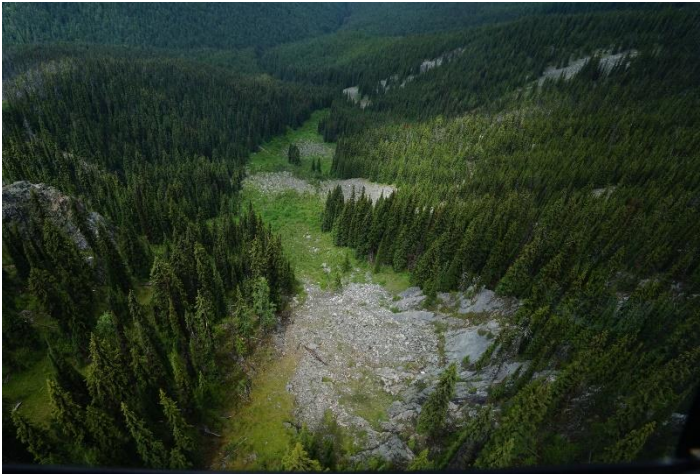
Photo 5.

Overview photo taken during helicopter overflight looking west at a scar from a former debris avalanche leading into Procter Creek, approximately 5 km upstream of the fan apex. Photo: BGC, July 6, 2019.

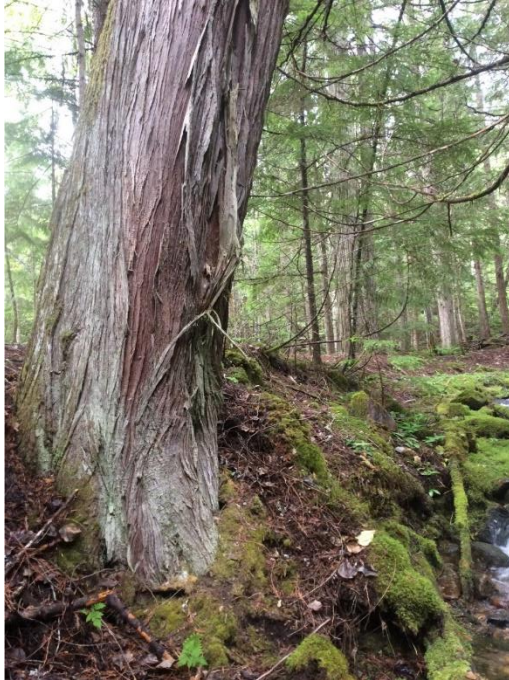
Photo 7.
Tree with scar approximately 200 m downstream of the fan apex. Photo: BGC, July 6, 2019.

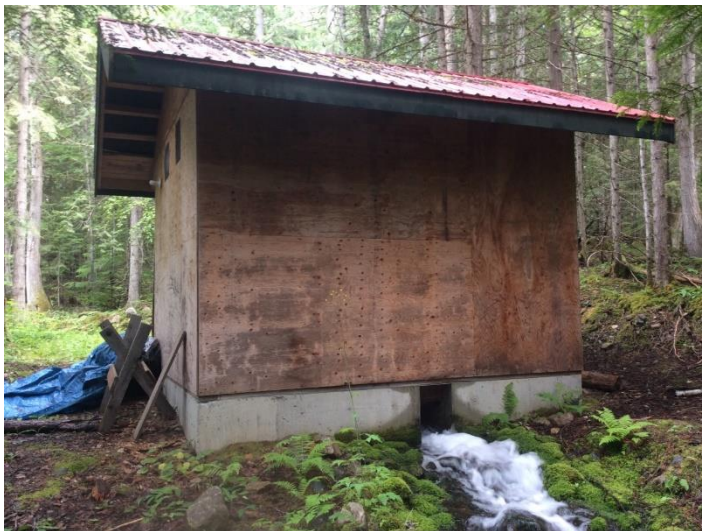
Photo 8.
Powerhouse approximately 6 m east of channel, approximately 200 m downstream of the fan apex. Photo: BGC, July 6, 2019.

Development on the Procter Creek fan-delta comprises the community of Procter (Drawing 02A, 02B) and the Canadian Pacific (CP) railway that transects the distal fan. Approximately 300 m downstream of the fan apex, there is a powerhouse 6 m east of the channel bank (Photo 8, Appendix B). A further 20 m downstream, is the water intake structure and weir that supplies water to some local households (Photo 9, Appendix B).

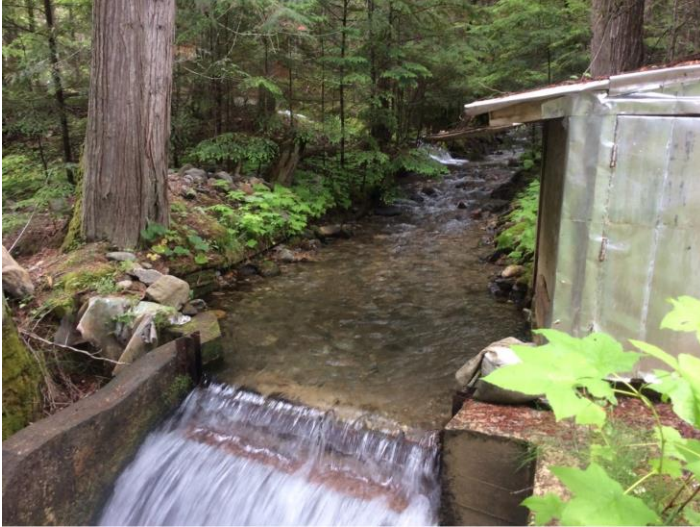
Photo 9.
Looking upstream (south) at the water intake on Procter Creek. Photo: BGC, July 6, 2019.

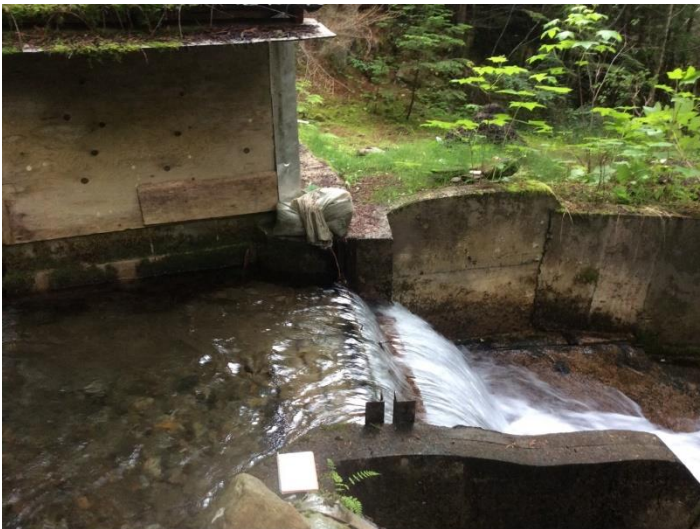
Photo 10.
Looking downstream (north) at the water intake weir on Procter Creek. Photo: BGC, July 6, 2019.

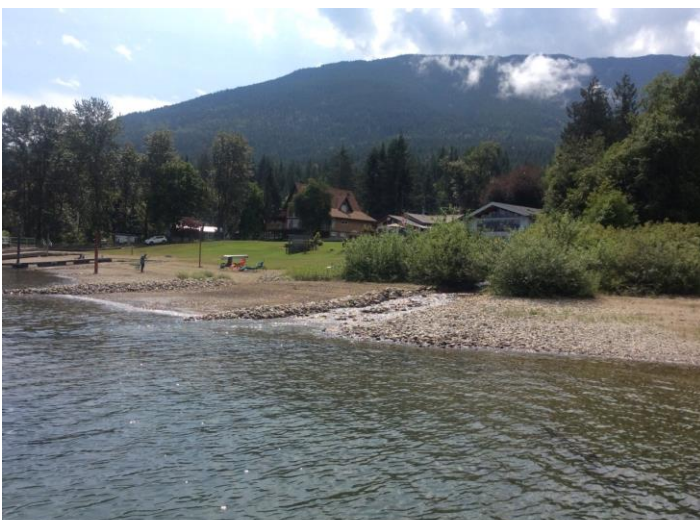
Photo 11.
Looking south at the east Procter Creek outlet to Kootenay Lake. Photo: BGC, July 7, 2019.

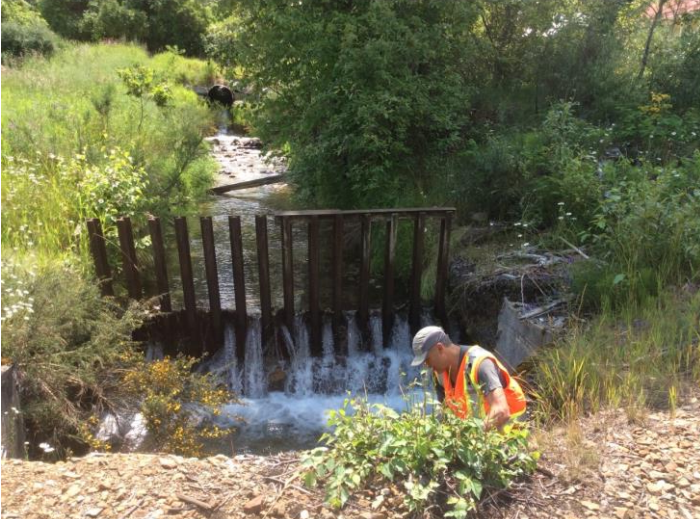
Photo 12.
Looking upstream (south) at a trash rack made from cantilevered rails protecting the railway culverts. Photo: BGC, July 7, 2019.

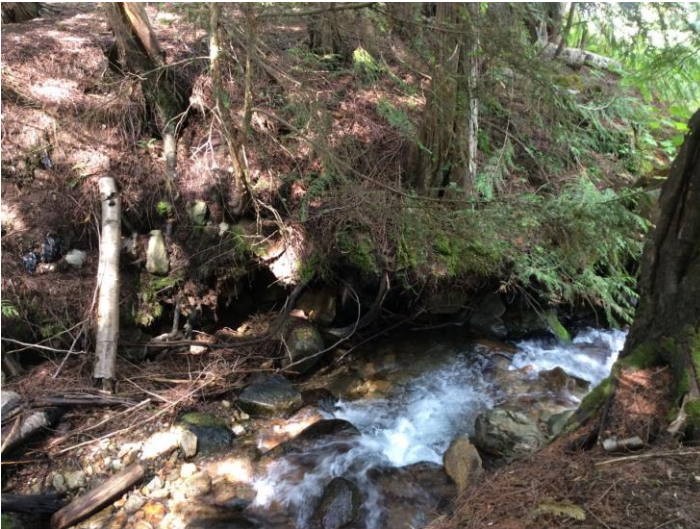
Photo 13.
Standing on the right bank of Procter Creek looking downstream (north) approximately 60 m upstream from the east outlet to Kootenay Lake. Bank erosion and failure visible on left bank. Photo: BGC, July 5, 2019.

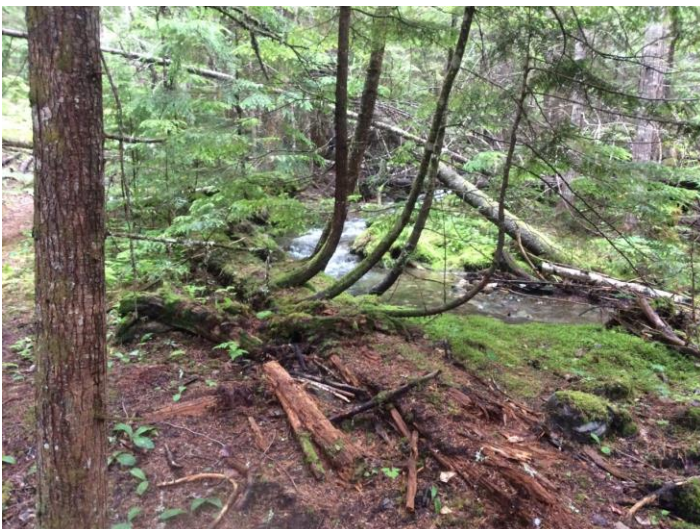
Photo 14.
Looking upstream at Procter Creek. A potential avulsion point is visible on the right bank, approximately 50 m upstream of the fan apex. Photo: BGC, July 7, 2019.

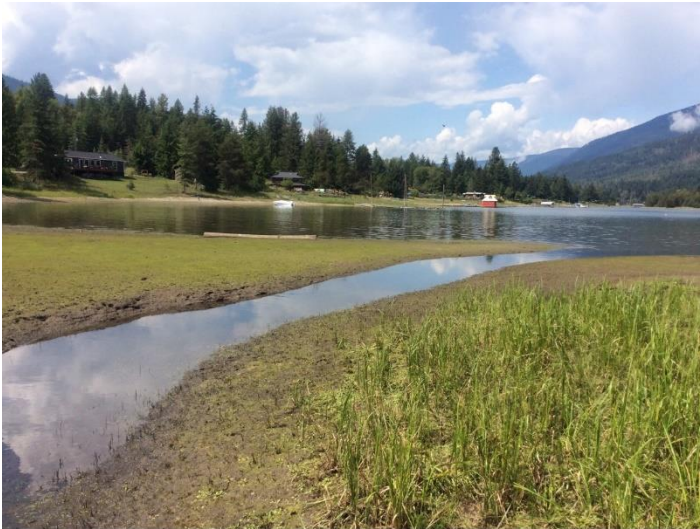
Photo 15.
Standing on the right bank of Procter
Creek at the west outlet to Kootenay
Lake looking downstream (west).
Photo: BGC, July 7, 2019.

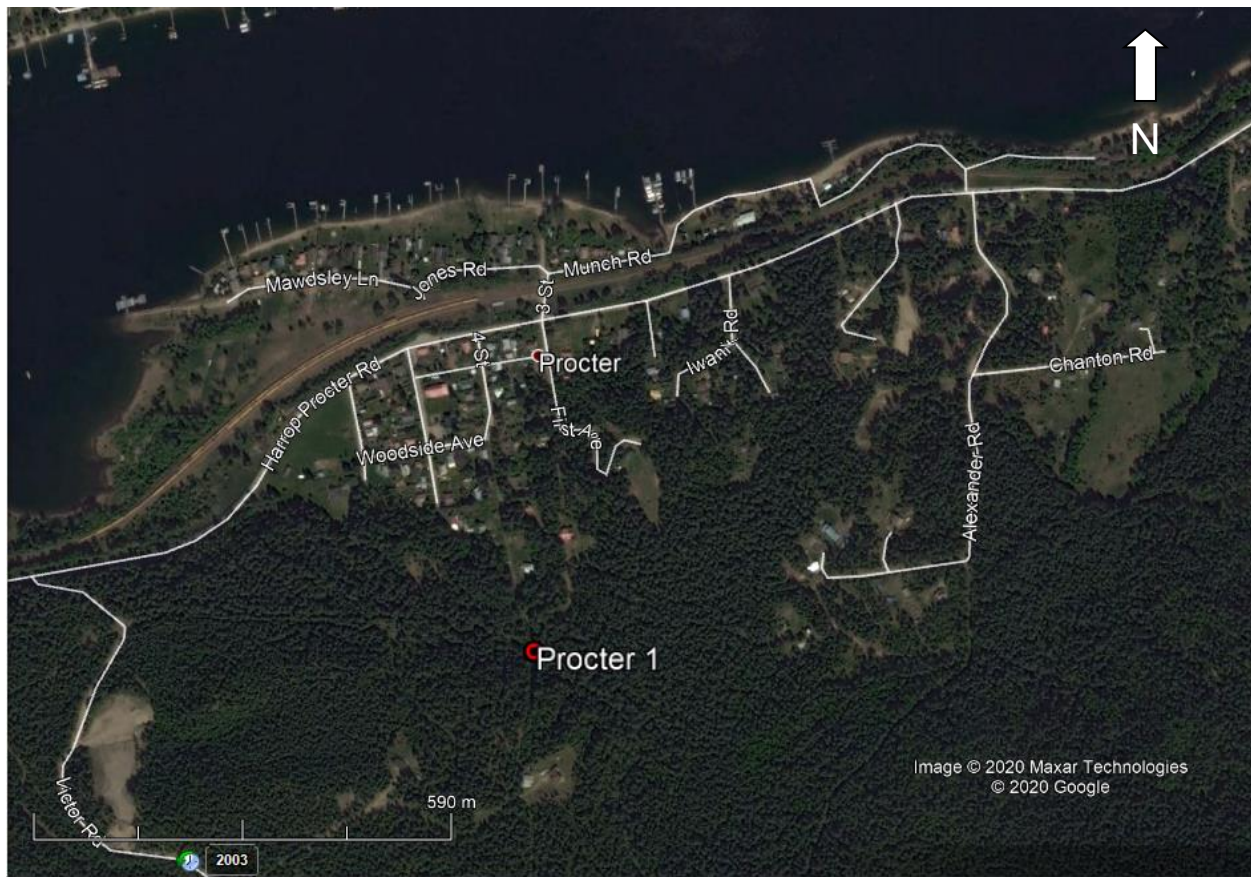
Figure C-1. Wolman sampling location along Procter Creek. Google Earth image of May 1, 2016.

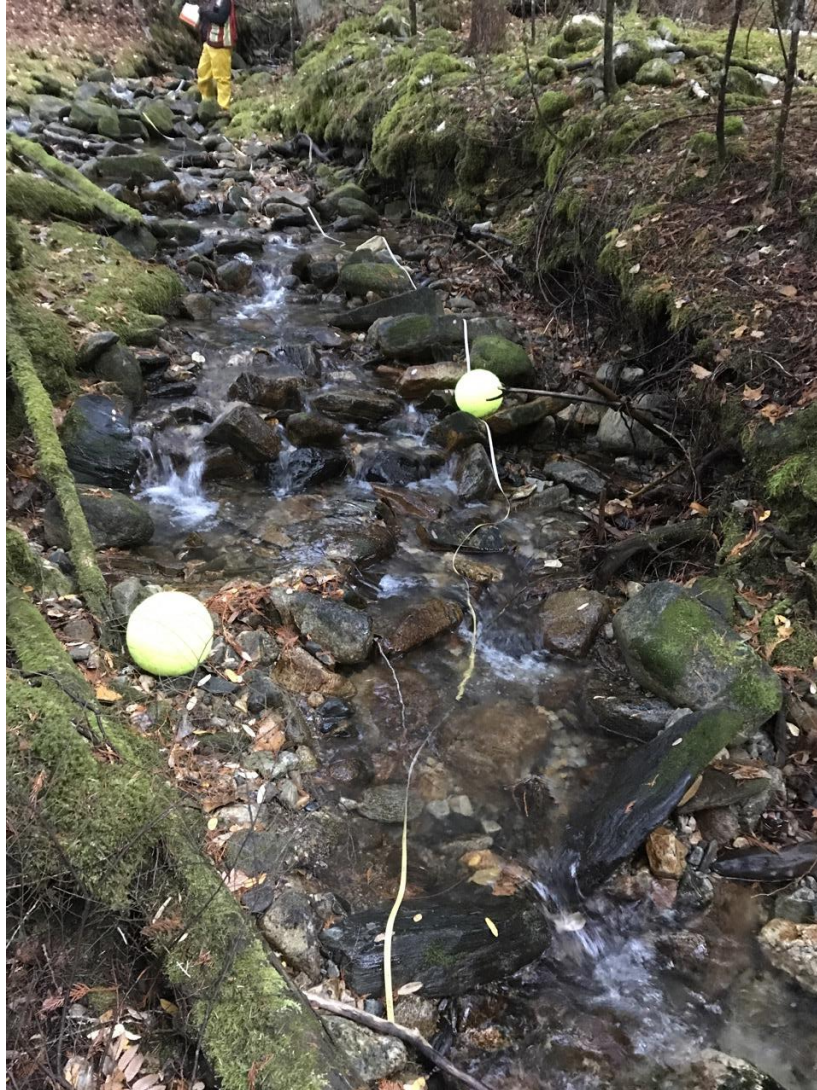
Figure C-2. Photograph taken of Wolman sampling location Procter 1. BGC photograph of November 20, 2019.
