RDCK FLOODPLAIN AND STEEP CREEK STUDY

Sitkum Creek

Final
March 31, 2020

Prepared by BGC Engineering Inc. for:
Regional District of Central Kootenay

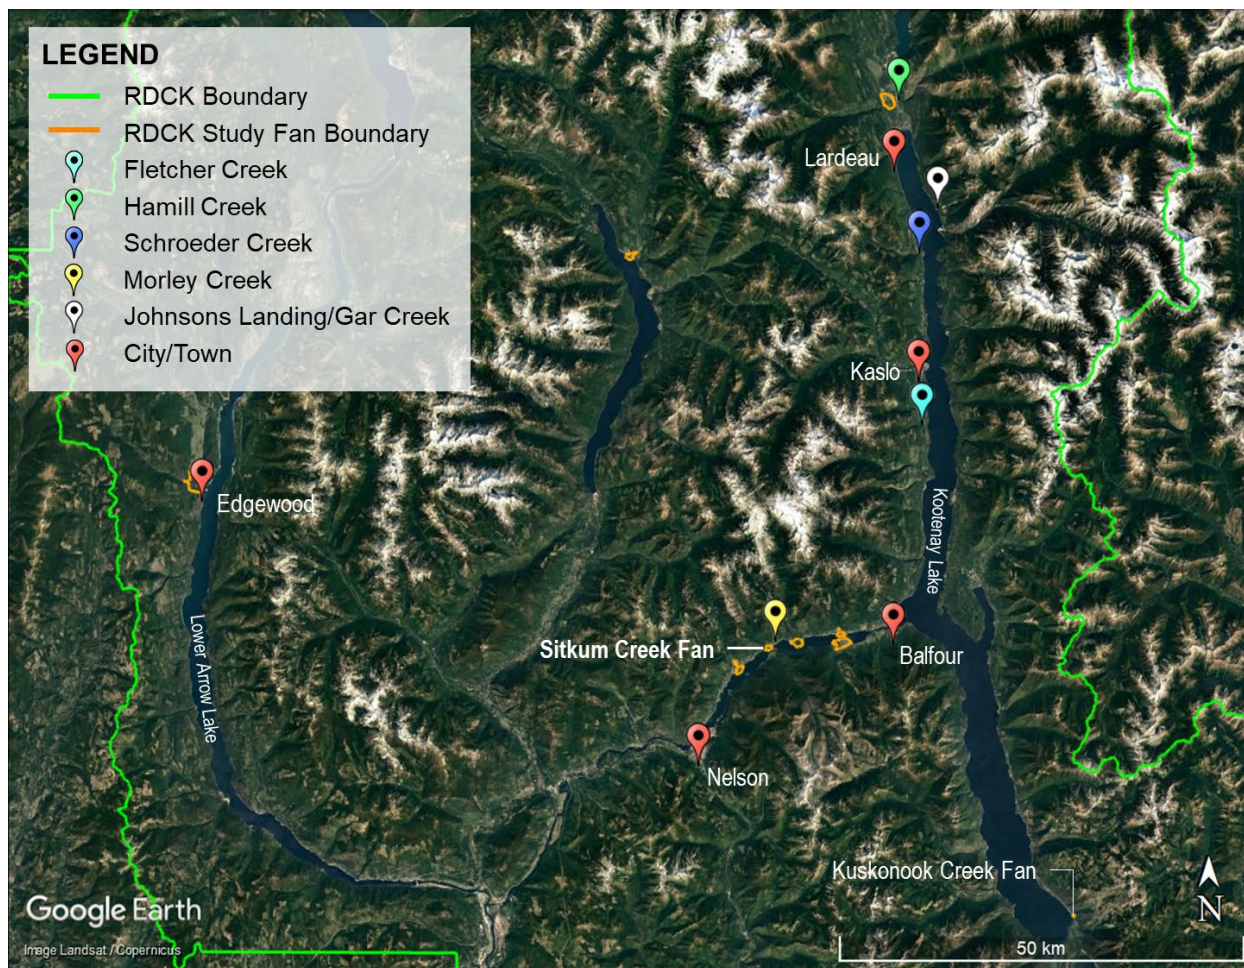
Figure 2-3. Locations of RDCK fan-deltas and recent clear-water floods, debris flows, and debris floods (Google Earth Pro, 2016).

Within the RDCK, recent debris floods occurred on Fletcher Creek and Hamill Creek in June 2013 (Figure 2-3). The June 2013 events were damaging at both creeks, with multiple homes being flooded and a home being eroded at its foundation (Nelson Star, 2013). Another damaging debris flood occurred at Schroeder Creek on June 19, 2013 where coarse woody debris partially blocked the Highway 31 culvert, excess flow flooded the road surface, dispersed flow ran through the Schroeder Creek Resort campground, and the lower reach of Schroeder Creek (below the highway culvert) experienced significant channel scouring and stream bank erosion (Perdue, 2015). On August 11, 2019 a damaging post-wildfire debris flood occurred on Morley Creek; where a road culvert was blocked, a water intake was destroyed, and several houses were damaged by muddy water (MFLNRORD S. Crookshanks, personal communication, August 20, 2019).

Debris flows are typically faster than debris floods and have substantially higher peak discharges and impact forces. They are particularly threatening to life and properties due to these characteristics. Recent debris flows occurred in the RDCK on Gar Creek, impacting Johnson's Landing, in July 2012, and on Kuskonook Creek in 2004.

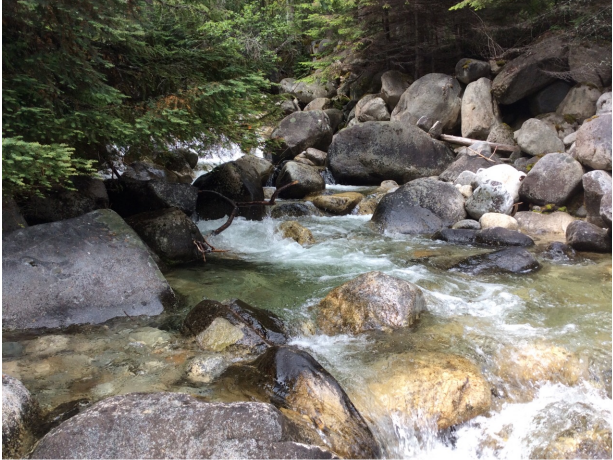
A) On right bank looking upstream from Highway 3A bridge. Bridge is to the right of this picture.

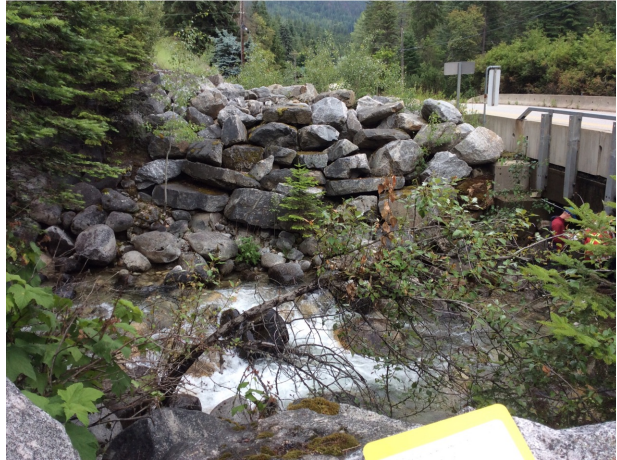
B) On right bank looking at left bank rip rap armouring approximately 1.5 m wide, 4 m high.

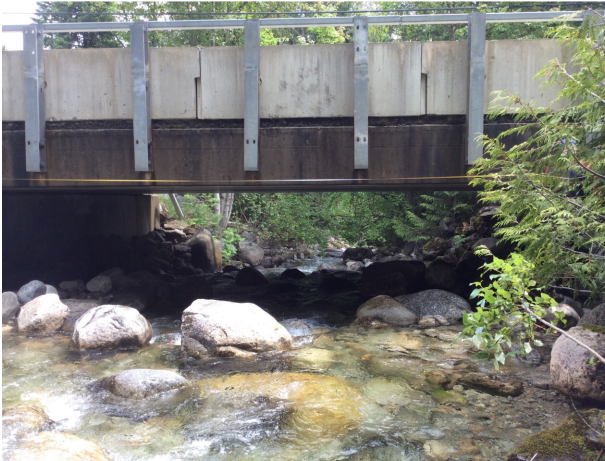
C) Looking downstream at Highway 3A bridge over Sitkum Creek.

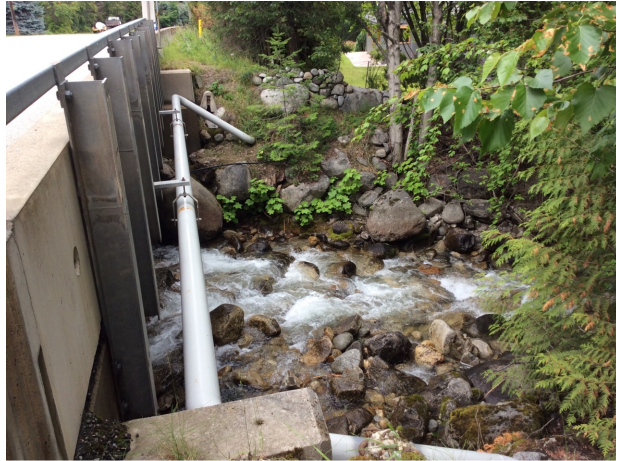
D) On right bank looking northeast at gas pipeline on downstream side of bridge.

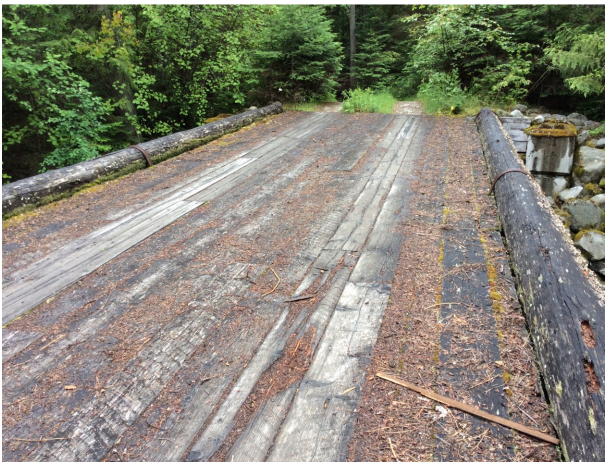
E) Wooden trestle bridge

Approximately 130 m downstream of the Highway 3A bridge, Sitkum Creek passes under a wooden trestle bridge (Figure 3-3E, Drawings 02A, 02B). The bridge is set onto concrete blocks above the active channel which is approximately 8 m wide at this location.

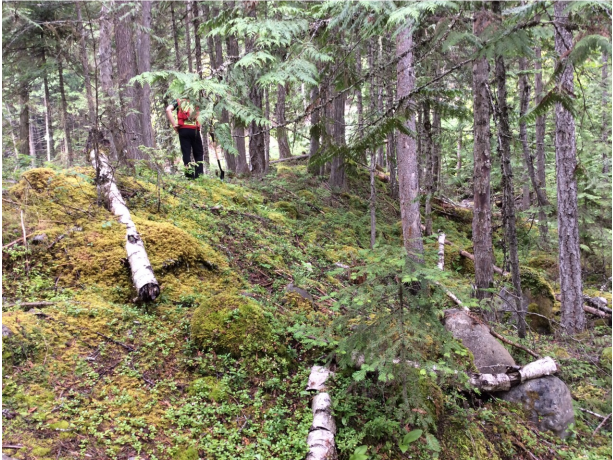
A) Berm approximately 75 m west of main channel in proximal fan-delta (STK-FP-1).

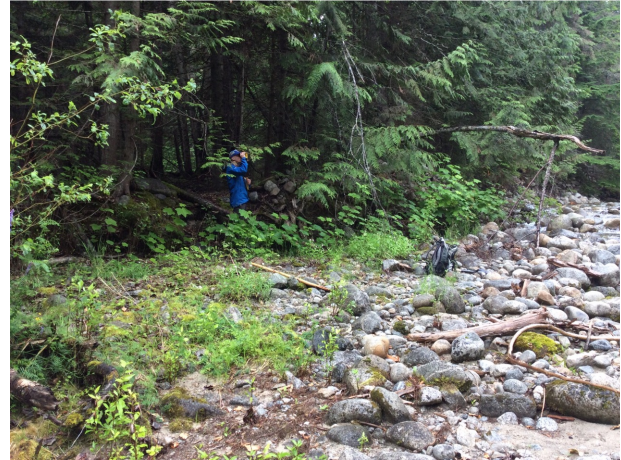
C) Low point in berm (STK-FP-6) on right bank approximately 275 m downstream of Hwy 3A. Right bank berm height was 0.6 m, left bank was 0.7 m compared with 1.2 m high upstream and downstream of this location on both banks.

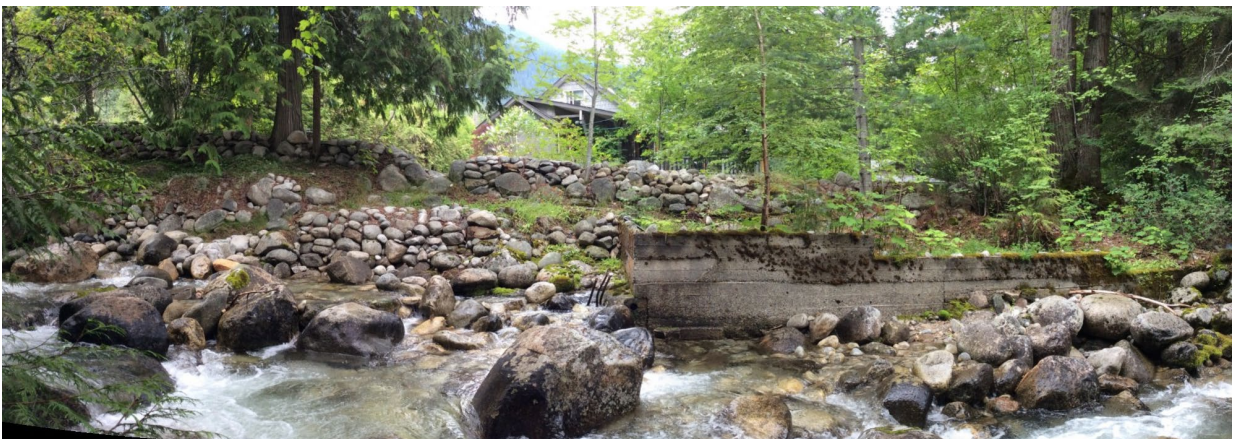
B) Berm constructed of rounded cobbles and old concrete foundation approximately 2 m high on left bank approximately 20 m downstream of Highway 3A bridge (STK-FP-4).

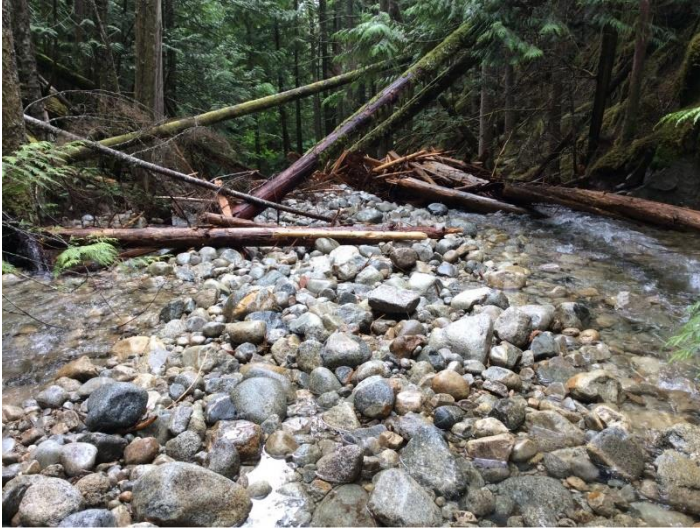
Photo 7.
Looking downstream at log jam on Sitkum channel just above the fan apex. Photo: BGC, July 4, 2019.

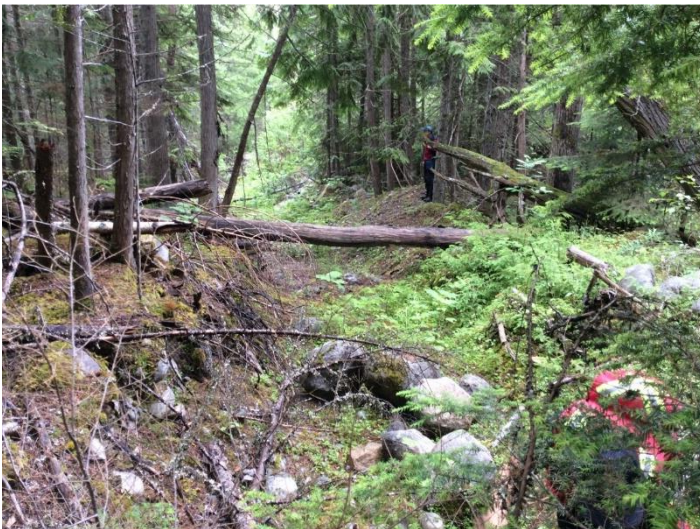
Photo 9.
Old road dug into fan surface. Photo: BGC, July 4, 2019.

Approximately 120 m upstream of the fan-delta apex, there is a 5 m high and 25 m long log and debris jam across the main channel with a total debris wedge volume of approximately 300 m³ (Photo 8, Appendix B). At the location of the debris jam, the channel is 5 m wide. There is no record as to when the jam occurred. Downstream of the jam, the channel is bedrock controlled leading to the fan-delta apex (Photo 9, Appendix B).

WSA Engineering Limited was retained to assess 3905 Highway 3A west of MacGregor Road on the Sitkum Creek fan-delta (WSA, 2007). WSA describes the Sitkum Creek channel as deeply incised and bedrock controlled at the fan-delta apex, transitioning to an approximately 8 to 10 m wide relatively straight channel with slight, gentle bends upstream of Highway 3A. WSA observed an abandoned avulsion channel on the southwestern side of the active channel approximately 100 m downstream of the fan-delta apex. The channel was noted to be vegetated with mature coniferous timber (over 100 years old) but with minor evidence of tree scarring and woody debris accumulation and surface flow in the upper extents of the channel indicating that the avulsion channel has accommodated flow in the past 100 years. This abandoned channel is in the vicinity of an old road dug into the fan-delta identified by BGC during the 2019 site visit (Photo 9, Appendix B, Drawings 02A, 02B).

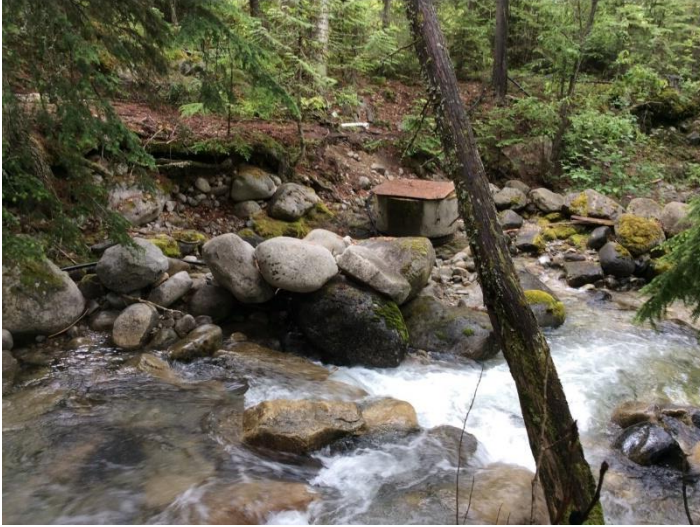
Photo 10.
On right bank looking downstream at water intake, approximately 170 m upstream of the Hwy 3A bridge. Photo: BGC, July 4, 2019.

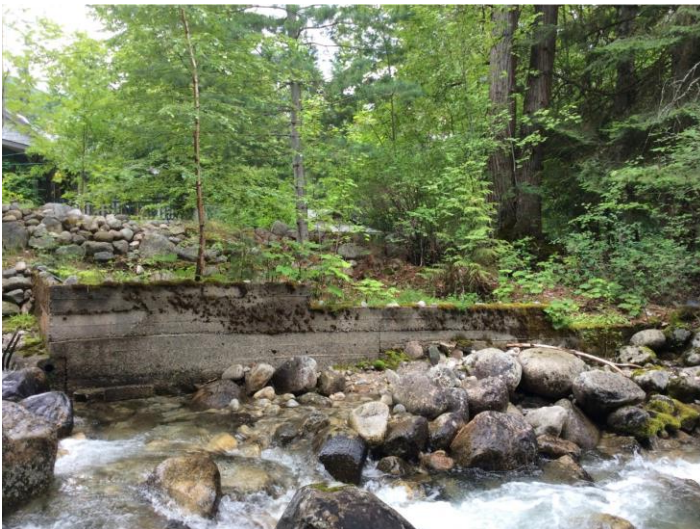
Photo 11.
On right bank looking at left bank low wall constructed of rounded cobbles, approximately 30 m downstream of the Hwy 3A bridge. Photo: BGC, July 4, 2019.

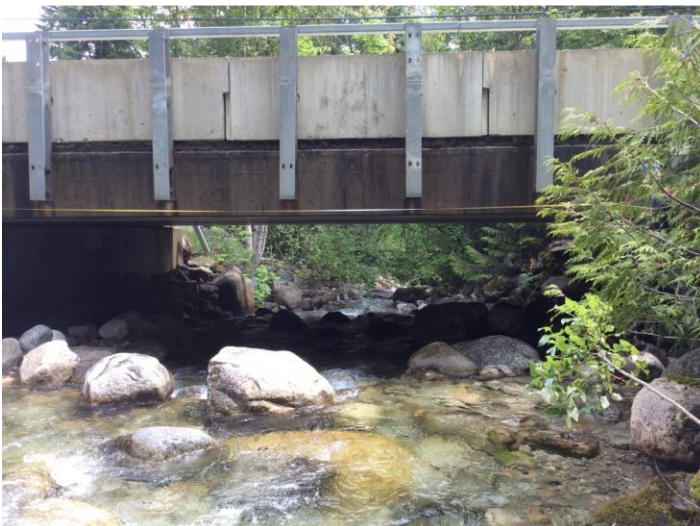
Photo 12.
Standing on the right bank of Sitkum Creek looking downstream at the Hwy 3A bridge. Photo: BGC, July 4, 2019.

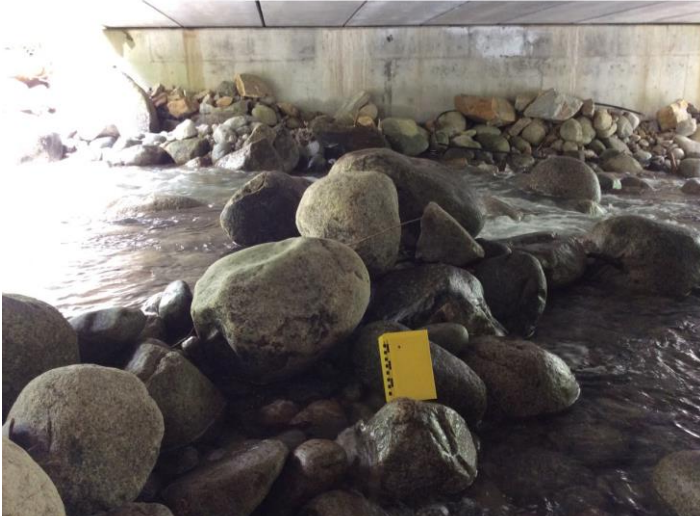
Photo 13.
Underneath the highway bridge showing clearance as well as grain size (with notebook for scale). Photo: BGC, July 4, 2019.

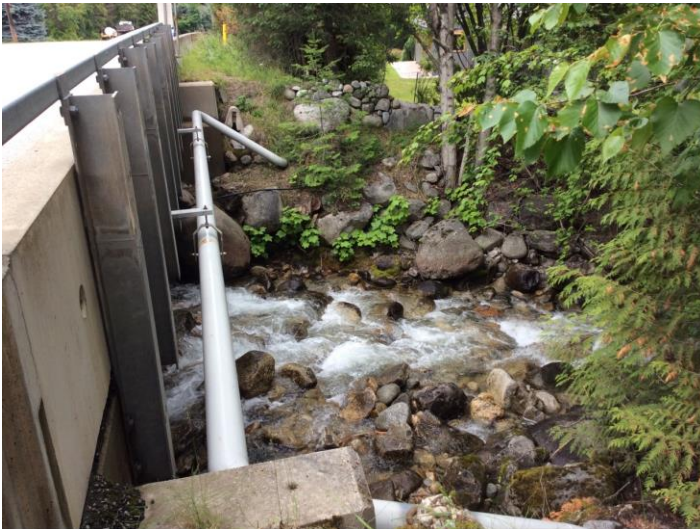
Photo 14.
Standing on the right bank of Sitkum Creek downstream of the Highway bridge looking across at the left bank. Photo: BGC, July 4, 2019.

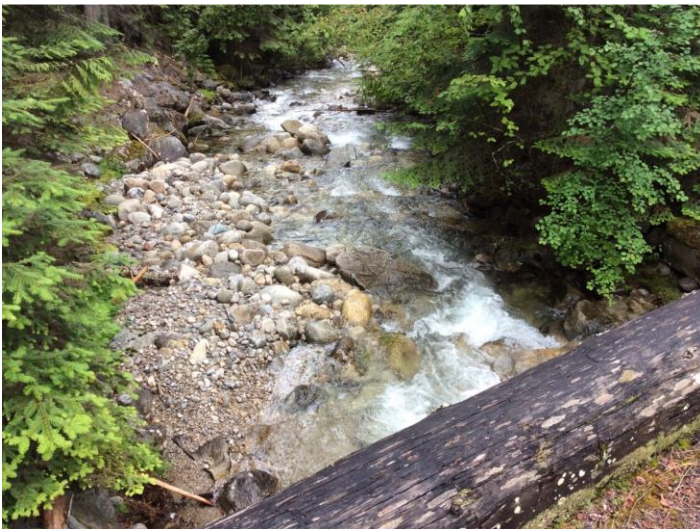
Photo 15.
Standing on the wooden trestle bridge approximately halfway between the highway and the river mouth. Photo: BGC, July 4, 2019.

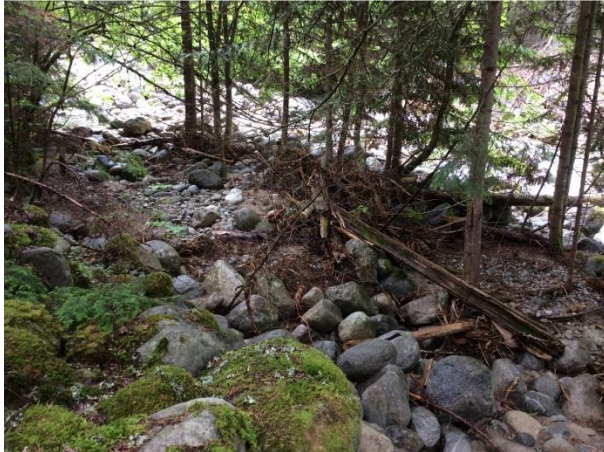
Photo 16.
On right bank looking across channel and upstream at boulder and cobble bar adjacent to flood protection berm. Photo: BGC, July 4, 2019.

In the distal fan-delta, a boulder and cobble bar was observed on the right bank adjacent to flood protection berm STK-FP-5 (Photo 16, Appendix B). The bar measured approximately 1 m high and 6 m wide and was vegetated with cedar trees estimated to be 30 to 50 years old. This bar was likely deposited during a major flood event.

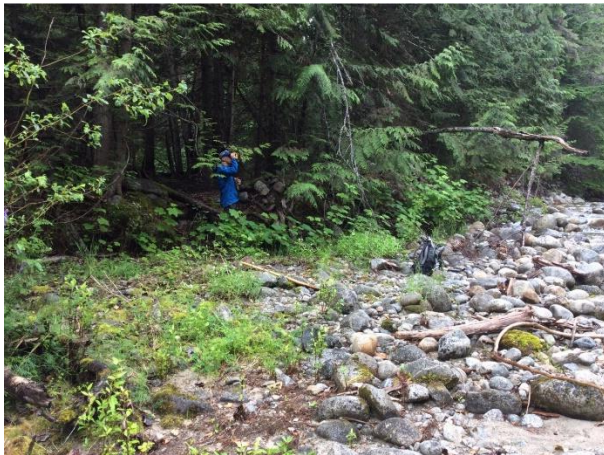
Photo 17.
Looking at right bank at low point in channel berm. Photo: BGC, July 4, 2019.

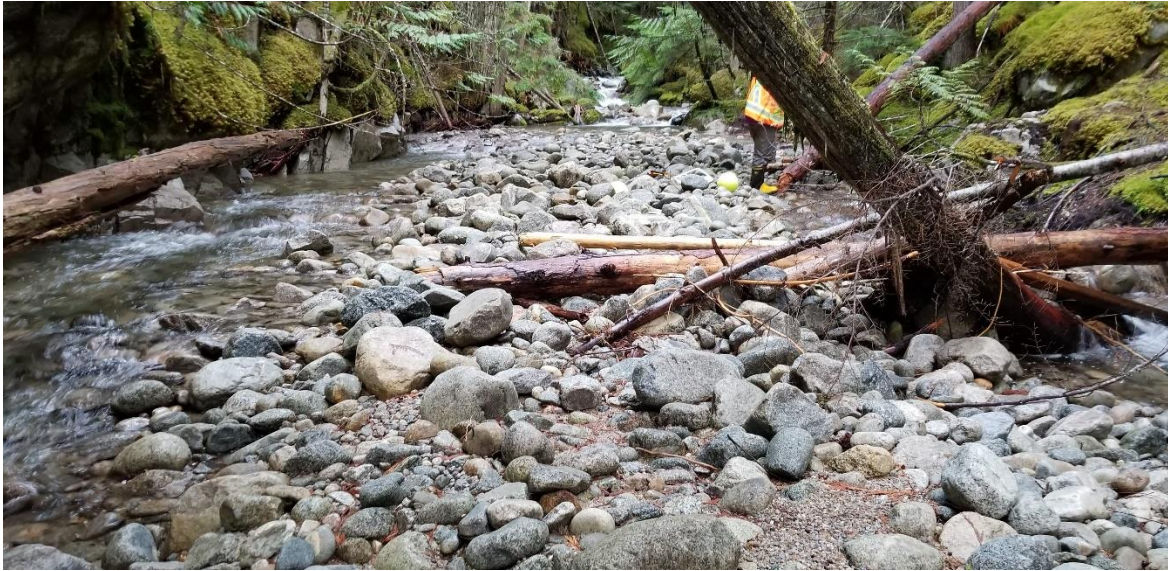
Figure C-2. Photograph taken of Wolman sampling location Sitkum 1. BGC photograph of November 20, 2019.

At the Sitkum 1 sampling location, the measuring tape was 20 m long and samples were randomly selected at intervals of 20 cm. At the Sitkum 2 sampling location, the measuring tape was 24 m long, and samples were taken every 20 cm.

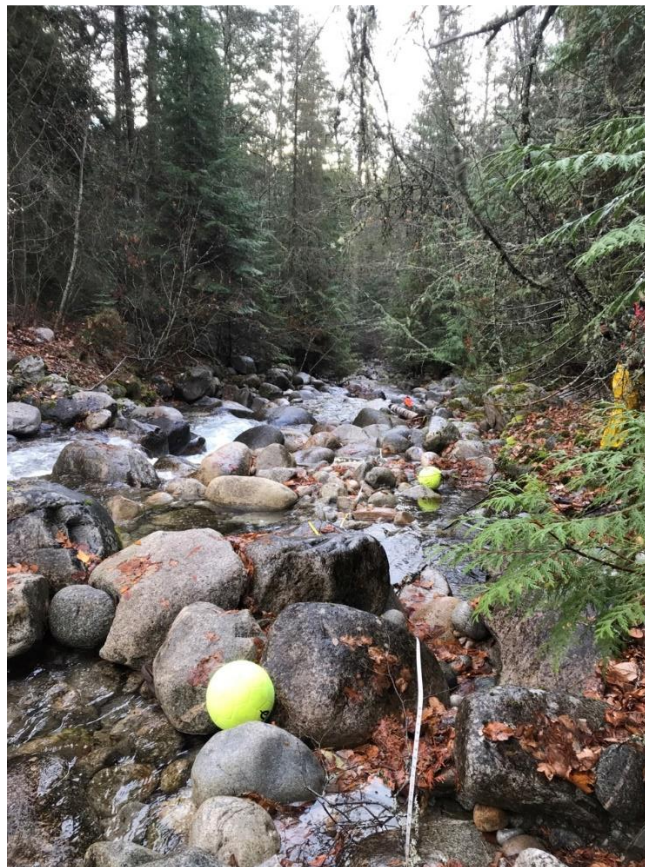
Figure C-3. Photograph taken of Wolman sampling location Sitkum 2. BGC photograph of November 20, 2019.

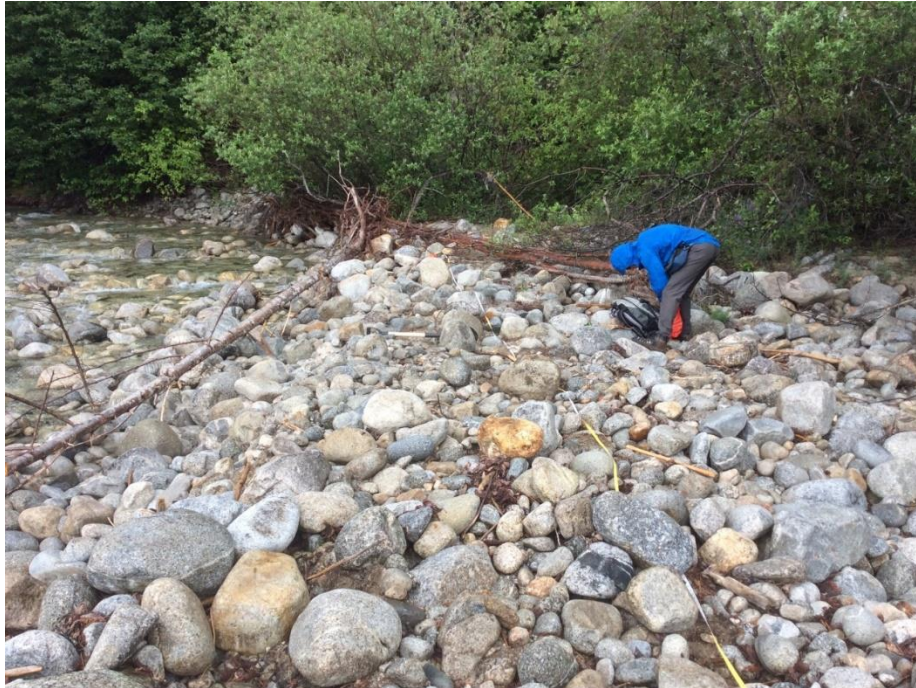
Figure C-4. Photograph taken of Wolman sampling location Sitkum 3. BGC photograph of July 5, 2019.
