# Provincial Emergency Program

## POST WILDFIRE HAZARD ASSESSMENTS *Springer and Sitkum Creek Fires*

M09468A01

March 21, 2008

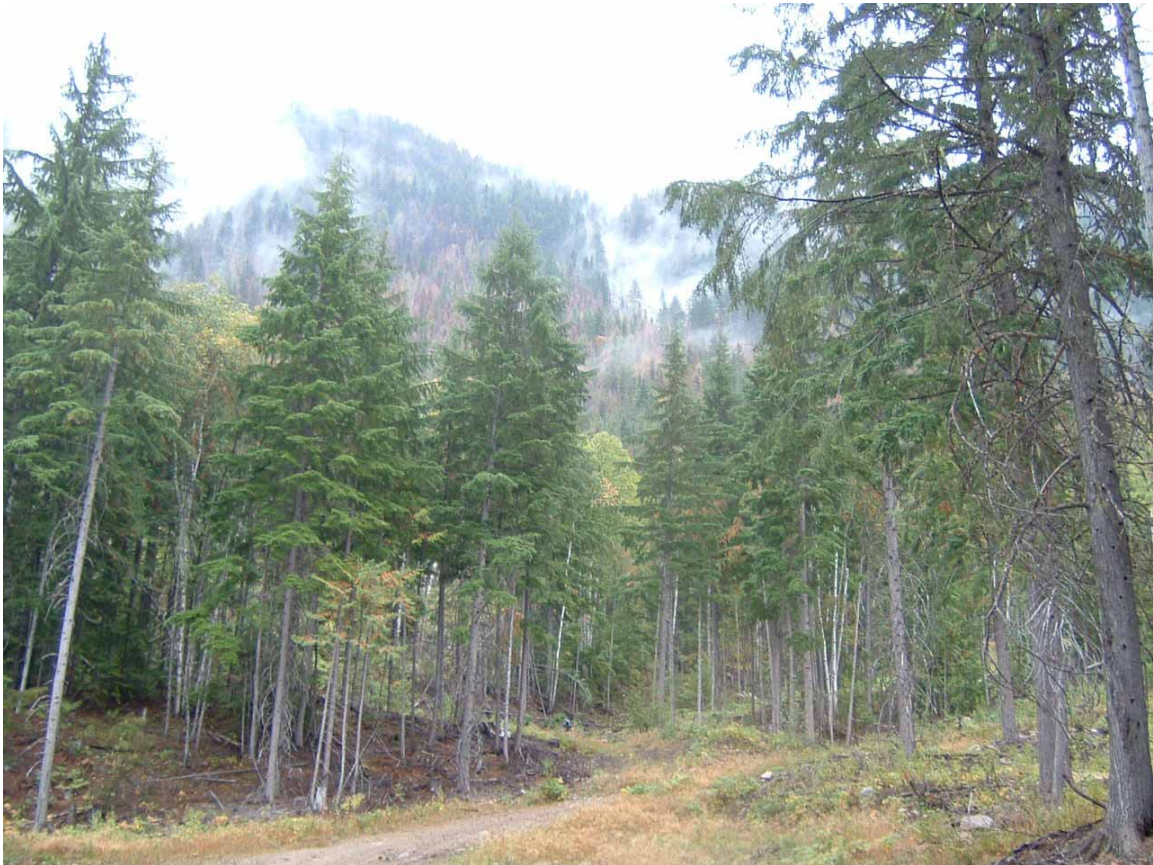
Mr. Rick Rodman, P.Eng. of KCBL, carried out a site visit with Mr. Doug Nicol, P.Eng., consultant to MoF, on September 21, 2007 and again with Mr. Rob Griffith, EIT, of KCBL, on February 22, 2008.. Areas adjacent to Highway 6 and the first 5 km of the Enterprise Creek Forest Service Road were visited. Photo 1 shows typical steep slopes upslope of Highway 6.

**Photo 1 Looking upslope from Highway 6 into Allen Creek catchment (September 21, 2007)**

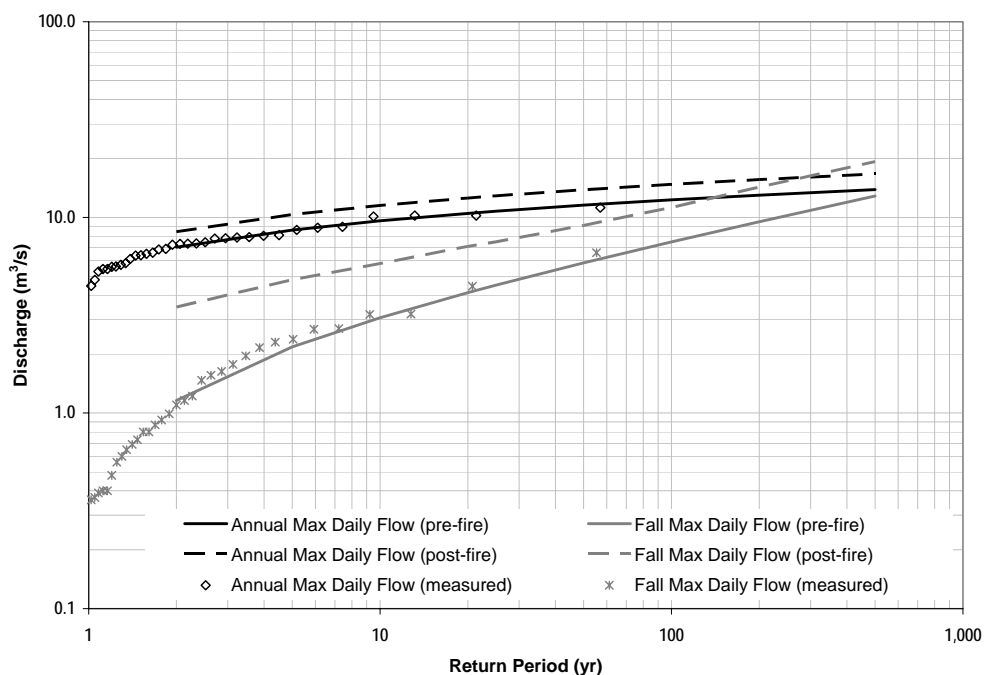
A flood frequency analysis was carried out using the 34 years of streamflow data. The Generalized Extreme Value distribution was used for both the fall and annual maximum daily flows. The fall period is assumed to be from September to February. The results of the analyses are presented in Table 3 and Figure 4. They indicate that, for example, the annual maximum daily  $Q_{200}$  (pre-wildfire) flow of  $13.0 \text{ m}^3/\text{s}$  will increase to a  $Q_{200}$  (post-wildfire) flow of  $15.6 \text{ m}^3/\text{s}$ . Because the frequency curves are so flat, a small increase in flow results in a significant increase the return period for that flow. For example, as illustrated in Table 3 and Figure 4, the post-fire annual maximum daily flow of  $11.5 \text{ m}^3/\text{s}$  has a return period of 10 years, but the estimated post-fire annual maximum daily flow of  $13.8 \text{ m}^3/\text{s}$  has a return period of 50 years.

**Figure 4 Redfish Creek Flood Frequency Analyses Results**

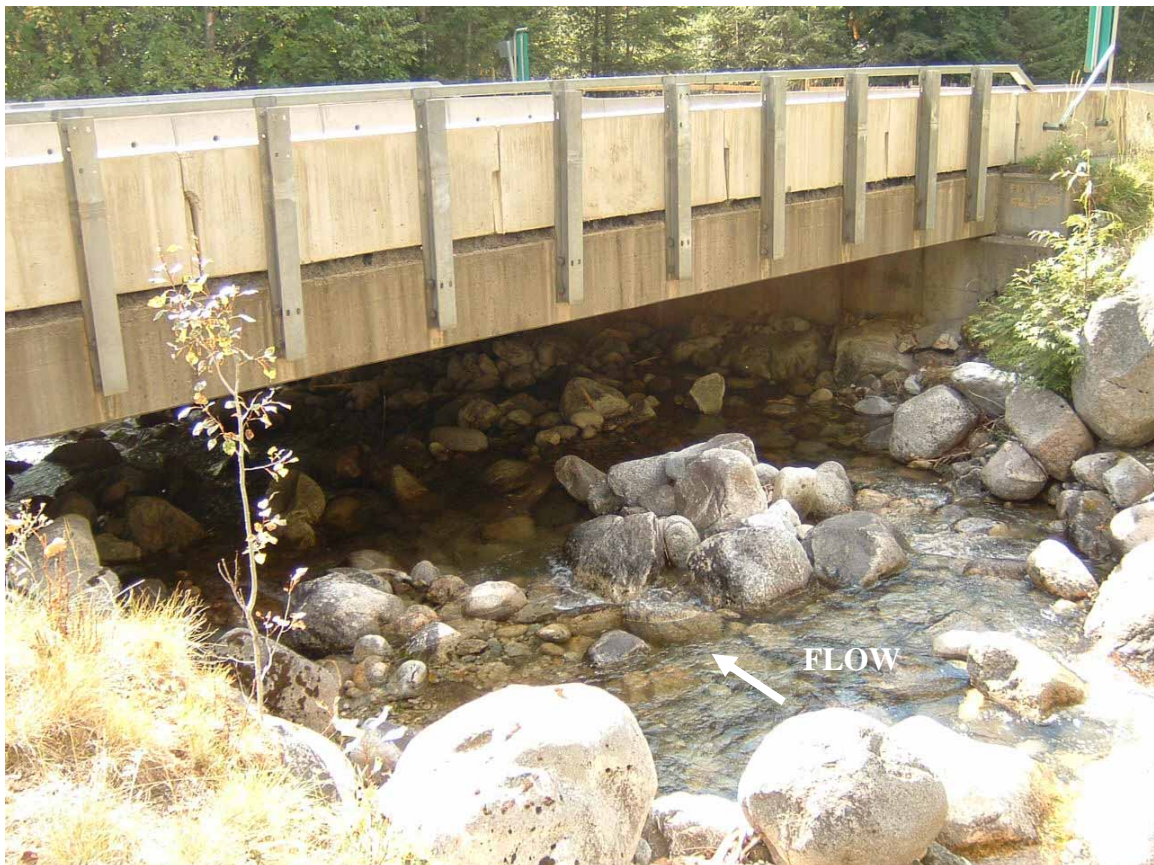
As part of KCBL's assignment, MoT requested that an estimate of the flow capacity and corresponding flood return period be determined for the existing Highway 3A bridge (see Photo 2). Based on the flood frequency analyses presented above, and the surveyed opening beneath the Highway 3A bridge, prior to the Sitkum Creek wildfire, it is estimated that the bridge could carry a 20 to 50-year return period flood. This estimate has no freeboard allowance and has a small amount of water flowing over the highway and splashing on the bridge deck. Due to the increase in maximum daily flows resulting from the Sitkum Creek wildfire, it is estimated the bridge can pass a 5 to 10-year return period flood under the same conditions of no freeboard allowance. MoT are investigating various mitigation and risk management options for this bridge.

**Photo 2 Upstream side of Highway 3A bridge (September 12, 2007)**

4. MoT should investigate various mitigation and risk management options for the Highway 3A bridge over Sitkum Creek.
5. Nelson Hydro, Shaw Cable, and Telus should be informed that the wooden poles on the Sitkum Creek fan could be affected by a flood or debris flood event.

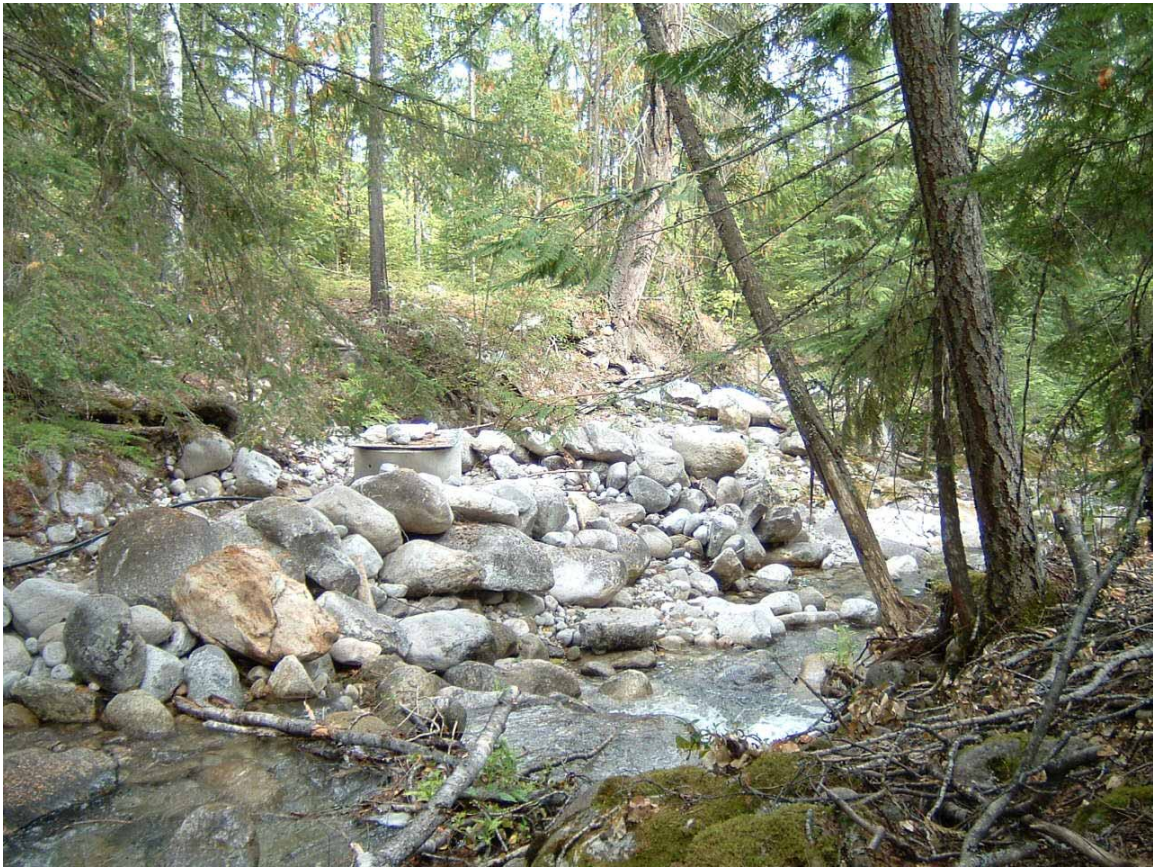
Two community water supply intakes are located on the Sitkum Creek fan, one near the apex of the fan (400 m upstream of the Highway 3A bridge, see Photo 3), and another 100 m upstream of the bridge, see Photo 4. Both these intakes could be affected by sediment laden water or could be washed out by a significant flood or debris event.

**Photo 4** Community water intake 100 m upstream of Highway bridge  
(August 28, 2007)

6. Both community water supply organizations on Sitkum Fan should be advised that their intakes on Sitkum Creek could be affected by sediment laden water or the intakes could be damaged out by a significant flood or debris flood.

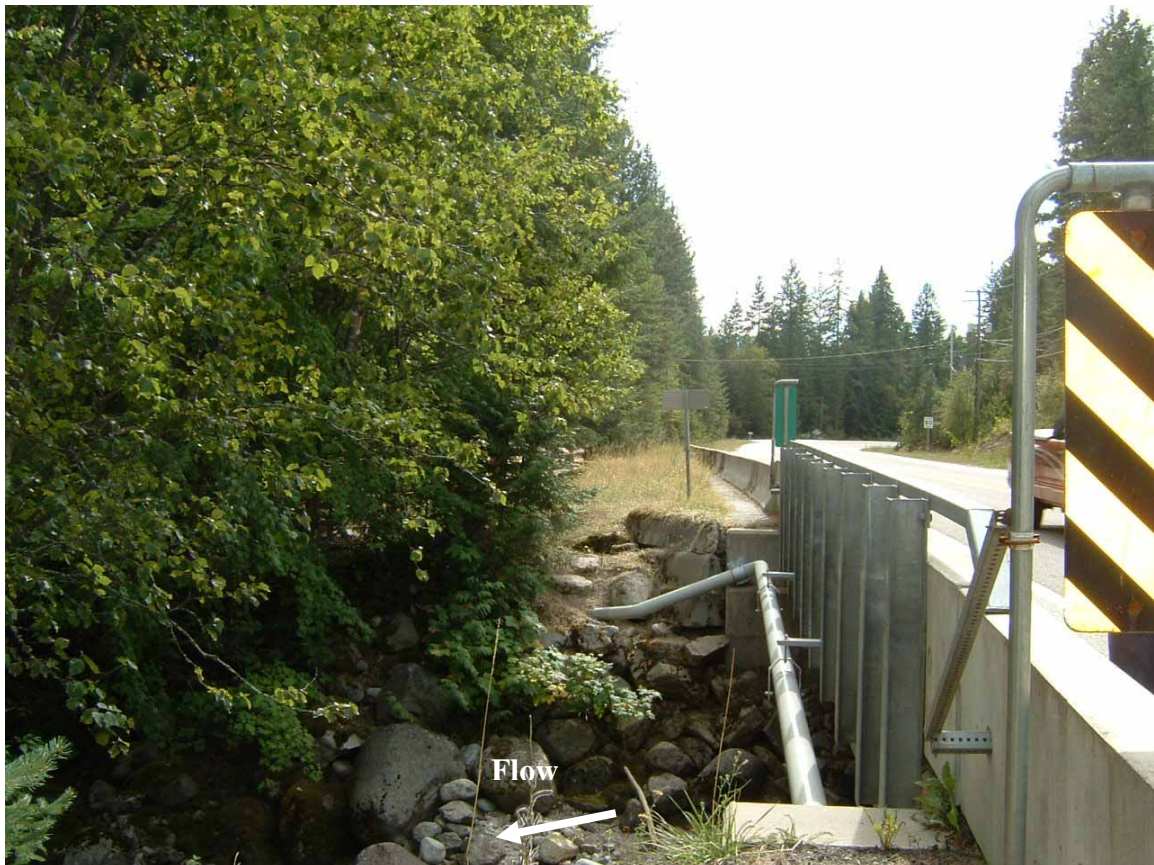
Terasen Gas have a 150 mm diameter gas pipeline buried in the downslope shoulder of Highway 3A. This pipeline is suspended from the downstream superstructure of the bridge (Photo 5). The pipeline is steel, where suspended from the bridge, and plastic in the shoulder of the road. The gas is at its distribution pressure of 60 psi (March 4, 2008 personal communication with Mr. Russ Arnott). Terasen Gas should consider placing a protective plate over the suspended pipeline so that if the bridge were overtopped by water and/or debris, there would be some protection for the suspended pipeline.

**Photo 5 Terasen Gas pipeline on the downstream superstructure of Highway 3A bridge (August 28, 2007)**

7. Terasen Gas should consider placing a protective plate over their suspended pipeline on Highway 3A bridge at Sitkum Creek, so that if the

bridge were overtopped by water and/or debris, there would be some protection for the pipeline.
