Subject: Blazed Creek Fire N72301
Post Wildfire Risk Analysis

MINISTRY OF FORESTS, LANDS AND NATURAL RESOURCE OPERATIONS, POST-WILDFIRE RISK ANALYSIS – PRELIMINARY REPORT

FIRE: Blazed Creek N72301		FIRE YEAR: 2018	DATE OF REPORT: Oct. 10, 2018
AUTHOR: Tedd Robertson, P.Geo. Eng.L., Sitkum Consulting Ltd.			
REPORT PREPARED FOR: South East Fire Centre, Selkirk Resource District			
<p>FIRE SIZE, LOCATION, AND LAND STATUS: Blazed Creek fire N72301 is approximately 6798 ha in size, which includes much unburned area within the fire perimeter. The fire was caused by lightning, and was discovered on August 7th, 2018. It is primarily located within the Summit Creek drainage on the north side of Highway 3, approximately 20 km west northwest of Creston, BC. The majority of the fire is situated on crown land, with a portion of the fire in the northern half situated on the Darkwoods Property, a large private land tract owned by the Nature Conservancy of Canada.</p>			
VALUES AT RISK: Highway 3, BC Hydro high voltage transmission line, existing forest roads			
WATERSHEDS AFFECTED:	TOTAL AREA	AREA BURNED	BURN SEVERITY (% of burned area // % of watershed area)

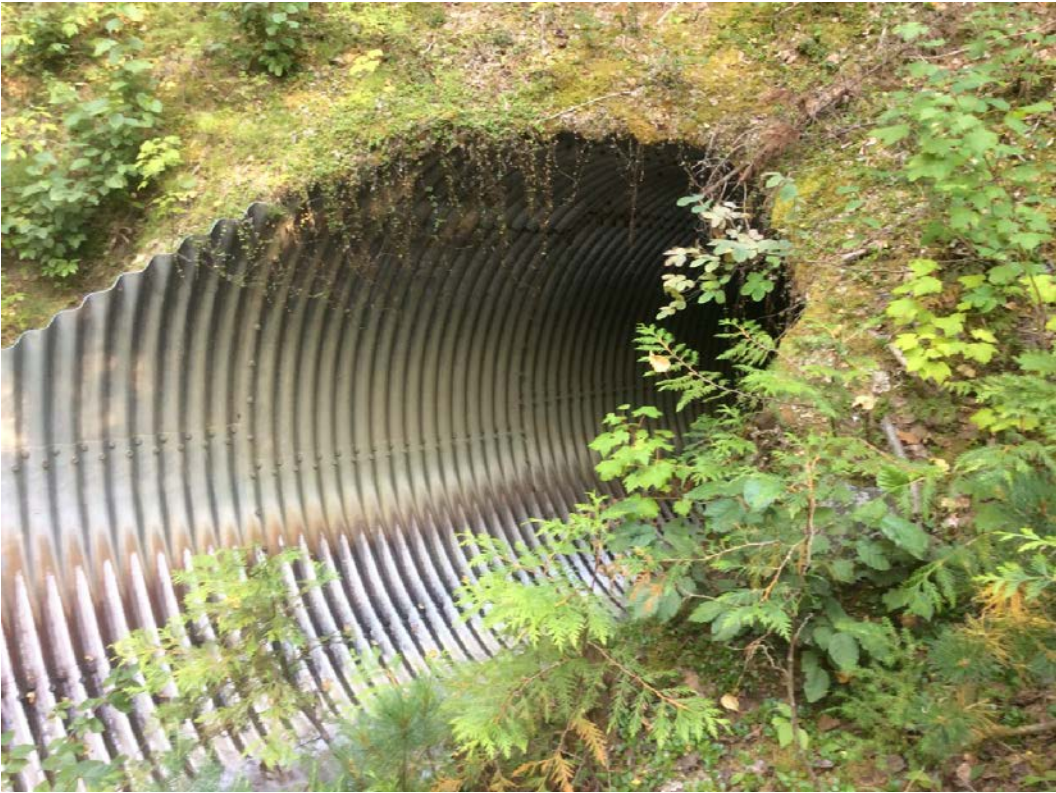
Photo 1: Highway culvert at Placer Creek.

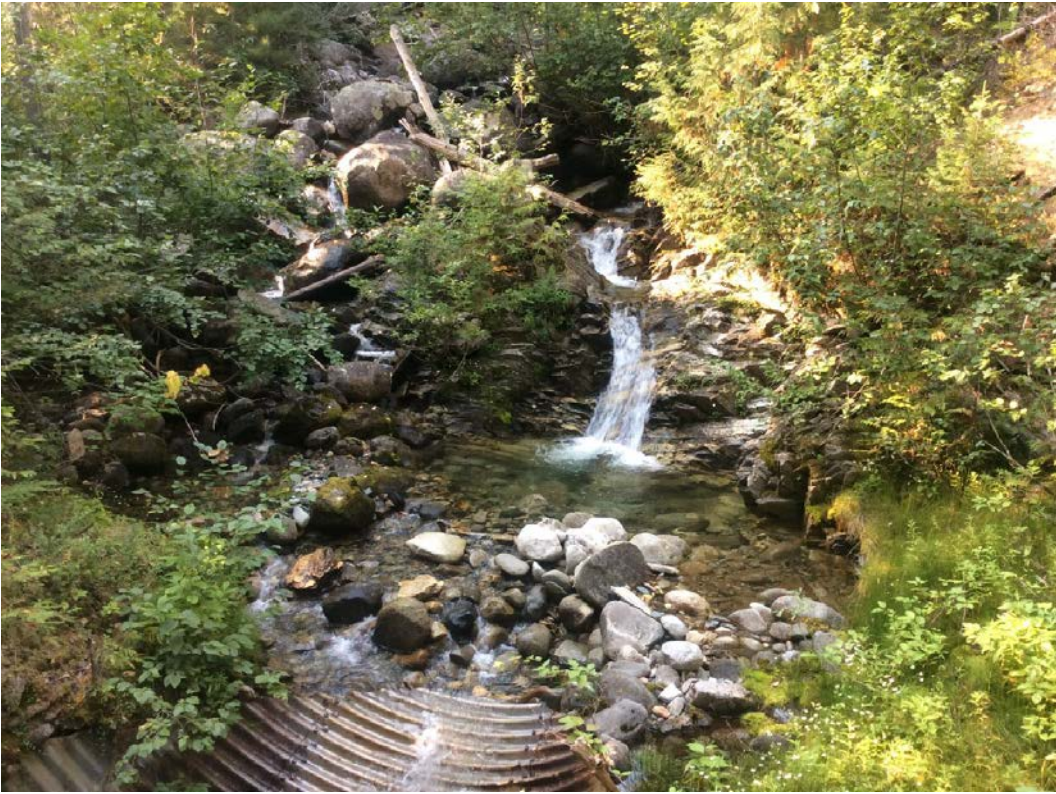
Photo 2: Placer Creek.

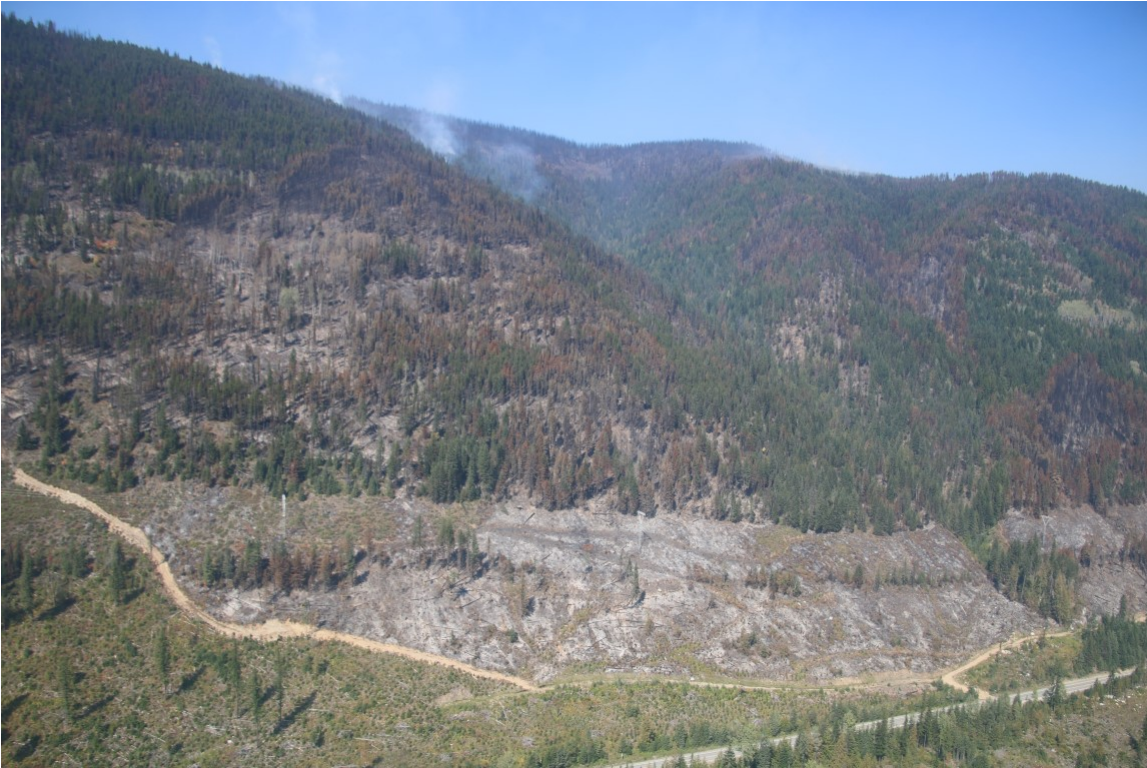
<p><u>East Placer Face – debris slides/rock fall : highway</u> <u>East Placer Face – snow avalanches : highway</u></p> <p>There is some area of moderate burn severity on moderately steep slopes with some minor natural rockfall (refer to Photo 3). The extent and severity of burn will moderately increase likelihood of debris slides and rock fall, but the magnitude of</p>	<p>M M</p>	<p>M L</p>

<p>events are unlikely to reach highway considering the lack of gullies to facilitate longer runout debris flow events. The forest approaching Highway 3 has been harvested in recent years.</p> <p>There is some evidence of old natural snow avalanches in the upper slopes above approximately 1300 m elevation. Some areas of high vegetation burn severity in this area may result in more active snow avalanche start zones, particularly between 1400 m and 1500 m elevation where slope gradients average 75%. There are no significant start zone features in this area, and no downslope gullies to facilitate longer runout, so avalanches are expected to remain in the size 2 to 3 range. However, the average slope gradient from 1500 m elevation to the highway at 1060 m elevation is 62%, therefore there an impact to the highway is possible in the event of a larger magnitude avalanche initiating upslope.</p>

Photo 3: East Placer Face. Machine guard visible ascending to left side of photo, with moderate to high burn severity area in mid-upper elevation of face unit.

5. Monitoring of potential new snow avalanche start zones in high burn intensity areas of the East Placer Face, Blazed –Toby Face, and Topaz-Toby Face, and any other location where a MoTI avalanche specialist may consider there to be an elevated risk of avalanches. These areas are located upslope of Highway 3 and have some high burn severity areas on sufficiently steep slopes such that they could become new snow avalanche start zones. Monitoring should occur for a period of several years to determine if there is sufficient risk to the highway that may require ongoing monitoring or avalanche control. A separate snow avalanche risk assessment should be completed by MoTI to confirm the extent of monitoring and mitigation works required.

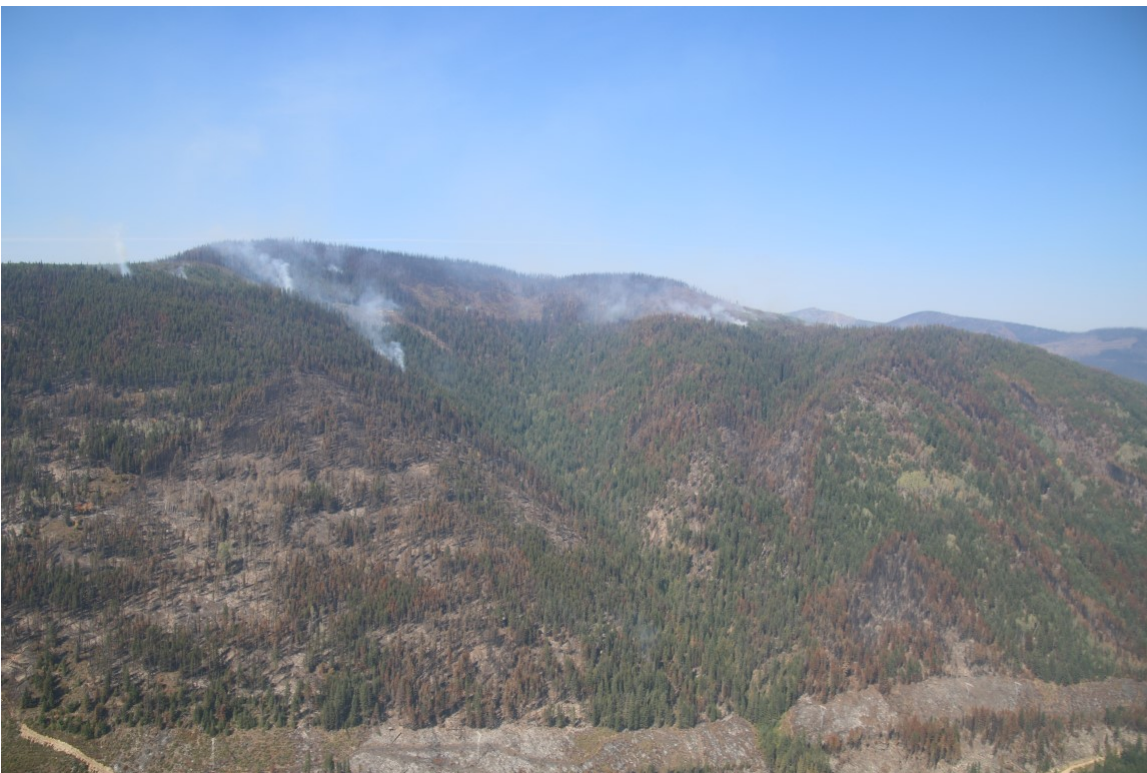
<p><u>Unnamed Creek 1 - increased runoff/peak flows : highway crossing</u> <u>Unnamed Creek 1 – debris flow : highway</u></p> <p>This unnamed gully system drains under Highway 3 with an 800 mm culvert (refer to Photos 4 and 5). This crossing is likely undersized for large peak flow events regardless of the post-fire conditions, so may be vulnerable to even small increases in runoff. Much of the high burn severity area is in the upper elevation, upslope of an existing forest road which traverses the drainage near 1620 m elevation. This forest road was bladed during firefighting operations to function as a fireguard, and will require deactivation to ensure effective drainage control. Majority of stream channel is unburned. Periodic debris flows are likely a natural process in this gully at a typical frequency ranging from several decades to a few hundred years, and the post-wildfire conditions are estimated to moderately increase the likelihood of debris flows. No recent natural events are apparent.</p>	<p>H</p> <p>M</p>	<p>VH</p> <p>M</p>

Photo 4: View of East Placer Face, Unnamed Creek 1, and Unnamed Creek drainage areas.

6. Consider upgrading flow capacity at Unnamed Creek 1; this crossing appears to be undersized and is likely to experience elevated peak flows in comparison with pre-fire conditions.

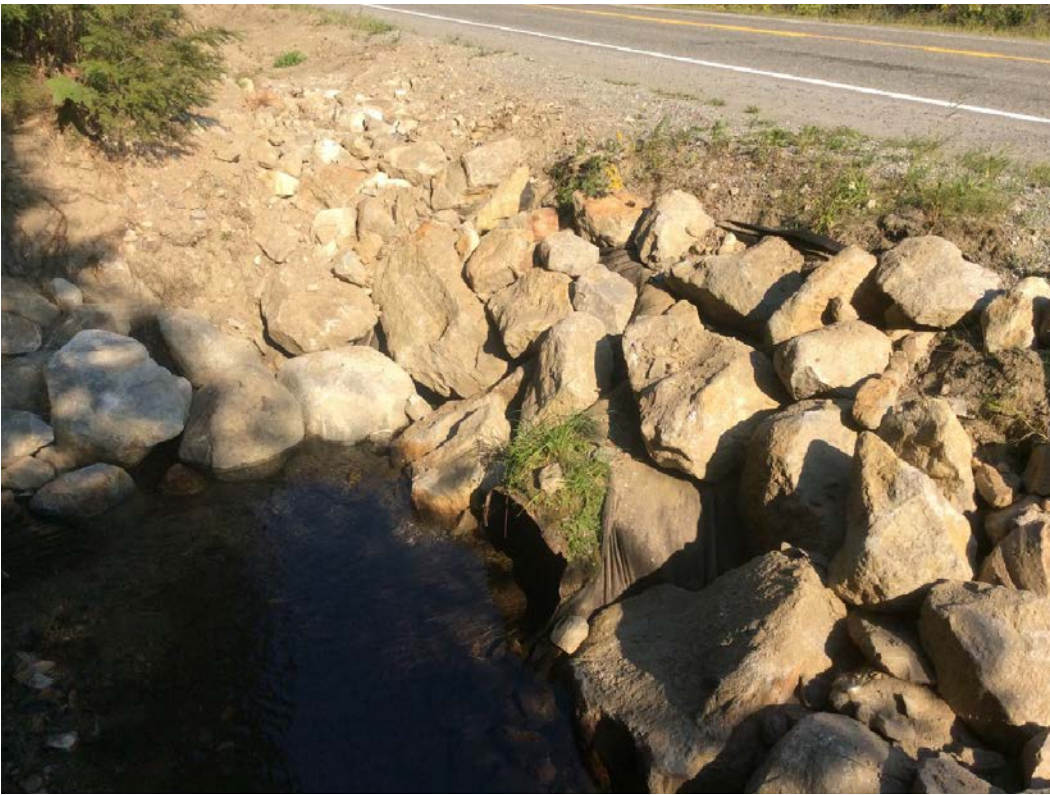
Photo 5: Highway culvert at Unnamed Creek 1.

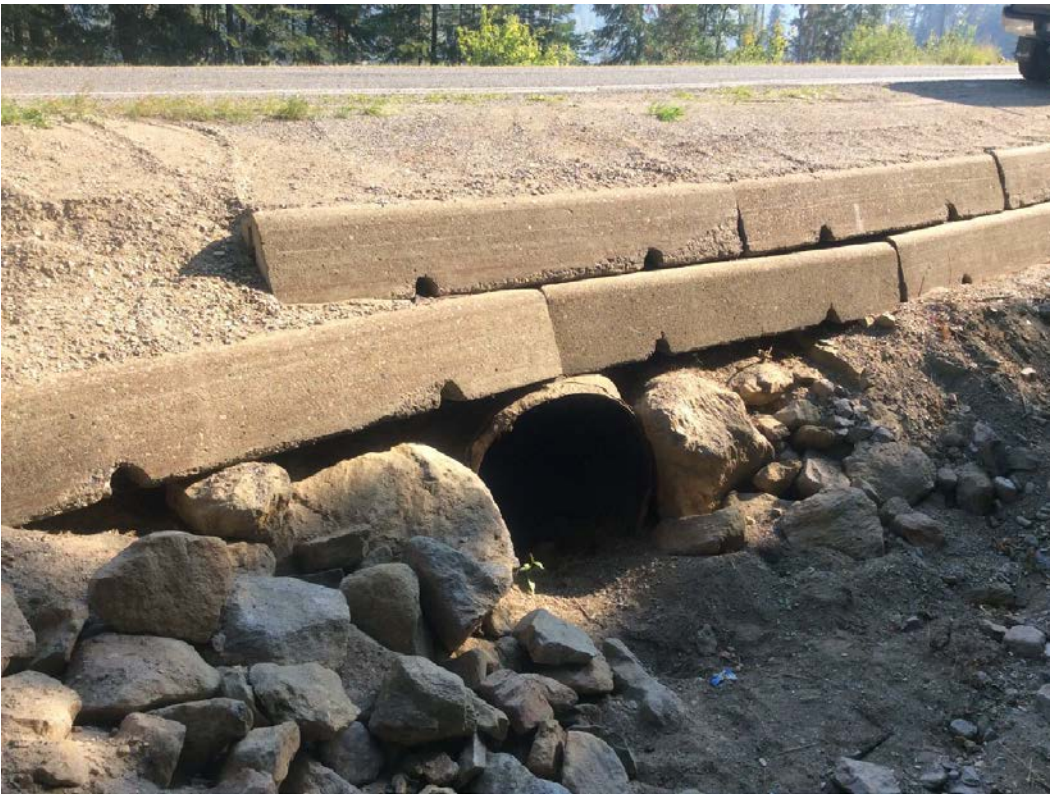
<p><u>Unnamed Creek 2 - increased runoff/peak flows : highway crossing</u> <u>Unnamed Creek 2 – debris flow : highway</u></p> <p>This unnamed gully system drains under Highway 3 with a 1200 mm culvert (refer to Photos 6 and 7). This crossing appears to be adequate for large peak flow events in pre-fire conditions, and is likely able to accommodate increased flow in the post-fire environment. While the majority of the watershed has burned, there is limited high burn severity area. Majority of stream channel is unburned. Periodic debris flows are likely a natural process in this gully at a typical frequency ranging from several decades to a few hundred years, and the post-wildfire conditions are estimated to slightly increase the likelihood of debris flows. No recent natural events are apparent.</p>	<p>M</p> <p>L</p>	<p>L</p> <p>L</p>
<p><u>West Blazed Face – rock fall : highway</u></p> <p>Adjacent to the highway is moderately steep slopes with predominantly moderate burn intensity and some high burn intensity. These slopes are likely to be subject to increased raveling and rock fall which could impact the highway due to proximity.</p>	<p>H</p>	<p>VH</p>

Photo 6: Highway culvert at Unnamed Creek 2.

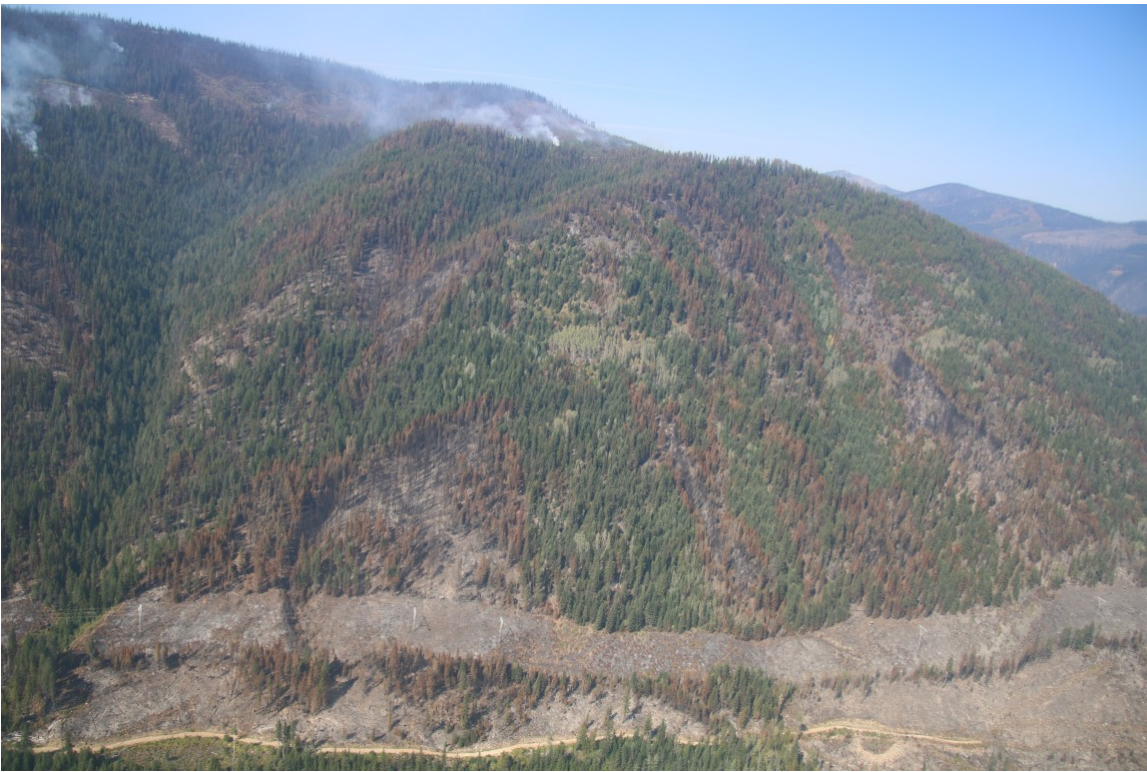
Photo 7: View of a portion of Unnamed Creek 1, Unnamed Creek 2, and West Blazed Face.

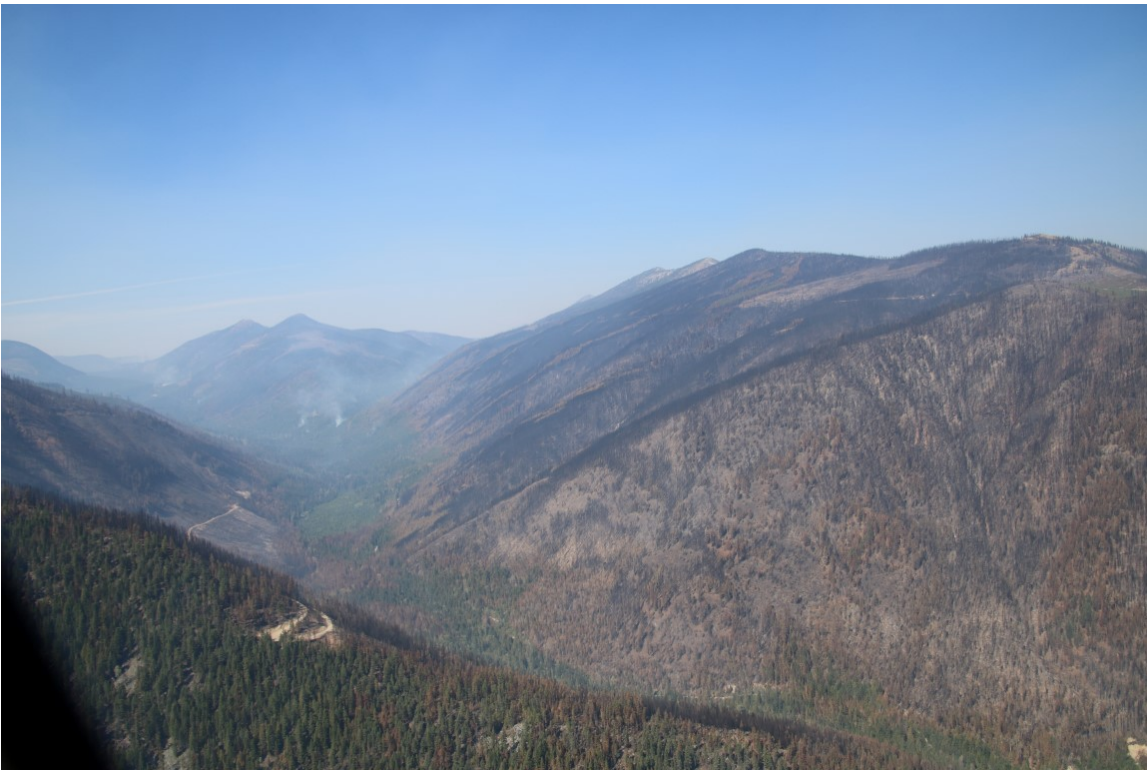
Photo 8: View looking upstream in Blazed Creek.

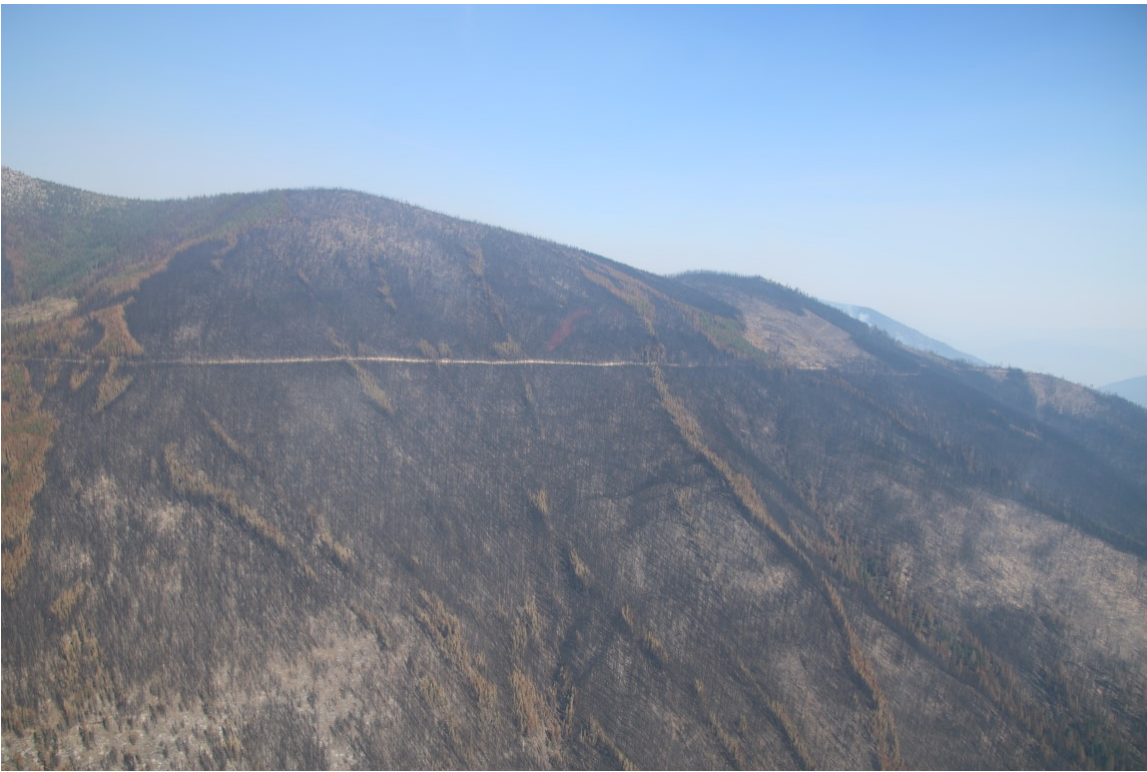
Photo 9: High burn severity along the west aspect slopes of Blazed Creek.

2. Blazed Creek FSR should have signage posted to warn snowmobile traffic of potential new snow avalanche terrain due to the high intensity wildfire upslope. This appears to be a common snow mobile access route, and recreational traffic may not be aware of the extent of upslope changes.

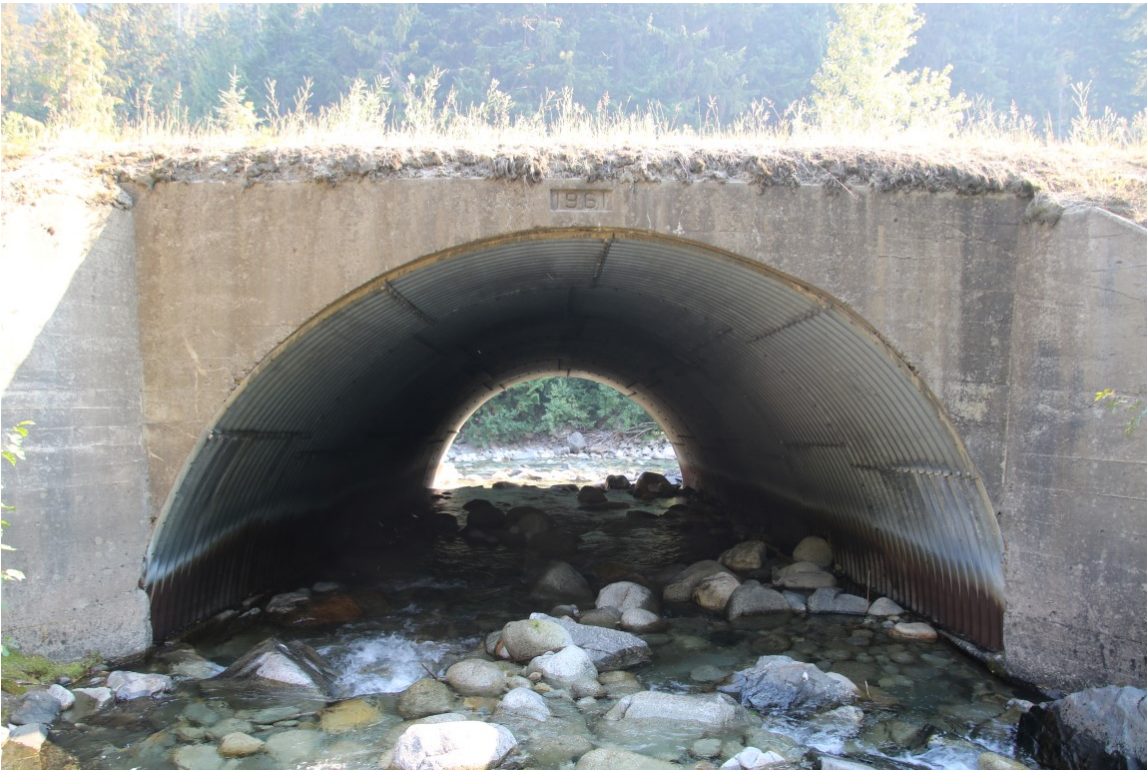
Photo 10: Highway 3 crossing of Blazed Creek.

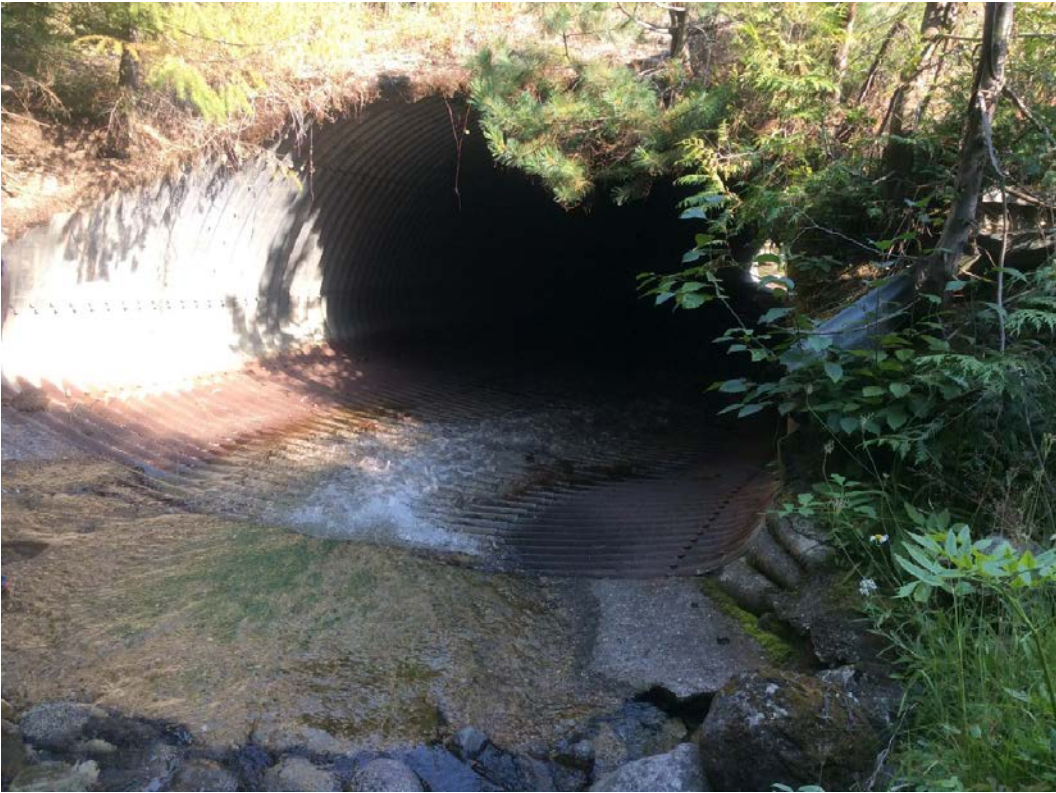
<p>Toby Creek is crossed by Highway 3 with a large arch culvert, approximately 4 m to 5 m in width, and 3 m in height (refer to Photo 11). Toby Creek is likely subject to periodic debris flows or debris floods, although none appear to have reached the highway crossing in the recent past. There is an area of steep gullied terrain with some high burn severity approximately 2 km northwest of the highway crossing which is likely to have a moderately increased debris flow hazard. Toby Creek has an average channel gradient of near 20% between this steeper gullied terrain and the highway, and as a result continued debris flow transport is possible under adverse conditions.</p>		
<p><u>Toby-Topaz Face – Snow Avalanches : highway</u> <u>Toby-Topaz Face – debris slides/flows : highway</u></p> <p>High burn severity area in gullied upper elevations of face unit (refer to Photo 12). Gentle basin at toe of slope separates highway from slope, reducing the likelihood of an impact to the highway in the event of an avalanche or landslide initiating upslope. A mid slope bench with unburned to low burn severity forest also separates the higher elevation high burn severity area providing a buffer between the valley bottom and potential snow avalanche start zones in some portions of this face unit.</p>	<p>M M</p>	<p>L L</p>

Photo 11: Highway 3 crossing of Toby Creek.

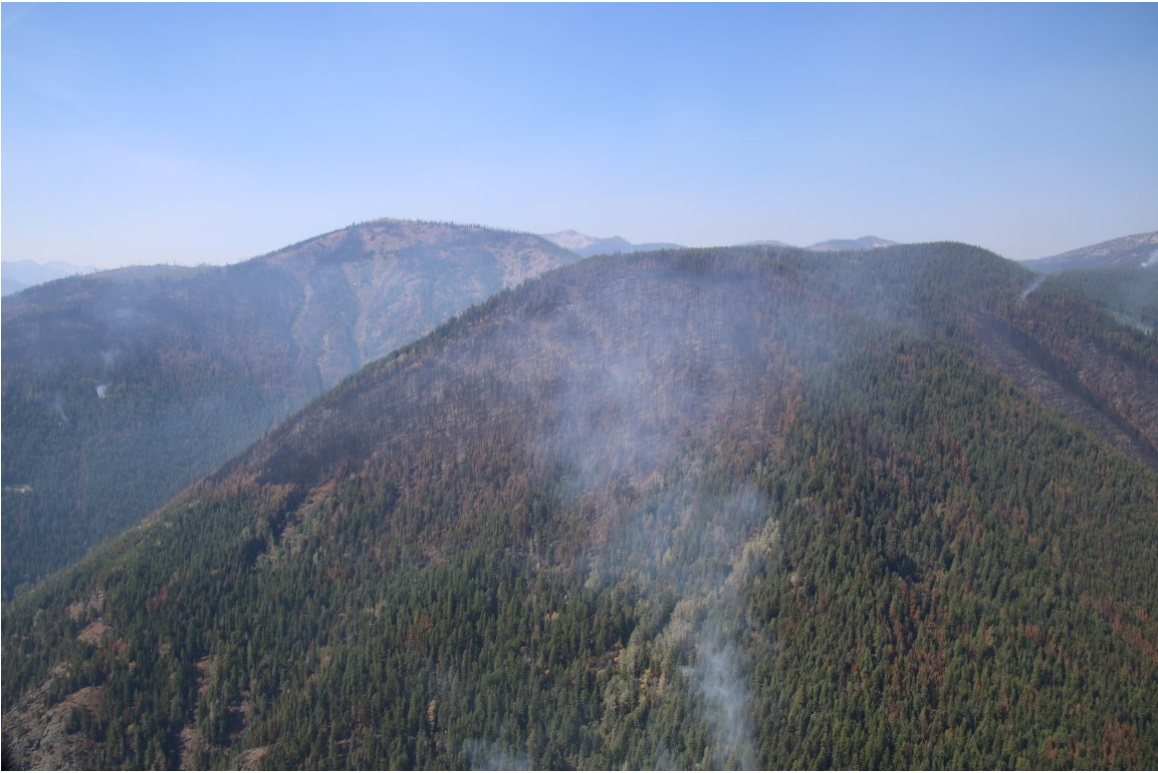
Photo 12: View of Toby-Topaz Face.

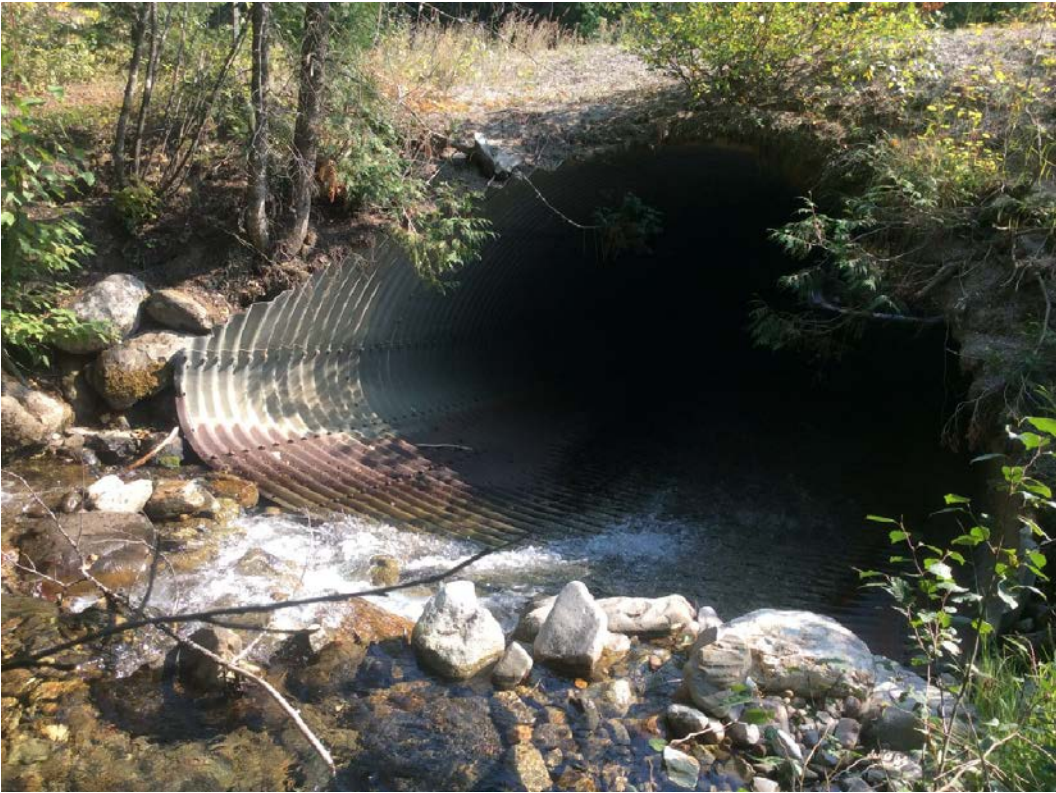
<p><u>Topaz Creek - increased runoff/peak flows : highway crossing</u> <u>Topaz Creek – debris flow : highway</u></p> <p>Topaz Creek is crossed by Highway 3 with a large arch culvert, approximately 4 m to 5 m in width, and 3 m in height (refer to Photo 13). Topaz Creek is likely subject to periodic debris flows or debris floods, although none appear to have reached the highway crossing in the recent past. There is an area of steep gullied terrain with some high burn severity approximately 1.8 km north of the highway crossing which is likely to have a moderately increased debris flow hazard which could reach Topaz Creek. Topaz Creek has an average stream channel gradient near 20% in the adjacent reach, and would likely be capable of continued debris flow transport and entrainment of material. There is a 500 m long reach with an average 16% gradient approaching the highway crossing where some debris flow deposition may occur, although longer than normal debris flow runout may be possible under adverse conditions due to the continued confinement. A debris flood could also continue downstream from where a debris flow ends.</p>	<p>L M</p>	<p>L M</p>

Photo 13: Highway 3 crossing of Topaz Creek.

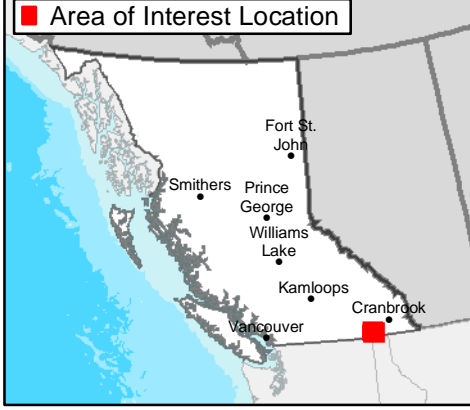
Burn Severity Mapping

BC Burn Severity 2018
(Same-Year Classification)

This burn severity mapping is created using a Differenced Normalized Burn Ratio (DNBR) calculation on pre- and post-fire imagery which is classified into four Burned Area Reflectance Classification (BARC) categories. Default breakpoints are used for all timber types across BC and therefore may not accurately reflect field conditions.

"Same-Year Classification" means that the burn severity mapping has been completed the same year the fire occurred (i.e. in summer/fall 2018 for 2018 fires).

Pre-Fire Imagery Date: 20180719
Pre-Fire Scene Identifier: S2B_MSIL1C_20180719T184919_N0206_R113_T11UNQ_20180719T235109

Post-Fire Imagery Date: 20180907
Post-Fire Scene Identifier: S2B_MSIL1C_20180907T184909_N0206_R113_T11UNQ_20180907T24321

The burn severity mapping was provided by the Ministry of Forests, Lands, and Natural Resource Operations based on Differenced Normalized Burn Ratio calculations using same year classification satellite imagery. The classification areas shown in this mapping appear to be reasonably accurate for the purposes of this assessment based on field observations by SCL.
