Sitkum Creek Fire, July-August 2007

Post-Wildfire Risk Analysis

Peter Jordan
Southern Interior Forest Region (Nelson)

18 September 2007

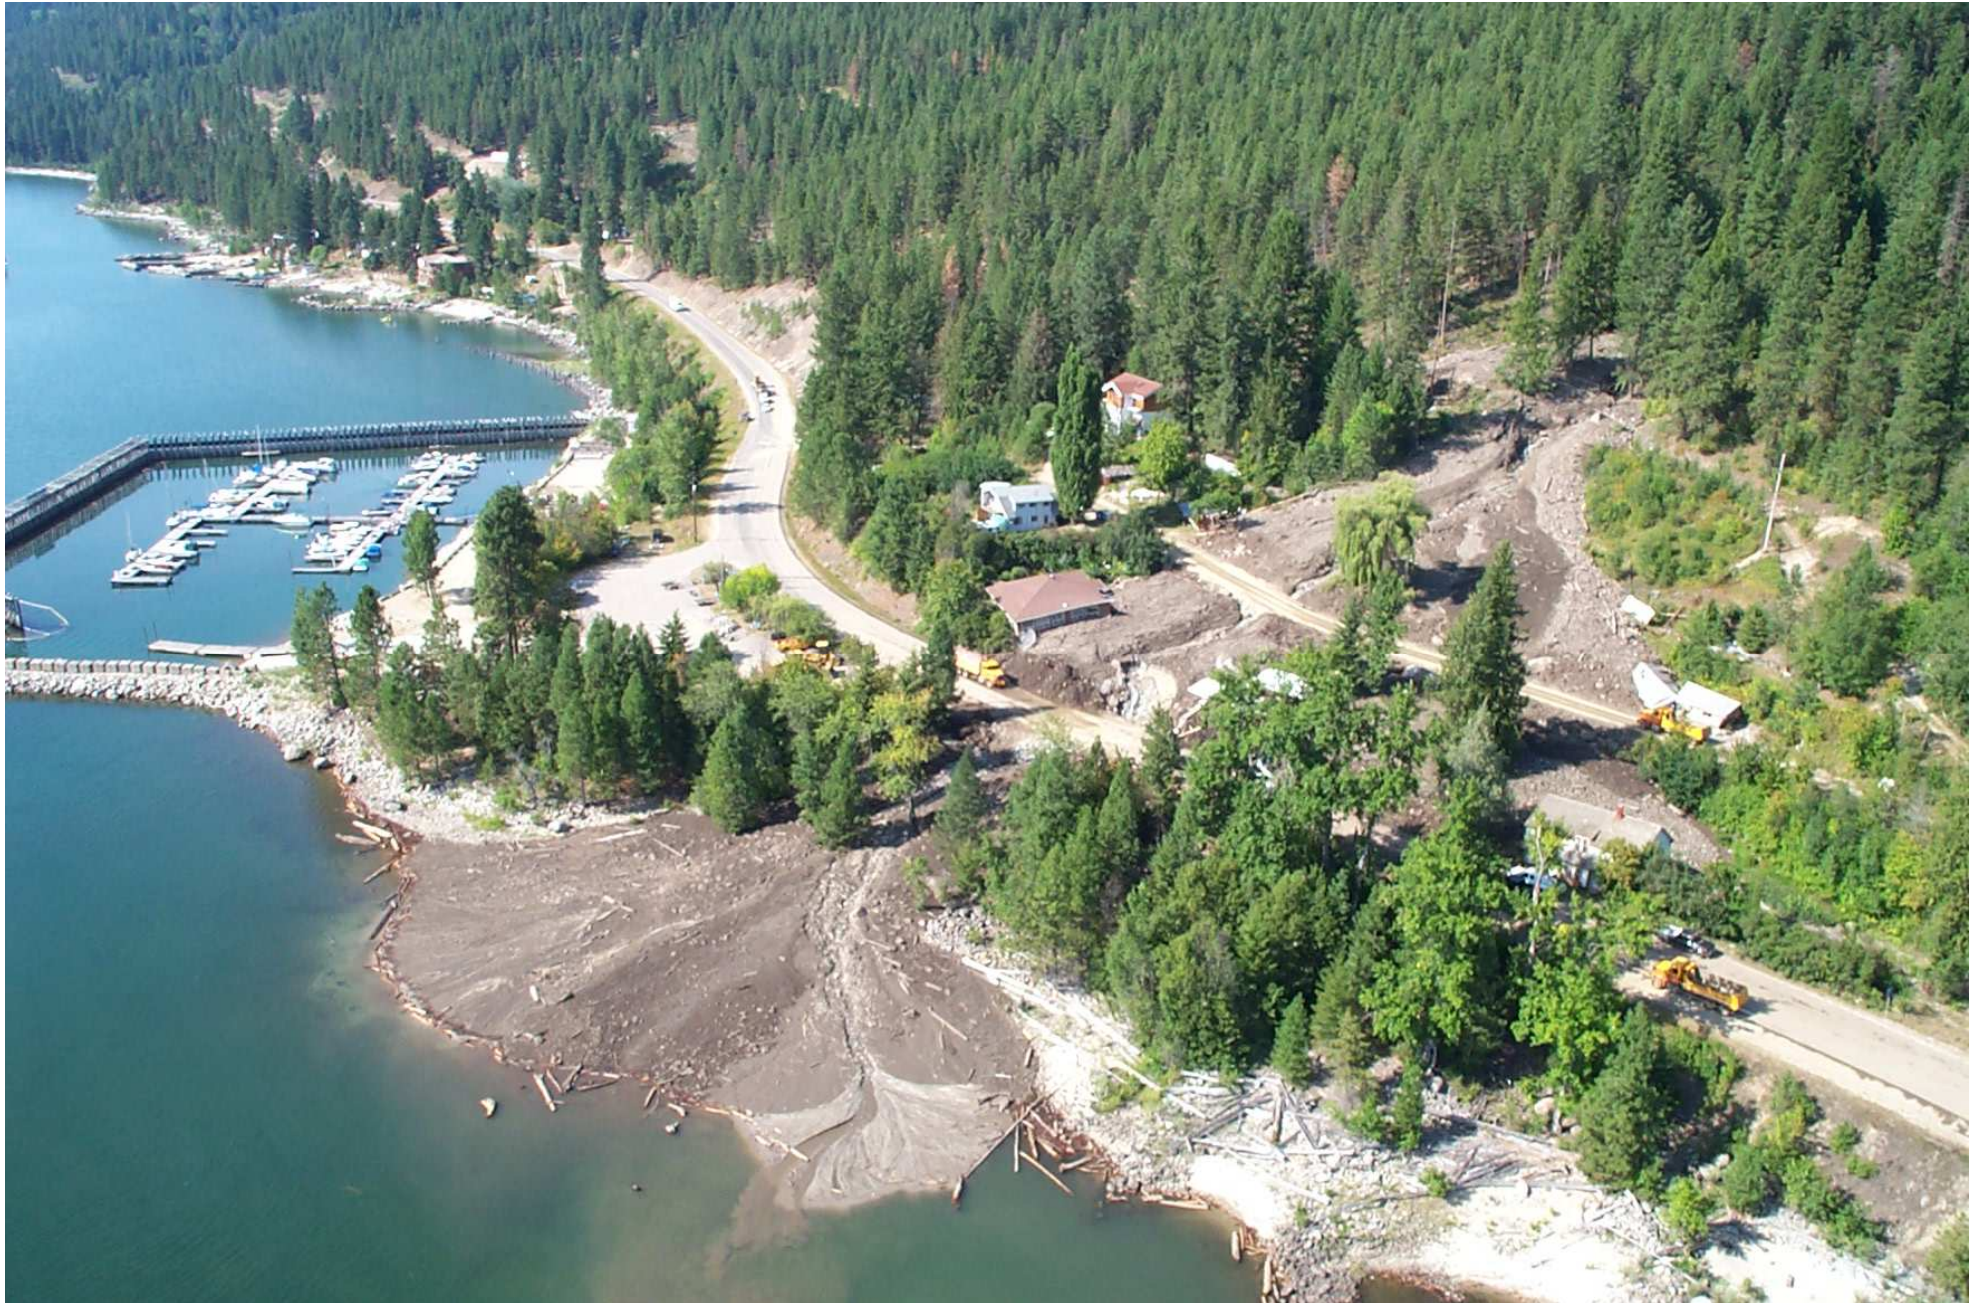
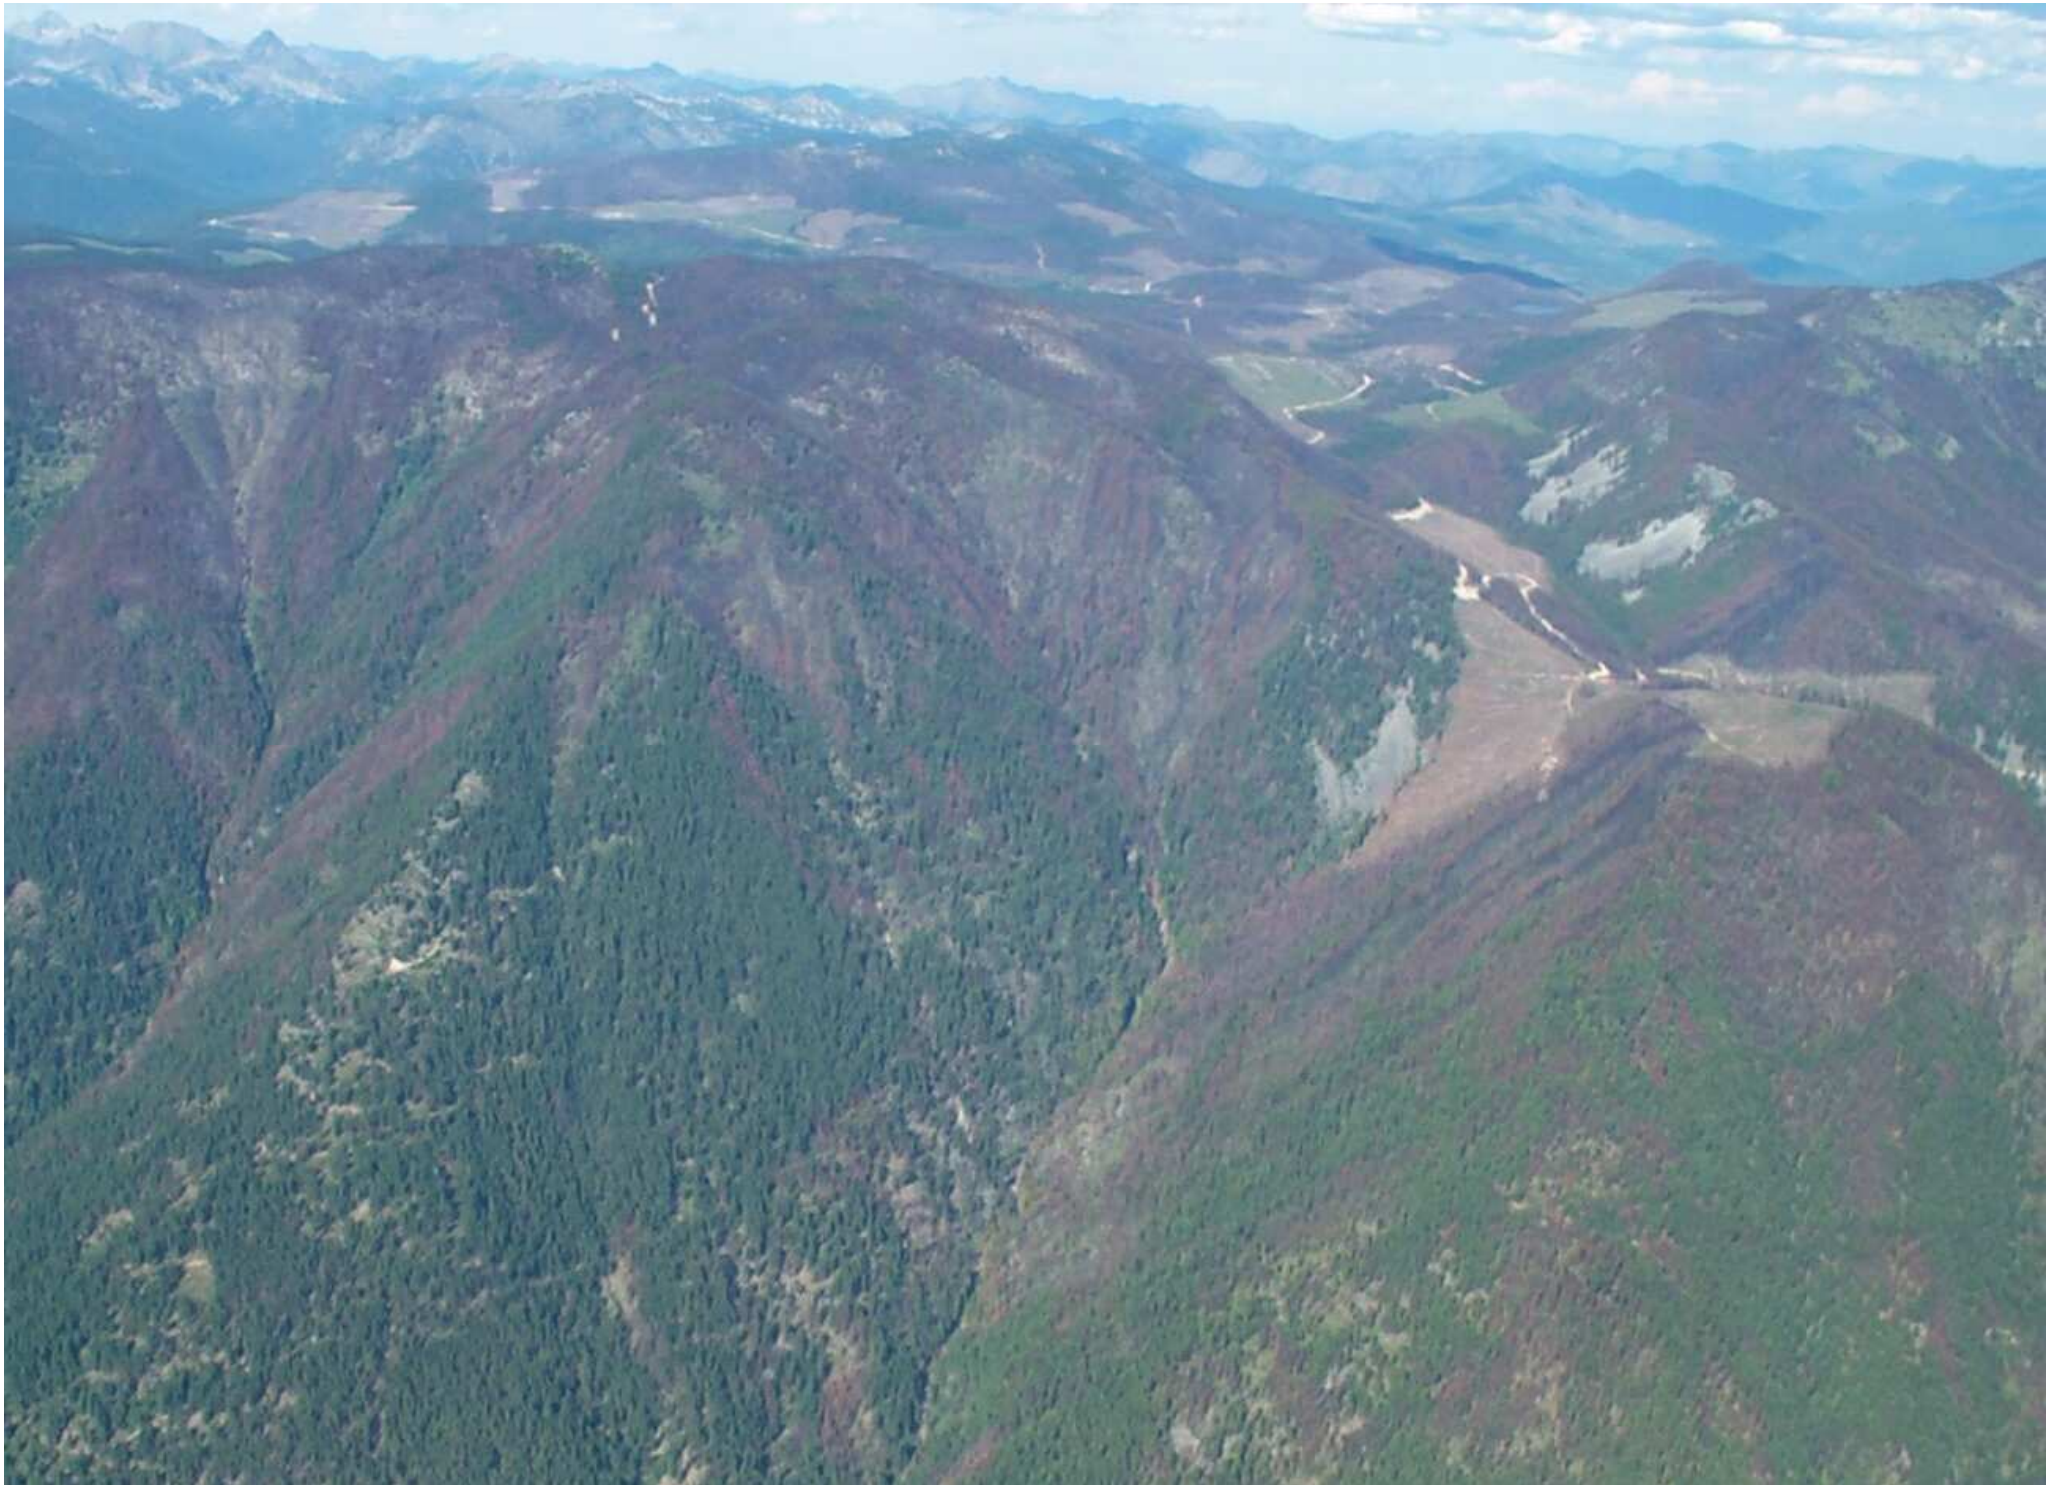
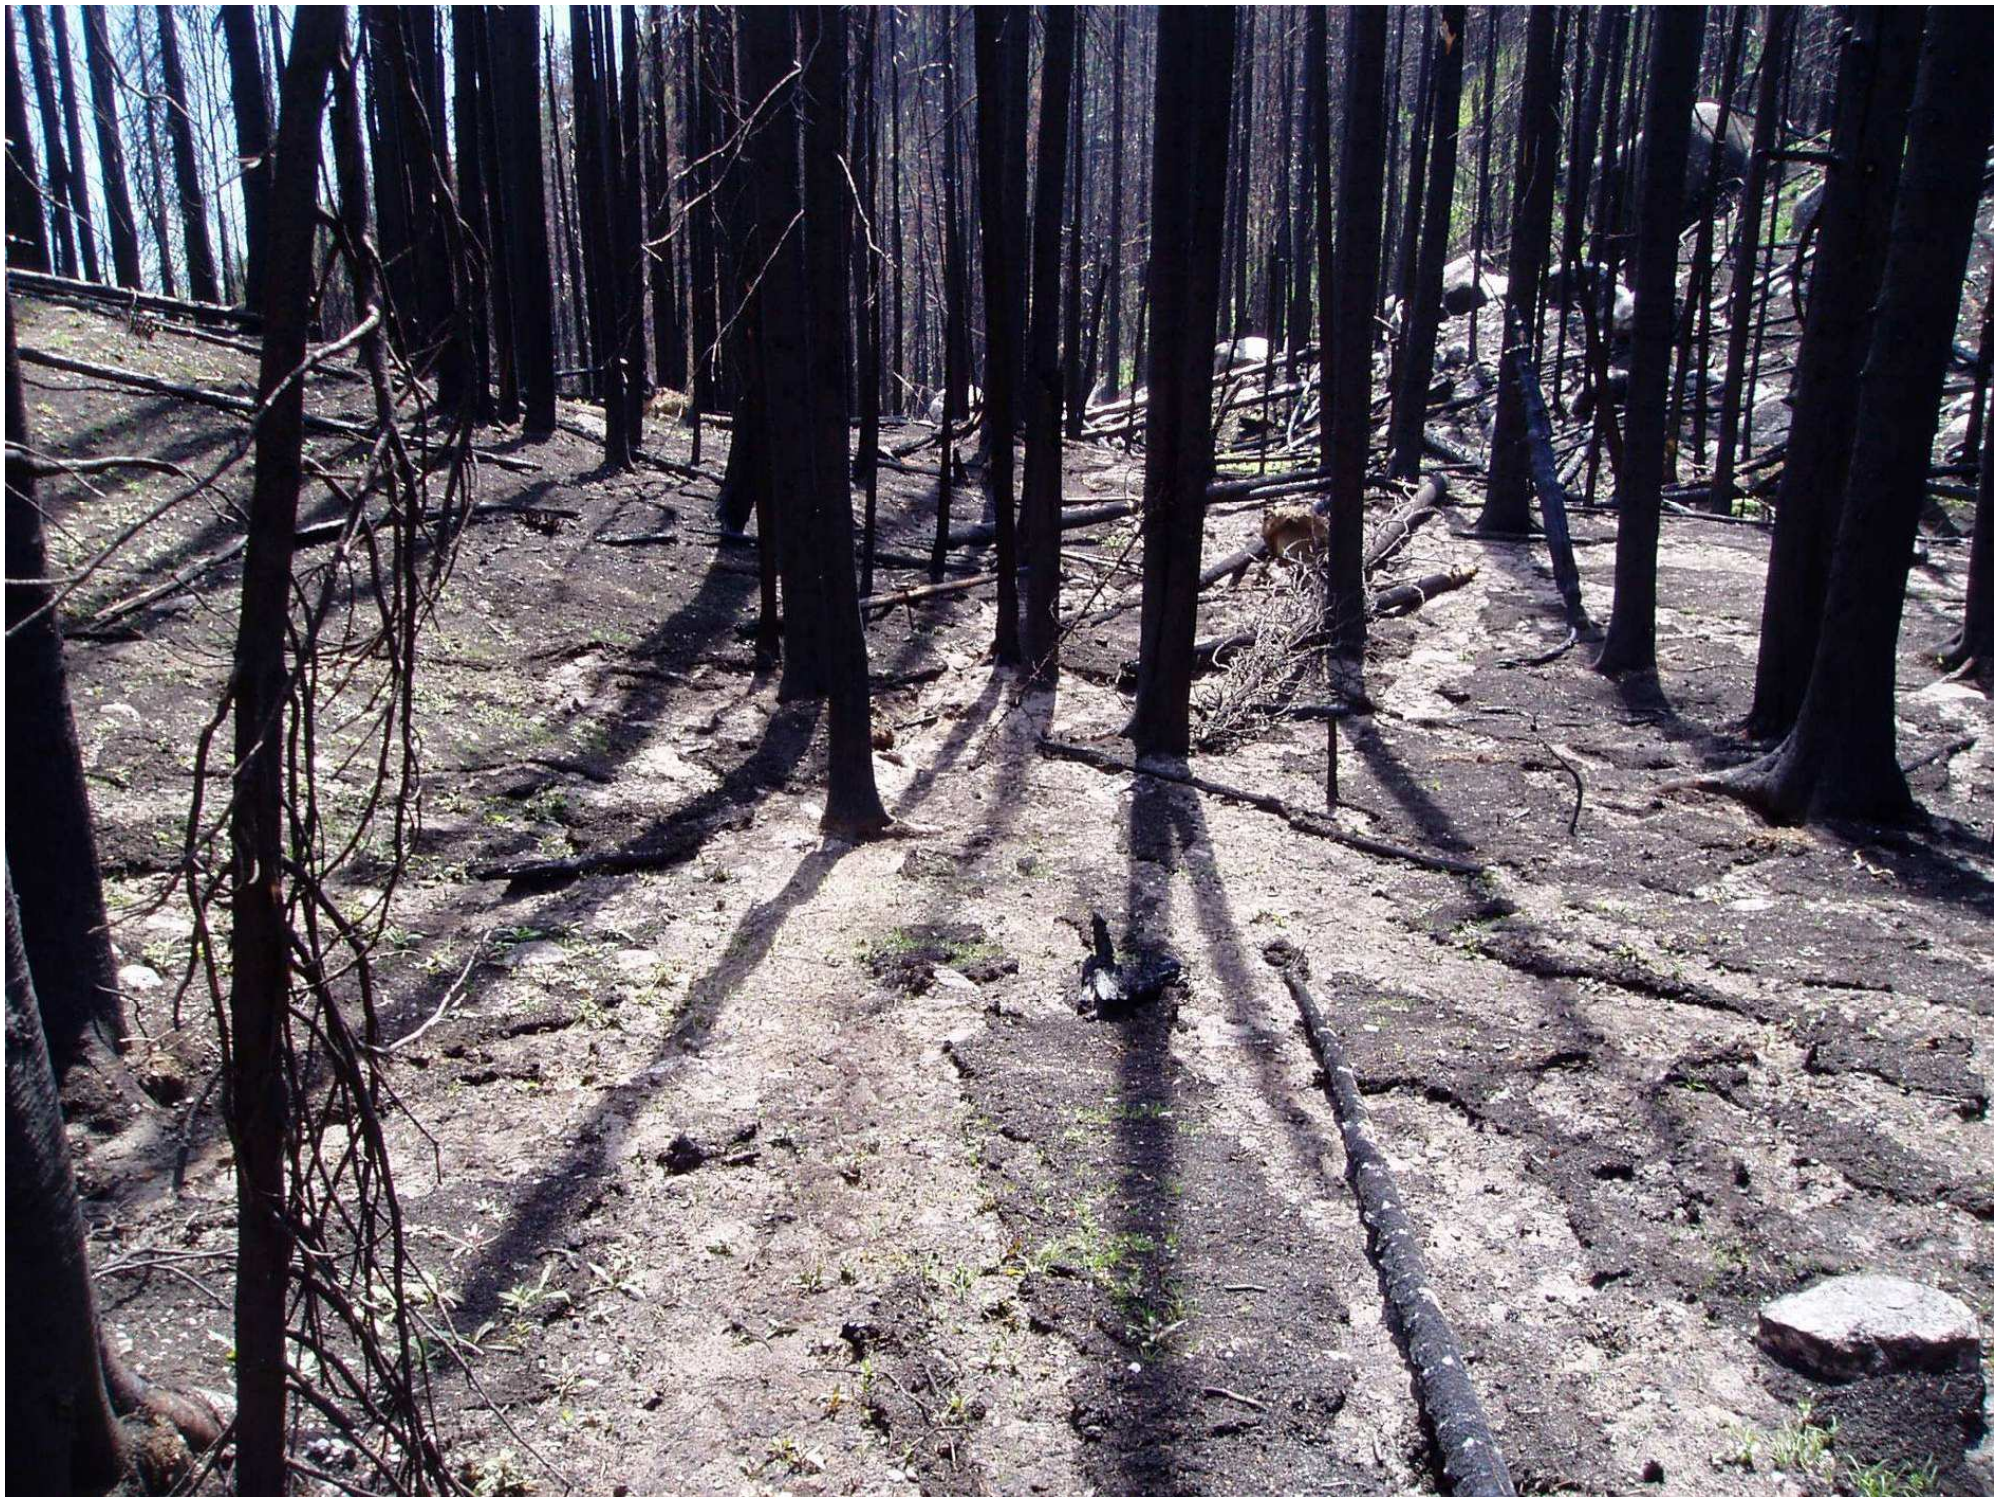
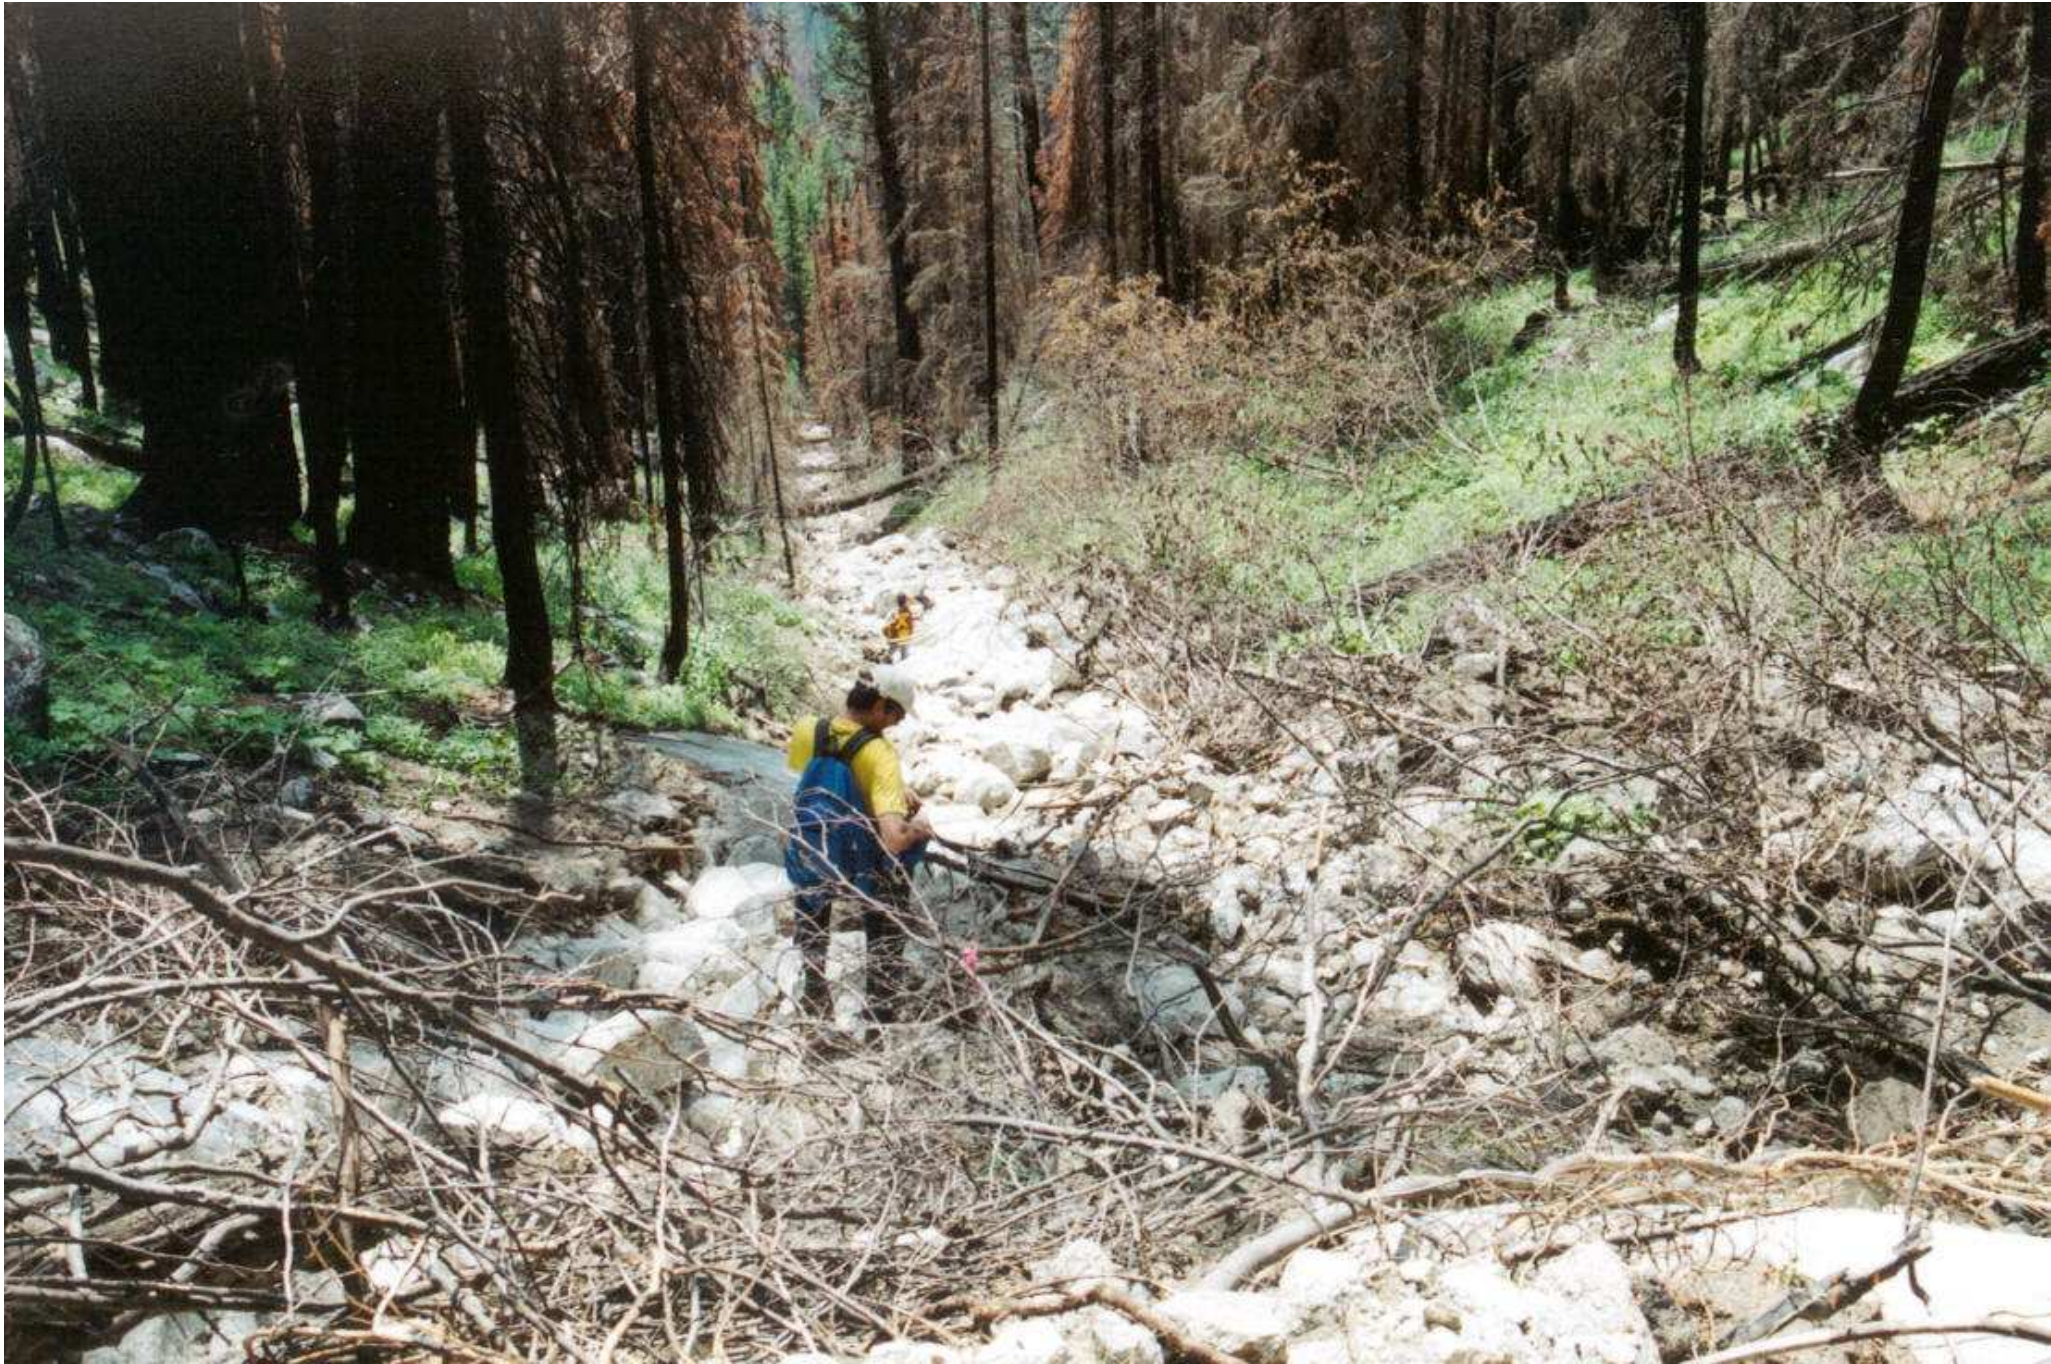
Kuskonook Creek debris flow, Aug. 6, 2004:

(this is a steep debris flow dominated fan, unlike Sitkum Creek)

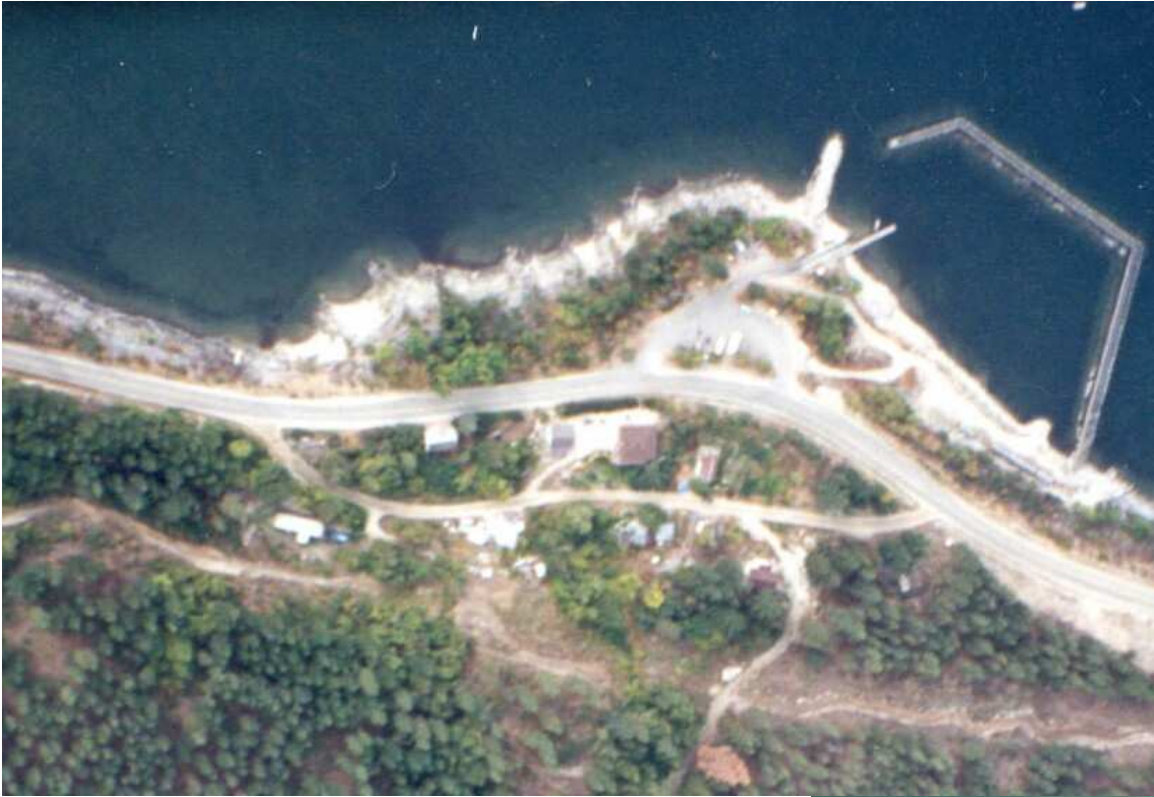
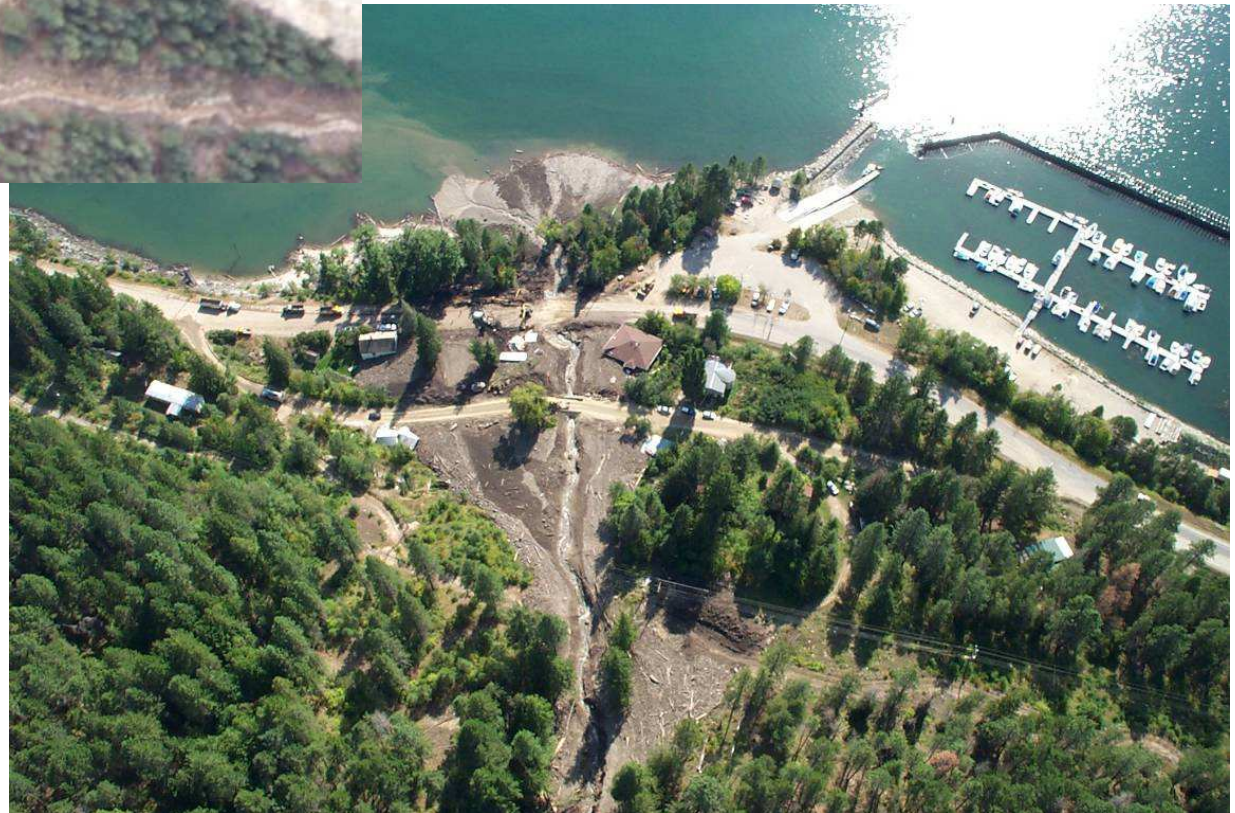
Kuskonook Cr fan in 1994

August 2004

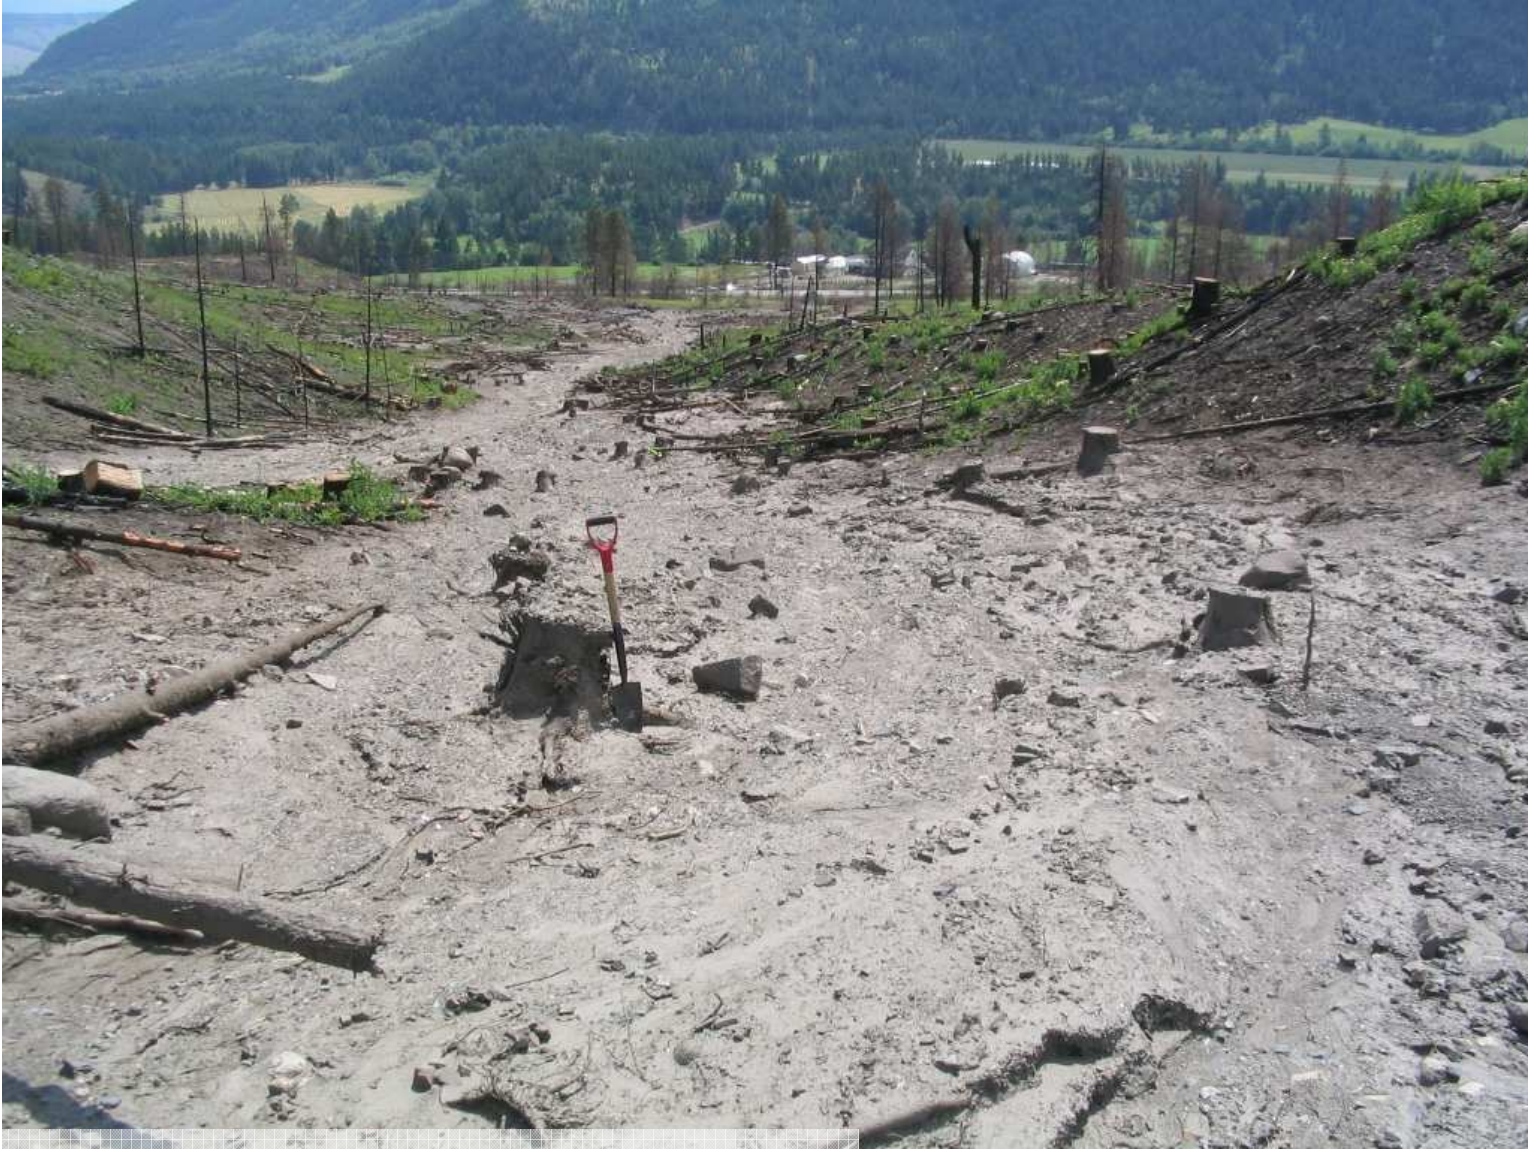
CEDAR HILLS FIRE

Small debris flows and floods affected the highway and farm properties

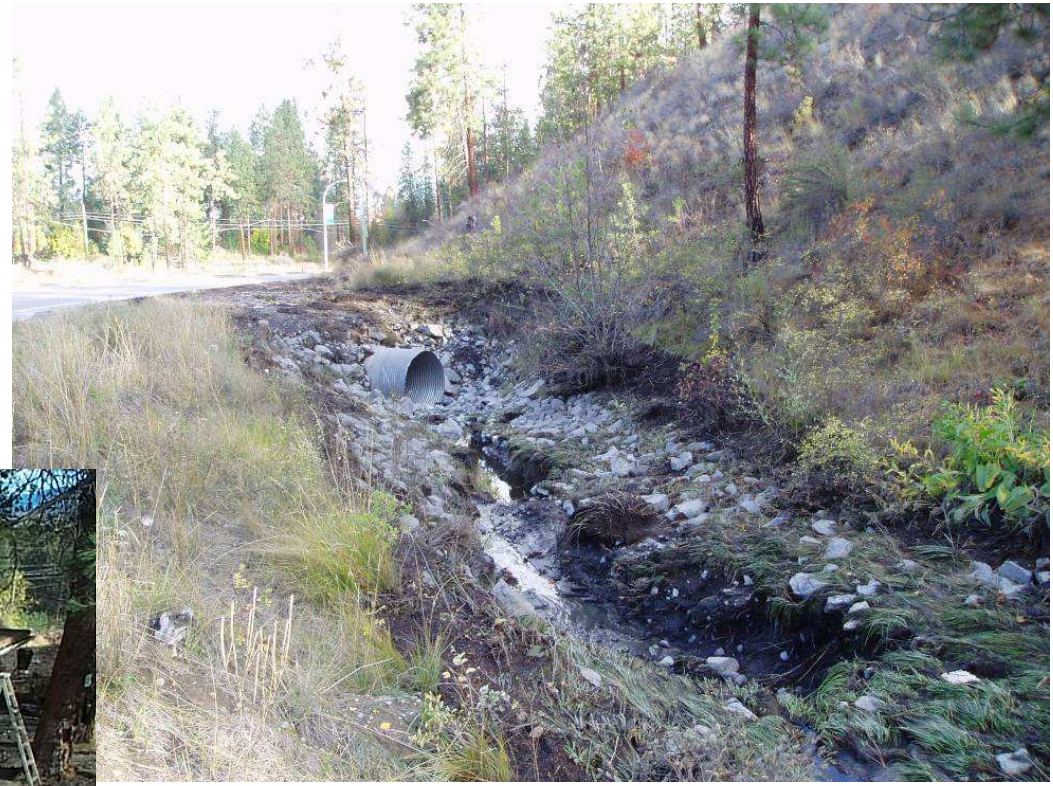
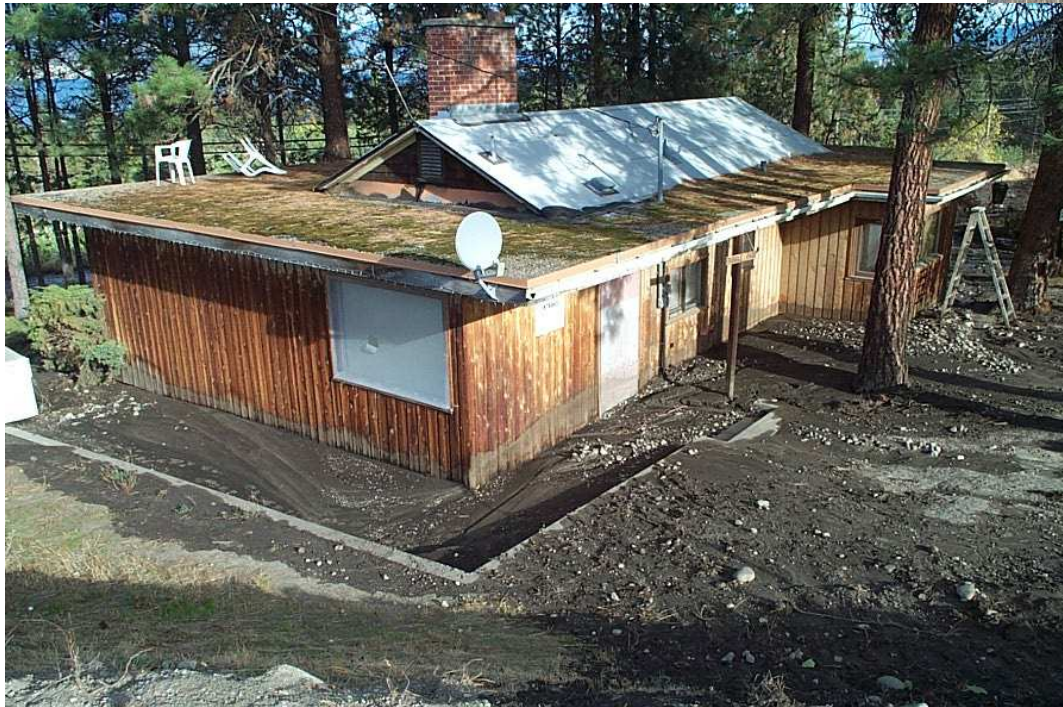
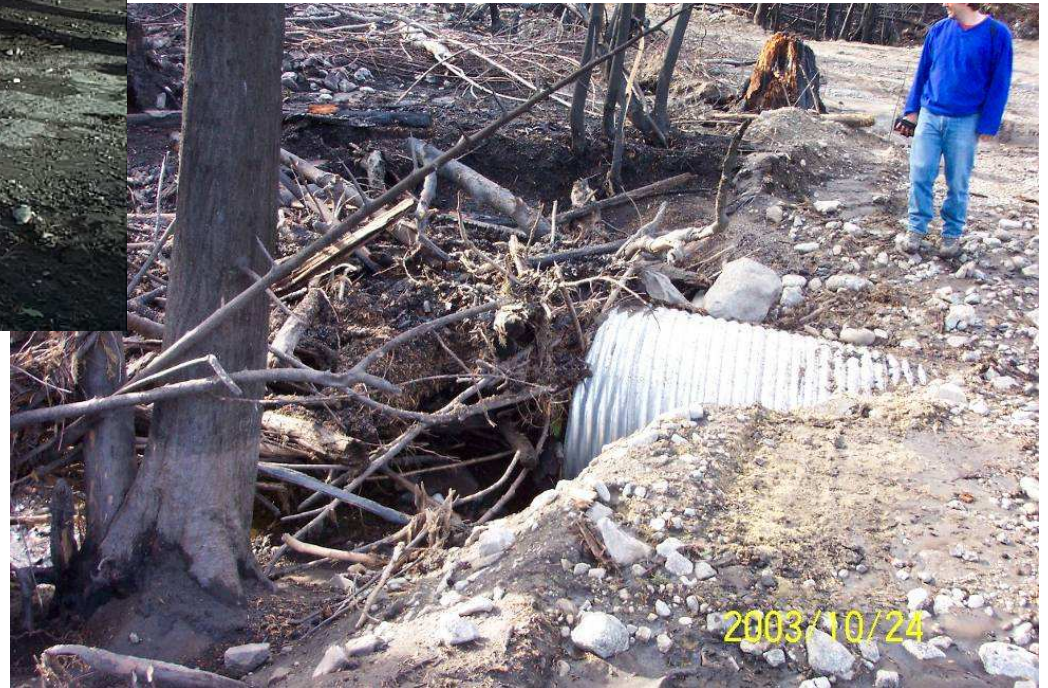
KELOWNA: Erosion event following 2003 Okanagan Mountain Park fire

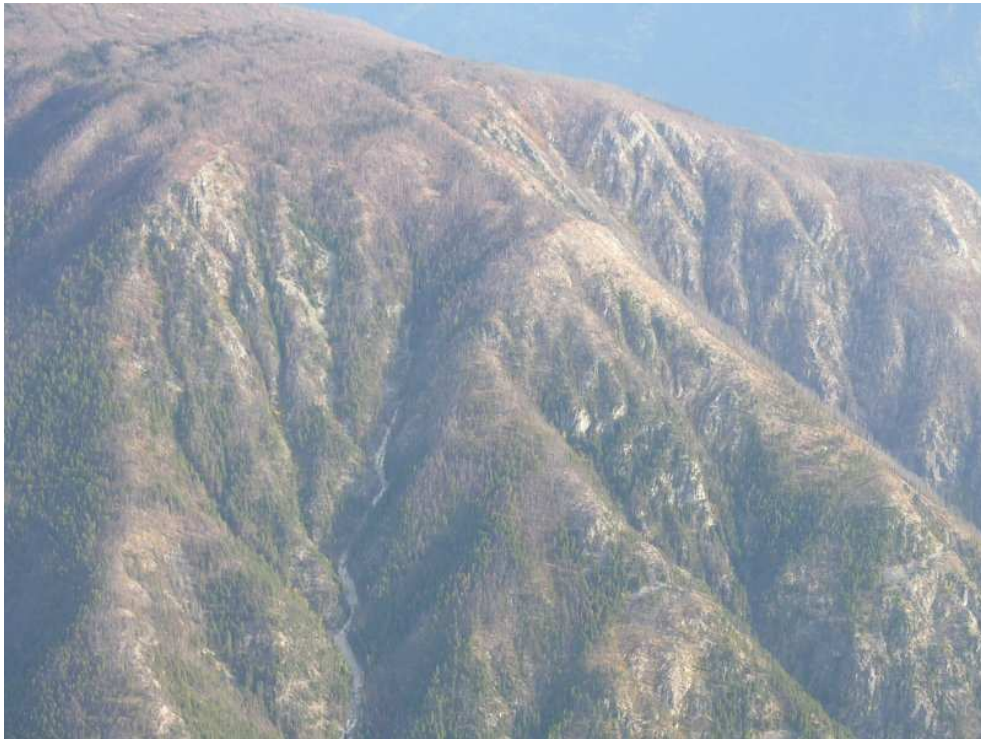
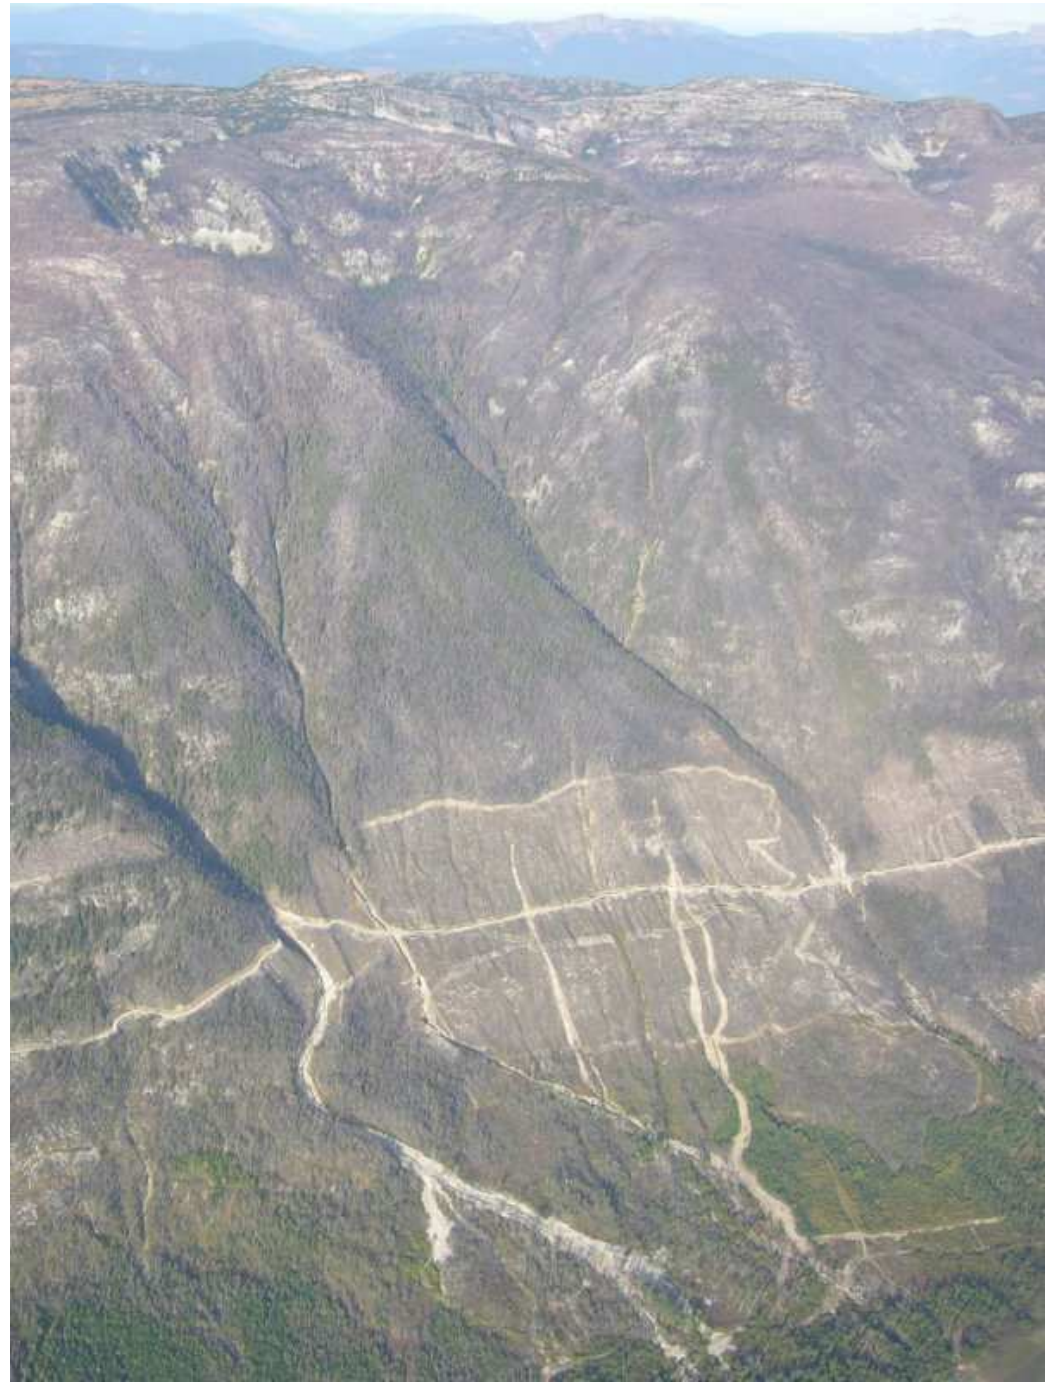
INGERSOLL FIRE (Burton):
15 debris flows and landslides
occurred in and below the burn
during a rainstorm in October 2005

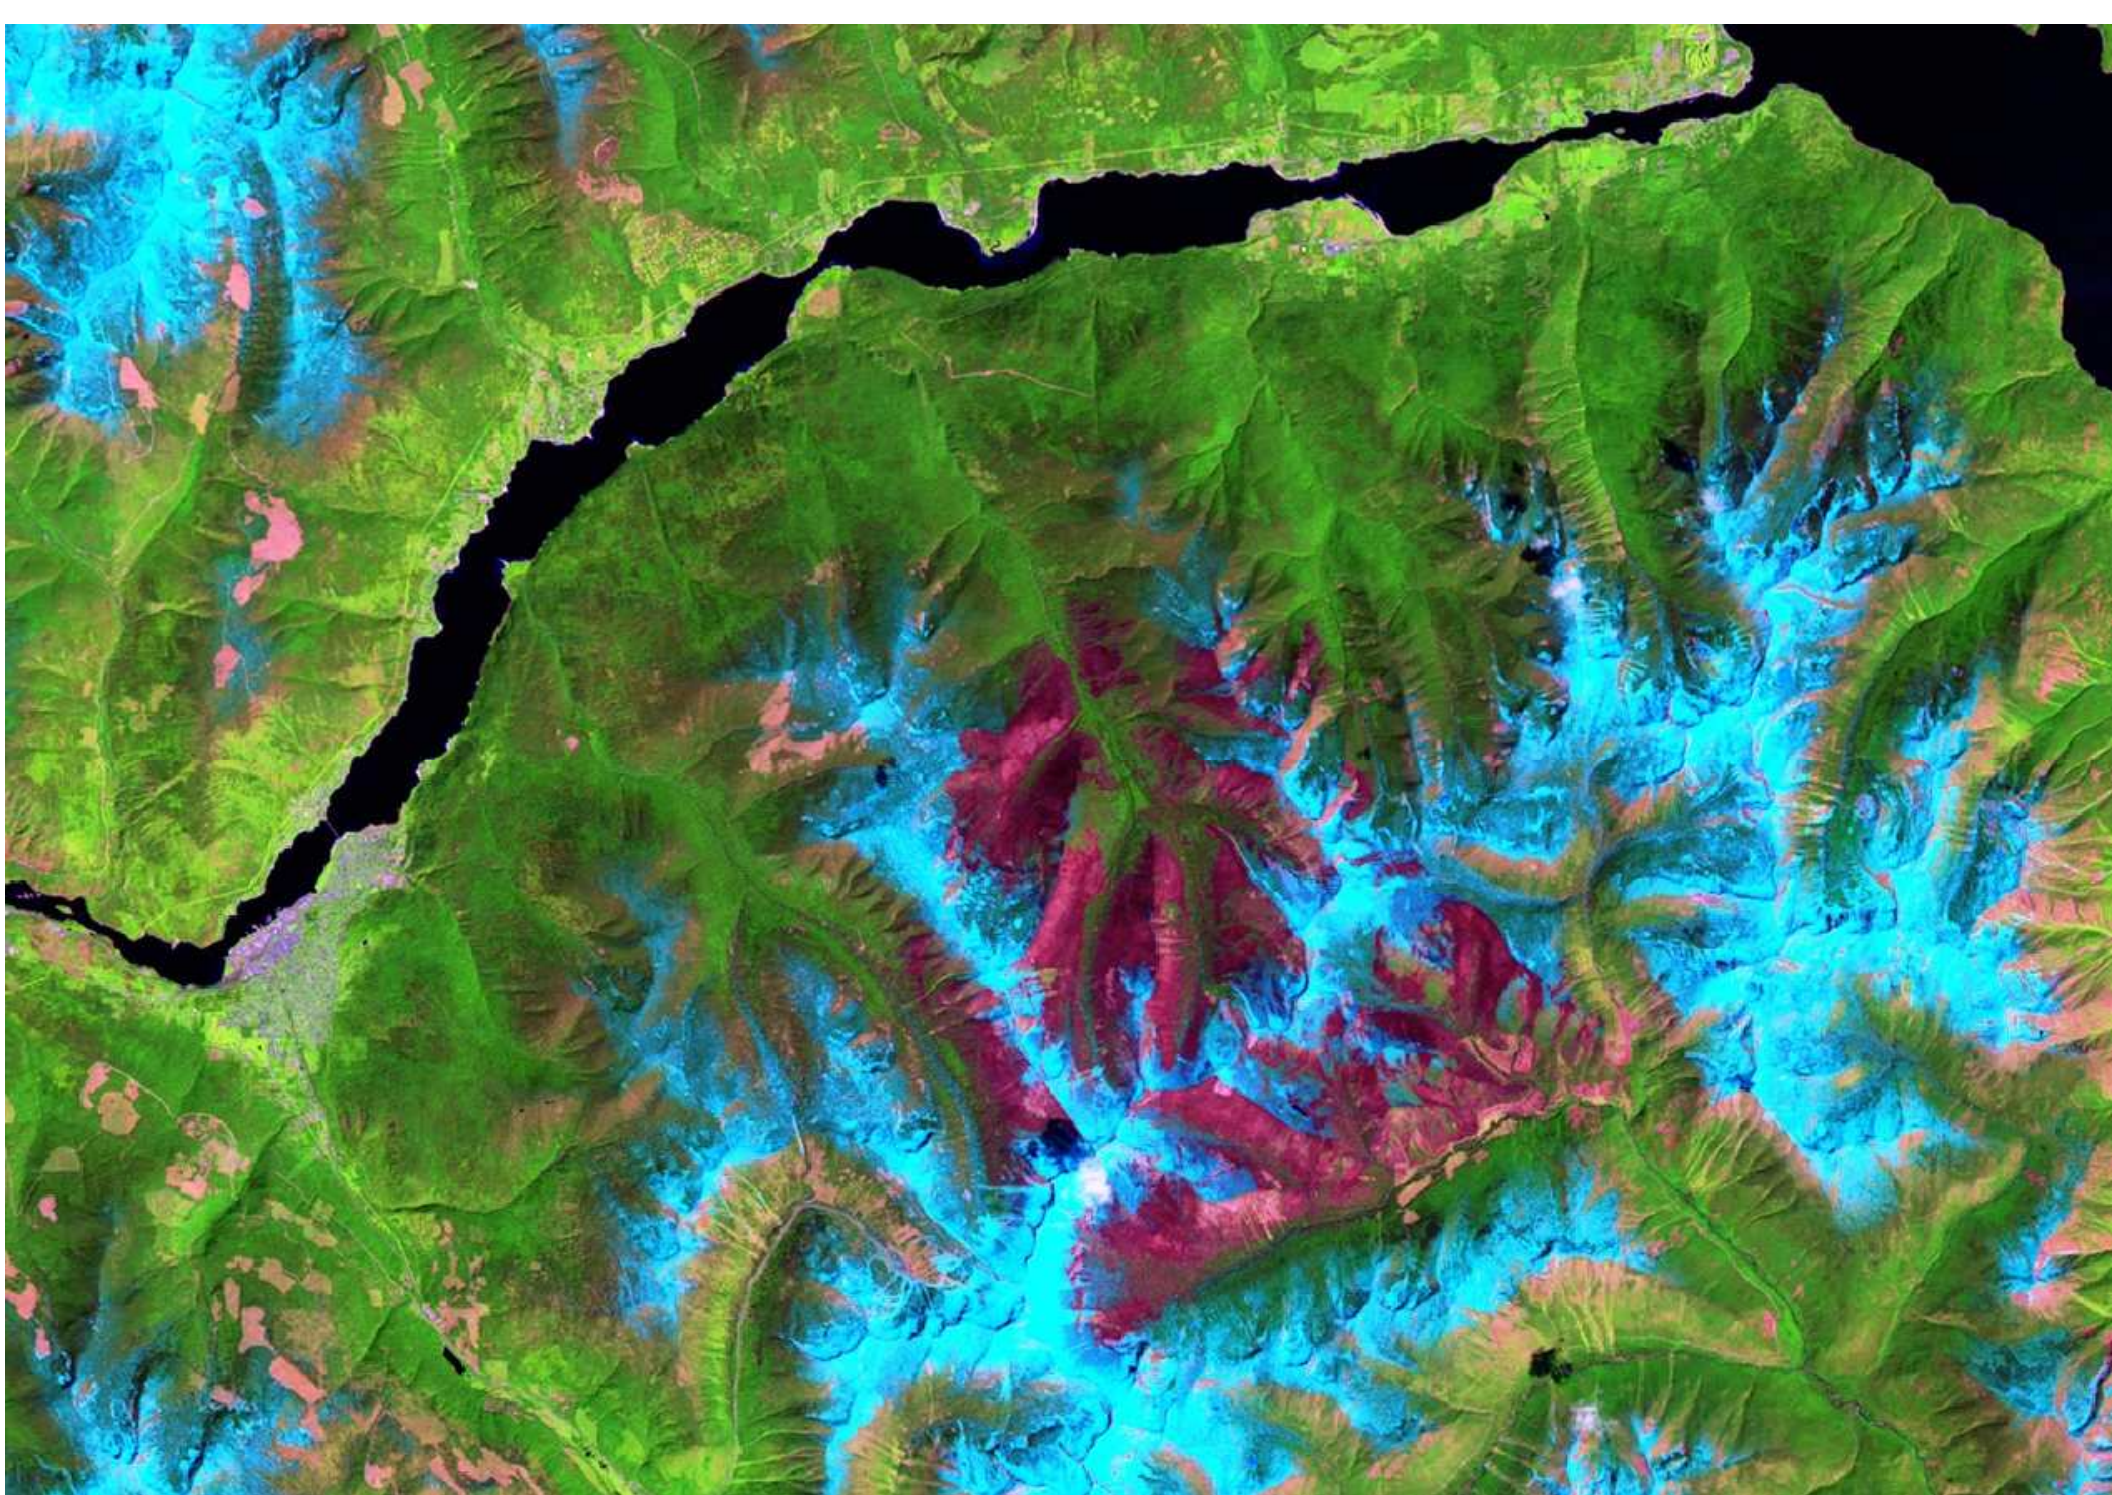
2003 Kutetl Fire – no significant landslide, erosion, or flood events have occurred
