Springer Creek Fire Number 50372 Post-Wildfire Risk Analysis

Prepared for B.C. Ministry of Forests and Range
Southern Interior Forest Region - September 1, 2007*

Assessment Team Doug Nicol¹ P.Eng. (Lead), Peter Jordan² PhD., P.Geo., Marc Deschenes³,
Mike Curran² PhD., P.Ag., Ashley Covert²

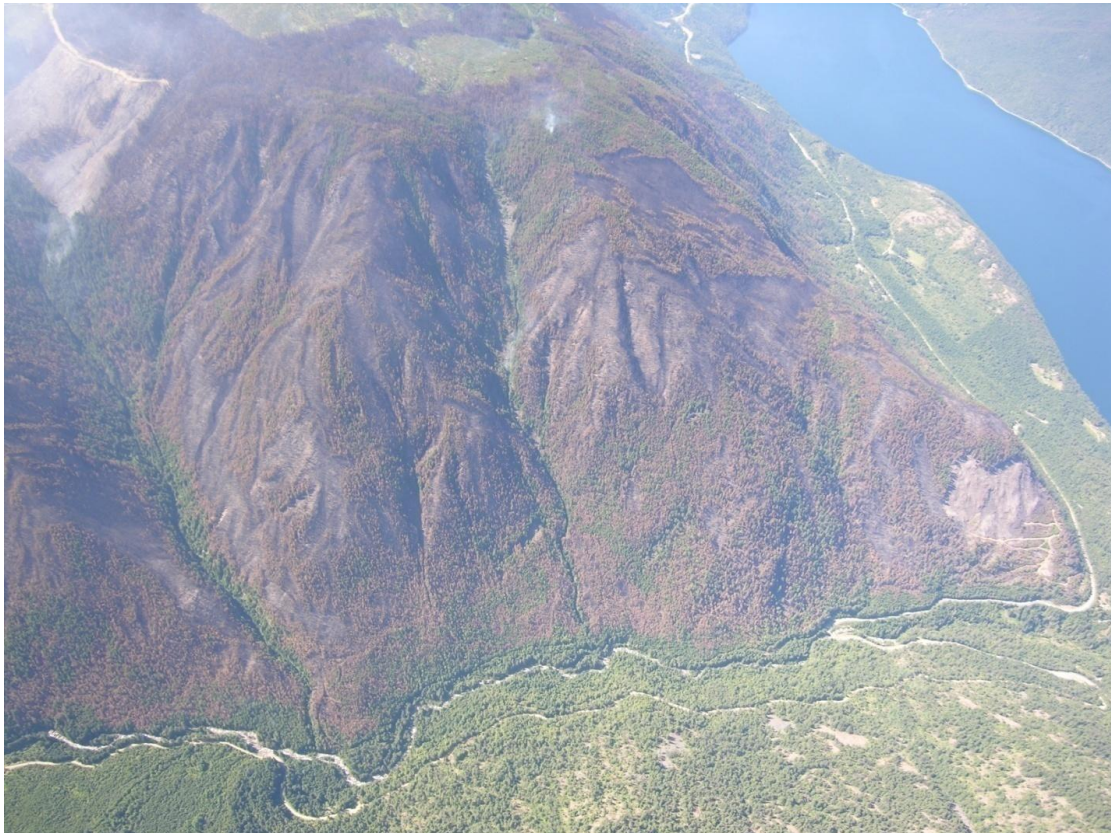
The lower 8km of the drainage was burned above and upstream of Highway 6 with the burn area predominately on the south side of Enterprise Creek for the westerly 4km of the burn (see Photo 1) and predominantly on the north side of Enterprise Creek for the easterly 3.5km of the burn (see Photo 2).

Photo 1 Burned slopes on the south side of Enterprise Creek

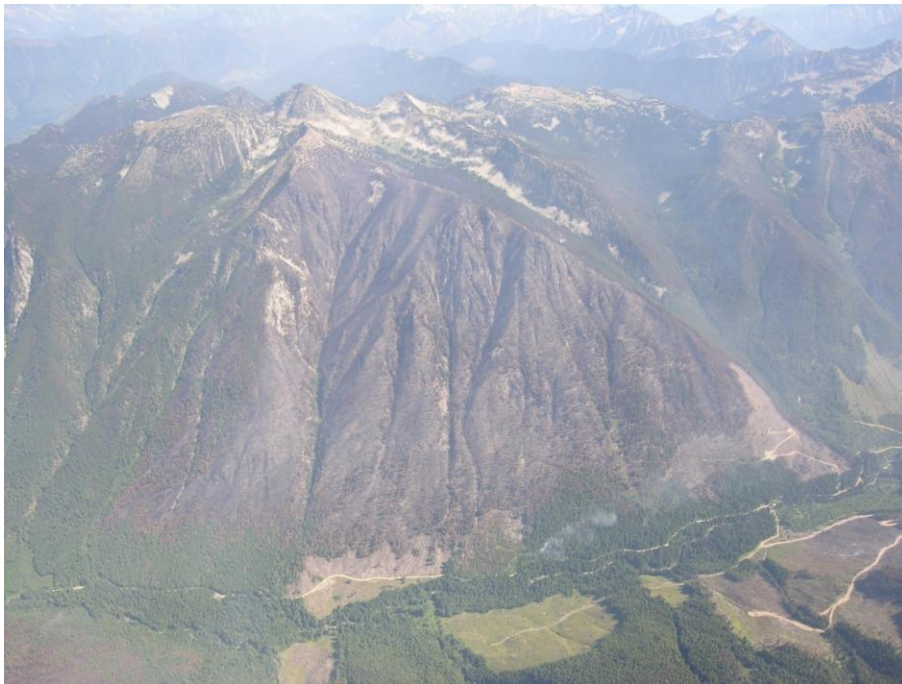
Photo 2 Burned slopes on the north side of Enterprise Creek

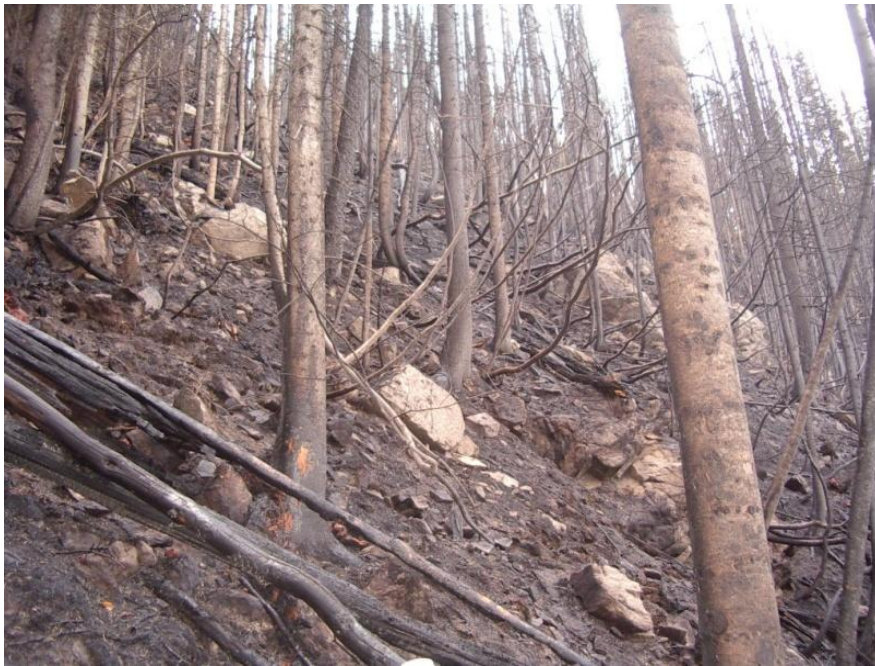
The vegetation burn severity was mapped as 11 hectares high and 8 hectares moderate (27% combined high and moderate burn severity). The high vegetation burn severity is located primarily between 1100m and 1500m elevation (see Photo 3). Part of the mapped high vegetation burn severity was reviewed on the ground to check soil burn severity and soil water-repellency. The results confirm the presence of water repellent soils along with the removal of the forest floor litter and duff, and the resulting exposure of mineral soil (see Photos 4 and 5). In addition, some of the area mapped as low vegetation burn severity (area upslope of the mapped high burn severity) is considered to have a moderate to high soil burn severity (likely as a result of a creeping ground fire).

Photo 3 High Burn Severity in Allen Creek Watershed

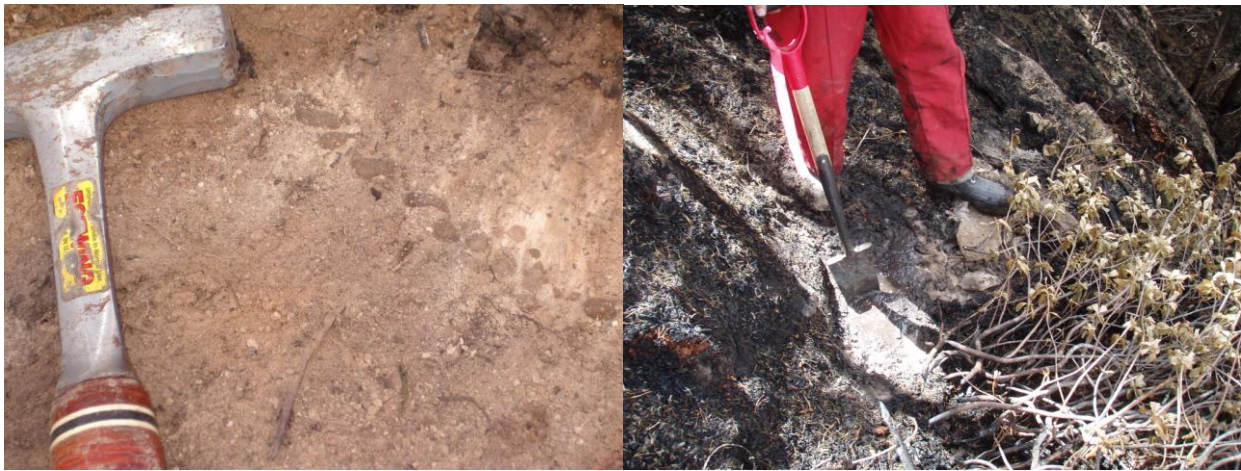
Photos 4 and 5 Water drops sitting on soil trench (left) dug to test for water-repellency, demonstrating non-infiltrating water. Right - water trapped above water repellent layer after small recent rainfall in Allen Creek – Allen Creek Watershed

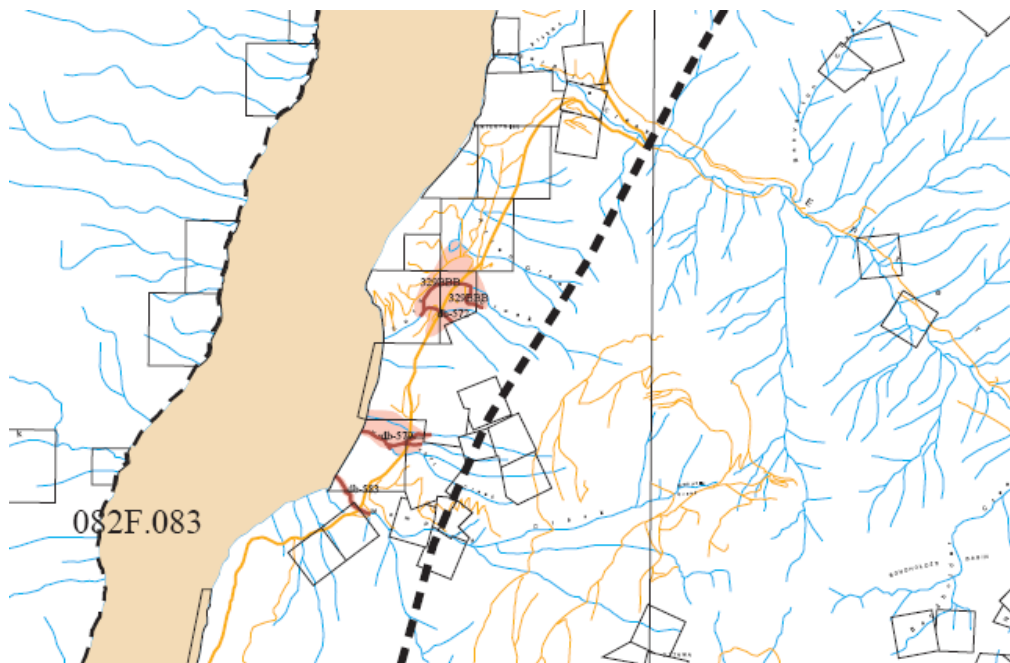
Possible debris flow levees were observed adjacent to all the Cory Creeks and the creek gradients between the fire guard and Highway 6 drop as low as 20%, with poorly defined channels at some locations. Discussions with local residents indicate the channel locations have been modified over the years. An area of flood hazard has been identified via a 1:50,000 MSRM flood hazard map (see Figure 4) that encompasses all three Cory Creek watersheds for a distance of about 300m upstream and downstream of Highway 6 in the region of low stream gradients. The flood hazard area extends to the bend of Allen Creek as it heads to the north.

Figure 4 MSRM 1:50000 2004 Flood Hazard Map

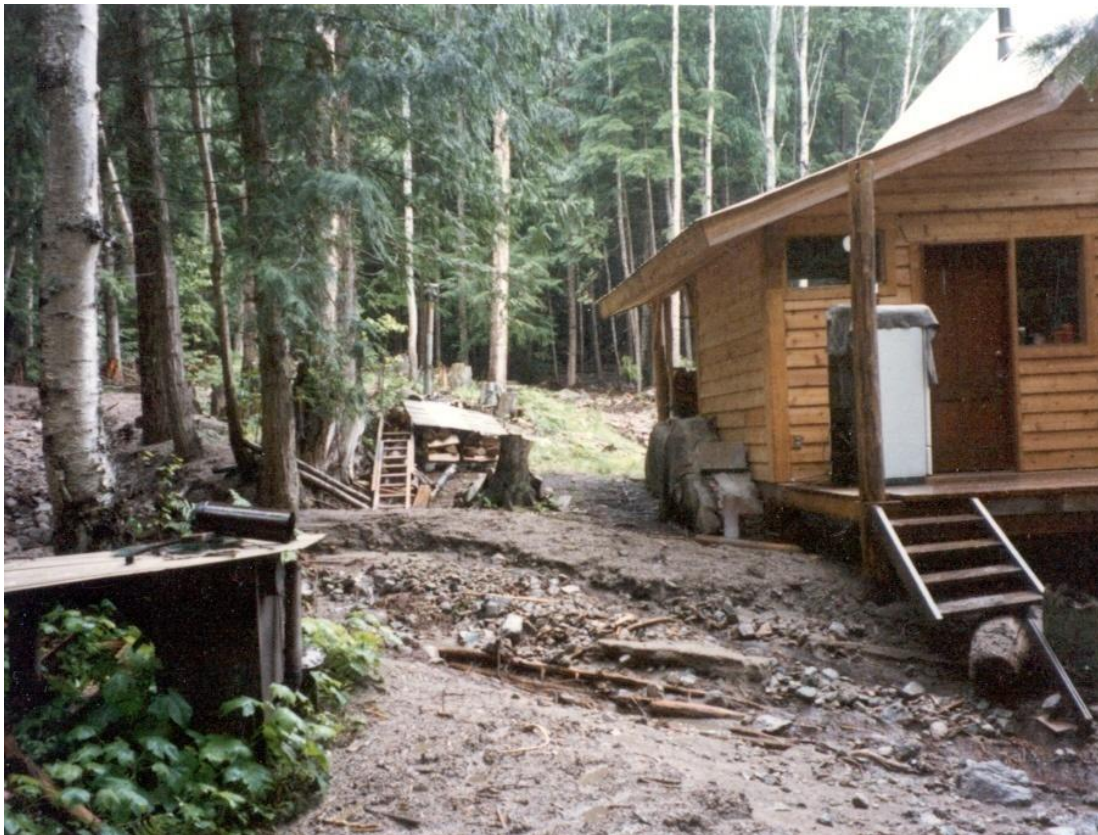
On May 30th, 1990 debris flows occurred in the North Cory and South Cory Creeks following a significant rain on snow precipitation event (see Curran et al). The North Cory debris flow was initiated by a small sidewall slump at the 1580m elevation. Slide deposition began at the 1100m elevation and continued to and across the highway and onto private property below (debris flowed up against a house [that is still occupied today] causing minor damage – see Photos 6 and 7). Slide debris at the highway coalesced with slide debris from South Cory to form a deposit over 200m wide. Slide volumes were estimated at between 10,000m³ and 12,500m³ for North Cory and between 7,500m³ and 10,000m³ for South Cory (VanDine 1990).

Photo 6 Debris against house after 1990 Slide

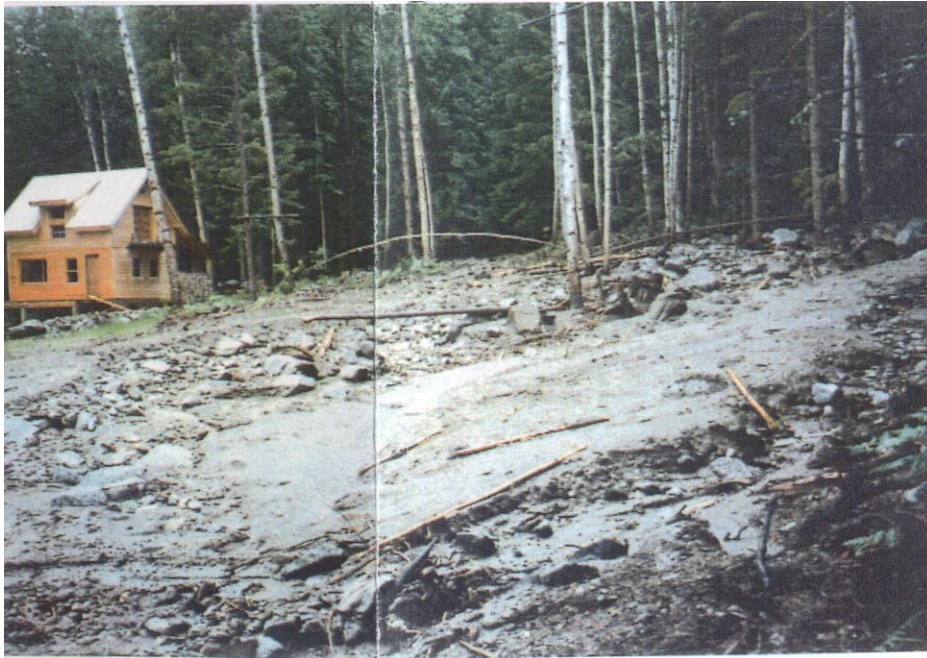
Photo 7 Debris from 1990 Cory Creek Slides

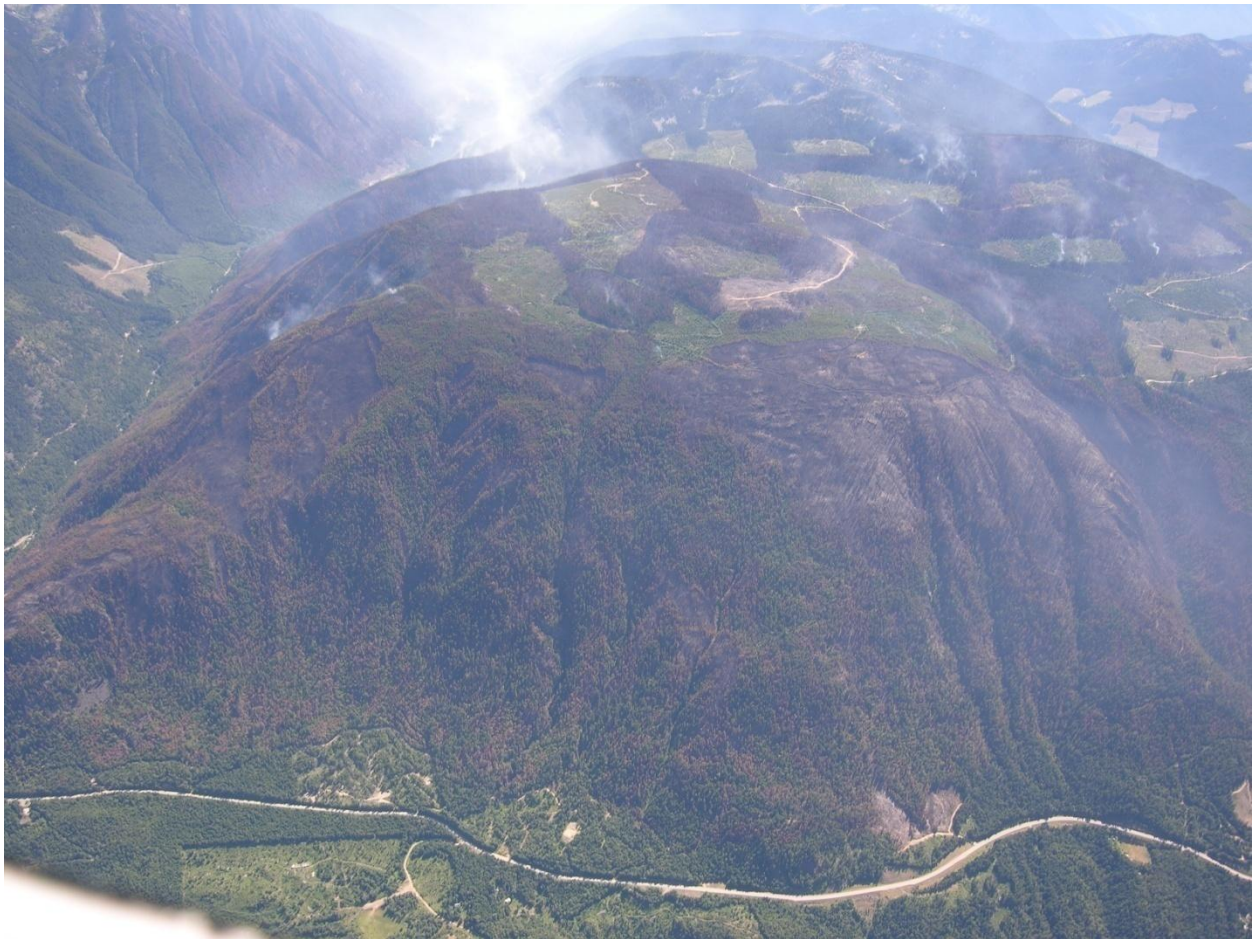
Photo 8 Burned areas of the Allen Creek and Cory Creek watersheds

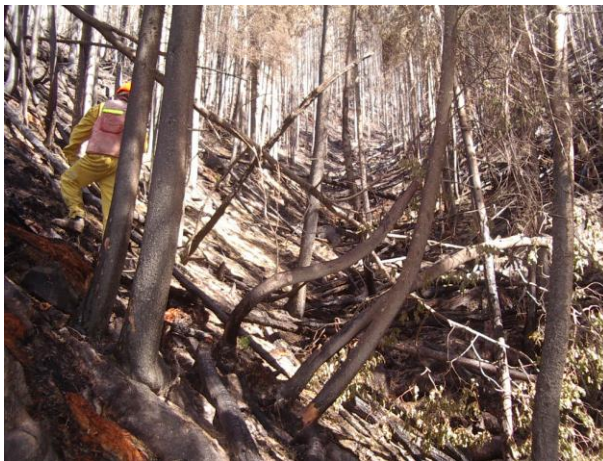
The channel of North Cory Creek was inspected (see Photo 9) at 1520m with evidence of alluvium and channel in-fill colluvium (however there were no surface flows at the time of the field review). The volume available for debris flow entrainment at the 1500m elevation is estimated at between 1m^3 and 2m^3 per linear metre. Over a length of 1200m (distance to deposition area) this volume would accumulate to 1200m^3 to 2400m^3 (actual debris flow volume would likely be much higher, perhaps 5000m^3 to $15,000\text{m}^3$, given additional potential bank erosion and the magnitude of the 1990 events and the resulting oversteepened banks; however, volume may be mitigated by segments scoured to bedrock.

Photo 9 Gully at top of Cory Creek

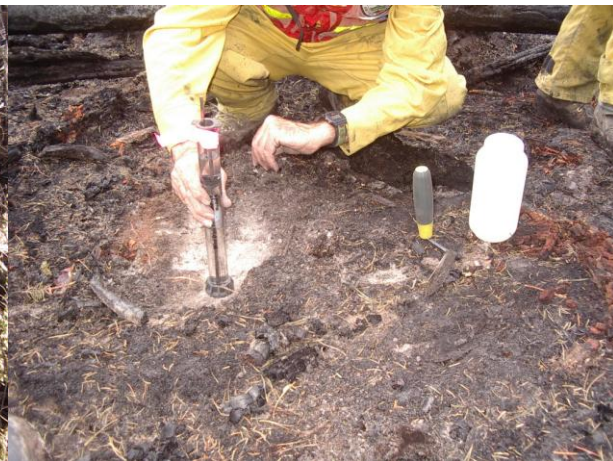
Photo 10 Infiltrometer Test – Cory Creek Watershed

Water-repellency and Infiltrometer testing in North Cory creek watershed confirmed the presence of highly water repellent soils (see Photo 10). Several old roads and trails criss-cross the Cory Creek from 1900m to 1650m. The lowest road was walked and some large (still effective) cross ditches were observed. Other roads and trails within the drainage were not reviewed.

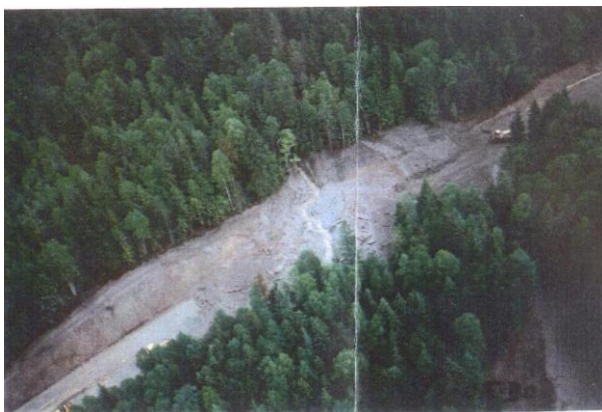
On May 30th, 1990 a debris flow occurred in North Van Tuyl Creek (see Curran et al) following a significant rain-on-snow precipitation event. The North Van Tuyl Creek debris flow was initiated in channel at about 1470m elevation below a small waterfall. Deposition of debris occurred from 790m elevation to the Highway 6. The debris flowed fanned out on the highway over an 80m length (see Photo 11) and continued below the highway and into Slocan Lake. The estimated volume of the slide was 10,000m³ to 12,500m³ (VanDine 1990). It was concluded in 1990 that stream flow which contributed to the debris flow had been concentrated from an upper landing with a pond at the 1690m elevation. It was noted in 1990 that the passing debris flow left much of the creek banks oversteepened and there was sufficient debris supply that could enter the channel, such that a repeat event was likely.

Photo 11 – Debris on Highway from 1990 North Van Tuyl Creek Slide

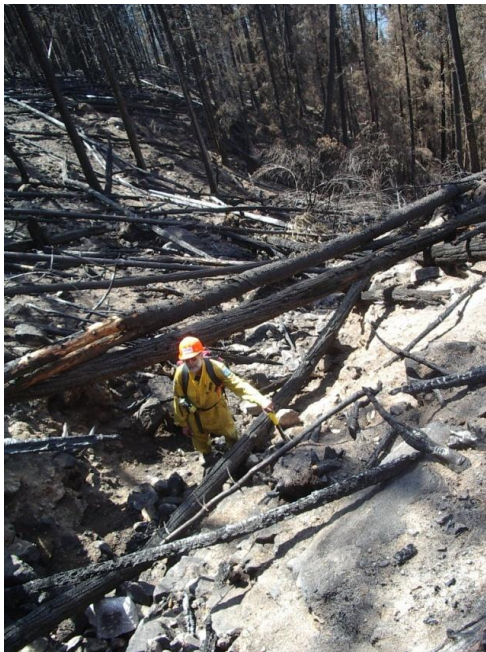
The channels of the Van Tuyl creeks were inspected down to the 1500m (see Photos 12 and 13) elevation and they were found to contain available volume of colluvium and alluvium that could be supplied in the event of a debris flow (0.5m^3 to 2m^3 per linear meter at the upper reaches, likely higher lower down). Possible debris flow events in the Van Tuyl creeks could range from 5000m^3 to $15,000\text{m}^3$. North Van Tuyl consists of 4 steep gullies (slopes 70% to 90%) that merge at about the 1400m elevation. Middle Van Tuyl is a 4m wide by 1m deep shallow gully at the 1500m elevation with a coarse sand channel infill. South Van Tuyl is comprised of 6 gullies at the 1500m elevation that merge downslope.

Photo 12 North Van Tuyl Creek

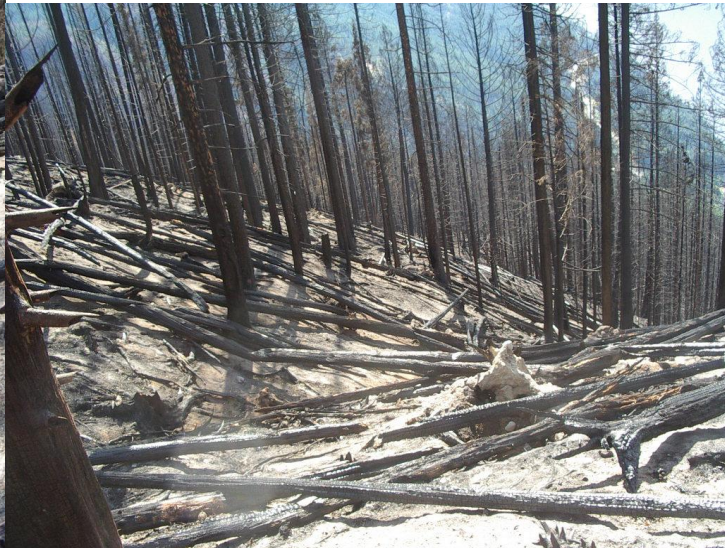
Photo 13 Burned gully at headwaters of Middle Van Tuyl

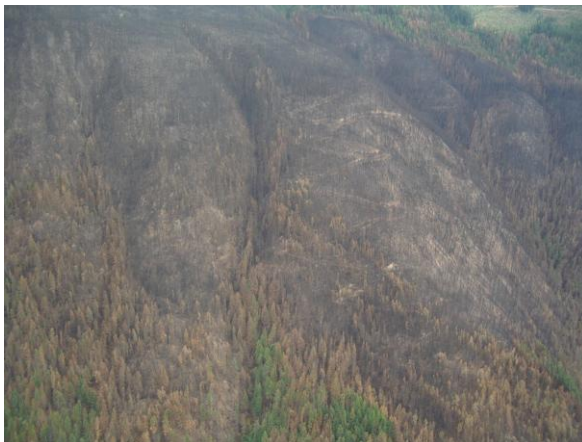
The largest gully is located at the southern side of the South Van Tuyl watershed and is a v-shaped 10m deep draw with sidewall slopes of 65% to 70% (see Photos 14 and 15). Soil in the South Van Tuyl drainage is very sandy and saprolitic. Soil depth to bedrock is deeper than the North Van Tuyl area.

Photo 14 South Van Tuyl Burn

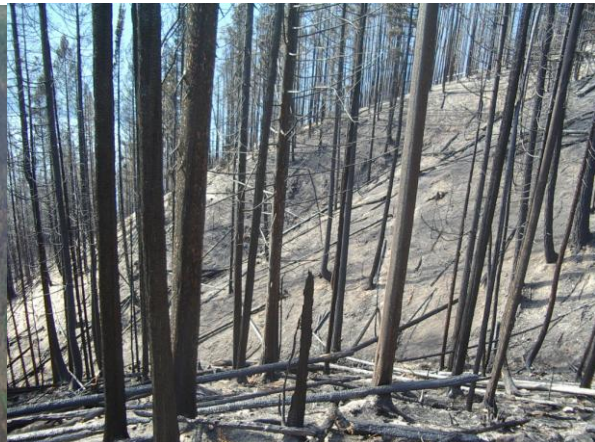
Photo 15 South Van Tuyl Creek Gully

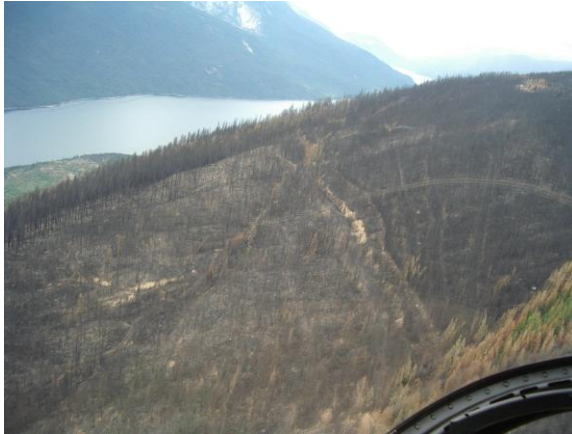
Several old roads and trails crisscross the Van Tuyl watershed from 1800m to 1500m (see Photo 16). Most of these trails and roads have been cross ditched and/or outsloped (see Photo 17).

Photo 16 Old road and trail network
Van Tuyl Creek Drainage

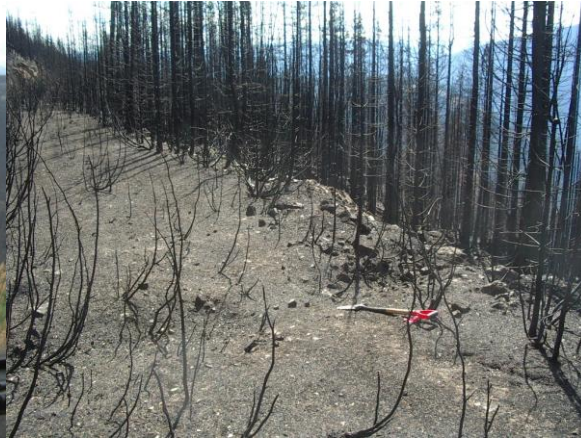
Photo 17 Cross ditch in old road in North Van
Tuyl Creek Drainage

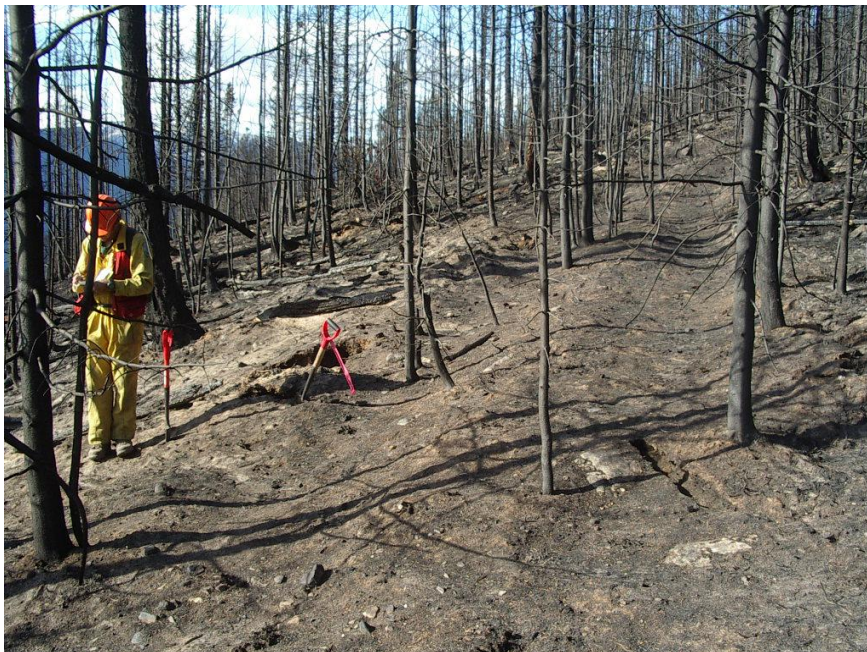
A trail observed at the South Van Tuyl drainage boundary with Memphis Creek was deeply rutted with no observed cross ditching (see Photo 18). Post wildfire surface erosion was observed where water was collected by this trail and directed downslope.

Photo 18 Old rutted trail causing post wildfire erosion

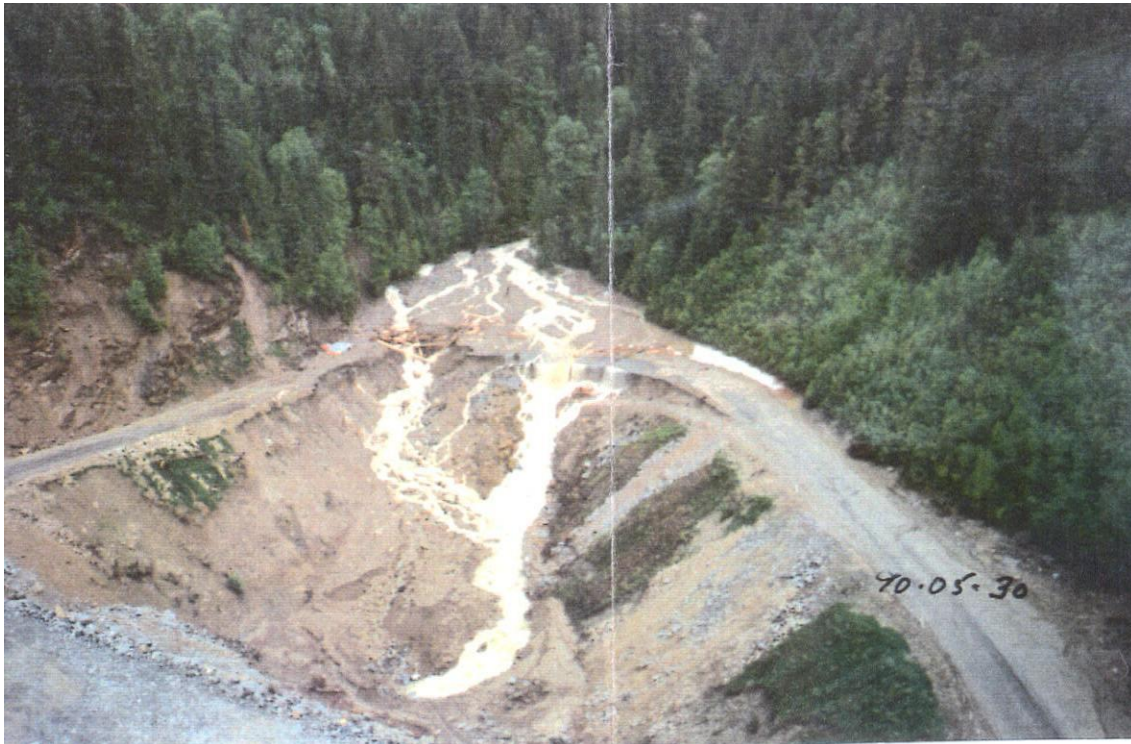
On May 30th, 1990 a debris flow occurred in South Memphis Creek. The debris flow initiated at a slope break at the 1250m elevation and scoured much of the channel to bedrock. Debris deposition initiated at the 760m elevation above the old highway location (the existing highway was under construction when the debris flow occurred – see Photo 19). Slide volume was

estimated at between 12,500 m³ and 15,000 m³ (Vandine 1990). Culverts in the new highway were partially plugged and an excavator on site was able to remove debris from the culverts in order to allow stream flow resumption. In 1990 it was concluded that the effective drainage area of South Memphis was augmented by 41% due to forestry roads.

Photo 19 Old Highway 6 location after Memphis Creek 1990 Slide

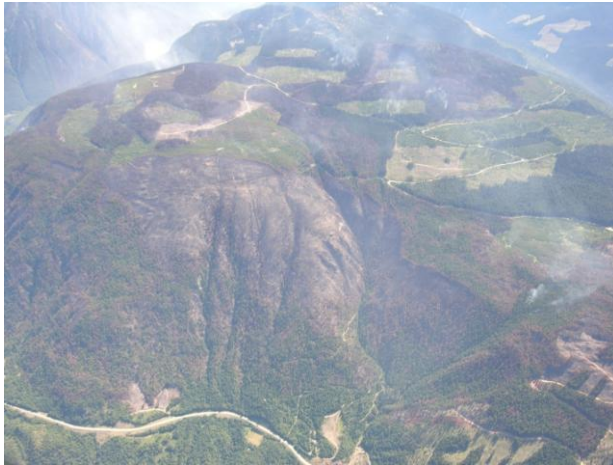
The mapped vegetation burn severities (combined moderate and high) are 29% for South Memphis and 52% for main Memphis (see Photo 20). Some areas of high vegetation burn severity areas in Main Memphis were correlated with high soil burn severity and the presence of water-repellent soils. Soil burn severity was not confirmed in South Memphis. In addition, some areas of moderate and low burn severity in Main Memphis also have high soil burn severity and water-repellency, although natural mulching from needle fall is expected to partially offset the risk of overland flow from these areas.

Photo 20 Burned Areas of the Van Tuyl and Memphis Creek Watersheds

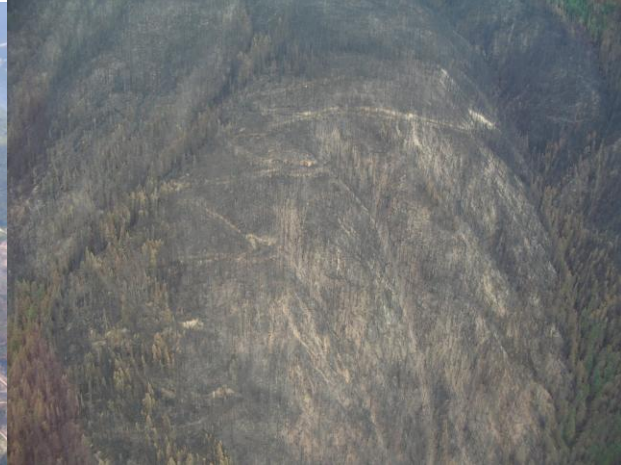
Several active roads, old roads and trails cross the Memphis Creek Watershed. An old mining road with a history of landslides climbs the drainage divide between Memphis Creek and South

Van Tuyl Creek (see Photo 21) and an old road crosses the three tributaries of Main Memphis at about the 1500m elevation. Both of these roads have been deactivated. An active road passes through both the South Memphis watershed and main Memphis Watershed (culverted with no cross ditches).

Photo 21 Old mining road on ridge between Memphis and Van Tuyl Creek

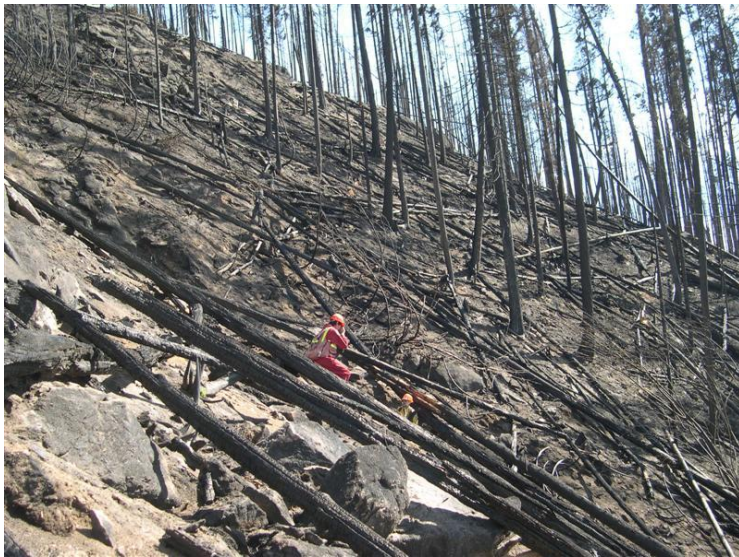
The remaining burnt or severely damaged standing timber will likely fall to the ground as a result of decay and blowing winds. The loss of the forest canopy has a direct influence on the formation of avalanches via increased snow depths on the ground, increased wind effect in open areas, and increased solar radiation effect on the snowpack.

Photo 22 Area of potential snow avalanche (Van Tuyl Creek)
