BC Ministry of Forests, Lands, and Natural Resource Operations
and Rural Development

POST-WILDFIRE NATURAL HAZARDS RISK ANALYSIS
TROZZO FIRE (N51705)

February 4, 2022

Report Number: 21.510.01.04.01

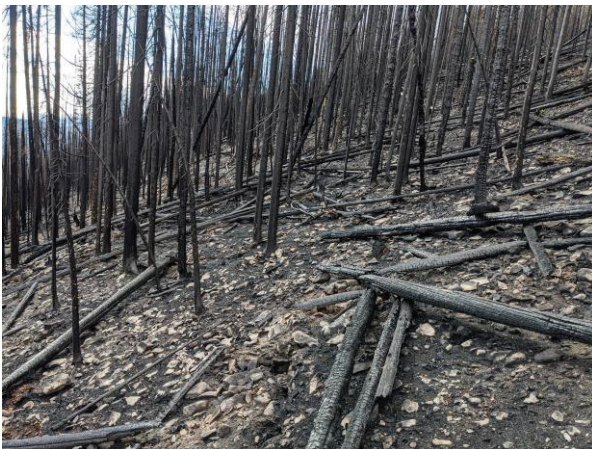
Photos 5 through 11 show examples of high burn severity sites. Some landslides have already occurred post wildfire as showed on Photos 9 through 11.

Photo 5. Example of high burn severity area

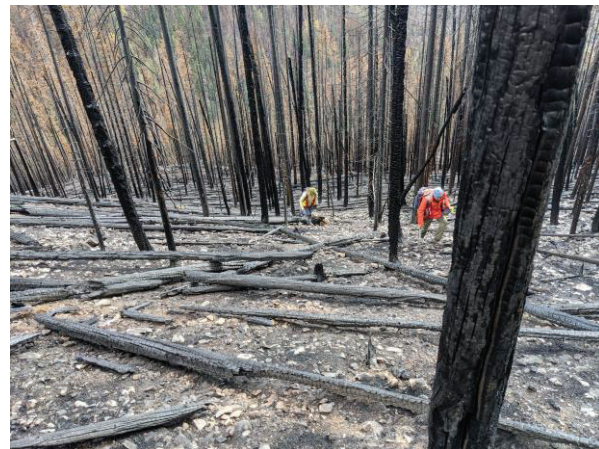
Photo 6. Example of high burn severity area

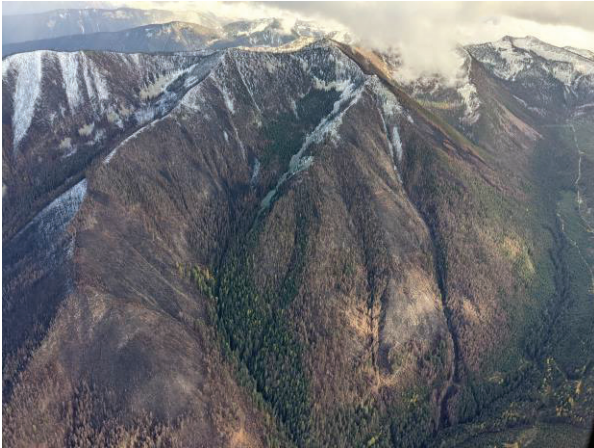
Photo 7. High Burn severity polygons - tributary to South Lemon

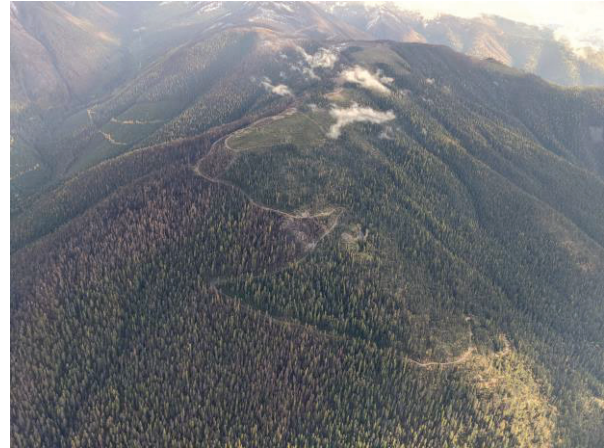
Photo 8. Representative of burned area divide (left side draining to South Lemon Creek: right side draining to Highway 6 face units)

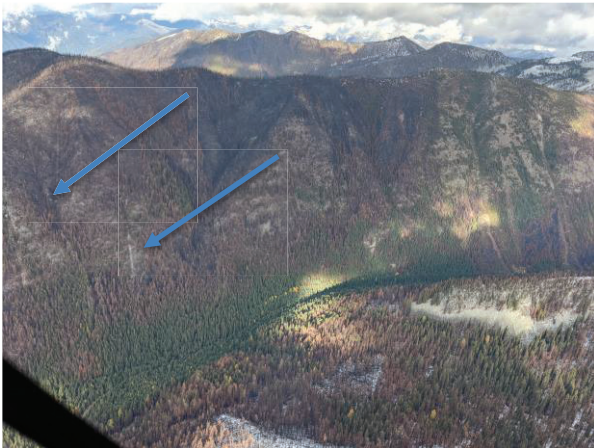
Photo 9. High and moderate burn in Trozzo Drainage - 2 recent landslides noted believed to have occurred in August - Drainages T4 (burned 95% combined Moderate and High) and face unit between T4 and T5 (100% moderate).

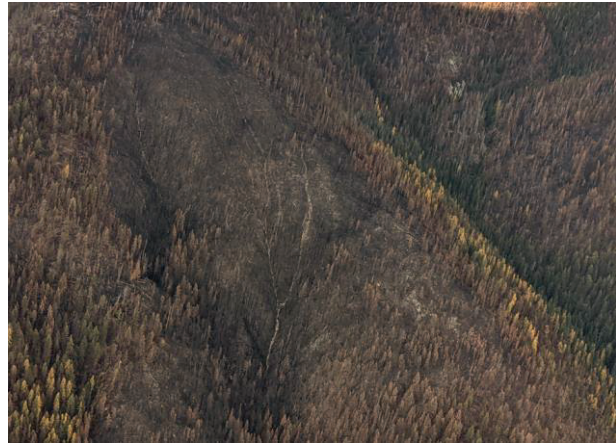
Photo 10. Recent landslides originating in a high burn area of Drainage W1 of Winlaw Creek with a 74% Moderate and High Burn Severity

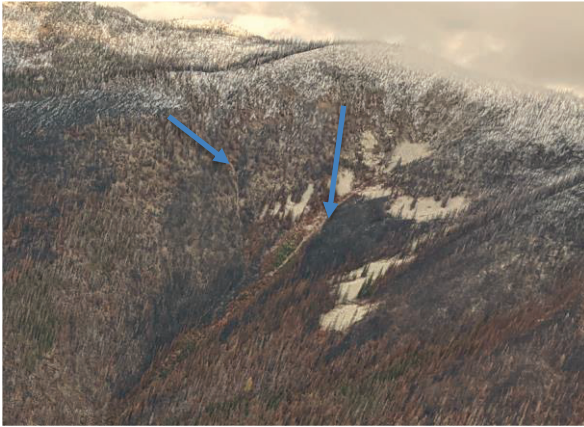
Photo 11. Landslides (date unknown) in upper Winlaw Creek drainage.
