Development Permit Application

Referral Form – RDCK File DP2313E

7642 Highway 3A, Balfour, BC
Riparian Assessment

Mitigation Plan

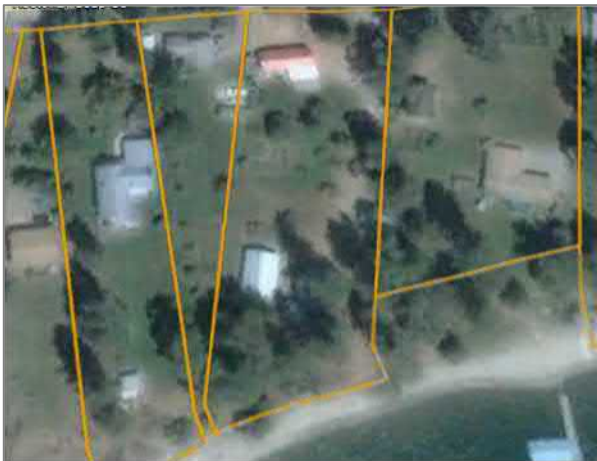
Photo 1. Aerial image of subject property in 2009 (Google Earth 2023).

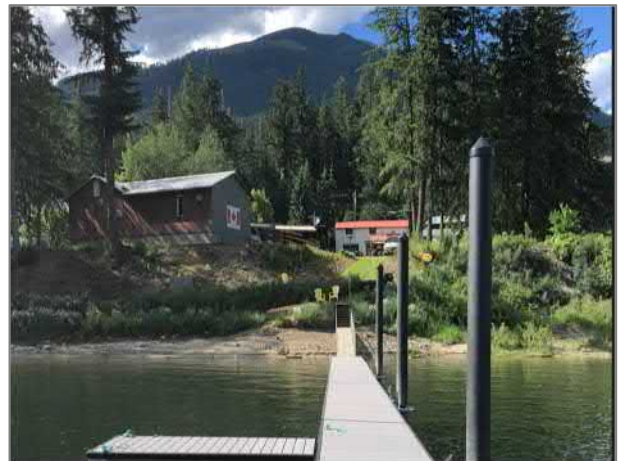
Photo 2. View of area on subject property in 2022 prior to most recent development activities (Photo credit Norm Cross).

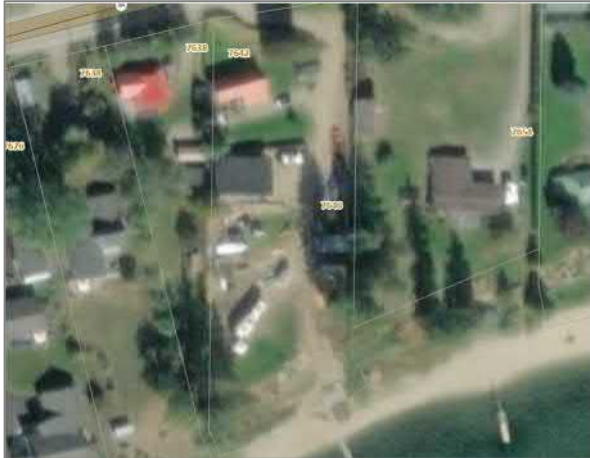
Photo 3. Aerial image of subject property 2023 (RDCK 2023).

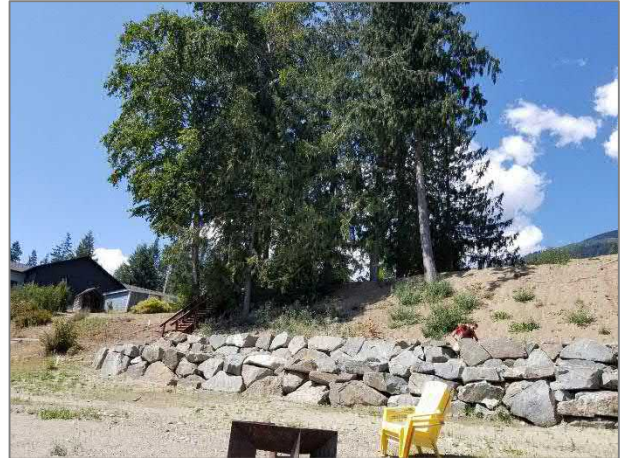
Photo 4. View of the recent landscaping works and riparian vegetation retained, looking north (July 27, 2023).

The area of ground disturbance within the WDP area was estimated to be ~420 m². It is unknown exactly how much riparian vegetation was removed; however, one mature Interior Douglas Fir tree (890 mm dbh) was removed at the south-east corner.

In order to help mitigate for the degradation and loss of riparian habitat both prior to re-development and post development, ~453 m² will be restored by replanting a mixture of native riparian plant species.

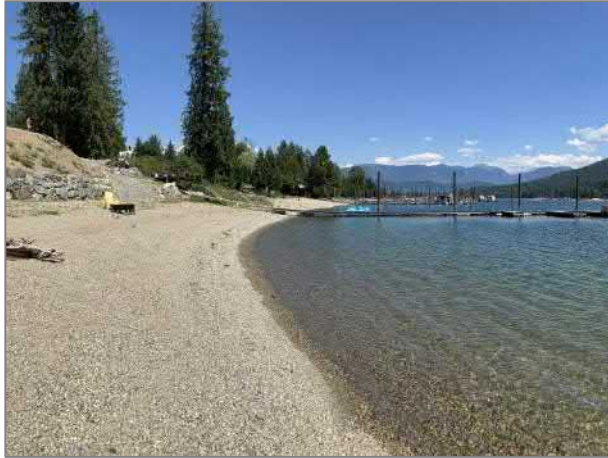
The visible natural boundary of Kootenay Lake was observed to be approximately along the southern property line (Parcelmap BC 2023). The natural boundary is commonly referred to as the "high water mark" around a lake or wetland. Based on the definition of high water mark¹, the property boundary shown on the SPEA map (Appendix 2) will be used to delineate the 15 m RDCK WDP area and streamside protection and enhancement area (SPEA) setbacks in accordance with the Riparian Area Protection Regulation (RAPR).

Photo 5. View of foreshore, looking east. July 27, 2023.

- Avoid any modifications to the beach substrate and preserve the remaining foreshore vegetation.
- Ensure that any power equipment used is well-maintained and leak free.

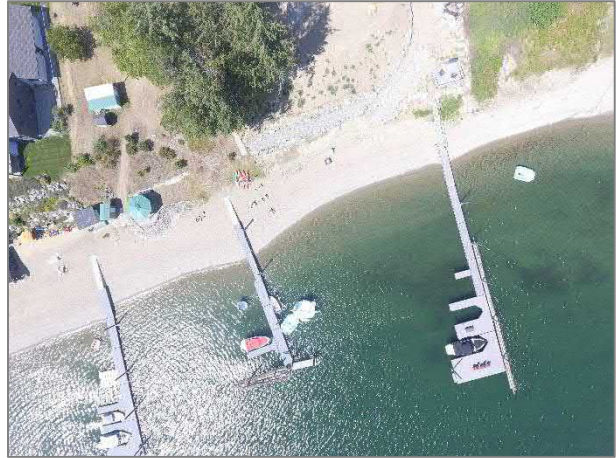
Photo 6. Aerial view of the foreshore of property. July 27, 2023.

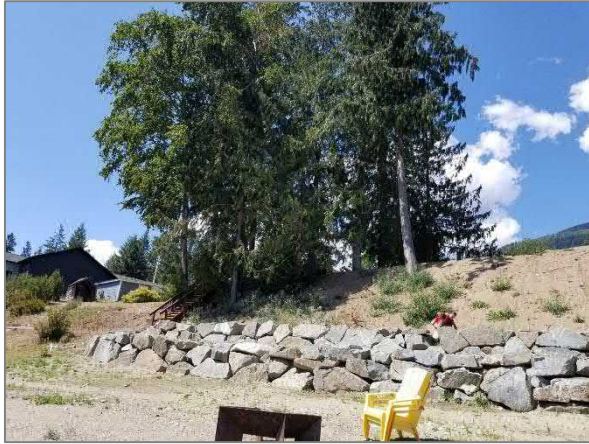
Photo 7. Western redcedar clump southwest of the property (top of bank). July 27, 2023.

The riparian vegetation is sparse with minimal tree and shrub cover. There is a clump of mature western red cedars (*Thuja plicata*; Photo 7), on the west end of the bank and a few mature western red cedar and paper birch (*Betula papyrifera*) on the east end of the bank. A few sparse shrub species are present including saskatoon (*Amelanchier alnifolia*) and snowberry (*Symphoricarpos albus*).

In addition, the Owners would like to remove one potential hazard tree which is leaning (western red cedar 470 mm dbh) located along the top of bank within falling distance of the house. Refer to Appendix 3 showing recent development located within the riparian area.

A Douglas-fir (*Pseudotsuga menziesii*) was removed from the subject property as it was leaning over the deck structure and was considered a hazard (per. comm Norm Cross 2023) and a leaning western red cedar is proposed for removal along the top of bank as it is in falling distance of the new home. Further

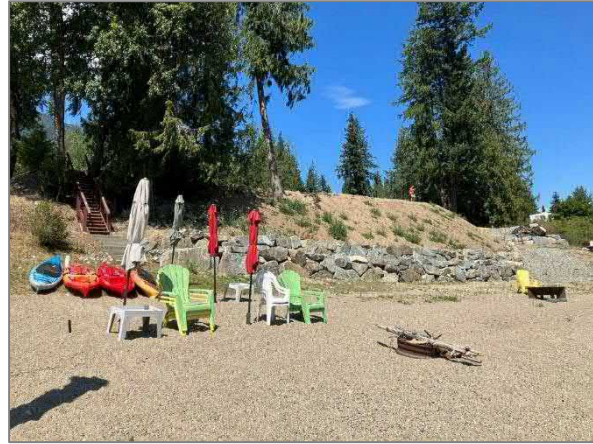
Photo 8. View of tree and low herb cover within the riparian area looking northeast. July 27, 2023.

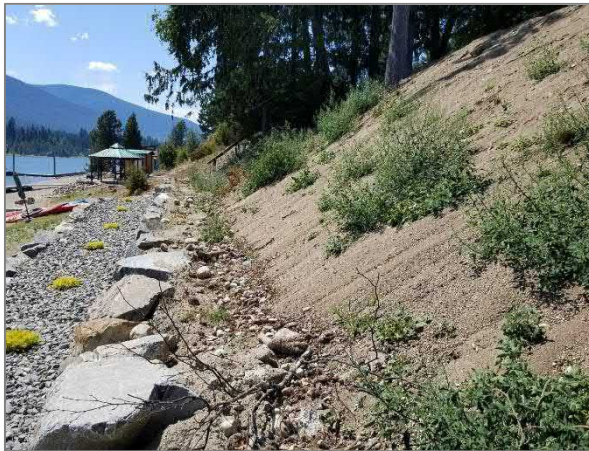
Photo 9. Low herb cover on the bank, looking west. July 27, 2023.

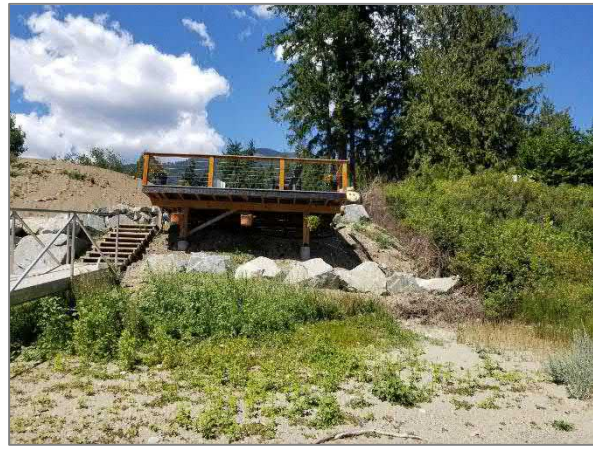
Photo 10. Riparian vegetation and weeds on east end of bank above and below the HWM. July 27, 2023.

It is recommended that hoary alyssum (Priority Level 3 species by CKISS (2023)) be managed within the SPEA in order to help contain and reduce its further establishment and proliferation. Management procedures for hoary alyssum is provided in Appendix 5.

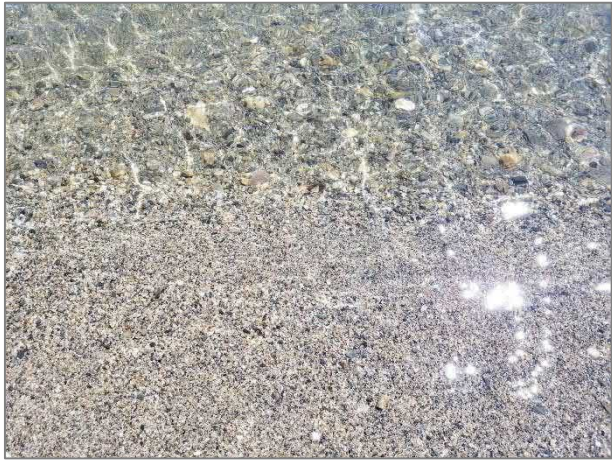
Photo 11. View of shallow water habitat with sand and gravel substrate.

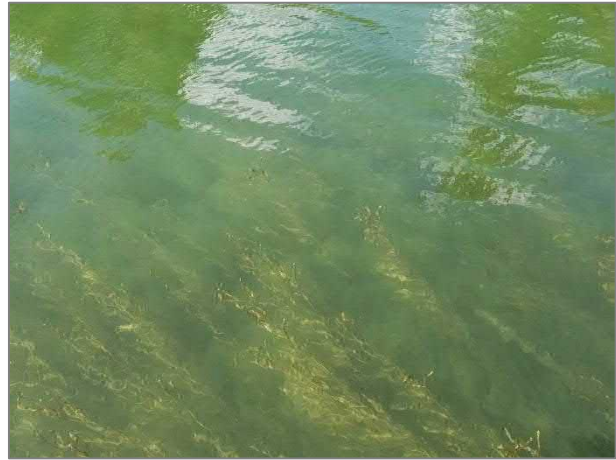
Photo 12. View of submergent vegetation. July 27, 2023.

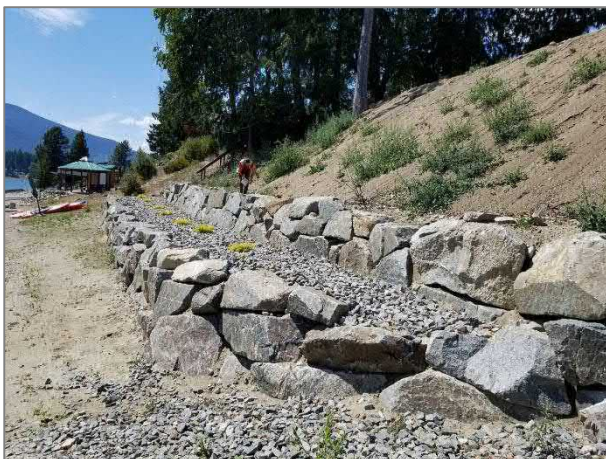
Photo 13. Tiered rock retaining wall. July 27, 2023.

The unauthorized landscaping and elevated deck and stairway development have caused a total of ~470 m² of disturbance to the riparian area. Within that, there is an estimated habitat loss of ~70 m² caused by the placement of retaining walls, stairway and elevated deck structure.

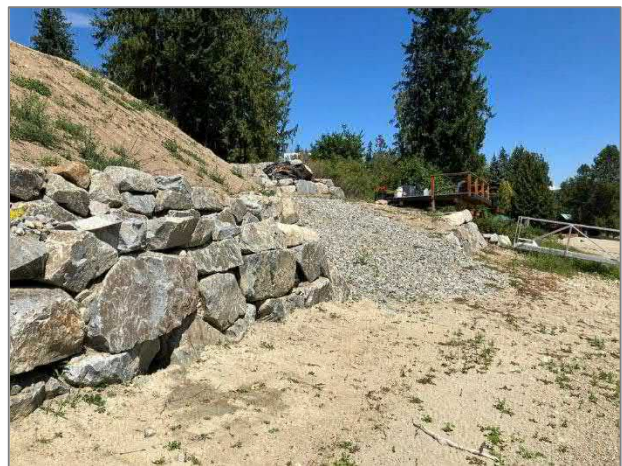
Photo 14. Crushed gravel access road. July 27, 2023

- Groundwater and surface water will be conveyed around any area where disturbed/exposed soils may occur.
- Pervious materials (e.g., gravel) are recommended for driveways, parking areas, and pathways. This minimizes stormwater runoff from impervious materials (e.g., asphalt and concrete), which must be managed using natural hydrologic pathways. Storm water will not be permitted to discharge directly into Kootenay Lake.
- Design roof rainwater collection systems that direct rainwater into suitable landscape features which can absorb and utilize runoff. Roof runoff will not be permitted to discharge directly into Kootenay Lake.
- Stormwater discharges must adhere to the Water Sustainability Act or any other applicable legislation.

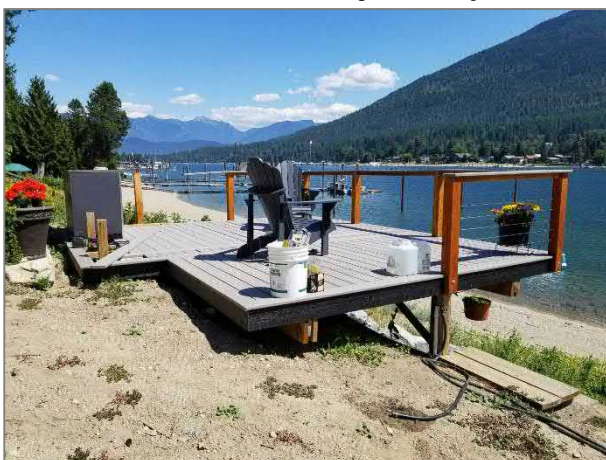
Photo 15. Elevated deck, looking southeast. July 27, 2023.

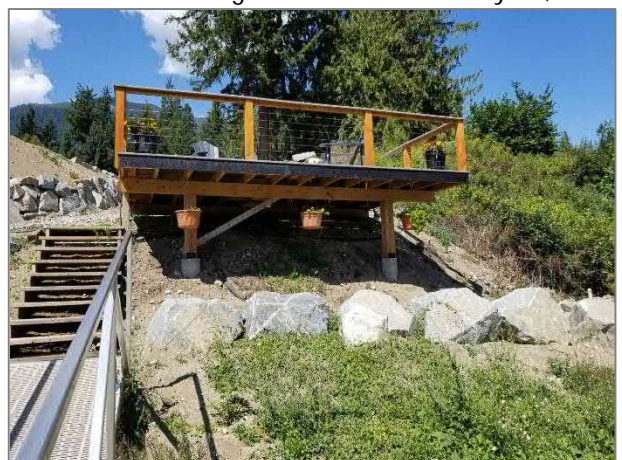
Photo 16. Elevated deck and staircase, looking north. July 27, 2023.

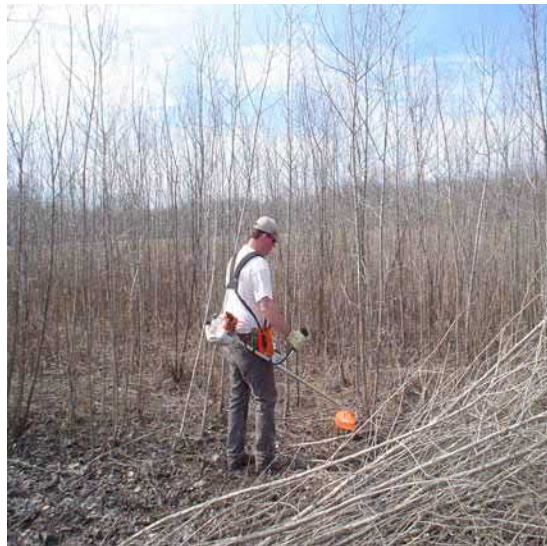
Once cutting size, source location is determined — and landowner permission obtained — the actual cutting process can begin. Lopping shears, pruning shears, a small wood saw, brush cutters, or a chain saw are appropriate tools for harvesting cuttings. Desired cutting size will determine the appropriate tool(s).

- Make clean cuts. Ensure all equipment is sharp.
- Use live wood at least 1 year old or older. Do not use very old or dry wood.
- Larger wood is difficult to root. The best wood is 2-5 years old with smooth bark which is not deeply furrowed.

- Avoid current year's growth. It lacks the stored energy reserves necessary to consistently sprout when planted.
- When harvesting from native stands, make sure the stand will not be denuded or destroyed by your cutting activity, most willow species will sprout and grow from base of harvested plant.

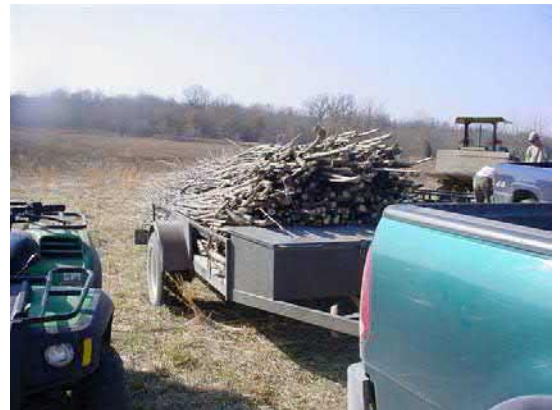
During harvesting, transportation, and storage, willow bundles should be kept moist and protected from sunlight and wind by covering or wrapping the bundles with wet burlap or a reflective moisture barrier to protect cuttings from becoming desiccated.

To minimize storage time, harvest cuttings in early spring within two to three weeks of the planned planting date. If this is not possible, cuttings can be harvested in late fall or winter and stored in a large cooler at 34-38°F until immediately prior to planting. Cuttings can be stored for several months in this manner. If cuttings are kept in a cooler, root cellar, garage, or shop floor, make sure the storage area is dark, moist, and cool at all times. Maintain a storage temperature slightly above freezing. Cuttings may be wrapped in a black tarp or plastic to be kept dark, if stored in an out building. Cuttings should be checked periodically for signs of frost damage and/or to insure that mold is not forming.

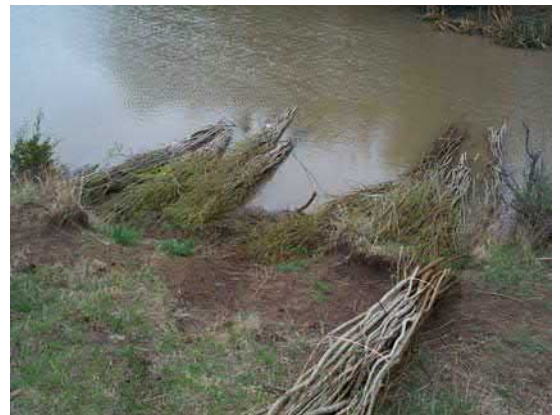
Soaking plant material, prior to planting, significantly increases the survival rate. Prior to planting, all cuttings should be soaked for a minimum of 36 hours, regardless whether they are stored or harvested for immediate planting. Research shows that soaking the cuttings for 7 to 10 days can double the survival rate. Cuttings should be removed from water prior to root emergence from the bark. This normally takes 7 to 10 days. Soaking initiates the root growth processes within the inner layer of bark in willows and cottonwoods.

Only the bottom 1/3 of the cuttings needs to be soaked. However, soaking the entire cutting is not detrimental. Soaking can be accomplished in any container that will hold enough water to the required depth. Cuttings can also be soaked in streams, ponds, lakes, or other bodies of water. Avoid soaking cuttings in areas that are susceptible to flooding or where beavers are present.

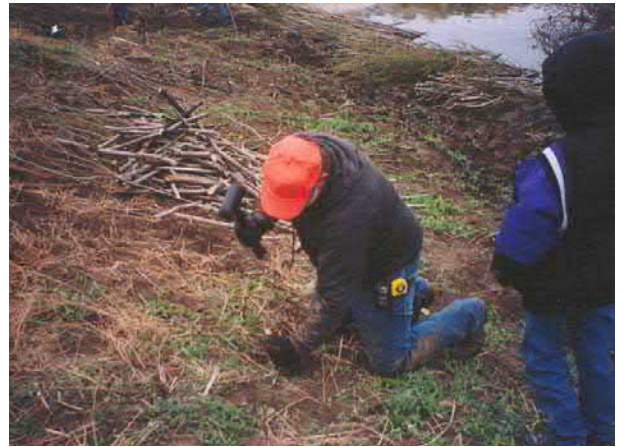
- If the hole dug is larger than the cutting, additional soil will be required to form a good soil to stem contact. Preference should be given to local topsoil to encourage mycorrhizal formation and/or nodule formation by nitrogen-fixing organisms. Do not backfill with clay.

- Carefully tamp the soil around the cutting firmly several times as you fill any drilled or augered hole.
- “Water In” the back-filled soil around large cutting holes to settle soil and provide good soil to cutting contact.

Cuttings shall have at least two leaf nodes, or bud scars, above the ground as illustrated on page 6. Cutting length is largely determined by the depth to the mid-summer vadose zone, or the area of moist soil at the lower bank. For ease of handling and transportation, cuttings should be harvested and stored at full length and then cut into shorter lengths prior to planting. Plantings should be placed on the lower portion of the streambank slope. Cuttings shall be long enough so the stem base reaches into the vadose zone. This zone extends slightly above the water surface elevation in most situations (See illustration on page 6).
