# Development Permit Application

Referral Form – RDCK File DP2317E

2309 Bealby Road, Rural Nelson, BC  
Riparian Assessment

2309 Bealby Road, Rural Nelson, BC  
Mitigation Plan

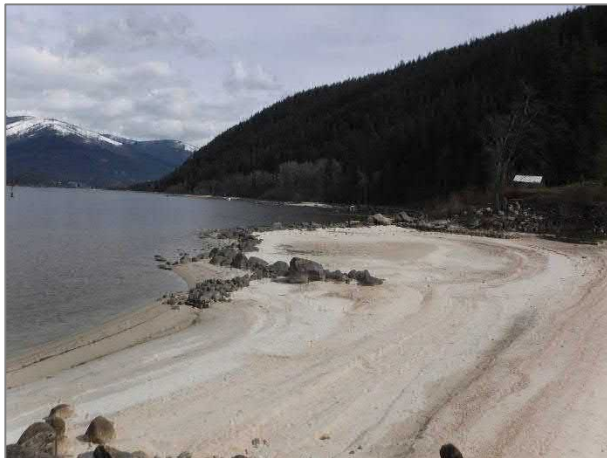
The foreshore of the property is a sloped beach (1-2 % gradient) with substrate consisting mostly of coarse sand with round boulders, cobbles, gravels, and the occasional large woody debris (LWD) (Photo 1 and Photo 2)

Photo 1. Kootenay Lake foreshore, southern portion of property at low water.

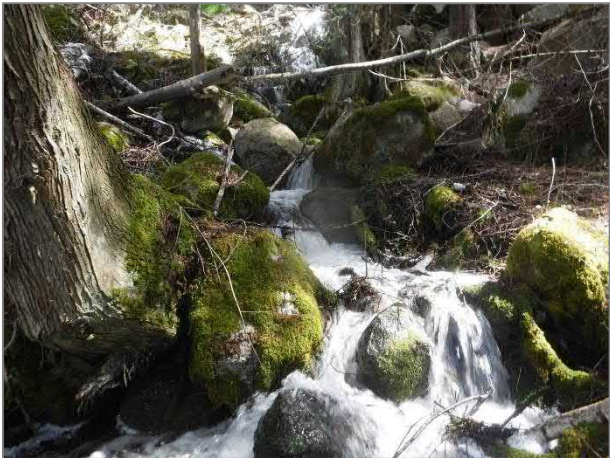
Bose Creek (WSC 300-625474-058307) is a 1st order stream with a mapped length of ~1.7 km. It originates on the eastern slopes of the West Arm of Kootenay Lake within the Svoboda Road community and flows northwest into the lake at the northern corner of the subject property (Appendix 2). The stream has a distinct channel within its lower reach (above and below the CP Railway), has an average stream width of 3.5 m, and flows year-round (Photo 3). Bose Creek was assessed up to 100 meters from its mouth. Stream morphology was step-pool (~20 % gradient) with predominantly boulder substrate. The lower reach of the stream was disturbed by the construction of the CP Rail Line; however, intact riparian areas had dense forest cover with overhanging vegetation and instream woody debris. A 600 mm mortared stone culvert conveys water under the CP Railway (Photo 4).

Photo 3. Bose Creek upstream of the CP Railway.

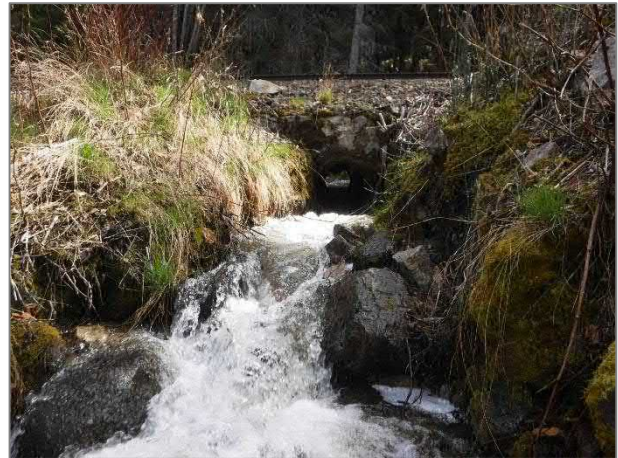
Photo 4. Bose Creek culvert under railway.

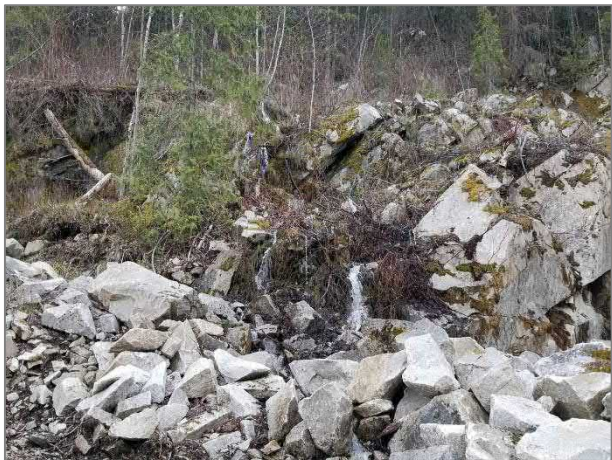
The unnamed stream flows in a poorly defined channel from the upper portion of the property, across exposed bedrock, and through the rock quarry (Photo 5). It then flows through a small double culvert under upper Bealby Road and into a defined ditch between Bealby Road and the CP Rail line. A series of two culverts (700 mm and 400 mm) convey the water under the railway and under lower Bealby Road. This water discharges onto the MoTI RoW where a pond was recently constructed (Refer to Section 2.2). Downstream of the pond, the stream flows through the subject property (Photo 6) and the neighbouring properties to the southeast in a defined, but modified channel, eventually discharging into Kootenay Lake approximately 50 m southwest of the property. Flows were observed in the stream channel downstream of lower Bealby Road on Aug 16, 2023; however, no flow was observed upstream of the channel during this time.

Photo 5. Unnamed stream flowing through quarry.

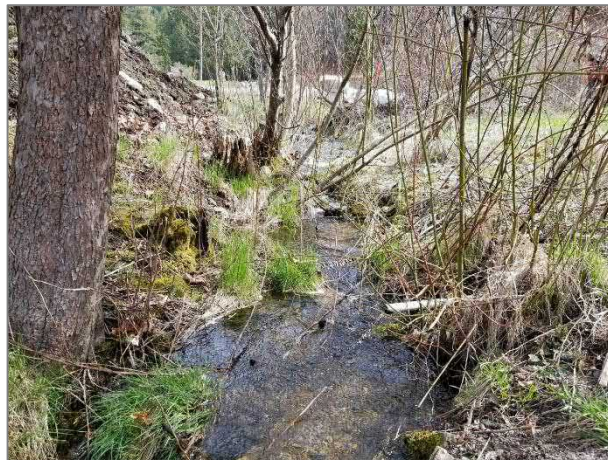
Photo 6. Unnamed stream flowing between Bealby Road and the CP Railway.

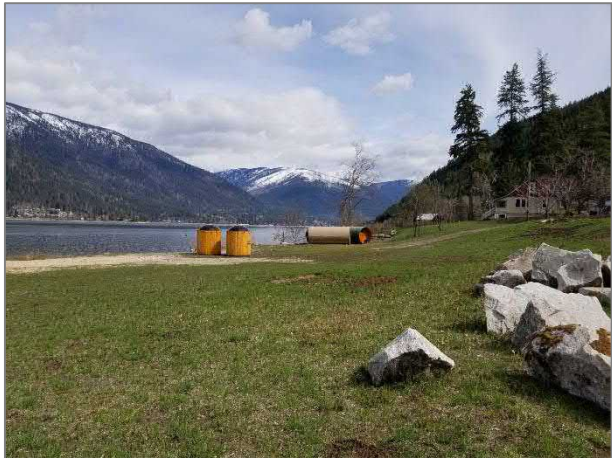
The riparian areas within the subject property have experienced significant disturbance due to development, resulting in large areas of lawn, open rocky areas, and sparse tree and shrub cover (Photo 7 and Photo 8). The northern portion of the property along Kootenay Lake and Bose Creek supports more intact and diverse riparian vegetation with native species including: alder (*Alnus* sp), black cottonwood, Douglas fir, elderberry (*Sambucus* sp.), red osier dogwood (*Cornus sericea*), rose (*Rosa* sp.), raspberry (*Rubus* sp.), snowberry (*Symphoricarpos albus*), and Western redcedar (Photo 9 and Photo 10).

Photo 7. Sparse tree and shrub cover within established lawn area at south end of property.

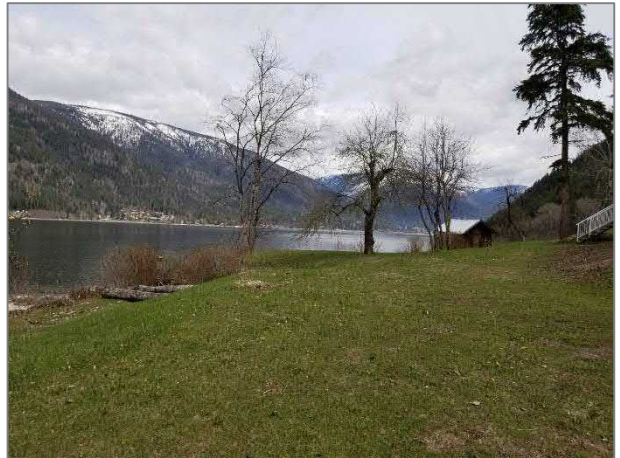
Photo 8. Sporadic trees and lawn along Kootenay lake foreshore below residence.

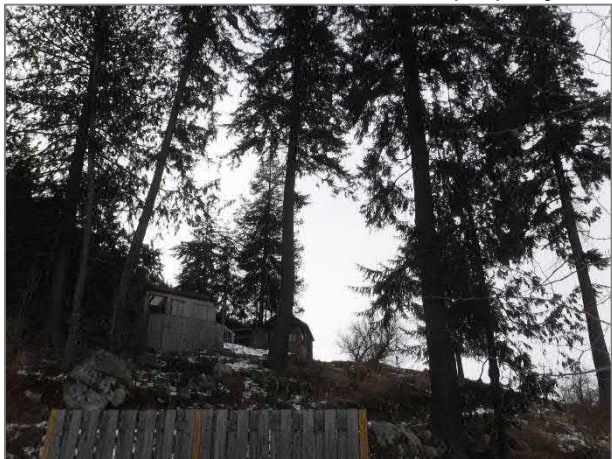
Photo 9. Young forest Kootenay at north end of property.

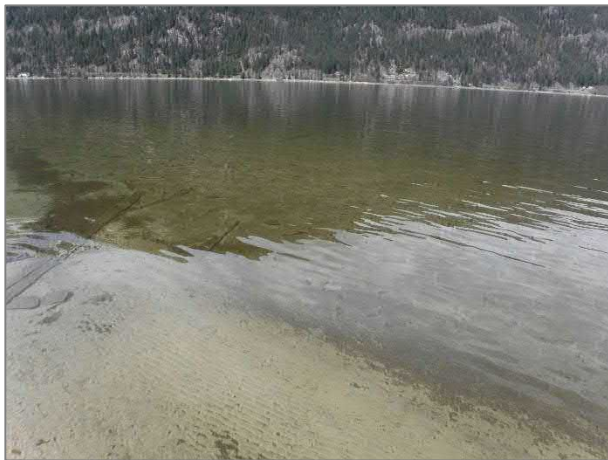
Fish habitat along this section of Kootenay Lake foreshore consists of shallow water habitat with large boulders and sporadic LWD. Shallow foreshore areas are used for rearing by smaller fishes and broadcast spawning by non-sport fish species (i.e peamouth chub (*Mylocheilus caurinus*) and northern pikeminnow (*Ptychocheilus oregonensis*); Photo 11). Boulders and LWD provide important cover habitat for fish when water levels are higher (Photo 1 and Photo 2).

Photo 11. Juvenile rearing fish habitat.

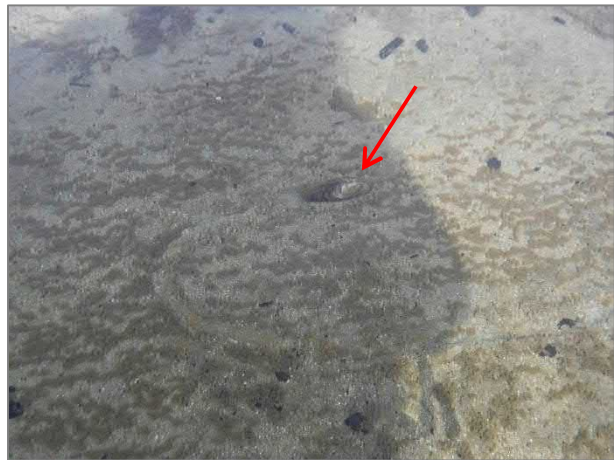
Photo 12. Freshwater mussels observed in shallow water.

Freshwater mussels (*Anodonta* sp.) were observed within the lake adjacent to the subject property (Photo 12); however, a complete mussel survey was not conducted as part of the riparian assessment as no works below the HWM are proposed.

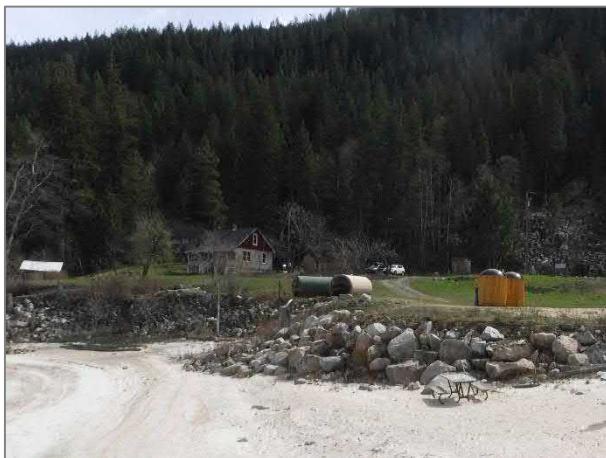
Historically this property was used as a hobby farm, seasonal campsite, and rock quarry. It supports a single family residence, a beach cabin, and numerous accessory buildings, tent platforms, and access trails to different areas of the property (Photo 19 through Photo 22). A large portion of the lower property (below Bealby Road) has been modified by development, including extensive vegetation removal, road construction, residential development, re-grading, and hardscaping (rock armouring and parking pad).

The current Owners are temporarily storing two sleeping barrels and two shower barrels ~4 m from the present natural boundary of Kootenay Lake (Photo 19); however, they do plan to reposition these accessory buildings outside the WDP area and on the south side of the main house.

Photo 19. View of subject property looking east showing existing development and rock armouring.

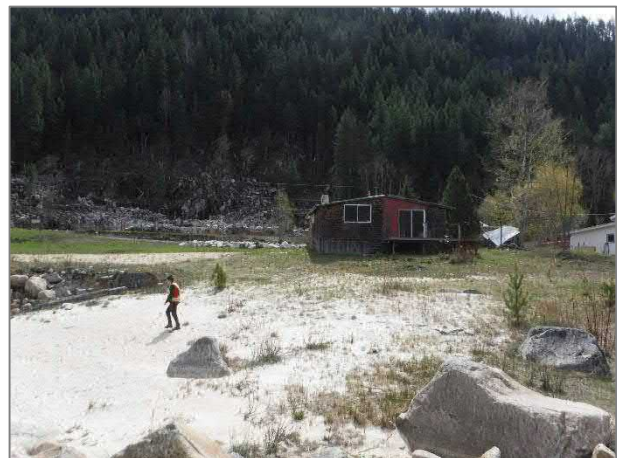
Photo 20. Beach house located along Kootenay Lake, just outside of WDP area.

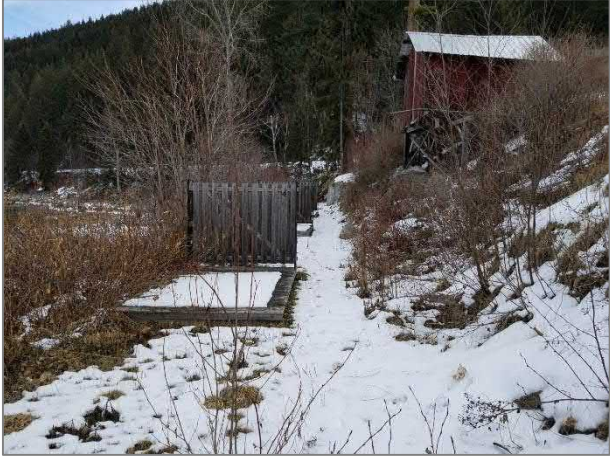
Photo 21. Tent platforms located along a constructed bench area on the foreshore of Kootenay Lake.

- Install one tent pad from natural materials in place of the six existing tent pads noted above identified on the attached site plan prepared by de Wit Designs.

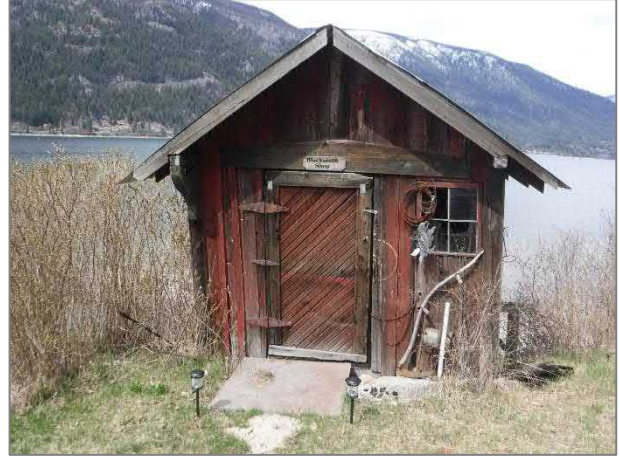
Photo 22. "Black smith shop" located along Kootenay Lake foreshore.

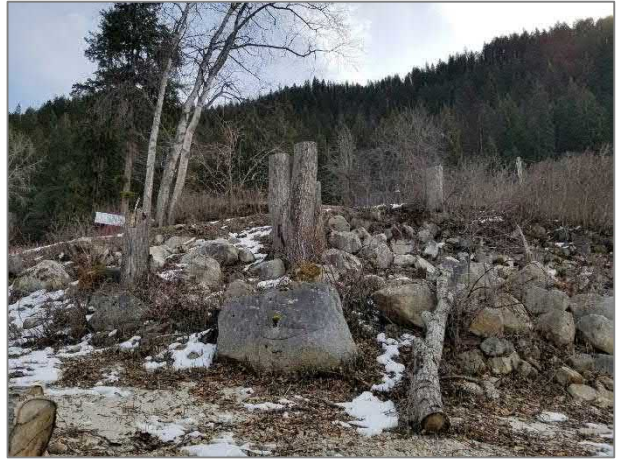
Unauthorized activities within the WDP areas completed by the current Owners include the removal of riparian vegetation along Kootenay Lake and Bose Creek including one mature standing dead fir tree (p comm. Richard Henry), seven mature black cottonwood trees (Photo 23 and Photo 24), brush cutting of native shrubs (regenerating black cottonwood, black hawthorn, lodgepole pine, and roses) and stripping of topsoil.

Photo 24. Mature black cotton wood trees removed along Kootenay Lake foreshore.

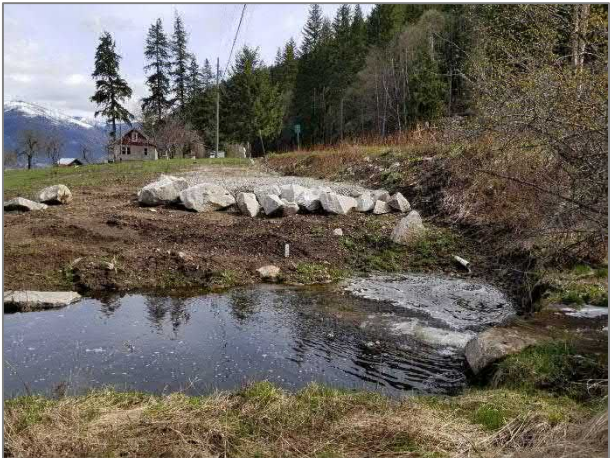
Unauthorized works completed on the unnamed stream by a hired contractor unbeknownst to the current Owners (p comm Richard Henry) was the construction of a pond located at south end of property, outside of property boundaries (Photo 25 and Photo 26). This work involved removal of riparian vegetation (assumed to be mostly shrubs), excavation of the streambed to create a pond, and placement of rock along the new pond edge. This work would have required permission by MoTI and a Section 11 Authorization through Front Counter BC.

Photo 25. Newly constructed gravel parking area and constructed pond.

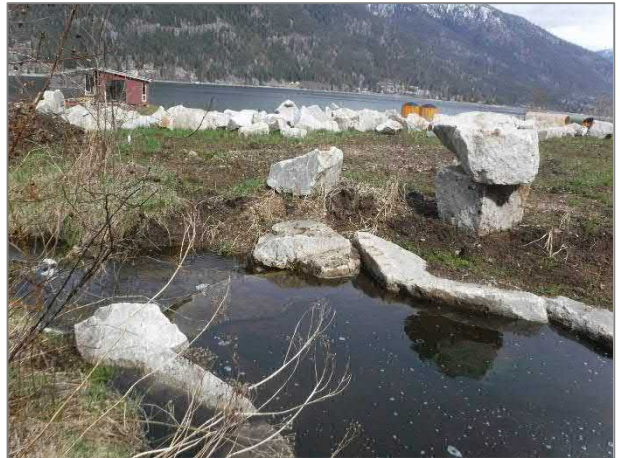
Photo 26. Newly constructed pond with rock placed along bank and instream.

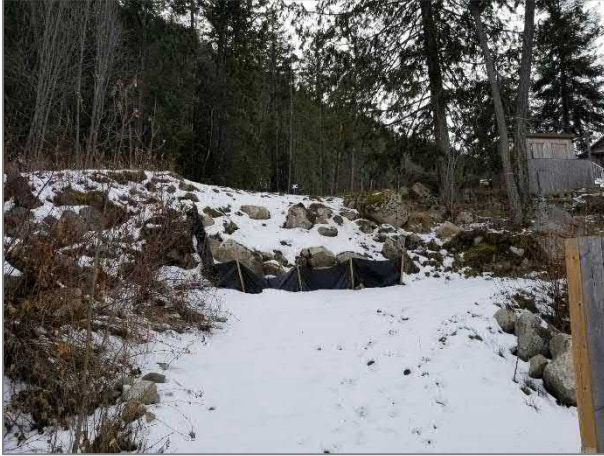
As part of the agreement of the sale of the property in 2022, an environmental assessment was completed. Recommended remediation outlined in this report was the responsibility of the Seller (p comm Richard Henry). As part of this agreement, soil remediation activities and property cleanup within the WDP area of Bose Creek was conducted. Based on the information provided in a Stage 1 PSI completed for the property (Bear 2022) and correspondence with Dave Diplock of Bear Environmental, remedial activities included removal of surface materials contaminated with cadmium, lead, and zinc adjacent to the CP railway to a depth of approximately 1 ft. Some rock was relocated during the remedial activities, and a dead birch tree and two fir trees next to Bose Creek were removed. Clean fill and topsoil were

imported to re-grade the remediated area, which was seeded and irrigated until grass cover was established (Photo 27 and Photo 28). A soil relocation agreement was filed with the RDCK for this work.

Photo 27. Remediation area beside shower house. Photo taken April 25 during initial onsite meeting.

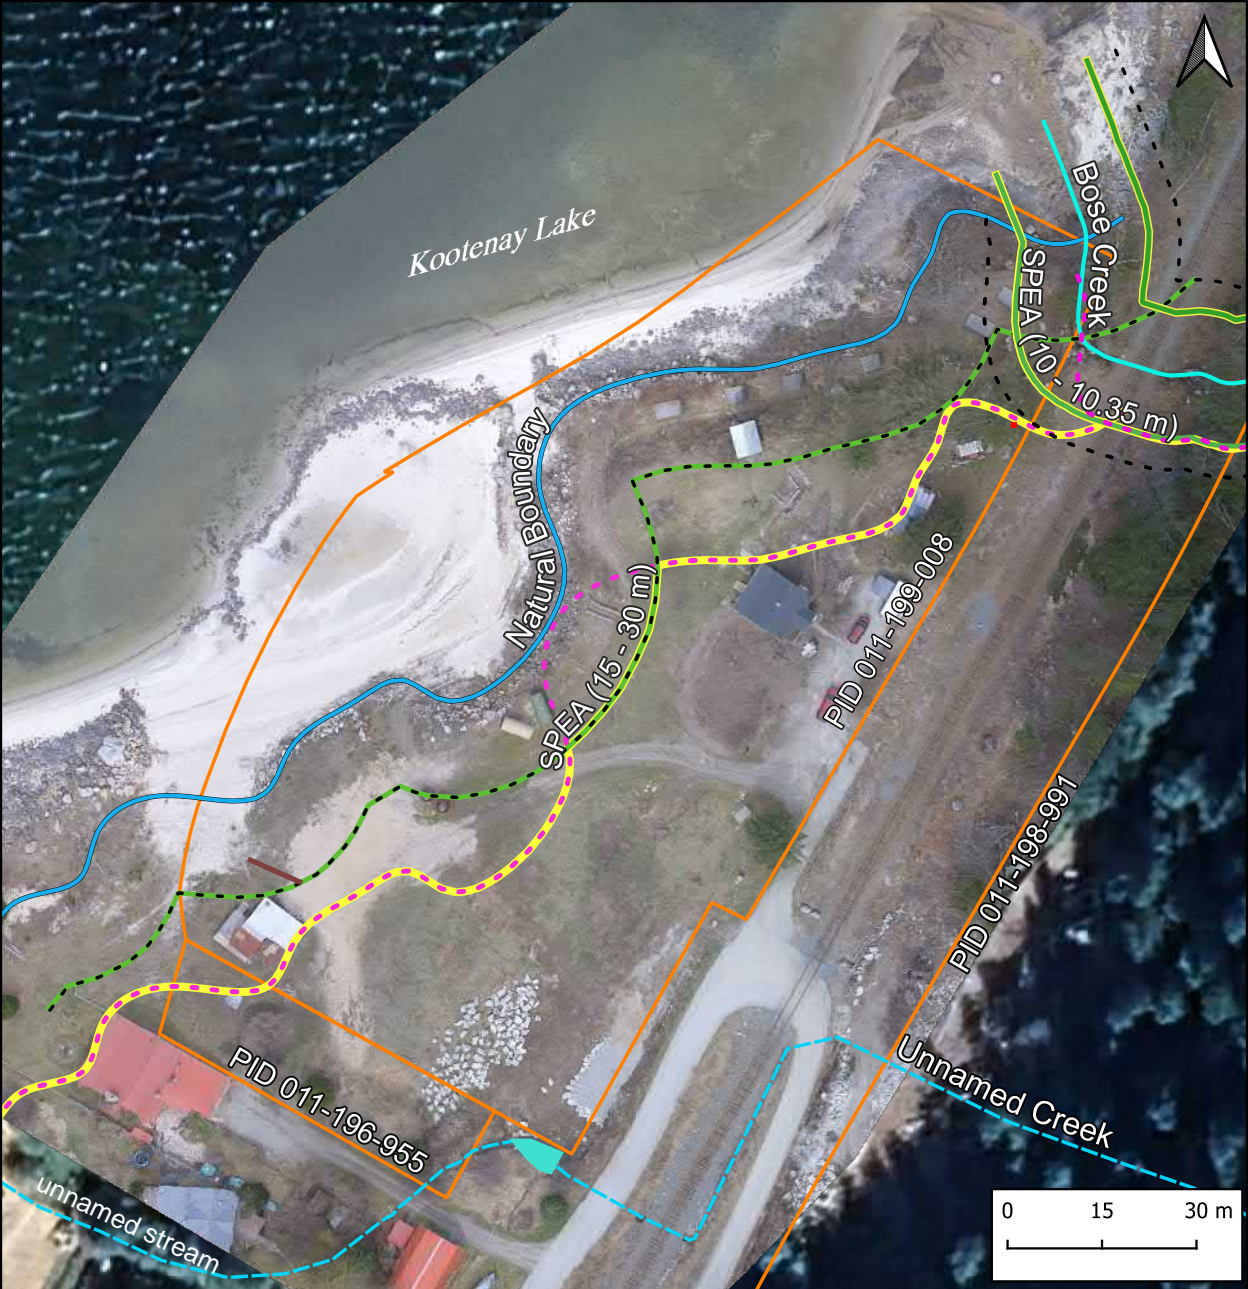
Henry Nugent Mitigation WDP | Riparian Assessment | SPEA Setbacks

Map Date: 09/26/2023  
 Projection: NAD83 UTM Zone 11  
 Project: 2309 Bealby Road  
 Map Scale: 1: 1250  
 Orthoimage Dale: April 20, 2023  
 Fortis BC Lake Level: 530.11 m

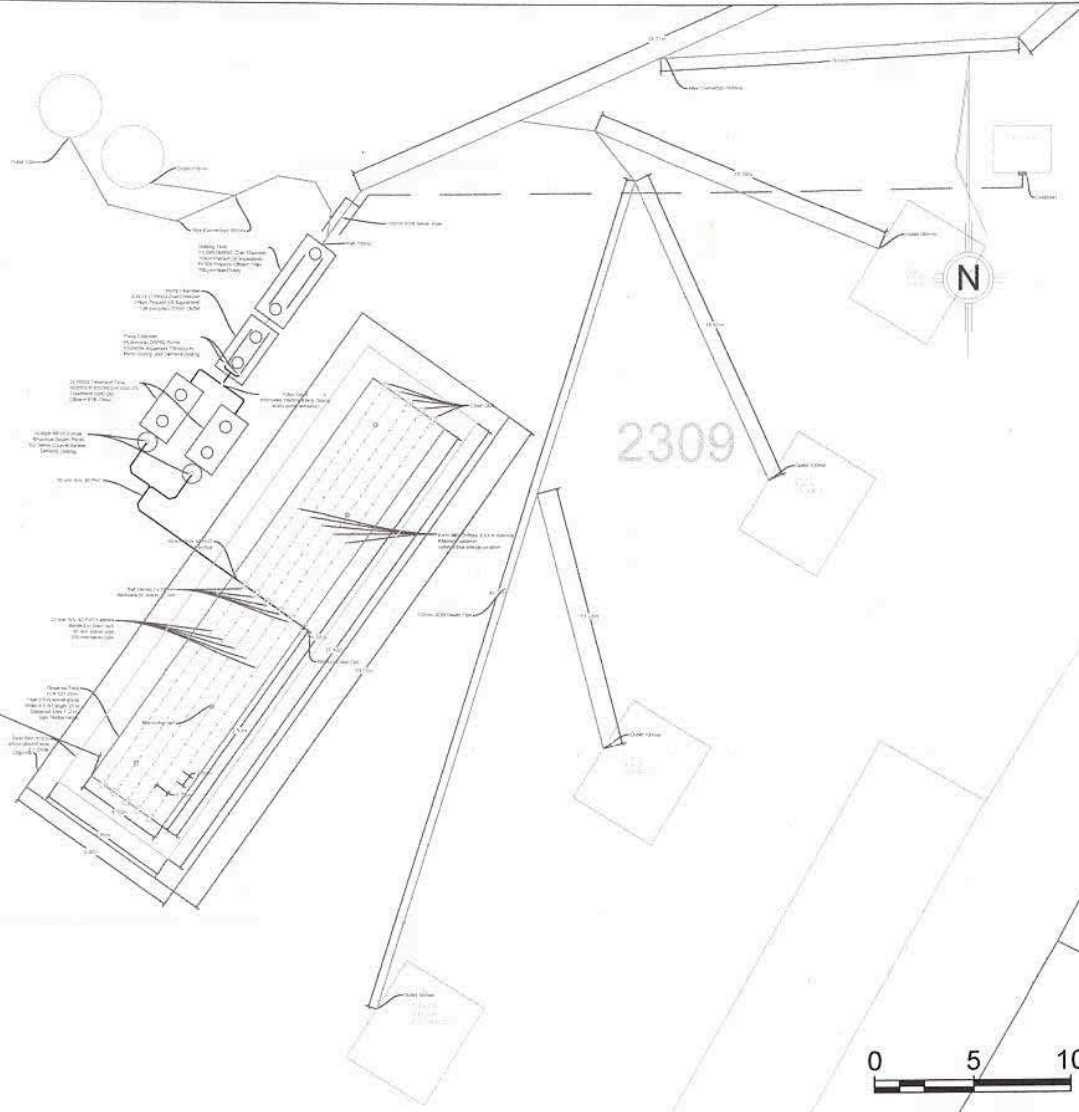
June 12, 2023  
 2023-05-WKNB-30T3SM5L  
 Scale: As-Shown (m)  
 Sheet 2 of 5  
 Detailed Design 1  
 Rev 3

1. System designed in accordance with BC Sewer System Practice Manual
2. Septic system shall be installed by authorized practitioner or under the supervision of a Professional Engineer registered with EGBC

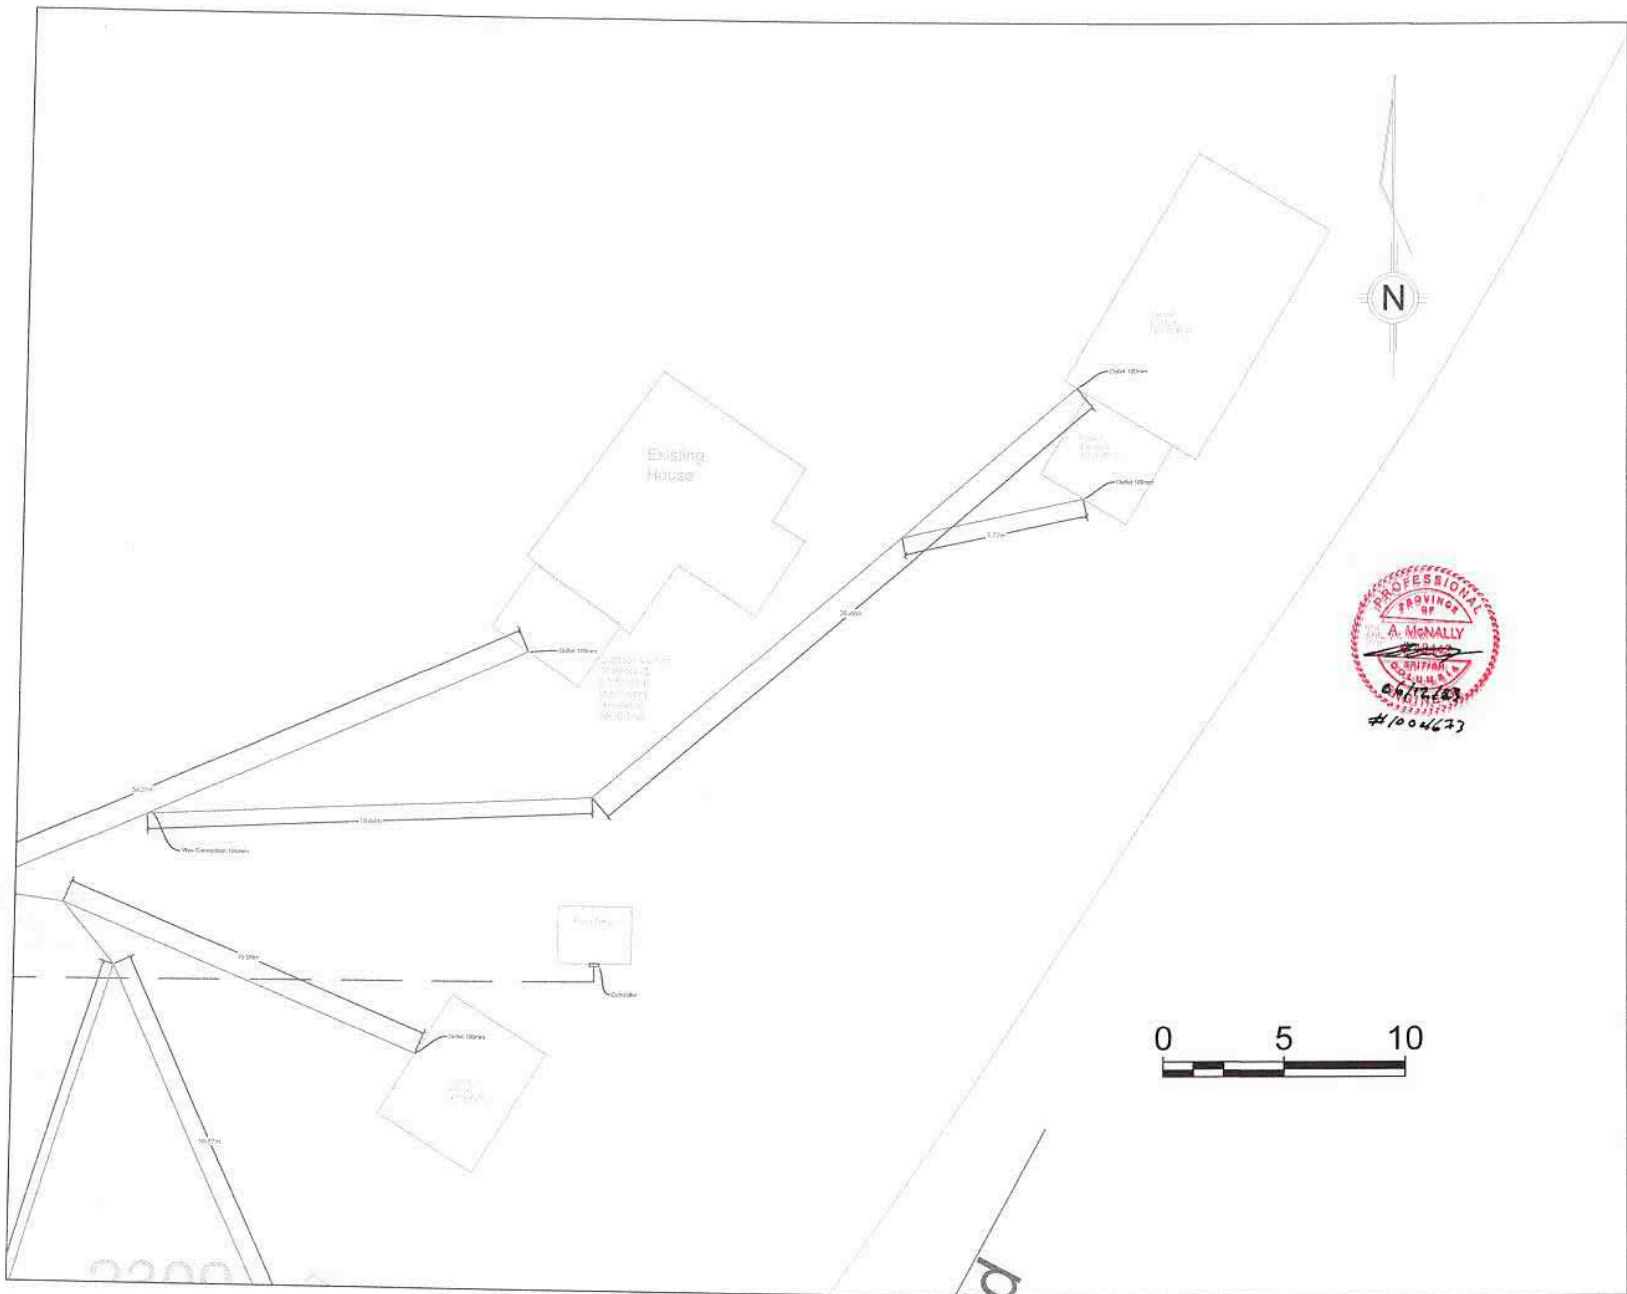
June 12, 2023  
 2023-05-WKNB-30T3SM5L  
 Scale: As-Shown (m)  
 Sheet 3 of 5  
 Detailed Design 2  
 Rev 3

1. System designed in accordance with BC Sewer System Practice Manual
2. Septic system shall be installed by authorized practitioner or under the supervision of a Professional Engineer registered with EGBC

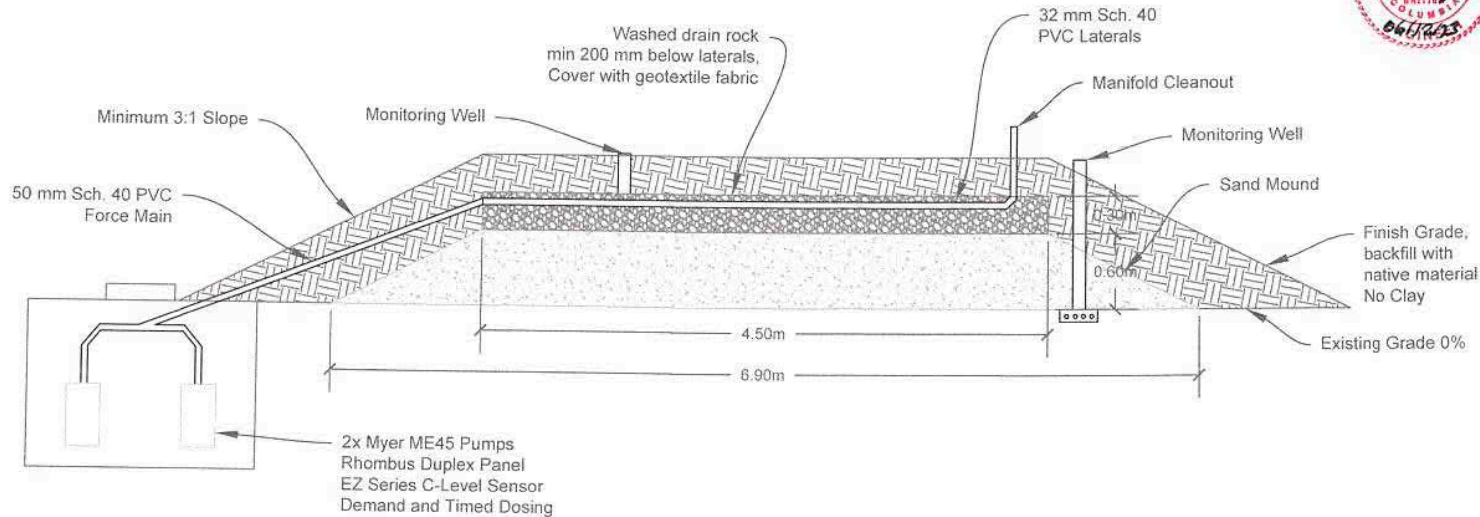
June 12, 2023  
2023-05-WKNB-30T3SM5L  
Scale: As-Shown (m)  
Sheet 5 of 5  
Layout  
Rev 3

16. 2.2 m head throughout system
17. Closest Water Body 44.5 Kootenay Lake and >30m French Drain

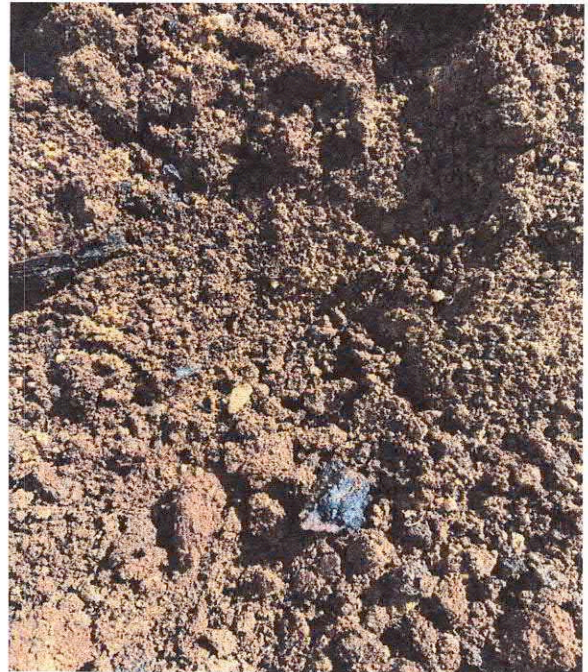
Fig 2. Clay loam with organics and coarse sand

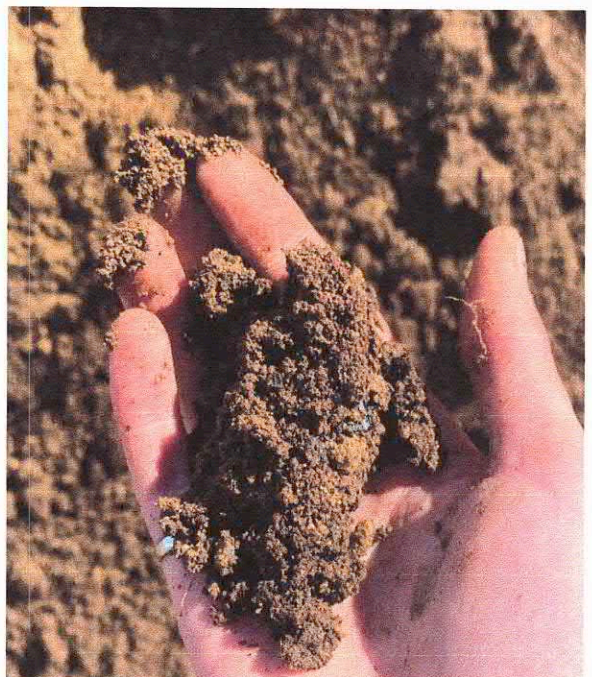
Fig 4. Clay loam containing organics and roots

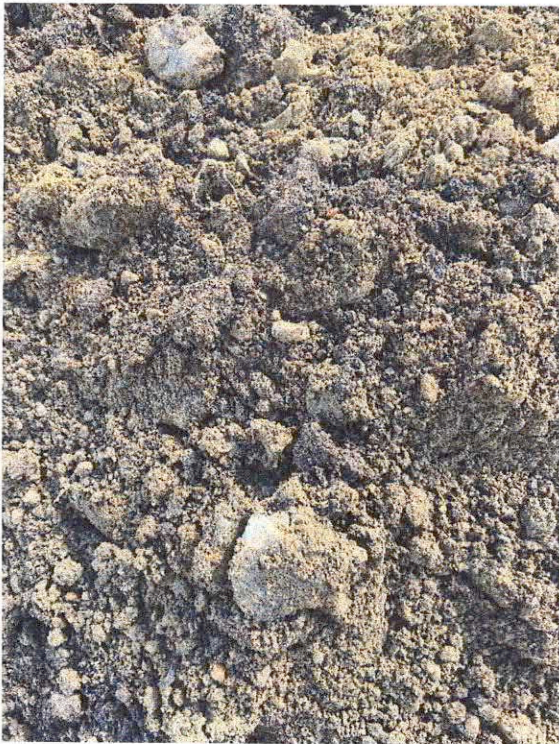
Fig 5. Pocket of sandy loam with 1-2cm gravel

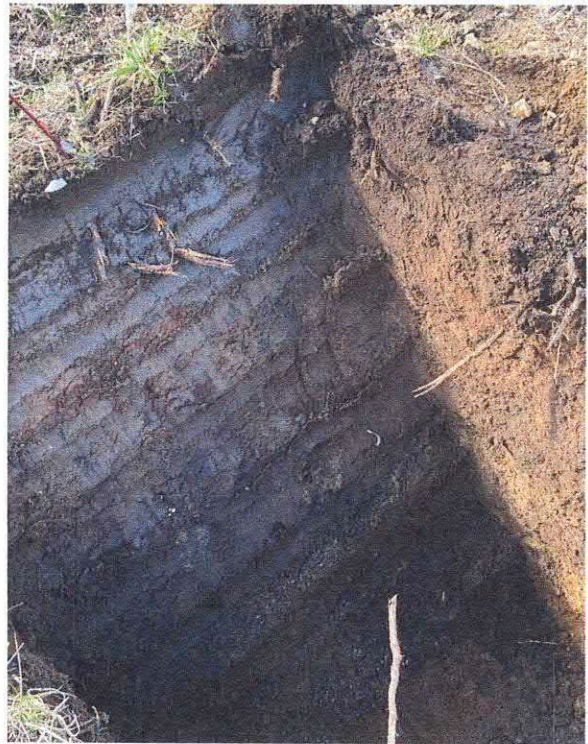
Fig 6. Excavation smear shows high clay content

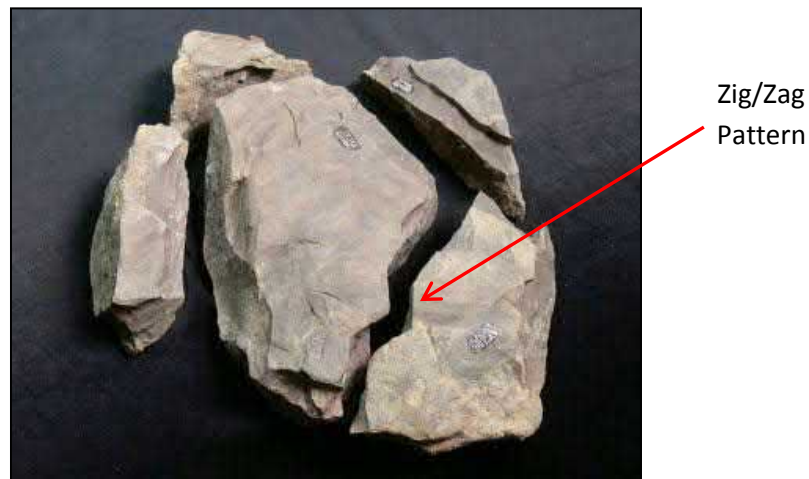
When looking for FBR, note concentrations of roughly fractured rock from rapid heating and cooling, rock showing signs of burning or oxidation and/or reddening or blackening of surrounding matrix.

Image 7: Example of FBR; note the zig/zag pattern of breakage common to FBR

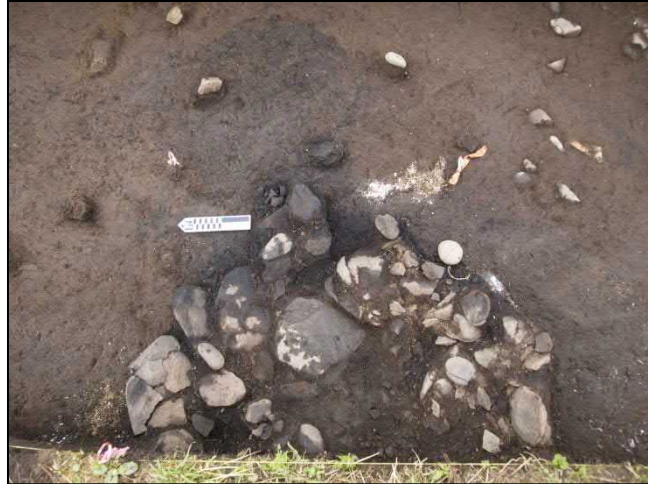
- FBR
- reddening or blackening of the associated soil/sediment
- charcoal
- layering of FAR and charcoal, and
- depressions in the earth associated with FAR, reddened or blackened matrix and charcoal.

Image 8: Example of a hearth uncovered along the wall of an excavation unit

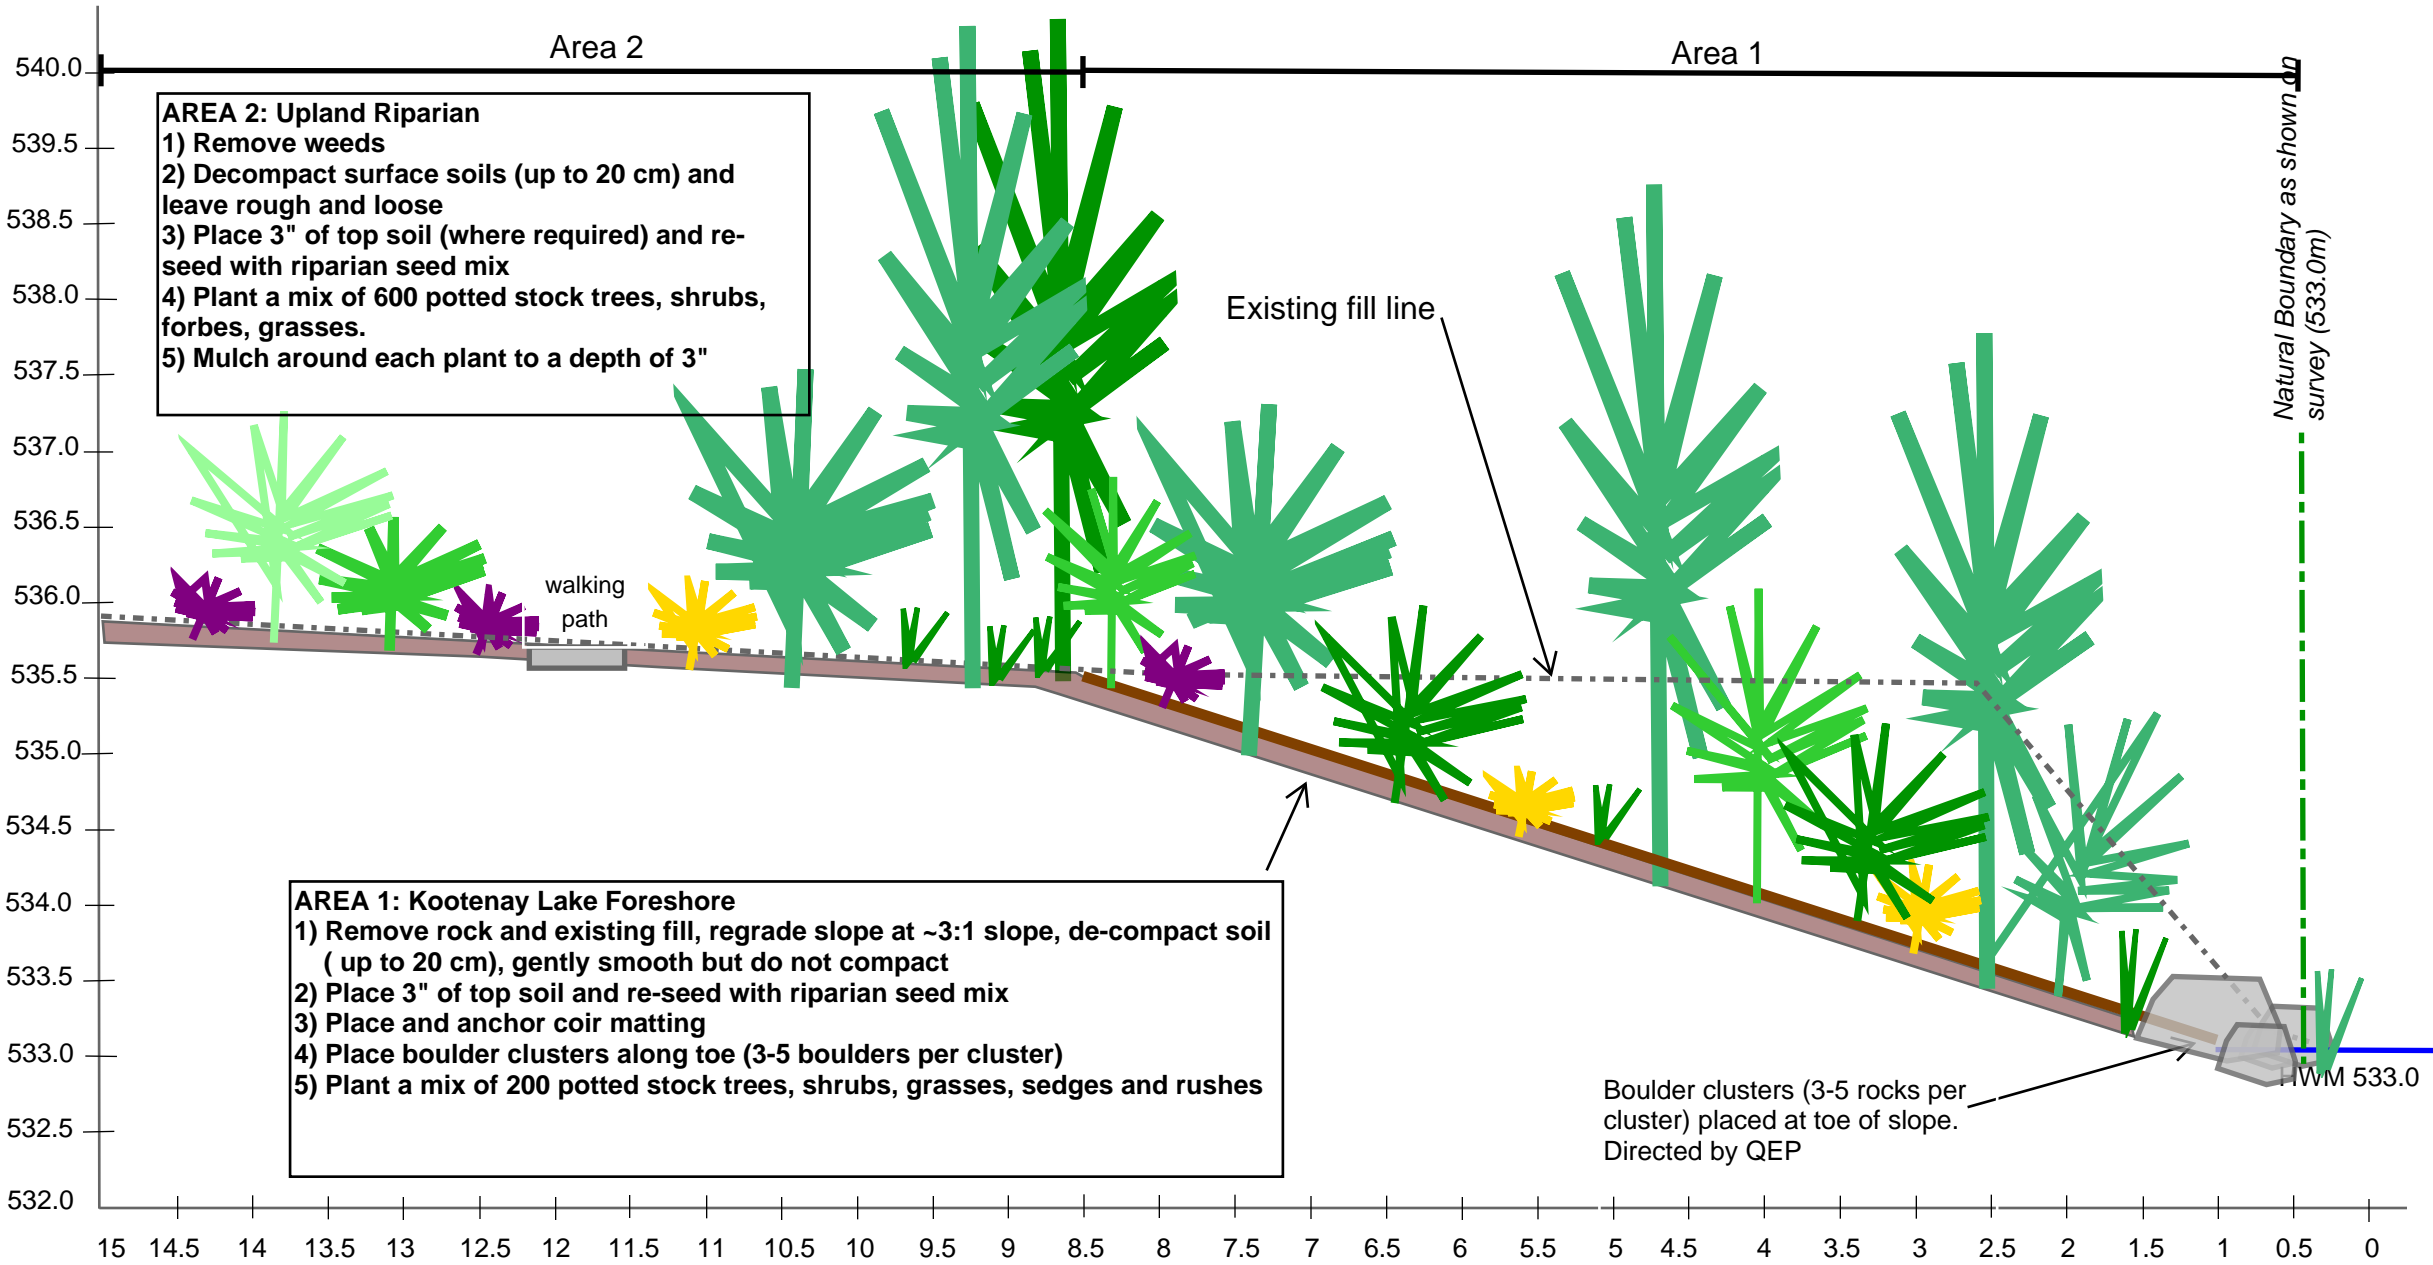
2309 Bealby Road Foreshore Restoration  
 Section A -Conceptual Design Profile  
 Drawn to Scale (as shown)  
 Drawn by: F.L  
 Date:Aug 22, 2023

### Section A- Foreshore Restoration

**Notes:**  
 -This is NOT an engineered drawing and is to be used for conceptual purposes only.  
 - Based on Survey completed by Hango Surveying

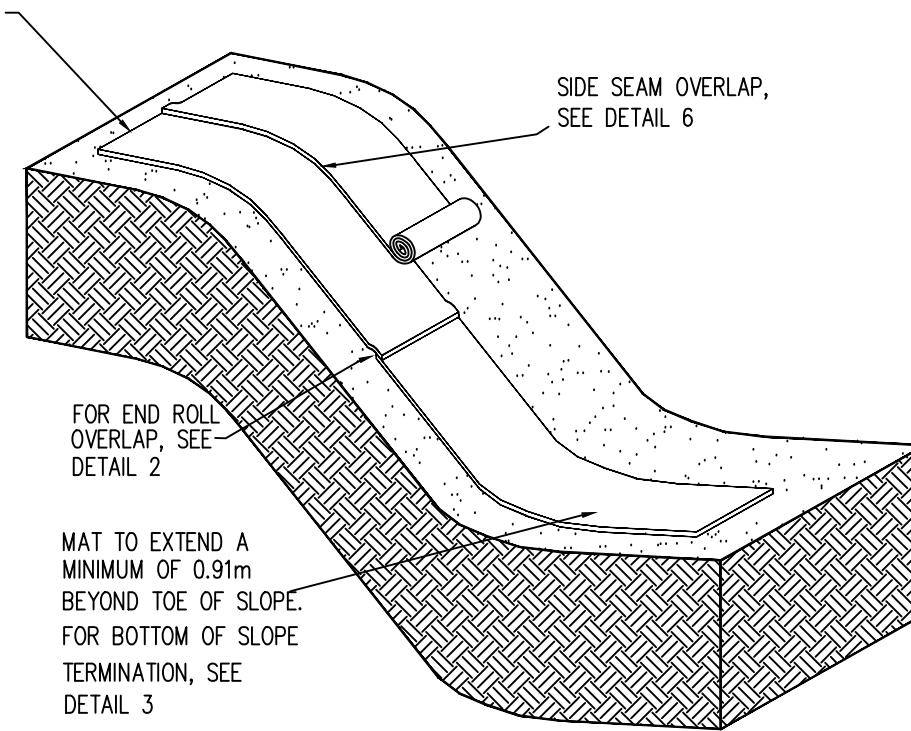
SLOPE DETAIL DETAIL 1

EXTEND MAT A MINIMUM OF 0.91m OVER CREST OF SLOPE, SEE DETAIL 4. TRENCHING NEEDED IF A MINIMUM OF 0.91m IS NOT AVAILABLE AT THE CREST OF SLOPE OR IF OVERLAND FLOW IS ANTICIPATED FROM UPLAND SEE DETAIL 5

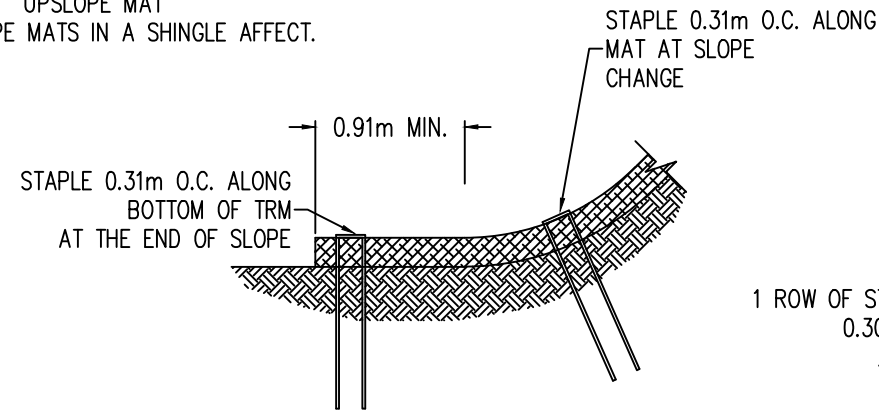
BOTTOM OF SLOPE TERMINATION DETAIL 3

END SEAM OF MAT OVERLAP 0.3m  
PLACE STAPLES, ONE ON EACH CORNER OF BLANKET, 0.15m O.C. ALONG MAT END THROUGH BOTH MATS. UPSLOPE MAT LAPS OVER DOWNSLOPE MATS IN A SHINGLE AFFECT.
