Bylaw No. 2943, 2024

A Bylaw to amend Electoral Area 'G' Land Use Bylaw No. 2452, 2018

The purpose of this application is to rezone the subject property from Tourist Commercial (C2) to Rumbling Creek Tourist Commercial (C3). This is being sought to facilitate the development of tourist accommodations and associated buildings on the subject property with on-site servicing (septic system and drilled well). The proposed development includes eight cabins with a total of twelve sleeping rooms as well as one communal building. The Site Plan is included as Attachment 'B' and includes details on the proposed layout of the buildings and parking areas. The communal building is proposed to contain a commercial kitchen, laundry facilities and storage space as well as a coffee shop that will be open to the public. The communal building is also intended to be used as an event space (e.g. wedding venue) which is considered incidental and related to the Tourist Accommodation Use. The draft amending bylaw is included as Attachment 'A' to this report.

4626 Highway 6 Riparian Assessment

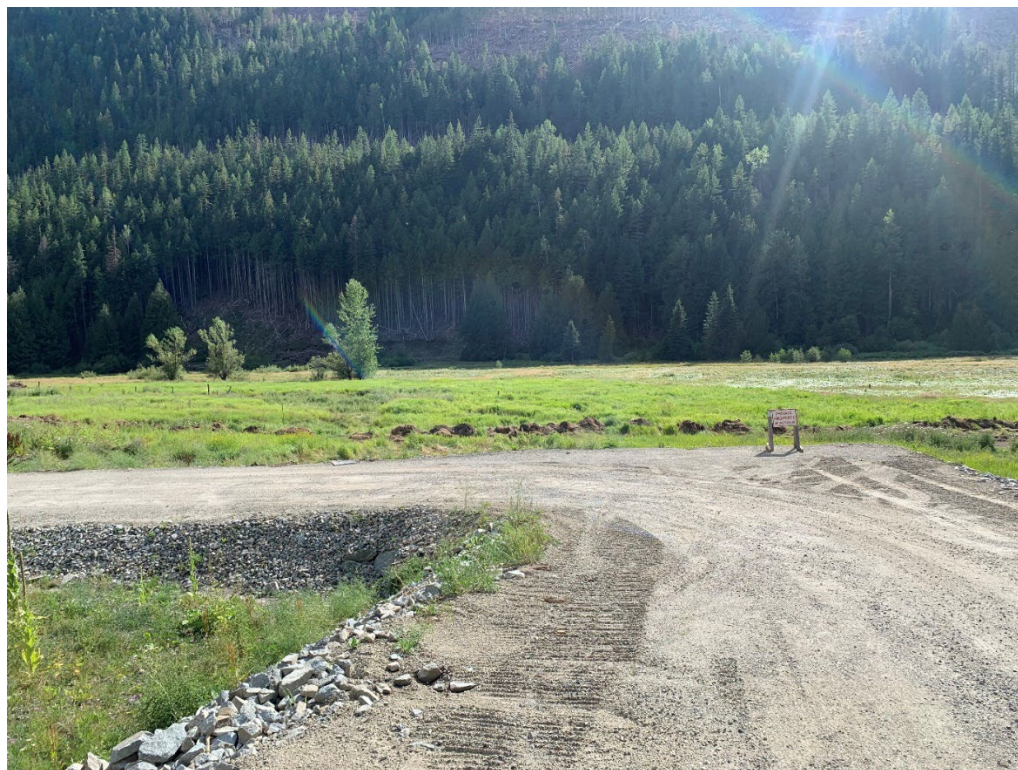
Figure 3: Subject property facing southwest from Highway 6

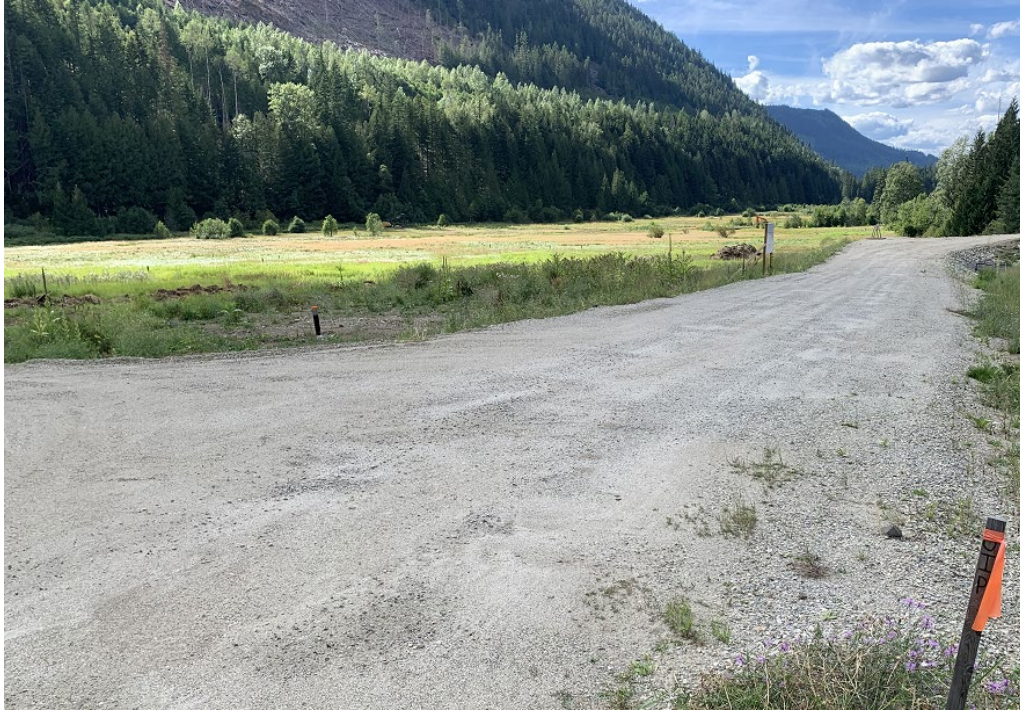
Figure 4: Subject Property facing Northwest

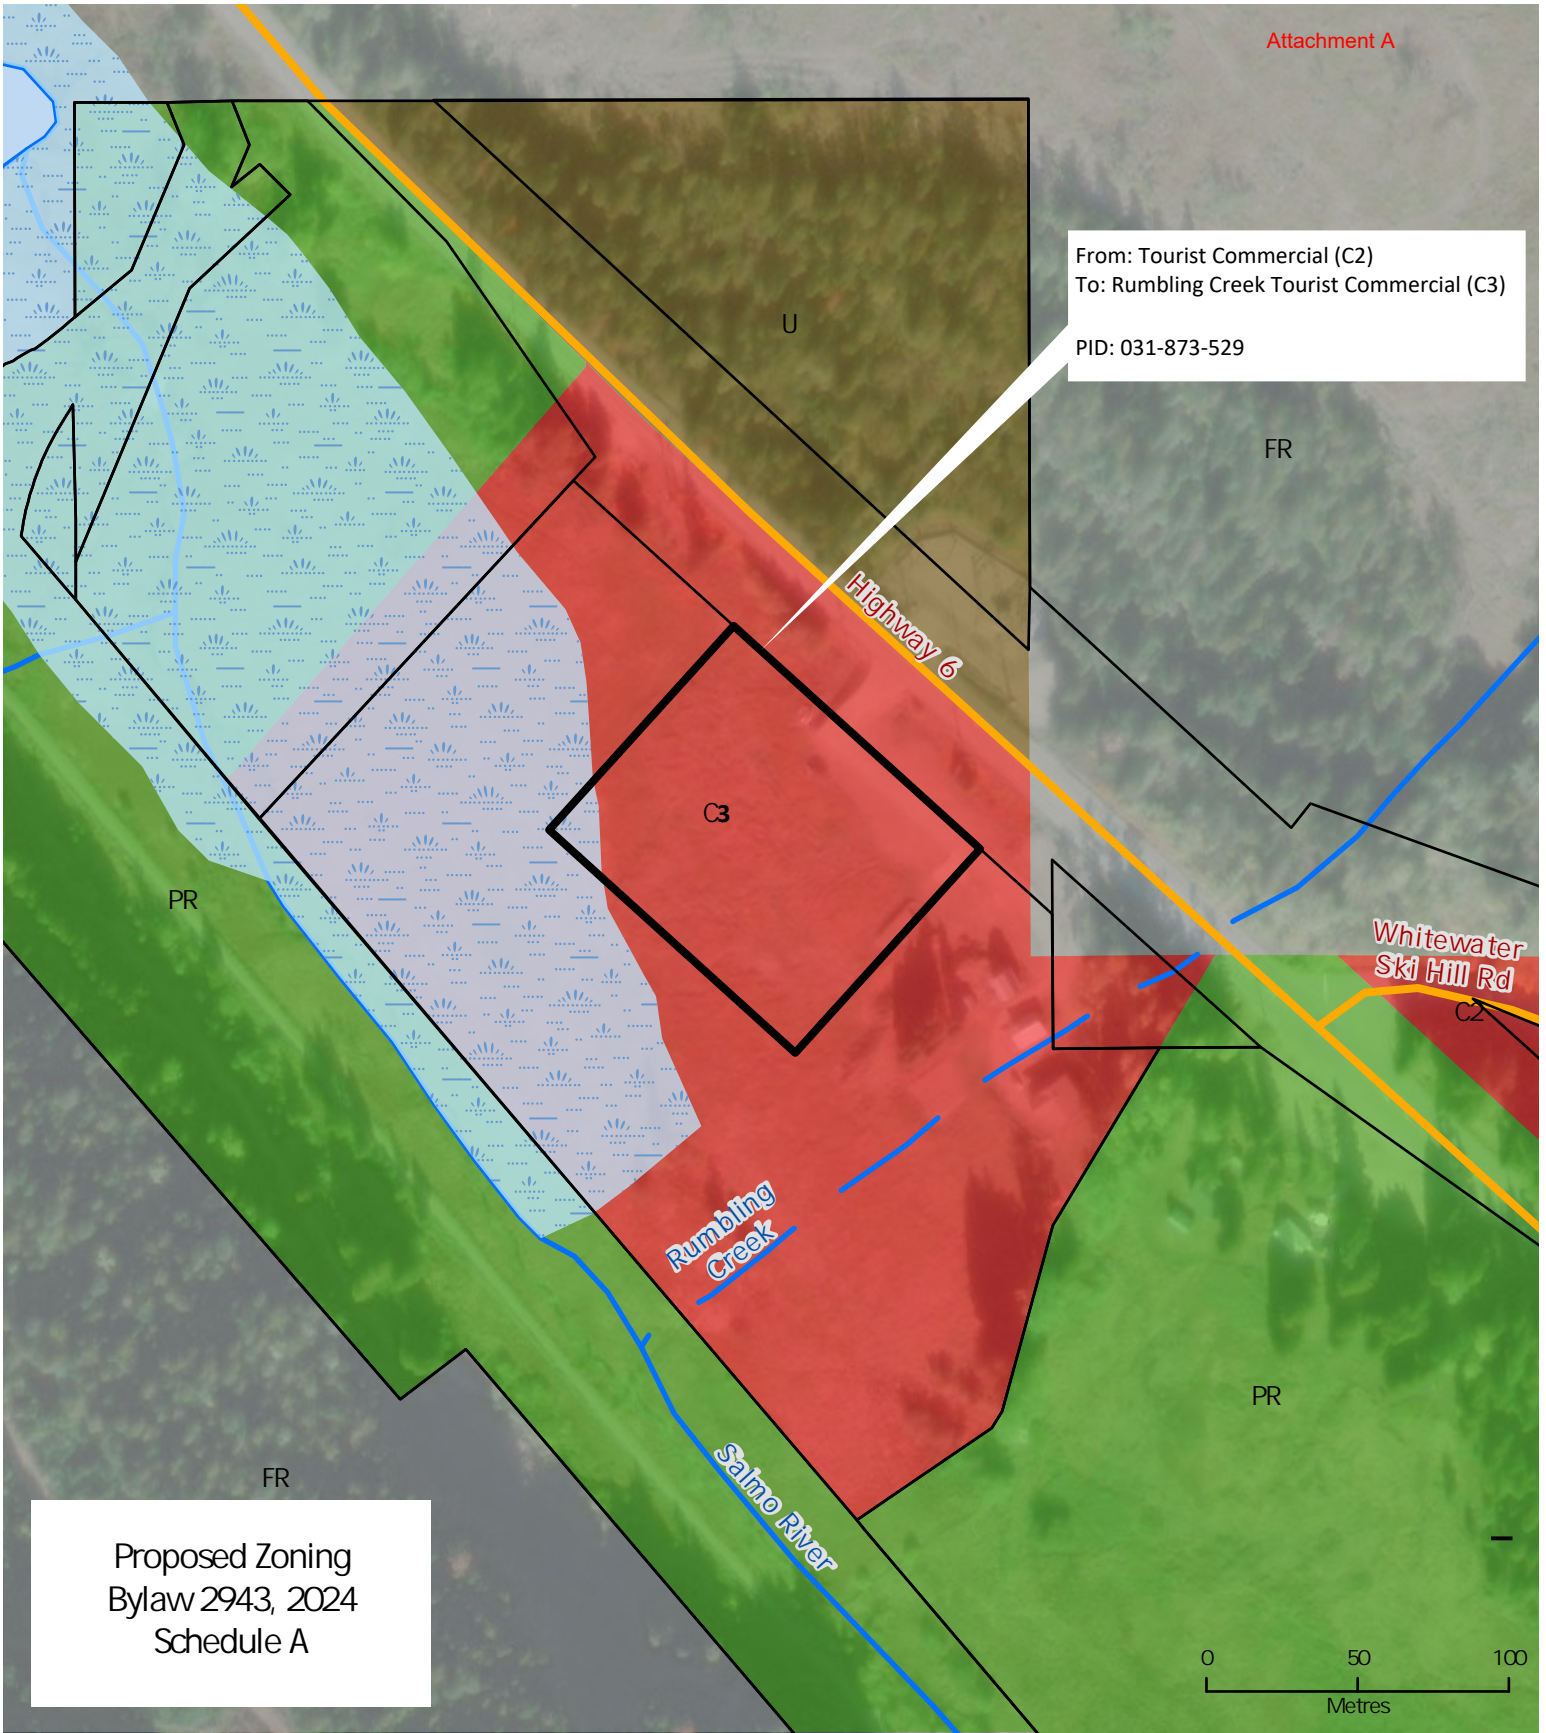
Proposed Zoning
Bylaw 2943, 2024
Schedule A

From: Tourist Commercial (C2)
To: Rumbling Creek Tourist Commercial (C3)
PID: 031-873-529

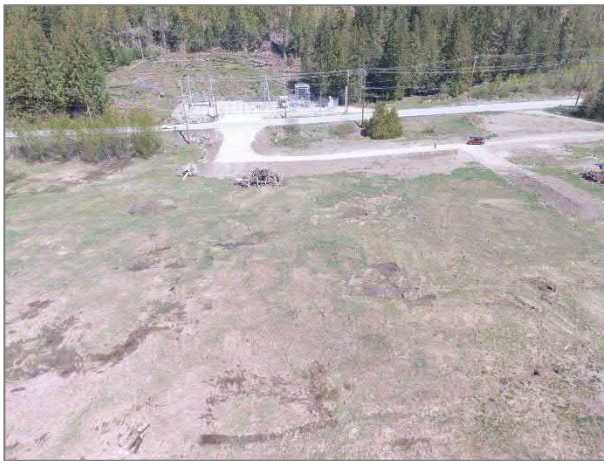
Photo 1. Aerial view of the property, looking northeast (May 10, 2023).

agricultural and human use, as evidenced by the presence of various exotic plants, mainly reed canary grass (*Phalaris arundinacea*), and the absence of tree and shrub cover (Photo 1). The property has been influenced by Rumbling Creek which has created an alluvial fan where material from the stream has deposited over time and has created an elevated bench next to the wetland. This bench was likely used for agricultural purposes and constitutes the disturbed area (~1.9 acres or 77% of the total property). Native vegetation is present on the boundary of the wetland and the toe of the disturbed bench.

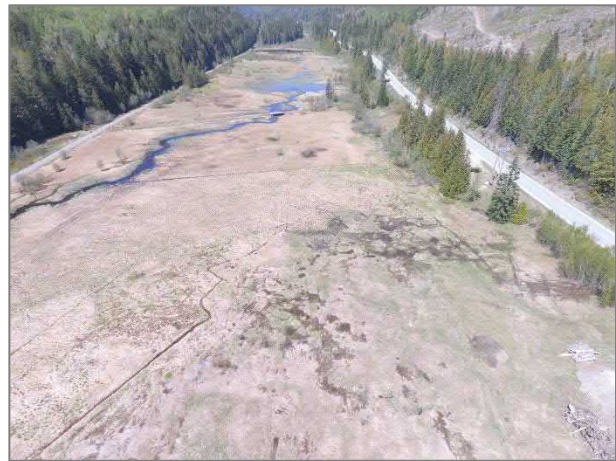
Photo 2. Aerial view of the property and Salmo River headwaters (May 10, 2023).

The property is at the headwaters of the Salmo River watershed, which originates from the wetland complex present to the northwest (Photo 2). The wetland is the only defined watercourse that transects the subject property. The wetland complex is broadly classified as swamp (Ws) at the northwestern extent, shallow open water (Ww) and marsh (Wm).

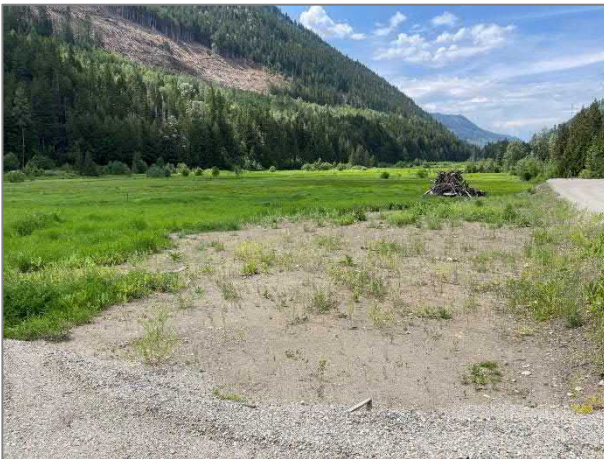
Photo 3. Photo taken from east corner, looking west (June 8, 2023).

The property has historically experienced site disturbances from past settlements and land clearing/agriculture activities (Photo 3). There is currently no building infrastructure on the property. The vegetation appears to be largely recovering from past disturbances through a legacy of a mix of agronomic grasses, including reed canary grass, and exotic species remain on the disturbed bench, with some scattered native sedges and shrubs (Photo 4). Areas of native vegetation exist within the wetland on the northwest corner of the property. Access to the property is from Highway 6 (Photo 5). There are steep embankments (>60% slope) leading up to the property driveway that was constructed on imported fill to the height of the highway (Photo 6).

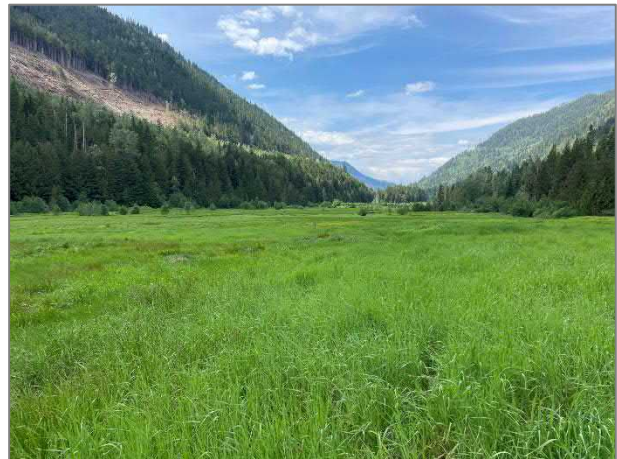
Photo 4. Photo taken from southeast property boundary, looking northwest (June 8, 2023).

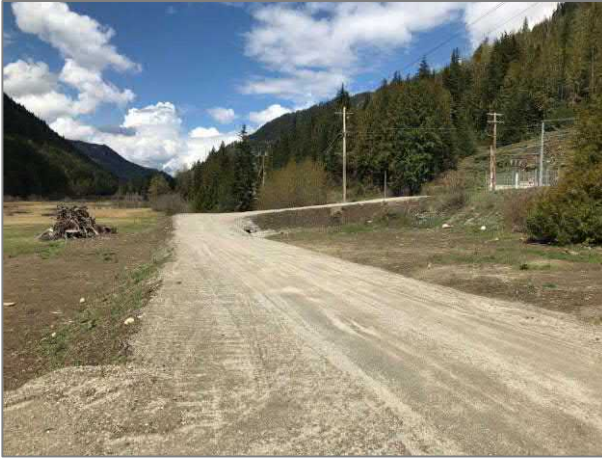
Photo 5. Access road to property, looking northwest (May 10, 2023).

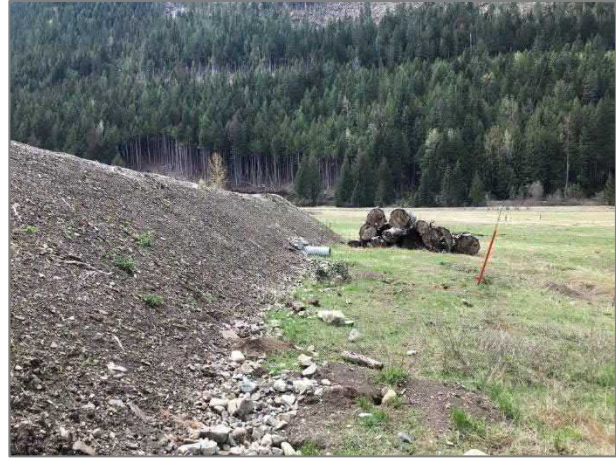
Photo 6. Access road embankment, looking west (May 10, 2023).

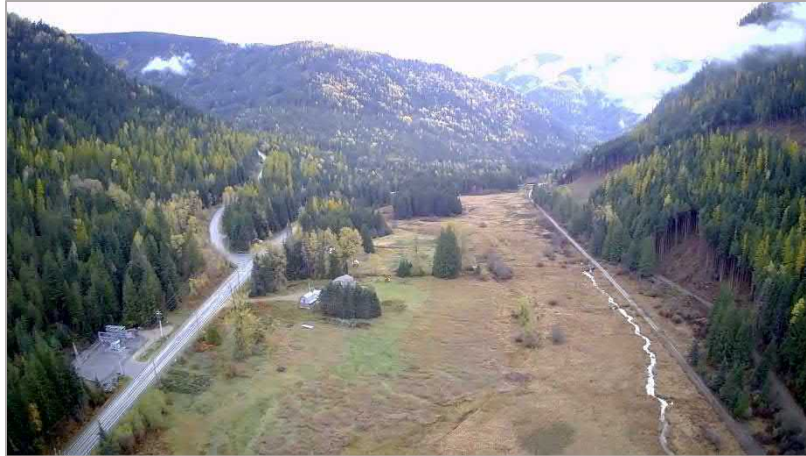
Photo 7. Aerial view of the property and wetland complex, looking south (Photo credit Jason Newton, fall 2021).

The headwaters of the Salmo River originate from an important wetland complex totaling ~9.3 ha (Photo 7), which is a sensitive ecosystem with regional significance as an important wildlife corridor. The Salmo River becomes a defined channel ~600 m north of the property. Wetlands are water-saturated for much of the year, with vegetation adapted to live in resultant water-logged and low oxygen soils (Mackenzie and Moran 2004). The vegetation community and site conditions on the property are in transition due to hydrologic changes caused by historical land clearing and water diversion of the melt water from Highway 6 into a ditch at the northwest and southwest property boundary (Photo 8, Photo 9).

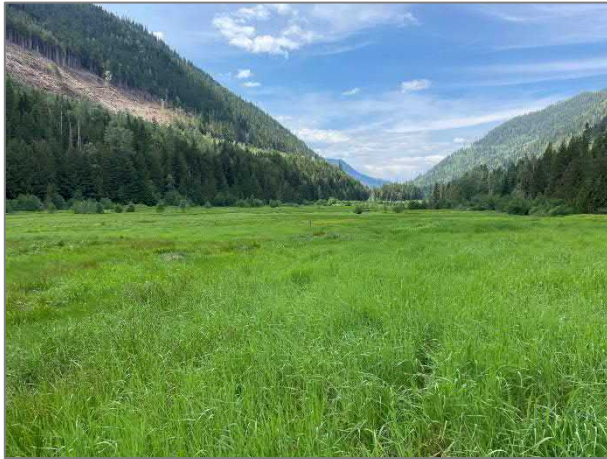
Photo 8. View of the disturbed area transitioning into the wetland, looking northwest (June 8, 2023).

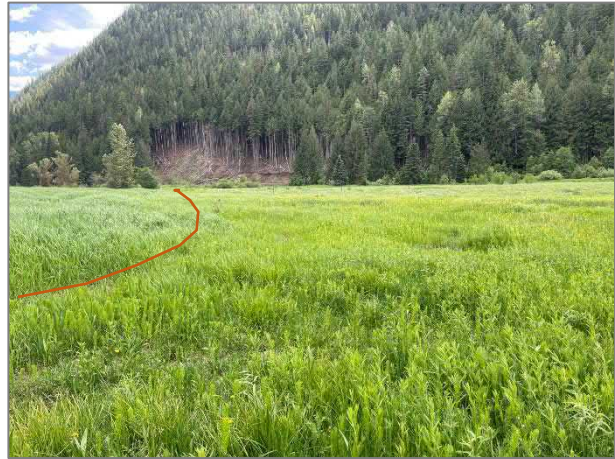
Photo 9. View of the natural boundary between the disturbed bench and the wetland, looking southwest (June 8, 2023).

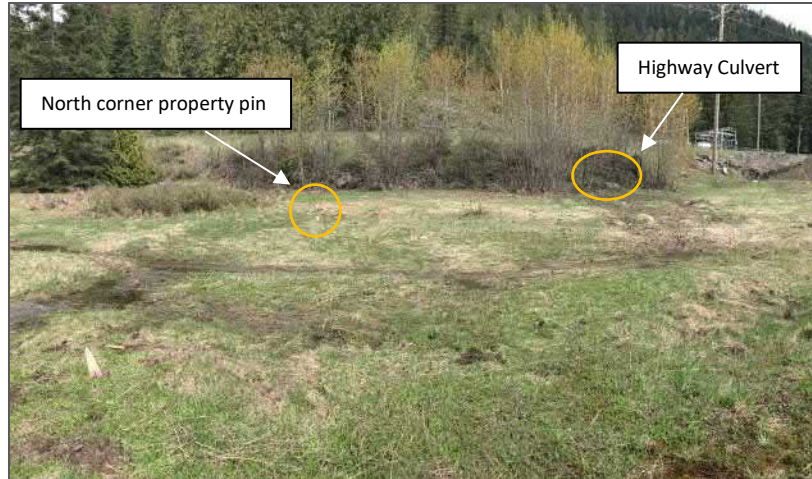
Photo 10. Location of highway culvert and north corner of the property (May 10, 2023).

Water is conveyed onto the property from a 600 mm culvert under Highway 6 (Photo 10, Photo 11) and originates from the highway ditch and a diversion ditch that appeared to have been constructed to divert water from Rumbling Creek to the property, possibly for historic irrigation purposes (Photo 12). The water source on the property is likely a combination of rainwater, snow melt and water from Rumbling Creek, which flows from the south end of the FortisBC substation and likely goes subsurface (Photo 13). The water from the culvert flows along the northwestern property boundary and eventually runs into the wetland and connects to a channelized ditch (Photo 12, Photo 13). The channelized ditch begins at the northwest corner of the property and flows south through the wetlands towards Nelson Nordic Ski Club (Photo 16). Seepage areas were also noted throughout the northwestern half of the property (Photo 17; Appendix 3), where saturated soils were present due to the high water table at ~15 - 20 cm depth (Photo 18).

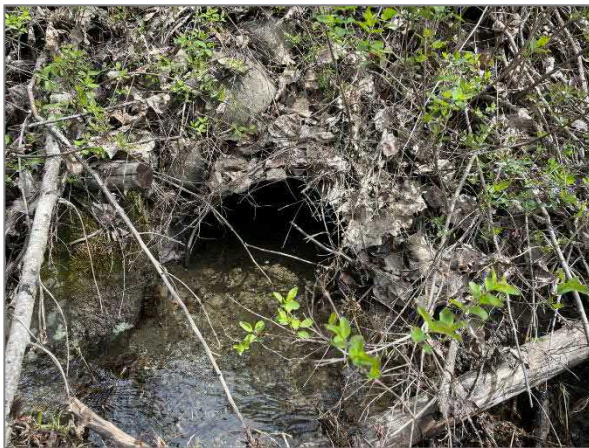
Photo 11. Water flow from culvert underneath highway 6 (May 10, 2023).

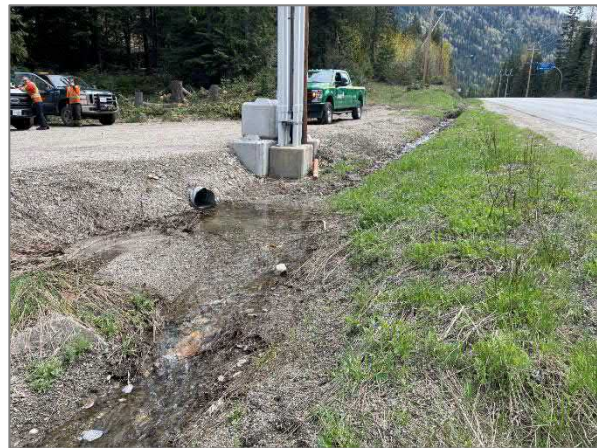
Photo 12. Ditch on the north side of Highway 6, supplying water to the property (May 10, 2023).

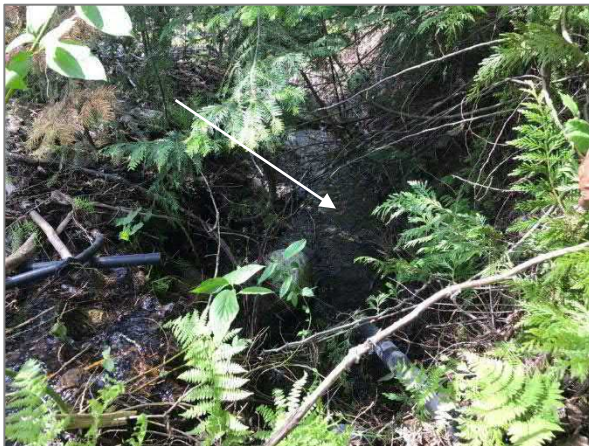
Photo 13. Start of side channel from Rumbling Creek (June 8, 2023).

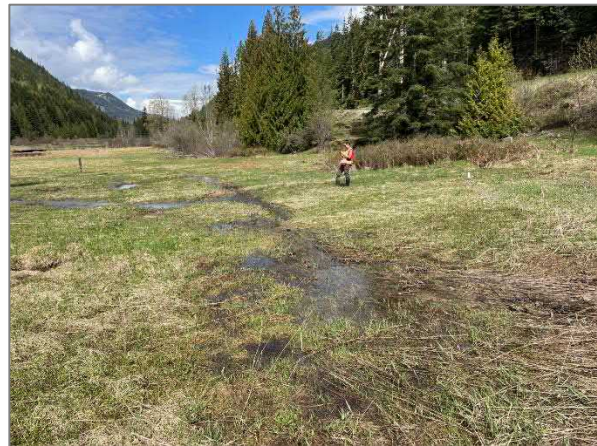
Photo 14. Surface water flow on northwest property boundary, from highway culvert (May 10, 2023).

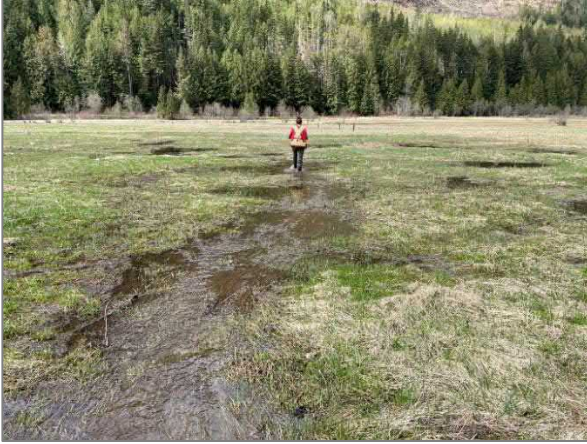
Photo 15. Surface water flowing west towards the wetland, along the northwest property boundary (May 10, 2023).

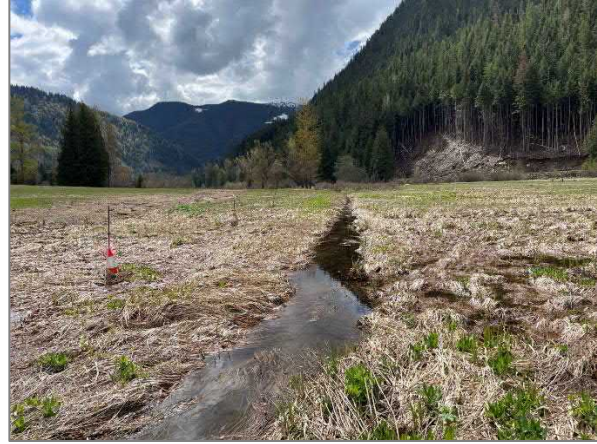
Photo 16. Channelized ditch west of property (May 10, 2023).

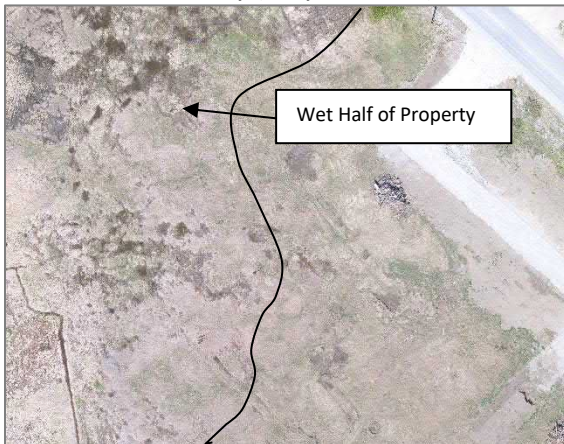
Photo 17. Surface water on the northwest half of the property (May 10, 2023).

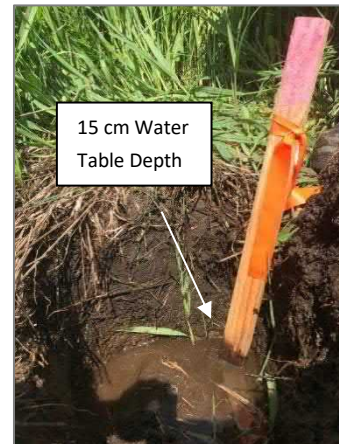
Photo 18. Water table located in the 15 m setback (June 8, 2023).

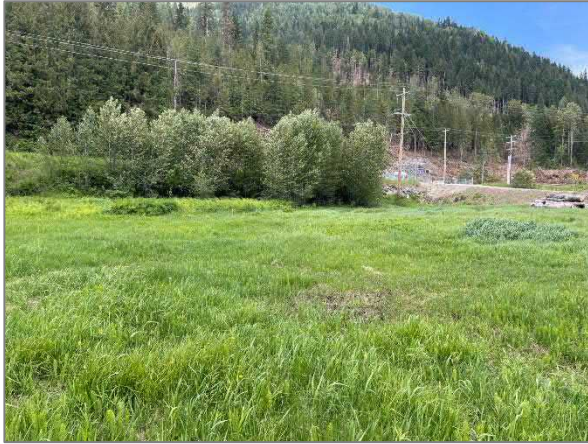
Photo 19. View of low cover vegetation and tree cover along the margins of the highway, looking northeast (June 8, 2023).

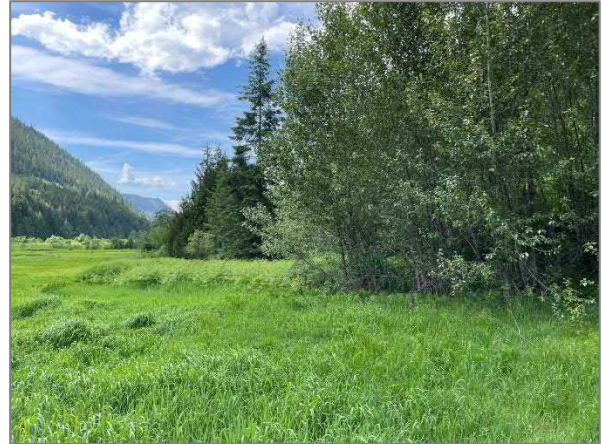
Photo 20. View of elevated bench transitioning to wetland, looking northwest (June 8, 2023).

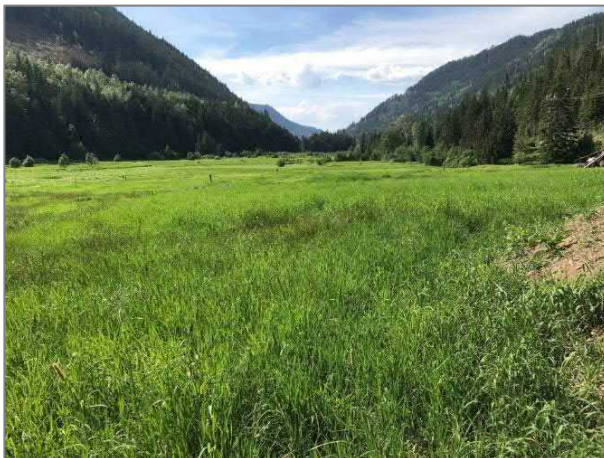
Photo 21. View of upper property, looking northwest (June 8, 2023).

The property has very little tree and shrub cover and is almost primarily low cover grasses, sedges, and herbaceous plants (Photo 21 – 24). The plant community on the disturbed bench is dominated by primarily non-native species, including canary reed grass, starry broomsedge (*Carex pachystachya*; native), Canada thistle (*Cirsium arvense*), stinging needle (*Urtica dioica ssp. dioica*), vetch (*Vicia sp.*), timothy grass (*Phleum pratense*), common tansy (*Tanacetum vulgare*), common burdock (*Arctium minus*), mullein (*Verbascum thapsus*), yarrow (*Achillea millefolium*; native), scouring rush (*Equisetum hyemale*; native), with a few black hawthorn (*Crataegus douglasii*; native) and thimbleberry (*Rubus parviflorus*; native) shrubs. The toe of the disturbed bench transitions to the wetland margins, which contains a variety of native species including arrowleaf senecio (*Senecio triangularis*), white bog orchid (*Platanthera dilatate*), Canada goldenrod (*Solidago canadensis*), large-leaved avens (*Geum macrophyllum*), swamp horsetail (*Equisetum fluviatile*), kentucky bluegrass (*Poa pratensis*), Columbian monkshood (*Aconitum columbianum*), false lily

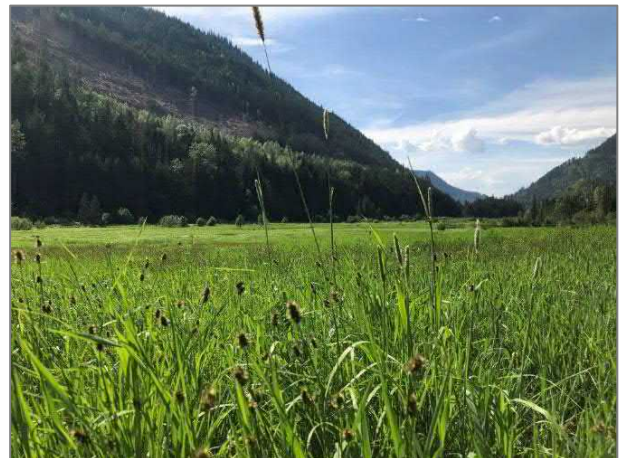
Photo 22. View of broomsedge (*Carex pachystachya*), which is one of the dominate species in the disturbed area (June 8, 2023).

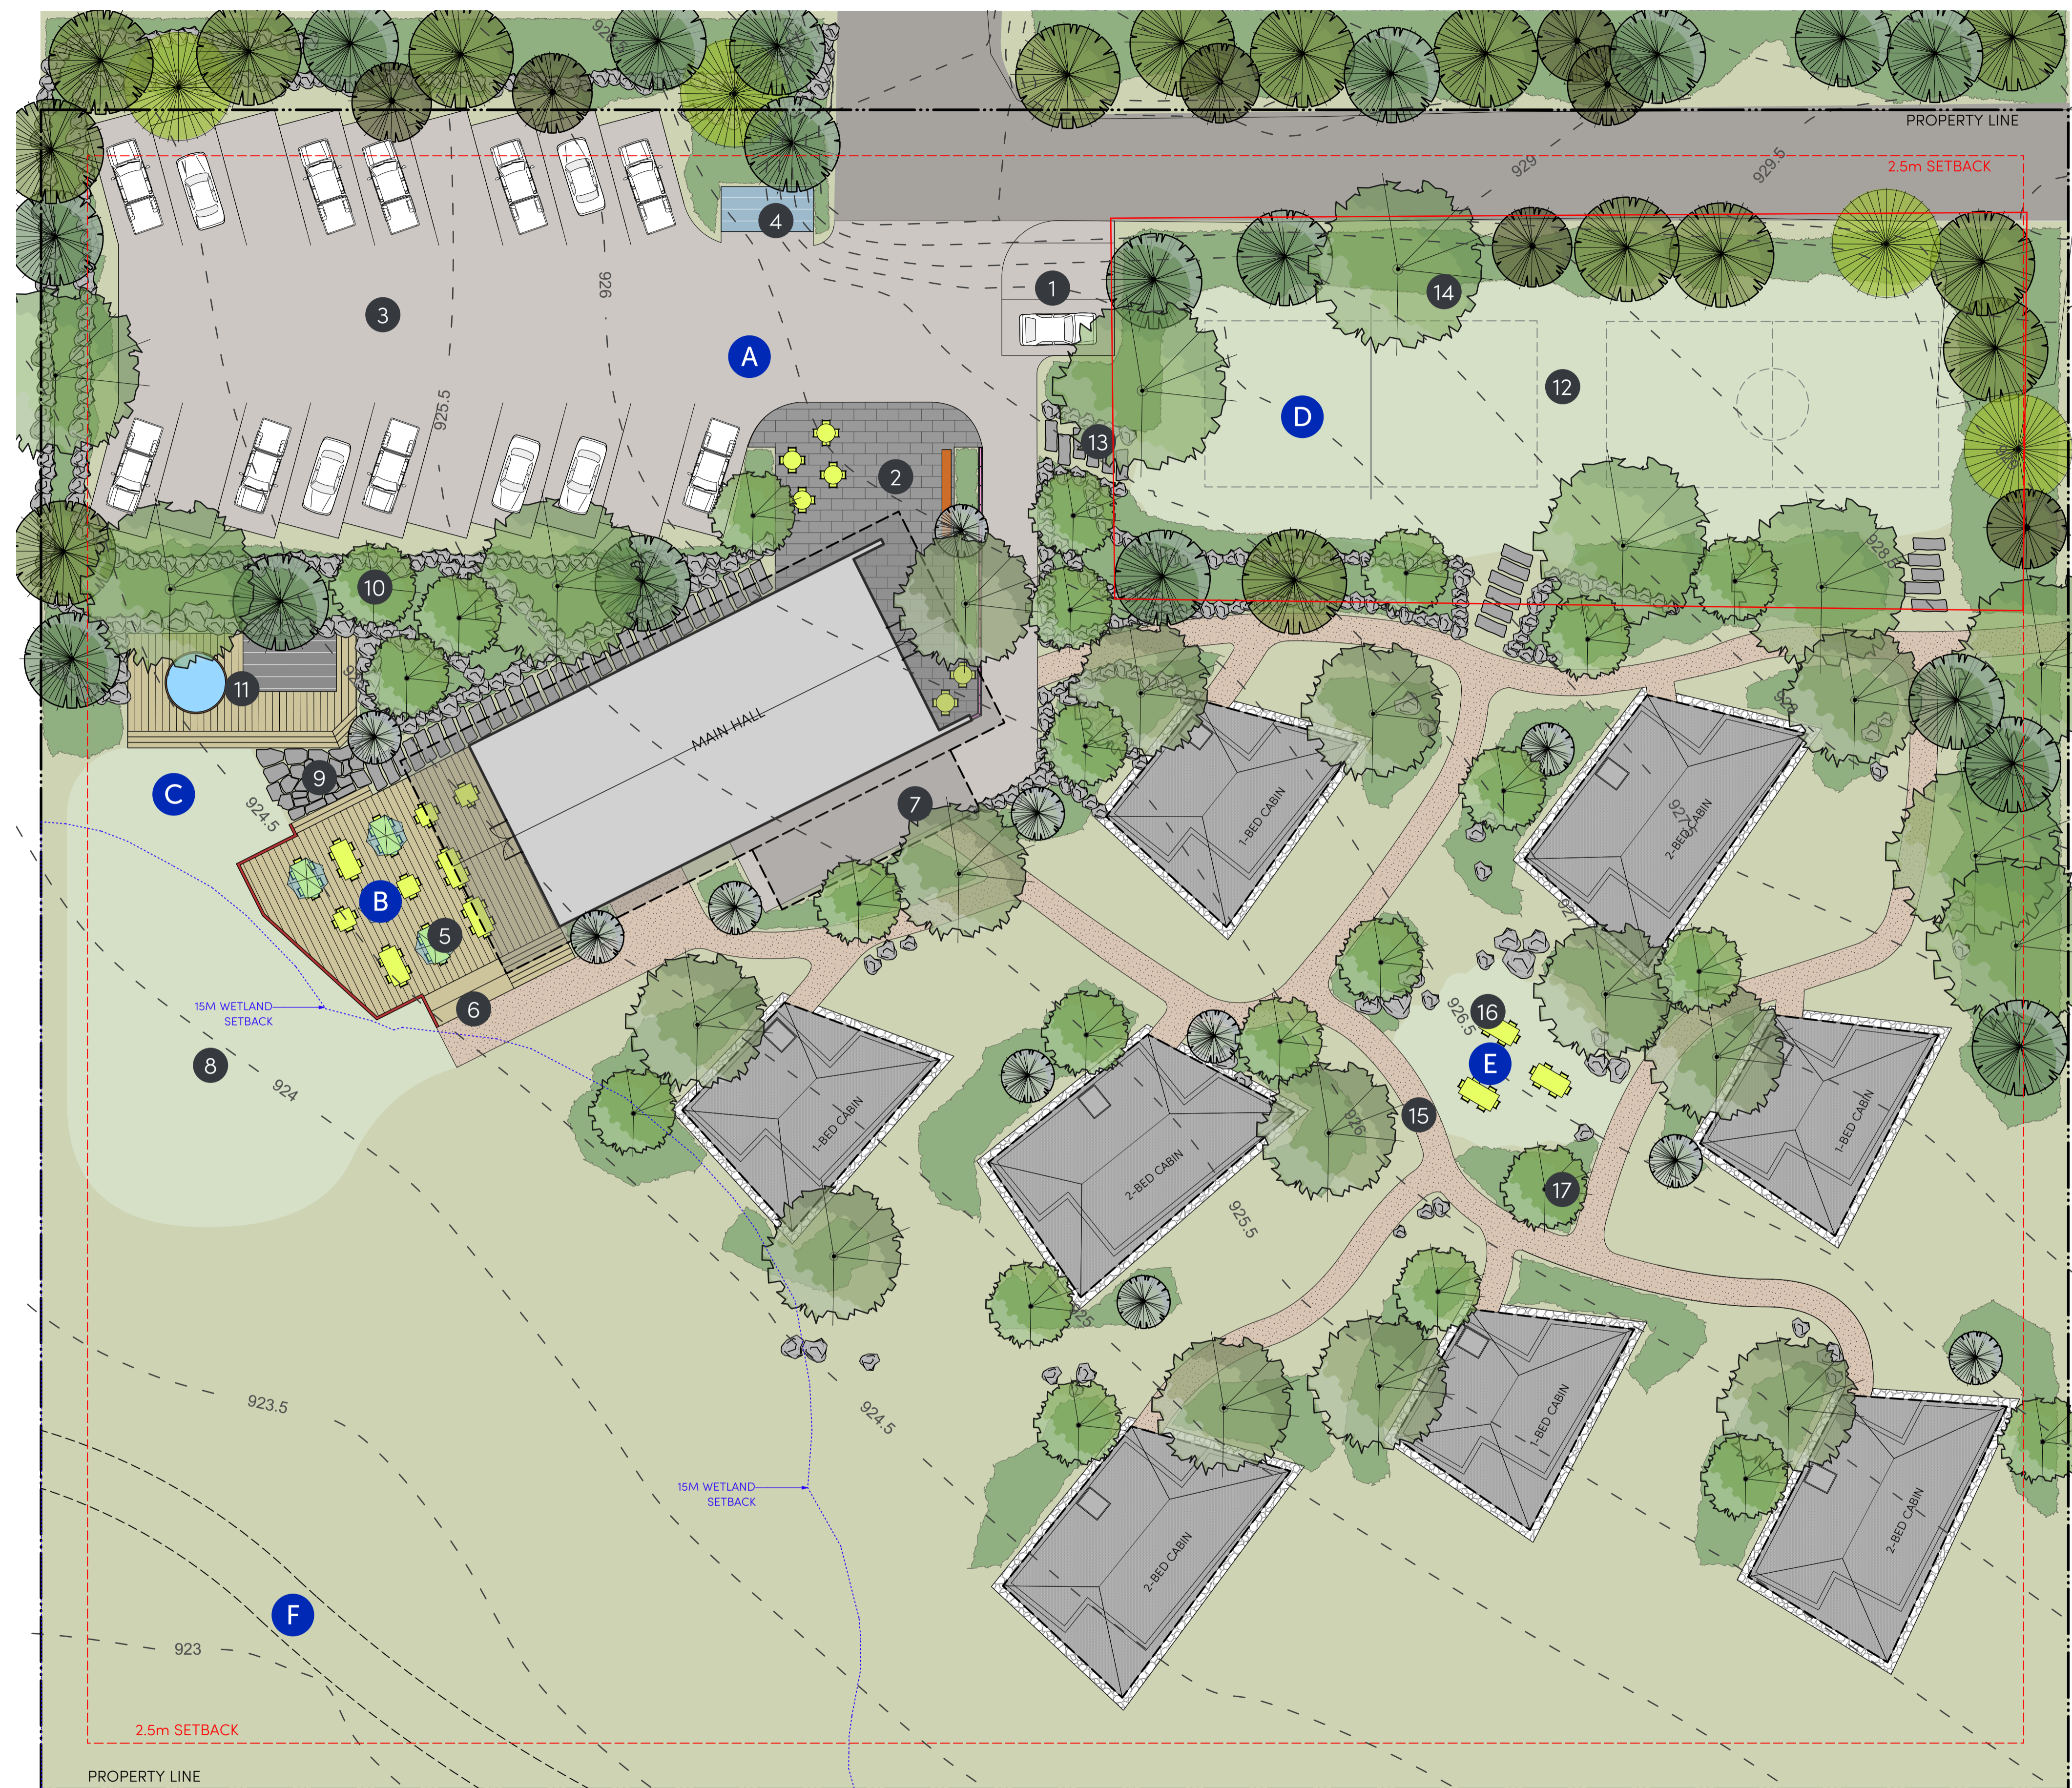
1 LANDSCAPE ILLUSTRATIVE PLAN
 Scale: 1:200

- A** ARRIVAL COURT + PARKING
- 1** RETAIL PARKING
- 2** FRONT ENTRY FEATURE PAVERS + BENCH SEATING + CAFE TABLES
- 3** GRAVEL PARKING LOT
- 4** GARBAGE ENCLOSURE
- B** SOCIAL DECK (RAISED)
- 5** RAISED DECK WITH MOVEABLE FURNITURE
- 6** SEAT STEPS/INFORMAL SEATING
- 7** ACCESS DRIVE WITH CONCRETE RETAINING WALL
- C** OVERLOOK LAWN + SAUNA / COLD PLUNGE
- 8** MOWED LAWN WITH EXPANSIVE VIEWS
- 9** FLAGSTONE LANDING
- 10** NATURALIZED BUFFER PLANTING SCREENING PARKING LOT + GRADE TRANSITION
- 11** SAUNA + COLD PLUNGE WITH DECK BUILT INTO SLOPE
- D** MULTIT-USE LAWN / SEPTIC FIELD
- 12** MOWED LAWN / FOR GAMES / RECREATION
- 13** PATH TO ROAD
- 14** BUFFER PLANTING TO SCREEN ROAD
- E** CENTRAL COMMON AREA
- 15** GRAVEL PATH 5' WIDE
- 16** PICNIC TABLES + SEATING BOULDERS
- 17** MEADOW GRASSES + WILD FLOWERS + NATURALIZED PLANTING
- F** NNSC SEASONAL CROSS COUNTRY SKI TRAIL

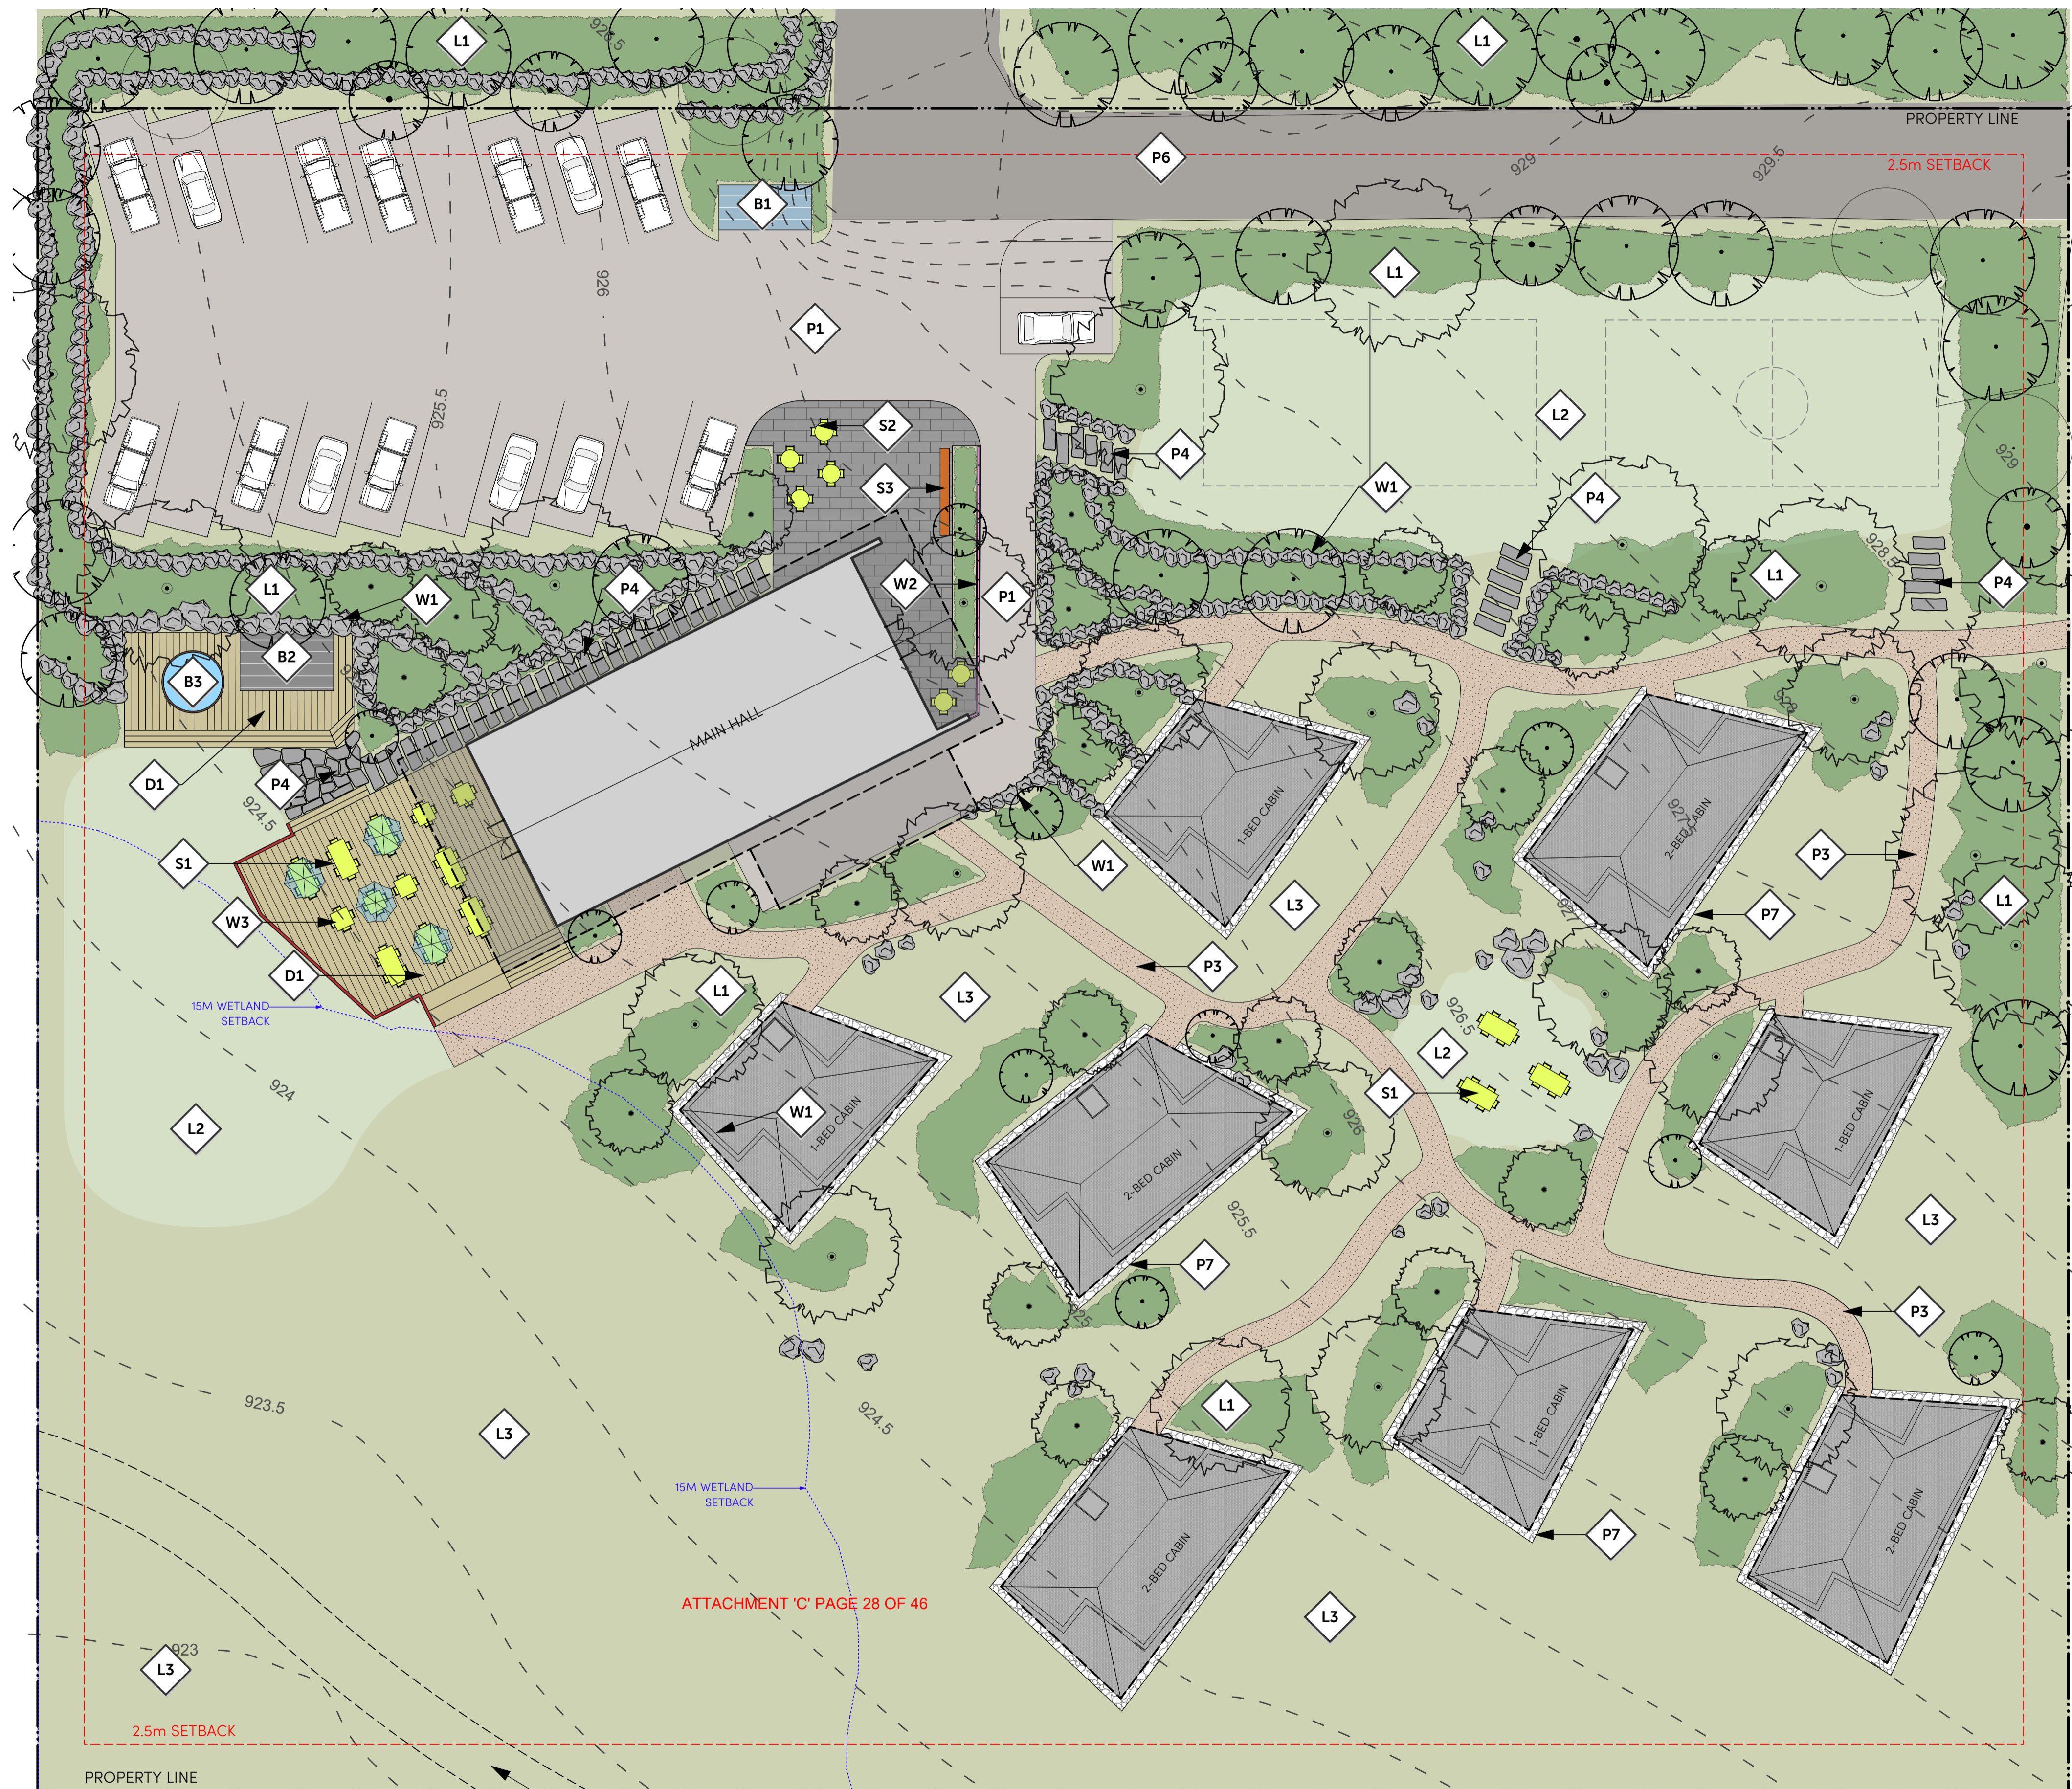
1 MATERIALS PLAN
Scale: 1:200

SYMBOL	KEY	DESCRIPTION
	P1	PAVING TYPE 1: GRAVEL PARKING LOT Compacted 3/4" Minus Road Mulch
	P2	PAVING TYPE 2: MAIN HALL ENTRY PAVING Precast Concrete Unit Pavers By Barkman Size: 900 X 450 X 100 mm - Colour: Ash
	P3	PAVING TYPE 3: GRAVEL PATHWAYS 3/8" Minus Limestone Rock Dust
	P4	PAVING TYPE 4: STONE SLAB PAVING Basalt Stone Slabs - Size Varies
	P5	PAVING TYPE 5: FIREPIT PAVING Storm Mountain Select Flagstone 1"-2" By Northwest Landscape Supply
	P6	PAVING TYPE 6: ACCESS ROAD PAVING By Others
	P7	PAVING TYPE 7: RAIN SPLASH STRIP Locally Sourced 3" Rock Mulch
	D1	WOOD DECKING Thermally Modified Ash By Scotty Wood
	S1	MOVEABLE BANQUET TABLES + BENCH Product TBD, by Owner
	S2	MOVEABLE CAFE TABLES + CHAIRS Product TBD, by Owner
	S3	ENTRY PLAZA BENCH Heavy Timber Bench, 4.7m Length
	B1	GARBAGE ENCLOSURE By Others
	B2	NORDIC SAUNA By Others
	B3	COLD PLUNGE TUB by Others
	W1	BOULDER / BOULDER WALLS Locally Sourced Granite Size: 300 - 400 mm

W2	CONCRETE RETAINING WALL CIP Concrete Wall with Guardrail (1070mm Ht.) To be Coordinated with Structural and Geotechnical Engineer
	W3	GUARDRAIL Guardrail Material TBD 42" Height
	L1	NATURALIZED PLANTING Assorted Deciduous and Coniferous Trees, Shrubs, Grasses, Perennials, and Boulder Clusters
	L2	LAWN HYDROSEED MIX - REGULARLY MOWED Native Grass Species
	L3	PERENNIAL HYDROSEED MIX- MOWED ONCE PER YEAR Colourful Native Perennials + Grass Species
