Bylaw No. 2943, 2024

A Bylaw to amend Electoral Area 'G' Land Use Bylaw No. 2452, 2018

The purpose of this application is to rezone the subject property from Tourist Commercial (C2) to Rumbling Creek Tourist Commercial (C3). This is being sought to facilitate the development of tourist accommodations and associated buildings on the subject property with on-site servicing (septic system and drilled well). The proposed development includes eight cabins with a total of twelve sleeping rooms as well as one communal building. The Site Plan is included as Attachment 'B' and includes details on the proposed layout of the buildings and parking areas. The communal building is proposed to contain a commercial kitchen, laundry facilities and storage space as well as a coffee shop that will be open to the public. The communal building is also intended to be used as an event space (e.g. wedding venue) which is considered incidental and related to the Tourist Accommodation Use. The draft amending bylaw is included as Attachment 'A' to this report.

4626 Highway 6 Riparian Assessment

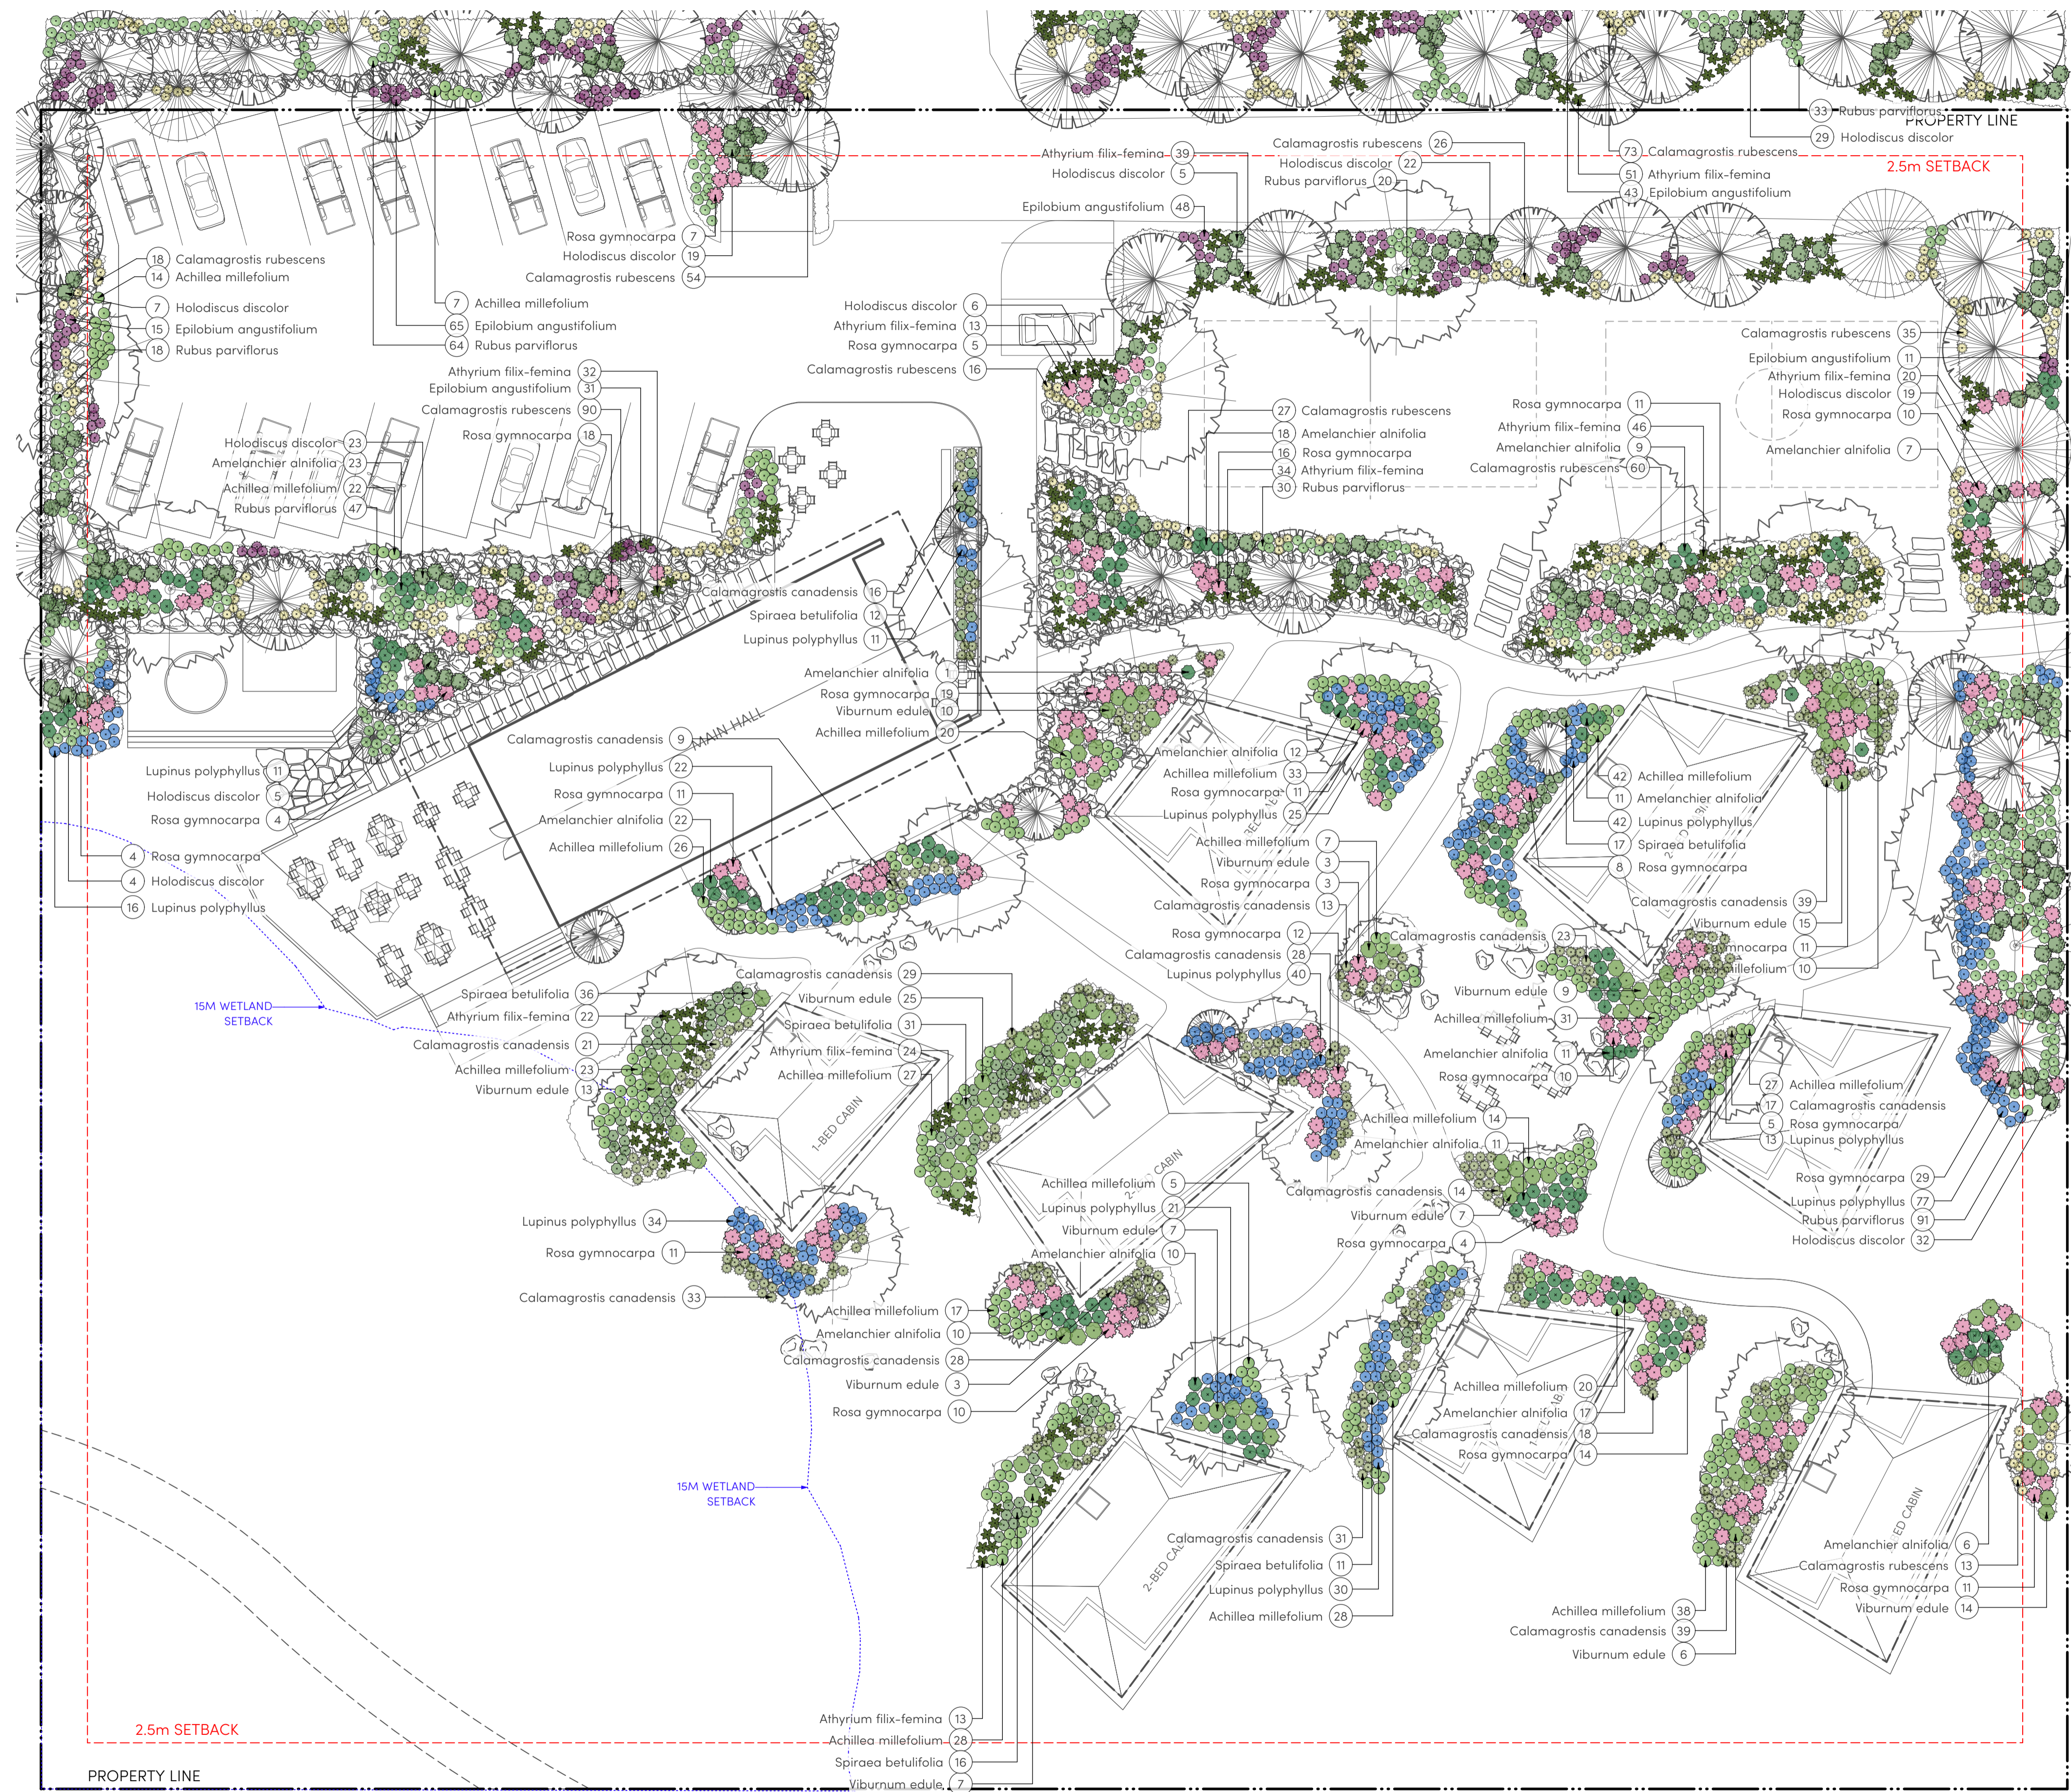
1 SHRUB PLANTING PLAN
Scale: 1:200

10. ALL PLANTING BEDS TO RECEIVE AUTOMATIC DRIP IRRIGATION AND/OR WATERED DURING THE ESTABLISHMENT PERIOD
