Development Permit Application

Referral Form – RDCK File DP2312G

4626 Highway 6, Hall Siding, Electoral Area 'G'
LOT 1 DISTRICT LOT 1241 KOOTENAY DISTRICT PLAN EPP121813
PID: 031-873-529

Riparian Assessment V1.1

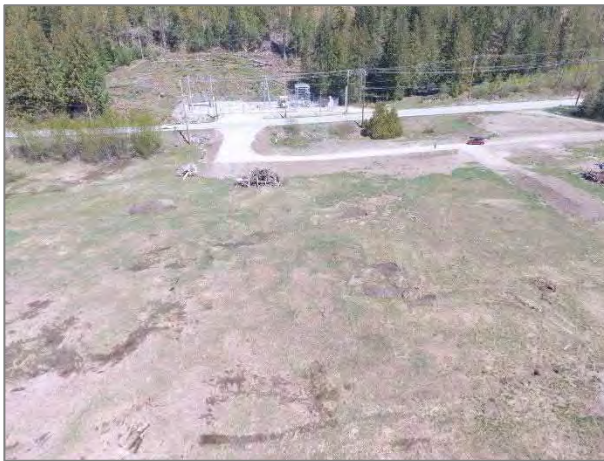
Photo 1. Aerial view of the property, looking northeast (May 10, 2023).

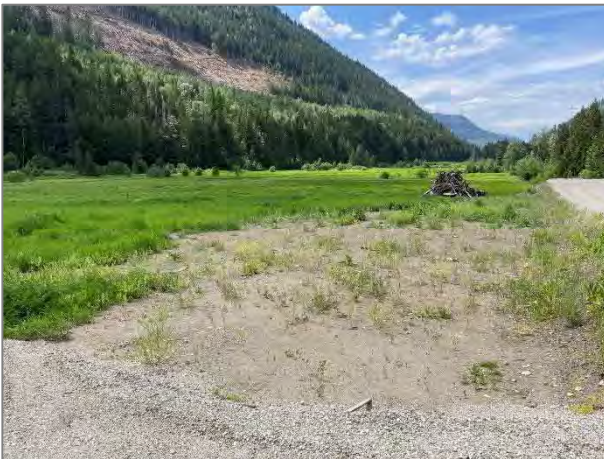
Photo 3. Photo taken from east corner, looking west (June 8, 2023).

The property has historically experienced site disturbances from past settlements and land clearing/agriculture activities (Photo 3). There is currently no building infrastructure on the property. The vegetation appears to be largely recovering from past disturbances through a legacy of a mix of agronomic grasses, including reed canary grass, and exotic species remain on the disturbed bench, with some scattered native sedges and shrubs (Photo 4). Areas of native vegetation exist within the wetland on the northwest corner of the property. Access to the property is from Highway 6 (Photo 5). There are steep embankments (>60% slope) leading up to the property driveway that was constructed on imported fill to the height of the highway (Photo 6).

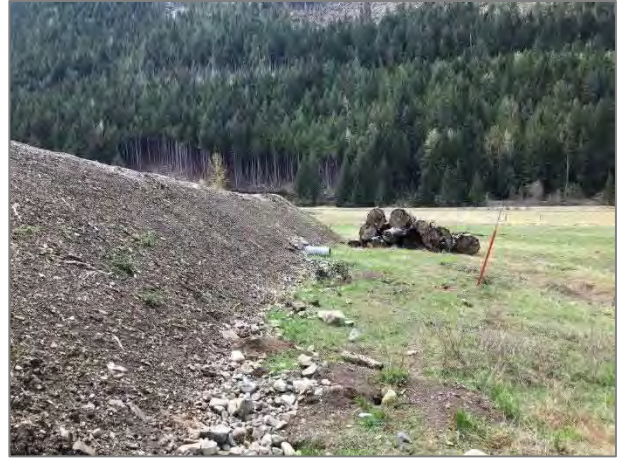
Photo 6. Access road embankment, looking west (May 10, 2023).

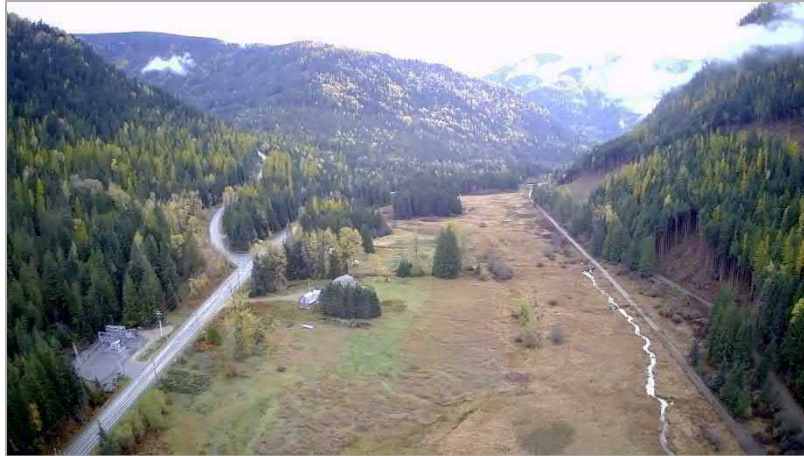
Photo 7. Aerial view of the property and wetland complex, looking south (Photo credit Jason Newton, fall 2021).

The headwaters of the Salmo River originate from an important wetland complex totaling ~9.3 ha (Photo 7), which is a sensitive ecosystem with regional significance as an important wildlife corridor. The Salmo River becomes a defined channel ~600 m north of the property. Wetlands are water-saturated for much of the year, with vegetation adapted to live in resultant water-logged and low oxygen soils (Mackenzie and Moran 2004). The vegetation community and site conditions on the property are in transition due to hydrologic changes caused by historical land clearing and water diversion of the melt water from Highway 6 into a ditch at the northwest and southwest property boundary (Photo 8, Photo 9).

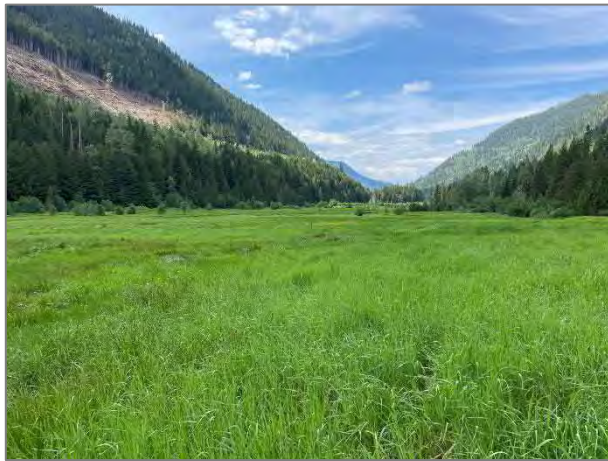
Photo 8. View of the disturbed area transitioning into the wetland, looking northwest (June 8, 2023).

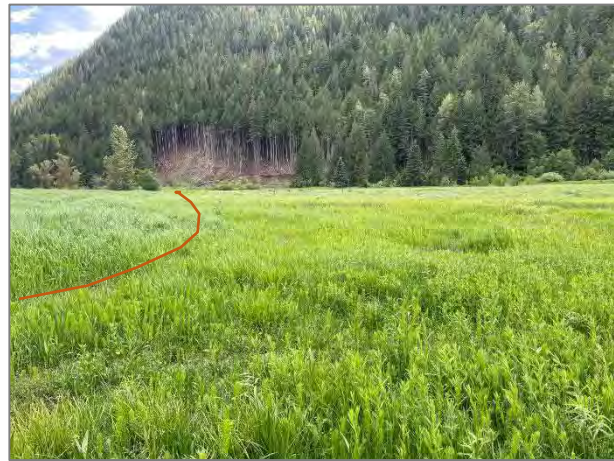
Photo 9. View of the natural boundary between the disturbed bench and the wetland, looking southwest (June 8, 2023).

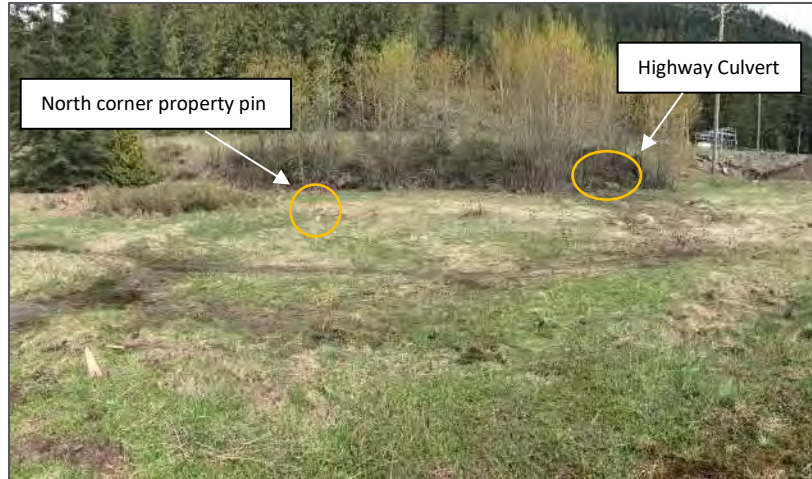
Photo 10. Location of highway culvert and north corner of the property (May 10, 2023).

Water is conveyed onto the property from a 600 mm culvert under Highway 6 (Photo 10, Photo 11) and originates from the highway ditch and a diversion ditch that appeared to have been constructed to divert water from Rumbling Creek to the property, possibly for historic irrigation purposes (Photo 12). The water source on the property is likely a combination of rainwater, snow melt and water from Rumbling Creek, which flows from the south end of the FortisBC substation and likely goes subsurface (Photo 13). The water from the culvert flows along the northwestern property boundary and eventually runs into the wetland and connects to a channelized ditch (Photo 12, Photo 13). The channelized ditch begins at the northwest corner of the property and flows south through the wetlands towards Nelson Nordic Ski Club (Photo 16). Seepage areas were also noted throughout the northwestern half of the property (Photo 17; Appendix 3), where saturated soils were present due to the high water table at ~15 - 20 cm depth (Photo 18).

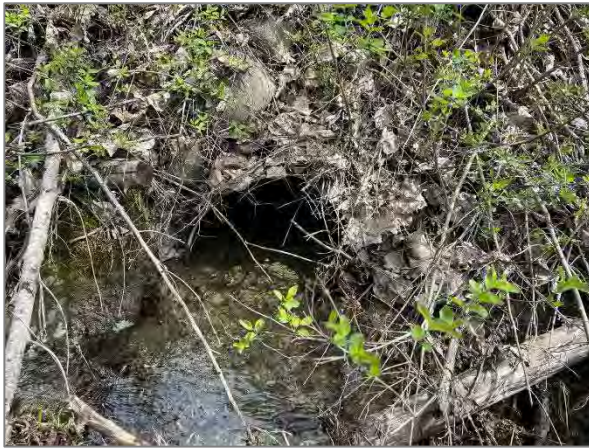
Photo 11. Water flow from culvert underneath highway 6 (May 10, 2023).

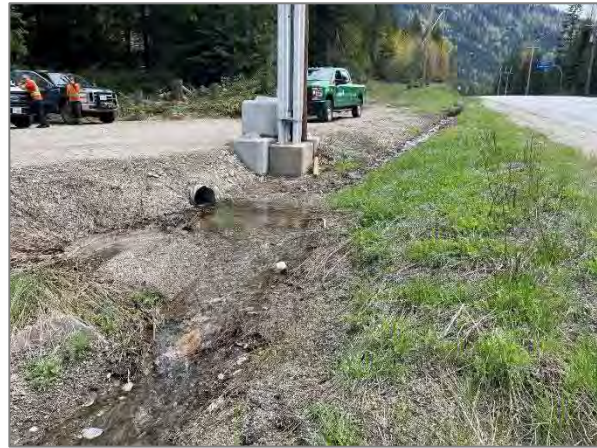
Photo 12. Ditch on the north side of Highway 6, supplying water to the property (May 10, 2023).

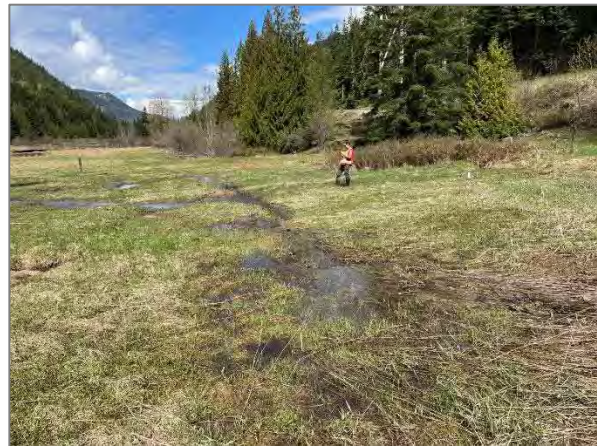
Photo 14. Surface water flow on northwest property boundary, from highway culvert (May 10, 2023).

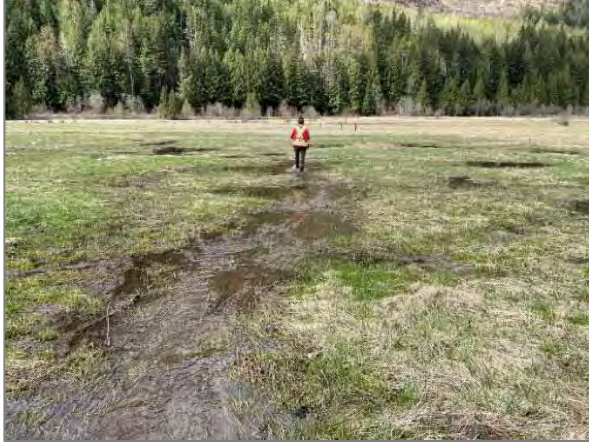
Photo 15. Surface water flowing west towards the wetland, along the northwest property boundary (May 10, 2023).

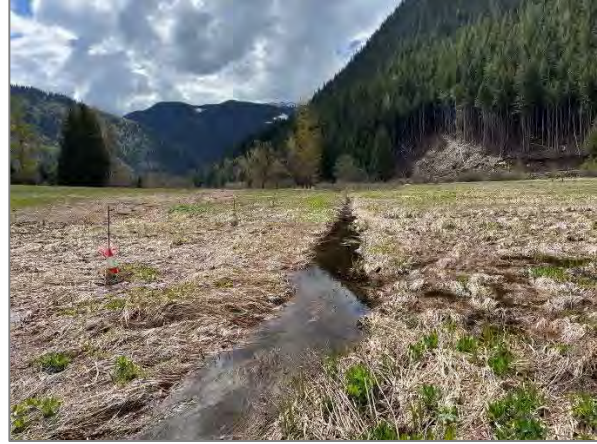
Photo 16. Channelized ditch west of property (May 10, 2023).

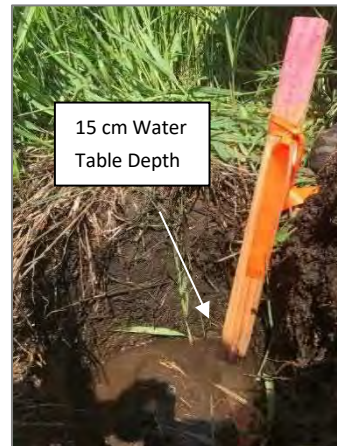
Photo 18. Water table located in the 15 m setback (June 8, 2023).

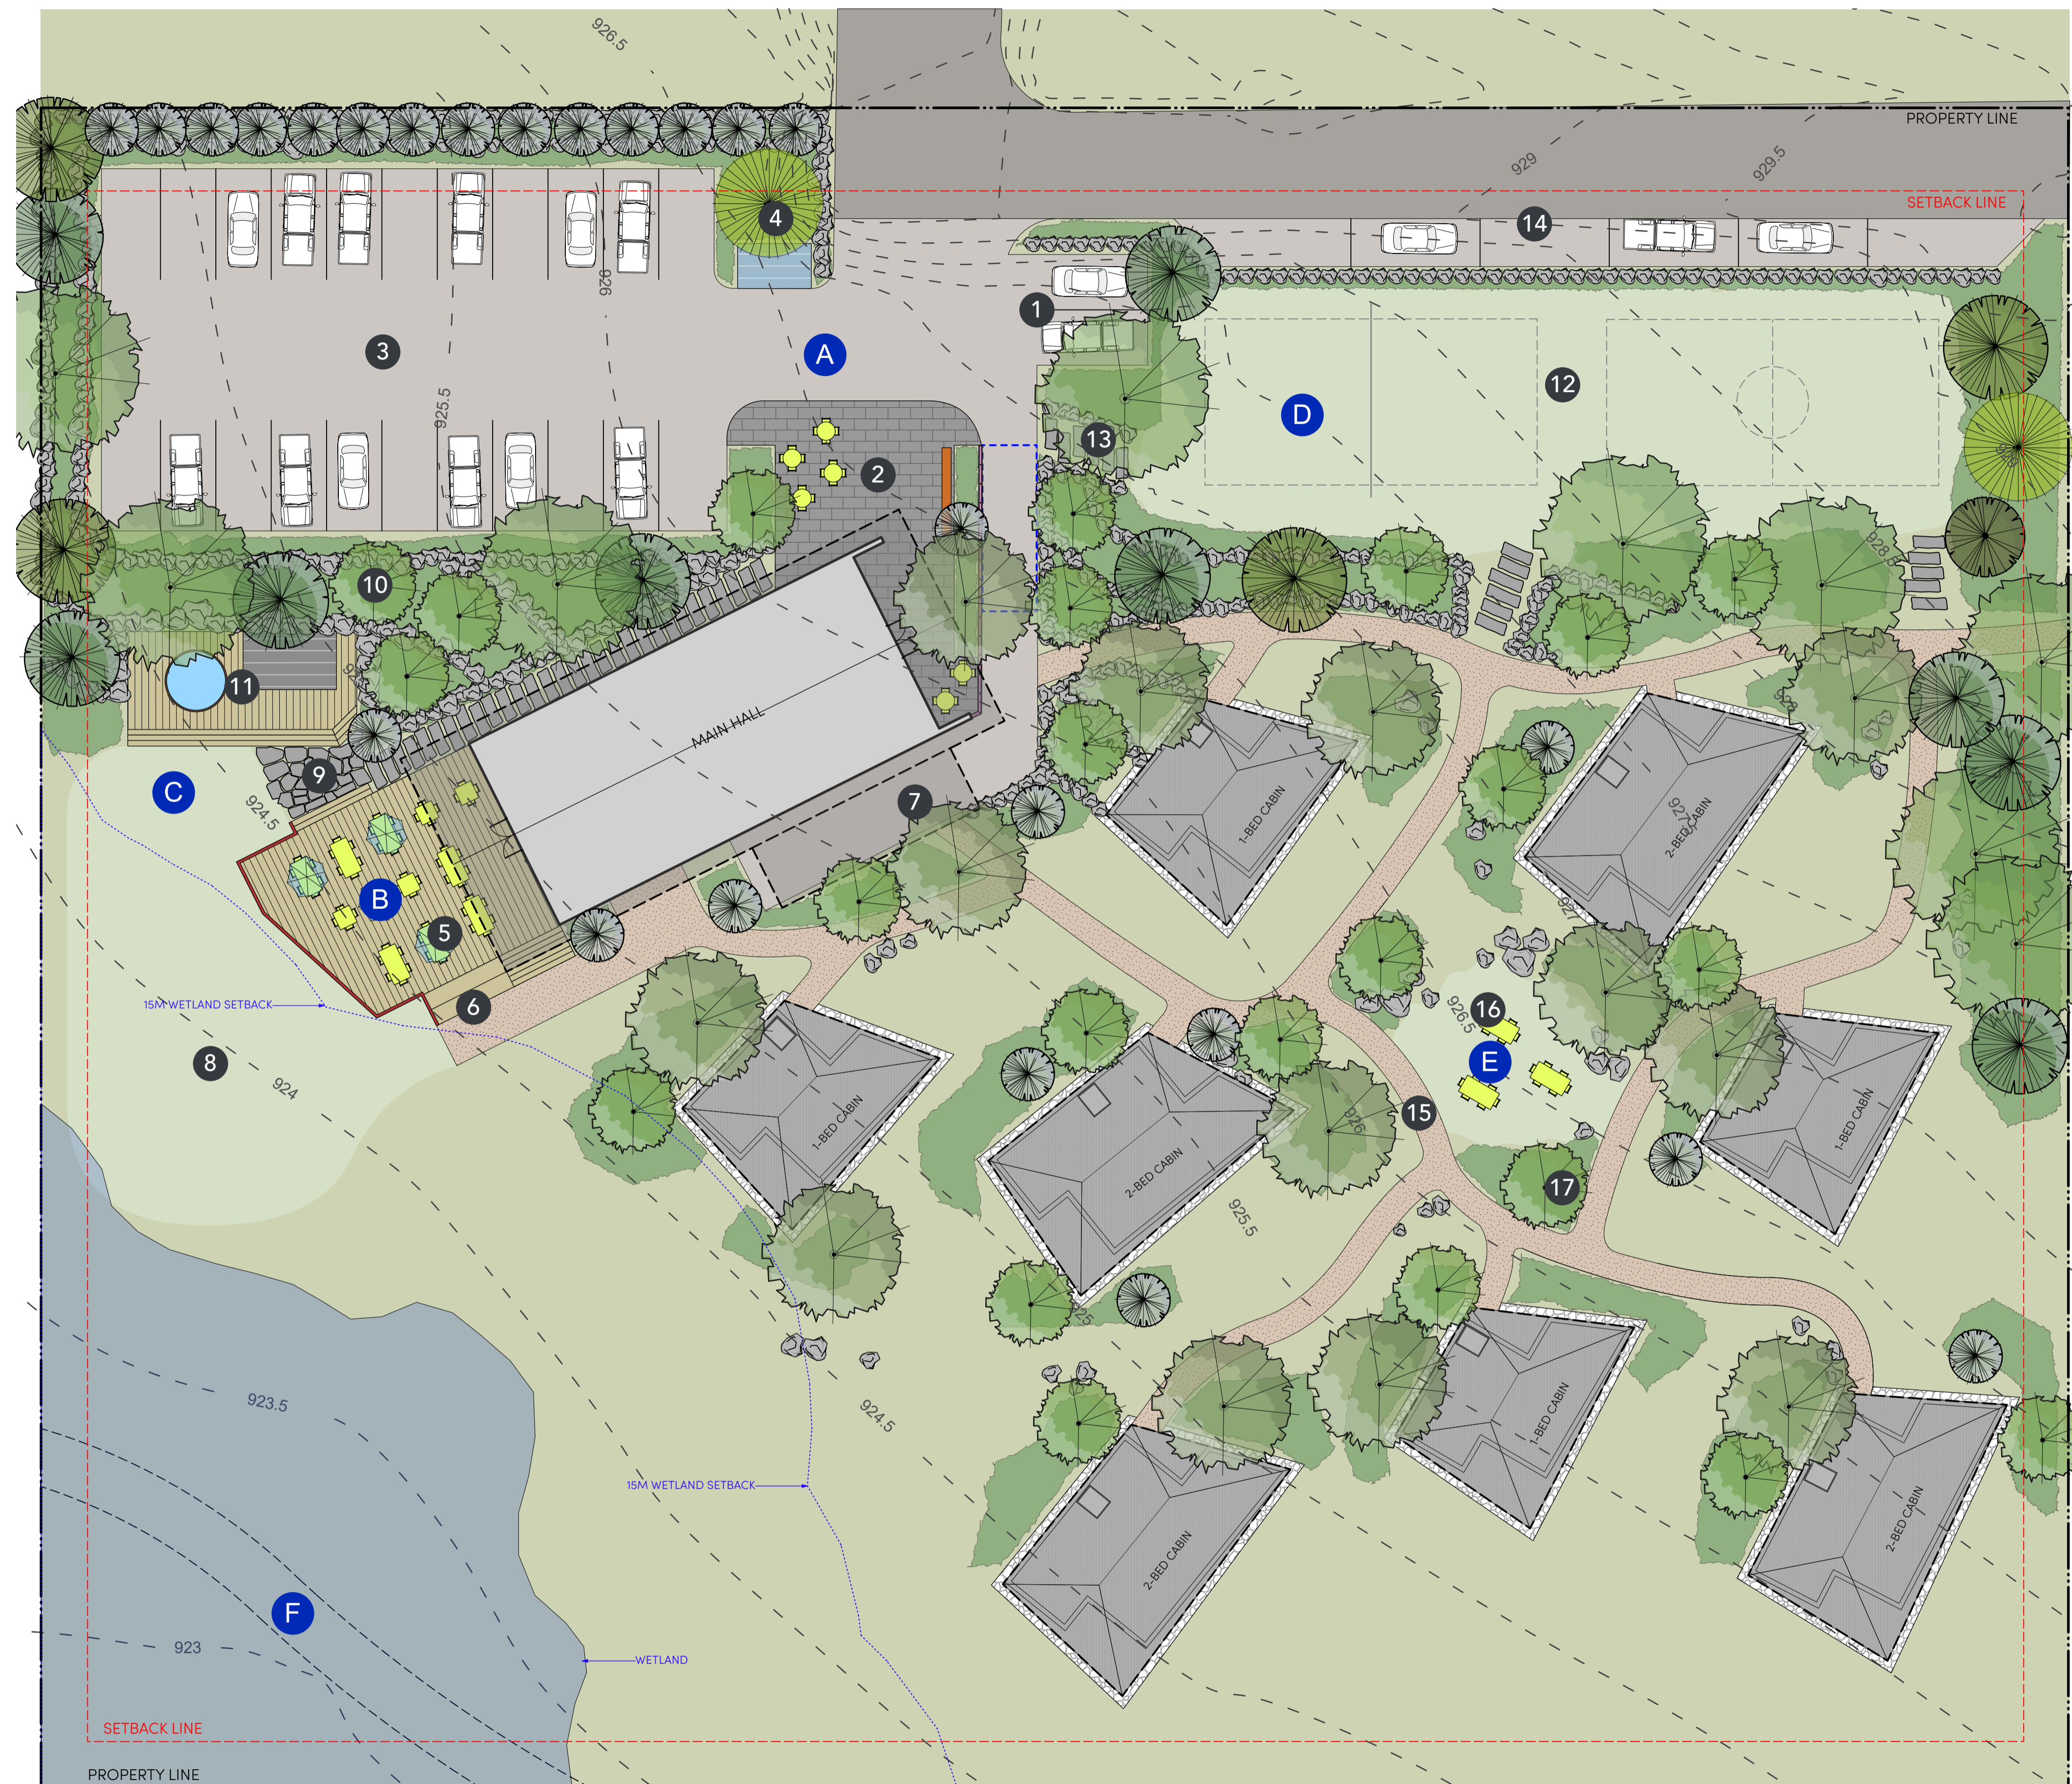
1 LANDSCAPE ILLUSTRATIVE PLAN
Scale: 1:200

- A** ARRIVAL COURT + PARKING
- 1** RETAIL PARKING
- 2** FRONT ENTRY FEATURE PAVERS + BENCH SEATING + CAFE TABLES
- 3** GRAVEL PARKING LOT
- 4** GARBAGE ENCLOSURE
- B** SOCIAL DECK (RAISED)
- 5** RAISED DECK WITH MOVEABLE FURNITURE
- 6** SEAT STEPS/INFORMAL SEATING
- 7** ACCESS DRIVE WITH CONCRETE RETAINING WALL
- C** OVERLOOK LAWN + SAUNA / COLD PLUNGE
- 8** MOWED LAWN WITH EXPANSIVE VIEWS
- 9** FLAGSTONE LANDING
- 10** NATURALIZED BUFFER PLANTING SCREENING PARKING LOT + GRADE TRANSITION
- 11** SAUNA + COLD PLUNGE WITH DECK BUILT INTO SLOPE
- D** MULT-USE LAWN / SEPTIC FIELD
- 12** MOWED LAWN / FOR GAMES / RECREATION
- 13** PATH TO ROAD
- 14** PARALLEL PARKING
- E** CENTRAL COMMON AREA
- 15** GRAVEL PATH 5' WIDE
- 16** PICNIC TABLES + SEATING BOULDERS
- 17** MEADOW GRASSES + WILD FLOWERS + NATURALIZED PLANTING
- F** NNSC SEASONAL CROSS COUNTRY SKI TRAIL

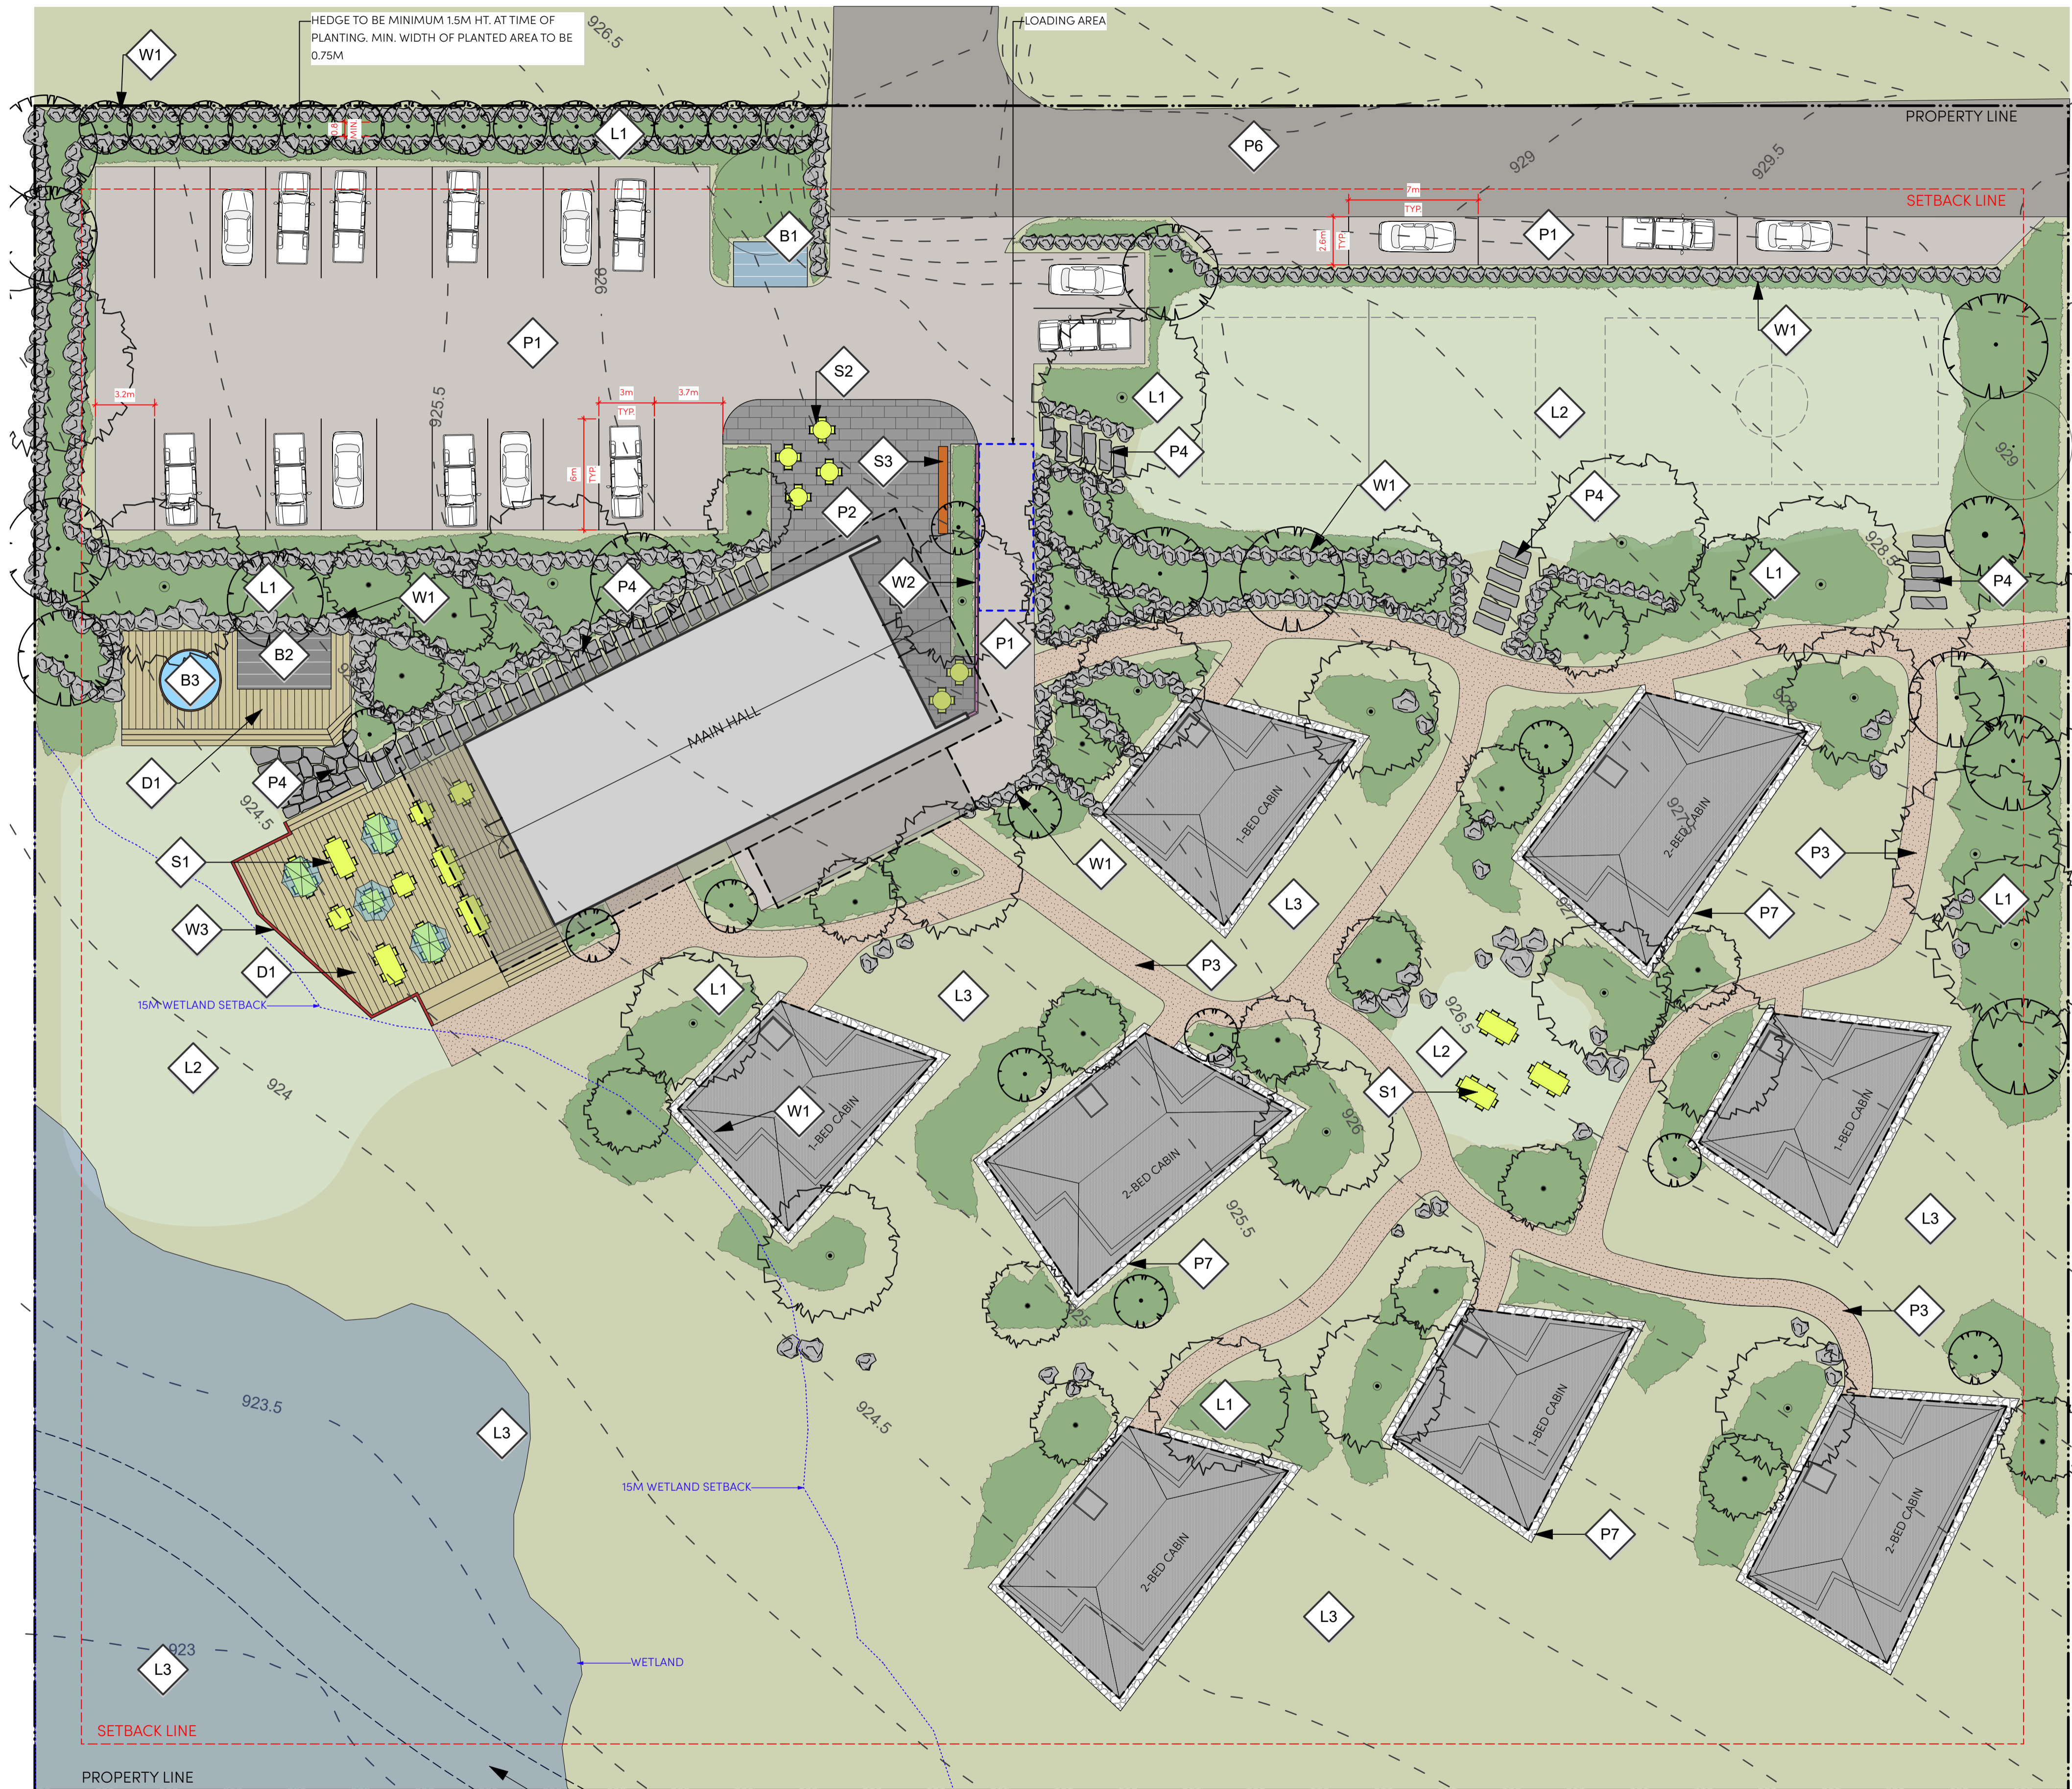
1 MATERIALS PLAN
Scale: 1:200

SYMBOL	KEY	DESCRIPTION
	P1	PAVING TYPE 1: GRAVEL PARKING LOT Compacted 3/4" Minus Road Mulch
	P2	PAVING TYPE 2: MAIN HALL ENTRY PAVING Precast Concrete Unit Pavers By Barkman Size: 900 X 450 X 100 mm - Colour: Ash
	P3	PAVING TYPE 3: GRAVEL PATHWAYS 3/8" Minus Limestone Rock Dust
	P4	PAVING TYPE 4: STONE SLAB PAVING Basalt Stone Slabs - Size Varies
	P5	PAVING TYPE 5: FIREPIT PAVING Storm Mountain Select Flagstone 1'-2" By Northwest Landscape Supply
	P6	PAVING TYPE 6: ACCESS ROAD PAVING By Others
	P7	PAVING TYPE 7: RAIN SPLASH STRIP Locally Sourced 3" Rock Mulch
	D1	WOOD DECKING Thermally Modified Ash By Scotty Wood
	S1	MOVEABLE BANQUET TABLES + BENCH Product TBD, by Owner
	S2	MOVEABLE CAFE TABLES + CHAIRS Product TBD, by Owner
	S3	ENTRY PLAZA BENCH Heavy Timber Bench, 4.7m Length
	B1	GARBAGE ENCLOSURE By Others
	B2	NORDIC SAUNA By Others
	B3	COLD PLUNGE TUB by Others
	W1	BOULDER / BOULDER WALLS Locally Sourced Granite Size: 300 - 400 mm

W2	CONCRETE RETAINING WALL CIP Concrete Wall with Guardrail (1070mm Ht.) To be Coordinated with Structural and Geotechnical Engineer
	W3	GUARDRAIL Guardrail Material TBD 42" Height
	L1	NATURALIZED PLANTING Assorted Deciduous and Coniferous Trees, Shrubs, Grasses, Perennials, and Boulder Clusters
	L2	LAWN HYDROSEED MIX - REGULARLY MOWED Native Grass Species
	L3	PERENNIAL HYDROSEED MIX - MOWED ONCE PER YEAR Colourful Native Perennials + Grass Species
