Development Permit Application

Referral Form – RDCK File DP2404Hn

243 Island View Road, Nakusp, B.C.
Riparian Assessment V1.0

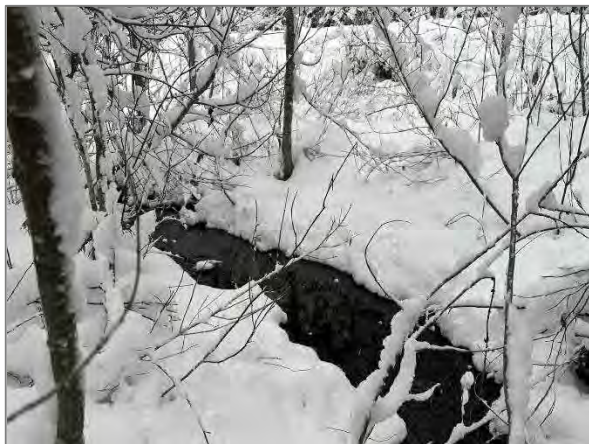
Photo 2. View of unnamed stream crossing north-east section of property.

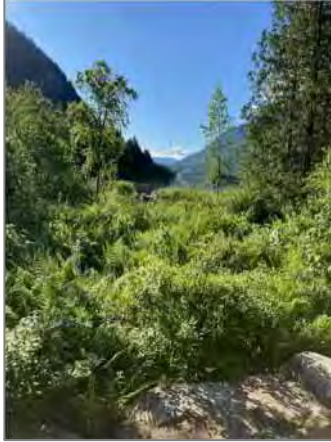
Photo 3. View of swamp between property and Summit Lake (Photo by Owners) .

The subject property supports both undisturbed and disturbed riparian habitat. The undisturbed riparian habitat is located along the northern and eastern property boundaries and consists of wetland habitat (Photo 3 thru Photo 6). The dominant species in the swamp are mountain alder (Photo 9), pink spirea, and sedge sp. The sedge genus could not be identified due to snow cover during the site visit. Additional vegetation species observed in the swamp include paper birch (*Betula papyrifera*), willow sp (*Salix* sp.), red osier dogwood (*Cornus sericea*), wild raspberry (*Rubus idaeus*) and lady fern (*Athyrium filix-femina*). A mixed riparian forest stand with dominant Western red cedar exists within the north-west portion of the property (Photo 10).

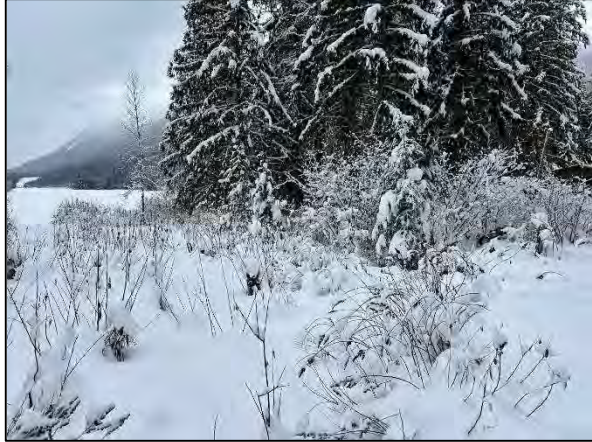
Photo 4. View of swamp between subject property and Summit Lake during winter.

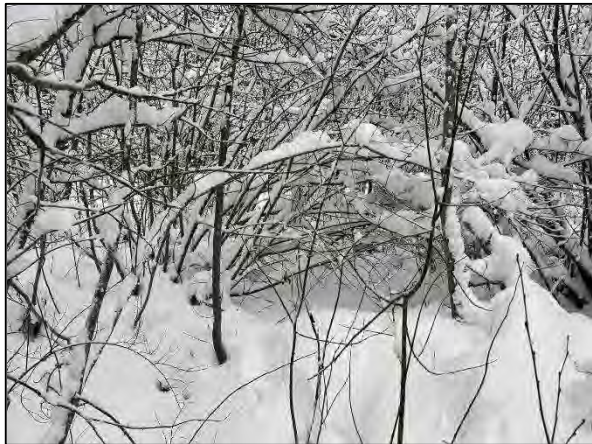
Photo 6. View of swamp along northern property boundary during winter.

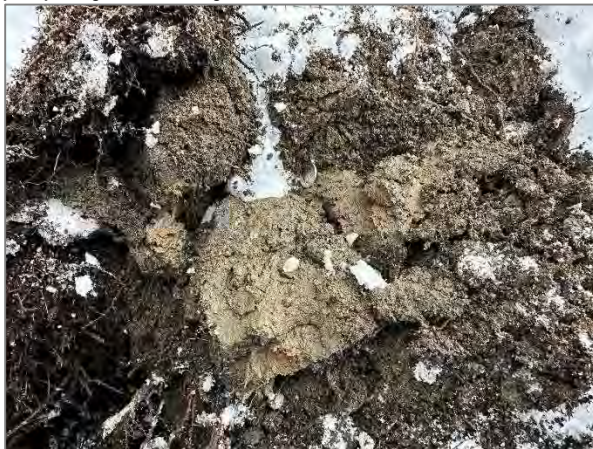
Photo 7. Soil test pit dug within along swamp perimeter-dark organic soil over silty clay layer.

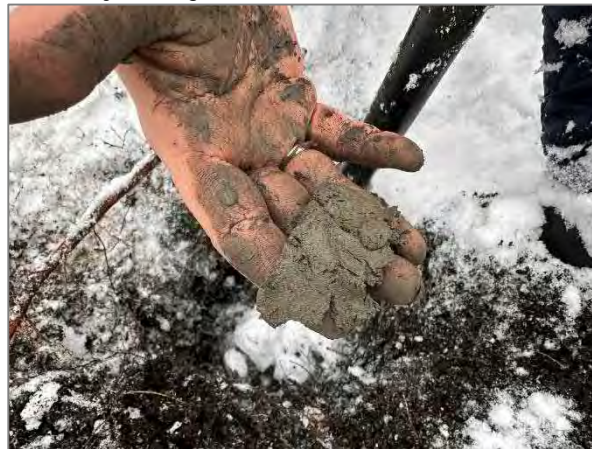
Photo 8. Silty clay layer soil sample taken from test pit within swamp.

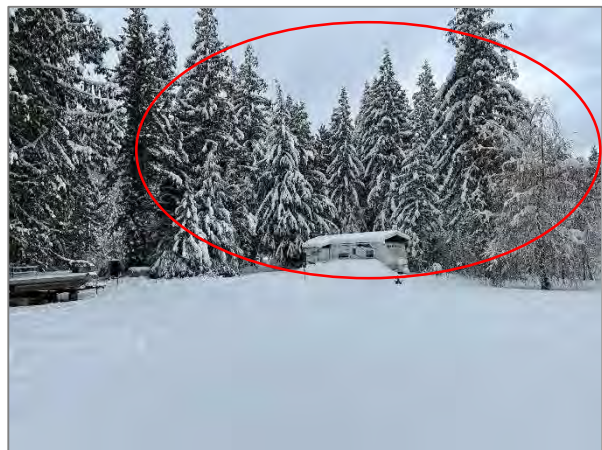
Photo 10. Mixed riparian forest stand within north-west portion of property.

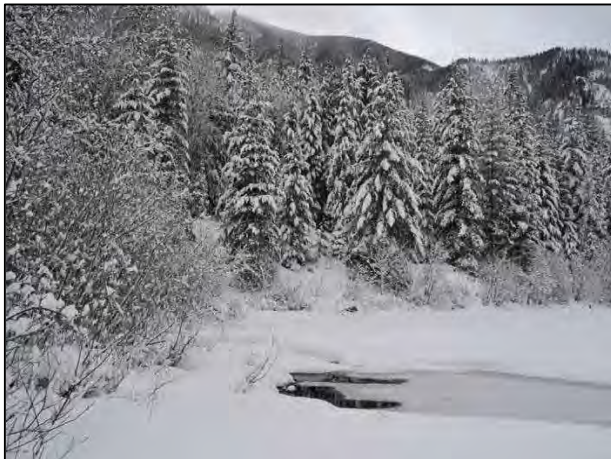
Photo 11. Mouth of unnamed stream into Summit Lake.

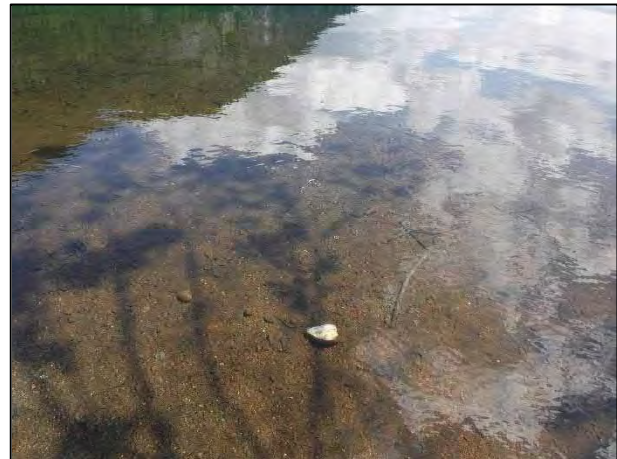
Photo 12. Typical substrate along the foreshore of Summit Lake (Masse 2022).

The Summit Lake foreshore is predominantly low gradient riparian and lake margin. Substrate along most of the shoreline consists of fine sediment, organics and small angular gravel (Photo 12). Emergent aquatic vegetation occurs along the fringe of the lake including yellow pond lily (*Nuphar lutea*), water sedge (*Carex aquatilis*), bluejoint reedgrass (*Calamagrostis canadensis*), shore sedge (*Carex lenticularis*) and common spike-rush (*Eleocharis palustris*) with an abundance of overhanging vegetation (Photo 13). Aquatic and overhanging vegetation provide high value cover habitat for fish, while the shallow waters also provide juvenile rearing habitat.

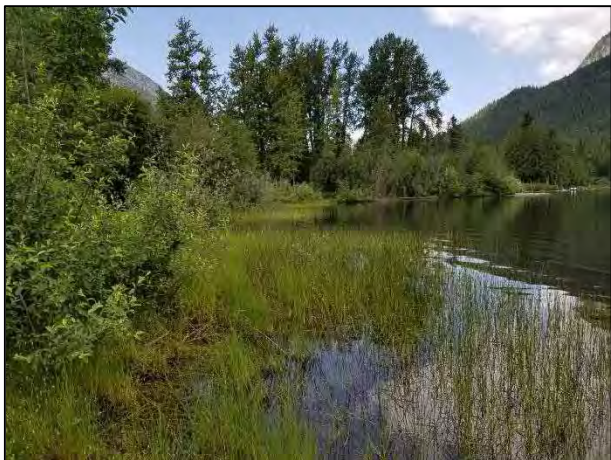
Photo 13. Typical emergent and overhanging vegetation along the foreshore of Summit Lake (Masse 2022).

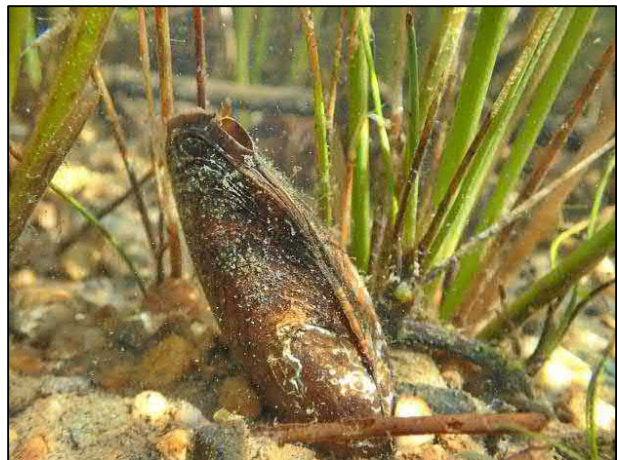
Photo 14. Underwater photo of live mussel in Summit Lake (Masse 2022).

Freshwater mussel beds have been confirmed along the south shoreline of Summit Lake (Photo 14). Mussel beds in Summit Lake are mostly concentrated between 5-10 m horizontal distance from shore at water depths between 0.75-1.5 m. Mussel species present are the Western Floater (*Anodonta kennerlyi*; Masse 2022). An underwater survey for freshwater mussels was not conducted along the shoreline of the property.

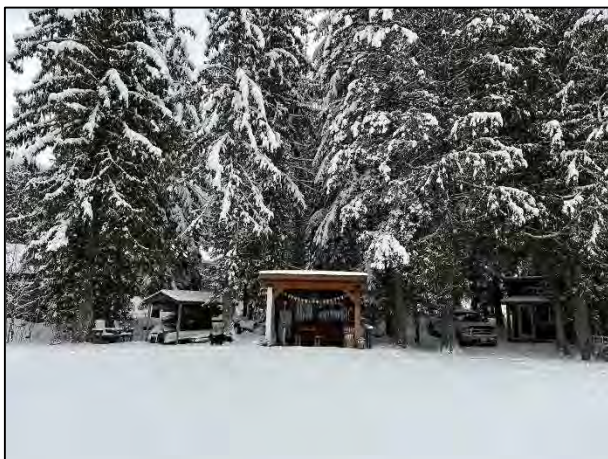
Photo 17. View of boat storage, outdoor kitchen and bunkhouse

Development outside of the 30 m riparian area consists of an outdoor kitchen structure, boat storage shelter and a bunkhouse (Photo 17). The property is serviced by groundwater, which is extracted from two private wells (Photo 18). Refer to the Site Plan (Appendix 3) for structure locations.

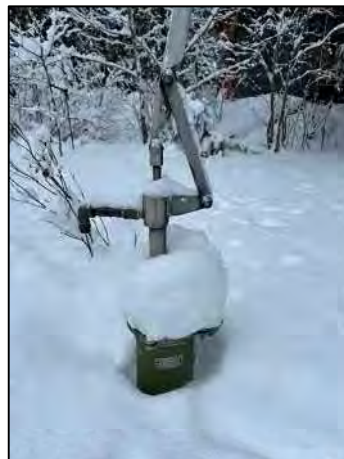
Photo 18. View of water pump at well location.

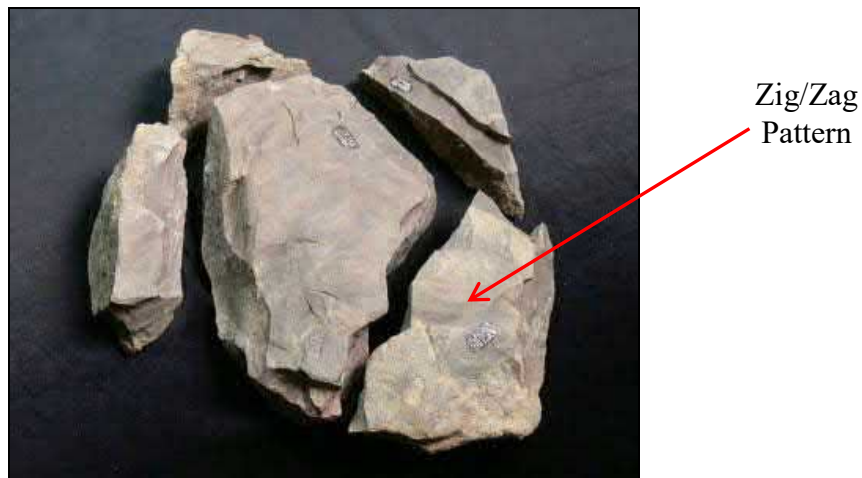
Image 7: Example of FBR; note the zig/zag pattern of breakage common to FBR. A hearth feature is evidence of a fire pit or other fireplace feature of any period. Hearths were used for cooking, heating, and processing of some stone, wood, faunal, and floral resources and may be either lined with a wide range of materials like stone or left unlined. Occasionally site formation processes (e.g., farming or excavation) deform or disperse hearth features, making them difficult to identify without careful study.

When looking for FBR, note concentrations of roughly fractured rock from rapid heating and cooling, rock showing signs of burning or oxidation and/or reddening or blackening of surrounding matrix.

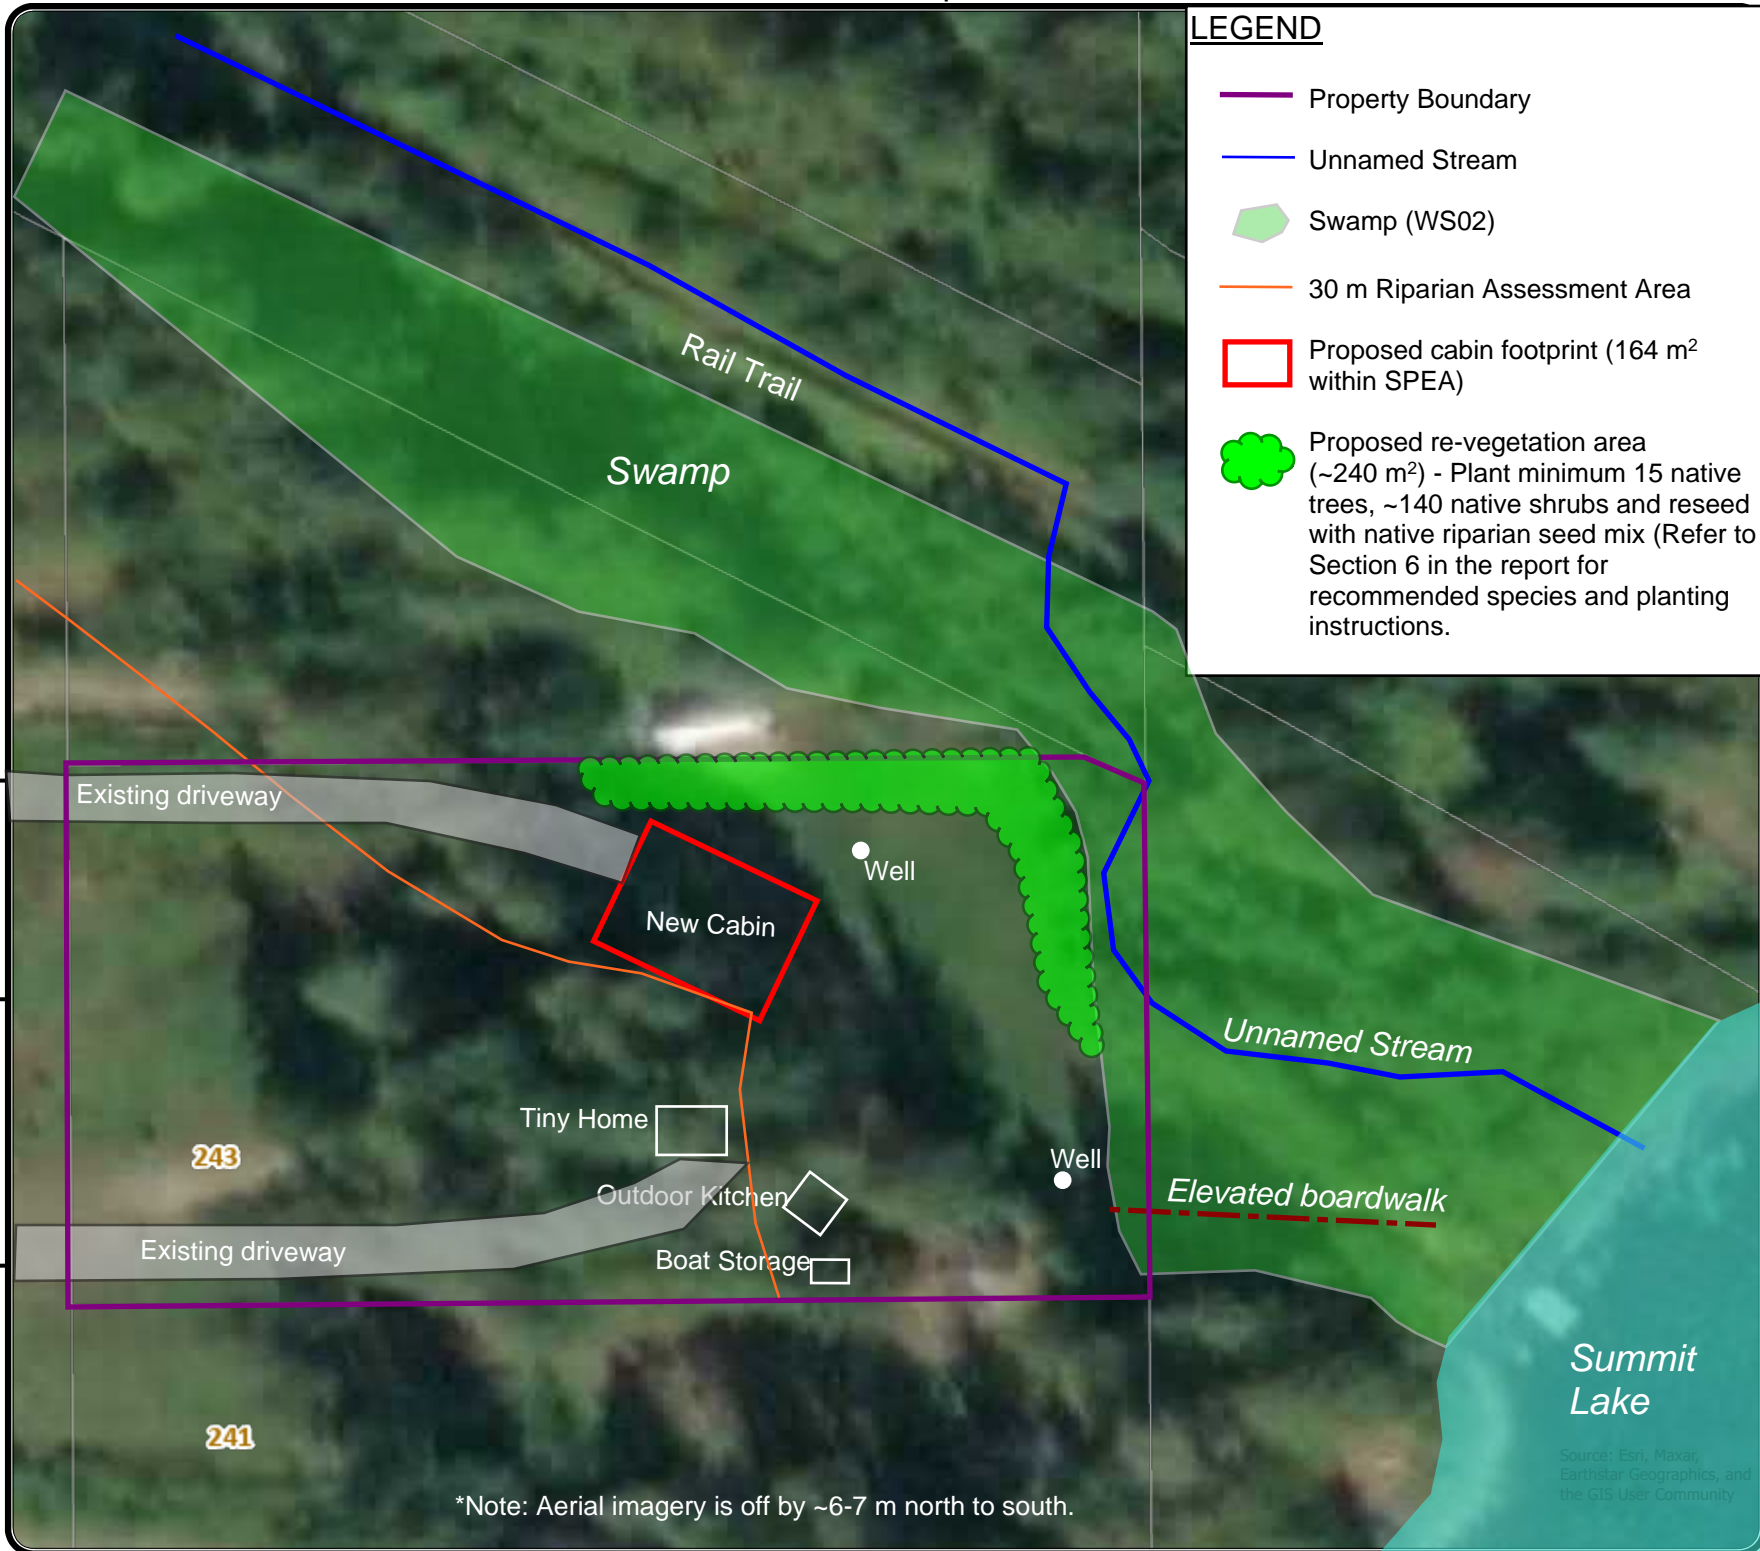
- Property Boundary
- Unnamed Stream
- Swamp (WS02)
- 30 m Riparian Assessment Area
- Proposed cabin footprint (164 m² within SPEA)
- Proposed re-vegetation area (~240 m²) - Plant minimum 15 native trees, ~140 native shrubs and reseed with native riparian seed mix (Refer to Section 6 in the report for recommended species and planting instructions).

*Note: Aerial imagery is off by ~6-7 m north to south.

The revegetation prescription entails removing the turf, loosening the soil, and revegetating the restoration area with 15 native trees (replacement ratio of 3:1 for trees removed), 140 native shrubs, and a native riparian seed mix. Refer to Appendix 5 for the proposed restoration area. A list of recommended plant species is provided in Table 4 with the recommended riparian seed blend prescribed in Table 5. Plant species were selected based on their suitability for the property (ecoregion, exposure, and moisture regime). The restoration area will require using a combination of live cuttings (collected locally), native potted stock (4" to 5 gallon pot size) and re-seeding with specifically formulated herbaceous seed blend.
