**REGIONAL DISTRICT OF CENTRAL KOOTENAY**  
**DEVELOPMENT PERMIT**  
**D1907D-03042.200-PEETERS-DP000091 (D1907D)**

Date: October 11, 2019

**10182, HIGHWAY 31  
SHUTTY BENCH, BC  
Riparian Assessment**

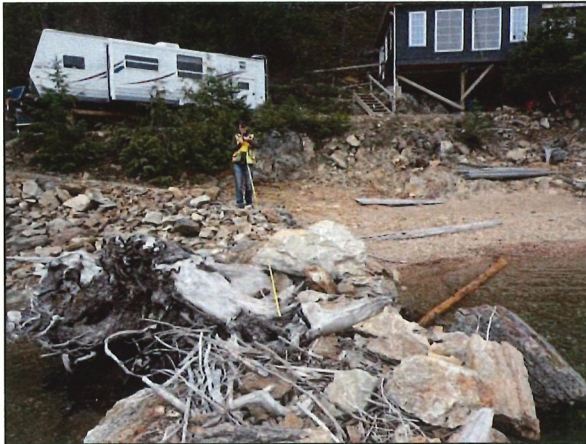
The high water mark (HWM) indicated on the site drawings from plan 8063 is located at ~536.6 m elevation (Photos 1 & 2). An application for an accretion of crown land was successful and the re-surveyed present natural boundary is at 533.5 m, as shown on the attached site plan (Appendix 2). The riparian setbacks were measured from the surveyed present natural boundary (Appendix 4).

Photo 1. Kootenay Lake high water mark and water level April 12, 2017.

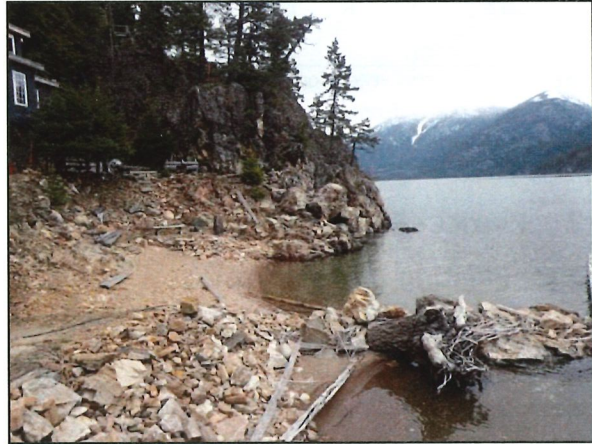
Photo 2. Kootenay Lake high water mark between the beach and the building, April 12, 2017.

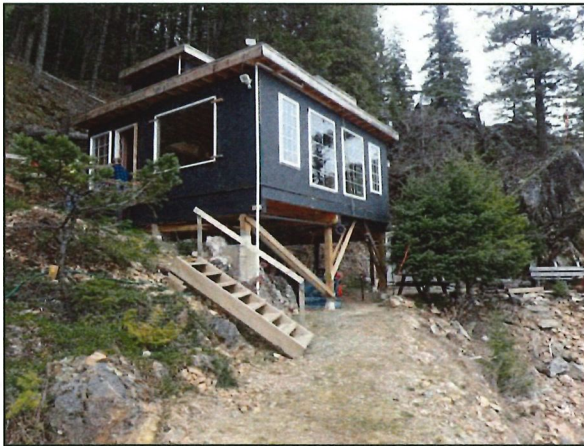
Existing development on the property consists of a 69.0 m<sup>2</sup> cabin, 6.0 m<sup>2</sup> outbuilding and ~4.0 m<sup>2</sup> outhouse constructed on a flat bench at the east end of the property that borders Kootenay Lake. The existing cabin was constructed in 2016 and is sited 4 m from the present natural boundary and completely within the 30 m WDP area and the 15 m SPEA. The cabin sits on concrete footings and posts and is located on one of the few benched areas of the property. A shared access road descends steeply from the highway to the four leasehold properties along the lakeshore. Currently the leaseholder has permission to use the driveway fronting the neighbouring property to the south to access a parking area (Photo 5). In addition, a small parking spot is located above the cabin. A wood staircase (~2 m<sup>2</sup>) is located on the south side of the cabin (Photo 3), providing access to the parking and foreshore area. Development within the foreshore includes an existing groyne to the south of the cabin (Photos 10 and 12). The remaining property is largely undeveloped.

Photo 3. Existing cabin constructed on bench within the 30 m WDP and 15 m SPEA.

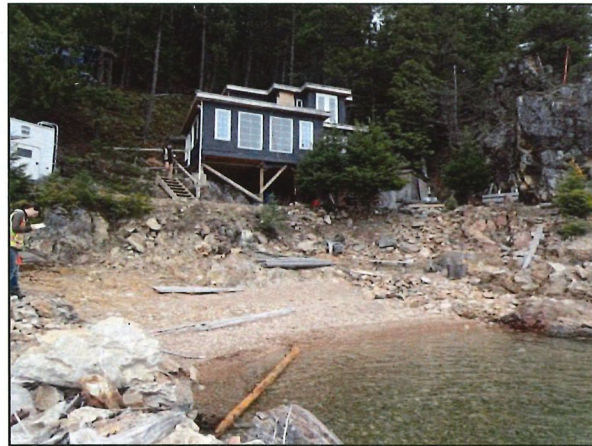
Photo 4. Looking west towards the cabin and outbuilding.

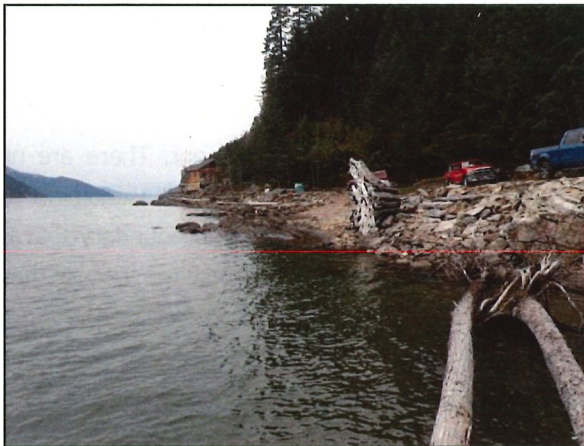
Photo 5. Parking area to the south of the cabin.

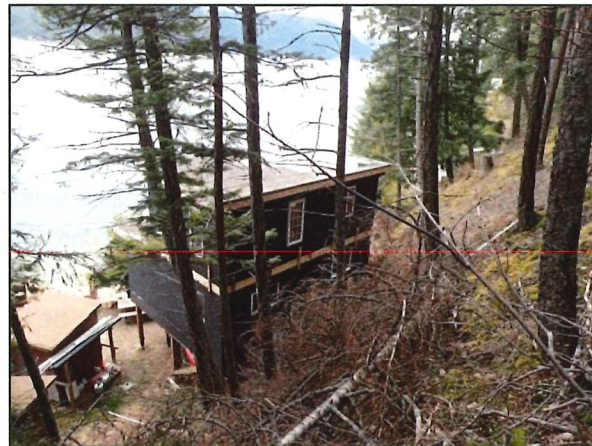
Photo 6. Looking east towards Kootenay Lake at outbuilding, cabin, and outhouse.

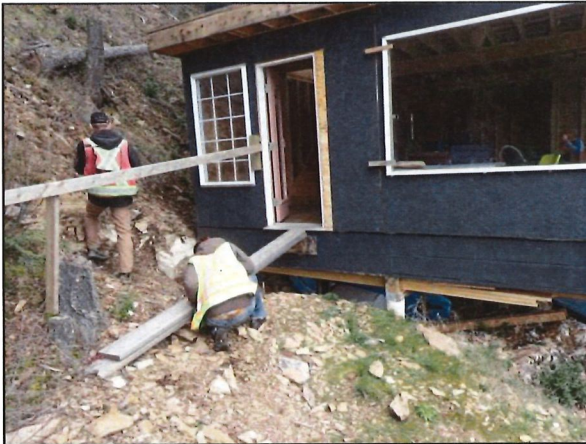
The leaseholder is considering building a deck off the south facing door of the cabin to connect a staircase that has been built on bedrock (Photo 7). There are also preliminary plans for a staircase to be constructed from the upper access road down to the south door of the cabin (Photo 8). The property leaseholder has informal plans to build this staircase with minimal ground disturbance or vegetation removal other than a top landing at the upper property access road (C. Campbell, pers. com, September 22, 2018). See Appendix 3 for proposed development plans provided by the property leaseholder.

Photo 7. Approximate location of proposed deck off south door of cabin to connect existing staircase down to foreshore area, April 14, 2017.

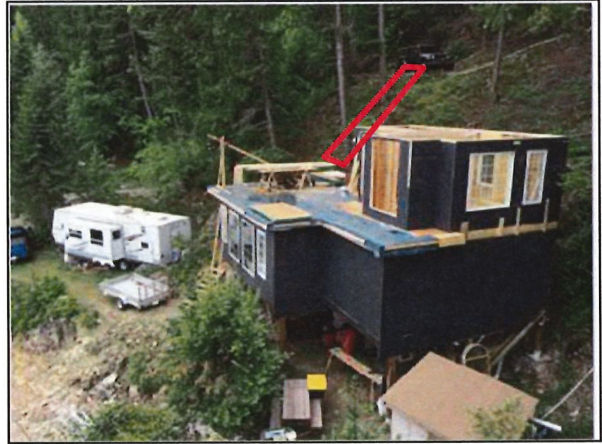
Photo 8. Approximate location of proposed staircase development (marked up in red) from top parking area down to cabin south side. Photo provided by the property leaseholder.

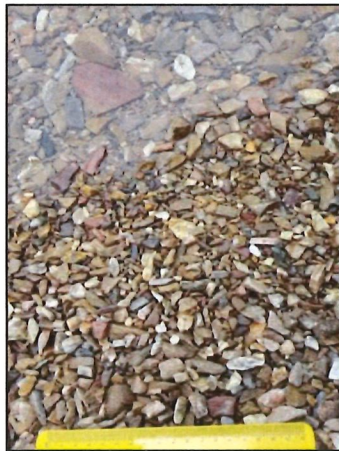
Photo 9. Beach substrate composed of angular gravel and cobble.

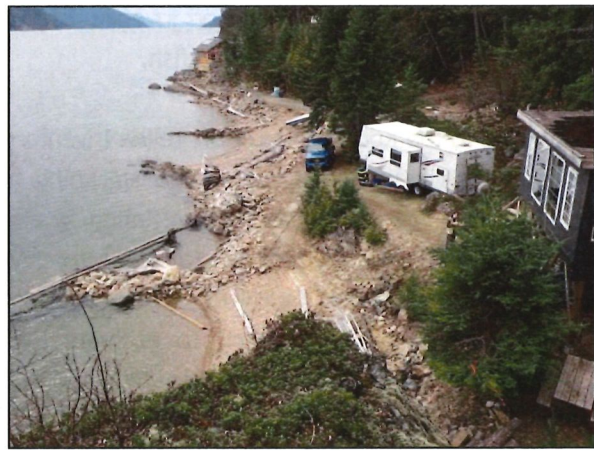
Photo 10. Shoreline looking south towards adjacent properties. Note presence of small and large cobbles, boulders, and large woody debris.

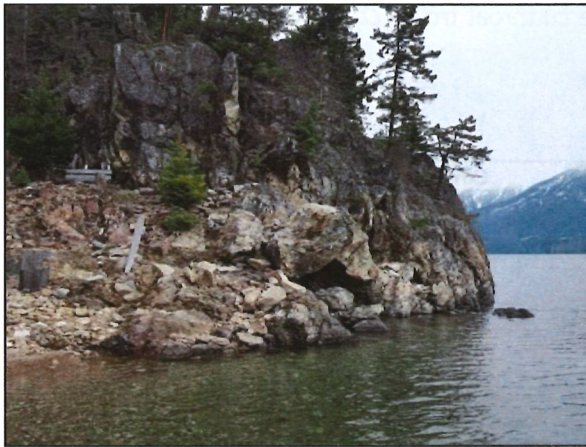
Photo 11. Shoreline composed of rocky cliffs and boulders on the north edge of the property.

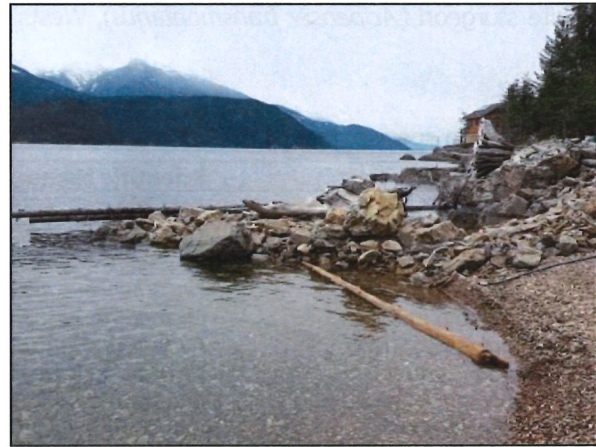
Photo 12. South view of rock groyne in front of subject property.

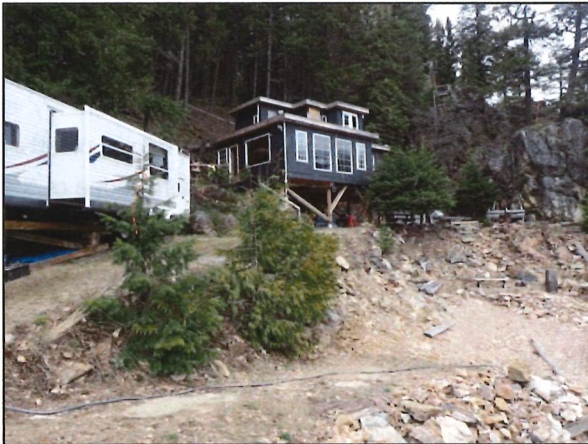
Photo 13. Driveway access showing small trees that appear immature or stunted from growing conditions.

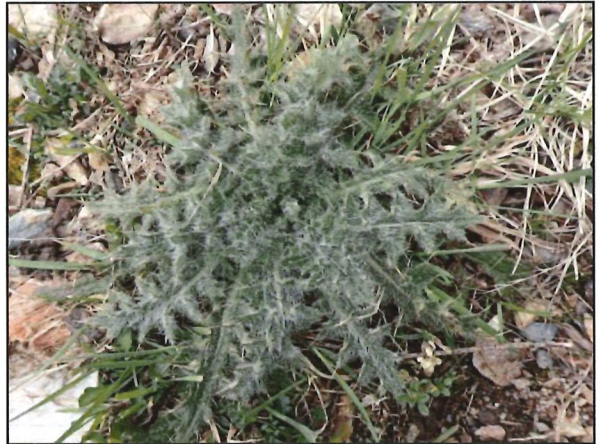
Invasive species noted on the site include great mullein, spotted knapweed, English ivy, and bull thistle (Photo 14 and 15). The leaseholder also mentioned burdock growing along the road (C. Campbell, pers. com, August 30, 2018). According to the Central Kootenay Invasive Species Society, English ivy is prioritized to contain to gardens so it doesn't spread into natural areas, transportation corridors, or other "natural" lands. As the English ivy noted on site is climbing up the bedrock cliffs on the north edge of the property, this could be a candidate species for control. A list of plant species encountered within the 30 m WDP area and on the slope above the cabin site is presented in Table 3.

Photo 14. Bull thistle noted on property.

bull thistle. The following mitigation measures are recommended in order to reduce the establishment and proliferation of invasive plant species on site:

- After construction, property owners should monitor areas of disturbed soils for the establishment of invasive plant species. New and known species of invasive plants found colonizing disturbed areas should be removed by hand, and disposed of.

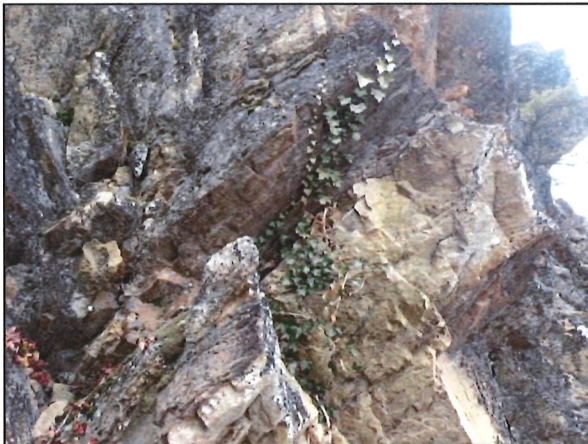
Photo 15. English ivy on bedrock cliffs on the north edge of the property.

In addition, it is recommended that the English ivy be controlled by hand pulling and cutting of vines in late summer or fall, when plants are easier to remove. Above ground vines should be cut and pulled so no rooted portions re-grow. Mechanically removed plants should be bagged and disposed of properly in a landfill, where plants cannot set new roots. Other species noted on site, although not prioritized regionally or provincially for immediate eradication, should be removed to encourage native ground cover to re-establish.

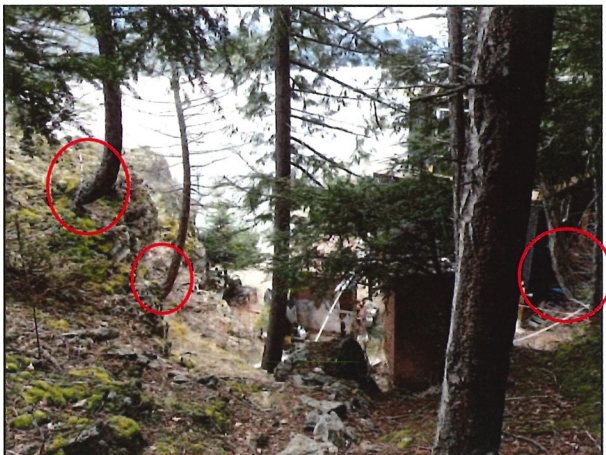
A geotechnical assessment was completed by Norm Deverney, P.Eng on April 12, 2017 in conjunction with the environmental assessment. Please refer to his report for assessment findings and recommendations. There are minor signs of long term slope mobility, as evidenced by curved trees with a sweeping trunk shape (Photo 16) that have adjusted to slope movement over their growing life (as per Table 3.8 of the RAR, BC, 2015).

Photo 16. Slope mobility over a longer time period evidenced by sweeping/curved tree trunks growing on the slopes to the north and west of the cabin
