DEVELOPMENT PERMIT

DP2115A-05146.000-May-DP000120

Riparian Area Assessment Report

10377 Highway 3A, Gray Creek, BC

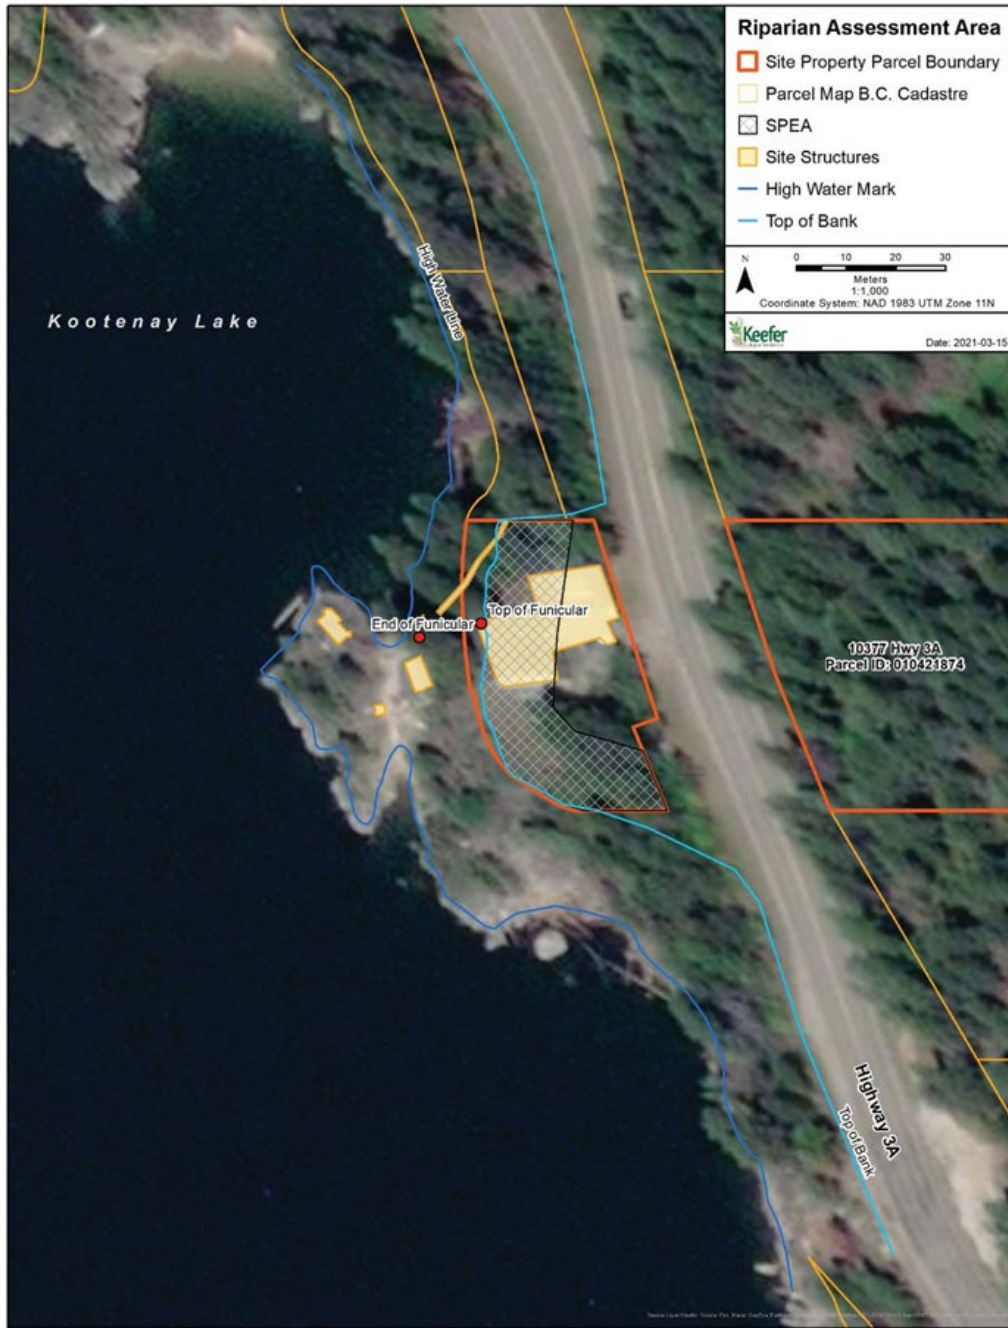
Schedule 2: Site Plan

Figure 7. SPEA determination for the assessed property.

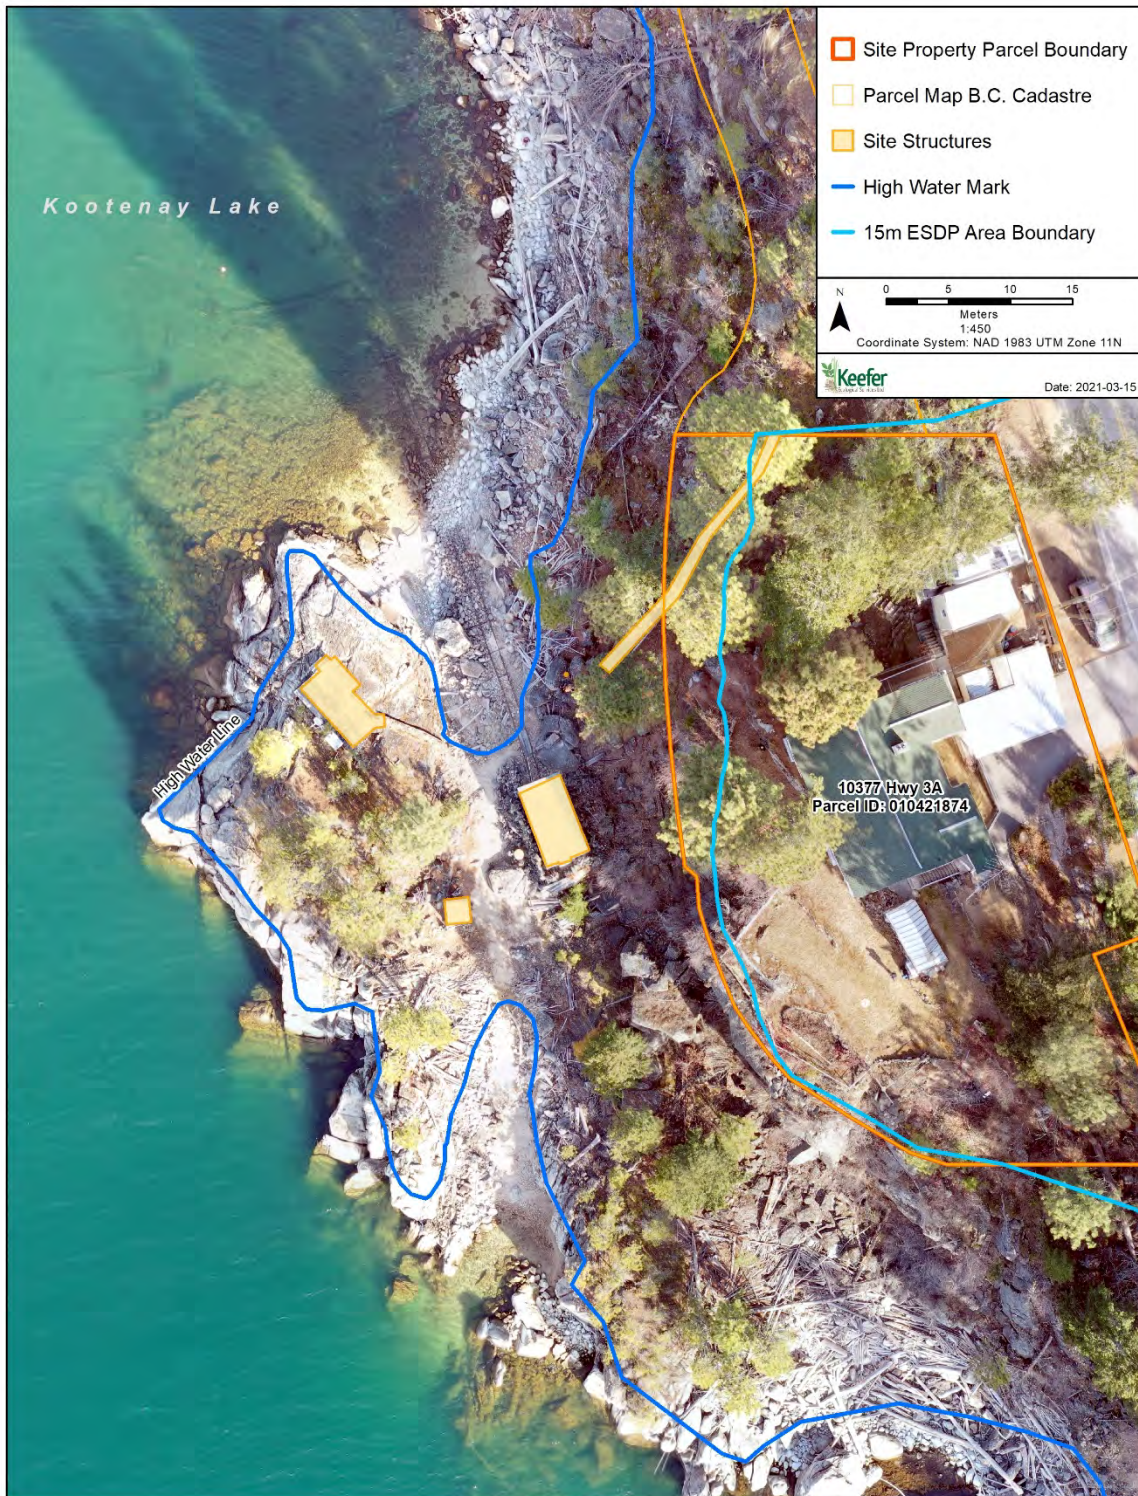
Figure 1. Existing development of the assessed property.

A two-storey house on a concrete foundation currently exists on the upper portion of the assessed property, immediately west of Highway 3A. The house was constructed in 1963 and has likely experienced several renovations since that time. On the south side of the house is a small greenhouse and the septic field. On the north side of the house, a wooden staircase connects the upper portion of the assessed property to the lower portion where a boat house, rail system, deck and storage shed are located. A cliff approximately 30 meters (m) in height separates the upper and lower portions of the assessed property. Other existing infrastructure found in the lower portion of the assessed property includes a decommissioned hydro pole and scrap wiring, other decommissioned electrical equipment (e.g., light on the shoreline), and several water lines that run from the waters edge up the cliff to the house above (Figure 1).

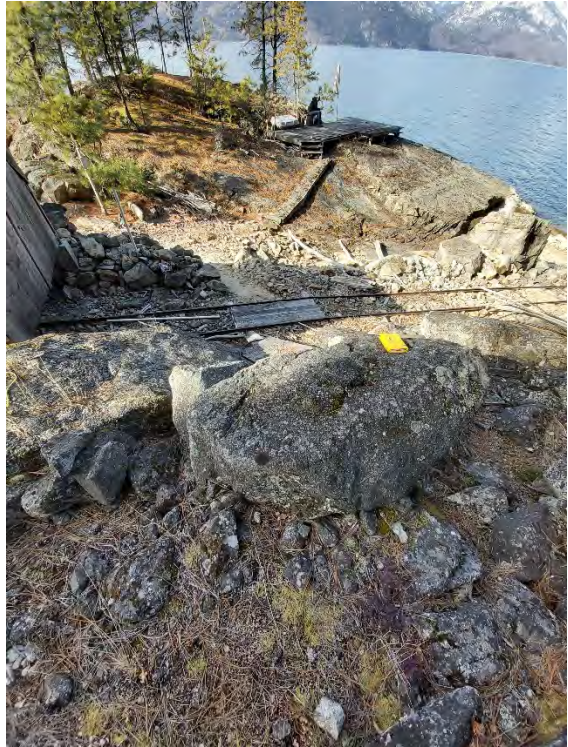
Figure 2. Top (left) and bottom (right) points of the proposed funicular.

The proposed development includes the installation of a funicular (a cable and rail system) intended to connect the upper and lower portions of the assessed property from a point on the western edge of the upper portion to a point above the high water mark in the lower portion (Figure 2), and a floating dock extending from gangway secured into the bedrock along the western shoreline, where a non-permanent deck area built of wood currently exists (Figure 3).

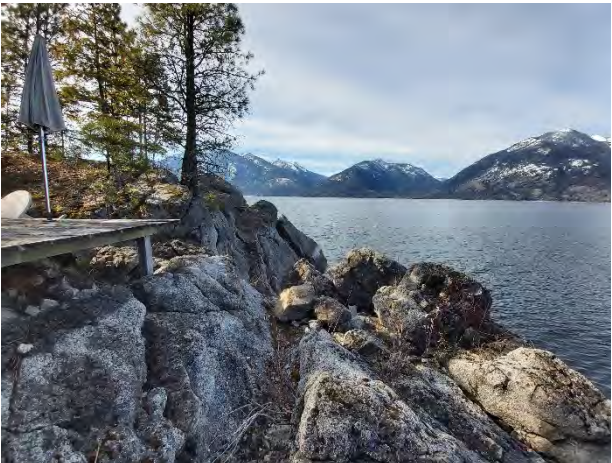
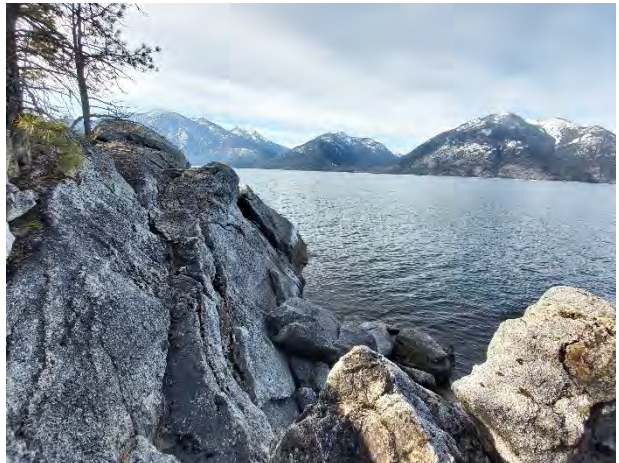
Figure 3. Location of proposed floating dock and gangway.

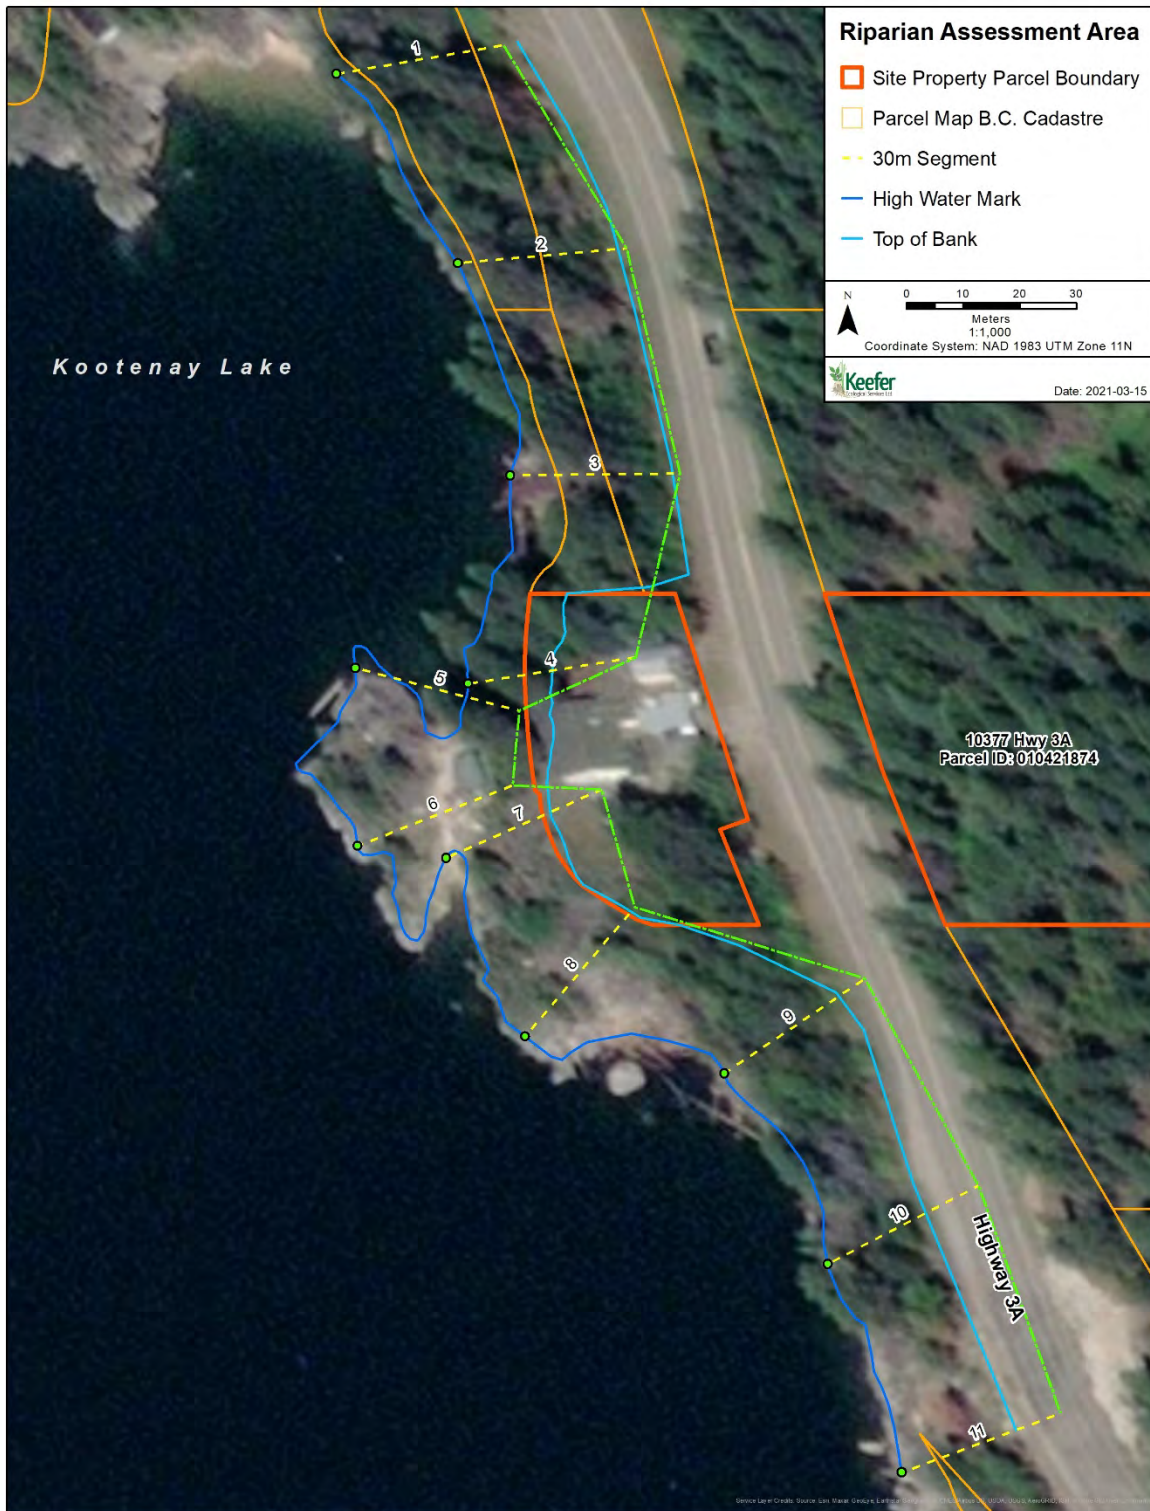
Figure 4. Riparian area assessment boundaries.

The vegetation category is assessed within a 30 m wide area starting from the middle of the assessed property and going 200 m both upstream and downstream along the bank where the development will occur. Within the 30 m and 200 m assessment boundaries, the distance from the top of bank (TOB) to the first permanent structure was estimated at 40 m intervals (Figure 4). An air photo was used to undertake this measurement prior to inspecting the site in person. While on site, KES utilized a drone to improve the quality of the available aerial photos of the site for the purposes of this assessment.

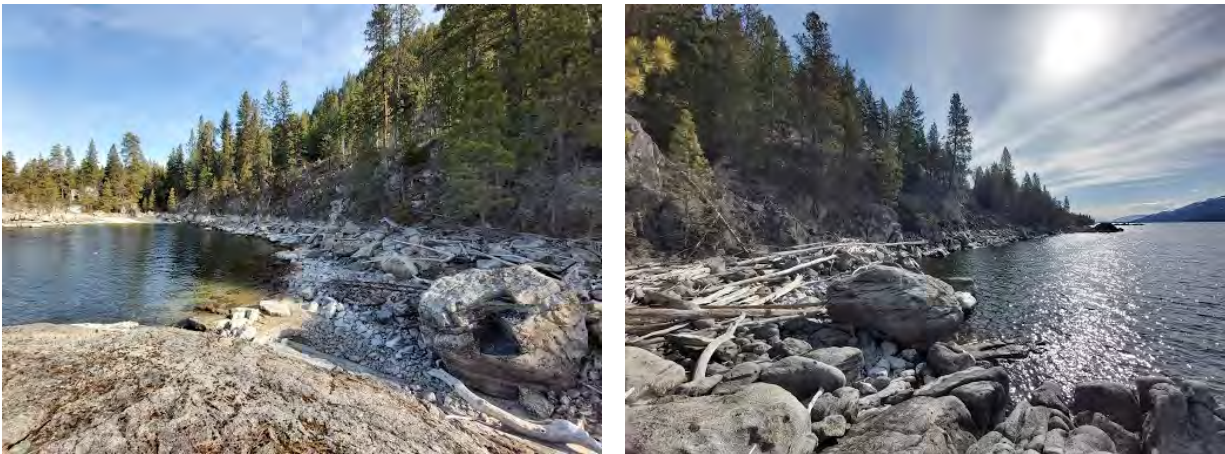
Figure 6. Upstream (left) and downstream (right) shorelines outside the assessed property.

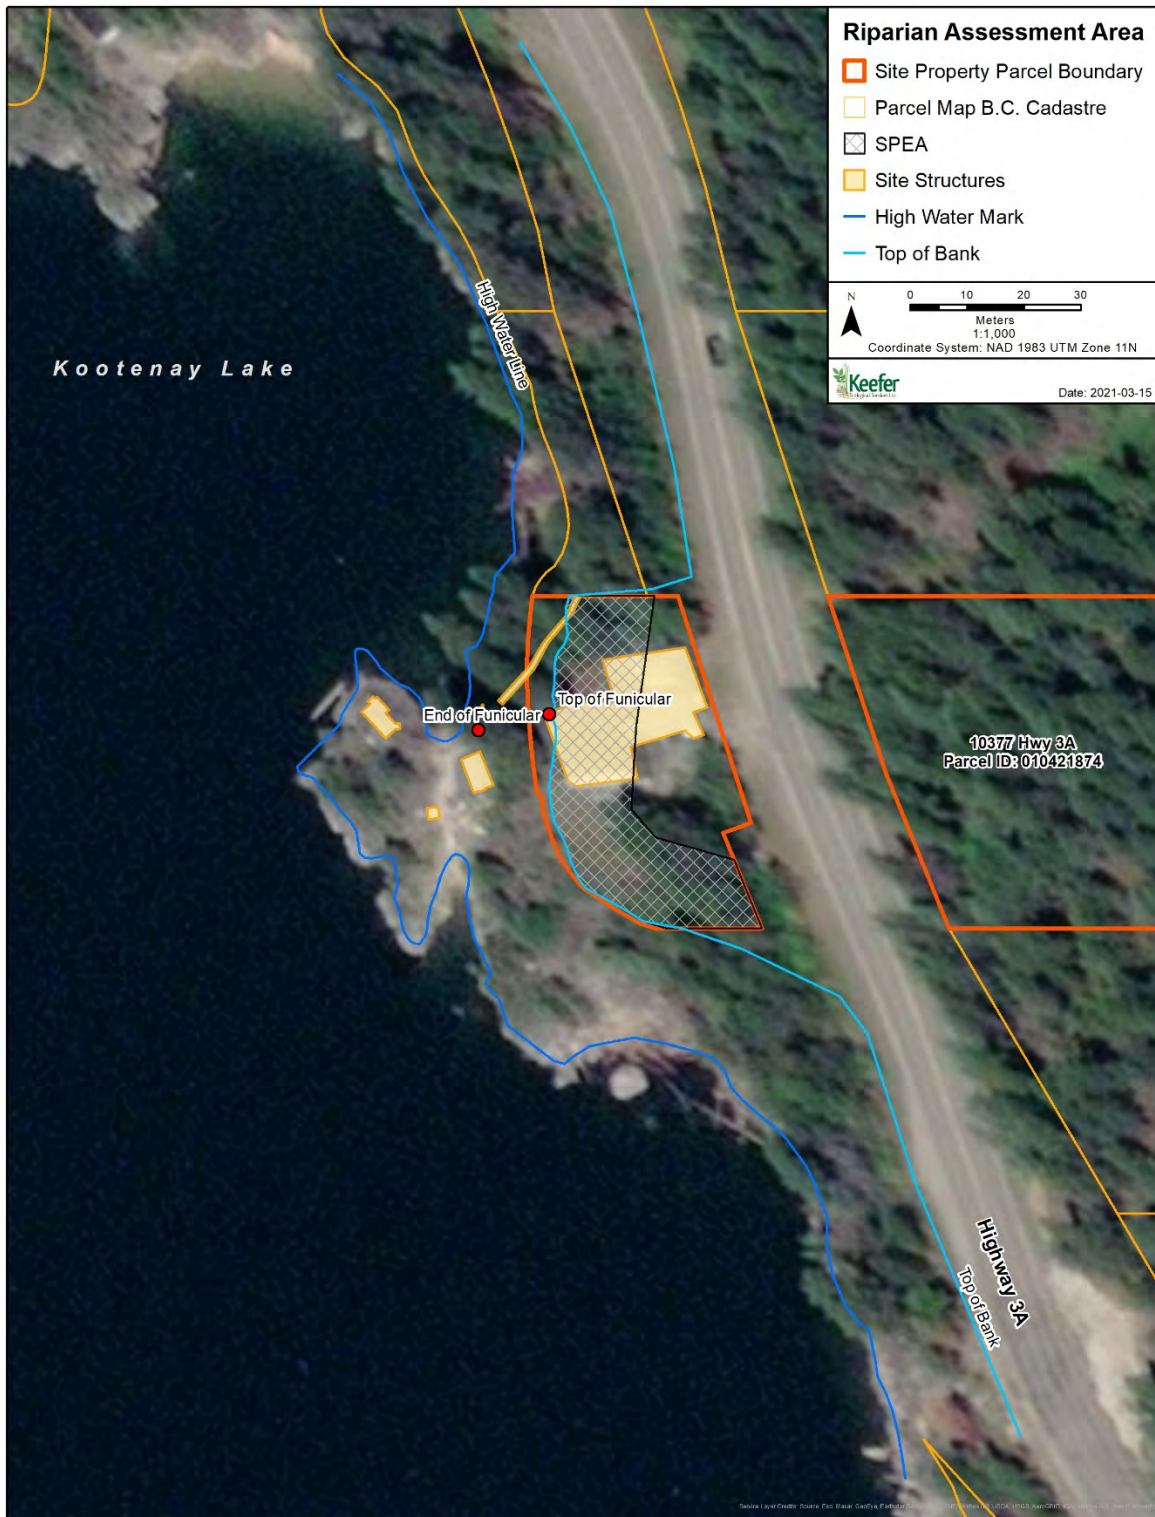
Figure 7. SPEA determination for the assessed property.

The vegetation category was determined to be 3 (Figure 5), based on the details provided in Table 2. This assessment was difficult given the irregular shape of the shoreline and the steep slopes up and downstream of the assessed property. Within the assessed property, the TOB lies outside the 30 m area used for determining the vegetation category in two instances (segments 5 and 6). This is attributed to the irregular shape of the shoreline in those segments (Figure 7). In the areas up and downstream of the assessed property, the shoreline rises steeply away from the HWM, unlike at the assessed property (Figure 6). This resulted in the TOB moving eastward towards the highway (the TOB is located alongside the highway, where the slope breaks). Using the determined vegetation category, fish-bearing status of Kootenay Lake and its permanence, KES has determined that the SPEA width for the assessed property is 15 m (Figure 5; Figure 7).

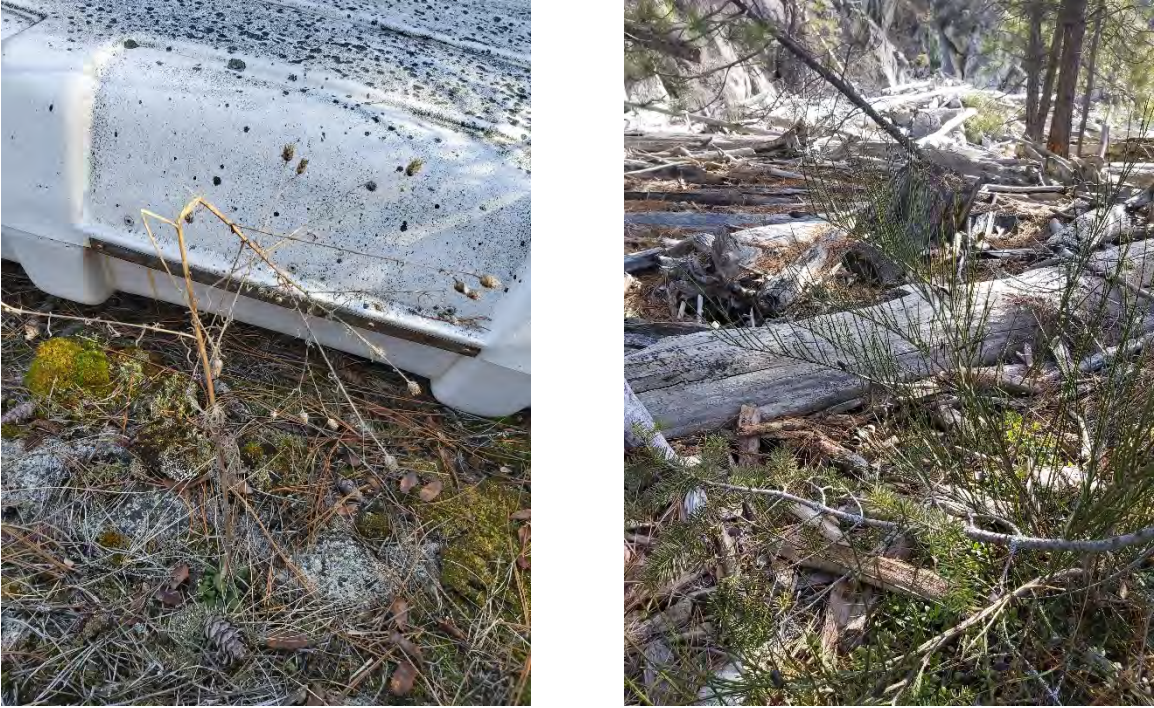
Figure 8. Invasive plant species found within the assessed property boundaries.

Two invasive plant species were observed on the assessed property and are presumed to have originated from populations along the side of the highway (Figure 8). These species were also observed 200 m up and downstream of the assessed property. Spotted knapweed (*Centaurea stoebe*) should be manually removed and chemically controlled, with extra care taken in its application given the proximity to the high water mark. Existing spotted knapweed skeletons should be carefully removed in such a manner that reduces the likelihood of spreading seeds in the process. Scotch broom (*Cytisus scoparius*) should also be removed through manual and chemical means. Plants should be dug or pulled, taking care to remove as much of the root as possible. Scotch broom may also be controlled via chemical means in the spring.

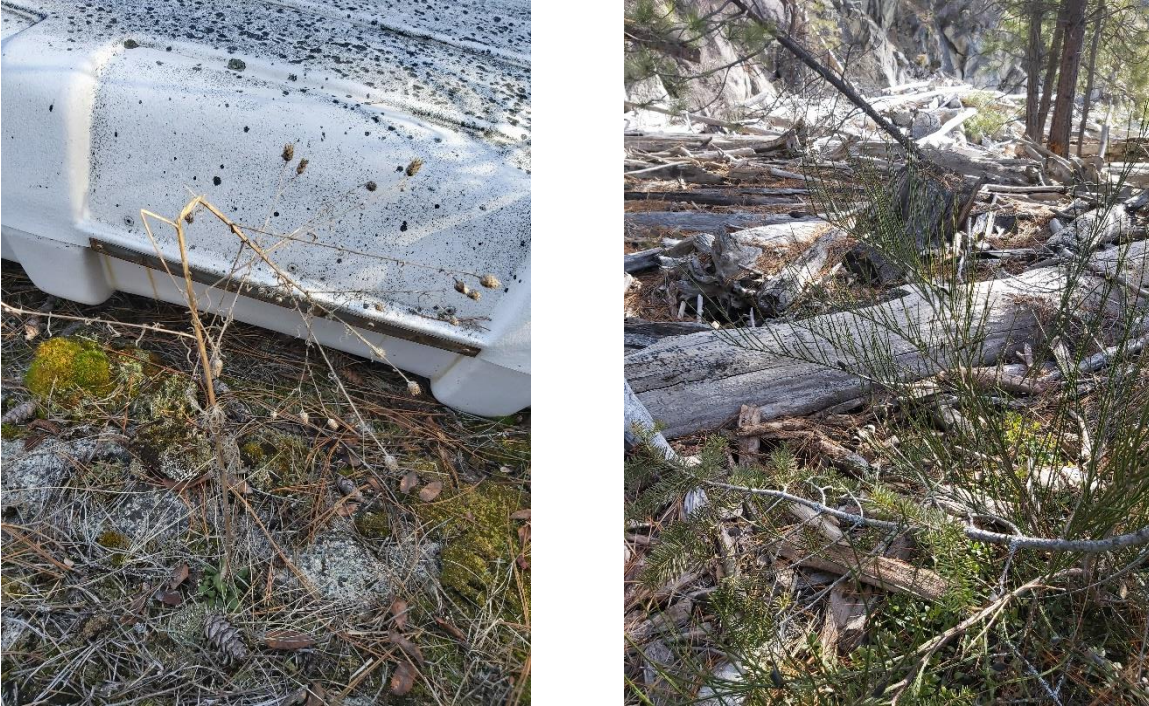
Figure 1. Invasive plant species found within the assessed property boundaries (spotted knapweed (left), scotch broom (right)).

Two invasive plant species were observed on the assessed property and are presumed to have originated from populations along the side of the highway (Figure 1). These species were also observed 200 m upstream and downstream of the assessed property.
