REGIONAL DISTRICT OF CENTRAL KOOTENAY
DEVELOPMENT PERMIT
DP1905A

- 6.1 Proposed construction of improvements to foreshore access and replacement and expansion of an existing deck and associated structures is authorized in accordance with the terms described in the report titled “10015 and 10025 Highway 3A Subdivision Twin Bays, Kootenay Lake Riparian Assessment” prepared by Masse Environmental Consultants Ltd., dated August 2017 and the addendum to said report dated January 26, 2021, attached to this permit including:

ADDENDUM

TO: Nelson Wight, Planning Manager - Regional District of Central Kootenay
FROM: Iraleigh Anderson, P.Ag., B.Sc. - Masse Environmental Consultants Ltd.
DATE: January 26, 2021
RE: Riparian Assessment for Amendment to Development Permit (DP1904A) at 10025 Highway 3A
REF DOC: 10015 and 10025 Highway 3a Twin Bays, Kootenay Lake Environmental Assessment.

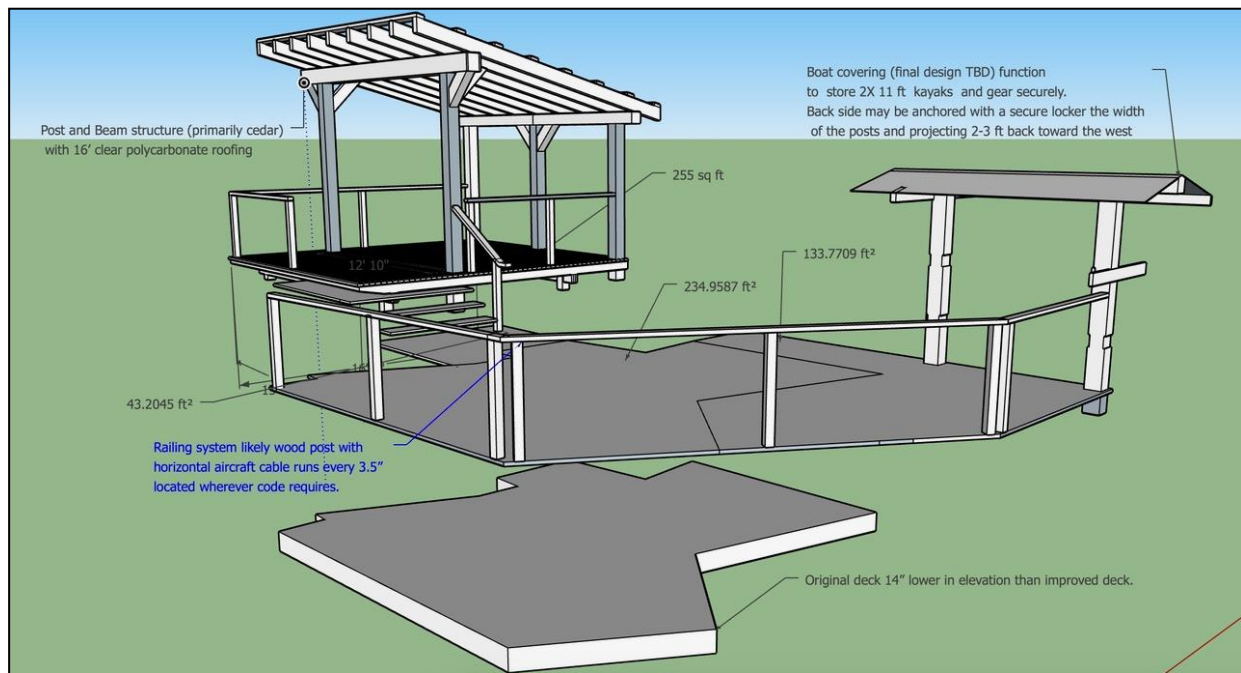
1. Replacement of deteriorating wood staircase within existing footprint (~22m²).
2. Replacement of deck within existing footprint (~22m²), elevated ~35 cm above existing elevation.
3. Construction of new deck expansion and access walkway to the north (~28 m²).
4. Construction of kayak storage shed to the southeast of the existing deck (~12 m²).

The primary construction material for all structures will be wood, which will be anchored onto the rock. With the exception of the upper portion of the staircase, all proposed construction is entirely within the SPEA. The proposed deck expansion and kayak storage area would increase the built footprint within the SPEA by 40 m². Refer to Figure 1 for conceptual diagram and Figure 2 (Pg. 8) for Site Plan.

Figure 1. Conceptual diagram provided by Corey Wells January 6, 2021.

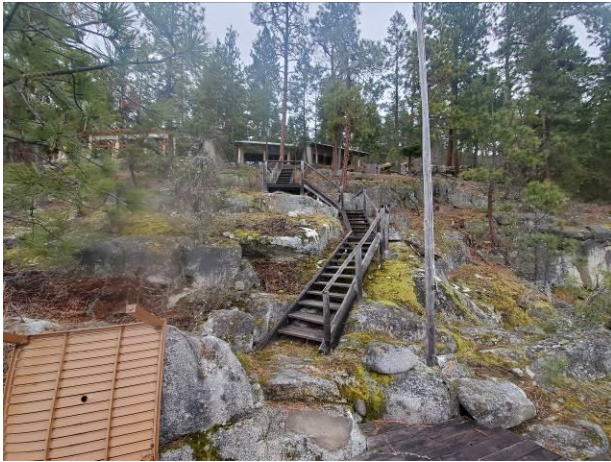
Photo 1. View of habitat around existing staircase, view east.

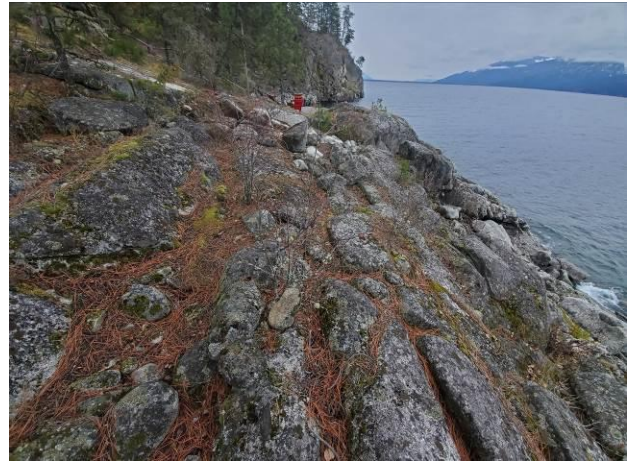
Photo 2. View of habitat within proposed deck expansion area, view south.

- Loss of ~ 40m² rock outcrop habitat within proposed deck footprint and alteration of habitat in the areas immediately adjacent (~1 m) to the new structures. Shading under the deck will reduce vegetation survival within the footprint and the habitat will no longer be suitable forage for insect pollinators or reptiles. Though the area under the deck may provide hiding cover for some small animals, this is not considered a habitat enhancement.
- Soil disturbance may provide sites where exotic plant species can become established.
- Expansion of human infrastructure could lead to future terrestrial habitat impacts if landowners continue to gradually remove SPEA vegetation.

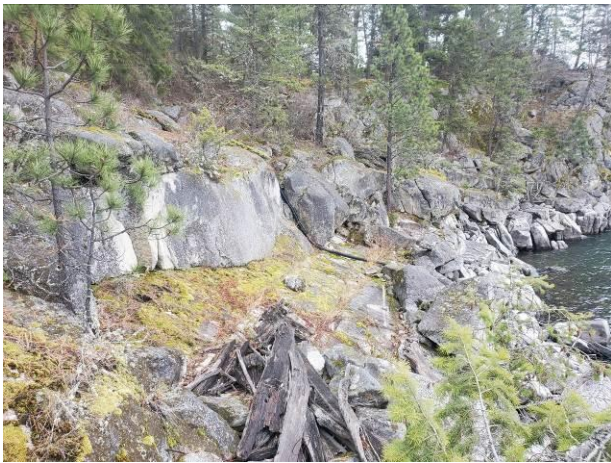
Riparian habitat at the project location consists of exposed bedrock outcrops with slopes typically between 35-50% on a south to west facing aspect. Exposed bedrock is the dominant substrate, and tree cover is sparse. There is high diversity of flowering shrubs and herbs; and mosses and lichens are prominent on all substrates (e.g., bedrock, woody debris, trees etc.). Trees within the SPEA are stunted and typically less than 10 m tall. Coarse woody debris is limited within the project area. A young ponderosa pine (~25 cm diameter at breast height; Photo 5) in poor health is leaning over the SPEA. When this tree falls it will add valuable cover to this open rock habitat where there is currently only a minimal amount of aged coarse woody debris. Shrubs are present in patches where small depressions have allowed soil development. Boulder and talus cover is minimal. Exotic plant cover is present, with Canada bluegrass (*Poa compressa*) dominating several cracks in the rock and pockets of soil; and hare's foot clover (*Trifolium arvense*) growing in a large patch of soil. An exotic rose (*Rosa* sp.; Photo 7 and Photo 8) is present south of the deck. The habitat type is Rock Outcrop (Ro05 - Juniper -

Photo 3. Rock outcrop habitat, south of deck.

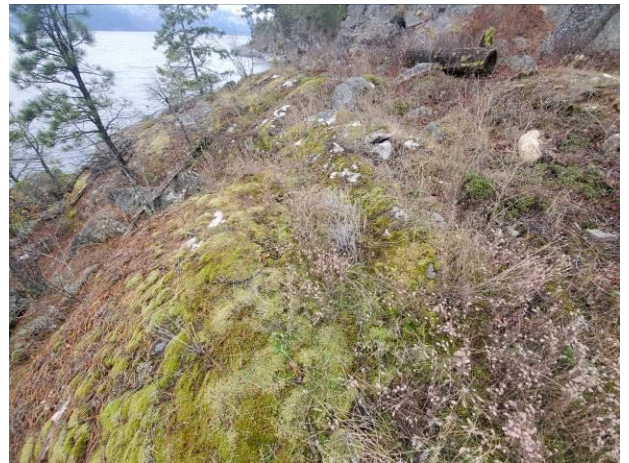
Photo 4. Outcrop with patch of hare's foot clover, northeast of deck.

1. Exotic plants throughout the rock outcrop should be pulled carefully so that all roots are removed, but soil disturbance is minimized. The large patch of [hare's foot clover](#) and numerous small patches of [Canada bluegrass](#) and [spotted knapweed](#) north and east of the deck should be removed.

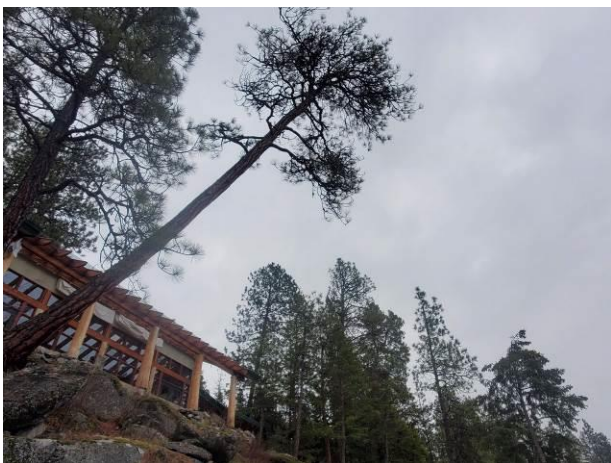
Photo 5. Leaning ponderosa pine view southeast leaning over SPEA.

- Retain coarse woody debris within the SPEA and allow the leaning ponderosa pine to fall in the rock outcrop. The resulting coarse woody debris as it provides valuable cover for reptiles and other wildlife.

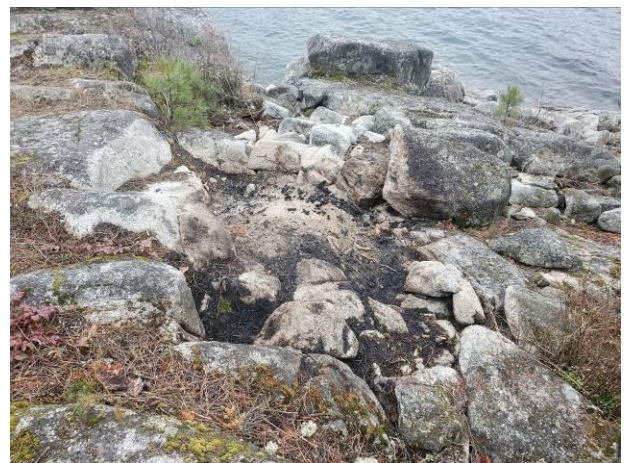
One small area of soil within a depressed rock outcrop has been damaged by bonfire activity (Photo 6) and the habitat has also been impacted by the removal of coarse woody debris. An exotic rose (*Rosa* sp.; Photo 7 and Photo 8) is sprawling south of the deck. Past pruning on the rose crown was evident.

Photo 6. Soil damage from bonfire northeast of deck.

- Avoid bonfires in sensitive rock outcrop soils. Fire degraded soils provide microsites for establishment of exotic plant species which compete with native species and degrade sensitive ecosystems.

The soil damaged by the bonfire northeast of the deck provides an opportunity for restoration. The following steps should be used to restore the bonfire area:

1. Soils from below the new deck should be carefully salvaged by hand and layered upon the fire damaged areas to provide a suitable medium for plant reestablishment. The soil should be spread carefully to match the surrounding microtopography.
2. After placement of soils this area should be seeded annually for at least two years with the West Kootenay Pollinator Seed Mix for Dry Sites. This seed is available from [Kinseed](#) in Nelson, BC. Seed application rates provided on the website indicate minimum values. Seeding will be most effective in the fall.
3. Exotic plants should be removed from this area to promote establishment of target species.

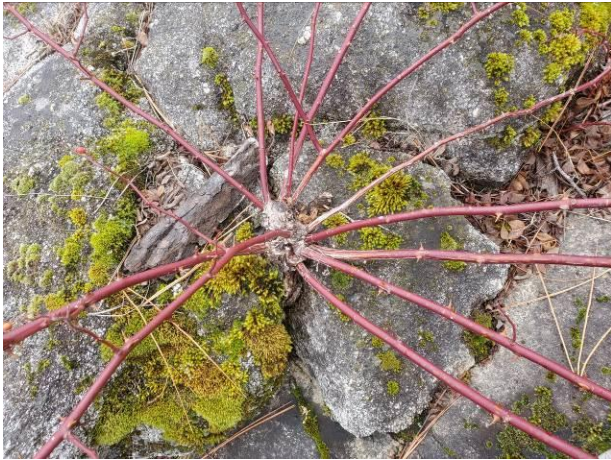
Photo 7. Exotic rose crown, south of deck.

2. The exotic rose south of the deck should also be eradicated. Any aboveground growth of the rose should be pruned immediately each time it is visible. If the rose is completely pruned regularly throughout the season the roots will gradually starve and die.
3. Bare soils previously occupied by exotic plants should be carefully seeded with the West Kootenay Pollinator Seed Mix for Dry Sites.

- Efforts to eradicate the exotic rose should be evident. Evidence of regular pruning of all aboveground biomass should be observable, or ideally the rose should be dead.

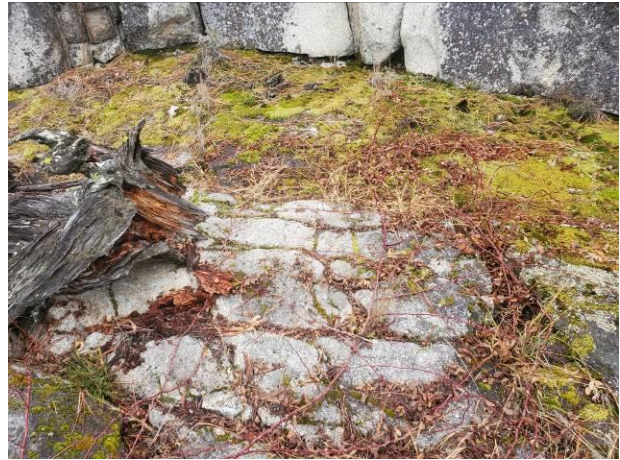
Photo 8. Exotic rose spreading across rock outcrop habitat, south of deck.
