REGIONAL DISTRICT OF CENTRAL KOOTENAY
DEVELOPMENT PERMIT
DP2208Hn (WELLS)

Schedule 2: "Site Plan – A1.0" drawn by Andrew V. and checked by Marc Brillon, revision no. 3 dated January 19, 2023.

Wells Glass Cabin, Slocan Lake Riparian Assessment Report (V2.1)

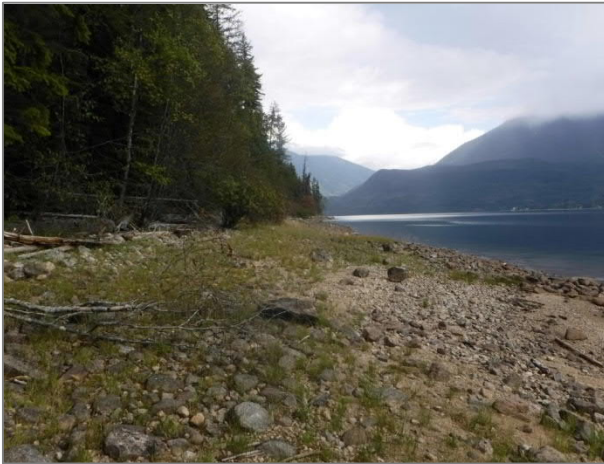
Photo 1. View of foreshore area looking north from creek mouth.

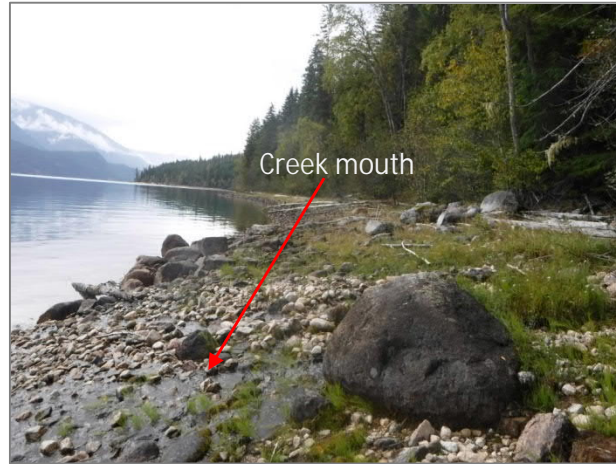
Photo 2. View of foreshore area looking south from creek mouth.

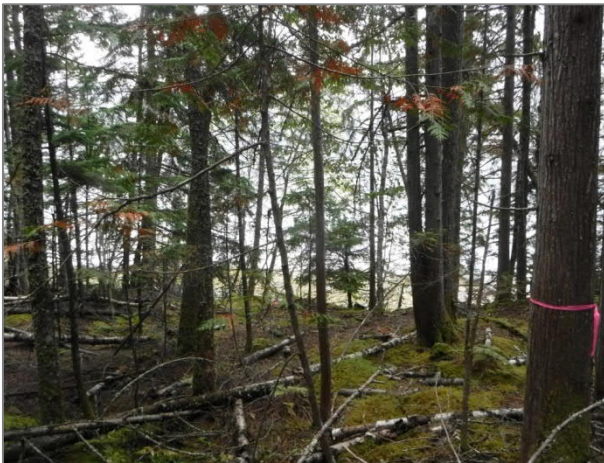
Photo 3. View of riparian area and foreshore from proposed cabin siting.

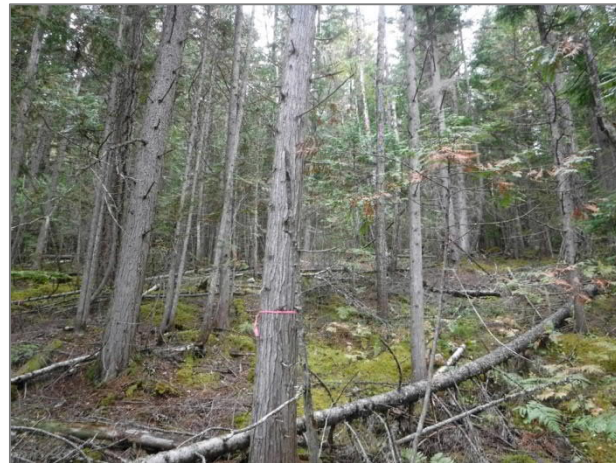
Photo 4. View of proposed cabin siting within 30 m lake setback.

The proposed works were assessed based on current site conditions and proposed construction activities within the SPEA. The proposed siting of the cabin is 15 m from the lake HWM and 15 m from the stream HWM, meeting the 15 m SPEA setback and 15 m floodplain setback.

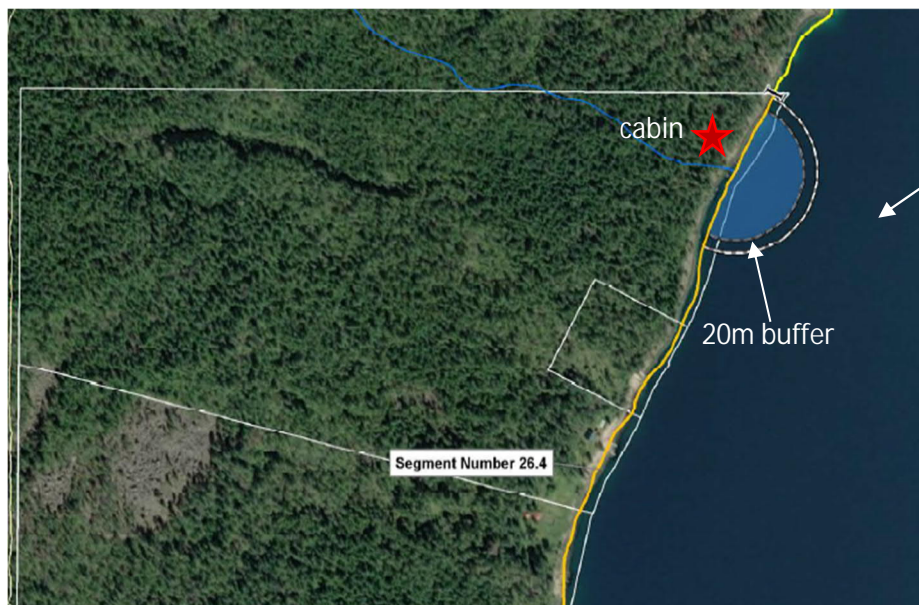
Figure 1. Slokan Lake FIMP showing project location along shoreline.

The Slokan Lake Foreshore Development Guide (Wood 2022) was used to help determine site specific risk for aquatic and riparian habitat, Okanagan Nation Alliance (ONA) and Syilx Natural Resources cultural values along the shoreline. The property is within Foreshore Inventory Mapping (FIM) segment 26.4 and indicates that it has a high ecological rank due to the high value fish and wildlife habitat. A Zone of Sensitivity (ZOS) located at the confluence of the unnamed stream and Slokan Lake recommends that no permanent development is located within or adjacent to the mapped polygons. A buffer of 20 m around the ZOS, as shown in Figure 1 is recommended (Wood 2022).

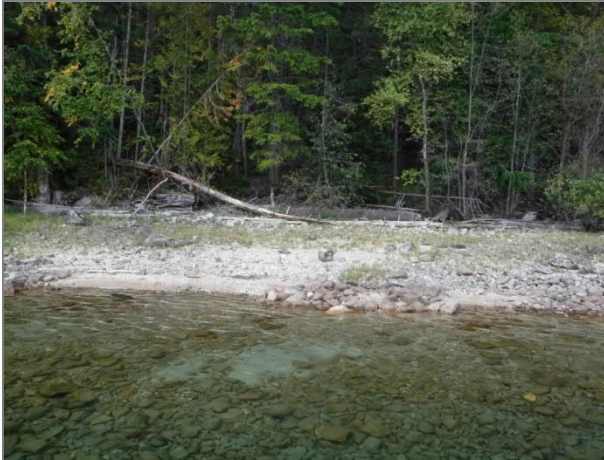
Photo 5. View of Slocan Lake aquatic habitat in front of proposed cabin.

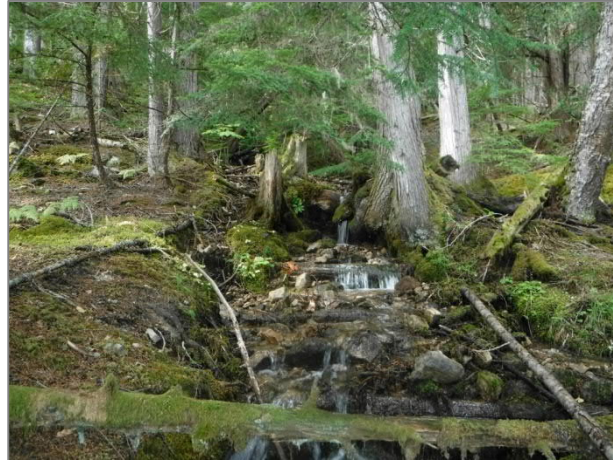
Photo 6. Upstream view of unnamed tributary next to proposed cabin.

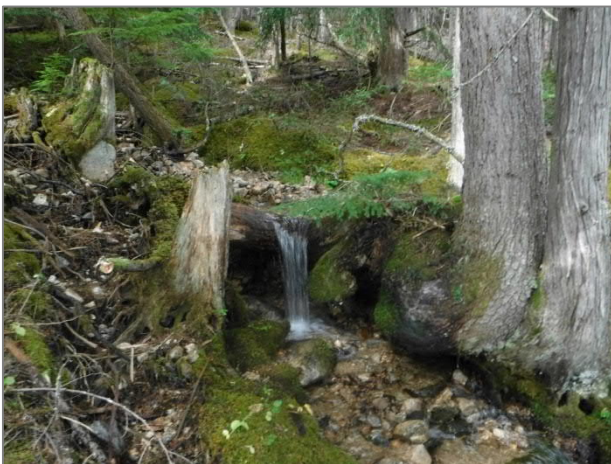
Photo 7. Upstream view of 1 m barrier located on unnamed stream, ~5 m upstream of mouth.

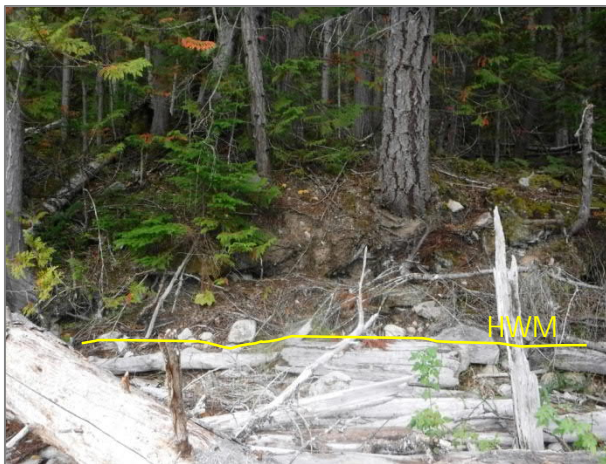
Photo 8. HWM and riparian habitat at Slocan Lake foreshore in front of proposed cabin.

During the site visit the HWM, also known as the natural boundary of Slocan Lake along the foreshore was confirmed to be at an elevation of ~545 m, as shown on the legal survey completed in 1980 by Gordon Stein (Appendix 2). The HWM along the unnamed stream was surveyed by Fiona Lau and Marc Brillon on site and is mapped on the proposed site plan (Appendix 3). Based on the definition of HWM (Section 3.1),

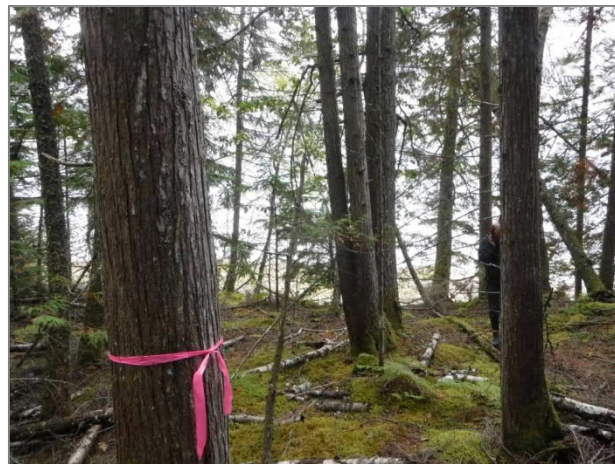
Photo 9. Riparian area within 15 m of lake HWM.

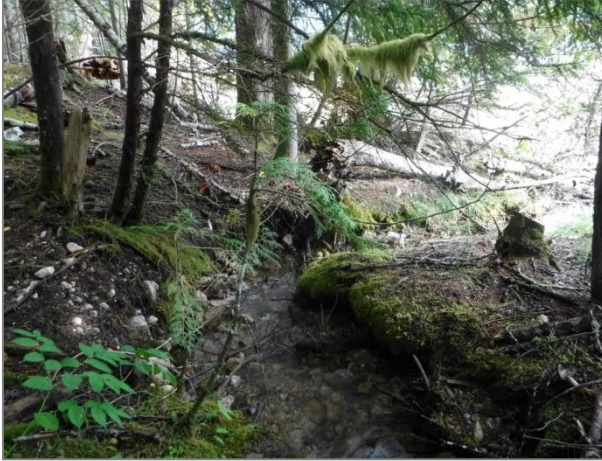
Photo 10. Riparian area near mouth of unnamed tributary.

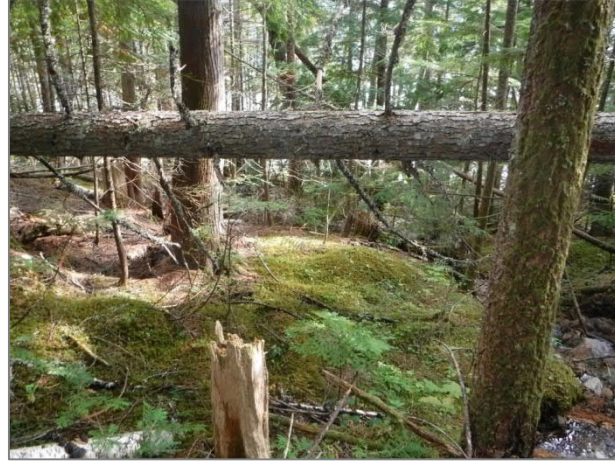
Photo 11. Riparian area of unnamed tributary adjacent to proposed cabin location.
