**REGIONAL DISTRICT OF CENTRAL KOOTENAY**  
**DEVELOPMENT PERMIT**  
**DP2309D (Ainsworth Hot Springs Ltd.)**

5. The Permittee has applied to the Regional District of Central Kootenay for a Watercourse Development Permit in order to construct an expansion to the existing Wastewater Treatment Plant (WWTP) and a crane pad supported by a retaining structure. Pursuant to this Development Permit and subject to the terms and conditions herein contained, as well as all other applicable Regional District Bylaws, the Regional District of Central Kootenay hereby authorizes the use of the said lands for this purpose.

# Ainsworth Hot Springs Resort Wastewater Treatment Plant Upgrades Riparian Assessment

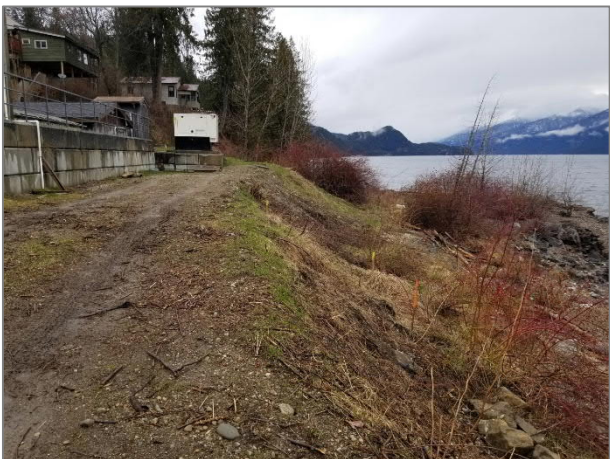
Photo 1. View of existing access road to waste water treatment plant, looking north.

Existing development within the riparian assessment area (30 m from the natural boundary of Kootenay Lake) includes a WWTP, associated infrastructure and a ~3 m wide access trail off Water Street along the waterfront to the plant (Photos 1-4). An effluent discharge pipe transects the property and discharges treated wastewater into the lake (Photo 5).

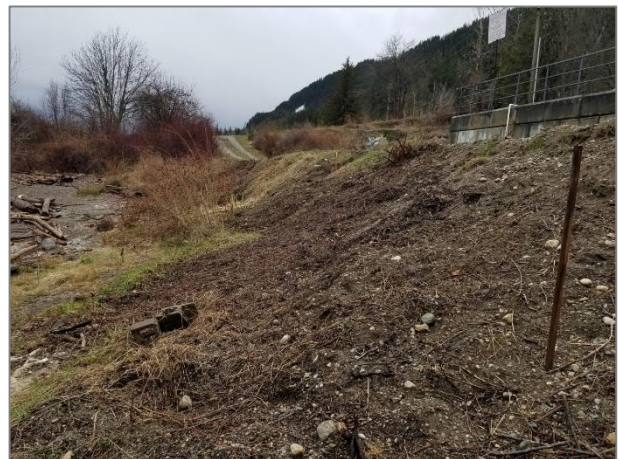
Photo 2. View of slope between Kootenay Lake and access trail, looking south.

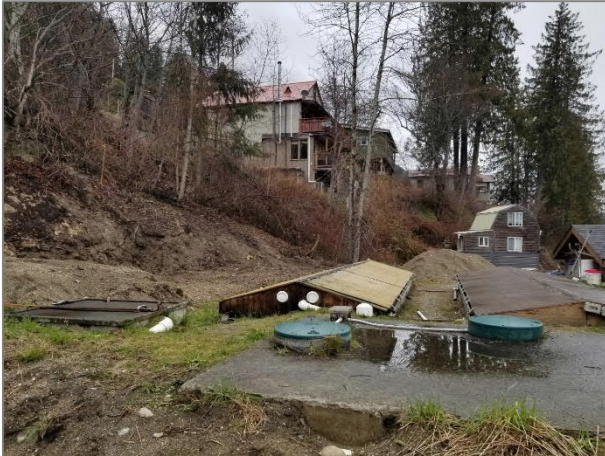
Photo 3. View of WWTP and expansion area looking north.

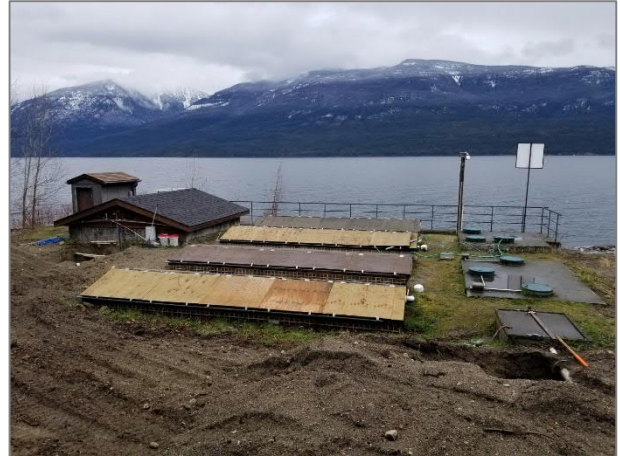
Photo 4. View of WWTP looking east.

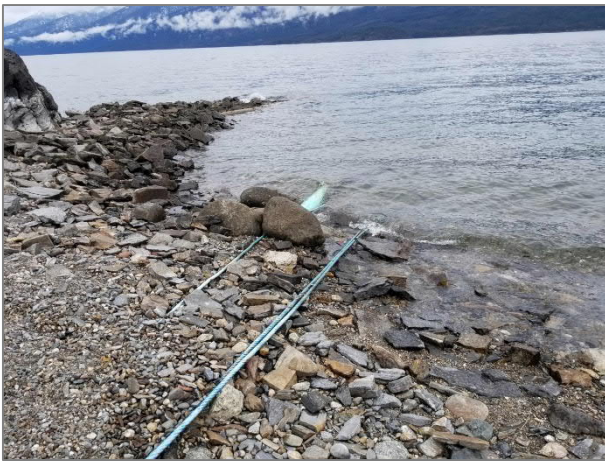
Photo 5. View of existing WWTP discharge line entering Kootenay Lake.

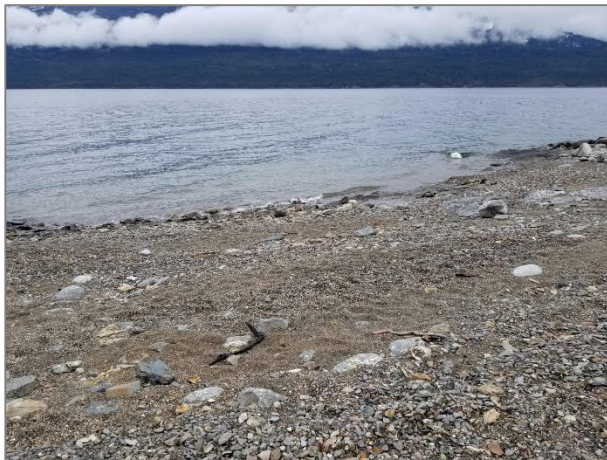
Photo 6. View of beach looking south east.

The foreshore of the property consists of a sloped beach (~15% gradient) with substrate consisting of mixed substrate: mostly gravel with sand, angular cobble, boulders, exposed bedrock and mineral deposits (Photo 6 and Photo 7). The mineral deposits are from the hot springs water, which have a high mineral content and have created a thin, cementitious, layer near the high-water mark. Fish habitat along this section of foreshore supports juvenile rearing habitat with larger substrates providing some cover for fish. No known kokanee spawning has been reported in this area.

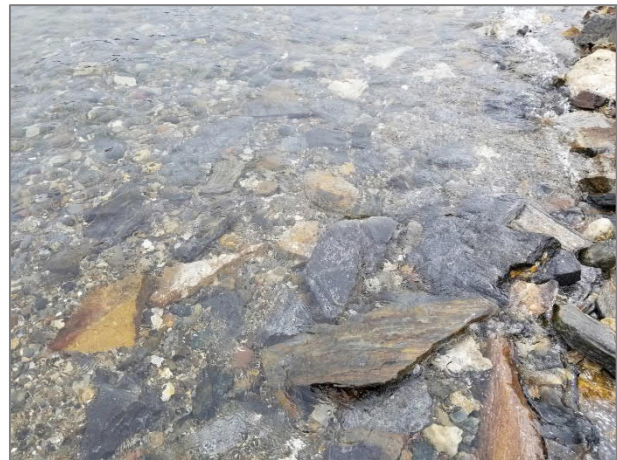
Photo 7. View of typical substrate along the shoreline.

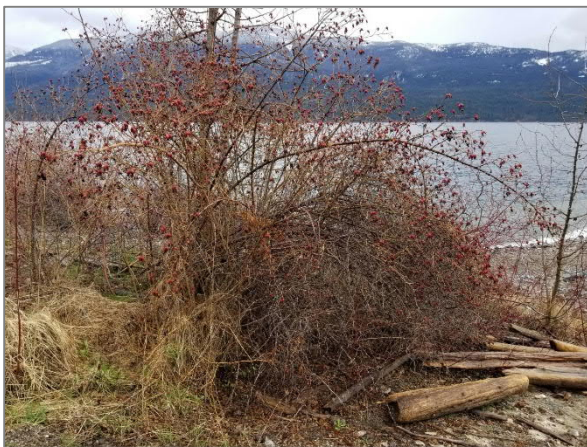
Photo 8. Sweetbriar rose and cottonwood along foreshore area.

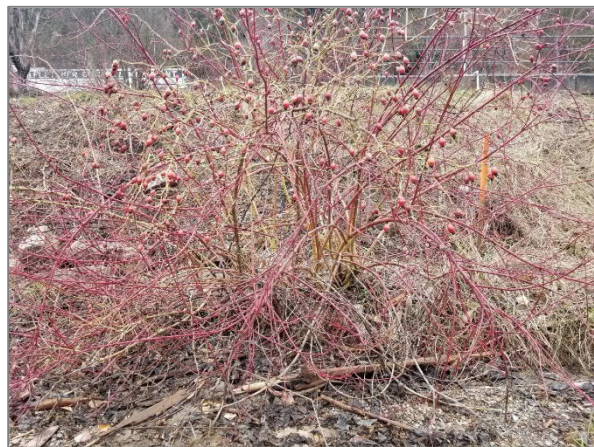
Photo 9. Sweet briar and red osier dogwood along foreshore next to proposed crane pad.

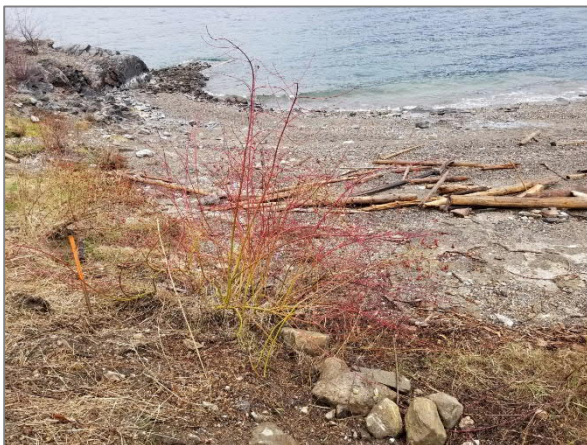
Photo 10. Red osier dogwood and grass located along the toe of the proposed retaining wall.

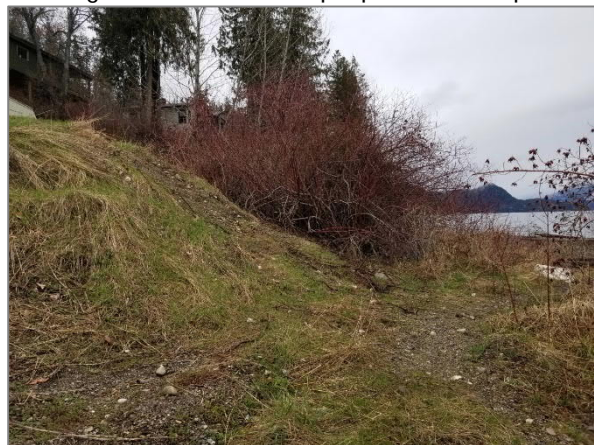
Photo 11. View of riparian area looking north of proposed crane pad.

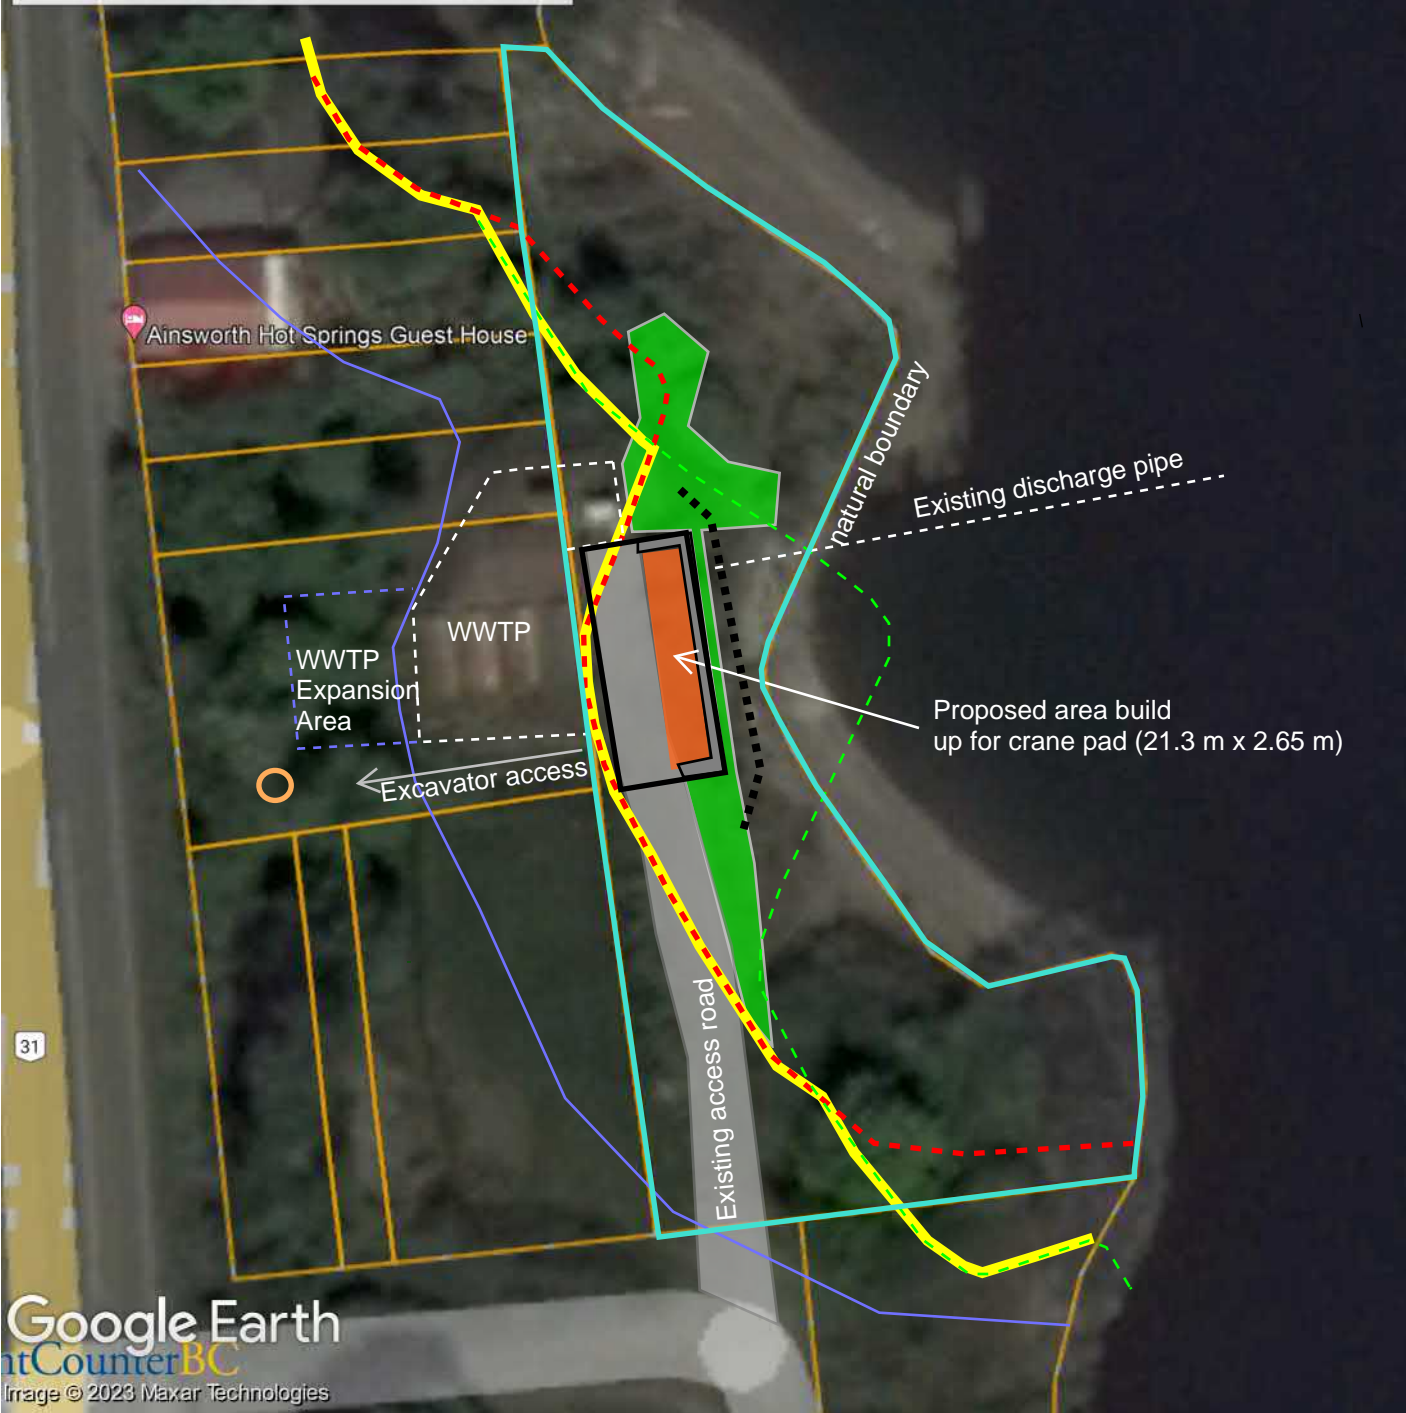
## Proposed Development within 30 m WDP area

- Crane pad overall footprint (21.3 x 5.3m)
- Proposed area build up for crane pad includes retaining wall (~ 56.5 m<sup>2</sup>)
- Revegetation Area (230 m<sup>2</sup>)  
Removal of non native plants and replanting with native plant species. Existing native plant species to be retained.
- Danger tree
- Silt fencing

To mitigate for the loss of potential riparian habitat within the SPEA, a degraded riparian area has been identified for restoration and enhancement (~230 m<sup>2</sup>; Appendix 3). Revegetation will include removal of all non-native plants, planting of 5 native trees and ~80 shrubs (including cuttings). Plants species, quantities and placement shall be determined by the Qualified Environmental Professional (QEP) assigned to the project. Plant species recommended for the revegetation area are listed in Table 4. Disturbed soils shall be re-seeded with an Interior Forestland seed mix (Table 5) to prevent erosion and establishment of invasive weeds at a rate of 25 kg/Ha.
