Development Permit

DP2305E (Drinkwater)

5. The Permittee has applied to the Regional District of Central Kootenay for a Watercourse Development Permit in order to permit the construction of a clear span bridge and upgrade of an existing access road within 15 m of Harrop Creek and to use land and structures situated on the said lands for this purpose. Pursuant to this Development Permit and subject to the terms and conditions herein contained, as well as all other applicable Regional District Bylaws, the Regional District of Central Kootenay hereby authorizes the use of the said lands for this purpose.

899 Lewis Road
Riparian Assessment

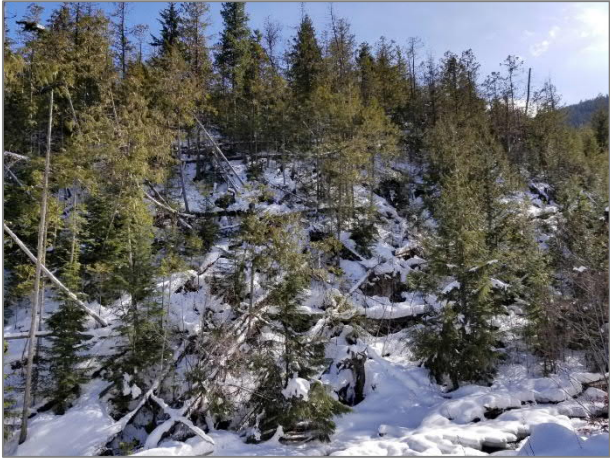
Photo 1. Steep bank within assessment area, on east side of Harrop Creek.

The assessment area has a northern aspect and has mixed topography ranging from gently sloping areas to steep embankments >60% slope. The assessment area has been disturbed from historical timber clearing activities and blow down (Photo 1). The area has mostly regenerated with young hemlock and has an average stand age of <50 years. The forest on the subject property is currently managed by the Owner and provides road access to the Harrop-Procter Community Co-op, who manages a licensed 40 ha parcel above the subject property for fuel treatment reduction purposes. Refer to Section 2.2.2 for Existing Development and Section 3.2 for Riparian Vegetation for detailed descriptions of the subject property.

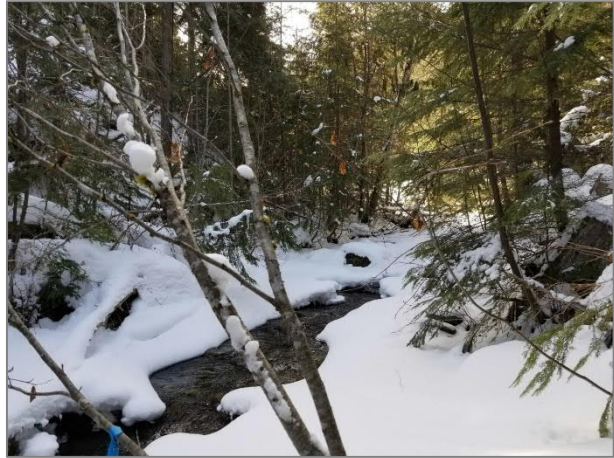
Photo 2. Harrop Creek looking downstream within assessment area.

Harrop Creek is the only watercourse located on the subject property (Photo 2). It is a 4th order stream that originates from Mill Lake, is ~12 km in length and flows in a north direction into the West Arm of Kootenay Lake. Fish and aquatic habitat descriptions are described in Section 4.1.

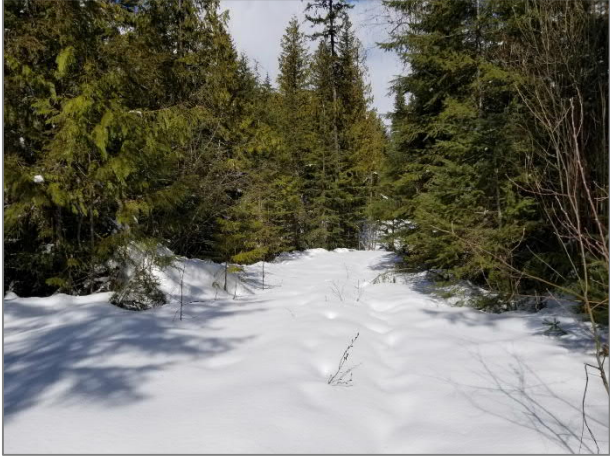
Photo 3. Existing access road above the pump house along the west side of Harrop Creek.

Existing development within the riparian assessment area includes an existing access road (Photo 3) from Lewis Road to a domestic water system pump house located on the west side of Harrop Creek just upstream of the proposed bridge location. The pump house is a wood structure (~3m x 3m) located ~3 m from the creek bank (Photo 4). This access road continues upstream for ~ 100 m to the water intake location. Erosion and scour protection work was completed by the previous owner along a 20 m section of stream bank on the left bank (west side) of Harrop Creek (UTM 11 U495657.5493703), upstream of the pump house (Photo 5). Works included riparian vegetation removal, re-grading of bank and placement of riprap to protect private property and the domestic water infrastructure. According to Google Aerial imagery, the disturbed soils within the work area appear to have been re-seeded. This was not visible during the site visit, due to the snow cover.

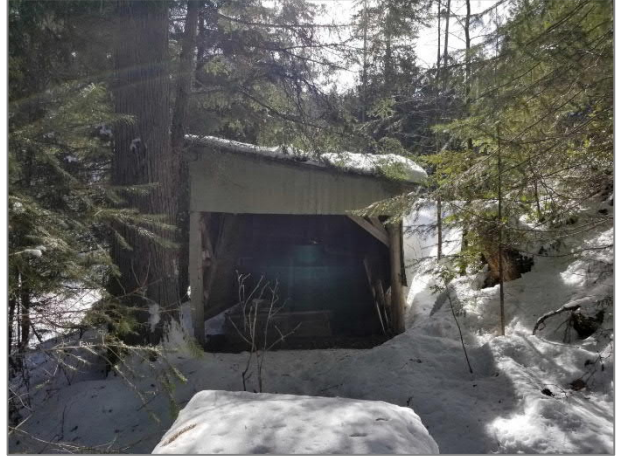
Photo 4. Domestic water system pumphouse structure, located just upstream of the proposed bridge crossing.

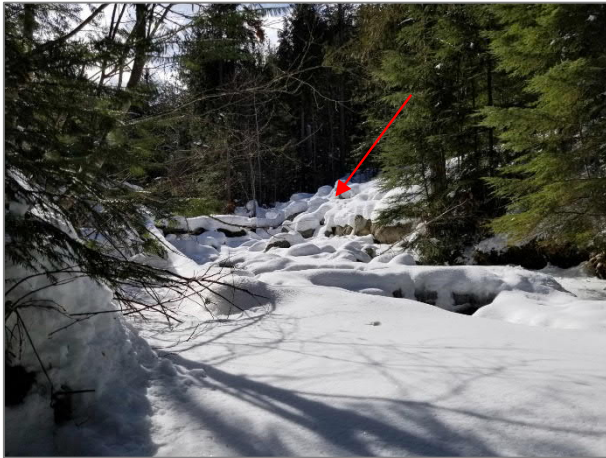
Photo 5. View of armoured rock bank upstream of bridge crossing and pump house.

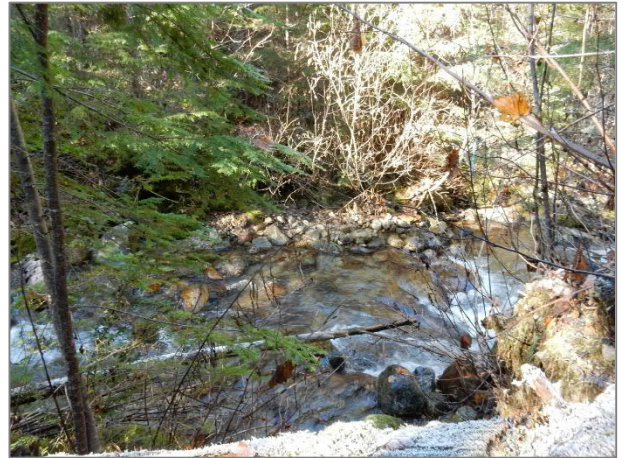
Photo 6. Proposed bridge crossing location looking east (Photo Credit Michael Drinkwater).

Historically an old timber bridge crossing existed at approximately the proposed bridge location providing access from Lewis Road into the property (Photo 6). Remnants of the timber sills on each side of the creek are still evident, but cannot be seen in the photo. Along the east and west sides of the creek an old access road existed providing the only access across the property from the west side of the creek (Photo 7). Natural regeneration of shrubs and trees were present along the edges of the old road and along the stream bank where the old bridge existed (Photo 8).

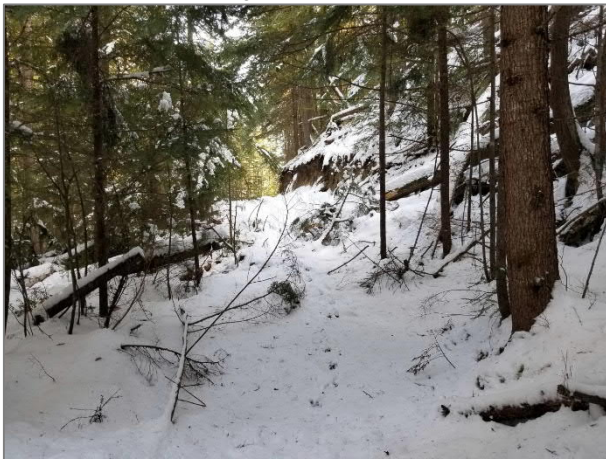
Photo 7. View of old access road on east side of Harrop Creek.

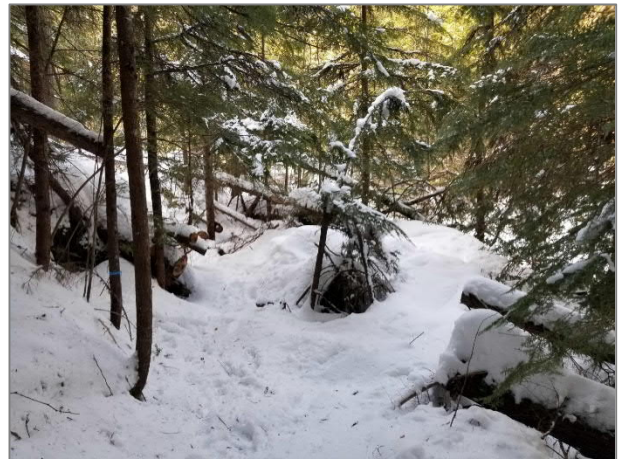
Photo 8. Trees regenerated on old access road next to Harrop Creek on right (east) bank.

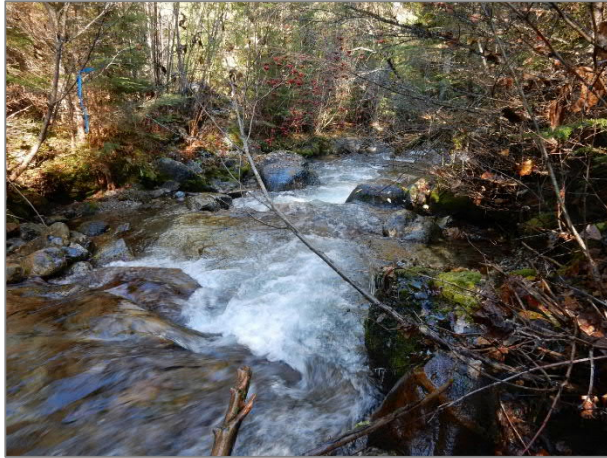
Photo 9. View downstream of proposed bridge crossing showing cascade pool habitat (Photo credit Michael Drinkwater).

Channel morphology within the assessment area is cascade-pool with substrate materials consisting predominantly of cobble with some boulders and pockets of gravel (Photo 9). The stream gradient in this section of the creek is ~6% with an average bankful channel width of 7.5 m. The bankful channel width at the proposed bridge crossing is 6 m. Instream cover for fish is provided by large boulders, some deep pools, and large woody debris. This section of stream provides both rearing, some overwintering and potential spawning habitat for salmonids.

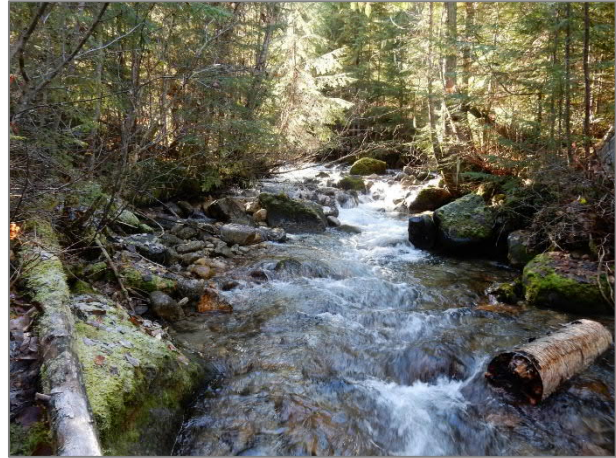
Photo 10. View upstream of proposed bridge crossing showing boulders and large woody debris habitat (Photo credit Michael Drinkwater).

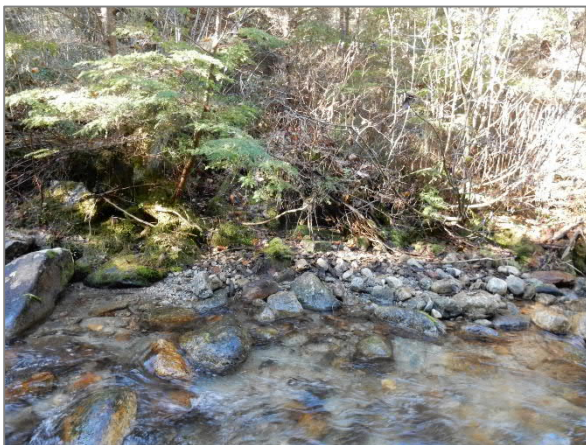
Photo 11. View of typical riparian vegetation along stream bank (Photo credit Michael Drinkwater).

The riparian area of Harrop Creek consists of a mix of western hemlock (*Tsuga heterophylla*), western red cedar (*Thuja plicata*), Douglas-fir (*Pseudotsuga menziesii*), grand fir (*Abies grandis*) and paper birch (*Betula papyrifera*). The understory vegetation consists of alder (*Alnus* sp.), Douglas maple (*Acer glabrum*), western yew (*Taxus brevifolia*), mountain ash (*Sorbus sitchensis*), thimbleberry (*Rubus parviflorus*) and falsebox (*Pachistima myrsinites*) (Photos 11-13). Knapweed (*Centaurea* sp) was observed within a disturbed cleared area upstream of the project site, where bank armoring works occurred (Photo 14). Species identification was limited due to snow cover on the site during the site visit.

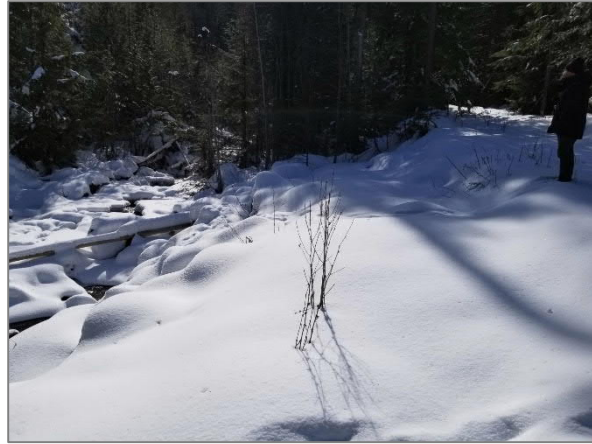
Photo 14. View of riparian vegetation removed along top of armoured bank upstream of site, where proposed revegetation will occur.

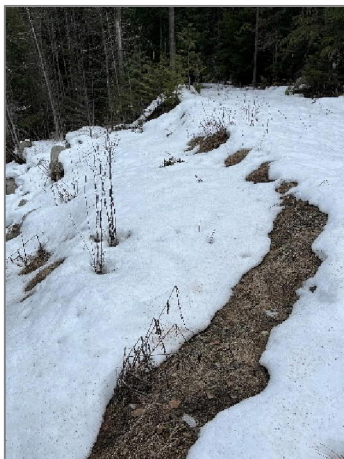
Photo 17. Proposed revegetation area along top of armored bank.

To mitigate for the loss of riparian vegetation within the SPEA, the disturbed area above the armored bank upstream was identified for mitigation through revegetation (~36 m²; Photo 17, Appendix 3). This area has been partially revegetated through natural regeneration of thimbleberry. Revegetation will include the planting of 8 native trees and 15 native shrubs within the identified disturbed riparian area (refer to Table 3 for recommended species), as well as re-seeding of all disturbed soils generated by the bridge and road upgrade works with an Interior Forestland seed mix (Table 4) to prevent erosion and establishment of invasive weeds.

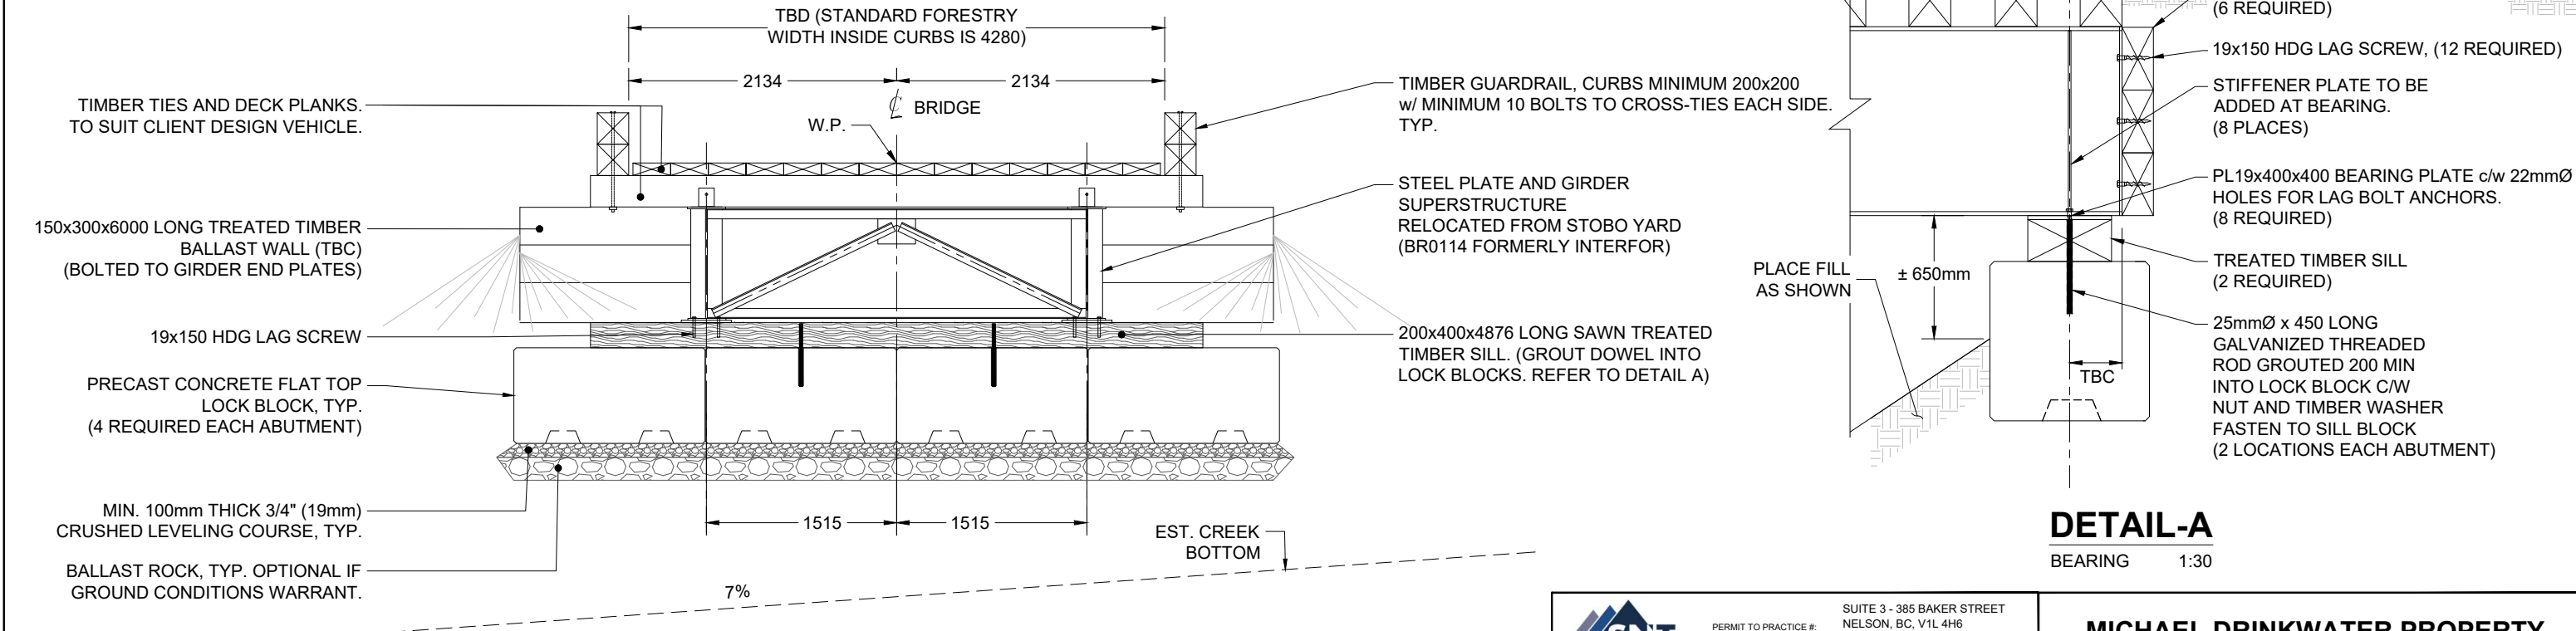
ELEVATION

ABUTMENT 1:50

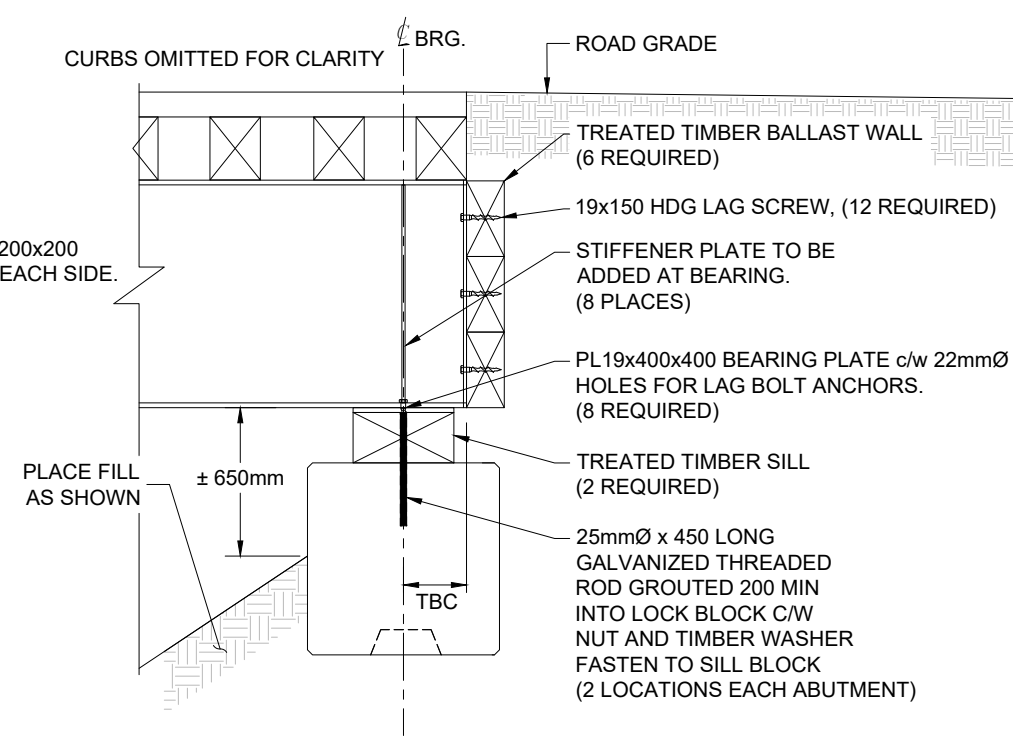
DETAIL-A

BEARING 1:30
