Development Permit

DP2306E (Ryan)

5. The Permittee has applied to the Regional District of Central Kootenay for a Watercourse Development Permit in order to permit the construction of two fences within 15m of Laird Creek. Pursuant to this Development Permit and subject to the terms and conditions herein contained, as well as all other applicable Regional District Bylaws, the Regional District of Central Kootenay hereby authorizes the use of the said lands for this purpose.

7096 Grays Road
Riparian Assessment

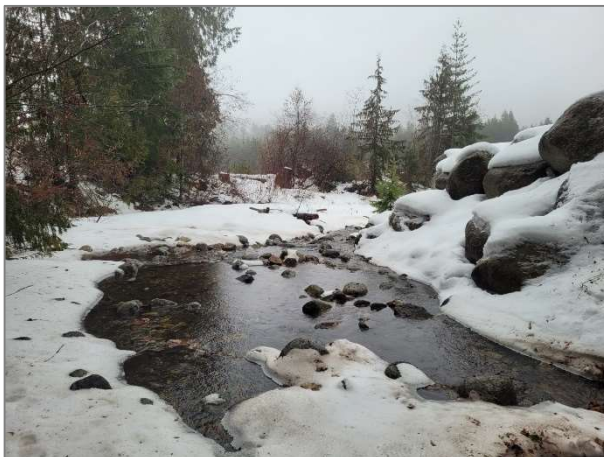
Two watercourses were mapped within the subject property: Laird Creek located along the west property boundary (Cover Photo and Photo 1), and Kootenay Lake (Photo 2) located along the south property boundary.

Photo 1. Laird Creek at subject property, facing downstream towards Kootenay Lake.

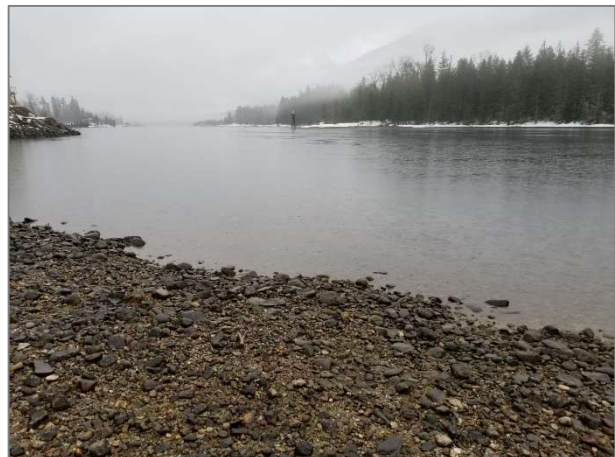
The foreshore of Kootenay Lake along the southern property boundary is defined as the active floodplain between high-water and low-water. During the site visit, the visible high-water mark (HWM) of Kootenay Lake is located ~10-15 m south of the property boundary as shown on the attached Site Plan (Appendix 2). The HWM was evaluated using high-water indications and presence of terrestrial vegetation on banks.

Photo 2. View of Kootenay Lake from subject property.

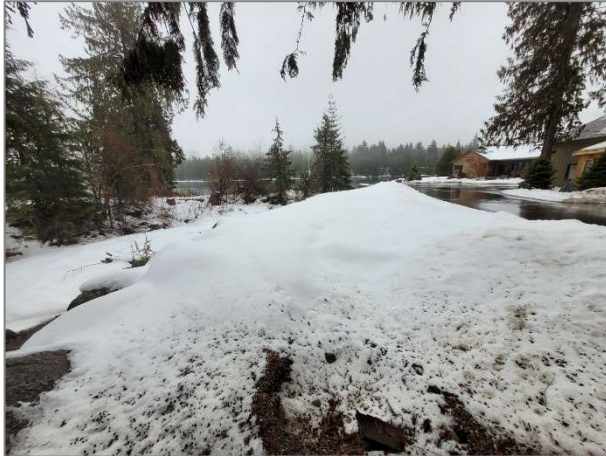
Photo 3. Fill placement along west side of Laird Creek and proposed alignment of lower fencing area.

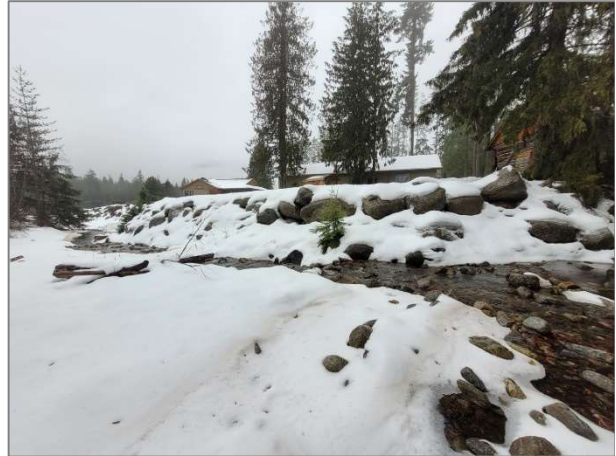
Photo 4. Angular rock placed along west bank of Laird Creek below placed fill.

The purpose of the previous development on the west side of Laird Creek (including riprap lining of the bank) is not known, but it may have been in part for erosion and scour protection along the creek. No other slope stability hazard indicators were observed during the site visit. Further assessment of geotechnical hazard is beyond the scope of this report, and any such assessment should be led by a P.Geol, or P.Eng.

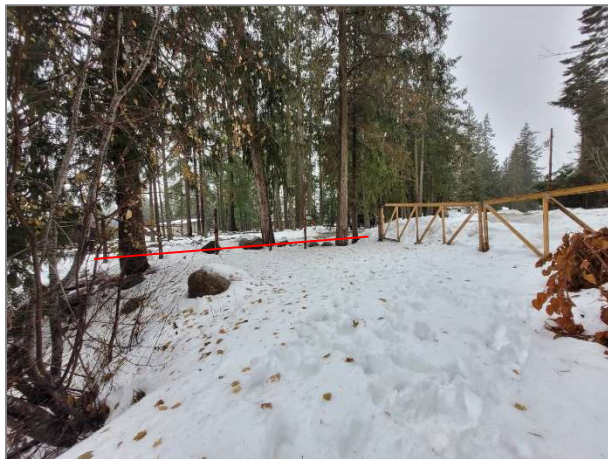
Photo 5. Southwest-facing view of gate and proposed upper fencing area, taken from bridge crossing of Laird Creek. Approximate extent of fencing shown in red.

- 6.3.2.2 The gate consists of multiple "N-frame" panels constructed out of 2"x4" lumber (see Photo 5), which will be covered with non-reflective corrugated sheet metal as used for the fences.

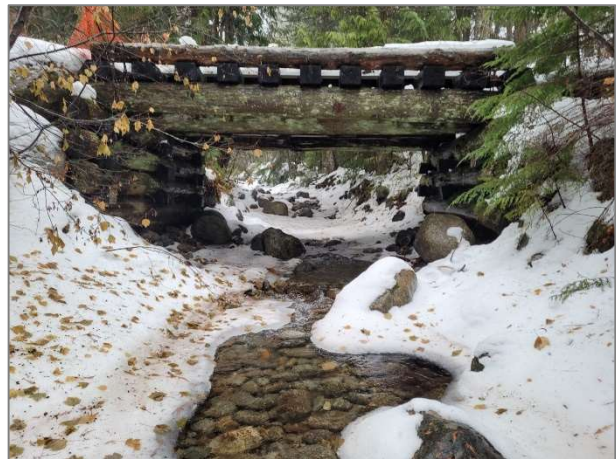
Photo 6. Upstream view of old timber bridge crossing Laird Creek.

An old timber bridge (3.7 m wide by 7 m long) crosses Laird Creek at UTM 11U 500147.5496192 through an easement shared with the property owner of 7086 Lee Road. This easement was created during the subdivision of the property. A gate and fence posts have been installed by the Owner along the northwest property corner on the west side of Laird Creek to discourage unauthorized access and crossing of the bridge (Photo 5 and Photo 6), as the bridge is currently unsafe (personal communication Benny Ryan). For the purposes of this assessment, the gate and fence posts are included as part of the proposed development under the Watercourse Development Permit.

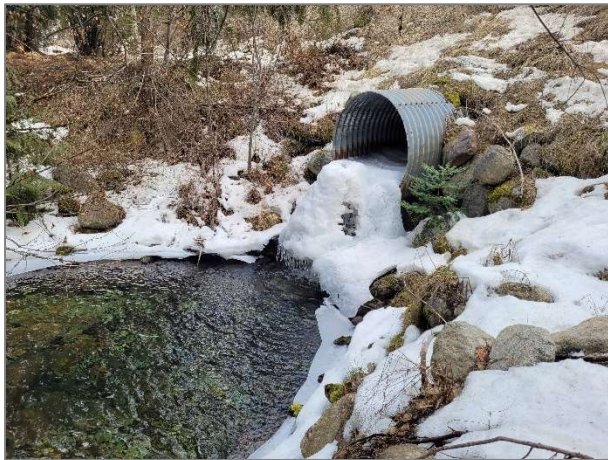
Photo 7. Perched culvert outlet under Hwy 3A.

Laird Creek supports Bull Trout (*Salvelinus confluentus*), Kokanee (*Oncorhynchus nerka*), Rainbow Trout (*O. mykiss*), and Westslope Cutthroat Trout (*O. clarkii lewisi*) (HabitatWizard 2023). Noakes and Haiseldean Lakes, ~8 km upstream of the subject property, were stocked with Rainbow Trout in the 1930s, and Noakes Lakes with Westslope Cutthroat Trout as recently as 2004 (FIDQ). The culvert which conveys Laird Creek flow under Highway 3A is perched by ~ 1 m and represents a barrier to fish migration, particularly during low flow periods (Photo 7).

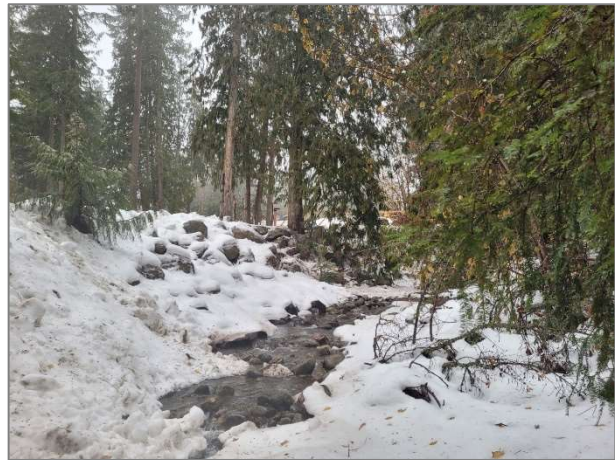
Within the extent of the subject property, Laird Creek is approximately 7.7 m wide, and has a gradient of ~ 4.5%. The stream channel has a cascade-pool morphology and is relatively confined by the steep channel banks (Photo 8 and Photo 9). The right (west) bank has been previously lined with riprap along the southern portion of the neighbouring property (Photo 9 and Photo 10). Streambed substrates are dominated by cobble and boulders (Photo 11), and side bars are present during low water periods. Instream cover was minimal, limited to overhanging vegetation, boulders, and shallow pools present during high water periods. This reach of the creek provides moderate rearing and spawning habitat for salmonids. The Owner confirmed that recent surveys undertaken by the province detected Kokanee spawning within Laird Creek from its outlet to Highway 3A.

Photo 8. Upstream view of Laird Creek by proposed upper fencing location.

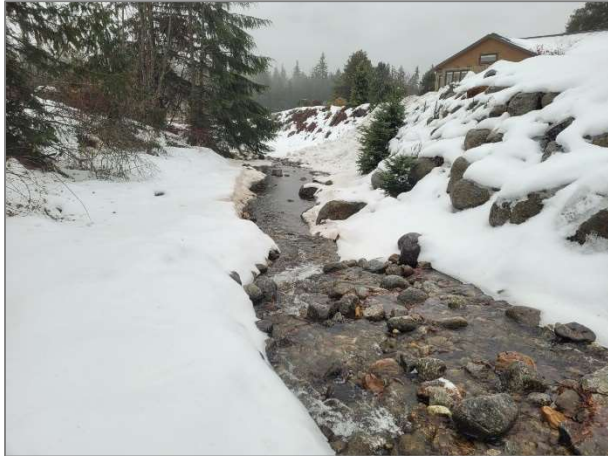
Photo 9. Downstream view of Laird Creek by lower fencing location, with riprap along bank.

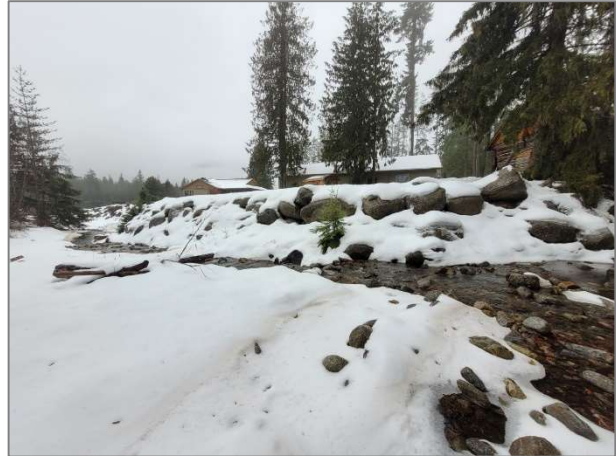
Photo 10. View of right bank and lower fencing location, with riprap along bank.

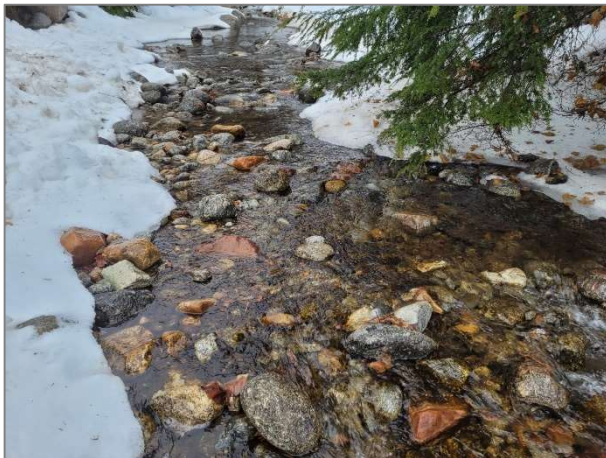
Photo 11. Cobble and boulder substrates in Laird Creek.

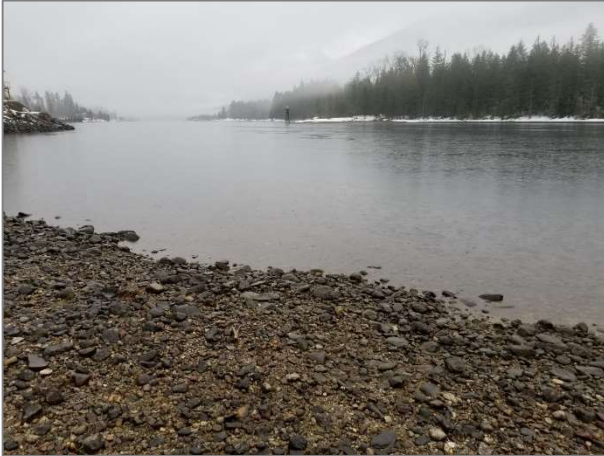
The foreshore of the property consists of a gently sloped beach (~4% gradient) with substrates dominated by cobble and gravel (Photo 12), and some accumulated sands at the mouth of Laird Creek (Photo 13). No

Photo 12. Kootenay Lake shoreline along property foreshore.

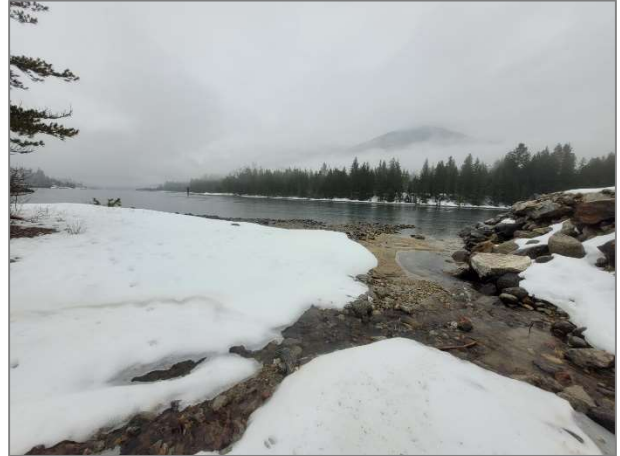
Photo 13. Mouth of Laird Creek into Kootenay Lake.

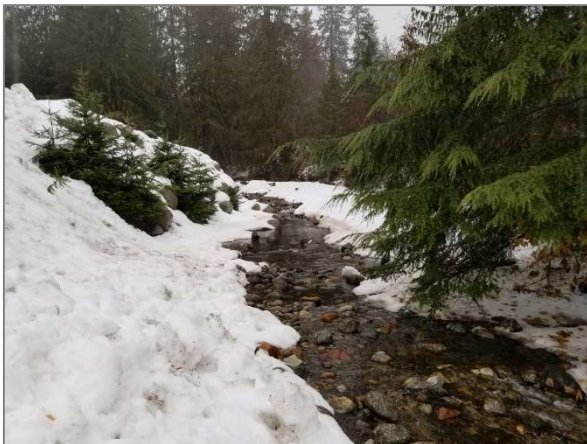
The riparian areas of Laird Creek consist of a mix of intact mature forest (i.e., undisturbed areas along the east bank, Photo 14), cleared area (i.e., left bank beyond strip of native vegetation, Photo 15), and disturbed areas with minimal vegetation (i.e., areas associated with previous fill import, (Photo 16 and Photo 17). Areas of mature forest had several large western redcedar (*Thuja plicata*), Douglas-fir (*Pseudotsuga menziesii*), and western hemlock (*Tsuga heterophylla*). The understory was dominated by alder (*Alnus sp.*), Douglas maple (*Acer glabrum*), beaked hazelnut (*Corylus cornuta*), thimbleberry (*Rubus parviflorus*), snowberry (*Symphoricarpos albus*) and rose (*Rosa sp.*). Several thickets of red osier dogwood (*Cornus sericea*) and willow (*Salix sp.*) were also present along the left bank. The agricultural field on the left bank was mainly grasses. An ~6m x 1m patch of invasive Japanese knotweed (*Reynoutria japonica*) is present adjacent to the upper fencing area, and a few patches of knapweed (*Centaurea sp.*) and curled dock (*Rumex crispus*) were observed on the left bank across from the lower restoration area. Vegetation identification was limited due to snow cover and winter conditions.

Photo 14. Patches of mature forest along east bank of Laird Creek, visible in upper portion of photo.

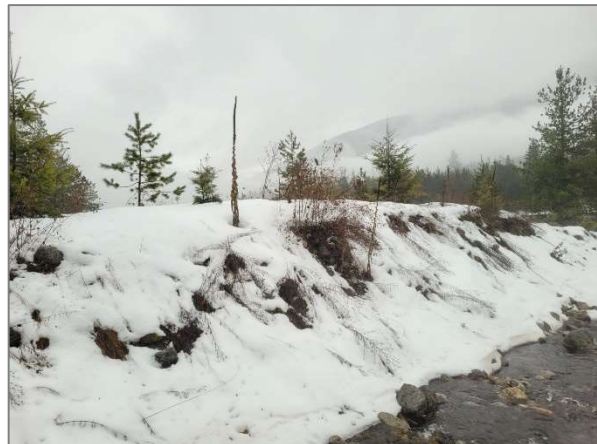
Photo 15. View of cleared area along the east bank in the southern portion of the subject property.

In time, the Owner intends to restore the previously disturbed riparian areas by replanting with native trees and shrubs, per the Recommendations for Riparian Planting by Masse Environmental (Appendix 3). As there is no machine access along the west side of the property, this work will need to be completed by hand and may take up to several years. Through discussions with the RDCK, it is understood that the planting will be undertaken outside the scope of the scope of this WDP, however if any deviations from the Recommendations for Riparian Planting are expected, these should be discussed with the RDCK and may necessitate an additional WDP.

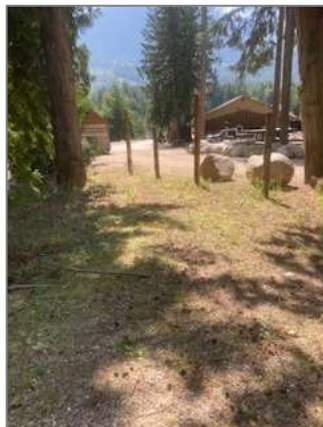
Photo 16. Disturbed area with minimal vegetation along upper fence alignment. Photo provided by Owner.

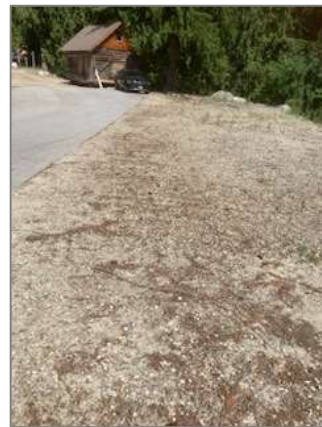
Photo 17. Disturbed area with minimal vegetation along lower fence alignment. Photo provided by Owner.

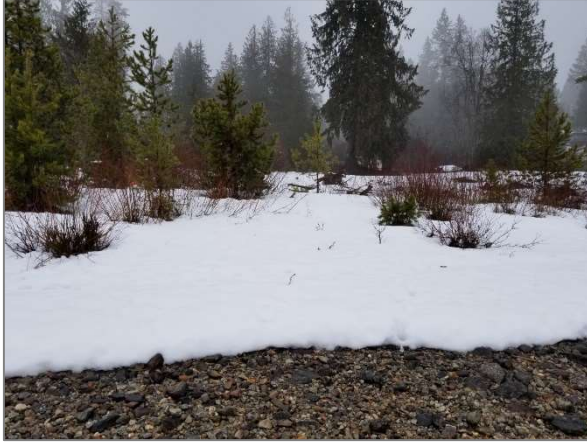
Riparian vegetation along the Kootenay Lake shoreline is relatively sparse, consisting mainly of mature lodgepole and western white pine (*Pinus contorta* and *P. monticola*), young black cottonwood (*Populus balsamifera*), red osier dogwood and grasses (Photo 18).

Photo 18. Sparse riparian vegetation along Kootenay Lake shoreline of subject property.

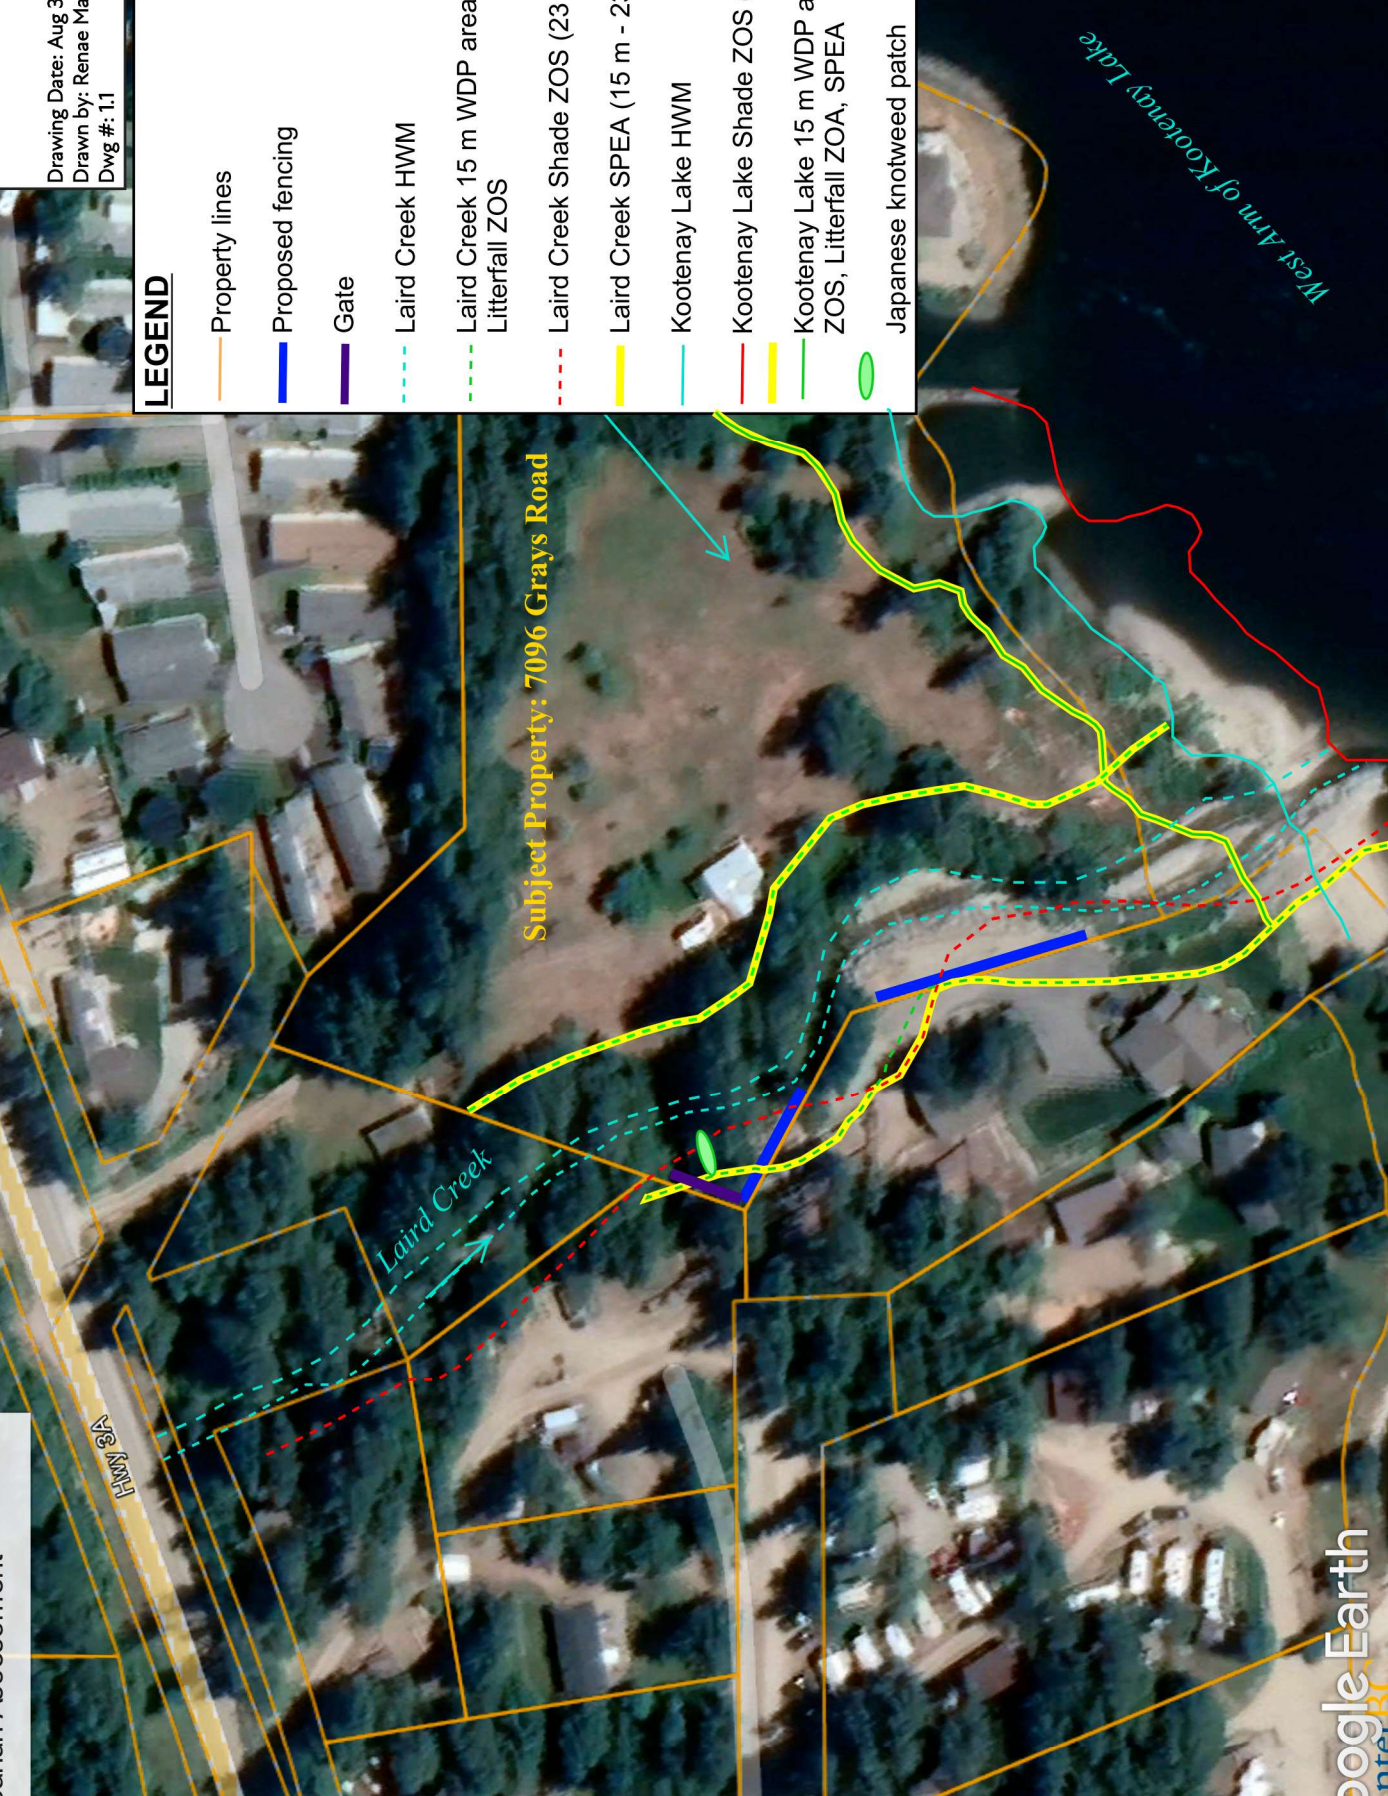
- Property lines
- Proposed fencing
- Gate
- Laird Creek HWM
- Laird Creek 15 m WDP area, LWD ZOS, Litterfall ZOS
- Laird Creek Shade ZOS (23 m)
- Laird Creek SPEA (15 m - 23 m)
- Kootenay Lake HWM
- Kootenay Lake Shade ZOS (30 m)
- Kootenay Lake 15 m WDP area, LWD ZOS, Litterfall ZOA, SPEA
- Japanese knotweed patch
