# HB Mine Tailings Facility Remediation and Closure Plan

BC Ministry of Energy, Mines and Petroleum Resources

1CR012.006  
August 2020

Project No: 1CR012.006

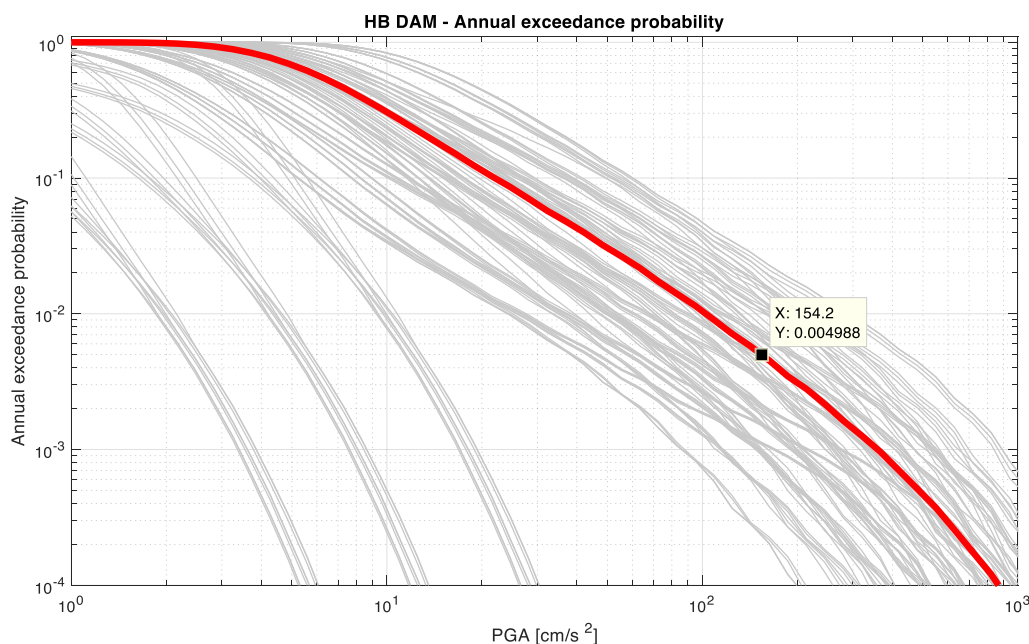
**Fig. 3: Mean Annual Exceedance Probabilities for PGA.**

The mean annual exceedance probability (AEP) for PGA and PGV are shown in Fig. 3 and Fig. 4. AEP curves are defined for a reference site condition class C ( $V_{s30} = 760 \text{ m/s}$ ) according to NBCC 2010 and ASCE 7-10 [2]

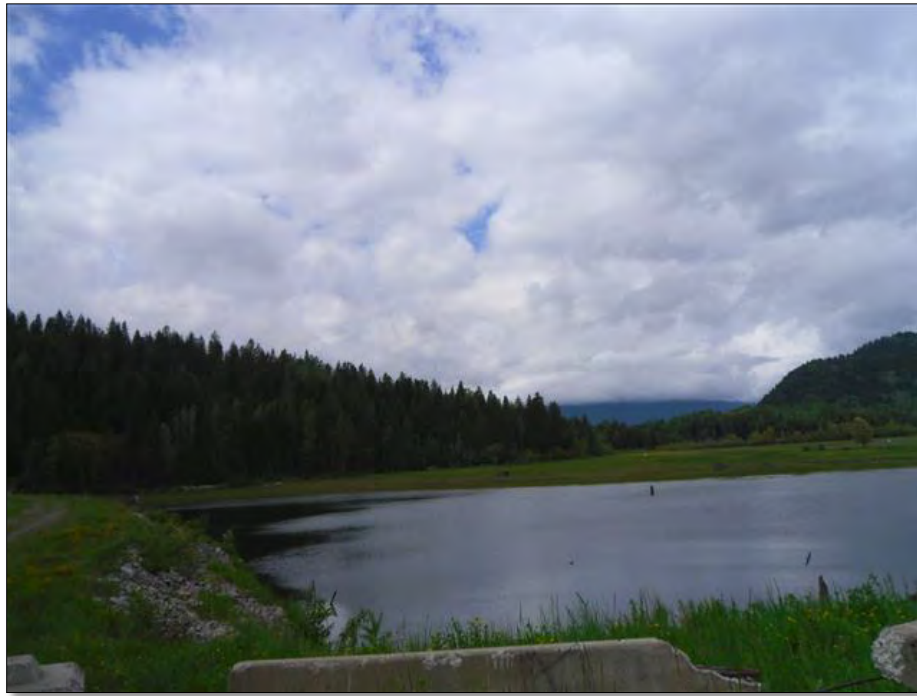
**Photo 1:** Tailings Deposition Area Looking North (1)

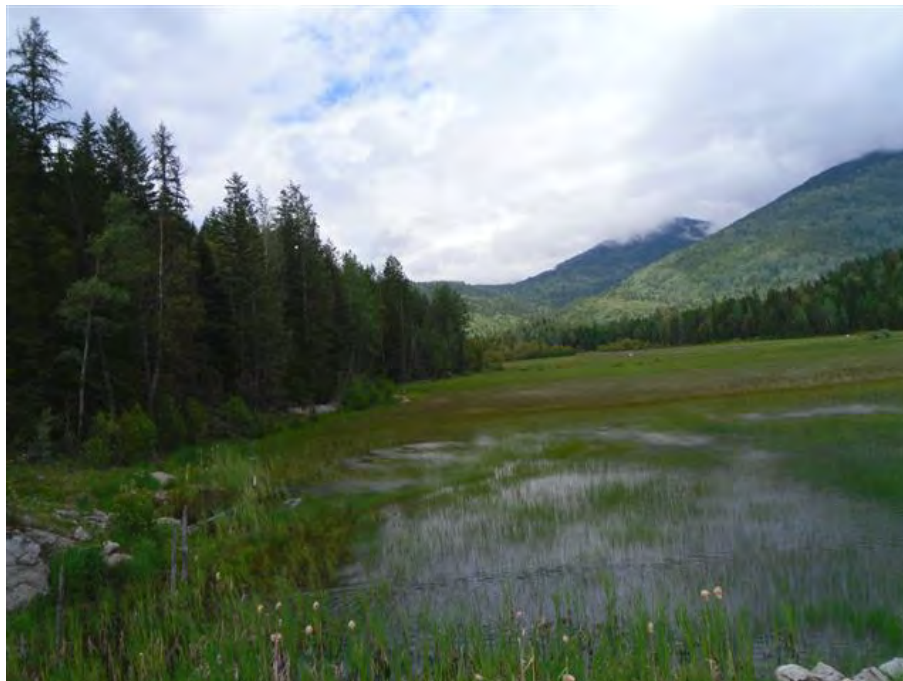
**Photo 2:** Tailings Deposition Area Looking North (2)

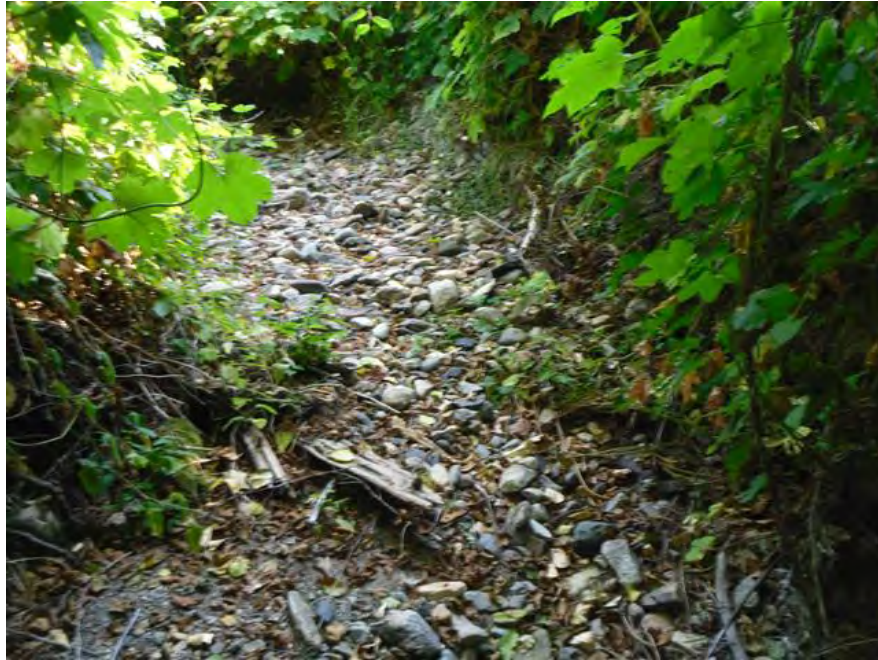
**Photo 3:** Downstream Drainage Channel (Dry)

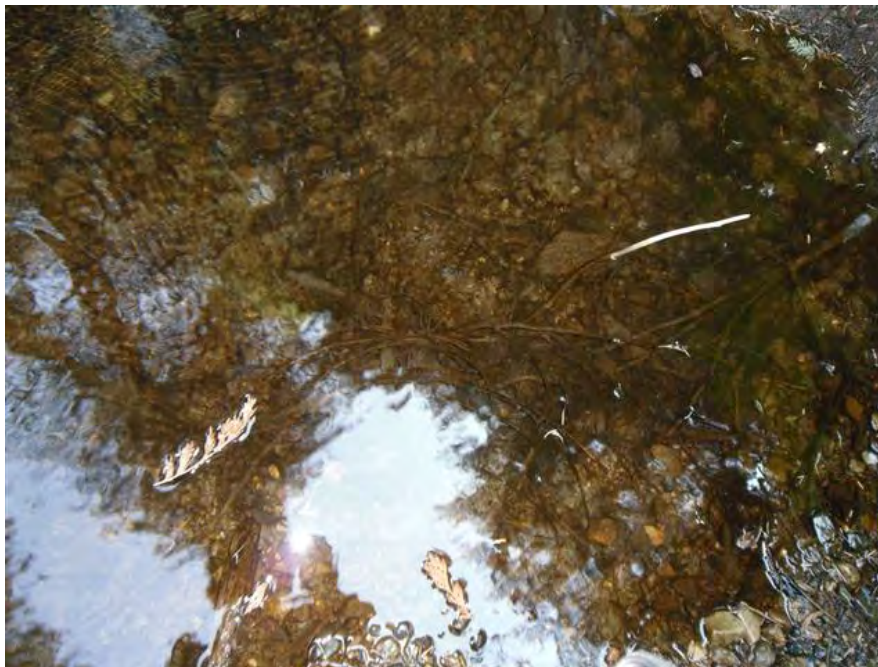
**Photo 4:** Downstream Drainage Channel (Wet)

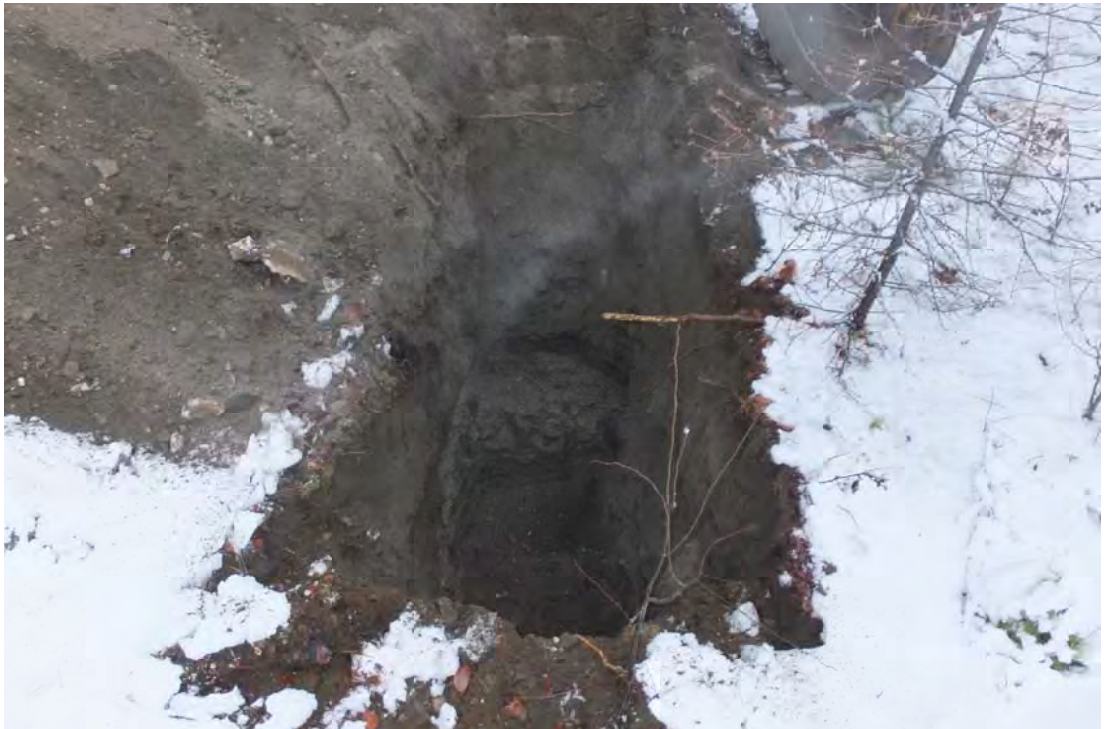
Test Pit Photograph

Depth (m)	Lithological Symbol						Sample Type	Tests Completed <small>(other than those shown to the right)</small>	Moisture Contents & Atterberg Limits			Particle Size Distribution			
	Symbol	Soil Description							Grab Undist.	Moisture Content Liquid Limit Plastic Limit	Gravel Sand Silt Clay Fines				
0		ORGANICS, roots/grasses													
0.2		Poorly-graded SAND with gravel some silt, little organics at top of zone, moist, non-cohesive. Gravel rounded, trace of cobbles up to 20 cm.													
1.2		Poorly-graded GRAVEL with sand, some silt, moist, non-cohesive. Gravel rounded, trace of cobbles					SRK17-TP01-1		■						
2.2		Poorly-graded SAND and GRAVEL, trace silt, light brown, dry, non-cohesive, massive.					SRK17-TP01-2		■						
2.6		Material similar as above but dry, less gravel					SRK17-TP01-3		■

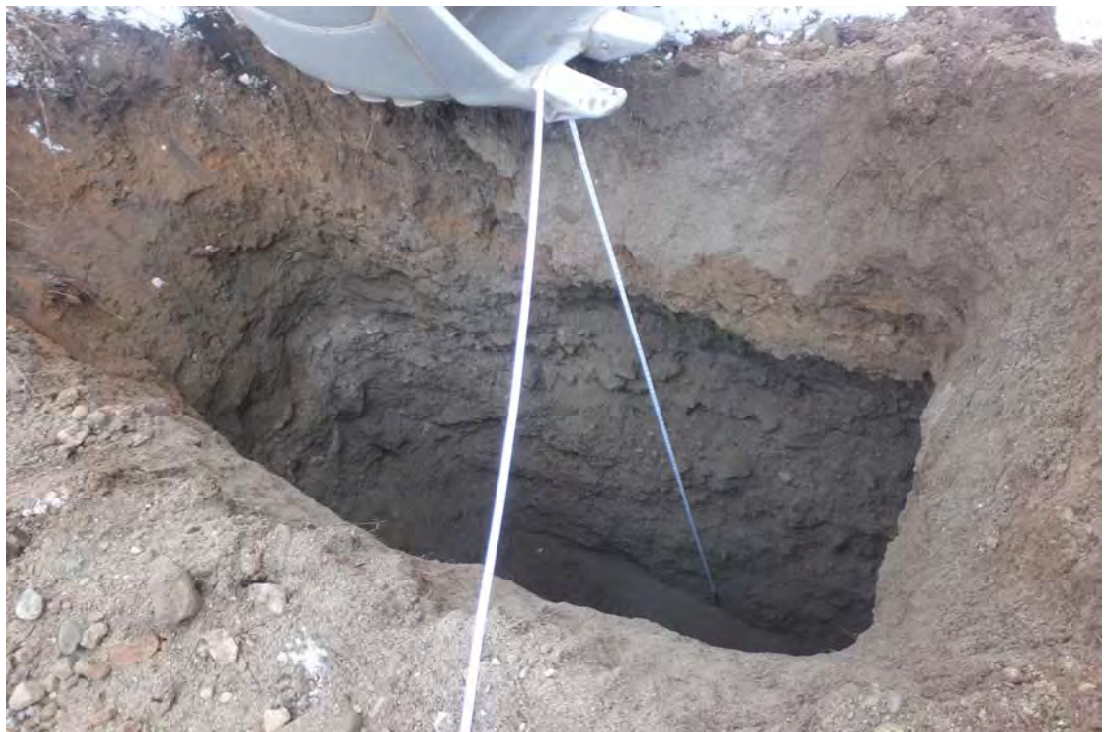
Test Pit Photograph

Depth (m)	Lithological Symbol		Sample Type	Tests Completed (other than those shown to the right)	Moisture Contents & Atterberg Limits		Particle Size Distribution				
	Symbol	Soil Description			Moisture Content	Liquid Limit	Plastic Limit	Gravel	Sand	Silt	Clay
0		Pooly-graded SAND and gravel, brown, moist, some cobbles (up to 25 cm)									
0.2											
0.4											
0.6											
0.8		Material not as good compared to the south east corner of the pit									
1											
1.2		Poorly-graded SAND and gravel, brown, moist, trace cobbles									
1.4											
1.6			SRK17-TP06-1		■						
1.8		Material getting better with depth, i.e. less coarse.									
2											
2.2											
2.4											
2.6		Poorly-graded SAND and gravel, brown, dry									
2.8											
3											
3.2			SRK17-TP06-2		■

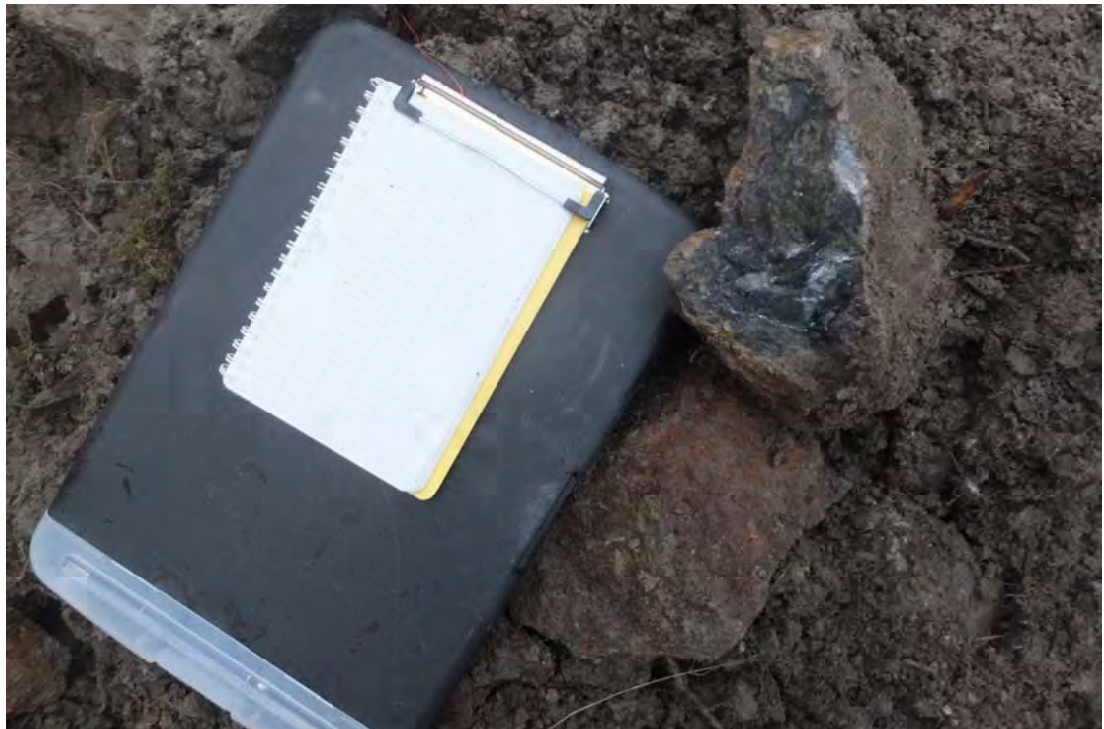
Test Pit Photograph

0.16	[Symbol]																					
0.17	[Symbol]																					
0.18	[Symbol]	Excavator unable to advance - rocks																				
0.19	[Symbol]	Weathered bedrock?

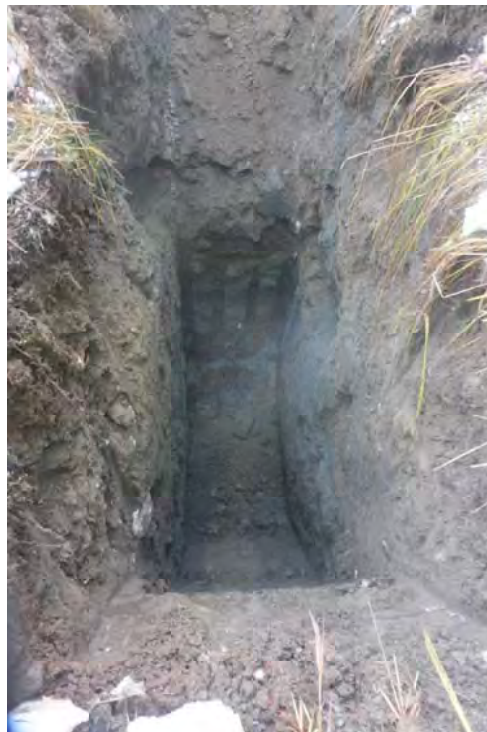
Test Pit Photograph

Depth (m)	Lithological Symbol										Sample Type	Tests Completed (other than those shown to the right)	Moisture Contents & Atterberg Limits					Particle Size Distribution					
	Symbol	Soil Description											Grab	Undist.	Moisture Content	Liquid Limit	Plastic Limit	Gravel	Sand	Silt	Clay	Fines	
0		Silty GRAVEL with sand, some cobbles up to 15 cm diameter, brown, moist. [Fill]

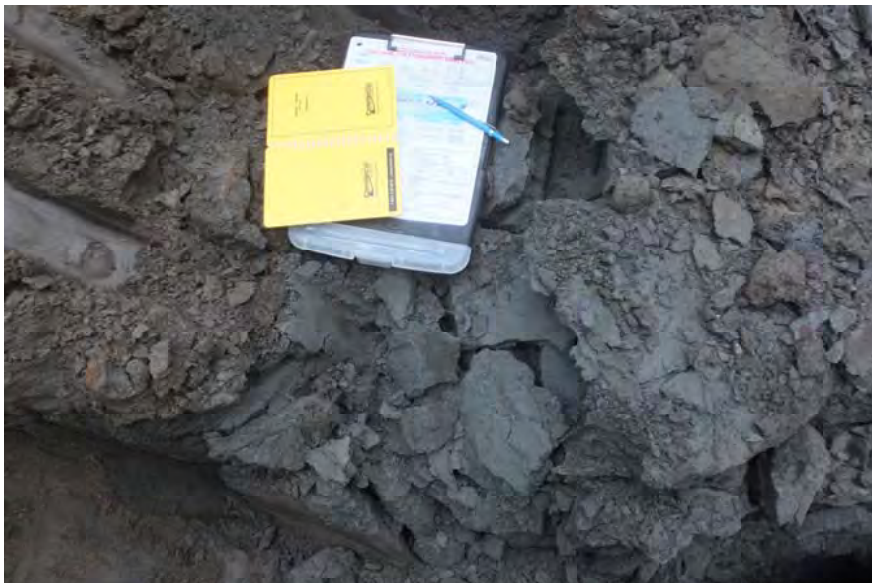
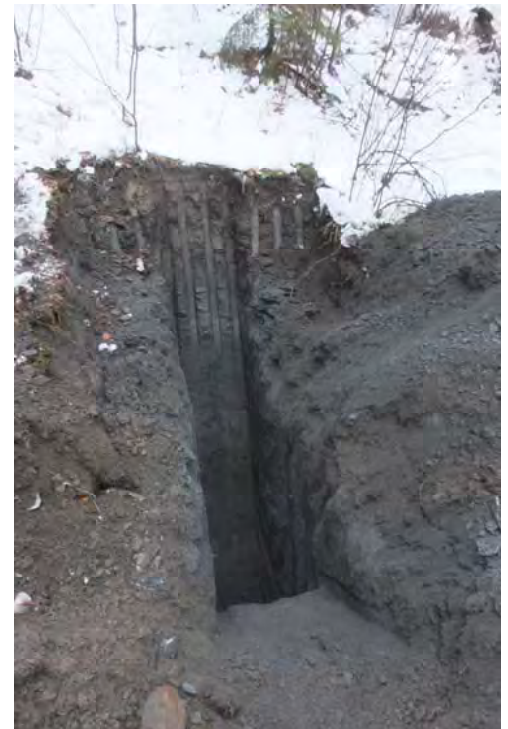
Test Pit Photograph

Depth (m)	Lithological Symbol										Sample Type	Tests Completed (other than those shown to the right)	Moisture Contents & Atterberg Limits					Particle Size Distribution					
	Symbol	Soil Description											Grab	Undist.	Moisture Content	Liquid Limit	Plastic Limit	Gravel	Sand	Silt	Clay	Fines	
0		Organic soil - silty SAND and gravel, broken angular rock

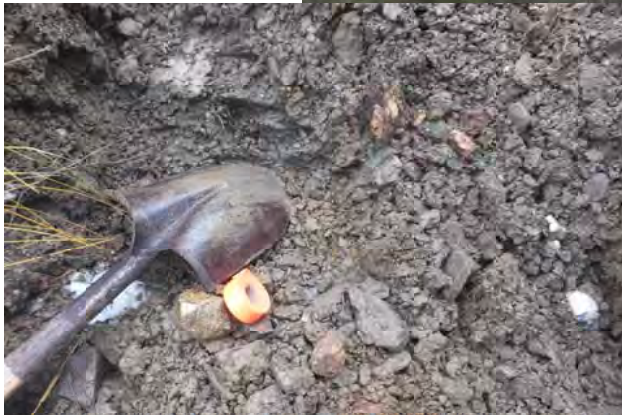
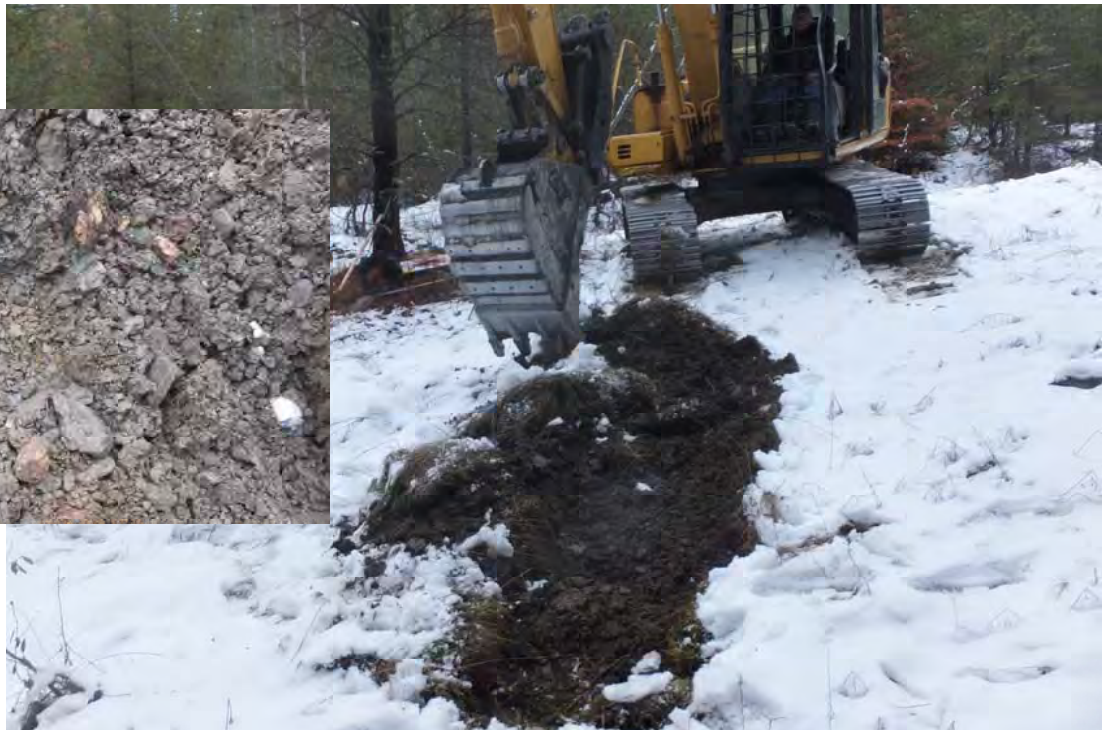
Test Pit Photograph

0.19		Weathered bedrock?

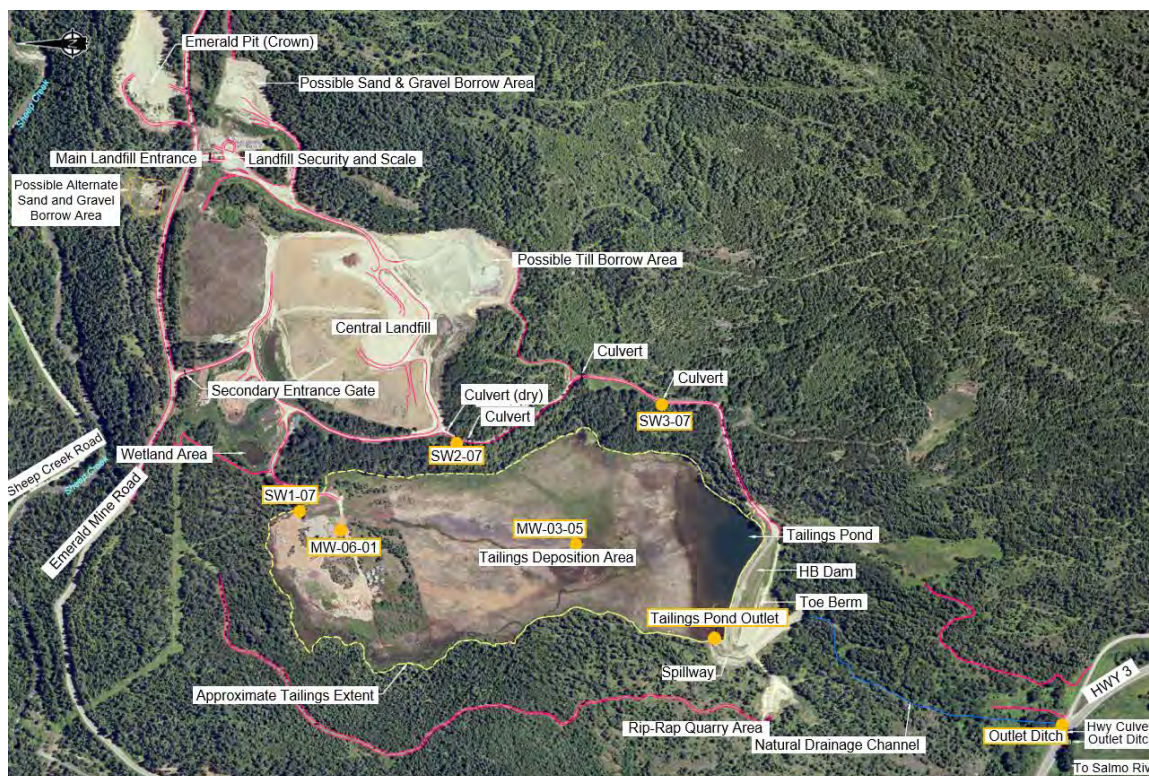
**Figure 1: HB Mine Tailings Facility Site Map**

The major drainage in the area is the Salmo River located in a floodplain area west of the tailings facility. The tailings deposition area is approximately 26 ha and situated in a hanging valley (Figure 1). The tailings facility receives runoff originating from the Central Landfill, to the East of the site. Water from the tailings facility discharges towards the south in an ephemeral stream that flows through a man-made ditch system to the Salmo River.
