STAGE 1, LEVEL 1 - GARP ASSESSMENT REPORT

Water system: Burton

Date of report: January 9, 2019

Location of water supply system: Burton, BC

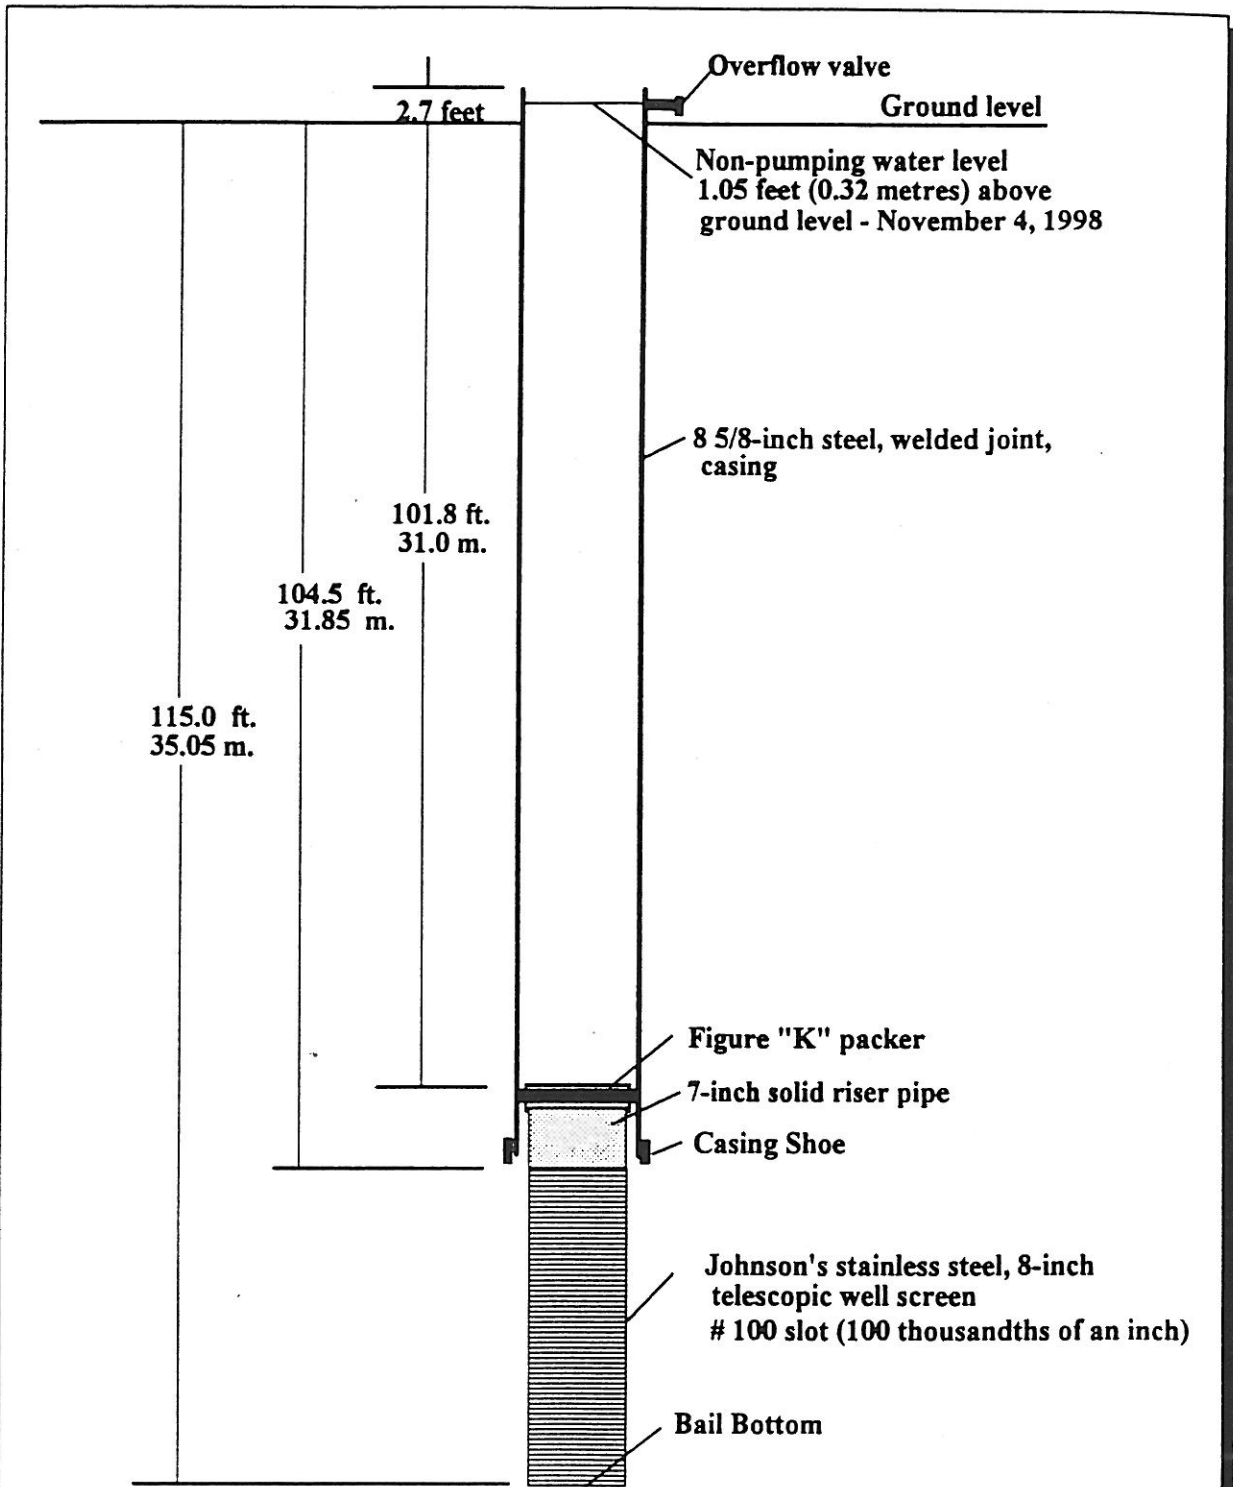
FIGURE 3
WELL COMPLETION DIAGRAM
 New 8-inch Production Well - District of Burton

The new 8-inch production well drilled for the District of Burton is completed with 8 5/8-inch diameter, steel welded joint casing of 0.188" wall thickness. The screen assembly is comprised of 8-inch telescopic, Johnson's stainless steel well screen, set between 104.5 and 115 feet (31.9 and

Note: Not to scale

- The new 8-inch production well drilled for the District of Burton is completed with 8 5/8-inch diameter, steel welded joint casing of 0.188" wall thickness. The screen assembly is comprised of 8-inch telescopic, Johnson's stainless steel well screen, set between 104.5 and 115 feet (31.9 and 35.1 metres) below surface. A well completion diagram is shown in Figure 3.

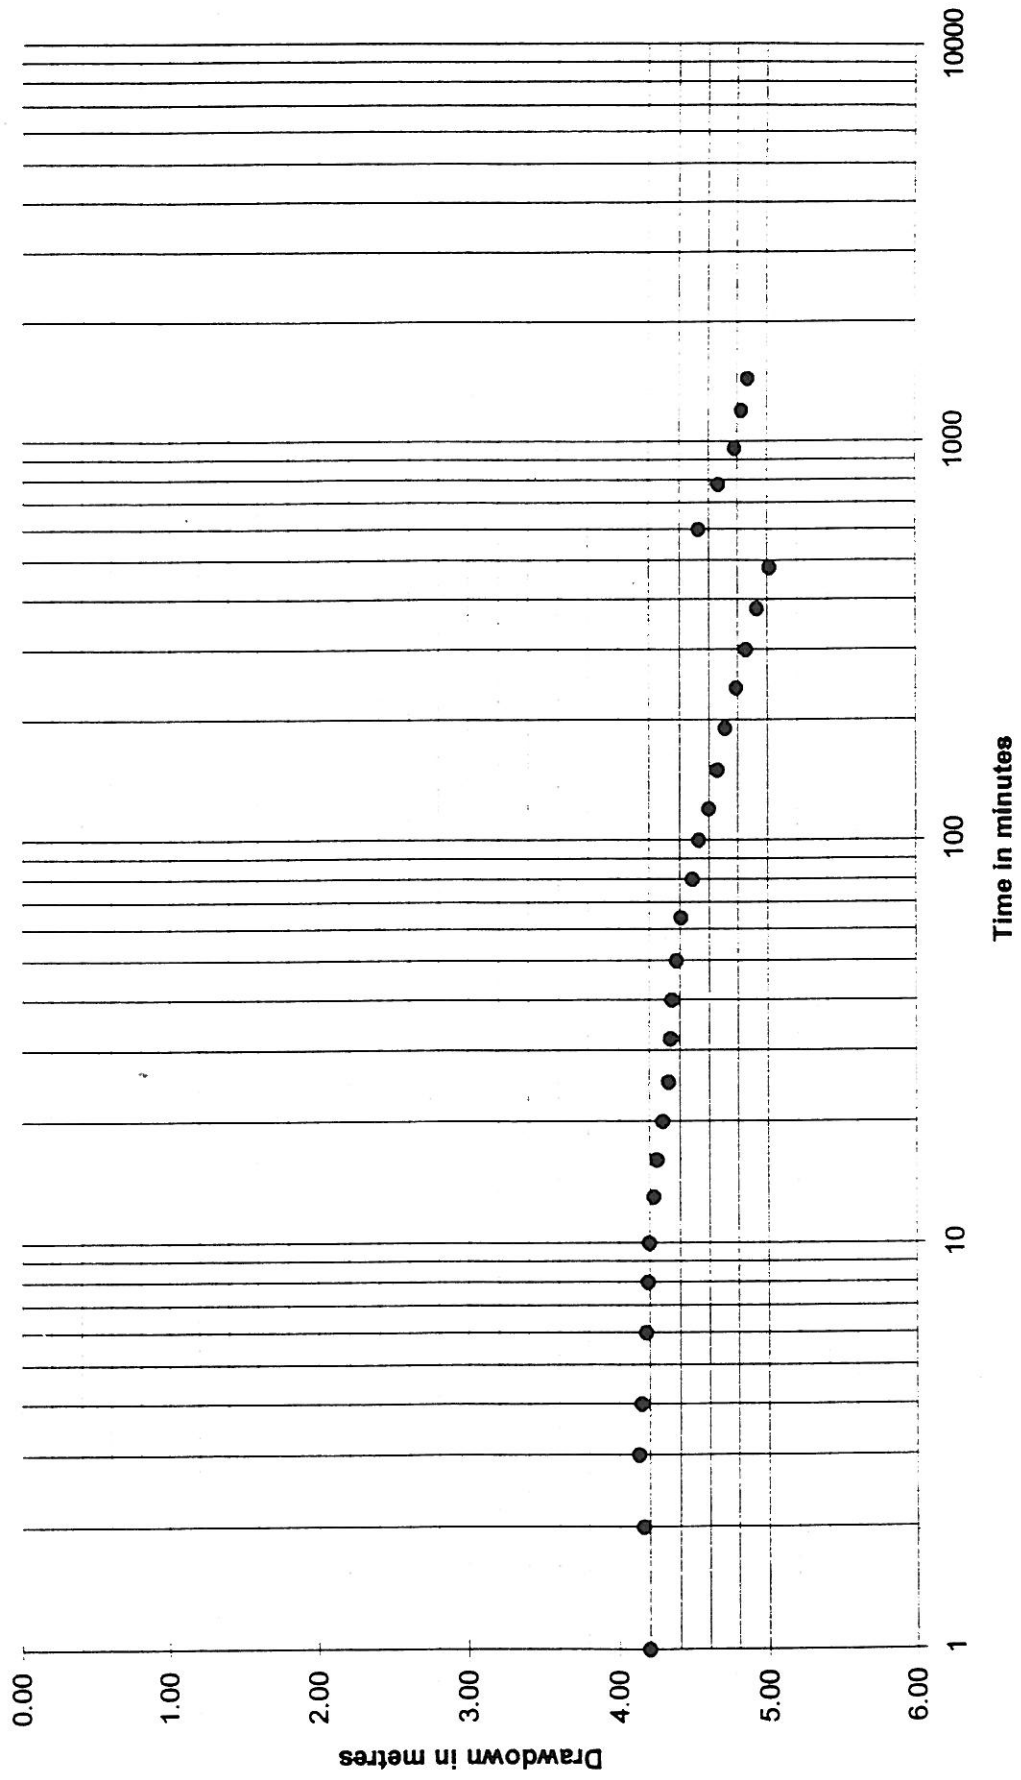
SEMI-LOG PLOT OF DRAWDOWN VERSUS TIME

Results of the 24-hour pumping test have been tabulated and plotted on semi-log and log-log graphs of drawdown versus time (see Appendix B). It should be noted that the test pump used during the present program was an 8-inch submersible pump, which meant there was very little tolerance between the pump and the casing. Because of this and to avoid severing the submersible wire, the pump was only lowered to 20 feet below the top of casing. Even with this shallow setting, the test was started at 738 USgpm, but after 480 minutes the rate had to be lowered to 676 USgpm due to a slight cavitation of the water level above the pump.

During the pumping test, a steady rate of drawdown was observed in the amount of 0.75 metres (2.46 feet) per log cycle while pumping at 738 USgpm and this reduced to 0.6 metres (1.97 feet) per log cycle after reducing the pumping rate to 676 USgpm. The maximum drawdown noted in the existing Rupp Well at the end of the 24-hour pumping test was 2.71 metres (8.89 feet). The rate of drawdown in the Rupp Well was similar to that observed in the new 8-inch production well. Based on the results of the testing program, the new 8-inch well has a safe yield of greater than 1000 USgpm. The well screen assembly however is designed to transmit 500 USgpm at the recommended entrance velocity of 0.1 feet per second, and *Kala* recommends a design capacity of somewhere in this range (500 to 600 USgpm).

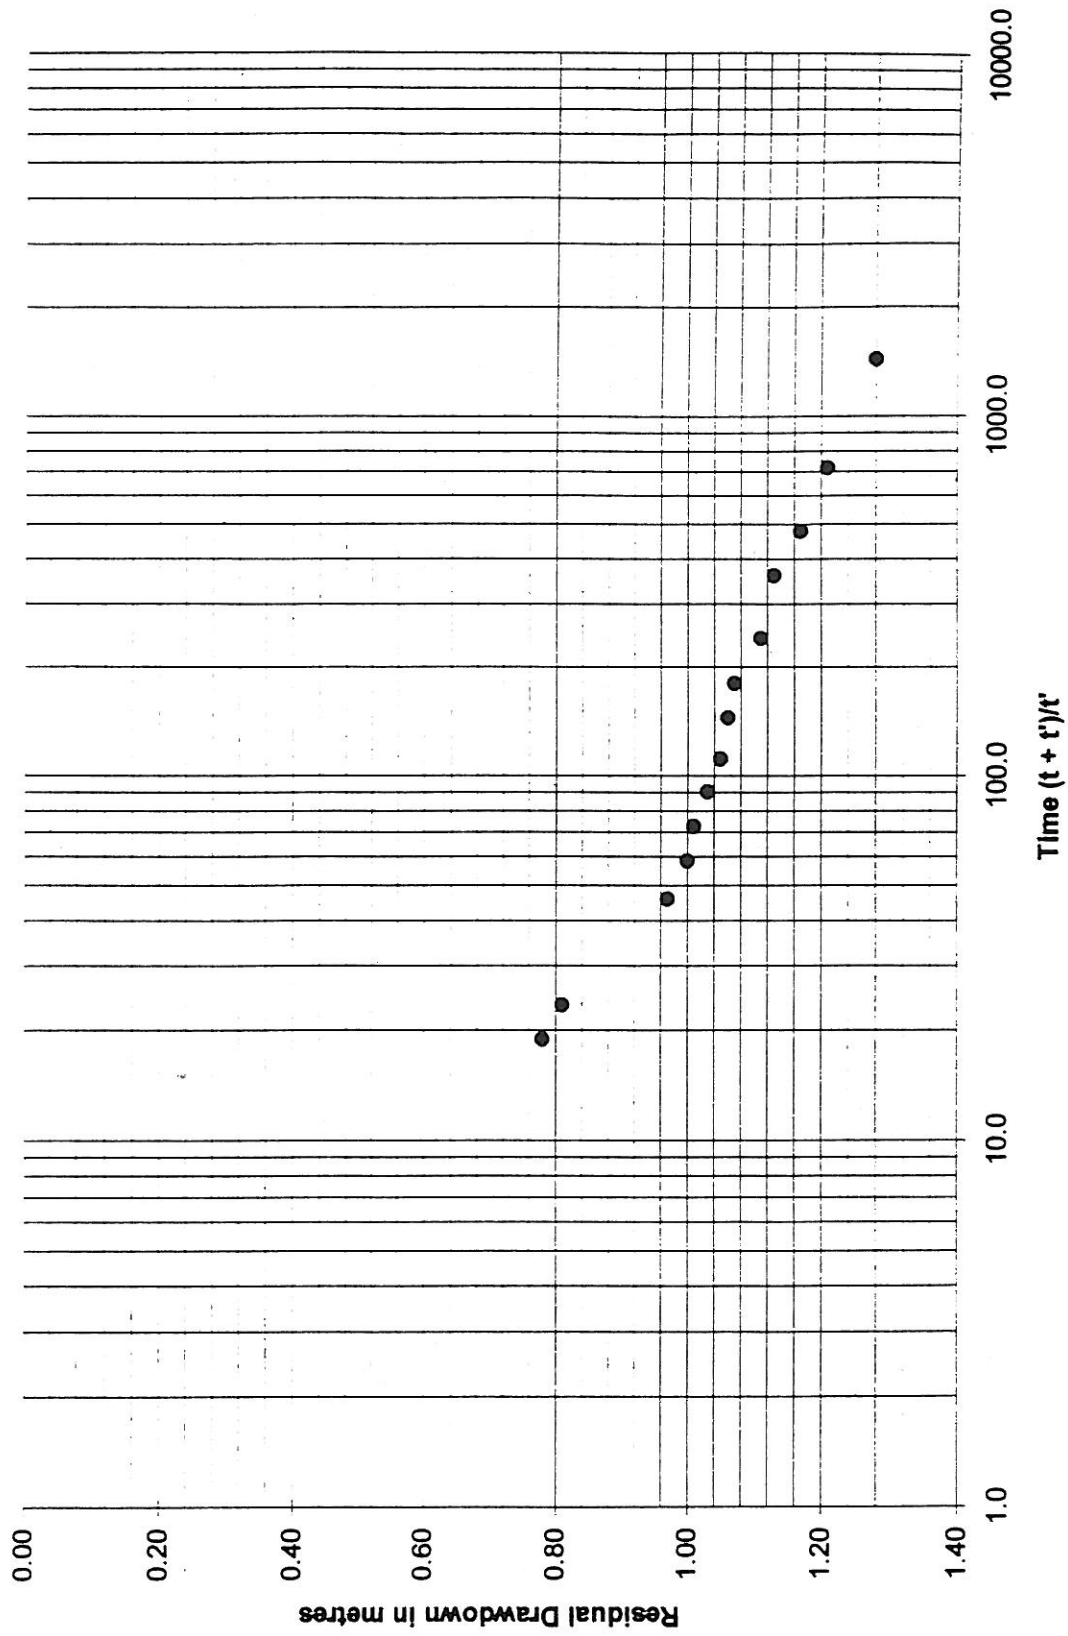
SEMI-LOG PLOT OF RECOVERY

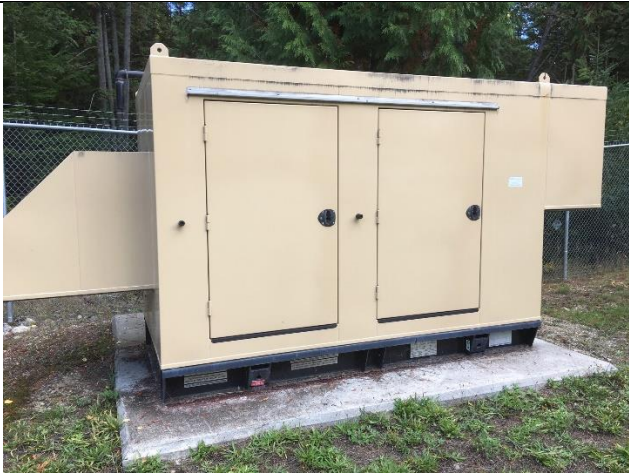
Onsite Diesel Generator

Does not meet GWPR (Part 3 Div. 5 and Part 7) for wellhead protection.	Yes	Yes	Field verified the well casing stick-up is greater than 30 cm. Nearby diesel generator is S601-07 ULC rated for shop fabricated steel aboveground tanks for flammable and combustible liquids (https://canada.ul.com/wp-content/uploads/sites/11/2014/06/Certification_Bulletin_2009-09ENG-S601-07.pdf). Wellheads are contained within a fenced area to prevent public access and physical damage. Ground is not sloped to prevent collection of water.
--	-----	-----	---

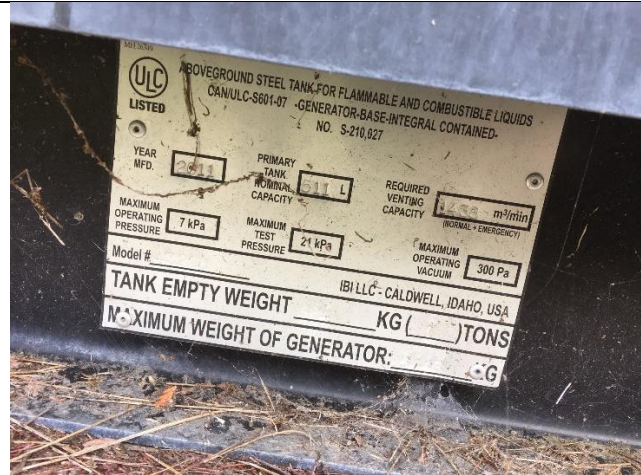
ULC Rating for Generator

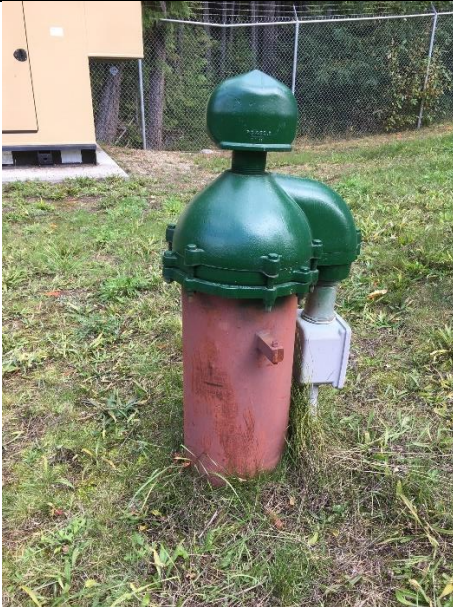
Well Head #1

Hazards	Present (Yes/No)	Risk (Yes/Low)	Comments
Does not meet GWPR (Part 3, Division 3) for surface sealing	Yes	Yes	Well completion diagram does not indicate a surface seal. Field investigation confirms no surface seal is present on either well.
Does not meet the GWPR (Part 4) and WSA (section 54) for well caps and covers	No	Low	Field investigation verifies the well caps are comprised of manufactured steel and secured (bolted) to the top of the production casing.
Does not meet GWPR (section 63) and DWPA (Section 16) for floodproofing.	No	Low	Wellheads are contained within a fenced area to prevent physical damage due to flood debris.

By applying the provincial Guidance Document for Determining Groundwater at Risk of Containing Pathogens, this Level 1, Stage 1 GARP assessment presents several parameters that may infer GARP-virus only potential. Recommendations include installation of a bentonite surface seal on both wells, and site grading away from the well heads to meet the GWPR requirements.

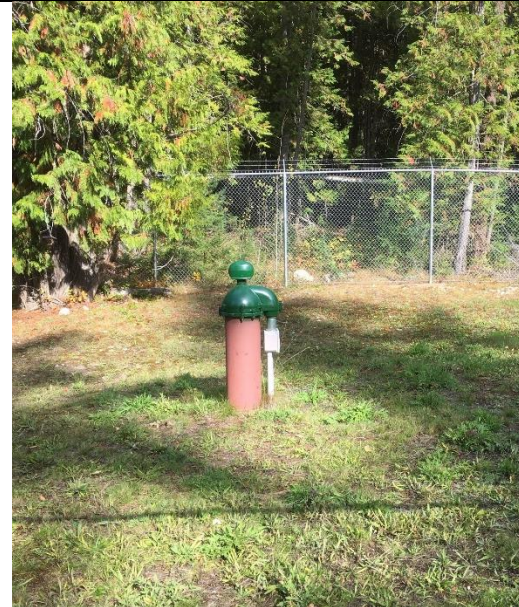
Well Head #2

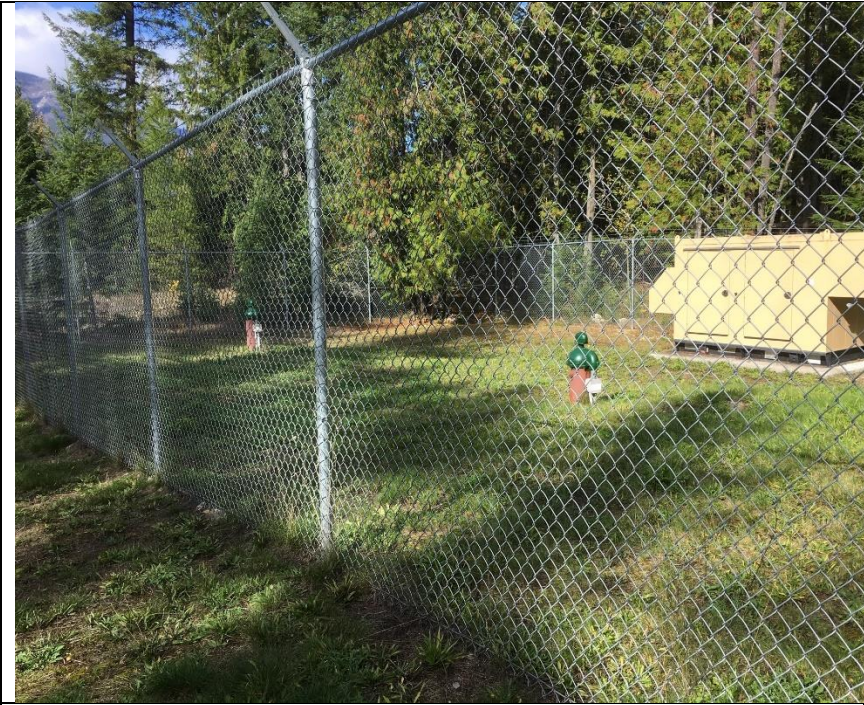
Fenced Enclosure for Well Heads
