**MINISTRY OF FORESTS: POST-WILDFIRE NATURAL HAZARD RISK ANALYSIS**  
**ARGENTA CREEK - LEVEL 2 RECONNAISSANCE REPORT**

<b>FIRE NUMBER:</b> N71058 Argenta Creek	<b>FIRE YEAR:</b> 2024	<b>DATE OF REPORT:</b> October 9, 2024
<b>AUTHOR:</b> Sarah Crookshanks, P.Geo., Ministry of Forests		
<b>REPORT PREPARED FOR:</b> Southeast Fire Centre, District Manager		
<b>FIRE SIZE, LOCATION, AND LAND OWNERSHIP:</b> 19,150 ha of provincially managed public land and private land from the Argenta Face north to Glacier Creek

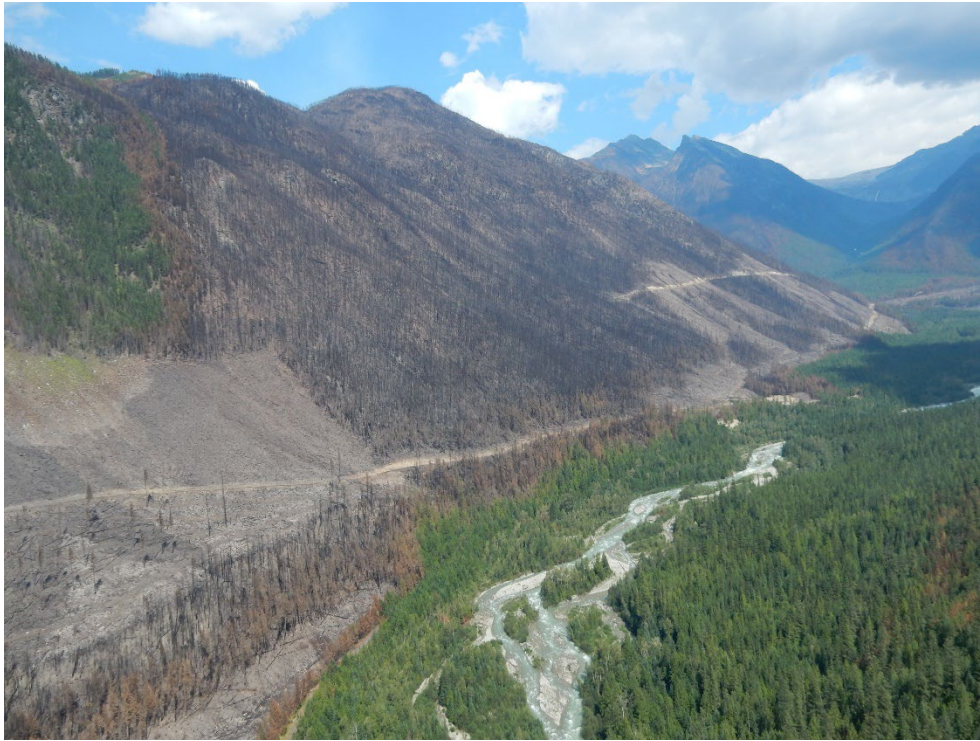
*Figure 2. Glacier Creek FSR just downstream of the confluence with Birnam Creek.*

The Glacier Creek FSR is located on the northwest side of the creek for the first 9.5 km, and several small, ephemeral drainages drain the slopes above the road along this section. The burn severity along the slopes above the first section of the FSR is mostly composed of low and moderate burn severity, with small patches of high. Sections of this slope, particularly towards the intersection with MacBeth FSR, burned at high severity. There will likely be an increased likelihood of small debris flows or flooding along sections of road, particularly during intense rainfall or spring snowmelt.

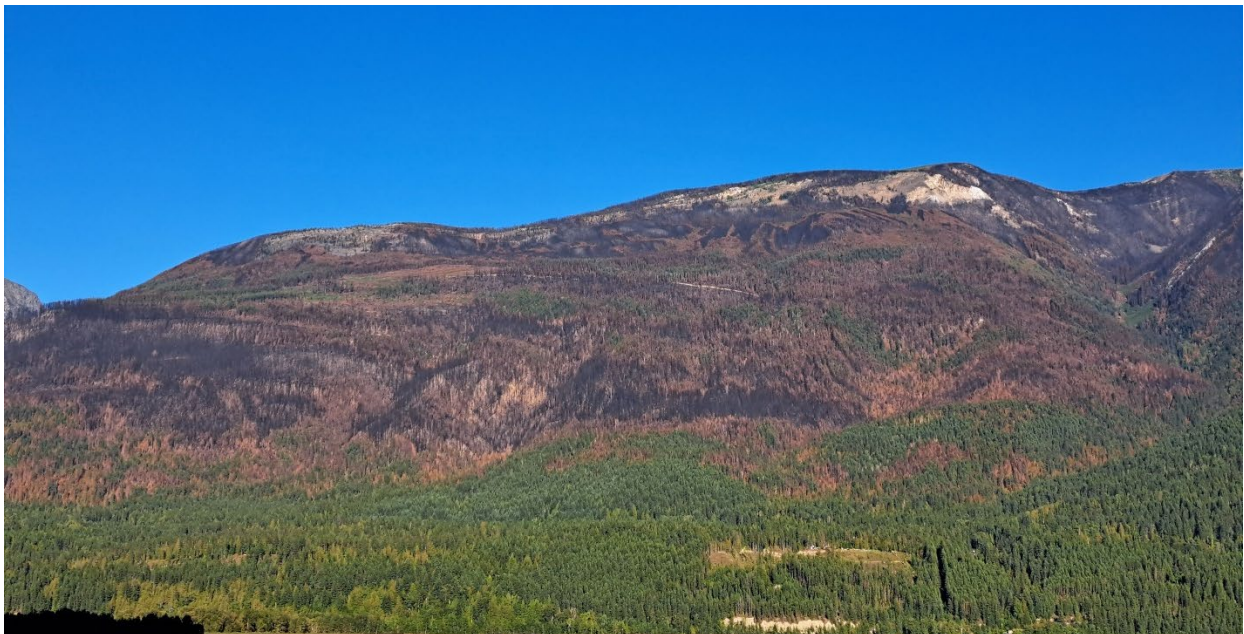
*Figure 3. Argenta Creek and the Argenta Face (photo: Florence Lanouette, Sitkum Consulting Ltd.).*

Argenta Creek is a steep channel (average gradient of ~ 30%) that is subject to debris flows. The creek drains mountainous terrain on the west side of Mount Willet (>2,700 m). The channel gradient moderates to on average less than 20% as it flows onto an area referred to as the Argenta Bench (between 900 and 680 m elevation). Below the bench the channel steepens to >25% below Argenta Road dropping 120 m down to Kootenay Lake. According to residents, a natural debris slide occurred in the south fork of Argenta Creek in May 1997. The slide transitioned to a debris flow, depositing some of its material ~900 m upstream of Argenta Road where the channel gradient moderates and channel confinement decreases near the uppermost water diversion point. As the channel steepens below this site, a second phase of the initial event was initiated, transporting logs and debris 700 m further downstream and depositing the bulk of this material upstream of the Argenta Road crossing. Some sediment-laden water of this secondary flow was diverted south along an access trail for a water line, flowed through private property, along Wolfe Road, and then Argenta Road before almost reaching the lake at the Argenta Johnsons Landing Road. The debris flow did not impact the lower fan along the lakeshore.

The headwaters of Argenta Creek were burned at mostly high and moderate vegetation burn severity, but the riparian zones and gully sidewalls contain patches of low vegetation burn severity and the southern end of the watershed remains unburned. Given the moderate and high burn severity over the steep terrain in the headwaters, the likelihood of a post-wildfire debris flow in this watershed is rated as high.

Argenta Creek is well-confined through the Argenta Bench as it flows towards the lake. Around 900 m upstream of the road, the channel gradient moderates and it becomes slightly less confined, providing an opportunity for deposition of debris flow material. During the field review, evidence of historical debris flow events, in addition to the 1997 debris flow deposit, were observed at this location. One potential avulsion site is 250 m upstream of Argenta Road along the water line access road that leads to the south. The 1997 debris flow event resulted in sediment-laden water flowing along this access road, impacting private property and two secondary roads. The second potential avulsion site is at the Argenta Road crossing. The creek passes through the road in a 1,200 mm culvert covered with 3 m of fill on the upstream side and 5 m of fill on the downstream side. If a debris flow event reached this crossing, it would be expected to plug the culvert and some of the flow could be diverted down the Argenta Road on the south side of the creek (downhill gradient of 3-4%).

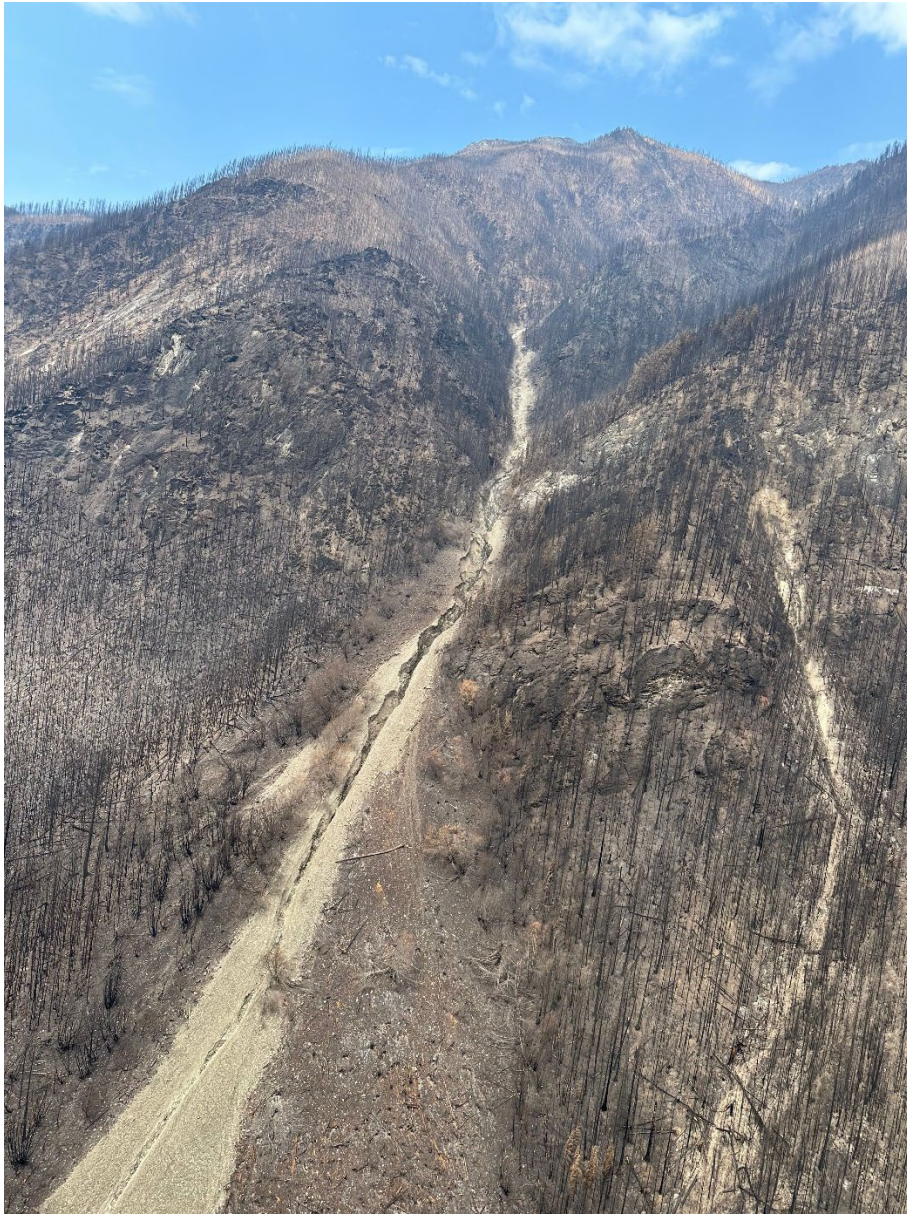
*Figure 4. Hamill Creek tributary showing evidence of a debris flow from August (photo: Tedd Robertson, Sitkum Consulting Ltd.)*

The Hamill Creek watershed burned at high burn severity, and numerous steep tributaries are composed of almost 100% high burn severity. In a rainstorm in mid-August debris flows occurred in several of these drainages, contributing debris and logs to the main channel. The Earl Grey trail traverses below terrain that has been severely burned and crosses numerous small debris-flow prone tributary channels to Hamill Creek. The likelihood of a post-wildfire debris flow is rated as high and the probability of spatial impact to the trail is also rated as high, resulting in a very high partial risk.
