MINISTRY OF FORESTS: POST-WILDFIRE NATURAL HAZARD RISK ANALYSIS
PONDEROSA FSR - LEVEL 2 RECONNAISSANCE REPORT

FIRE NUMBER: N51069 Ponderosa FSR	FIRE YEAR: 2024	DATE OF REPORT: September 11, 2024	
AUTHOR: Sarah Crookshanks, P.Geo., Ministry of Forests			
REPORT PREPARED FOR: Southeast Fire Centre, District Manager			
FIRE SIZE, LOCATION, AND LAND OWNERSHIP: 1860 ha on provincially managed public land and private land southeast of the village of Slocan			
VALUES AT RISK:			
<ol style="list-style-type: none"> 1. Private residences and/or potentially occupied buildings along Highway 6 and Martens Road 2. Domestic surface water quality on creeks originating from within the fire 3. Highway 6 and Austyn, Martens and Springer Roads 			
WATERSHEDS AFFECTED	TOTAL AREA	AREA BURNED	BURN SEVERITY (% of watershed area)
<i>Lemon Creek</i>	20200 ha	664 ha (3%)	0% H, 1% M
<i>Ringrose Creek</i>	126 ha	85 ha (67%)	0% H, 25% M
<i>O'Shea Creek</i>	128 ha	74 ha (57%)	0% H, 16% M
<i>Vincent Creek</i>	50 ha	22 ha (43%)	4% H, 28% M

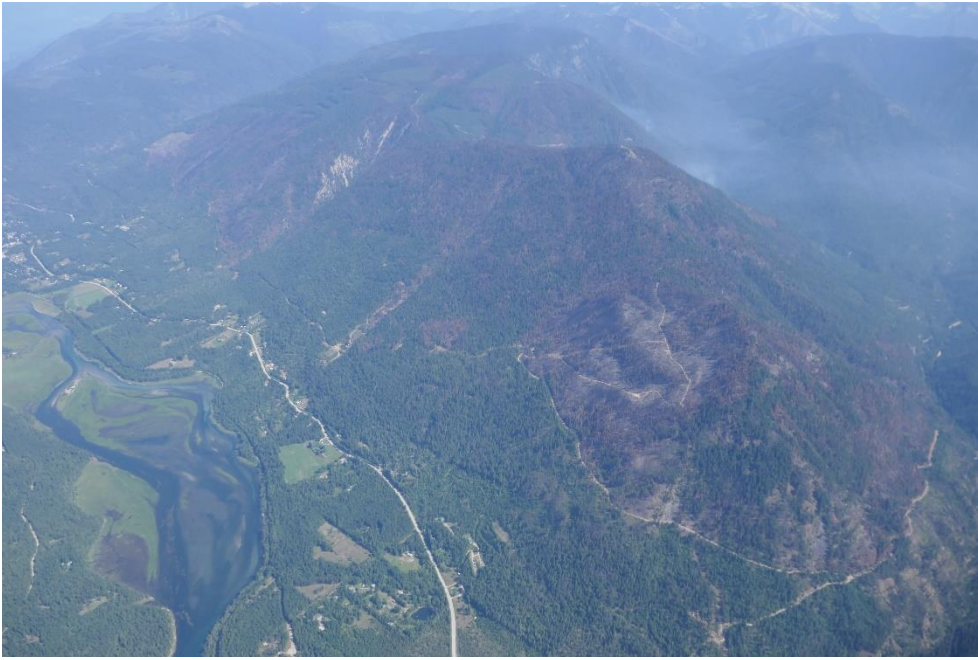
Figure 2. Overview of the Ponderosa FSR fire looking north (Photo: T. Giles, SNT Geotechnical).

The fire burned the western face between Lemon Creek to the south and Springer Creek to the north. This slope ranges in elevation from 600 m to 1700 m. The drainages to the north exhibit flat-over-steep terrain, where the upper portions of the watersheds are gently sloping and drain into steeper draws below. Ringrose Creek to the south has a more consistent channel gradient from top to bottom.

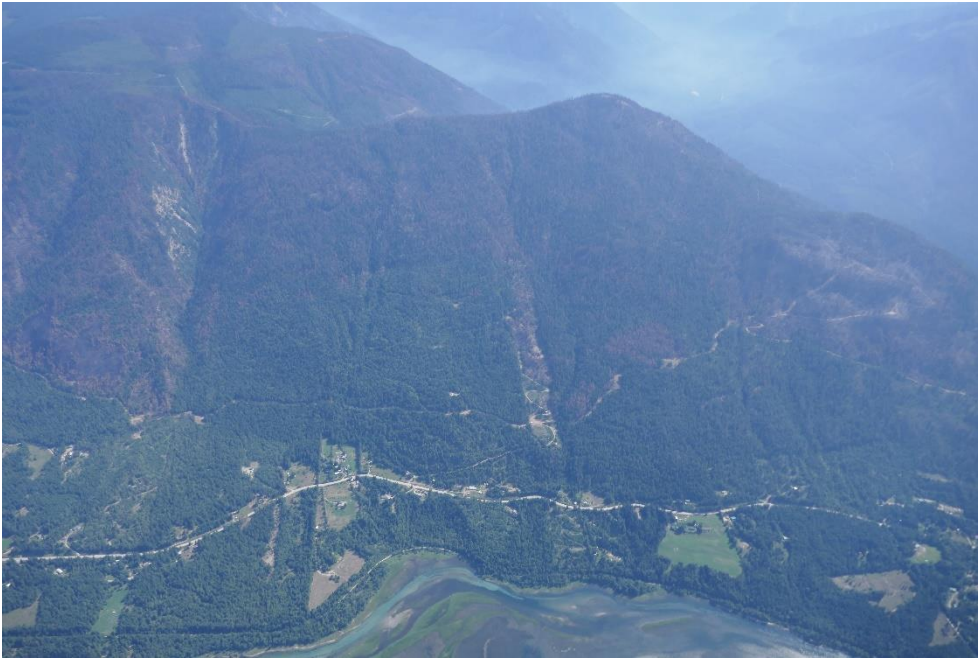
Figure 3. Overview of the Ponderosa FSR face including O'Shea Creek and Ringrose Creek (Photo: T. Giles, SNT Geotechnical).

The highway crosses the fan a third of the way downslope from the apex. Ringrose Creek passes under the highway through a 500 mm culvert. If a debris flow or flood event were to occur on Ringrose Creek, the highway would almost certainly be impacted given the steep fan gradient, small culvert, and limited storage capacity in the ditch upslope of the highway.

O'Shea Creek is a small catchment (1.3 km²) with a large (0.6 km²) fan at its outlet. The watershed is short and steep (700 - 1760 m), and the catchment's sidewalls are highly gullied with patches of exposed soil and rock that were exposed before the fire. Lidar hillshade imagery shows evidence of historical channels across the fan's surface. The morphology of the watershed would suggest that it is subject to debris flows, though the fan may indicate a greater susceptibility to debris floods. Additional field work is required to confirm the dominant process. Due to the mostly low burn severity in the O'Shea Creek watershed, the debris flow or debris flood hazard in this catchment has only slightly increased post-fire and is thus rated as low.

The RDCK mapping indicates 11 address points on the O'Shea Creek fan; most are located along the downslope perimeter of the fan, except for one structure located midway up the fan. Field investigation as part of a more detailed (level 3) assessment is recommended to confirm the probability of spatial impact and risk of avulsion.

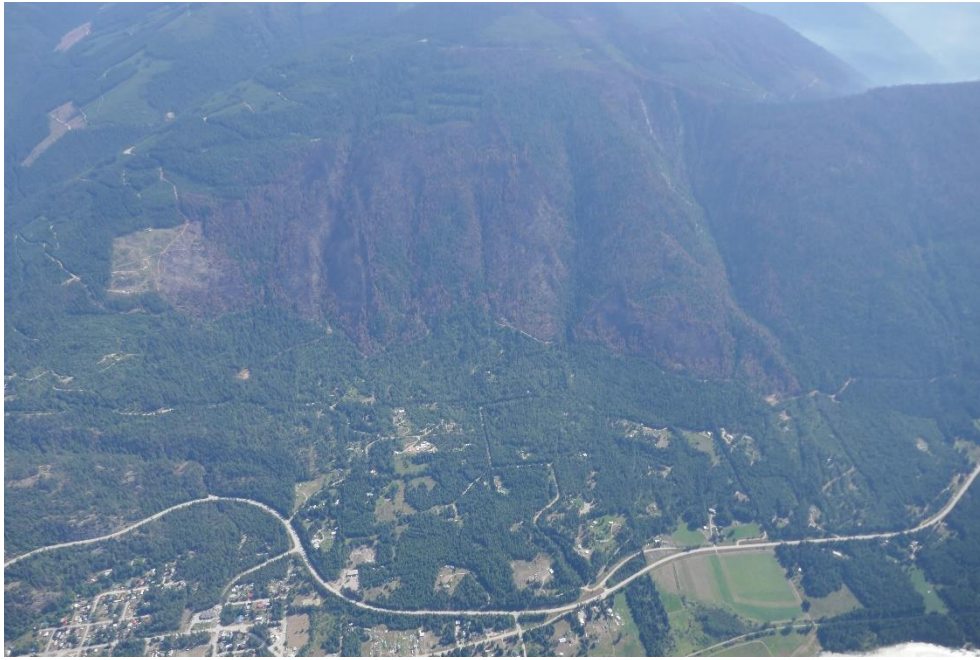
Figure 4. Overview of the Ponderosa FSR face including the drainages to the north of the O'Shea Creek (Photo: T. Giles, SNT Geotechnical).

There are several long narrow drainages to the north of O'Shea Creek (Erhard, Shook, Grant and Vincent Creeks) that do not have mapped alluvial fans, yet they are small, steep watersheds with channel gradients averaging around 40%. Field investigation as part of a more detailed (level 3) assessment is recommended to evaluate how active these watersheds have been historically, as well as the probability of spatial impact to elements at risk. Lidar data would be very helpful in delineating the watershed areas of these draws, as well as better evaluating the hazards from these drainages.

Burn severity across these four drainages is mostly low and moderate, with several small high burn severity patches. The headwaters of these drainages remain largely unburned, and the total burned area in these watersheds are 40-50%. The hazard and probability of spatial impact are rated as low for these drainages, but additional work is recommended to better refine these estimates.

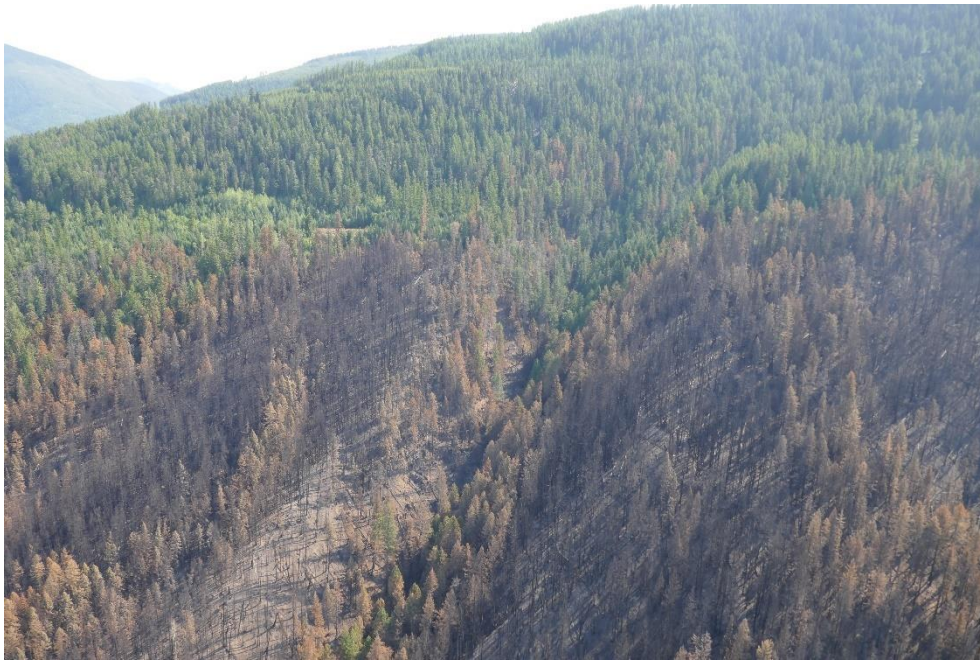
Figure 5. Headwaters of Vincent Creek (Photo: T. Giles, SNT Geotechnical).
