Development Permit

DP2404H (Liszt and Mackay)

243 Island View Road, Nakusp, B.C.
Riparian Assessment V2.0

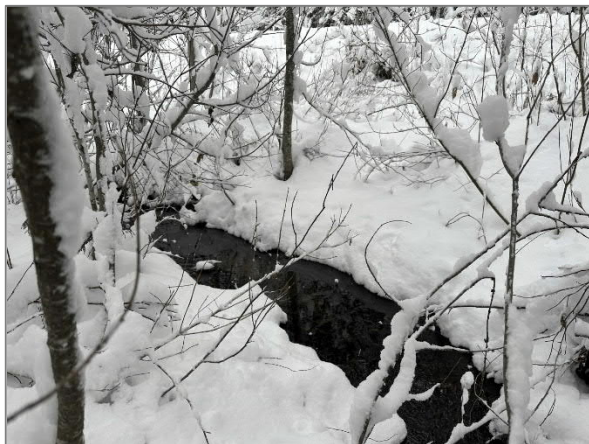
Photo 2. View of unnamed stream crossing north-east section of property.

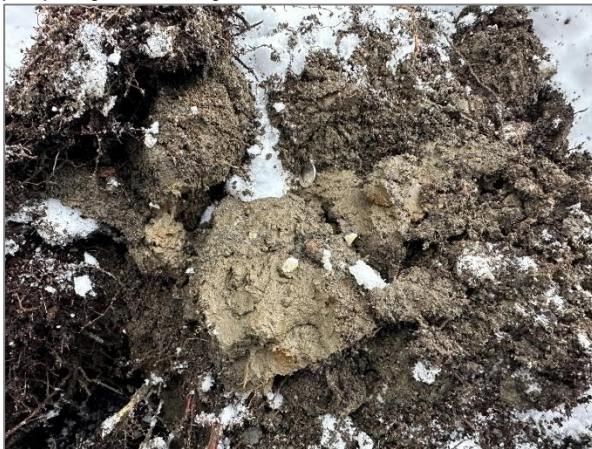
Photo 7. Soil test pit dug within along swamp perimeter-dark organic soil over silty clay layer.

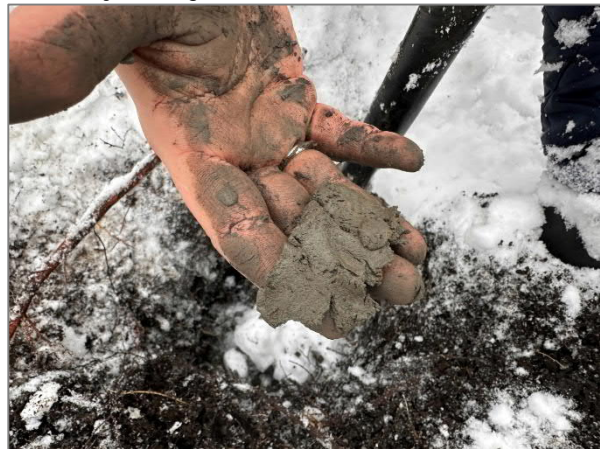
Photo 8. Silty clay layer soil sample taken from test pit within swamp.

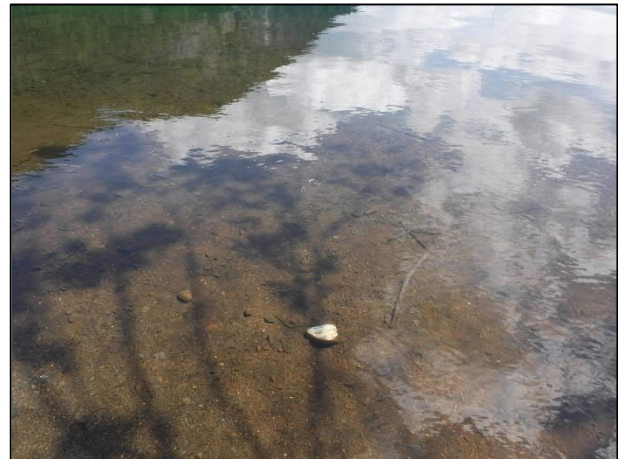
Photo 12. Typical substrate along the foreshore of Summit Lake (Masse 2022).

The Summit Lake foreshore is predominantly low gradient riparian and lake margin. Substrate along most of the shoreline consists of fine sediment, organics and small angular gravel (Photo 12). Emergent aquatic vegetation occurs along the fringe of the lake including yellow pond lily (*Nuphar lutea*), water sedge (*Carex aquatilis*), bluejoint reedgrass (*Calamagrostis canadensis*), shore sedge (*Carex lenticularis*) and common spike-rush (*Eleocharis palustris*) with an abundance of overhanging vegetation (Photo 13). Aquatic and overhanging vegetation provide high value cover habitat for fish, while the shallow waters also provide juvenile rearing habitat.

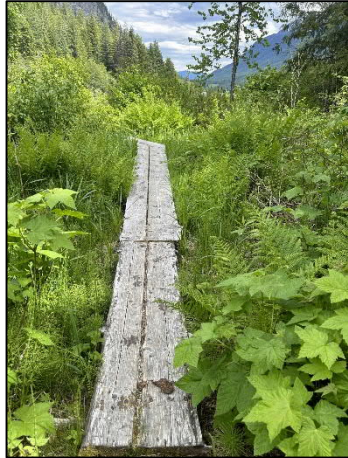
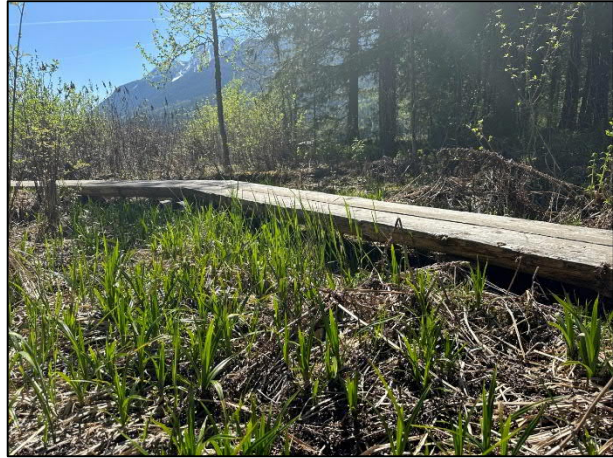
Photo 19. Split cedar plank walkway (June 9, 2024). Photo 20. Split cedar plank walkway (May 12, 2024).
