MINISTRY OF FORESTS: POST-WILDFIRE NATURAL HAZARD RISK ANALYSIS
MULVEY CREEK - LEVEL 2 RECONNAISSANCE REPORT

FIRE NUMBER: N51117 Mulvey Creek	FIRE YEAR: 2024	DATE OF REPORT: November 14, 2024	
AUTHOR: Sarah Crookshanks, P.Geo., Ministry of Forests			
REPORT PREPARED FOR: Southeast Fire Centre, District Manager			
FIRE SIZE, LOCATION, AND LAND OWNERSHIP: 2235 hectares of provincially managed public land, mostly within Valhalla Provincial Park, and private land southwest of the Village of Slocan.			
VALUES AT RISK:			
<ol style="list-style-type: none"> 1. Private residences 2. Mulvey Creek Road and Little Slocan Road North 3. Licensed water diversion structures 4. Water quality impacts to the Village of Slocan water supply 5. Evans Creek trail (BC Parks) 			
SUMMARY OF TERRAIN CONDITIONS AND THE EFFECTS OF THE FIRE:			
<p>The Mulvey Creek fire was discovered on July 18, 2024, and burned over 2000 ha of land on the rocky terrain to the west of the Village of Slocan. The fire is located between 540 m and 2000 m and burned an area extending from Mulvey Creek north to Slocan Lake. Both Gwillim and Mulvey Creek are u-shaped valleys that drain alpine terrain within Valhalla Provincial Par

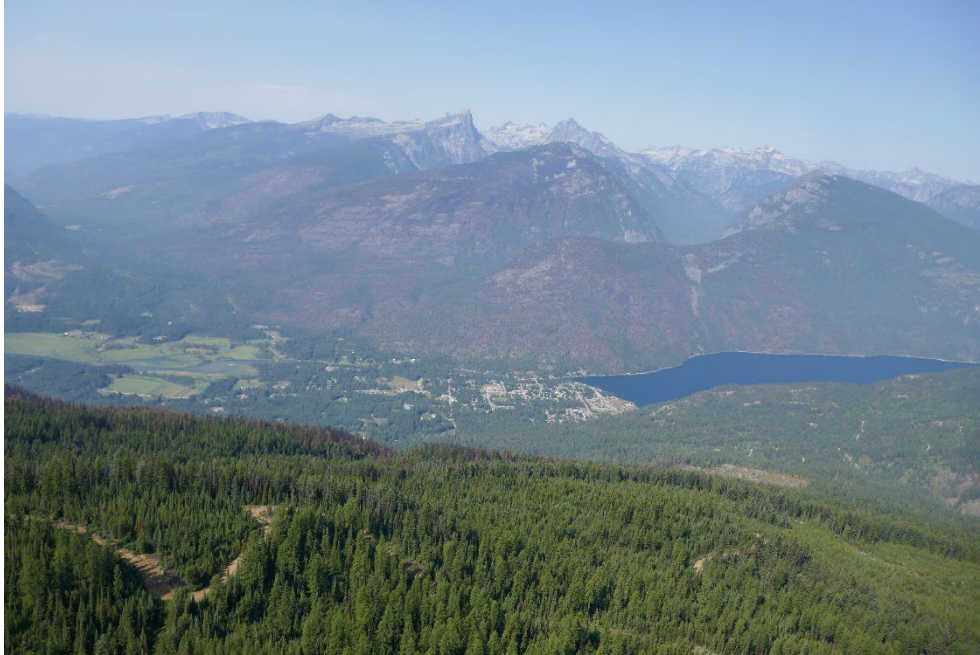
Figure 2. Overview of the Mulvey Creek fire.

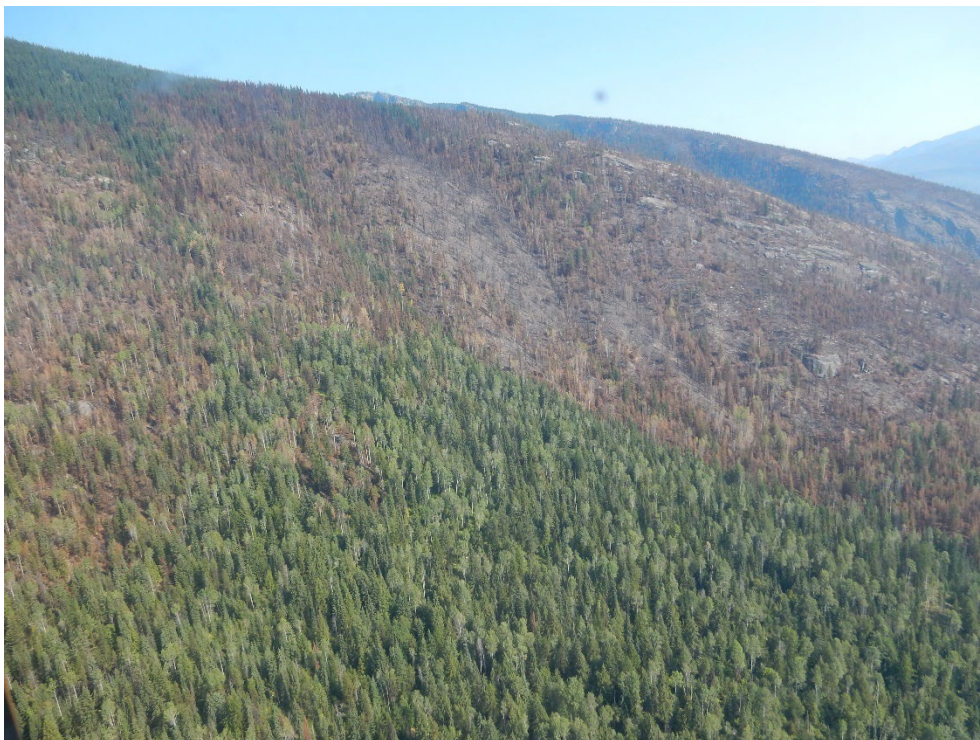
Figure 3. Burn severity in the unnamed drainages above Mulvey Creek Road.

Multiple small (<0.5 m width) channels drain the slope above Mulvey Creek Road, though not all are mapped in the provincial freshwater atlas. The slope has many bedrock outcroppings, and irregular topography. The unnamed channel that was most affected by the fire (*Unnamed Creek 2 above Mulvey Creek Road* on Figure 1) crosses Mulvey Creek Road several times and flows near several residences located on the Mulvey Creek Land Cooperative lot (PID 023-527-714). The overall proportion of this watershed that burned is 61%, and the headwaters were burned almost entirely at moderate burn severity. The channel gradient is steep (averaging ~ 45%) in the headwaters, and moderates to an average gradient of 17% before reaching any elements at risk. Given the proportion moderate vegetation burn severity in the watershed (50%), the likelihood of a post wildfire debris flow is rated as moderate.

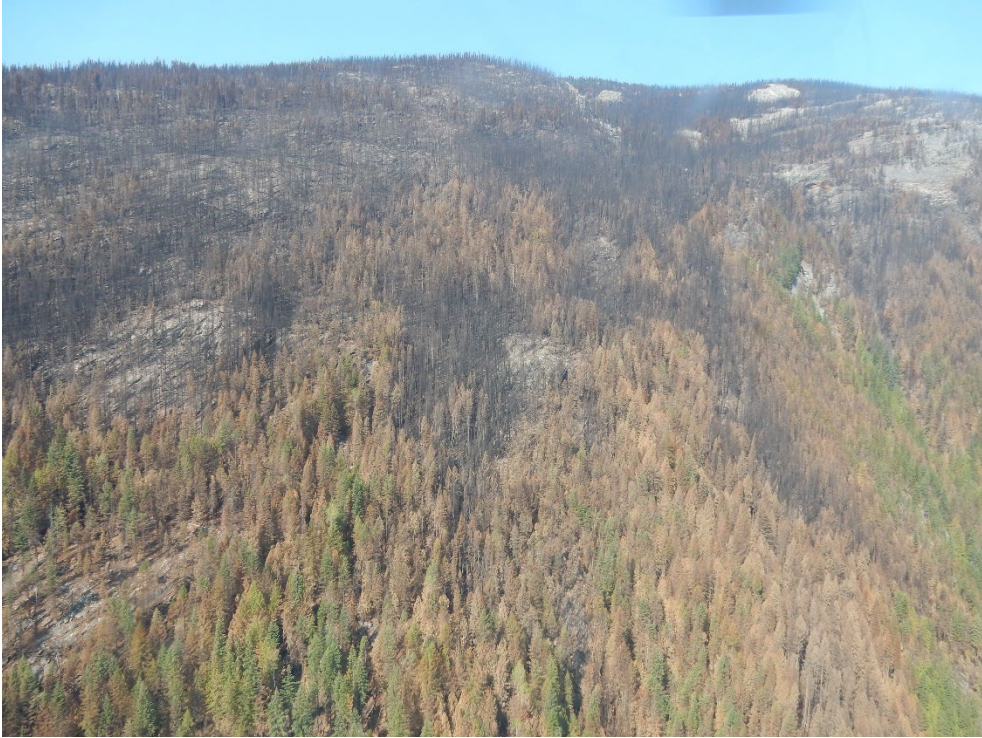
The Gwillim Creek watershed was only 7% burned; therefore, the likelihood of post-wildfire induced water quality impacts has been rated as very low. One potential source of post-wildfire sediment in the watershed is a patch of high vegetation burn severity on the west side of the creek approximately 3 km upstream from the outlet (Figure 4). This area is located on steep ground, and increased overland flow may be generated

from this slope. The stream channels that drain this patch of high burn severity are rocky with limited sediment availability, reducing the likelihood of sediment bulking contributing to the volume. While channel gradients beneath this area are low (~2%) and substantial sediment deposition is anticipated, the probability of spatial impact is rated as high, particularly for fine sediment in suspension that may be transported considerable distances. Any turbidity effects would be anticipated to be highly episodic in nature.

Figure 4. High burn severity in a steep tributary to Gwillim Creek.
