# PROFESSIONAL ENGINEERING SERVICES FOR THE CRESTON VALLEY FLOOD RISK ASSESSMENT

## RISK ASSESSMENT UPDATE

TOWN OF CRESTON

APRIL 2023

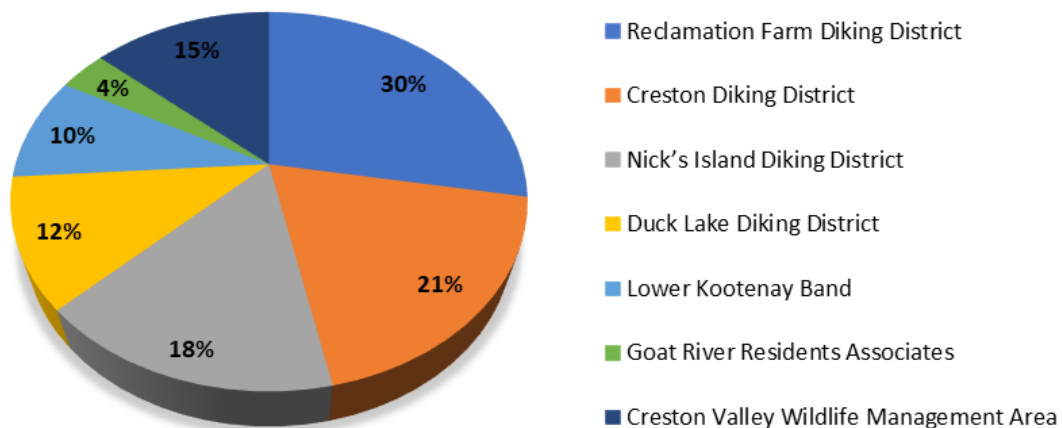
**Figure 2.3 Diking Ownership Shares**

Figure 2.3 shows the share of each diking authority as a percentage of the whole diking system in the area. The Reclamation Farm Diking District owns 30% of the dikes, followed by Creston Diking District (21%), Nick’s Island Diking District (18%), and Creston Valley Wildlife Management (15%).

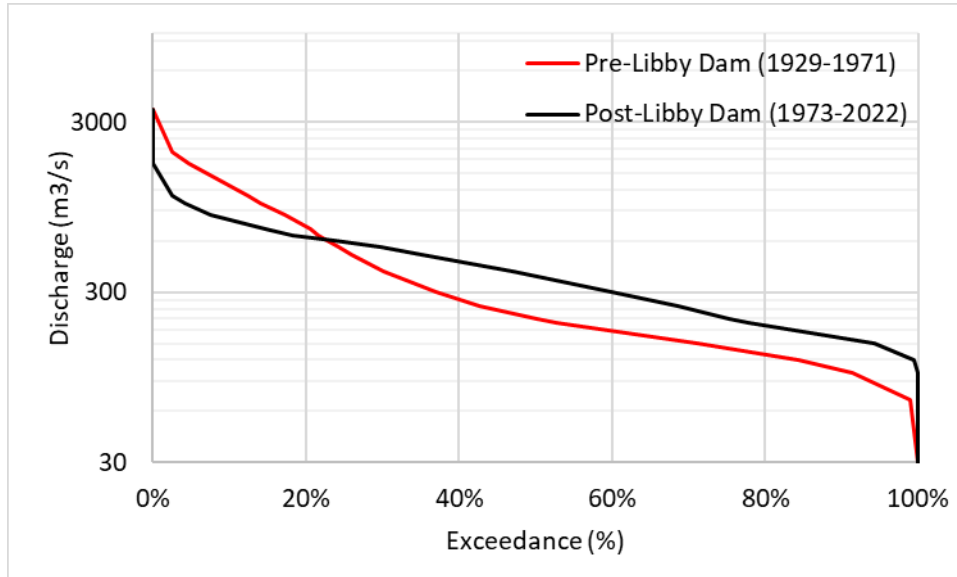
**Figure 3.1 Discharge Exceedance Curve of Kootenay River at Porthill**

Further flow analysis shows that for about 77% of the streamflow record, discharge is below 605 m<sup>3</sup>/s for both pre- and post-Libby Dam conditions (Figure 3.1). Kootenay River flows were below 200 m<sup>3</sup>/s about 47% of the time during the pre-Libby period, compared to 22% after dam construction. However, flows used to exceed 1,100 m<sup>3</sup>/s 12% of the time. Since the Libby Dam construction, this percentage has dropped to 2%, and the daily recorded flow hasn't exceeded 1,780 m<sup>3</sup>/s. The results presented in Figure 3.1 indicate that the Libby Dam operations sharply reduced the occurrence of severe flood events but increased the occurrence of mid-range flow events.

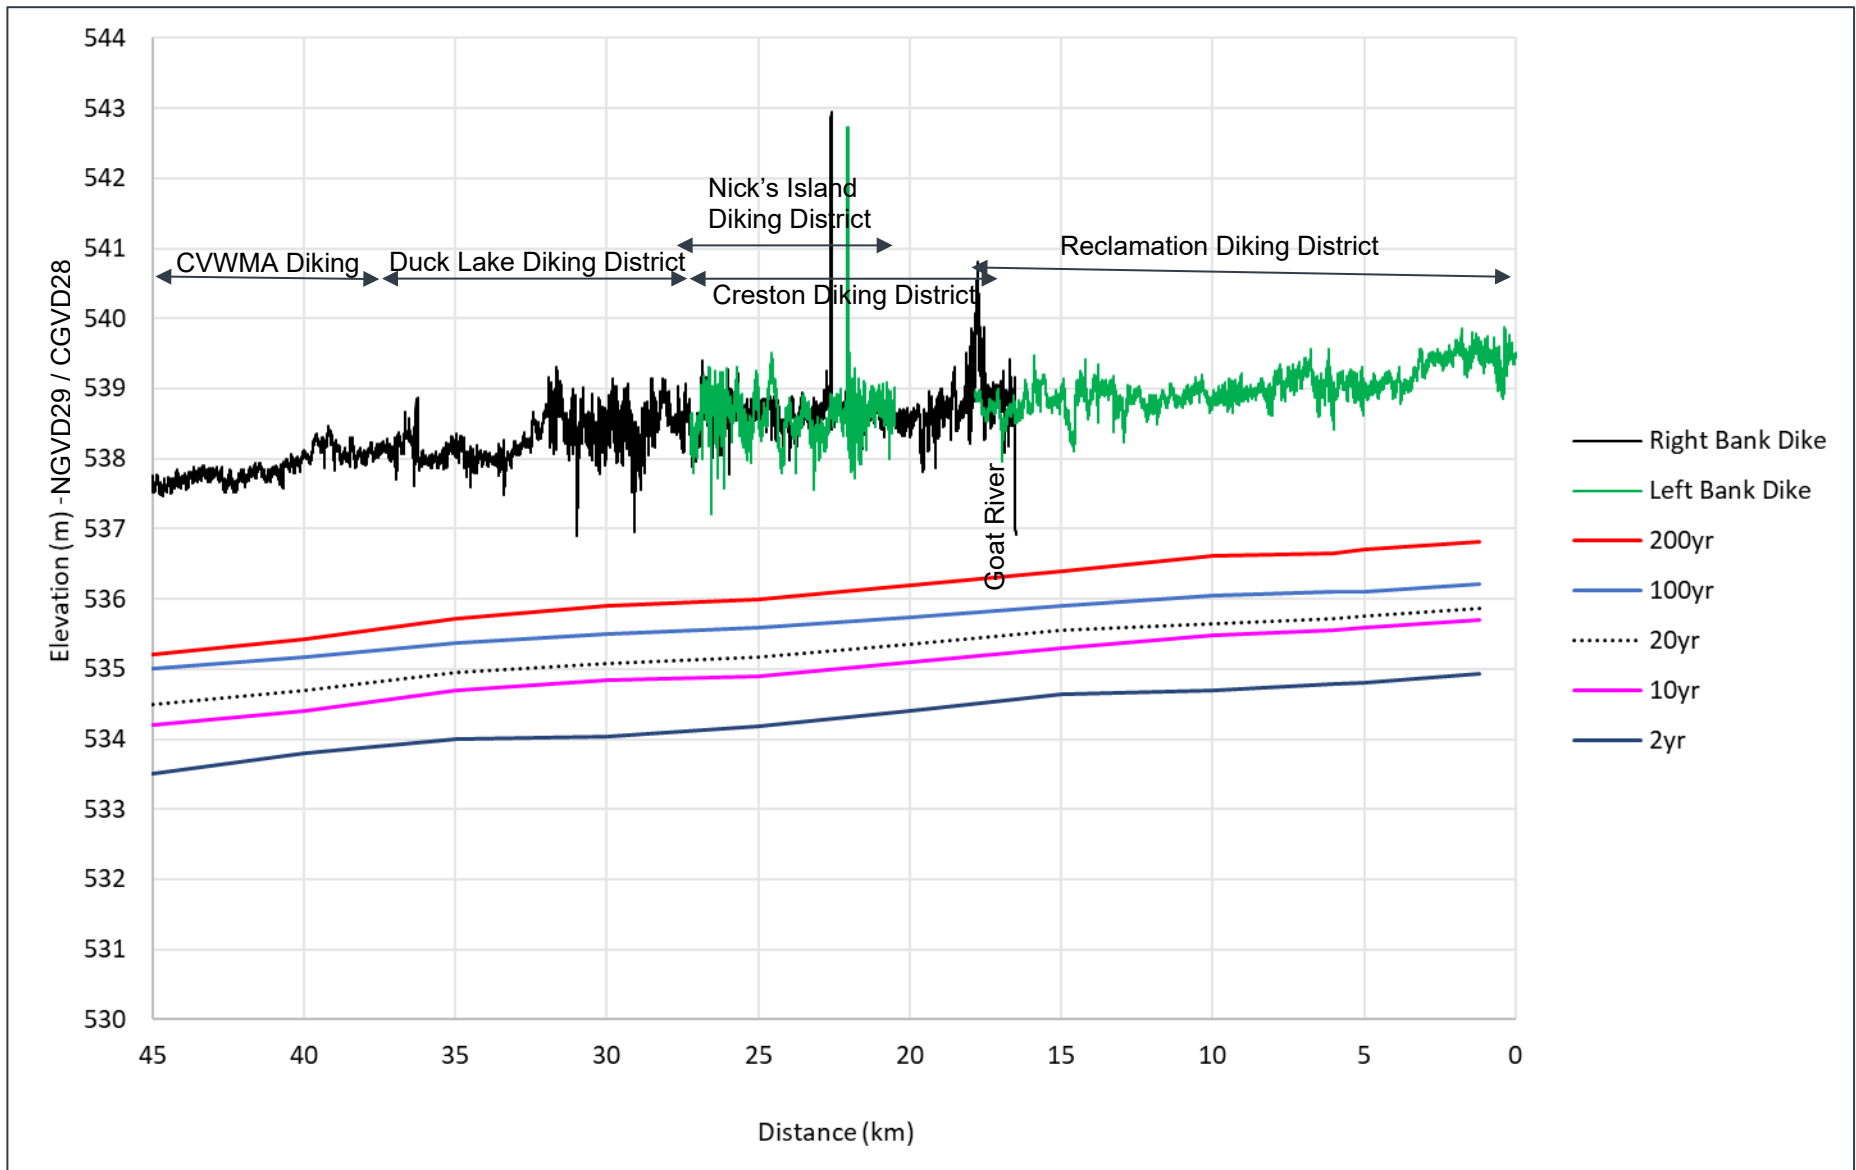
**Figure 4.1 Kootenay River Simulated Water Levels Versus Bank/Dike Crest**

The calibrated model was then used to model floods with return periods of 2, 5, 10, 20, 50, 100, and 200 years for regulated conditions (post Libby Dam). Kootenay Lake levels (Table 3.1) were used as the downstream boundary condition, while the upstream boundary condition flow was varied so that water levels at Porthill, Idaho, matched those provided in Table 3.1. In this model, the Goat River flows were assumed to be 75% of their peak flow for a given return period to account for the observed lag between the two watersheds' peak flows. BGC concluded that the 200-year flood level would generally be about 2 m below the dike crest along the river (BGC, 2014a).

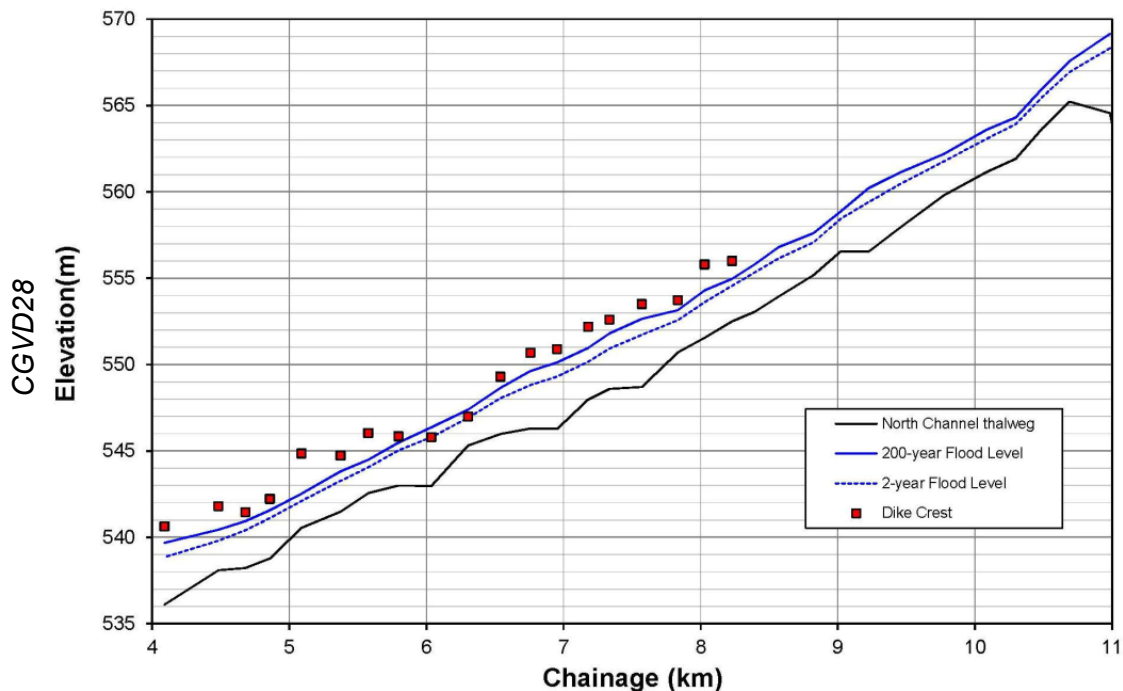
**Figure 4.2** Goat River Simulated Water Levels, 2-year and 200-year Floods (BGC, 2014a)

Figure 4.2 shows the results of the model for 2-year and 200-year flood conditions upstream of Highway 21. The dike freeboard for a 200-year flood is generally 0.6 m, except for the area around km 6, where the dike was constructed in 2007.

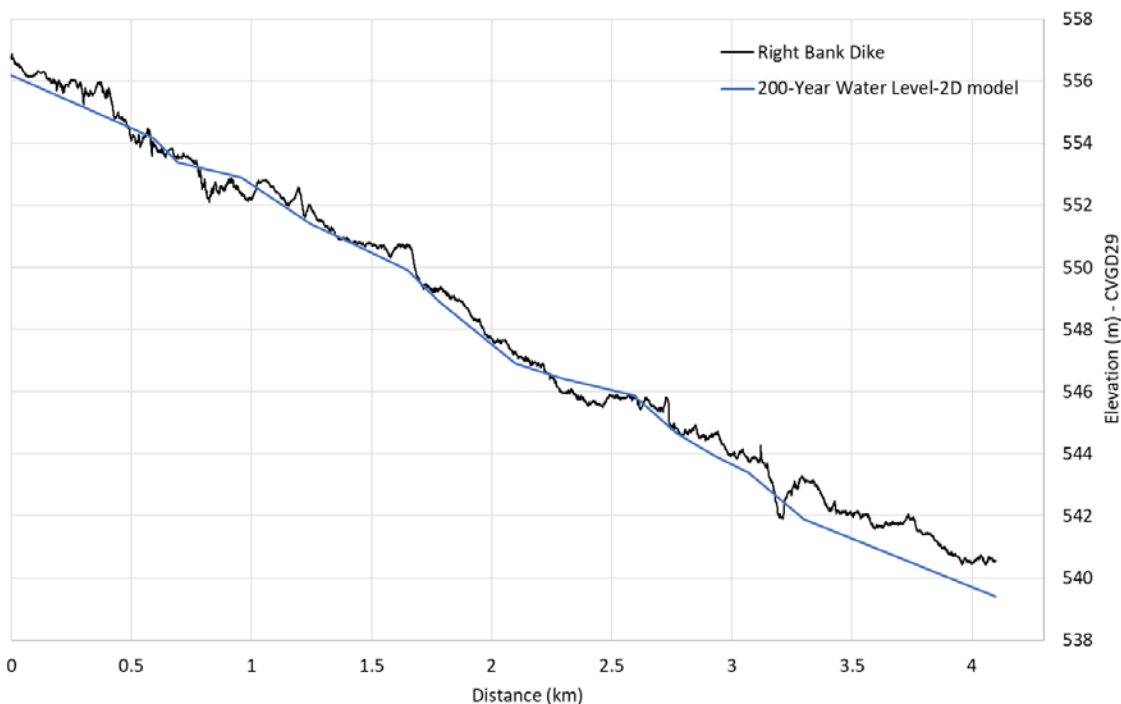
**Figure 4.6 Simulated Water Levels for Goat River – 2D model**

The 2020 BGC flood inundation maps show the Flood Construction Level (FCL), which includes 0.6 m of freeboard. The results of this modelling show that:

- The dike crest is typically greater than 0.4 m above the 200-year flood level (without considering the 0.6 m freeboard). An exception is several hundred metres of the dike that was built in 2006/2007, including about 330 m of the dike around km 2.4, where the dike is expected to be overtopped by a 200-year flood by about 0.8 m. For more details, refer to Figure 4.6, below. The dike at km 0.51 to 0.55, 0.65 to 1.0, 2.7 to 2.8, and 3.1 to 3.45 is not classified as a dike in the BC Water Resource Atlas;
- Part of the inundation is due to flow around dikes (BGC, 2020b).

Comparing the simulated water levels from the 2020 2D model and the 2014 1D model shows that the simulated water levels are similar immediately upstream of Highway 21 but the difference increases in upstream areas. 2D water levels are about 1 m higher about 3 km upstream of Highway 21. The results of the 2D model are expected to be more reliable since the more recent topographic and LiDAR data were used in the model and 2D models are generally more appropriate for braided rivers such as the Goat River. The results of the 2D model are comparable to the 1984 flood inundation study results. Considering the analysis presented above, results from the 2D model presented in the 2020 BGC report were used for the current risk assessment.

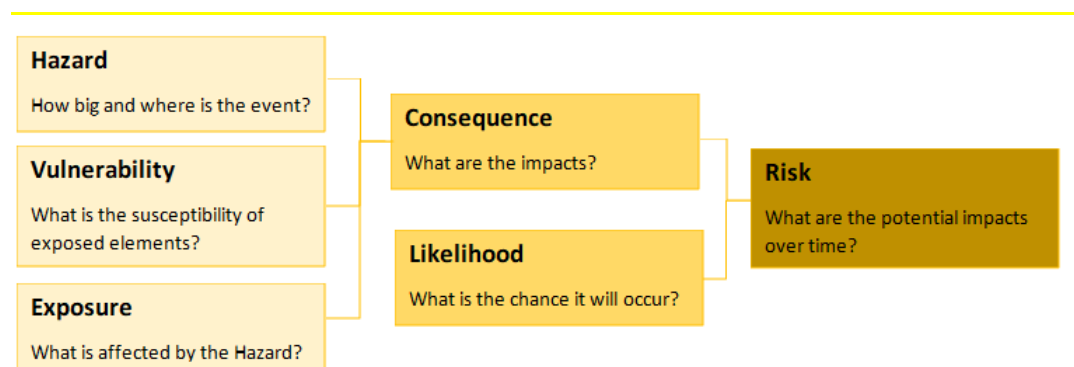
**Figure 5.1 Conceptualization of a Flood Risk Assessment**

Figure 5.1 presents a schematic arrangement of the main components of a flood risk assessment.

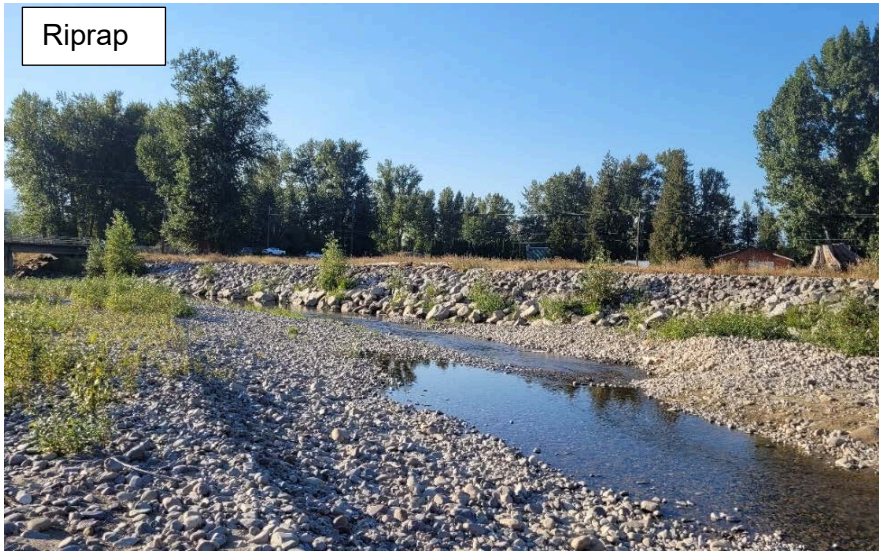
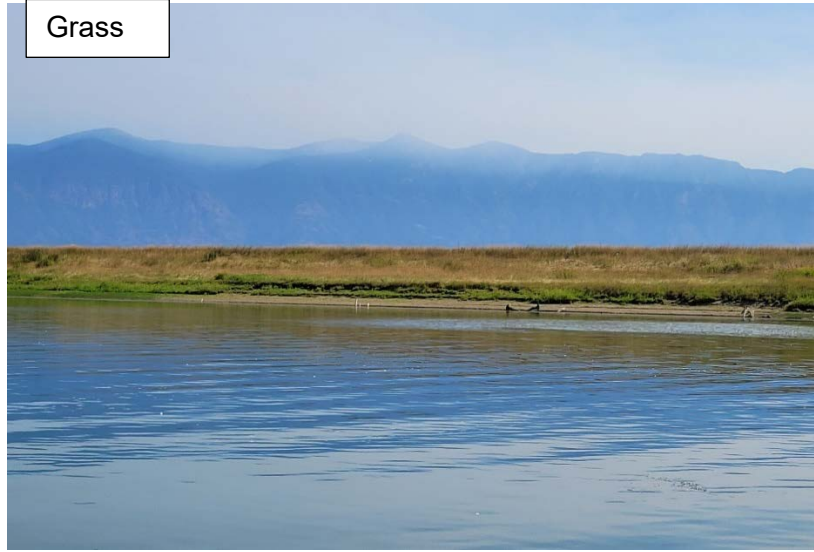
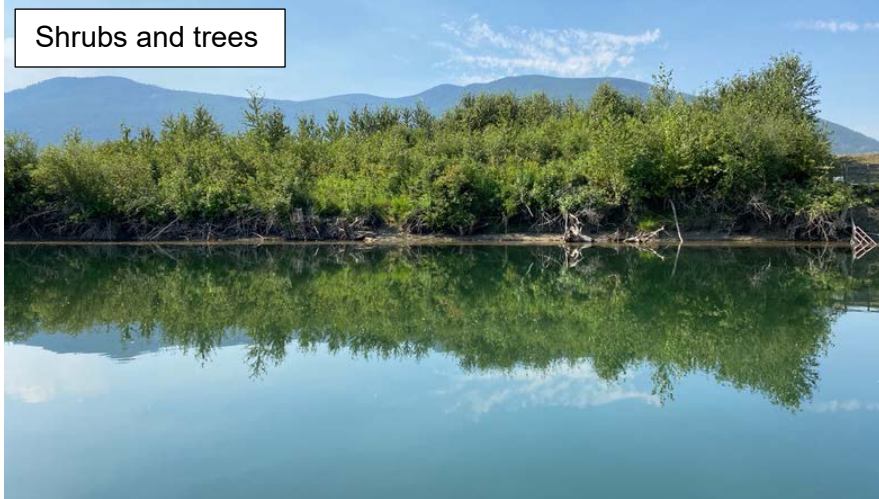
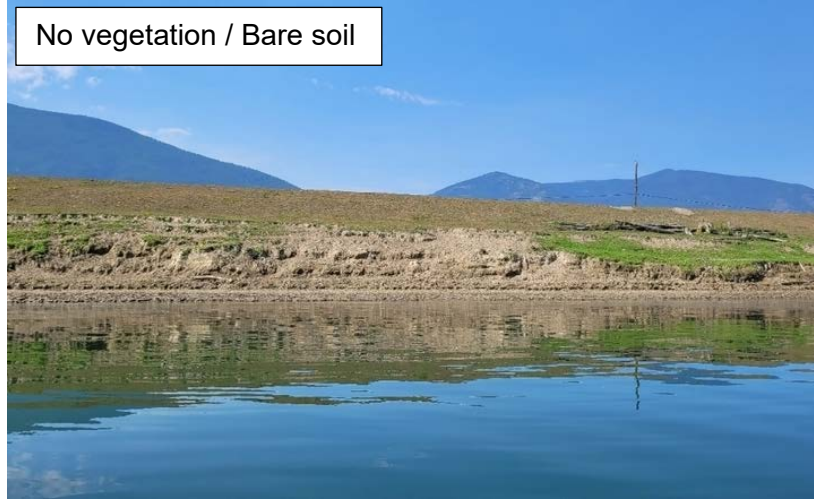
**Figure 5.5**      **Examples of Vegetation Types**

Figure 5.5, Figure 5.6, and Figure 5.7 show examples of river banks/dikes with different vegetation types, erosion severity, and protection efficiency, respectively.

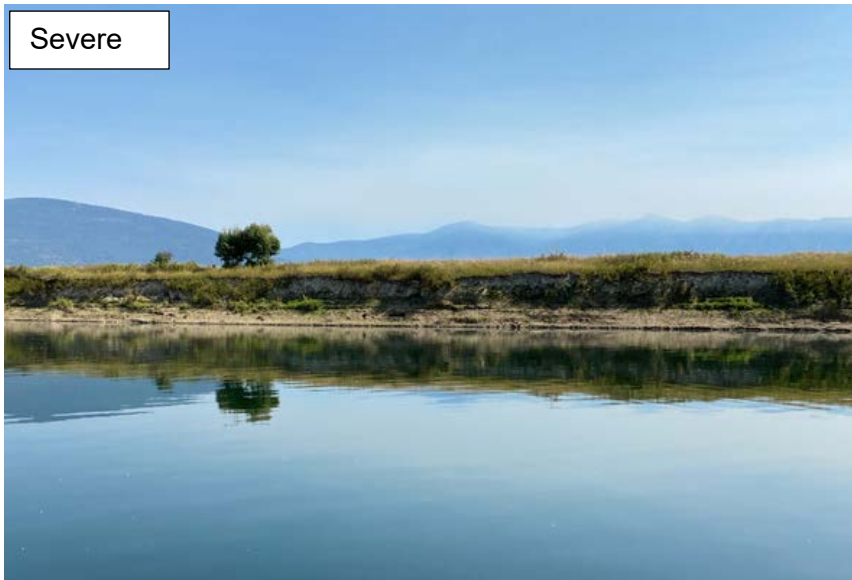
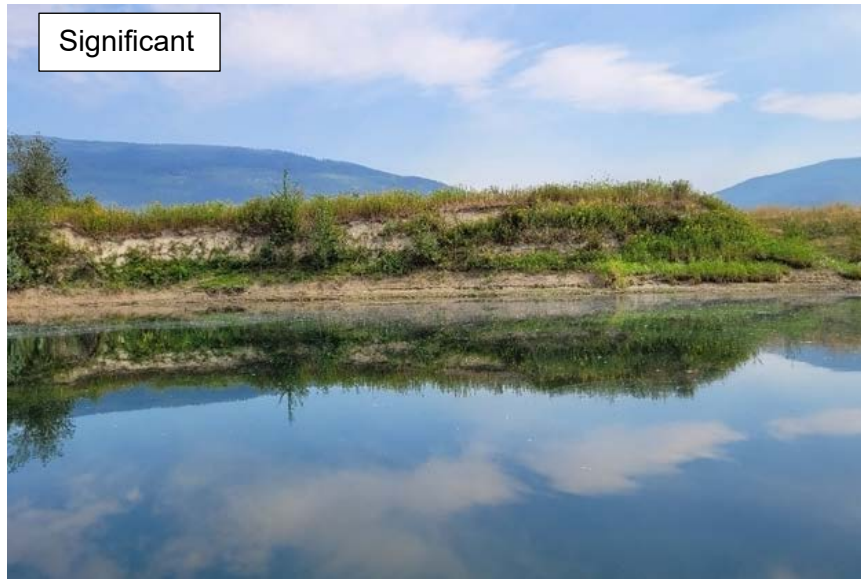
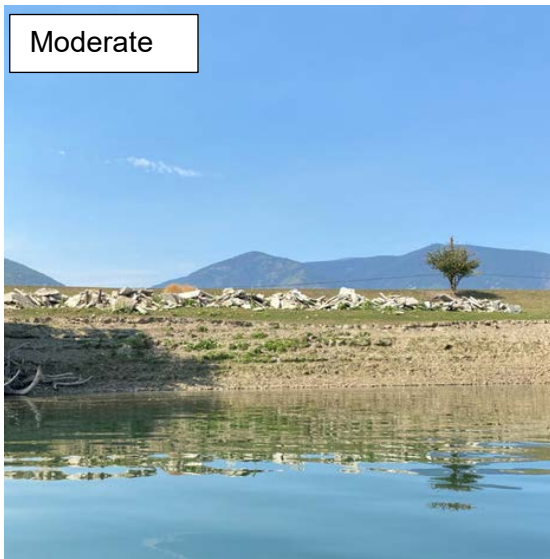
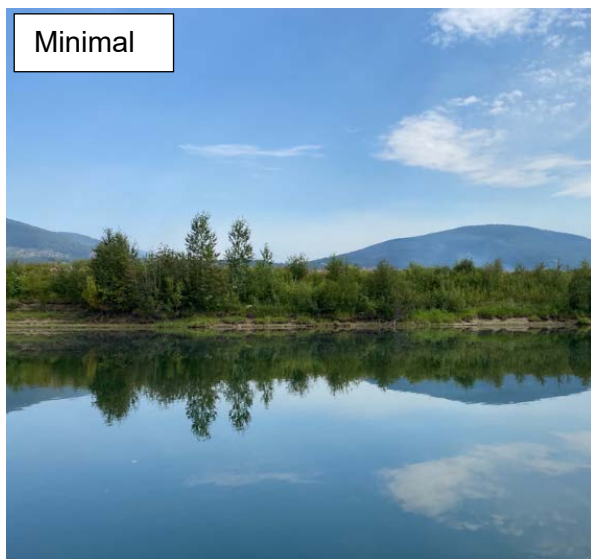
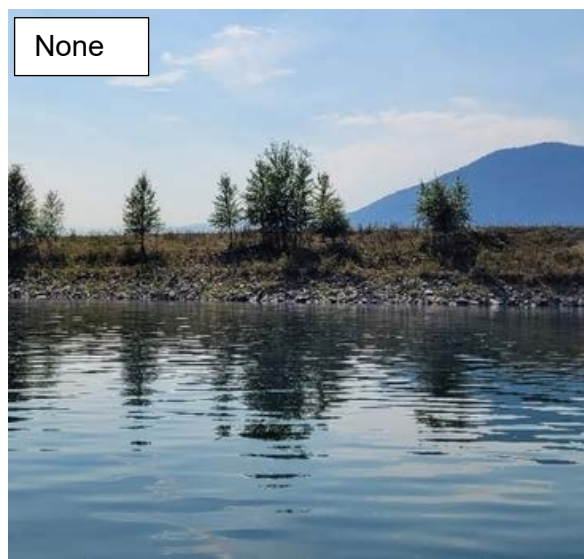
**Figure 5.6**      **Examples of Erosion Severity**

Severe

Significant

Moderate

Minimal

None

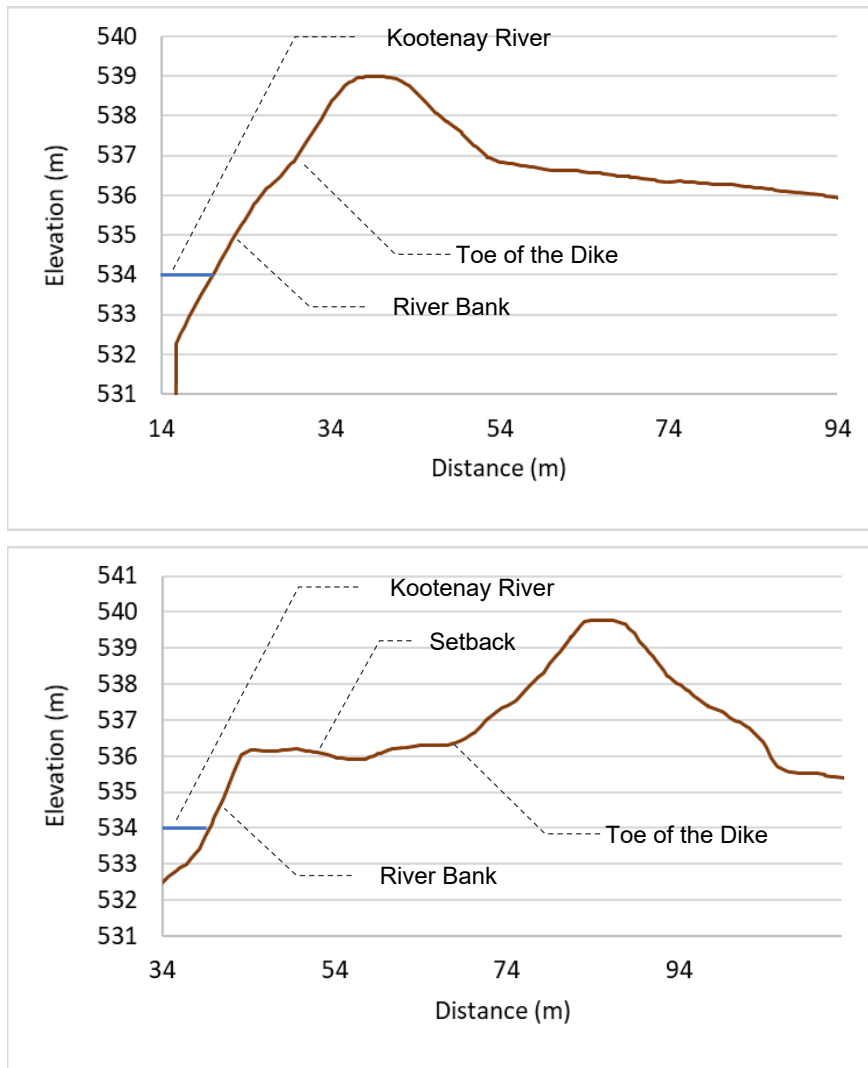
**Figure 5.8 Typical Dike Cross-Sections**

The site survey and LiDAR data review show that the dike configuration is generally similar to one of the two cross-sections shown in Figure 5.8. The toe of the dike is either adjacent to the river bank or located further from the river (set backed). The erosion severity criterion only applies to the erosion observed on the dike face. For cases where the bank is eroded but the dike is set back from the river and does not exhibit significant erosion, a score of 0 was assigned to the dike for the erosion severity criterion.

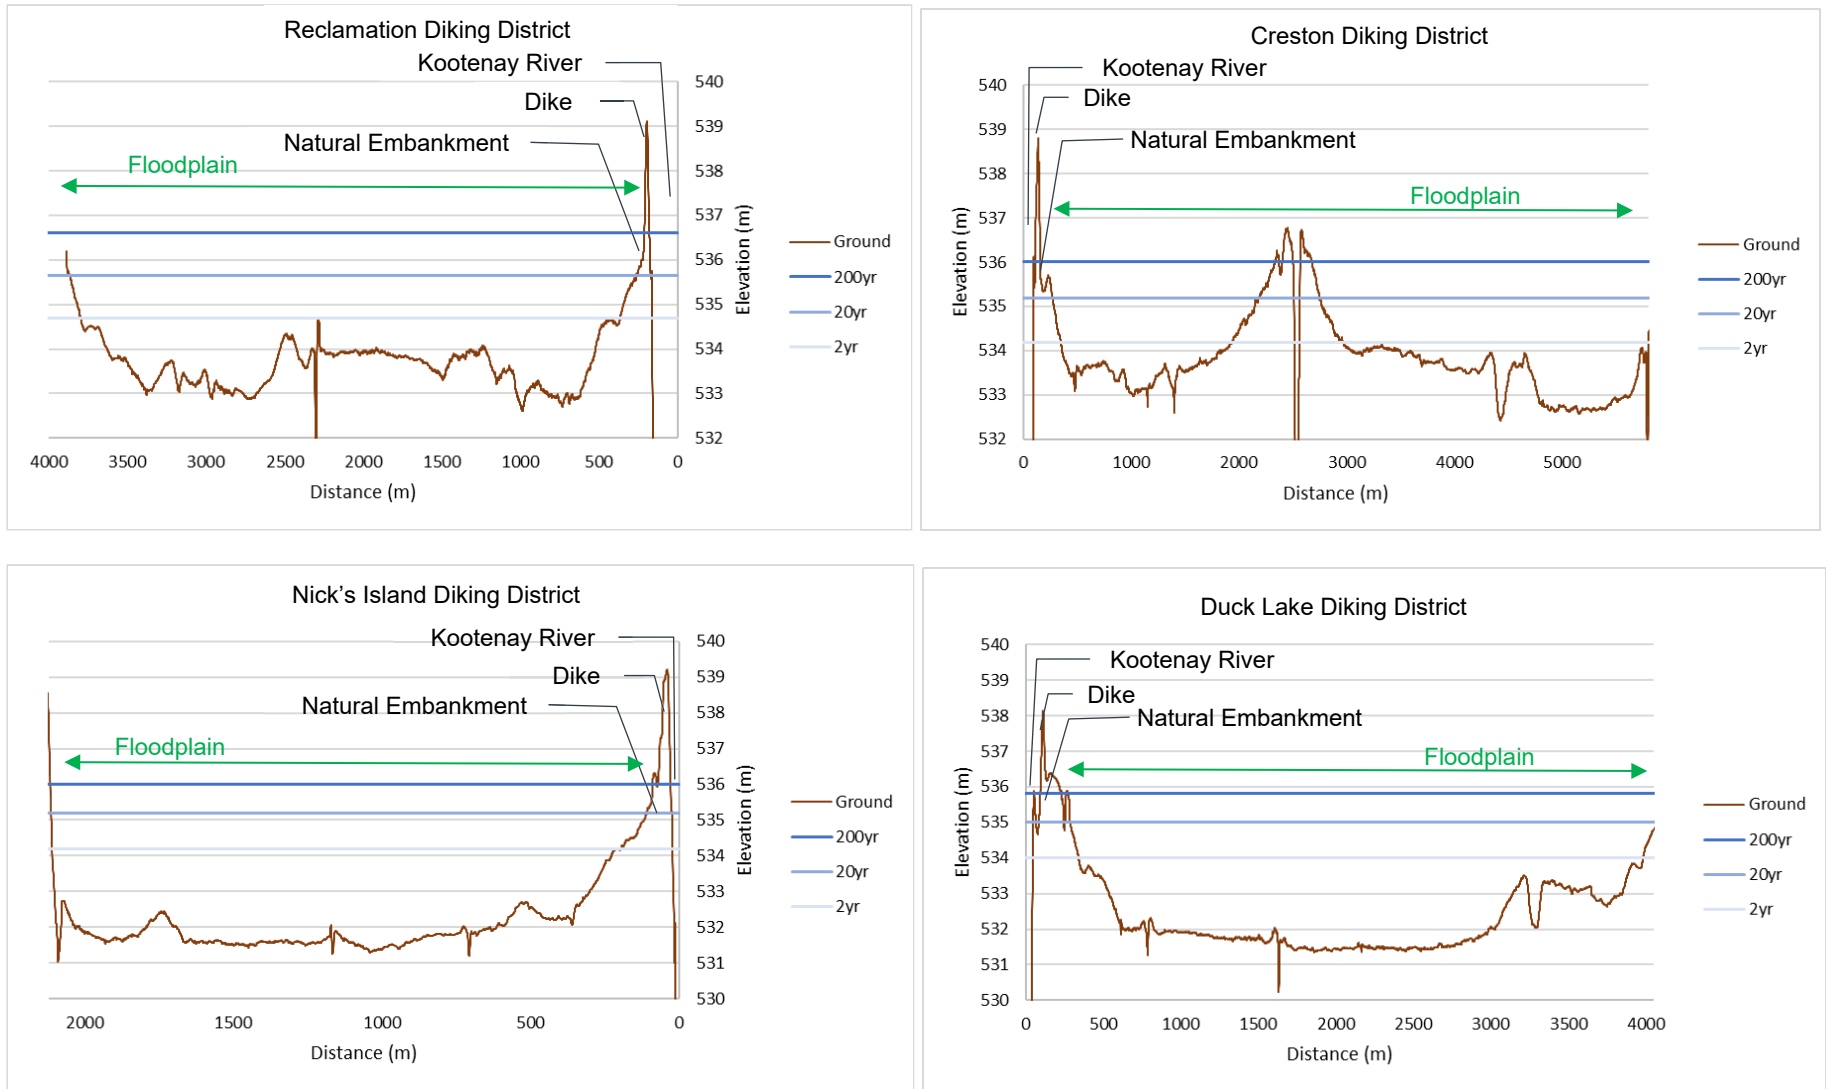
**Figure 5.9 Cross-Sections Along Kootenay River Floodplain**

In order to define the consequences associated with a dike failure, it is essential to know the extent and severity of flood in the floodplain induced by a dike breach. Generally, comparing the simulated water levels along the river and LiDAR data shows that the majority of the diking districts are lower than the 1:2-year flood. However, the natural river embankments provide natural protection against low flows such as a 2-year flood even if the dike fails. Floodplain flooding is possible for more extreme floods, such as a 200-year event, as shown in Figure 5.9.

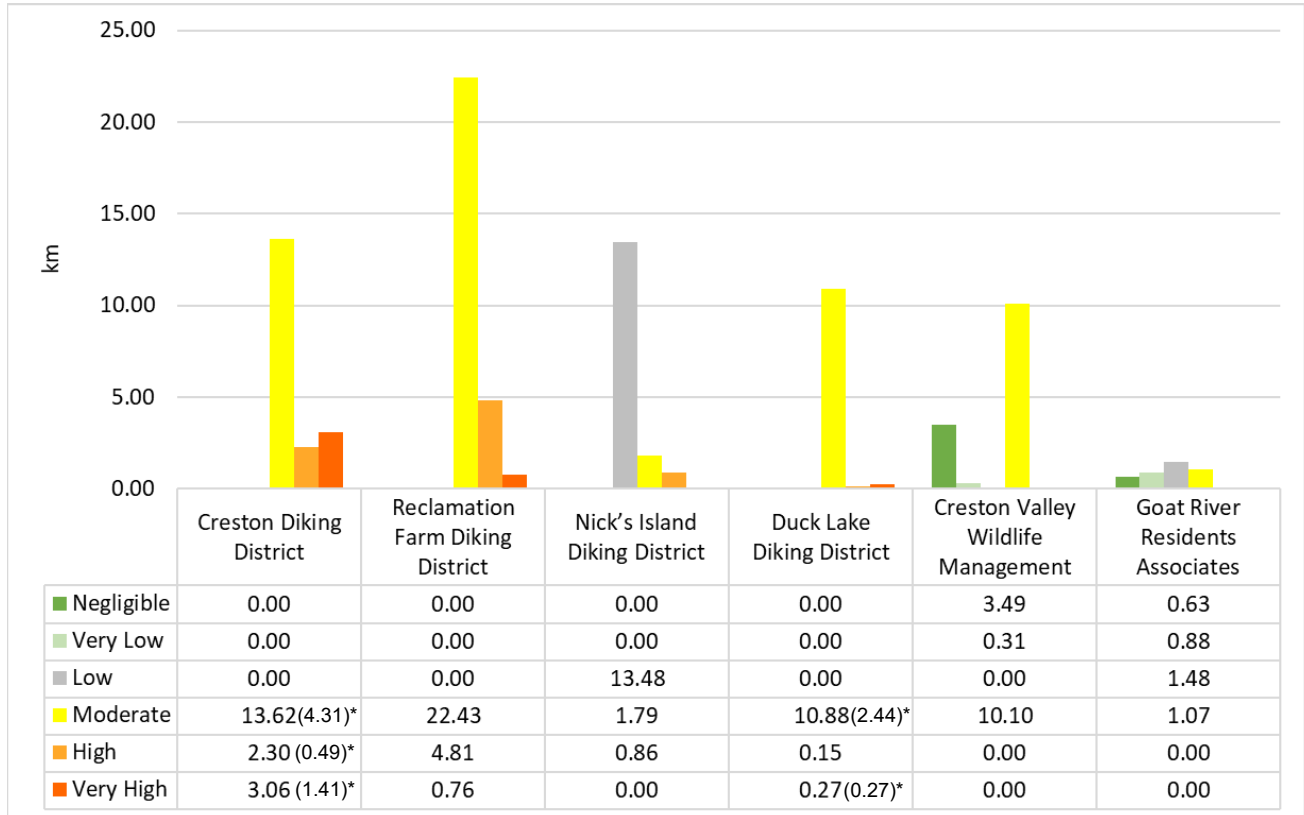
**Figure 5.10 Total Length of Vulnerable Dikes by Districts**

- 0.49 km of the LKB dikes within the Creston Diking District (IR1C and IR3) are classified as High;
- 4.31 km of the LKB dikes within the Creston Diking District (IR1C, IR2, IR3) and 2.44 km of the LKB dikes (IR5) within the Duck Lake Diking District are classified as Moderate;

- All the dikes with a flood risk rating of Very High have an erosion likelihood of High and a consequence rating of Major. These dikes are primarily identified to have Significant to Severe erosion, to be covered with shrubs and trees, and to be in a meandering area with no or insufficient bank protection.

\* The LKB dikes are shown in the parentheses.
