# Development Permit Application

Referral Form – RDCK File DP2302A

10377 Highway 3A, Sanca  
Lot 2 District Lot 4595 Kootenay District Plan 4523 (PID: 010-421-874)  
Electoral Area A

**SKETCH PLAN TO ACCOMPANY ACCRETION APPLICATION FOR LOT 2 DISTRICT LOT 4595 KOOTENAY DISTRICT PLAN 4523**

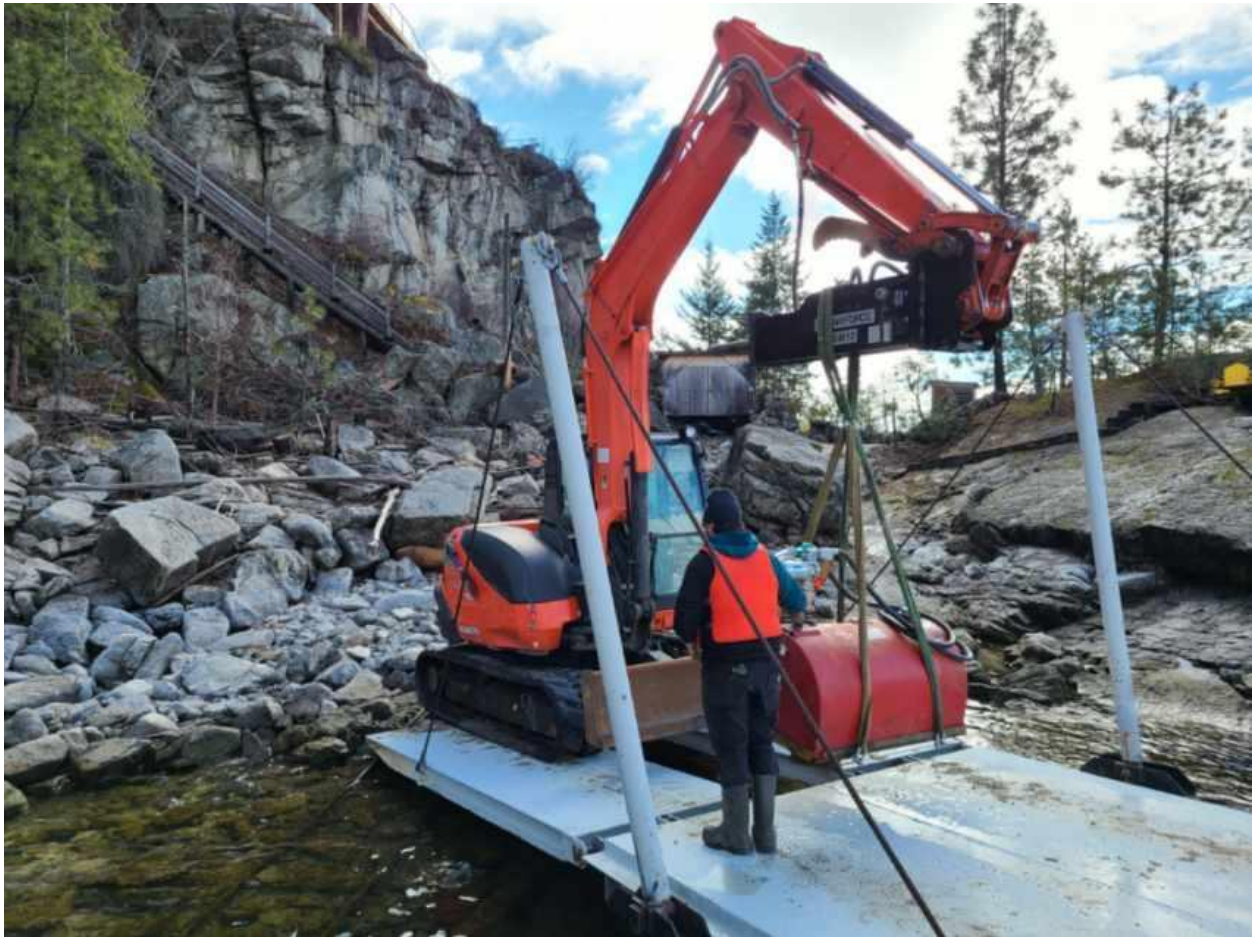
Figure 1. Excavator and fuel tank are unloaded on the north shore from a barge.

*Image was taken on March 11, 2022*

Date	Actions
<b>March 4, 2022</b>	<ul style="list-style-type: none"> <li>● Excavator unloaded on-site (Appendix A: Figure 1)</li> <li>● Fuel tank secured near shore</li> <li>● Note to move large boulders coming up the shore for the machine to pass before the fuel tank can be relocated away from the water</li> </ul>
<b>March 5, 2022</b>	<ul style="list-style-type: none"> <li>● Begin breaking large boulders up the shoreline               <ul style="list-style-type: none"> <li>○ Sufficient to allow machinery to pass</li> </ul> </li> </ul>
<b>March 11, 2022</b>	<ul style="list-style-type: none"> <li>● Breaking and removal of the boulder at the apex of the peninsula               <ul style="list-style-type: none"> <li>○ Boulder was precluding clearing stone from away from boathouse base)</li> <li>○ Clearing revealed that the boathouse foundation was poor, and dismantling was required</li> <li>○ Further removing boulders on the south side of the boathouse required</li> </ul> </li> <li>● Set up dust control water pump</li> </ul>

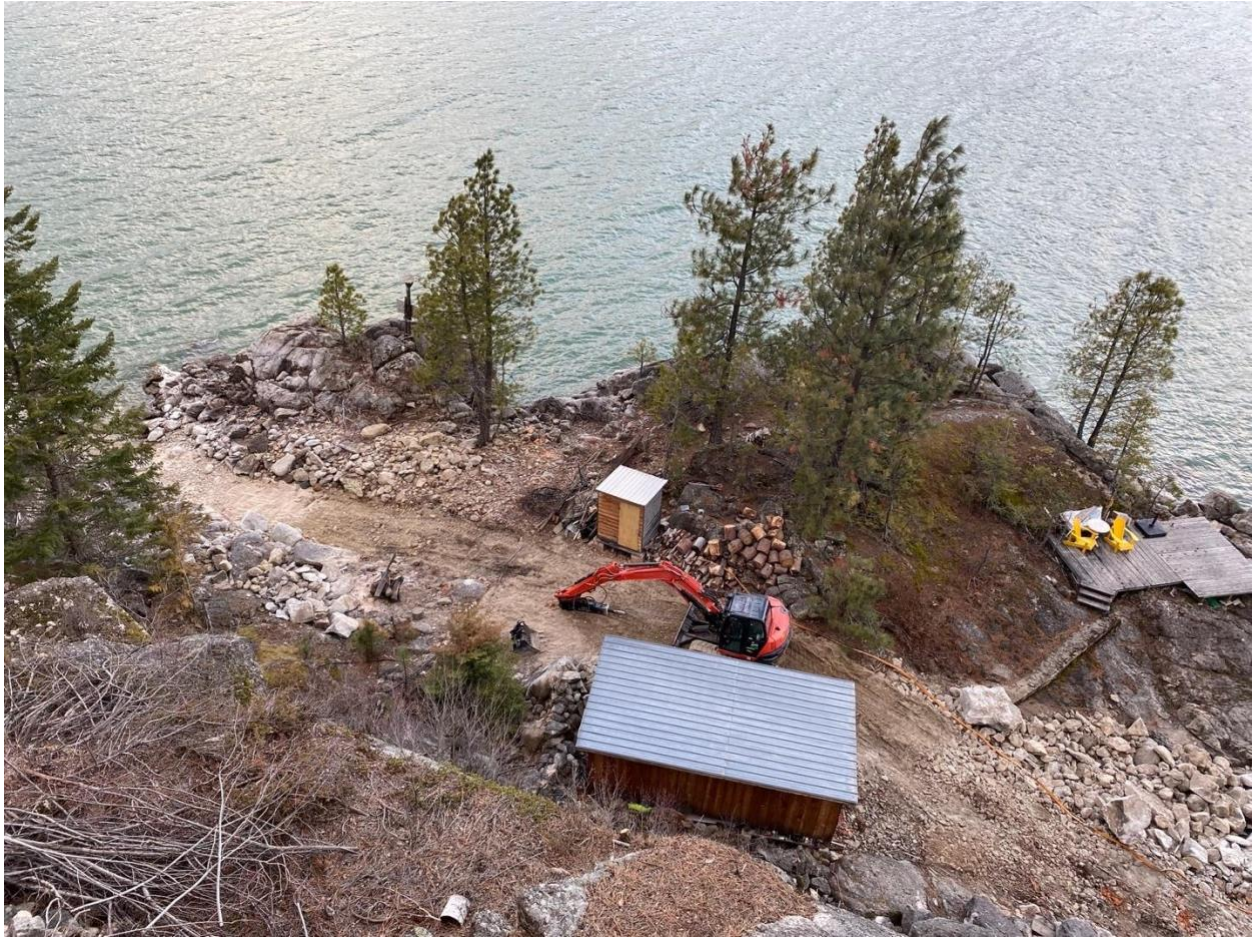
**Figure 2. Overhead view of the south channel after the path was widened and cleared of debris.**

*Image was taken on March 13, 2022*

<b>March 13, 2022</b>	<ul style="list-style-type: none"> <li>● Cleared machine pathway of rubble (Appendix A: Figure 2 &amp; Figure 3)               <ul style="list-style-type: none"> <li>○ Through the south channel and up to the boathouse</li> <li>○ The path was widened for the passage of the machine, so the material removed could be placed higher</li> </ul> </li> </ul>
<b>March 14, 2022</b>	<ul style="list-style-type: none"> <li>● KES QEP and a KES staff member arrive on site (Jessica Lowey &amp; Danielle Smart)               <ul style="list-style-type: none"> <li>○ QEP observes work to date</li> </ul> </li> <li>● QEP observes the hammering of large boulders and the funicular base area with and without a water system               <ul style="list-style-type: none"> <li>○ QEP recommends using a water system for dust control</li> </ul> </li> <li>● QEP reviewed invasive species present on-site and a management plan</li> <li>● QEP departs</li> <li>● Continue to remove boulders from around the south side of the boathouse</li> <li>● Material from around the boathouse was distributed along the south channel</li> <li>● Clearing around the north channel to facilitate proper further cleanup and removal of prominent large boulders (Appendix A: Figure 4)</li> <li>● Job is 80% complete</li> </ul>

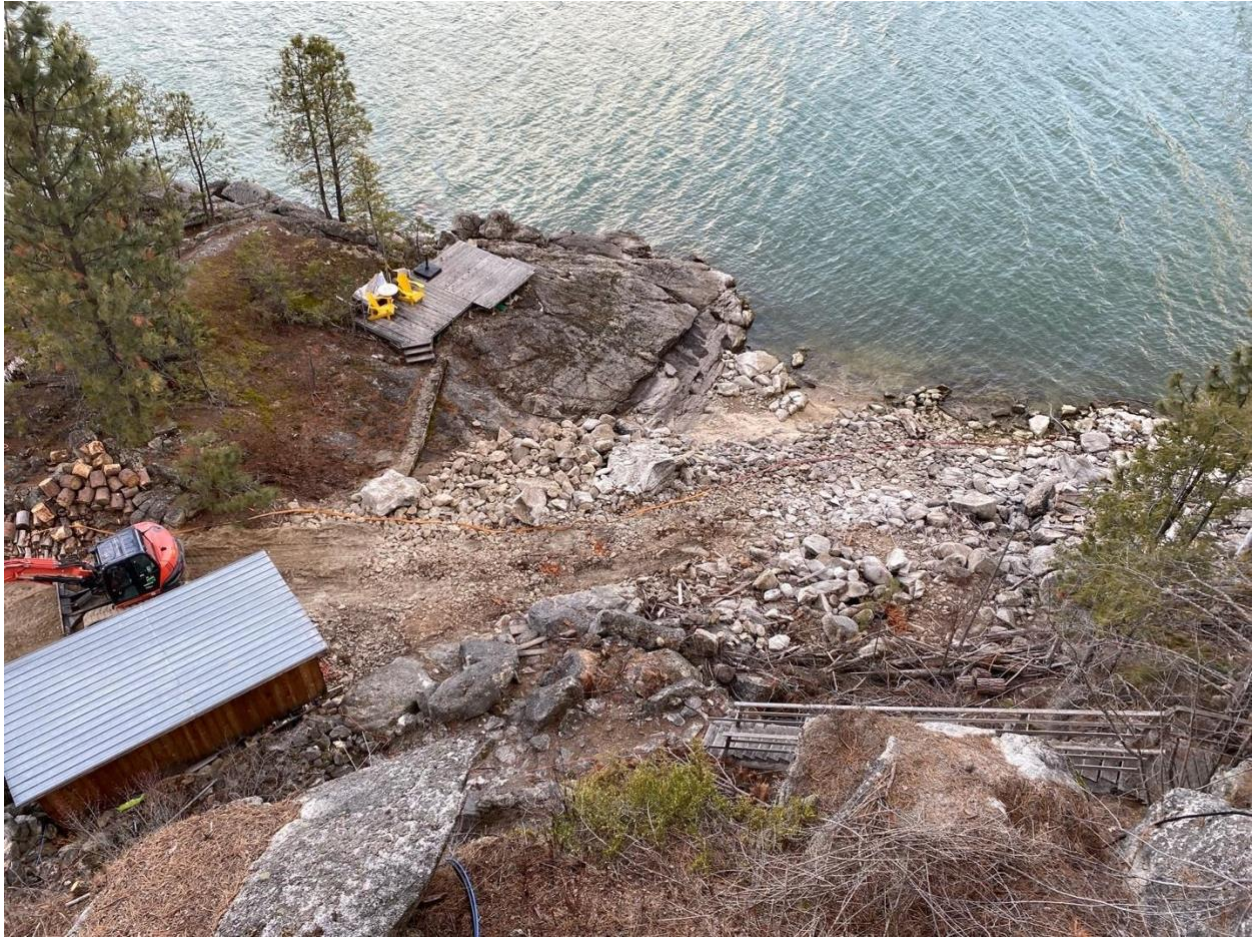
**Figure 3. Overhead view of the north channel after the path was widened and cleared of debris.**

*Image was taken on March 13, 2022*

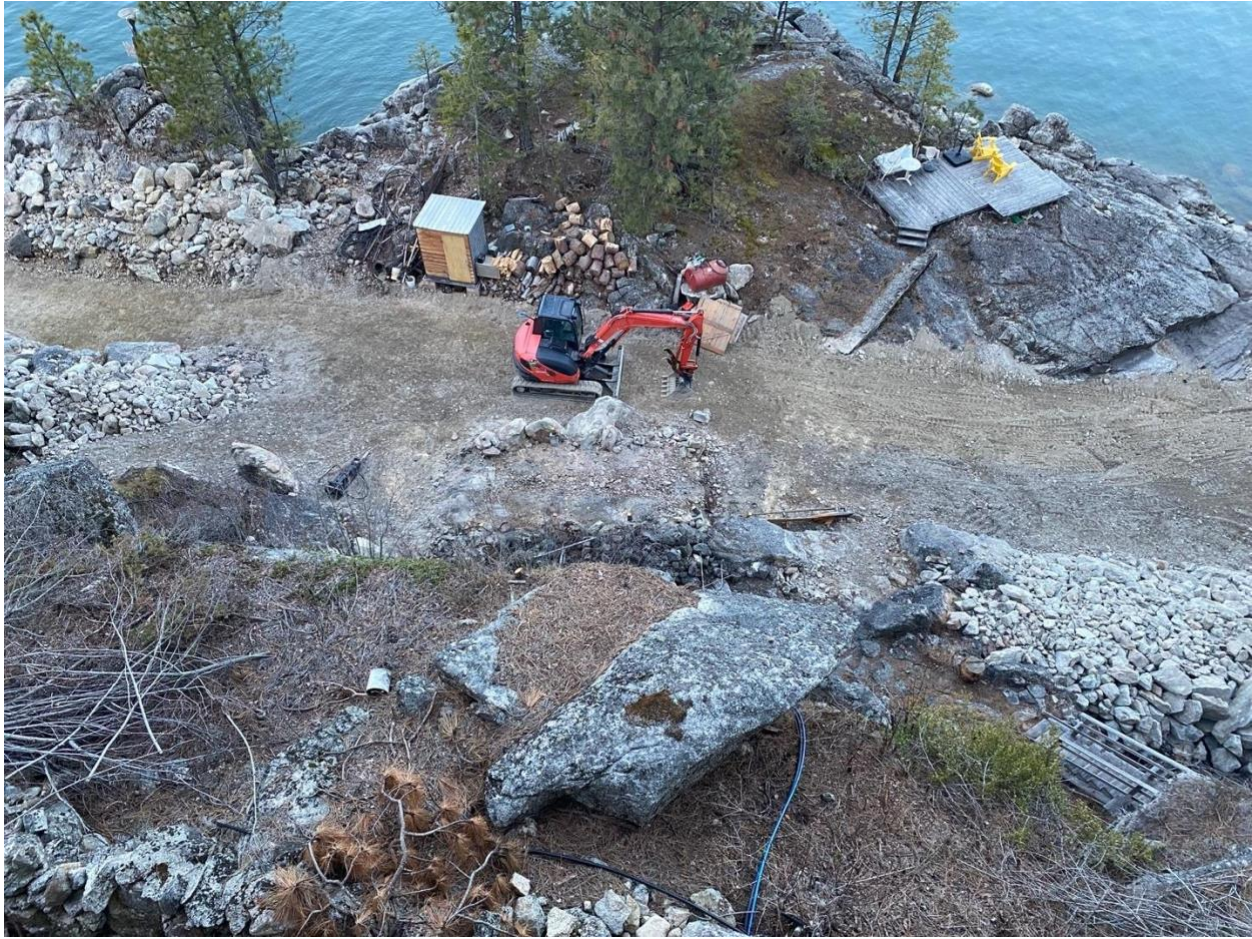
**Figure 8. Overhead view showing the location of the dismantled boathouse.**

*Image was taken on April 1, 2022*

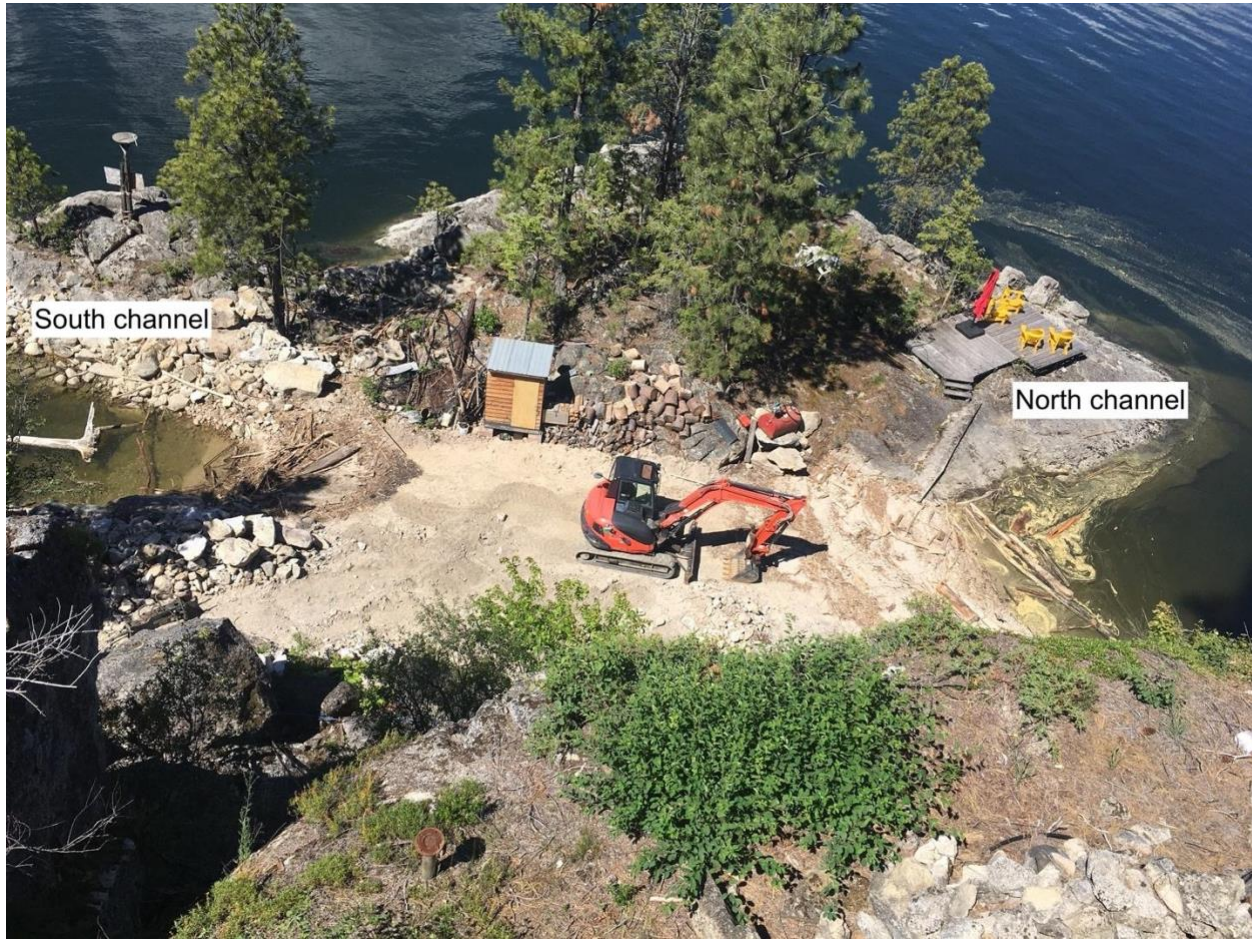
**Figure 10. Overhead view of the site following construction activities.**

Terrestrial conditions were assessed as those above the natural lake boundary (i.e., high-water mark). A path approximately 10 m wide was observed from north to south connecting the two channels on-site (Appendix A: Figure 10). The path was predominantly sand with minimal coarse rock fragments and no coarse woody debris above the natural lake boundary (Appendix A: Figure 11). No vegetation was seen growing in the sandy area.

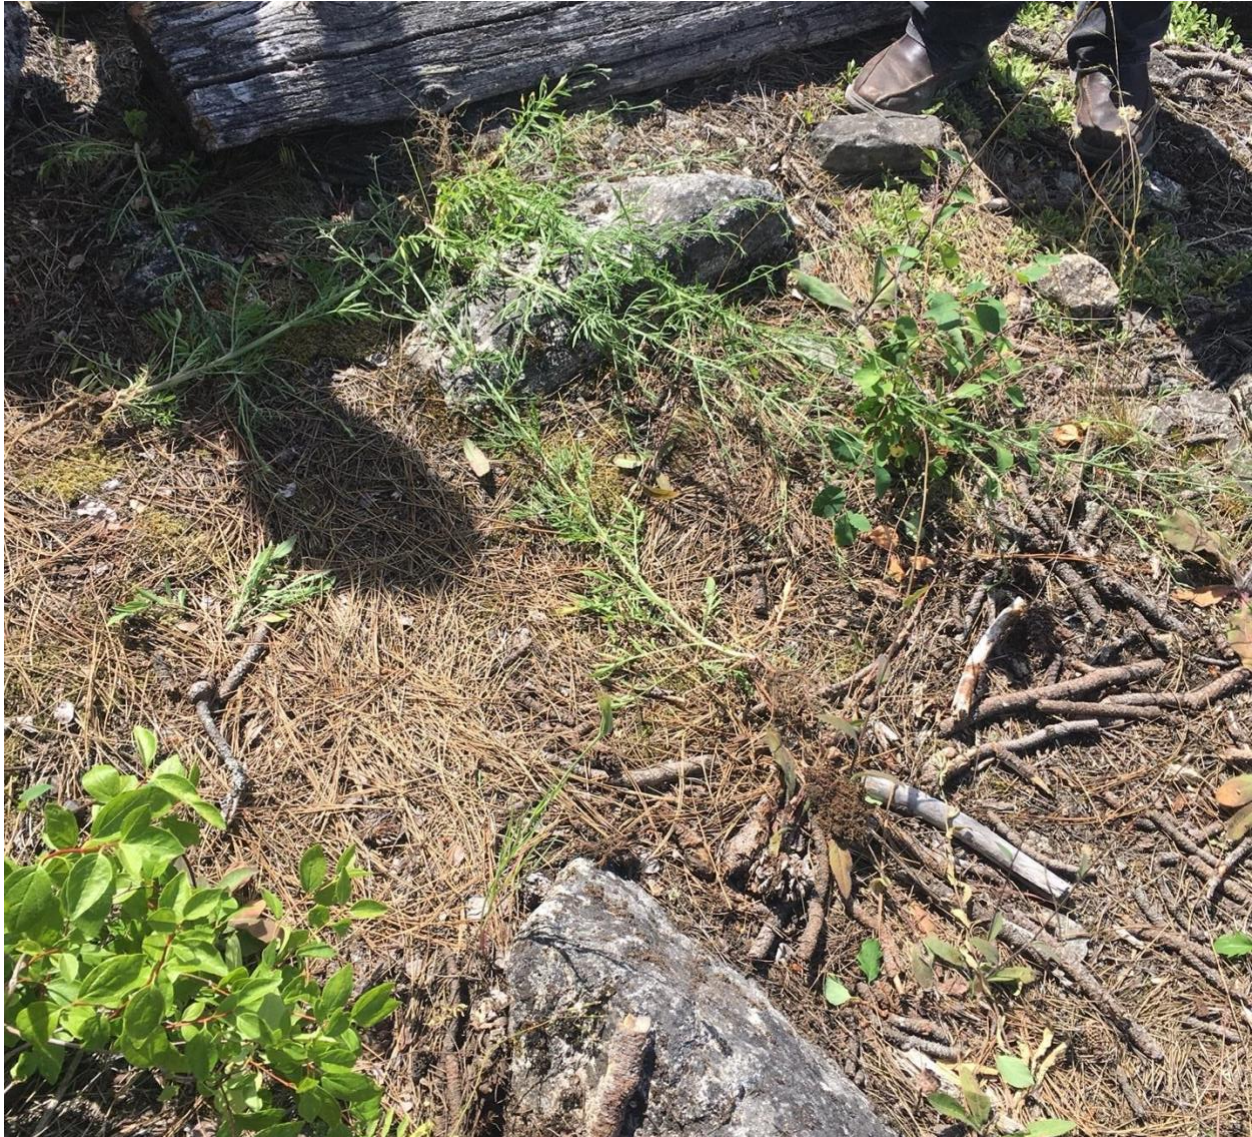
**Figure 16. Spotted knapweed manually removed by KES during the June 30 site visit.**

Spotted knapweed (*Centaurea stoebe*) and downy brome (*Bromus tectorum*) were observed on-site along the footpath leading from the house to the site, beginning approximately 10 m north-east of the dismantled boathouse (Appendix A: Figure 16).

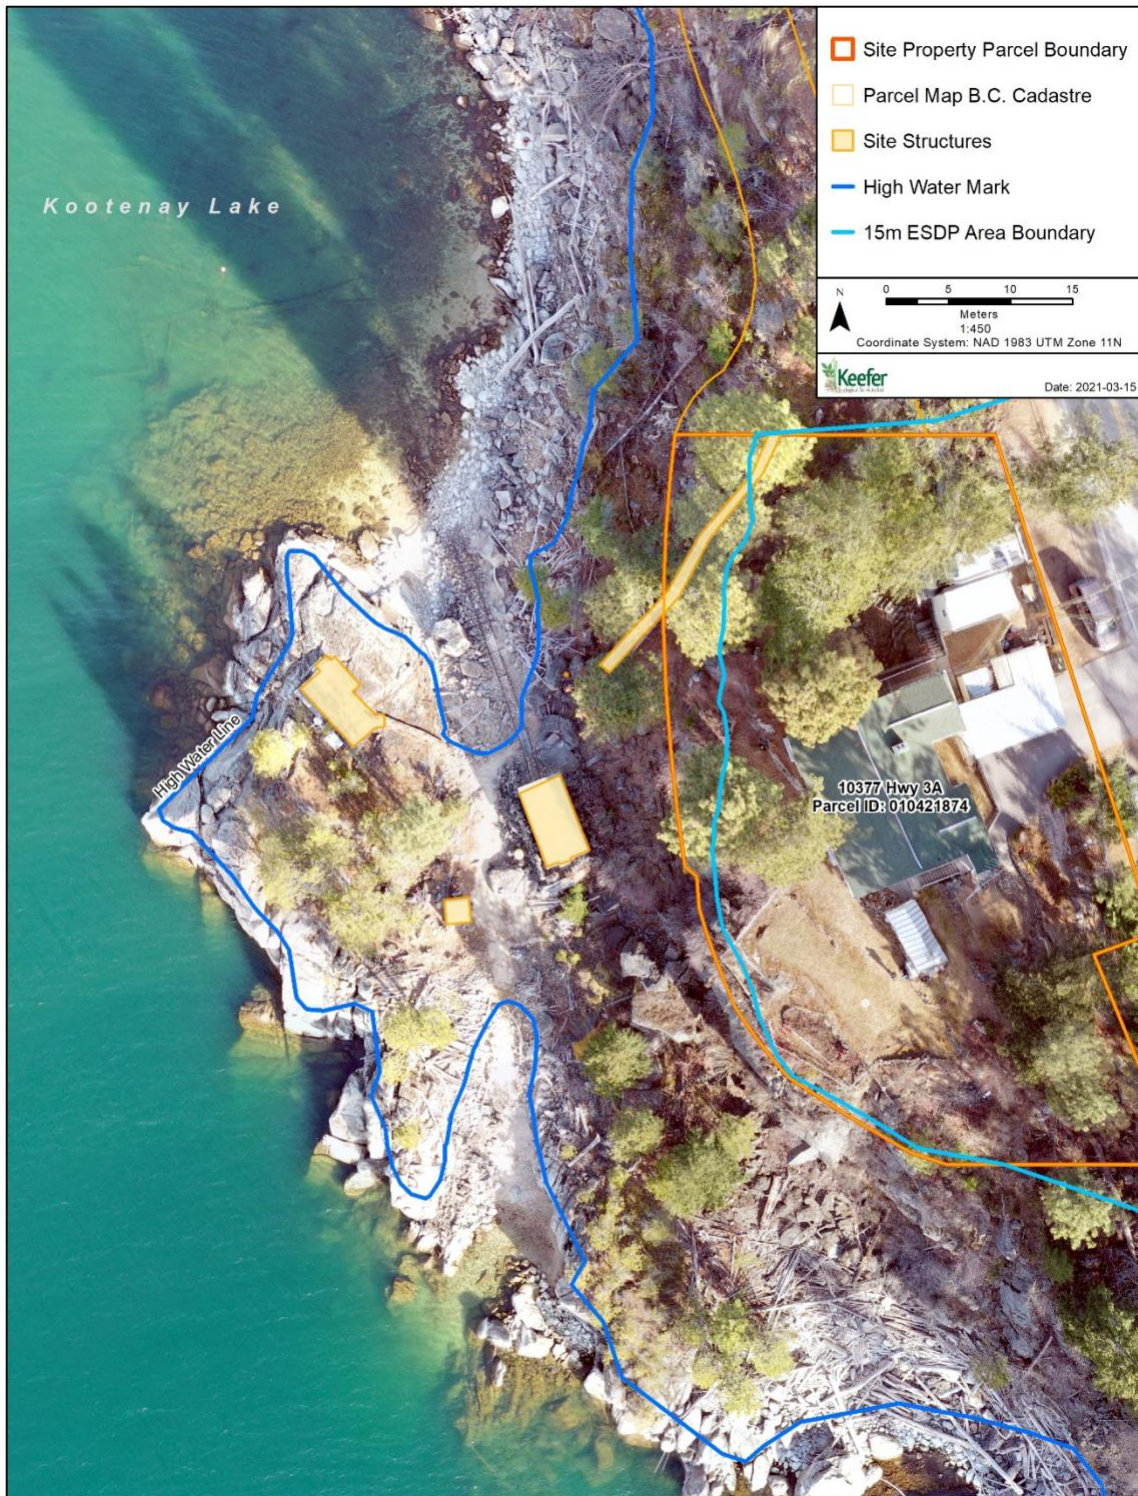
Figure 1. Existing development of the assessed property.

A two-storey house on a concrete foundation currently exists on the upper portion of the assessed property, immediately west of Highway 3A. The house was constructed in 1963 and has likely experienced several renovations since that time. On the south side of the house is a small greenhouse and the septic field. On the north side of the house, a wooden staircase connects the upper portion of the assessed property to the lower portion where a boat house, rail system, deck and storage shed are located. A cliff approximately 30 meters (m) in height separates the upper and lower portions of the assessed property. Other existing infrastructure found in the lower portion of the assessed property includes a decommissioned hydro pole and scrap wiring, other decommissioned electrical equipment (e.g., light on the shoreline), and several water lines that run from the waters edge up the cliff to the house above (Figure 1).

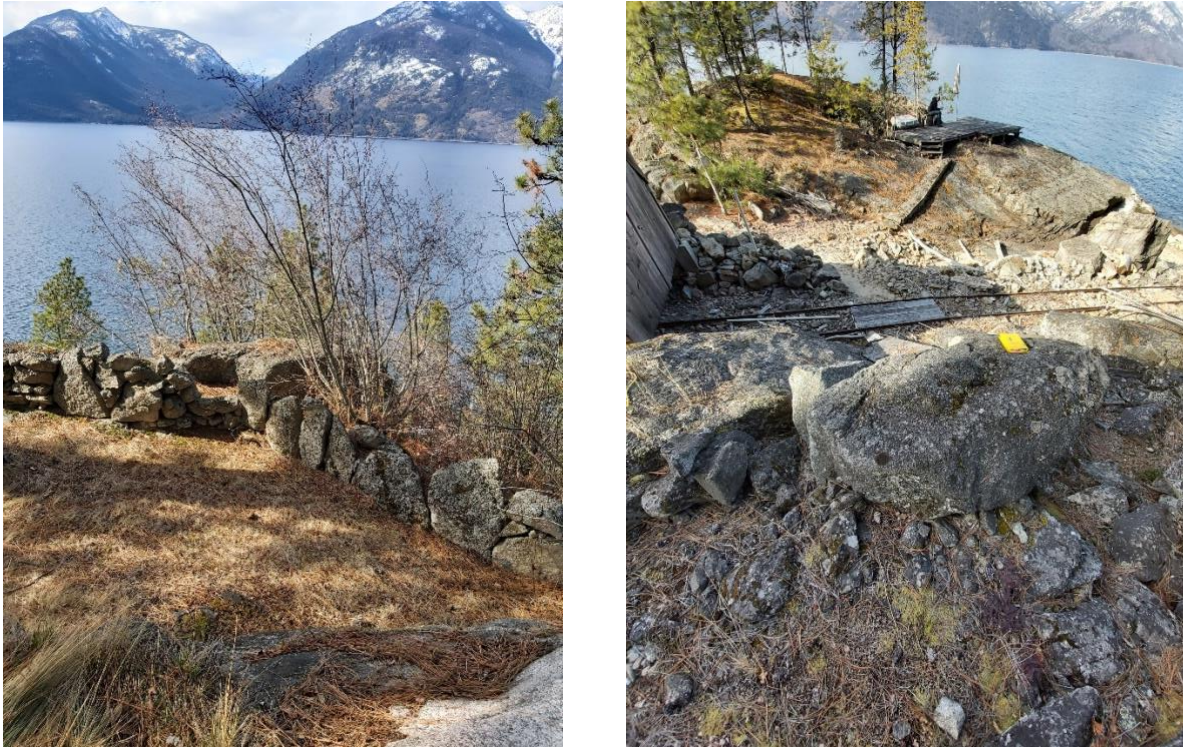
Figure 2. Top (left) and bottom (right) points of the proposed funicular.

The proposed development includes the installation of a funicular (a cable and rail system) intended to connect the upper and lower portions of the assessed property from a point on the western edge of the upper portion to a point above the high water mark in the lower portion (Figure 2), and a floating dock extending from gangway secured into the bedrock along the western shoreline, where a non-permanent deck area built of wood currently exists (Figure 3).

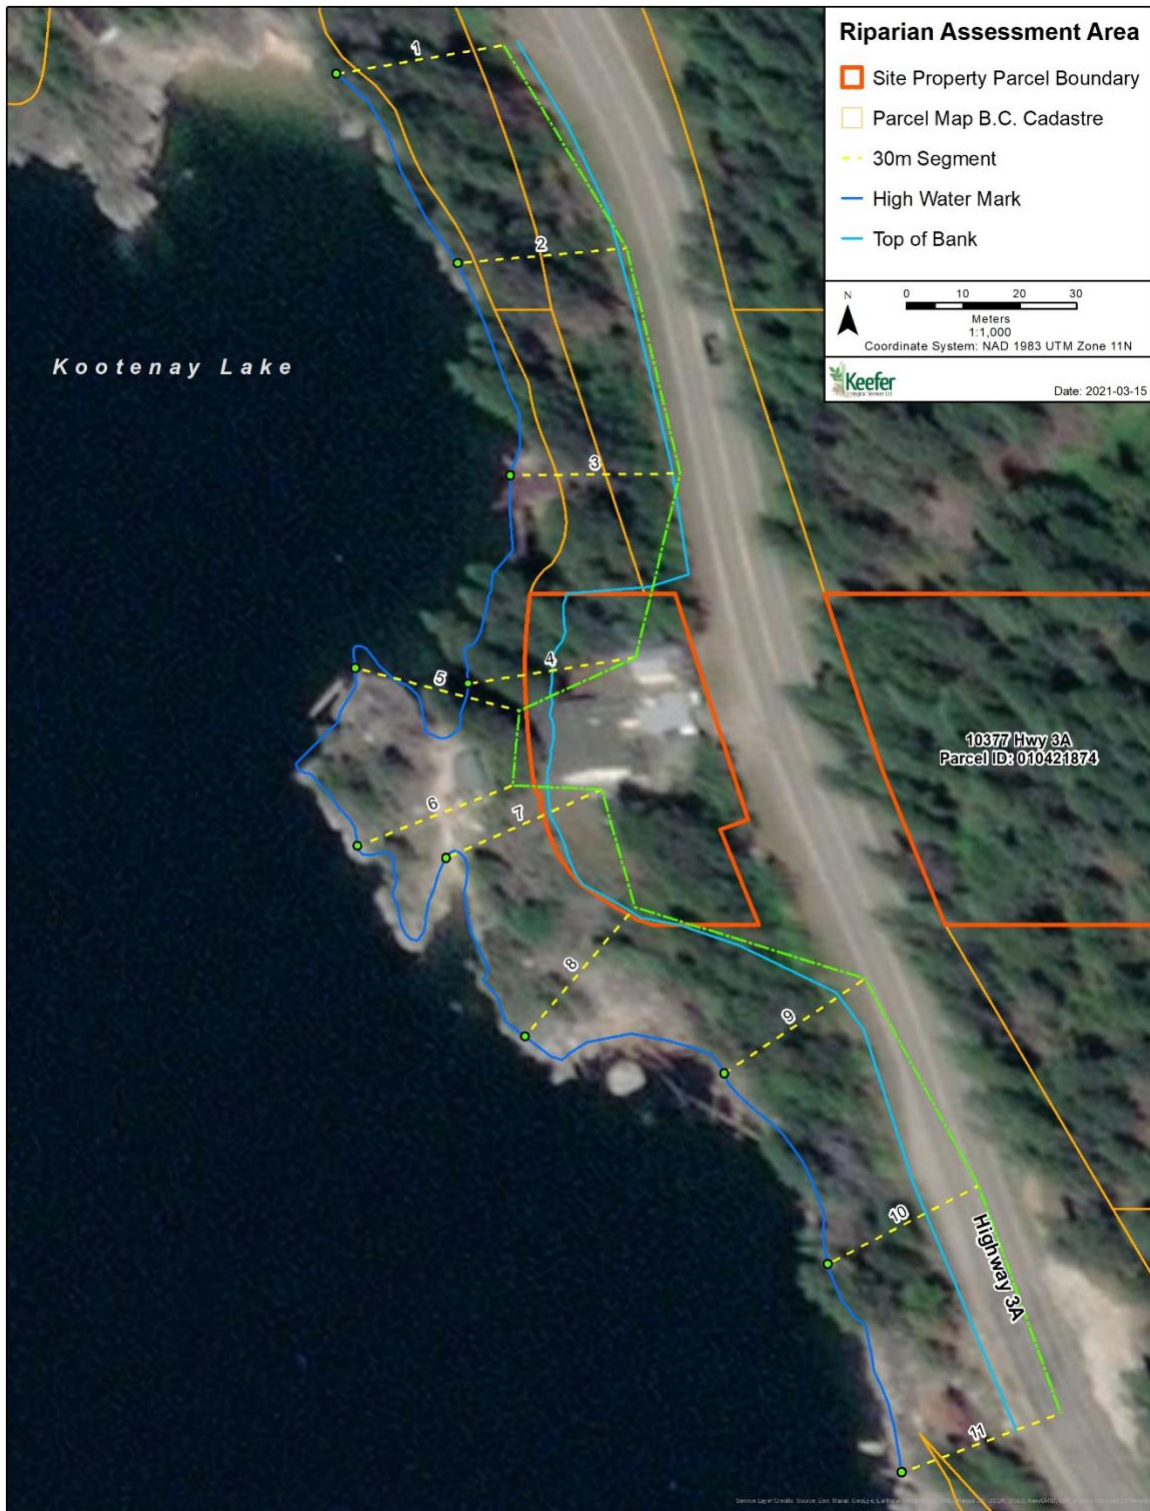
The vegetation category is assessed within a 30 m wide area starting from the middle of the assessed property and going 200 m both upstream and downstream along the bank where the development will occur. Within the 30 m and 200 m assessment boundaries, the distance from the top of bank (TOB) to the first permanent structure was estimated at 40 m intervals (Figure 4). An air photo was used to undertake this measurement prior to inspecting the site in person. While on site, KES utilized a drone to improve the quality of the available aerial photos of the site for the purposes of this assessment.

Figure 4. Riparian area assessment boundaries.

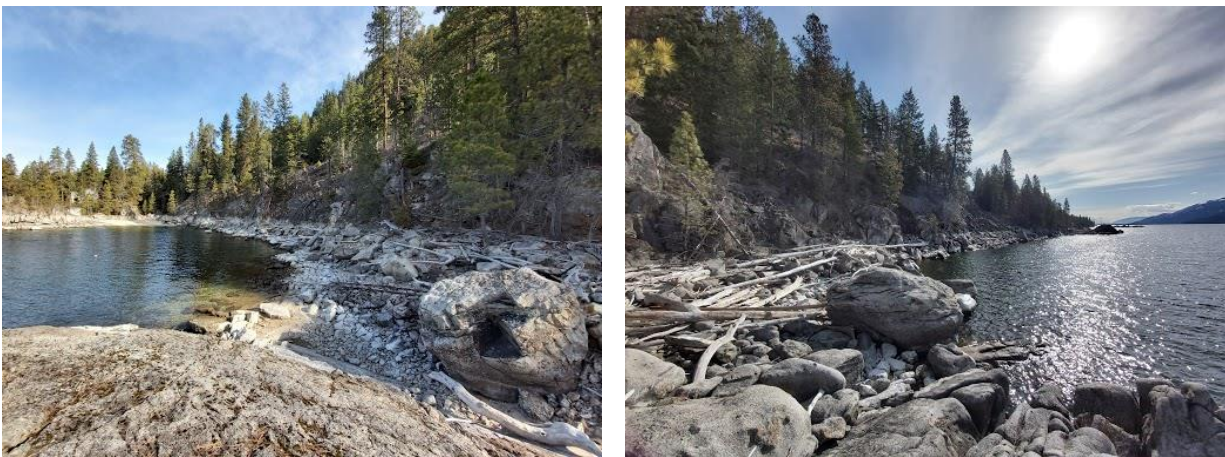
**Figure 6. Upstream (left) and downstream (right) shorelines outside the assessed property.**

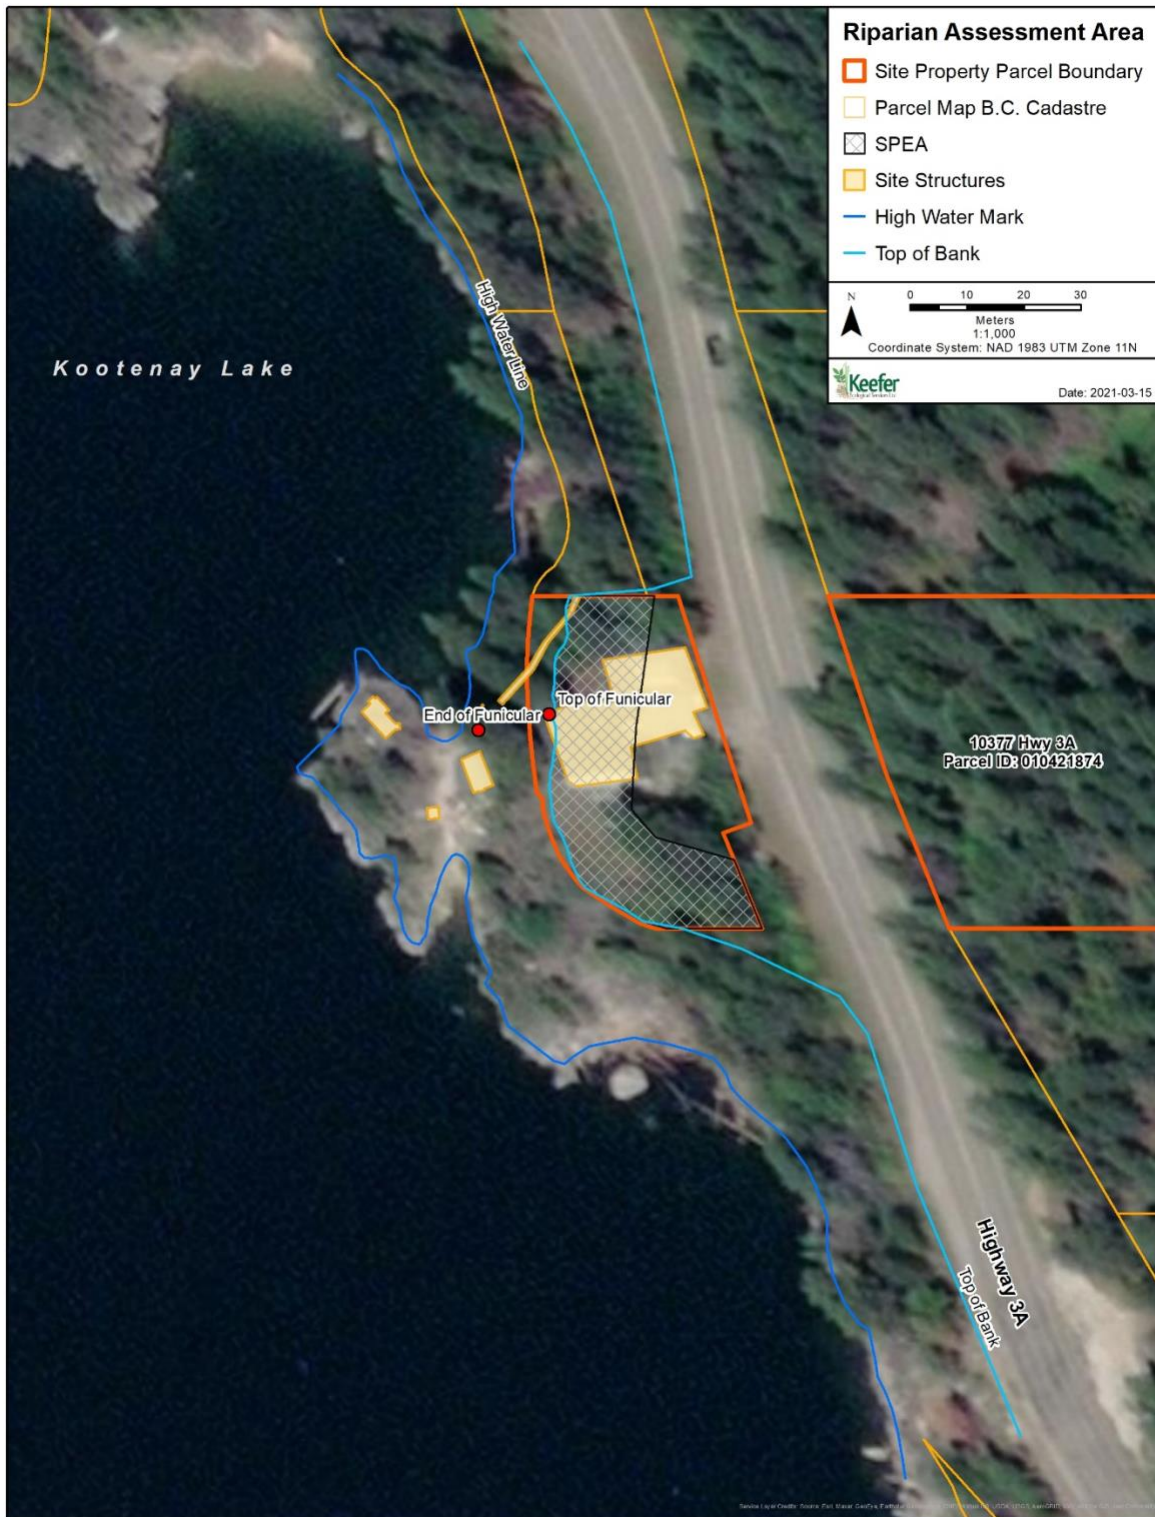
Figure 7. SPEA determination for the assessed property.

Segment Assessed	Distance to First Permanent Structure
1	5 m
2	4 m
3	3.5 m
4	20 m
5	6.5 m
6	6 m
7	12 m
8	15 m
9	4.5 m
10	5.5 m
11	5 m
<b>Average</b>	<b>8 m</b>

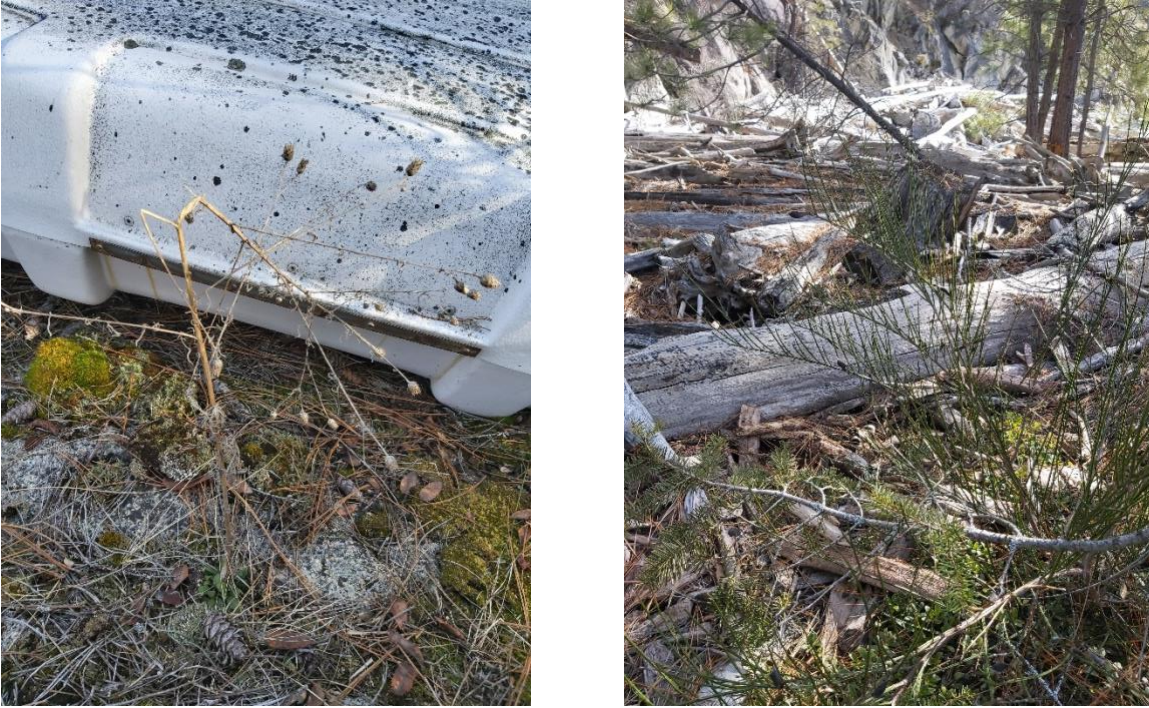
Figure 8. Invasive plant species found within the assessed property boundaries.

Two invasive plant species were observed on the assessed property and are presumed to have originated from populations along the side of the highway (Figure 8). These species were also observed 200 m up and downstream of the assessed property. Spotted knapweed (*Centaurea stoebe*) should be manually removed and chemically controlled, with extra care taken in its application given the proximity to the high water mark. Existing spotted knapweed skeletons should be carefully removed in such a manner that reduces the likelihood of spreading seeds in the process. Scotch broom (*Cytisus scoparius*) should also be removed through manual and chemical means. Plants should be dug or pulled, taking care to remove as much of the root as possible. Scotch broom may also be controlled via chemical means in the spring.
