### **Development Permit Application**

Referral Form – RDCK File DP2403A

129 Boulder Beach Road, Kootenay Bay, Electoral Area 'A'
LOT 5 DISTRICT LOT 4595 KOOTENAY DISTRICT PLAN 811, EXCEPT PARTS INCLUDED IN PLANS 3062, 16541, R127, NEP60734, NEP68076, NEP69201 AND NEP72451 (PID: 011-123-877)

# 129 Boulder Beach Road, Crawford Bay BC Riparian Assessment (V1.2)

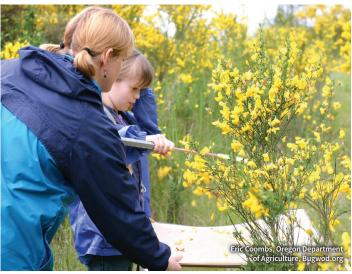
Stems: Woody and 5-angled; 1-3 m tall shrub.

**Leaves:** Stalked lower leaves are composed of three leaflets; un-stalked upper leaves are simple.

**Fruits:** Flat, hairy seedpods that are initially green, turn brown to black in color.

**Similar Species:** Spanish broom (*Spartium junceum*), a non-native species, has flowers that' grow at the tips of stems (crowning the plant), whereas Scotch broom flowers grow along stems.
