# **Watercourse Development Permit Application**

Referral Form - RDCK File DP2307E

# 2205 Bealby Road, Rural Nelson, BC

# Riparian Assessment V 2.1

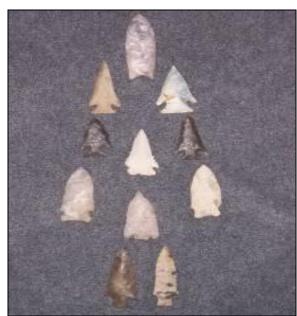
Image 4: Example of formed lithic artifacts

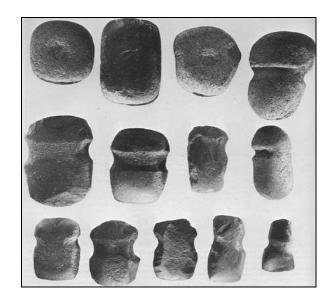
Image 5: Ground stone artifacts

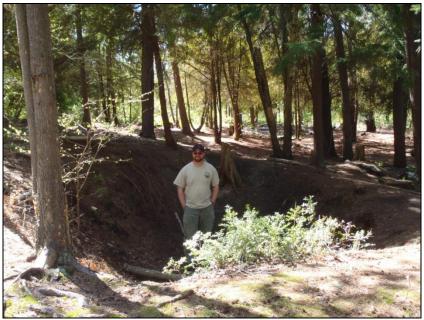
Image 9: Example of a large cultural depression in a natural setting 4.6 Rock Alignments

Any depression seen on the ground surface that appears to have been excavated by man can be a cultural depression and have archaeological significance. These "pits" were dug for a variety of reasons such as for food storage, cooking or as a base for a dwelling. They can range in size from 1m across to 7-10m across, and are usually found associated with other artifacts such as FBR and lithic scatters.
