REGIONAL DISTRICT OF CENTRAL KOOTENAY DEVELOPMENT PERMIT DP1801D-01231.010-JULIEN-DP000082 (DP1801D)

Schedule 2: 4724 Twin Bays Road Riparian Assessment, dated February 27, 2018 by Masse Environmental Consultants Ltd.

Masse Environmental Consultants Ltd. was retained by Purcell Timber Frame Homes to conduct a riparian assessment at 4724 Twin Bays Road (Lot A, Plan NEP 14760, District Lot 193, Kootenay District). Purcell Timber Frame Homes is acting as general contractor for Steve and Marielle Julien for the purpose of building a residence on their property. Construction of the proposed building will involve work within the 30 m Watercourse Development Permit Area (WDP) as defined in the Electoral Area 'D' Comprehensive Land Use Bylaw No. 2435, 2016. A site visit was conducted on February 15, 2018 by Sylvie Masse MSc, RPBio, and Tyson Ehlers BSF, RPBio, to conduct a riparian assessment on the property.

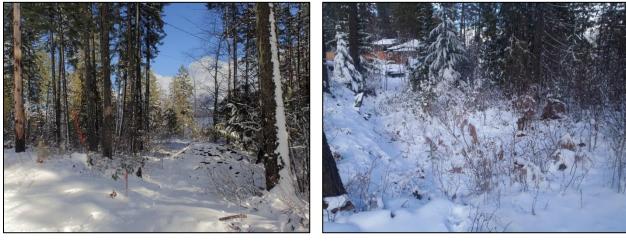
The property has been largely cleared of timber approximately 10-13 years ago, and the proposed building site has been landscaped with a low retaining wall and site levelling. The dominant vegetation is a regenerating stand of mixed conifer and deciduous saplings, native shrubs and some invasive weeds. The riparian area east of the proposed site has also been cleared for an additional 5-10 m from the proposed building footprint up to the point where the slope begins to drop sharply to Kootenay Lake. A buffer patch of approximately 15 mature (~120 year-old) Douglas-fir (*Pseudotsuga menziesii*) trees has been retained on the western side of the proposed building site by visually blocking Twin Bays Road. The site is accessed via a rough trail to Twin Bays Road, just north of the patch of Douglas-fir (Photo 1). A 5.5 x 7.6 m septic field has been dug in the northwest corner of the property, and a 2700 L septic tank has been installed just northwest of the proposed building footprint (Photo 2; Appendix 3).

Photo 1. Entrance to property from Twin Bays Road and small stand of mature Douglas fir to the left.

Photo 2. Septic field.

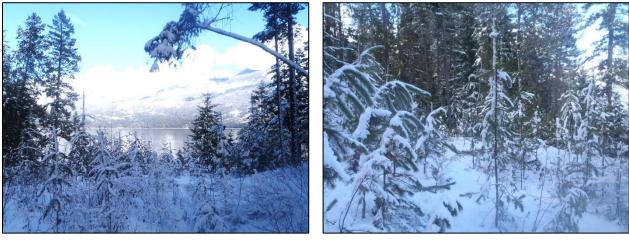
The proposed building is a two storey timber frame home with attached carport and patios, covering a total area of \sim 183 m² along the southern property margin (Appendix 2). The proposed building site is flat

and currently covered in young regenerating forest. A driveway to the proposed building will access the property from Twin Bays Road to the west along an existing trail.

Photo 3. Proposed building site.

Photo 4. Young forest with SPEA adjacent to building site.

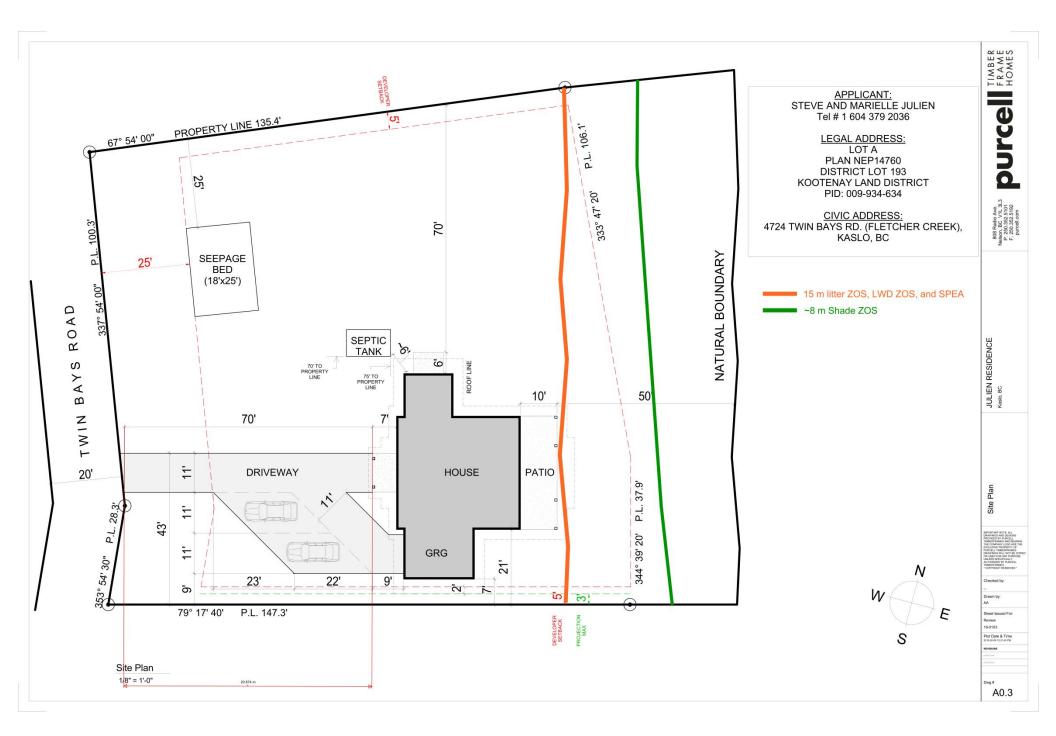
APPENDIX 2
SITE PLAN AND STREAMSIDE ENHANCEMENT AND PROTECTION AREA SETBACK MAP

To determine whether the WDP setback of 30 meters from the HWM of Kootenay Lake aligns with the criteria in the Riparian Area Regulation (RAR), a detailed assessment of the site was conducted to calculate the SPEA for Kootenay Lake on the property. As per the RAR, the large woody debris (LWD), and litter Zone of Sensitivity (ZOS) were plotted 15 m inland from the HWM. The shade ZOS was determined by plotting a traced facsimile of the natural boundary as recorded in the Parcel Map BC cadastral fabric 30 meters due south of its mapped position. The resulting shade ZOS is between 8.25-8.5 m inland from the high water mark on the subject property. The SPEA is determined based on the ZOS with the greatest width. The SPEA throughout the site was determined to be 15 m from the HWM based on the 15 m LWD and litter ZOS. Results for the Zones of Sensitivity (ZOS) and SPEA are presented in Table 1 below, and on the SPEA setback map (Appendix 2).

The property owners do not intend to encroach into the SPEA and will allow the young regenerating forest within the SPEA to re-establish. Though the owners wish to access the views of Kootenay Lake from within the SPEA, there are no plans for any further clearing of vegetation in this area. Any other activities that may cause impacts to the riparian vegetation should be avoided.
