REGIONAL DISTRICT OF CENTRAL KOOTENAY
DEVELOPMENT PERMIT
DP1909D (Wing Creek Resort)

Schedule 1: Subject Property

WING CREEK RESORT Riparian Assessment

Prepared by:
Masse Environmental Consultants Ltd.
812 Vernon St.
Nelson, BC, V1L 4G4

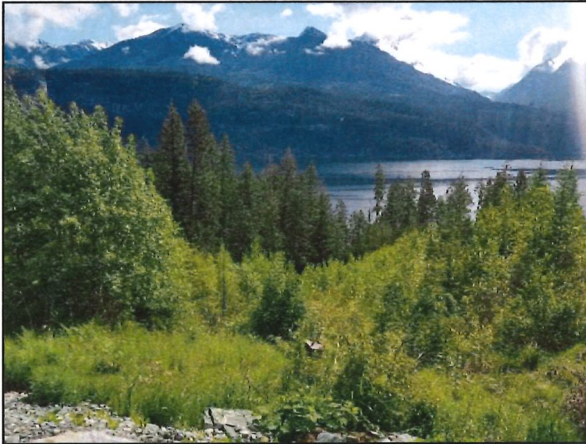
Photo 1. Young forest regeneration in foreground within upper part of the property. Conifer forest in the background covers the steeper lower part of the property.

The subject property slopes along an eastern aspect toward Kootenay Lake (Photos 1-6). The property is bisected by a small west to east flowing creek which drains into Kootenay Lake. The creek is not recorded in BC Freshwater atlas data and is assumed to be a first order stream draining an area <100 ha.

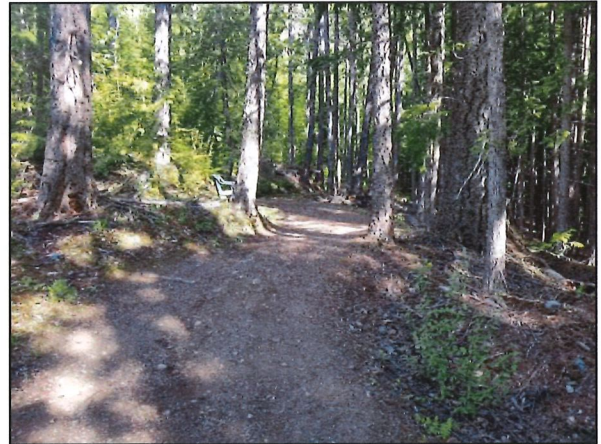
Photo 2. Kootenay Lake access path through steep conifer forest in the lower part of the property.

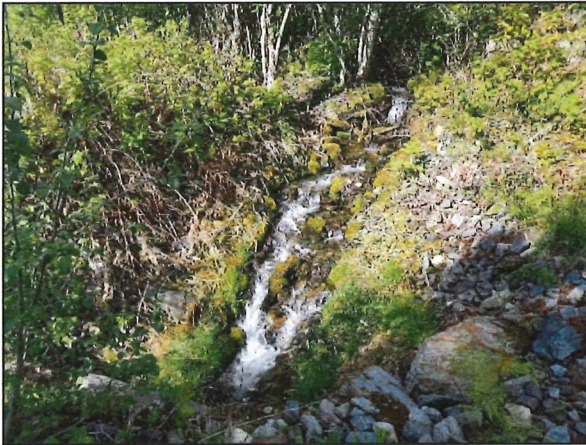
Photo 3. Early seral riparian vegetation along the creek.

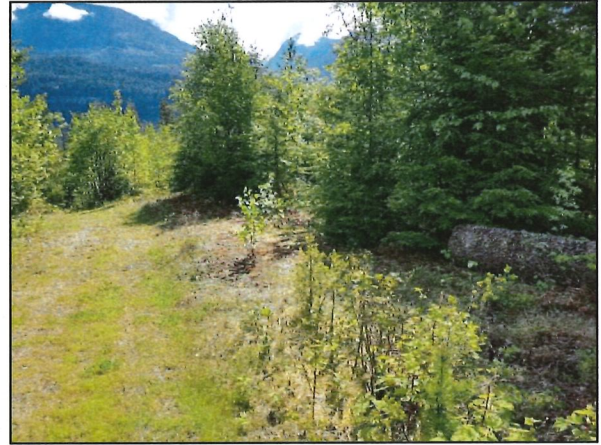
Photo 4. Kootenay Lake access path through young forest along upper part of the property.

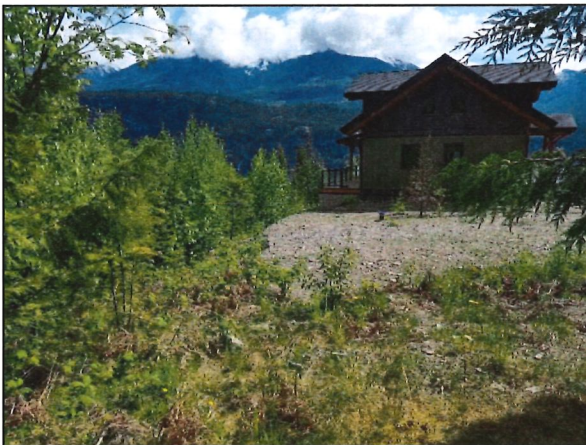
Photo 5. Recently completed cabin 3.

A recently constructed cabin (cabin 3) sits on the steep southern bank above the creek. Cabin 3 is the first of five new cabins proposed in this part of the property and is covered under a site-specific exemption to the *Floodplain Management Bylaw 2080*, which allows the building footprint to extend no closer than 5.25 m from the creek. Excavation for the next proposed cabin (cabin 1) has begun above cabin 3, just east of the access road and south of the creek.

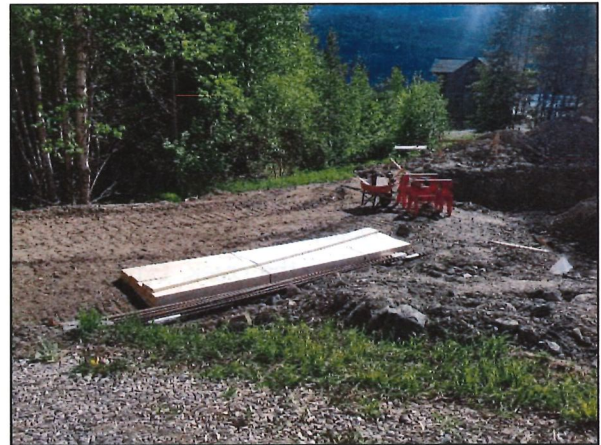
Photo 6. Excavation for cabin 1 next to creek

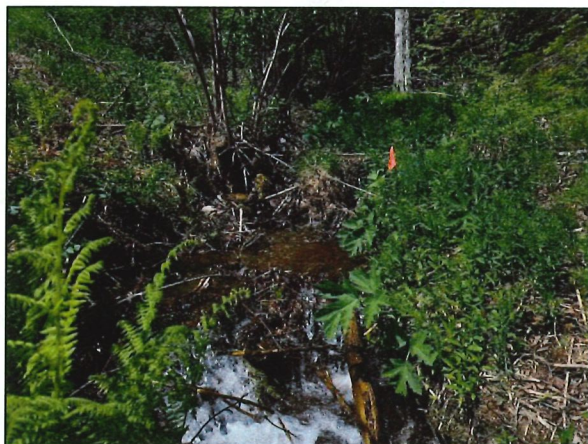
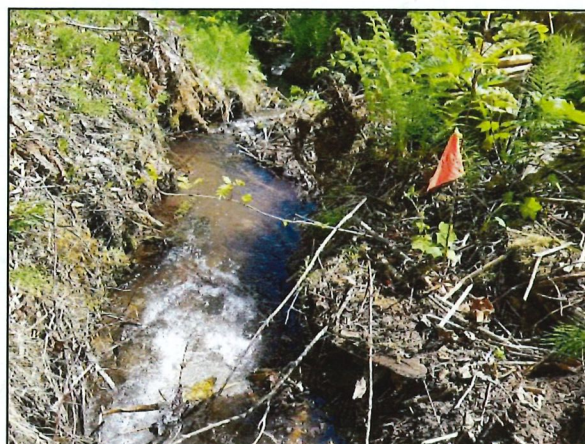
Photo 7. Orange flag indicates HWM.

Photo 8. Orange flag indicates HWM.

The HWM within the subject property was well defined along the creek, which was generally confined within steep banks. General indicators of the HWM along the creek included perennial vegetation and mineral soil. The HWM was always placed above areas of undercut banks which occurred frequently along the creek. Two marker flags were left as an example of the HWM below cabin 1 (Photo 7 and Photo 8).

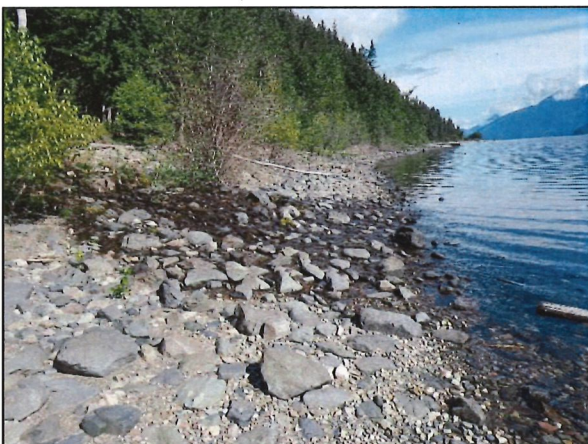
Photo 9. Mouth of Creek on Kootenay Lake.

The portion of the creek that flows through the subject property is likely non-fish bearing (Photo 9 to Photo 12). The gradient of the lower part of the creek was generally 30%, with 2 culverts and several cascades which would limit upstream fish movement near the mouth of the creek. However, because the creek drains into a fish-bearing waterbody (Kootenay Lake), the SPEA on both banks of the creek is protected under the RAR. A domestic water intake is located at the lower part of the creek, above the cascades and culverts which limit upstream fish movement.

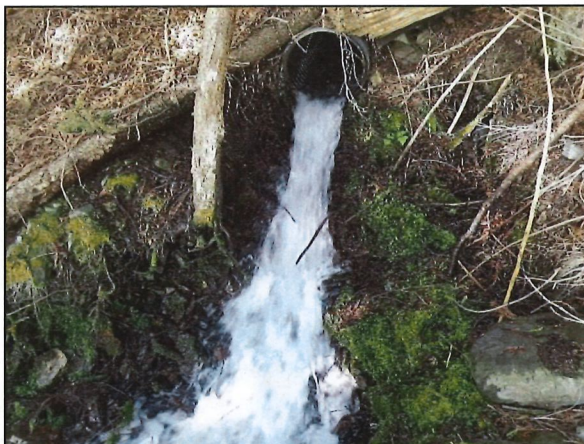
Photo 10. Cascade below culvert near mouth of the creek on Kootenay Lake.

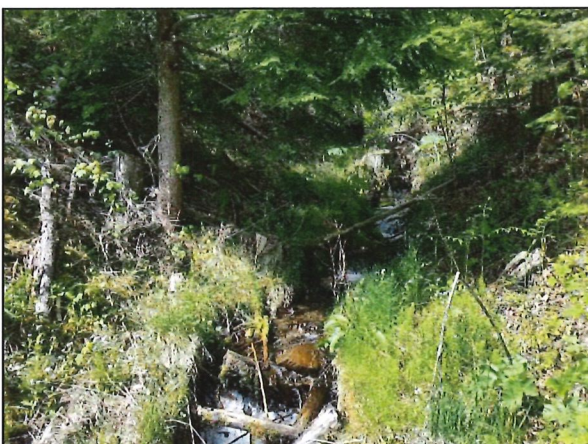
Photo 11. Creek below cabin 3.

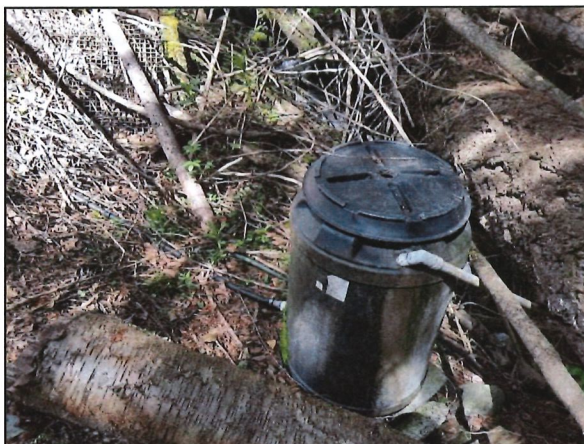
Photo 12. Water intake near lower end of creek.

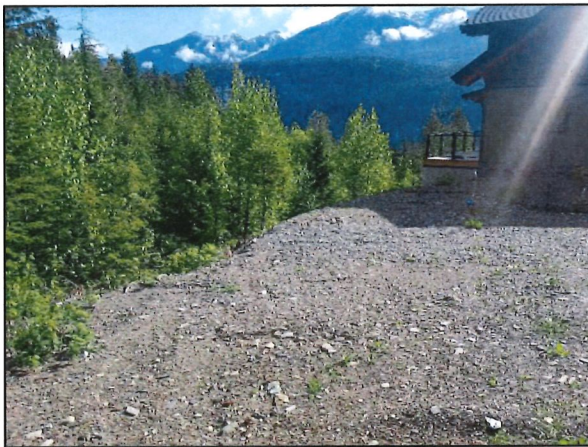
Photo 13. Recently disturbed area within 10 m SPEA at cabin 3.

1. Within the recently disturbed footprint of cabin 3 (Photo 13).
2. Along areas of the Kootenay Lake access path which have been widened into the 10 m SPEA (Photo 14).

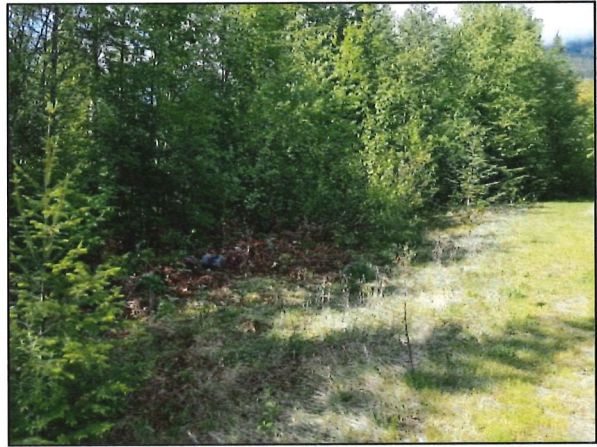
Photo 14. Area of widened footpath encroachment into 10 m SPEA.
