**REGIONAL DISTRICT OF CENTRAL KOOTENAY**  
**DEVELOPMENT PERMIT**  
**DP2101D (The Sentinel c/o Built Prefab Corp.)**

**5308 AMUNDSEN RD  
MIRROR LAKE, BC**

**Riparian Assessment**

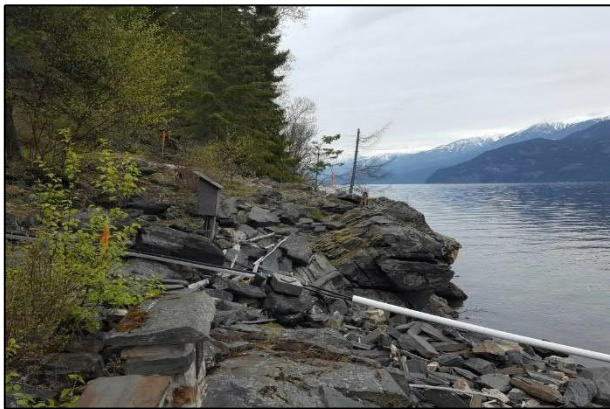
Photo 1. View of Kootenay Lake along east property boundary, looking north.

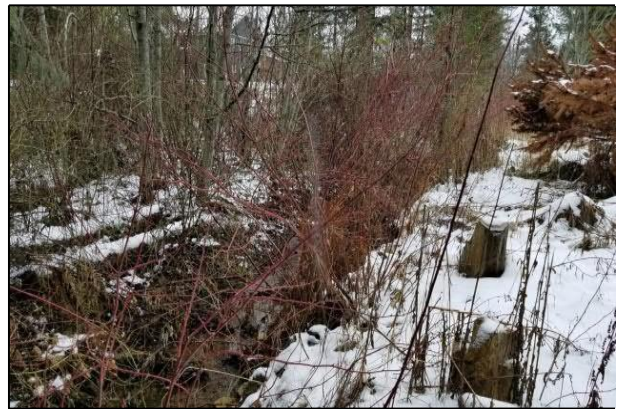
Two connected drainage courses were observed on the subject property (See Appendix 2 for locations). The first drainage ditch (Ditch 1) is located along the north property line, which captures drainage from Amundsen Road above and 5318 Amundsen Rd. The water flows through a 600 mm culvert across Amundsen Road, discharging onto the property and flows in an easterly direction through a defined, open channel into Kootenay Lake (Photo 2). A steep ~ 3 m high cascade (>60% slope) creates a barrier to fish

Photo 2. View of Ditch 1 along north property boundary, looking east.

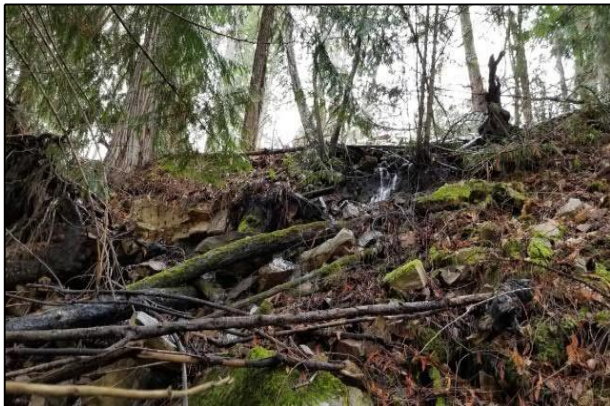
Photo 3. Cascade on Ditch 1 near foreshore.

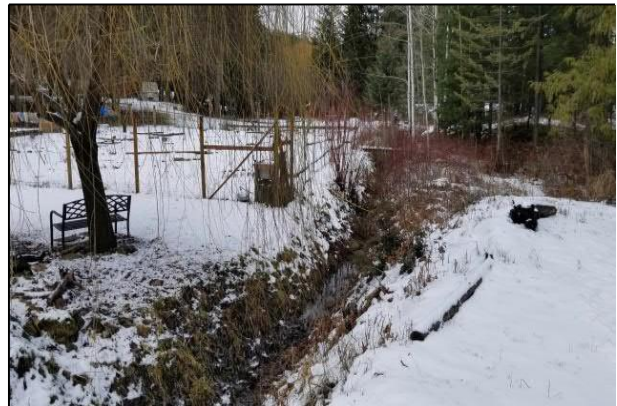
A second drainage ditch (Ditch 2) bisects the property and flows in a northerly direction into Ditch 1 at the north property boundary. Ditch 2 flows intermittently, dries up before Ditch 1 and flows < 6 months per year (pers. comm. Dustin East; Photo 4). Both ditches have a watershed area < 2 km<sup>2</sup> and are assumed to be non-fish bearing based on site conditions; however, no fish presence survey was completed as part of this assessment. Ditch 2 is not considered a watercourse under the RDCK bylaw.

Photo 4. View of Ditch 2 bisecting property, looking north.

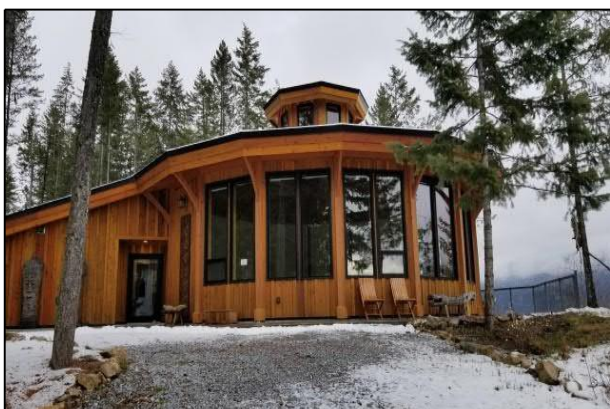
The subject property has undergone some recent development within the WDP area of Kootenay Lake and Ditch 1 including a portion of a new amenity building, referred to as the “Roundhouse” (Photo 5), new driveway, and parking area (Photo 6). The Roundhouse structure was constructed under the approved 2017 watercourse development permit for 5278 Amundsen Rd and straddles the two property lines. The upgraded driveway and new parking area construction is currently unauthorized and is proposed as part of the development within the WDP areas. A large area within the north-west quadrant of the property has been cleared between the driveway and Ditch 1 (Photo 7). In addition, two large Interior Douglas fir trees (510 mm and 480 mm DBH) were observed to have been cut in recent years in front of the Roundhouse (Photo 8). According to the Owner, these trees were standing dead and posed a risk to the Roundhouse and its occupants and were therefore removed.

Photo 5. View of Roundhouse located on 5278 and 5308 Amundsen Road.

To mitigate for the permanent loss of vegetation within the SPEA, caused by the previous construction of the Roundhouse within 5308 Amundsen Road (~35 m<sup>2</sup> within the SPEA), the Owner will revegetate an area of ~40 m<sup>2</sup>, located north of the Roundhouse. In addition, all disturbed areas within the 30 m WDP area shall be re-seeded with a native seed blend.

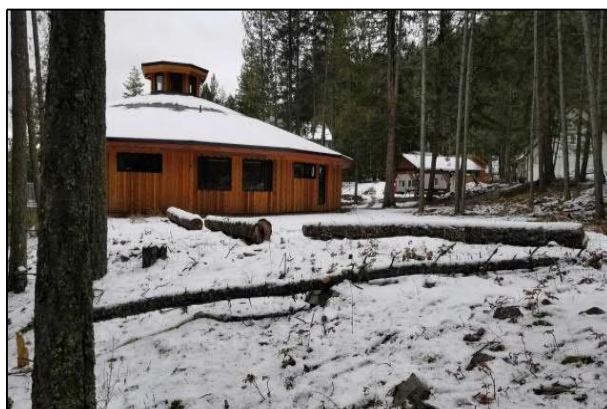
Photo 6. View of cleared parking area next to Roundhouse.

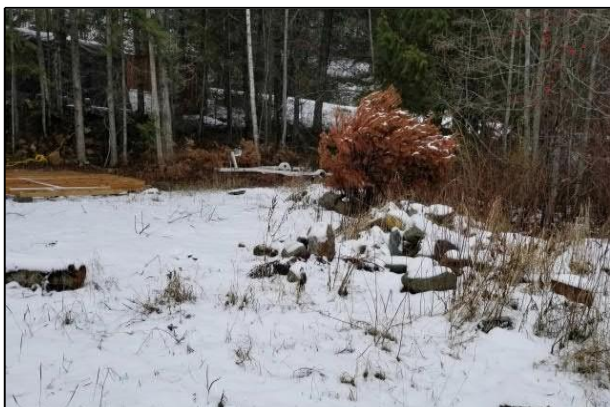
Photo 7. Cleared area next to Ditch 1 in north-west quadrant of property.

It was noted on the site visit that re-vegetation had not yet occurred north of the Roundhouse, as required on the RDCK Development Permit 2017 for 5278 Amundsen Road. Refer to 7.1 for revegetation plan.

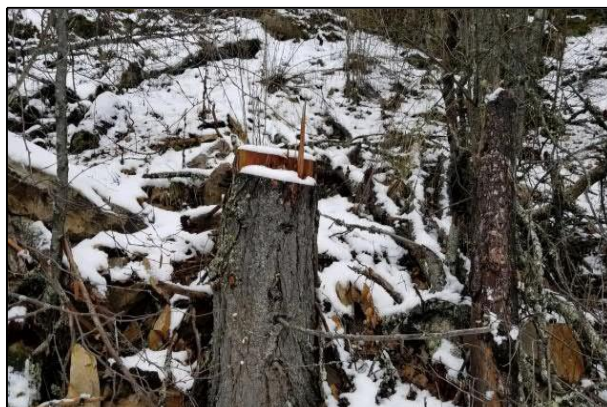
Photo 8. Interior Douglas Fir tree cut in front of Roundhouse along foreshore.

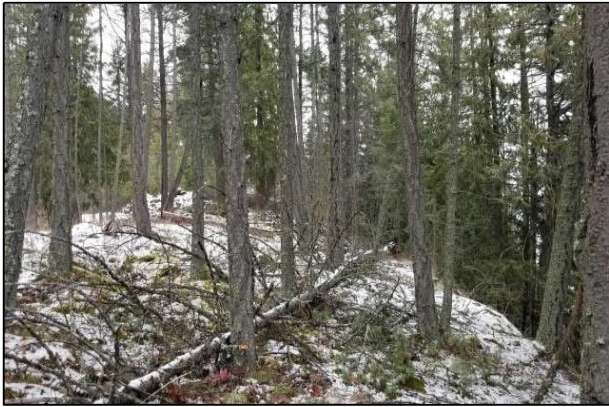
The proposed development is sited in a partially disturbed young conifer forest (< 30 years old) along the top of the embankment above Kootenay Lake, which appears to have been historically managed by some clearing and thinning of trees and understorey vegetation (Photos 9 and 10). The new driveway and parking

Photo 9. Proposed siting of duplex development along top of embankment, looking north.

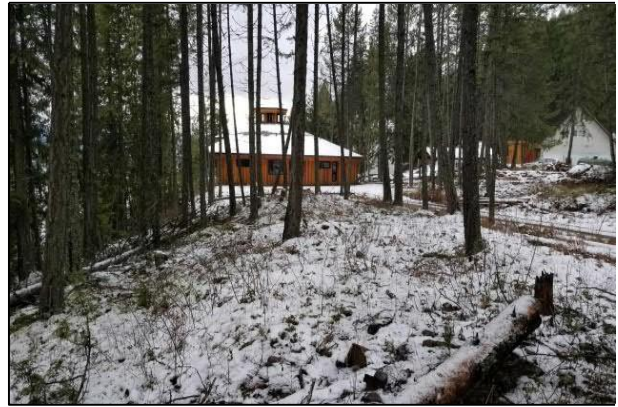
Photo 10. Proposed siting of duplex development along top of bank, looking south.

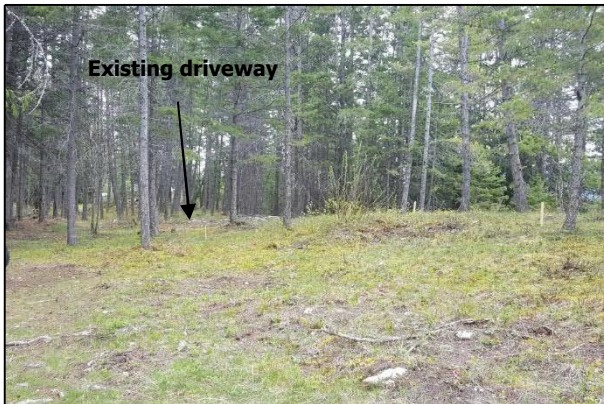
area have already been constructed; however historical photos taken during the 2017 assessment of this area show similar habitat, as described above (Photo 11).

Photo 11. Proposed siting of duplex development, looking north and upgraded driveway alignment, 2017.

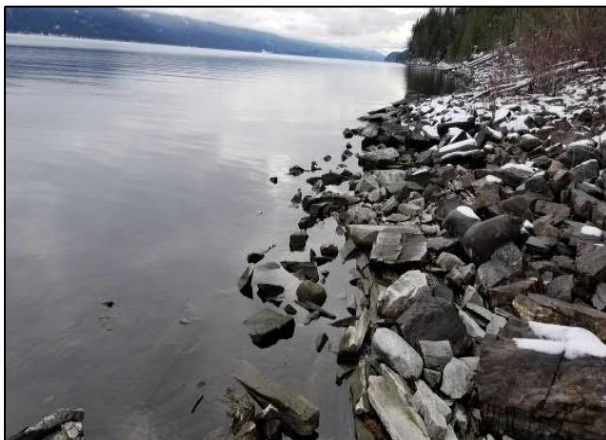
The Kootenay Lake foreshore consists of a rocky shoreline with angular boulders and cobble substrate (Photos 12 and 13) and is moderately sloped at ~30 % gradient. The instream habitat provides potential rearing and cover habitat for juvenile and adult fish. No aquatic vegetation was observed within this segment along the shoreline; however, it has been noted in the FIM mapping as having some submergent vegetation fronting the property (EEC 2016, KLP 2018).

Photo 12. View of angular rock along shoreline.

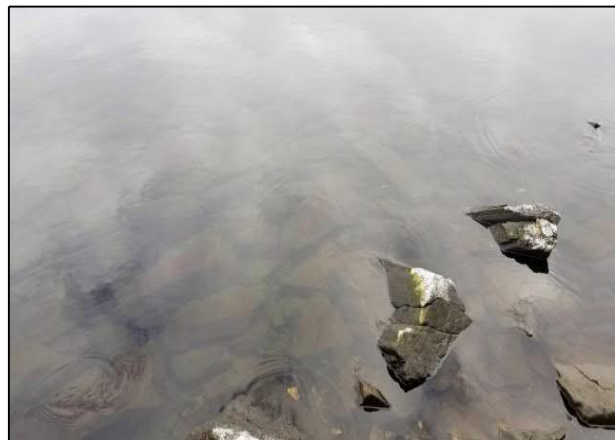
Photo 13. View of rearing and cover habitat.

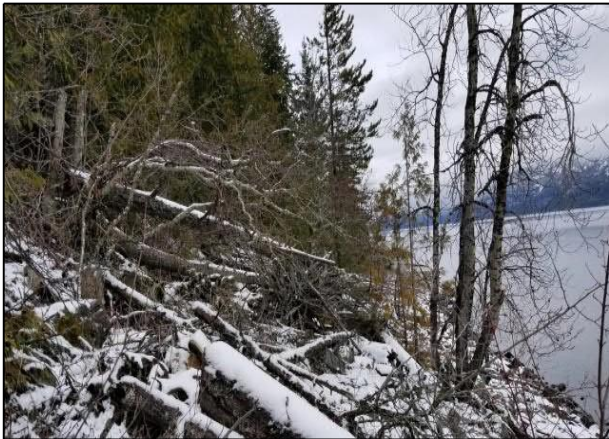
The riparian area along Kootenay Lake has an eastern aspect, with a shoreline gradient of ~30%, graduating to a steep embankment >55%. Exposed fractured bedrock is evident throughout the riparian area, with a thin layer of top soil. Dominant shoreline vegetation consists of Black cottonwood (*Populus trichocarpa*), Paper birch (*Betula papyrifera*), Red osier dogwood (*Cornus stolonifera*) and Alder sp. (*Alnus sp.*) (Photos 14). Vegetation along the steep embankment consists mostly of Western red cedar (*Thuja plicata*), with minimal understorey and presence of moss and lichens (Photo 15). Many of the trees within the SPEA may have shallow root systems due to the lack of soils and available nutrients and may be susceptible to windthrow.

Photo 14. View of shoreline vegetation looking north.

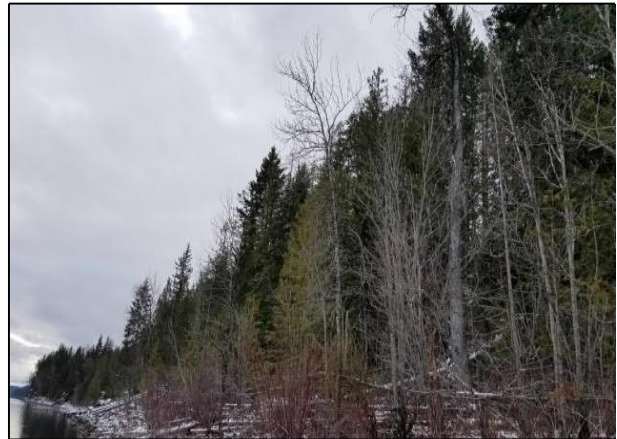
Photo 15. View of entire riparian area along foreshore looking south.

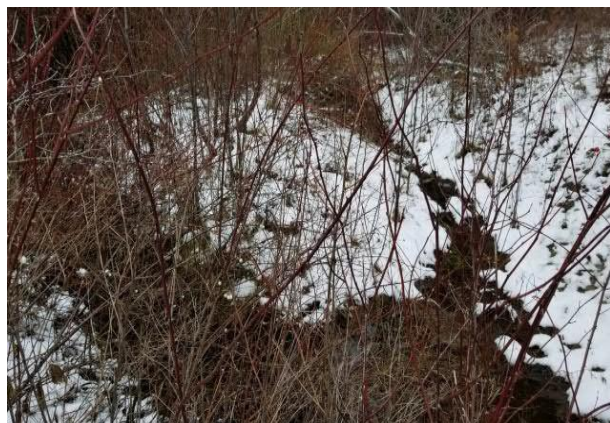
The riparian area along Ditch 1 consists of a variety of native tree and shrub species, agronomic grasses and exotic species. Native plants within the SPEA help provide bank stability, erosion protection and shade. Dominant tree species included Western red cedar, Interior Douglas fir and Paper birch with shrubs consisting mostly of red osier dogwood, alder sp, and rose sp. (*rosa sp.*) (Photos 16 and 17).

Photo 16. View of overhanging vegetation along banks of Ditch 1, looking north.

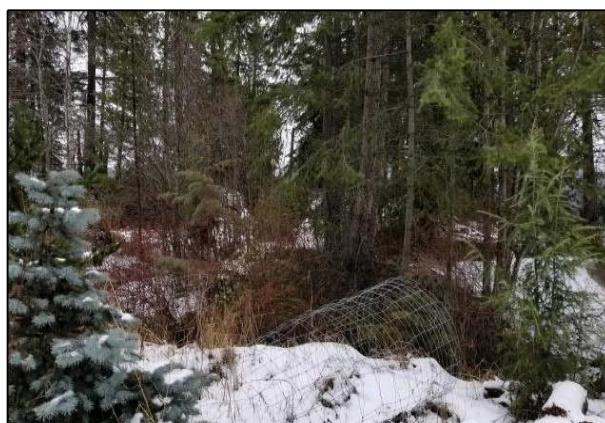
Photo 17. View of conifer trees along banks of Ditch 1, looking east.
