DEVELOPMENT PERMIT

DP2008Hn (DP2008Hn-02401.000-Dascher-DP000105)

600 Slocan Lake Boat Access

DETAILED RIPARIAN ASSESSMENT

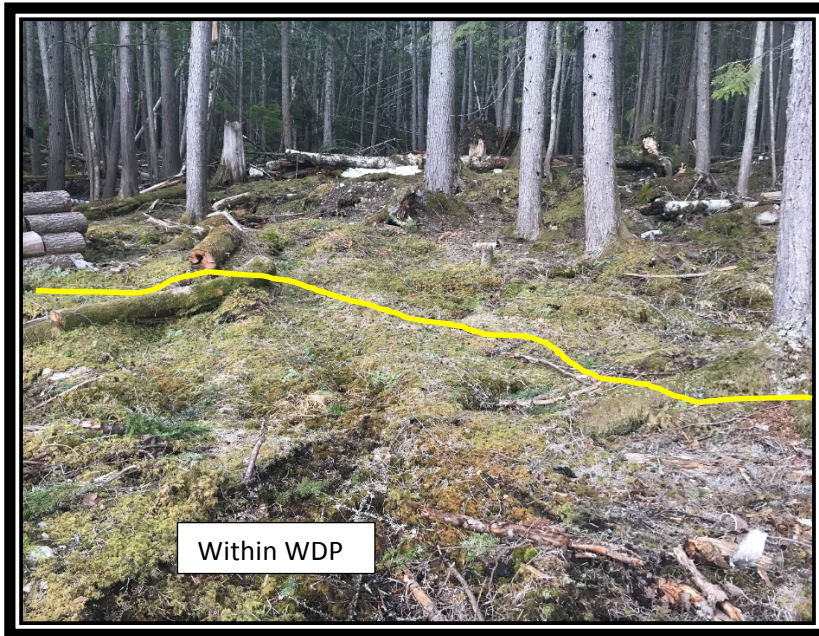
Photo 1: Pre-existing WDP Area. **Yellow line** represents the approximate upper boundary of WDP area.(30 meters from foreshore). This is a typical representation of the understory vegetation within the 30 meter WDP area and the SPEA area.

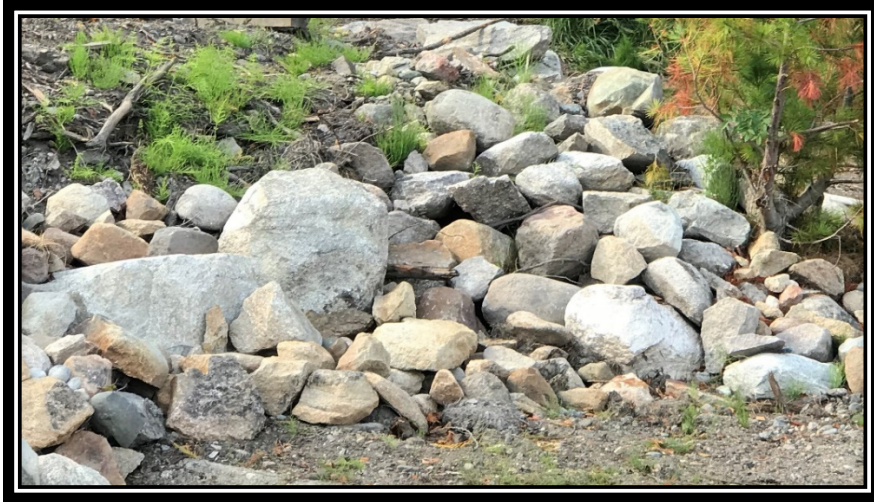
Photo 6: Rip rap area to be removed and planting of conifer and deciduous stems to be undertaken

Rip Rap Riprap was placed at high water mark. The plan is to intermix additional plantings of hemlock, alder, sedges, and natural grasses in the area and remove the rip rap. The end result after plantings is considering this area to be fully rehabilitated.	n/a	35m ²	0m ²	Fully rehabilitate (100%) 35m ² .

- Planting an erosion control mix of natural grasses to provide immediate ground cover along with the natural horse tail growing in the area already.
- Remove all **rip rap** and all **structures** within the SPEA
- Plant native conifers and deciduous trees/shrubs to repair the riparian habitat
- Maintain the settling ponds as they filter water before entering the lake.

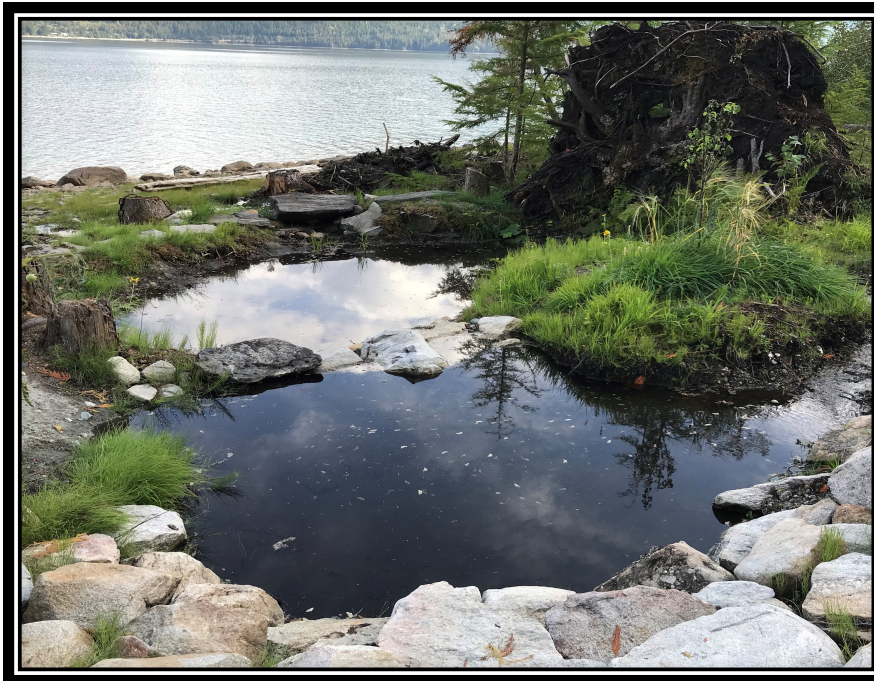
Photo 7: Settling pond . Ponds will remain with tree plantings surrounding

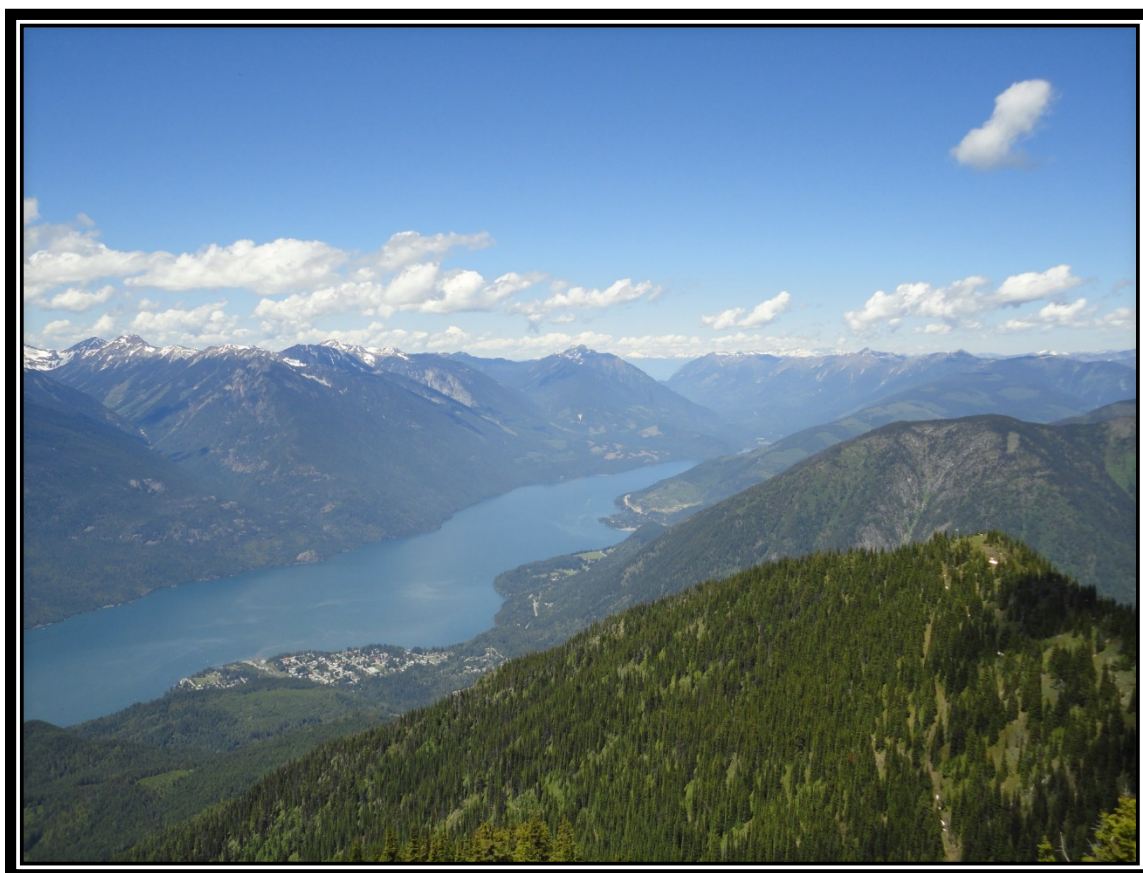
Photo 8: Slocan Lake

Slocan Lake is a 39 km long, cold, oligotrophic lake that covers a surface area of 6908 ha). The lake has a foreshore length of approximately 87km, a mean depth of 171 m and a maximum depth of 298 m. The lake differs from its neighbors in that it does not have a major river flowing through it. As a result, its bulk water residence time is 7 years, compared to Arrow Reservoir (< 1year) and Kootenay Lake (1.5 years). The longer residence time for Slocan Lake is somewhat misleading due to its deep water volume (Andrusak 2006). The Slocan Lake watershed code is 340-047200 and the waterbody identifier is 00115SLOC.
