REGIONAL DISTRICT OF CENTRAL KOOTENAY **DEVELOPMENT PERMIT** DP2114A-04339.100-Premier_Resorts_Ltd.-DP000119

10141 HIGHWAY 3A SUBDIVISION

TWIN BAYS, BC Environmental Assessment

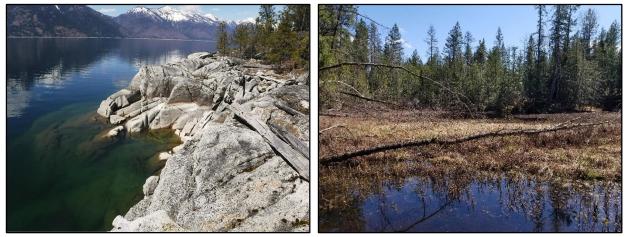
Photo 1. View of Kootenay Lake along west property Photo 2. Small wetland located on proposed Lot 4. boundary, looking northwest.

unnamed wetland.

Photo 3. Potential high-water outlet for small Photo 4. Road bordering northwestern edge of small unnamed wetland.

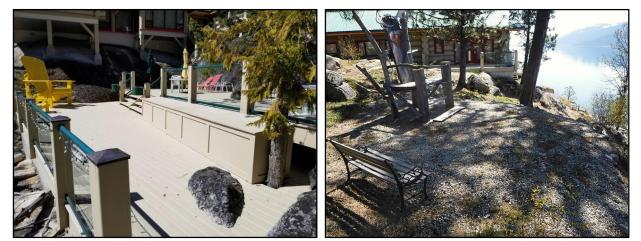
Photo 11. View of two sundecks.

Photo 12. View of gravel pad.

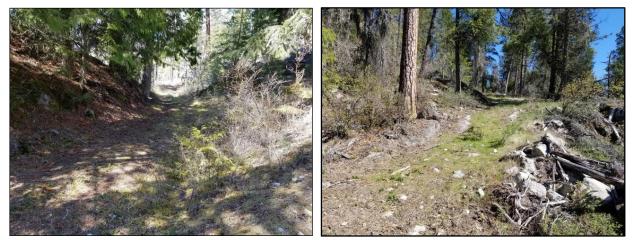
A few overgrown access roads have been constructed across the subject property. One short access road used to provide access to the cove at the northwestern property boundary from the driveway (Photo 13). Another road accesses the unnamed wetland from Highway 3A and continues to the shoreline of Kootenay Lake, along the southern property boundary (Photo 14).

Photo 13. Access road from driveway to cove at Photo 14. Access road from Highway 3A to shoreline of Kootenay Lake via the unnamed wetland.

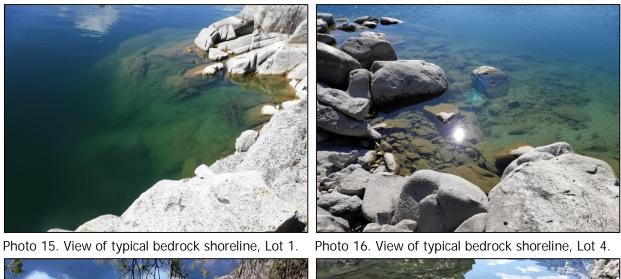
The Kootenay Lake foreshore is predominantly steeply sloping bedrock (50-60 % gradient) with some overlying cobbles and boulders (Photo 15-16) and some lower gradient areas located in two small coves within proposed Lots 1 and 3. Deep water habitat along the shoreline provides both cover and migratory habitat to adult fish. Cover is also provided by infrequent large woody debris (LWD) and boulders. The substrate in the coves is predominantly sand with some small and large woody debris (Photo 17-18). The coves provide potential rearing and cover habitat for juvenile and adult fish. No aquatic vegetation was observed in Kootenay Lake along the subject property.

Photo 17. View of sandy cove, north end of Lot 3.

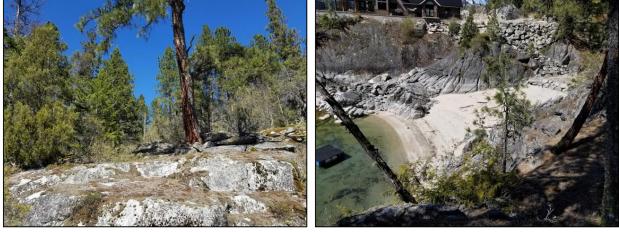
Exposed fractured bedrock is evident throughout the riparian area and is overlain with a thin layer of topsoil. Trees are sporadic with a well-developed understory of shrubs, herbaceous species, mosses, and lichens (Photo 21). Dominant riparian vegetation in Lots 1-3 consisted of ponderosa pine (*Pinus ponderosa*), Douglas fir (Pseudotsuga menziesii), juniper (Juniperus spp.), kinnikinnick (Arctostaphylos uva-ursi), pine grass (Calamagrostis rubescens), mosses, and lichens. Dominant riparian vegetation in Lot 4 consisted of the same species with mallow ninebark (Physocarpus malvaceus). Several snags and wildlife trees (Photo 22) were observed throughout the riparian area. Many of the riparian trees may have shallow root systems due to the lack of soils and available nutrients and may be susceptible to windthrow. Several large, uprooted ponderosa pine trees were observed in Lot 3.

typical of riparian areas, photo from Lot 4.

Photo 21. Sporadic trees and exposed bedrock Photo 22. Typical riparian vegetation on steep slope taken from Lot 3.

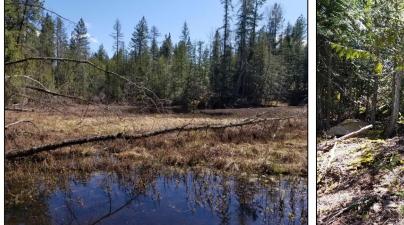
The riparian area of the small unnamed wetland is disturbed along the northern edge (access road) (Photo 4) and there is some evidence of logging (stumps) in the area. Dominant aquatic vegetation encountered within the wetland included sedges spp. (*Carex spp*.) and forget me not spp. (*Myosotis spp*). The shoreline around the wetland is rocky with bedrock outcrops and slopes ranging from 2 – 20 % (Photo 23). The riparian vegetation consists of a variety of native tree, shrub, and herbaceous species (Photo 2, 24) that provide bank stability and erosion protection, shade, litter fall, and insect drop that benefit aquatic organisms and wildlife including birds, amphibians, and reptiles. Dominant riparian vegetation included Western red cedar (*Thuja plicata*), black cottonwood (*Populus balsamifera ssp. trichocarpa*), trembling

Photo 23. View of wetland and riparian vegetation Photo 24. Typical riparian vegetation around the along fringe.

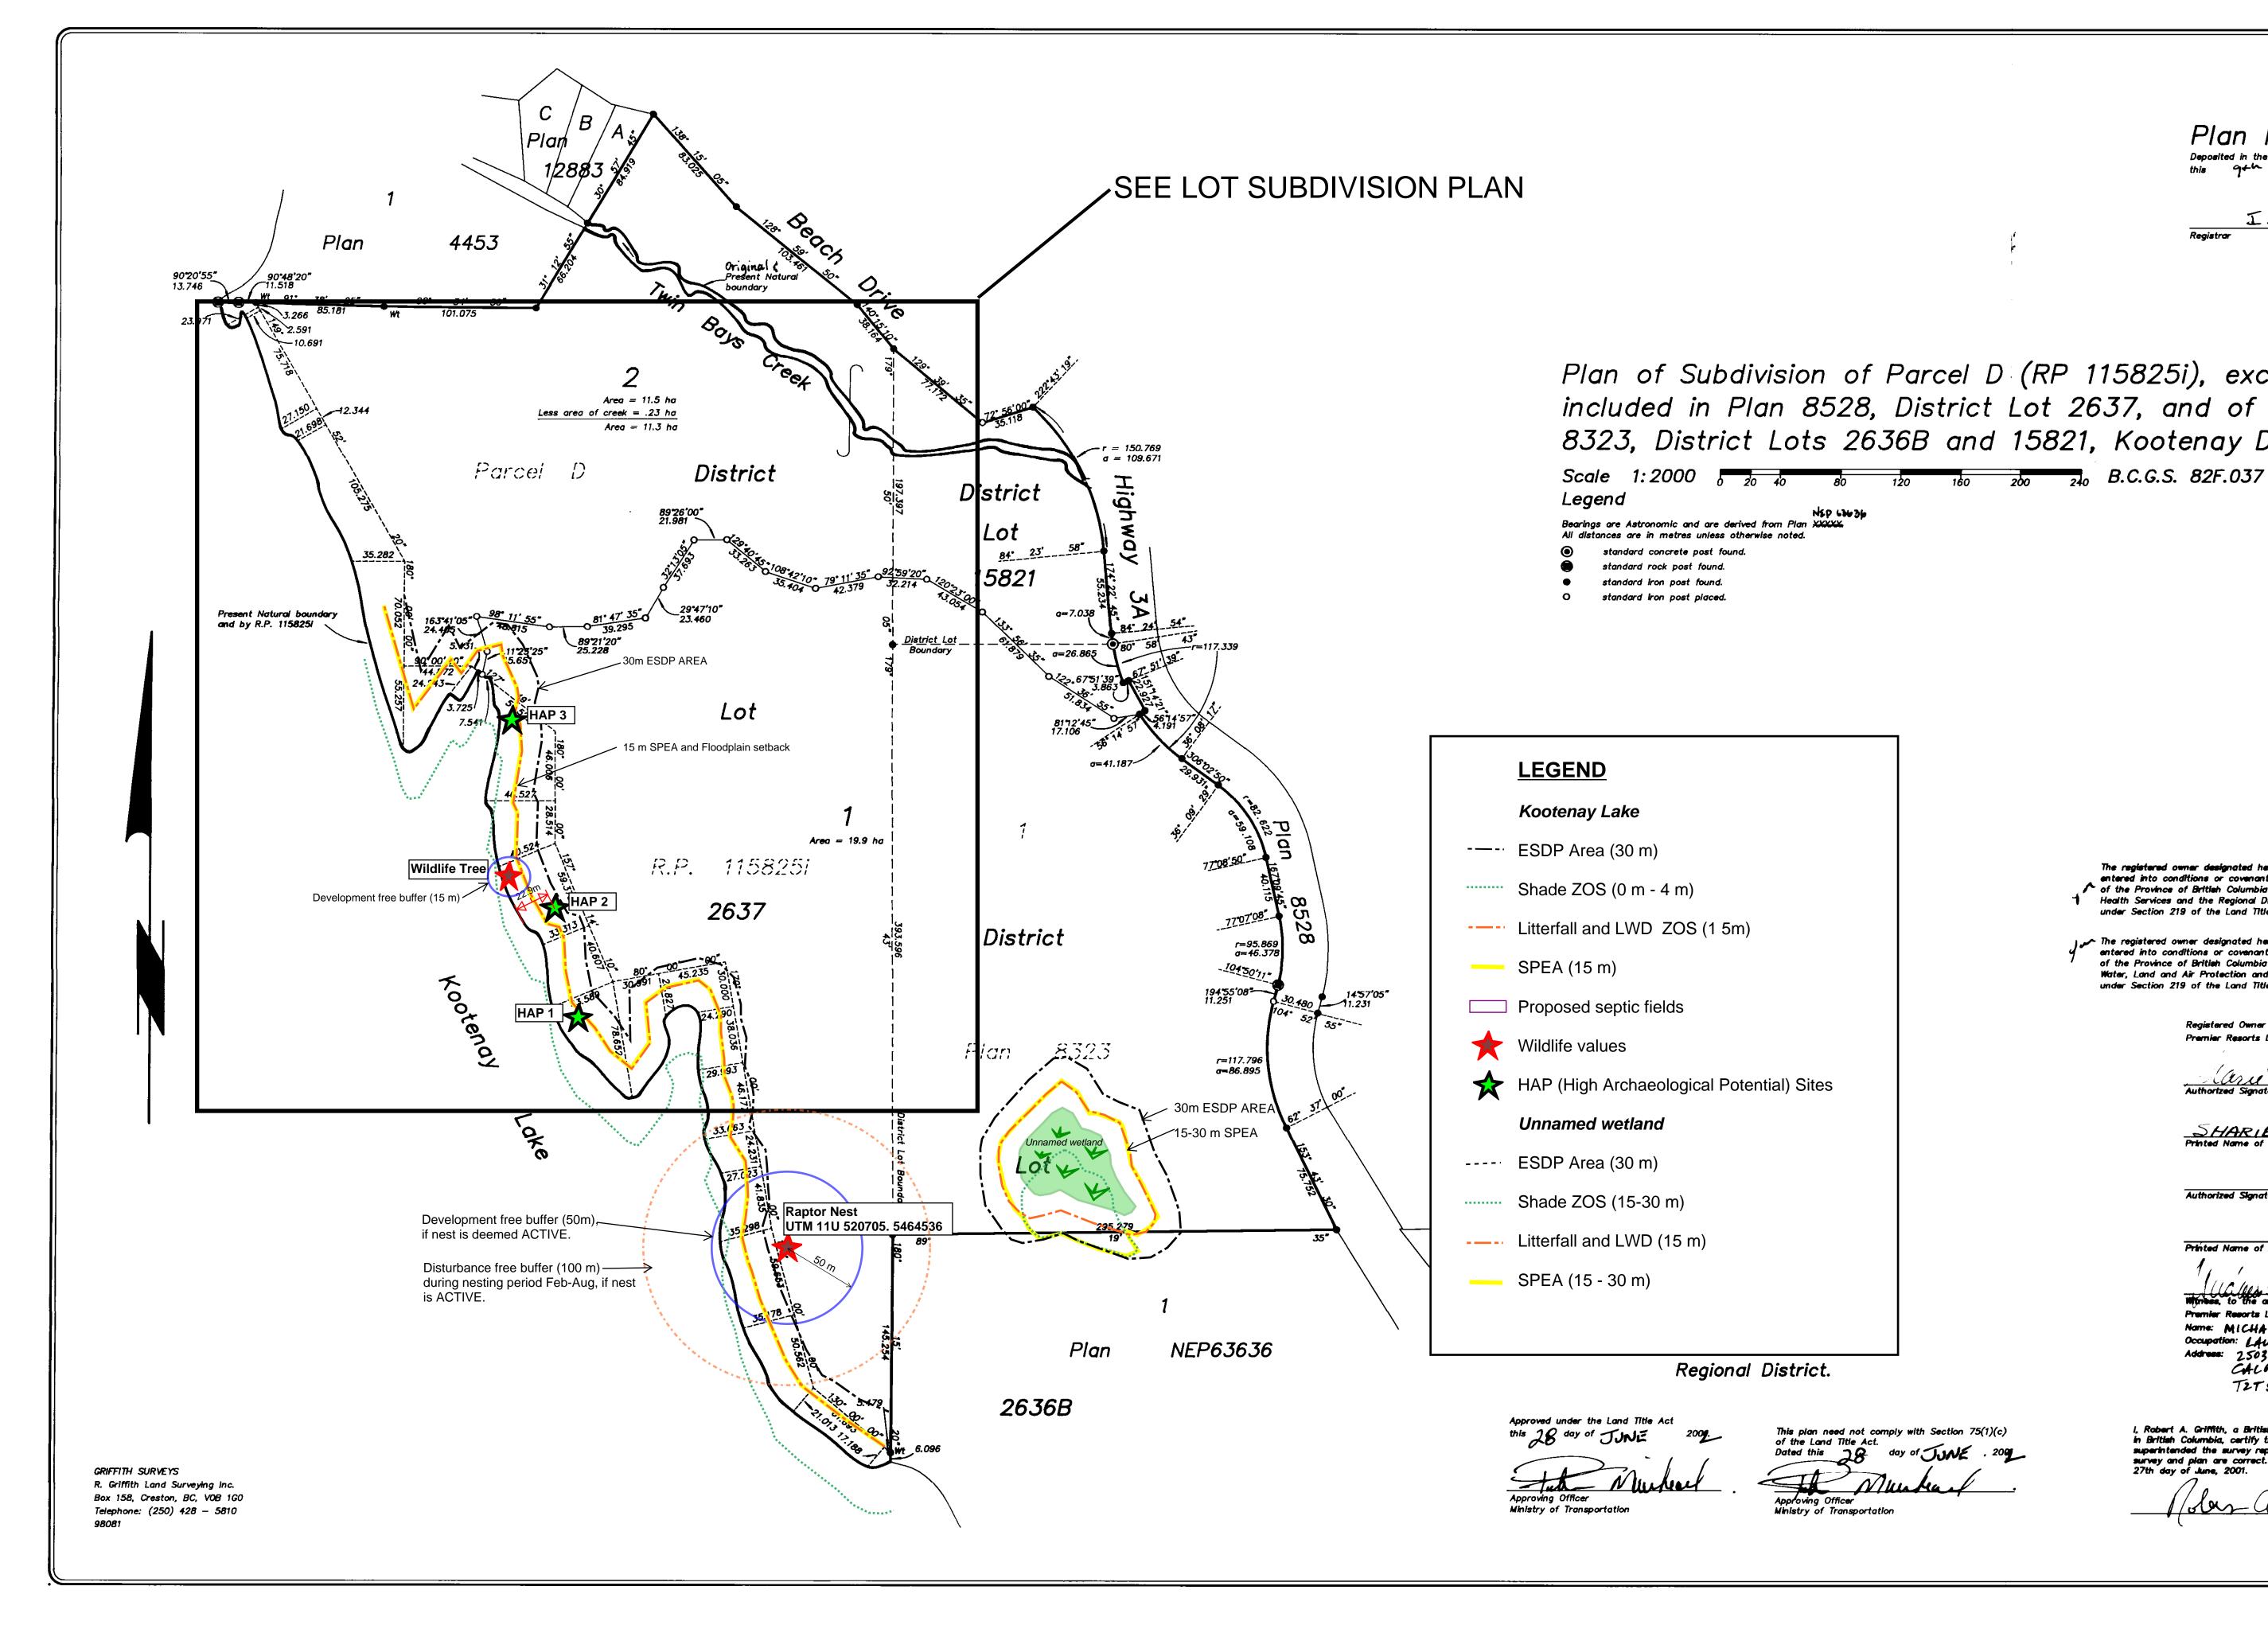
APPENDIX 2 SITE PLANS

The proposed development within the 15 m ESDP area consists of subdivision of a single 49.17-acre lot into four lots (Lot 1 (3.37 ha), Lot 2 (2.61 ha), Lot 3 (2.39 ha), Lot 4 (11.53 ha). At this time, no further development is proposed. Refer to Site Plan for proposed subdivision development layout (Appendix 2).

This section provides measures to protect the integrity of the SPEA as described in RAPR, as well as recommended best management practices. The SPEA was determined to be at a 15 m setback from the natural boundary of Kootenay Lake and from 15 m to 30 m from the HWM of the wetland (Refer to Appendix 2).

- Maintain a 15 m development free buffer around the wildlife perch tree identified on Lot 2. Buffer shown on Site Plan (Appendix 2). This is to ensure that the tree does not become a hazard to development and is retained.
- Live and dead trees, especially deciduous trees, over 30 cm diameter at breast height (DBH) should be retained, unless considered a hazard.
- To protect nesting bird species, any clearing of trees and vegetation should be conducted outside of the songbird breeding season (April 1-August 15). If clearing is to occur during the songbird breeding season a QEP should be retained to evaluate the presence of any active nests within areas to be cleared and propose measures to protect these nests.
- Design access to the foreshore to allow for wildlife movement across the riparian area.
